ECMC
Environmental
Field Inspection

Lowe B-2 TB
© 30-May-25 01:43:57 PM
ECMC Environmental Inspection

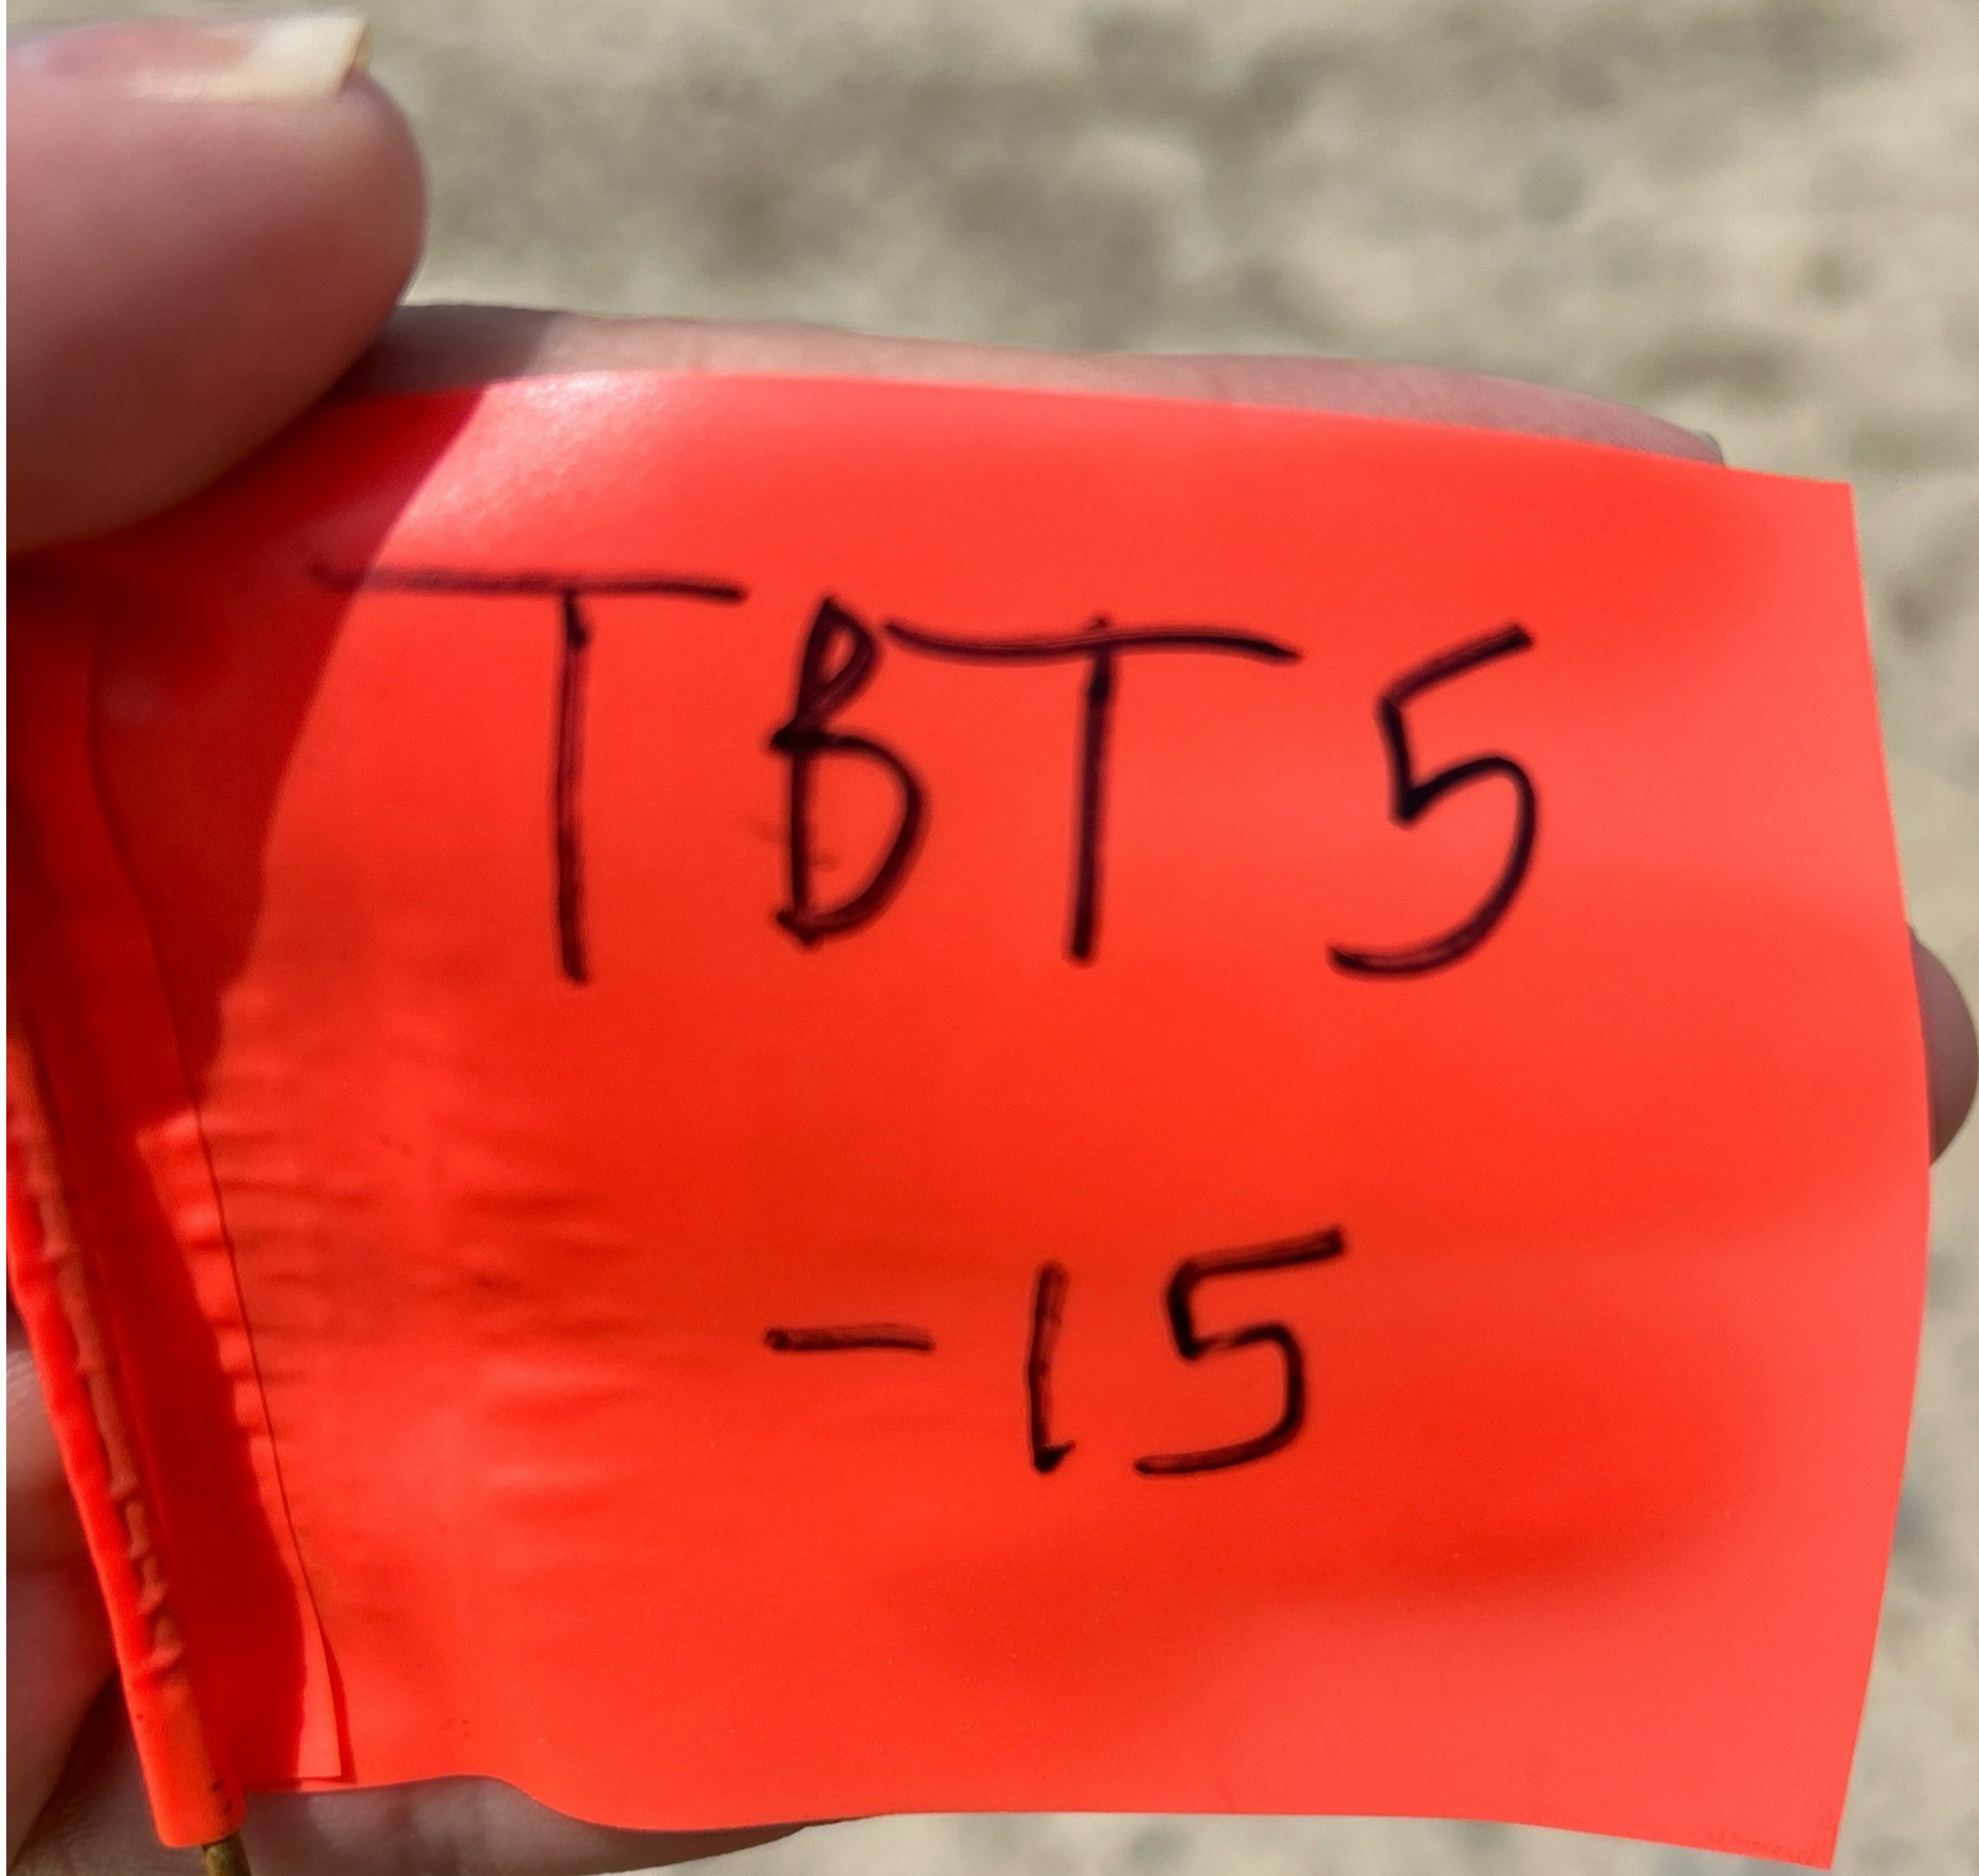
Multiple pin flags are visible throughout the location and appear to have been placed adjacent to areas of ground disturbance.
