WELL NAME: WILD TURKEY 23-5, API #: 071-06624, INSP. # 716301120

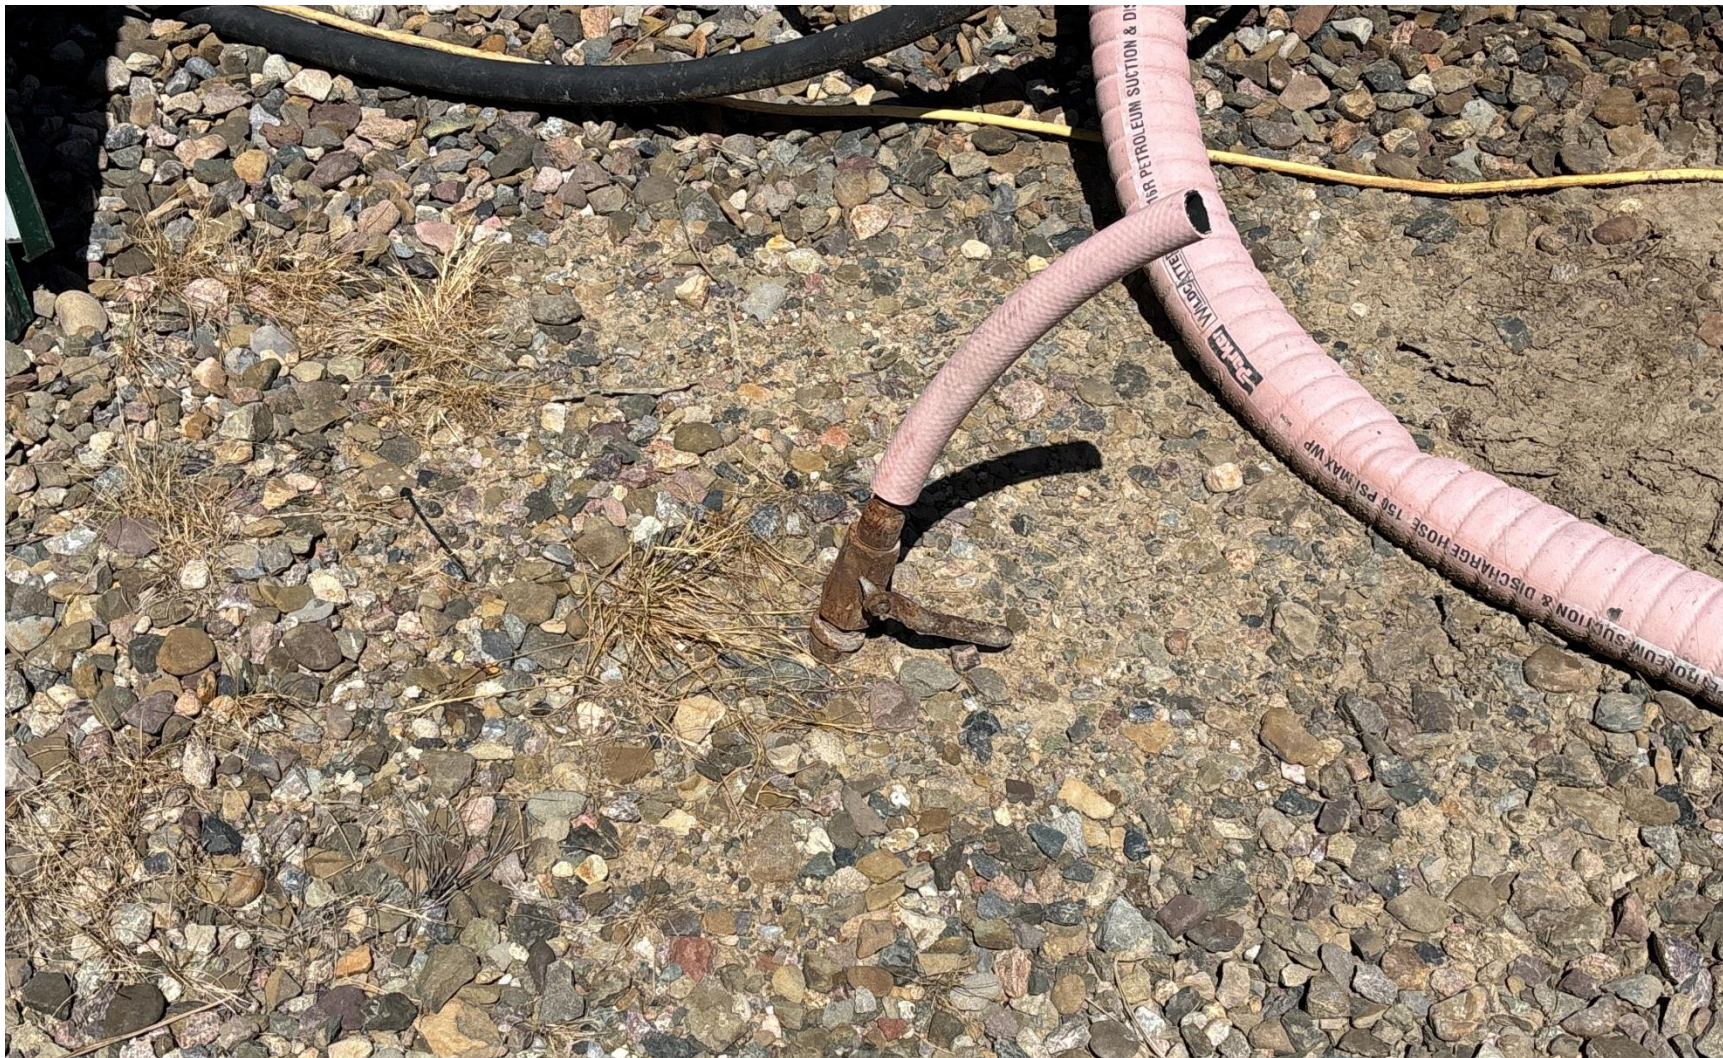
PHOTO 4: UNUSED EQUIPMENT (1" RISER NOT IN US AND NOT MARKED WHAT ITS USED FOR i.e. gas or water). **USE, REMOVE OR LABEL RISER PER RULE 606. CA DATE 6-25-25.**

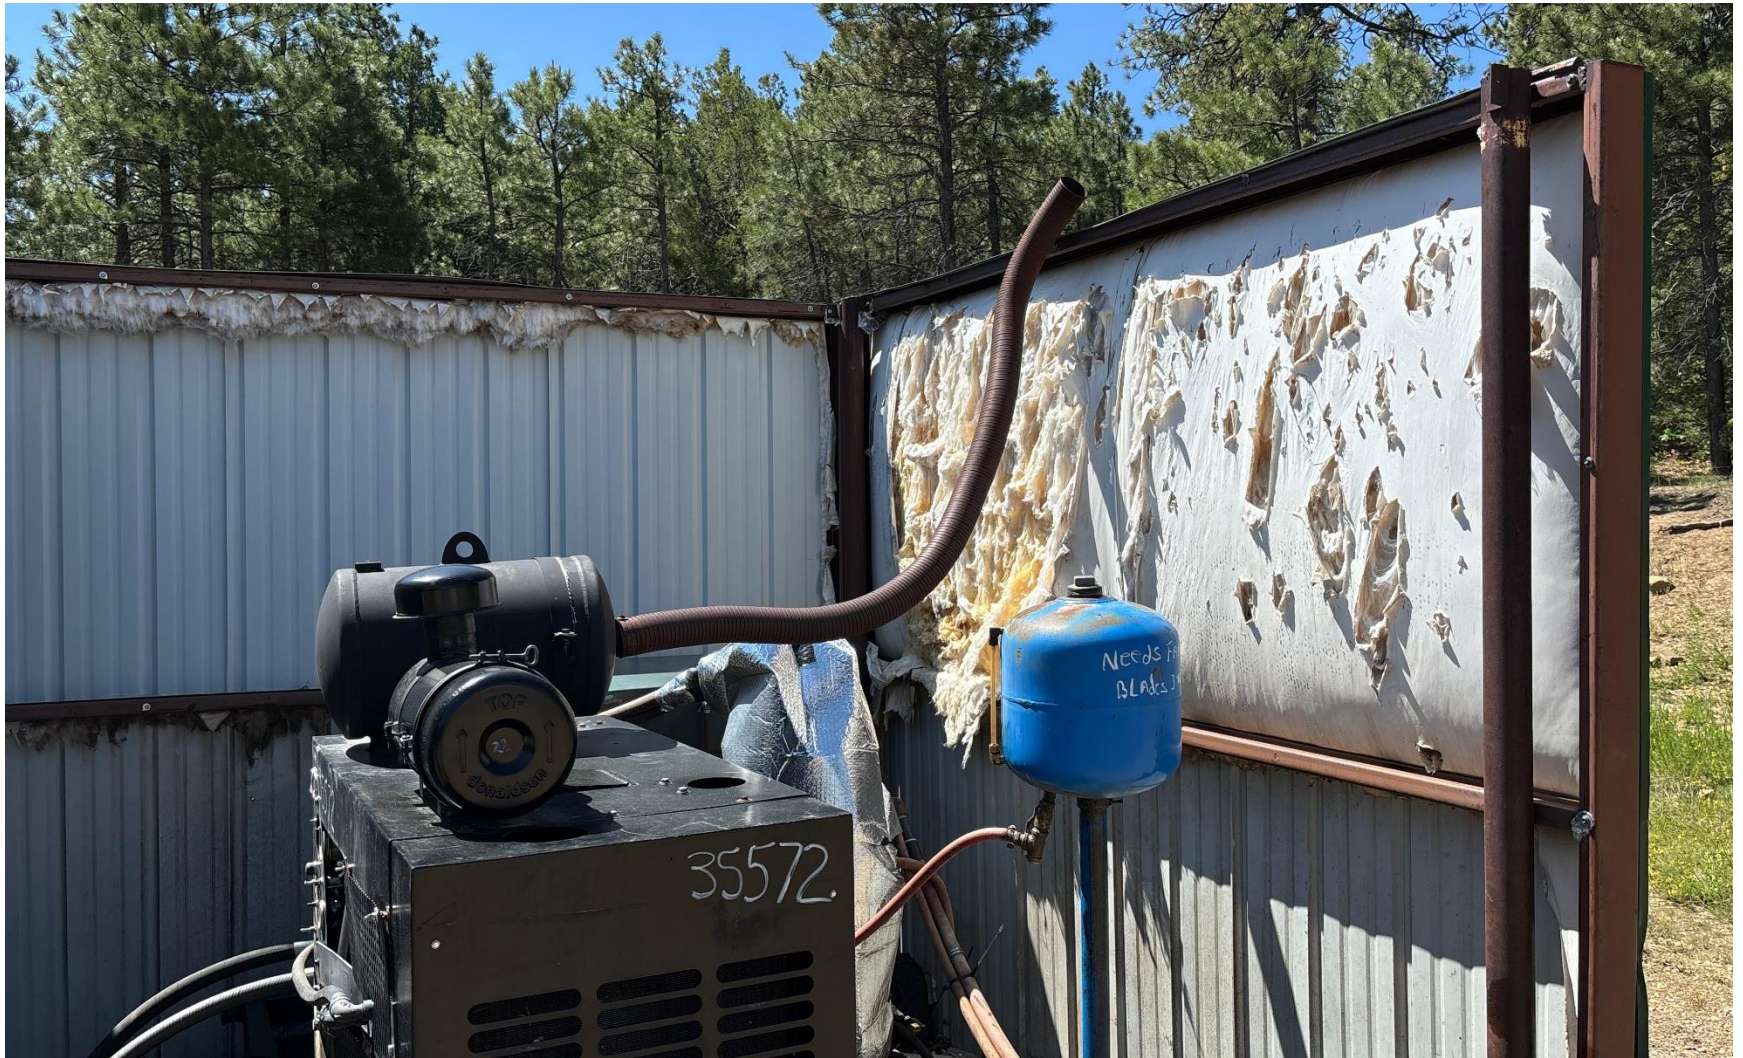
PHOTO 5: TRASH AND OR DEBREE (INSULATION ON SOUND WALLS IS DETERIORATING AND SPREADING ON AND AROUND LOCATION). PICK UP ALL TRASH ON AND AROUND LOCATION AND SECURE OR REPLACE INSULATION PER RULE 606. CA DATE 6-25-2025.

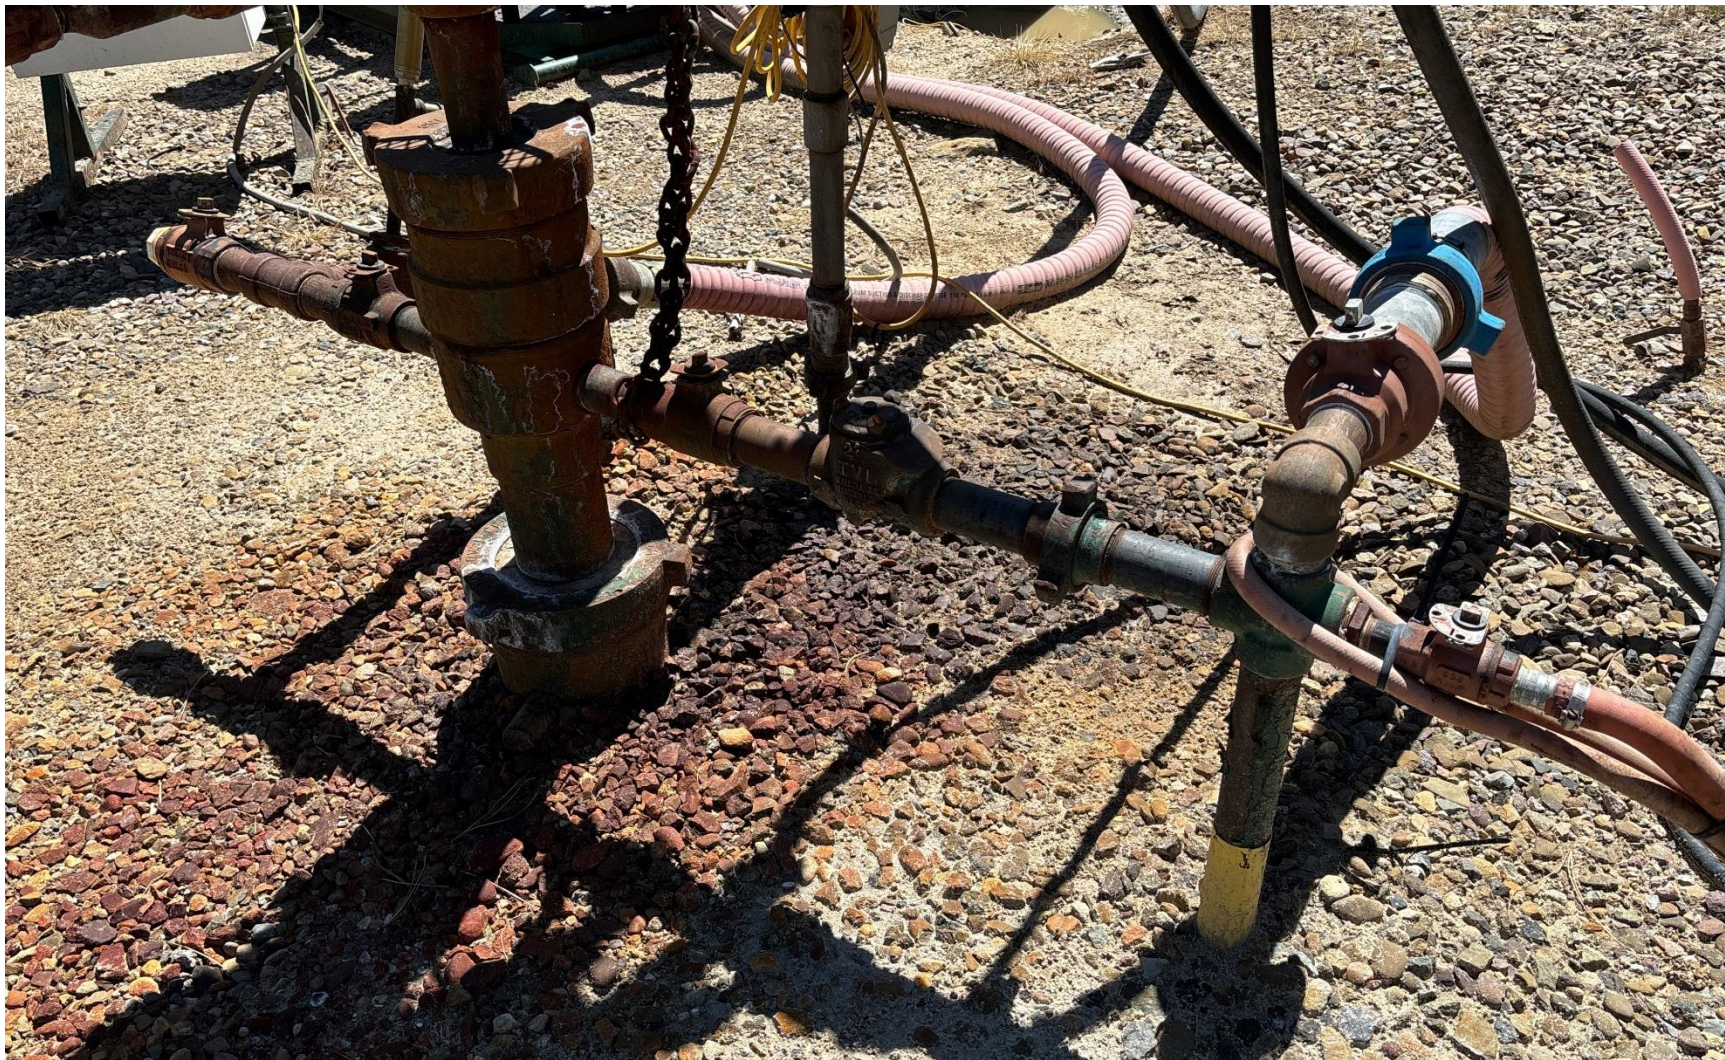
PHOTO 6: AREA OF IMPACTED SOIL AROUND WELLHEAD APPEARS TO BE FROM LEAKING DRIVEHEAD MOTOR SHOWN IN NEXT PHOTO. Conduct maintenance on equipment, cleanup stained material and review self inspection processes. COMPLY WITH RULE 1002,.(2).D. CA DATE 6-25-2025.

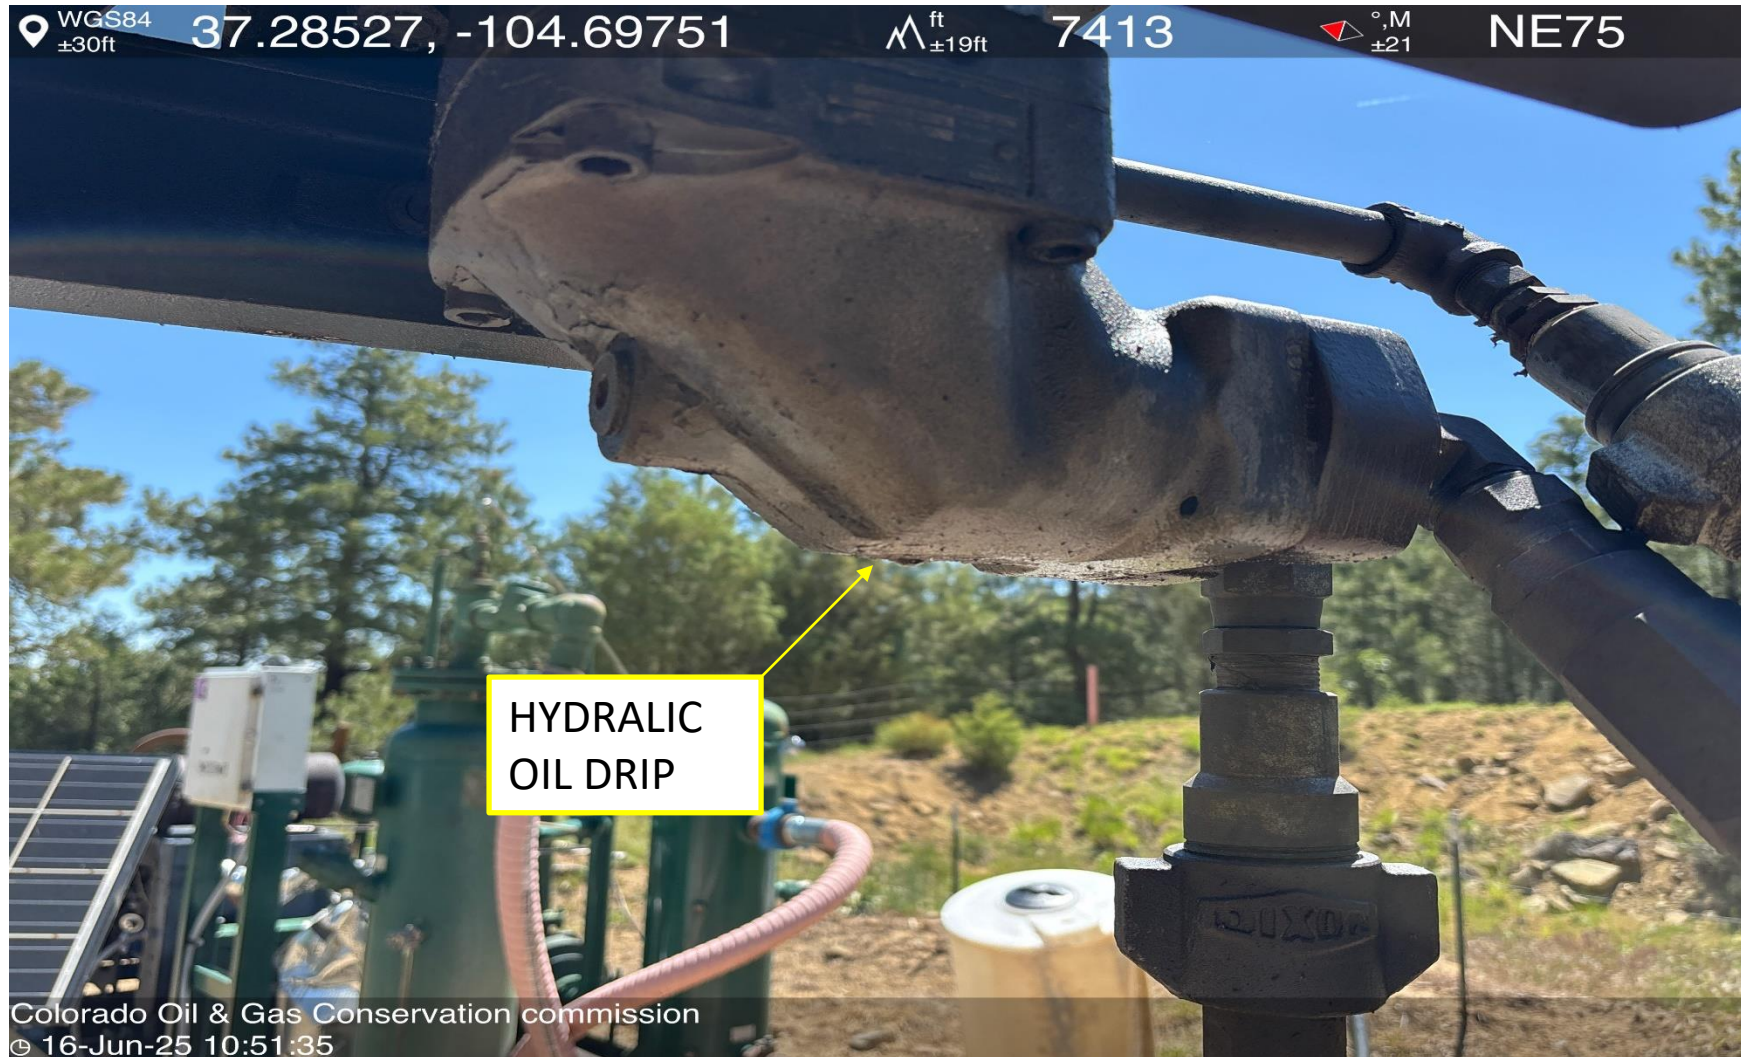
HYDRALIC
OIL DRIP

PHOTO 7: PHOTO SHOWING LEAKING DRIVEHEAD MENTIONED IN PREVIOUS PHOTO.

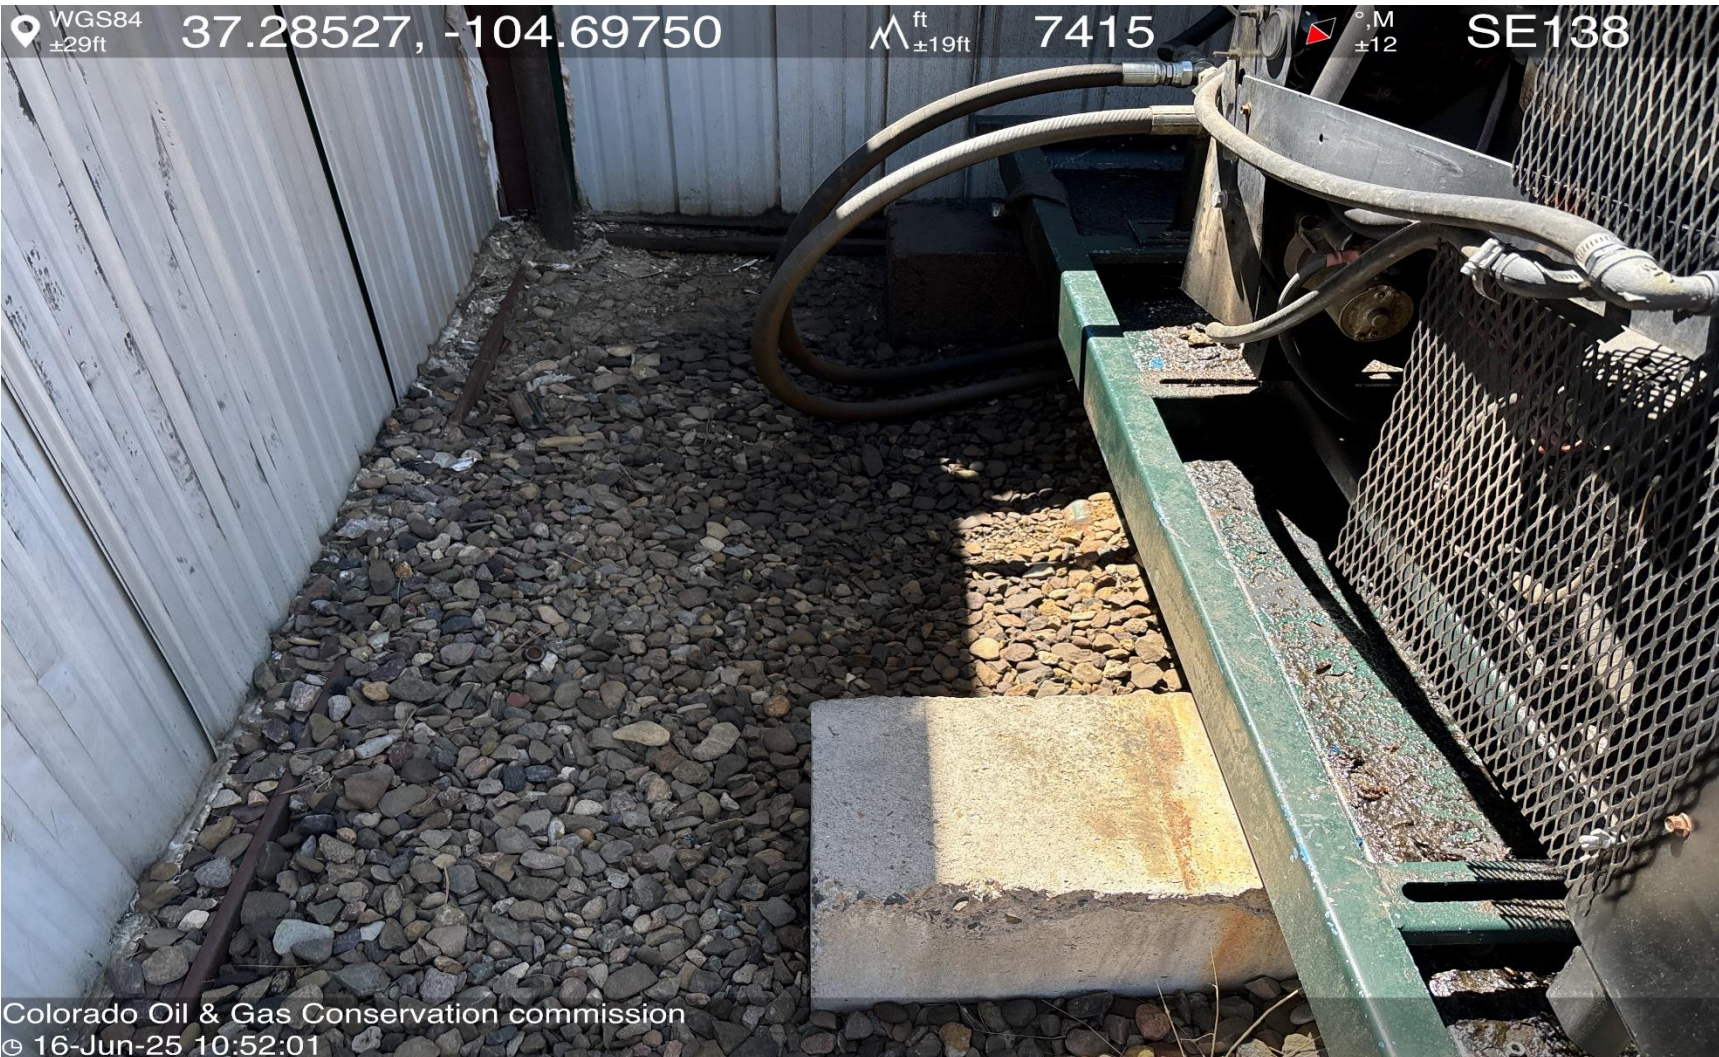
PHOTO 8: AREA OF IMPACTED SOIL AROUND PRIME MOVER ENGINE SKID (IMPACTED SOILS ON OTHER SIDES OF SKID ALSO). Conduct maintenance on equipment, cleanup stained material and review self inspection processes. COMPLY WITH RULE 1002,.(2).D. CA DATE 6-25-2025.

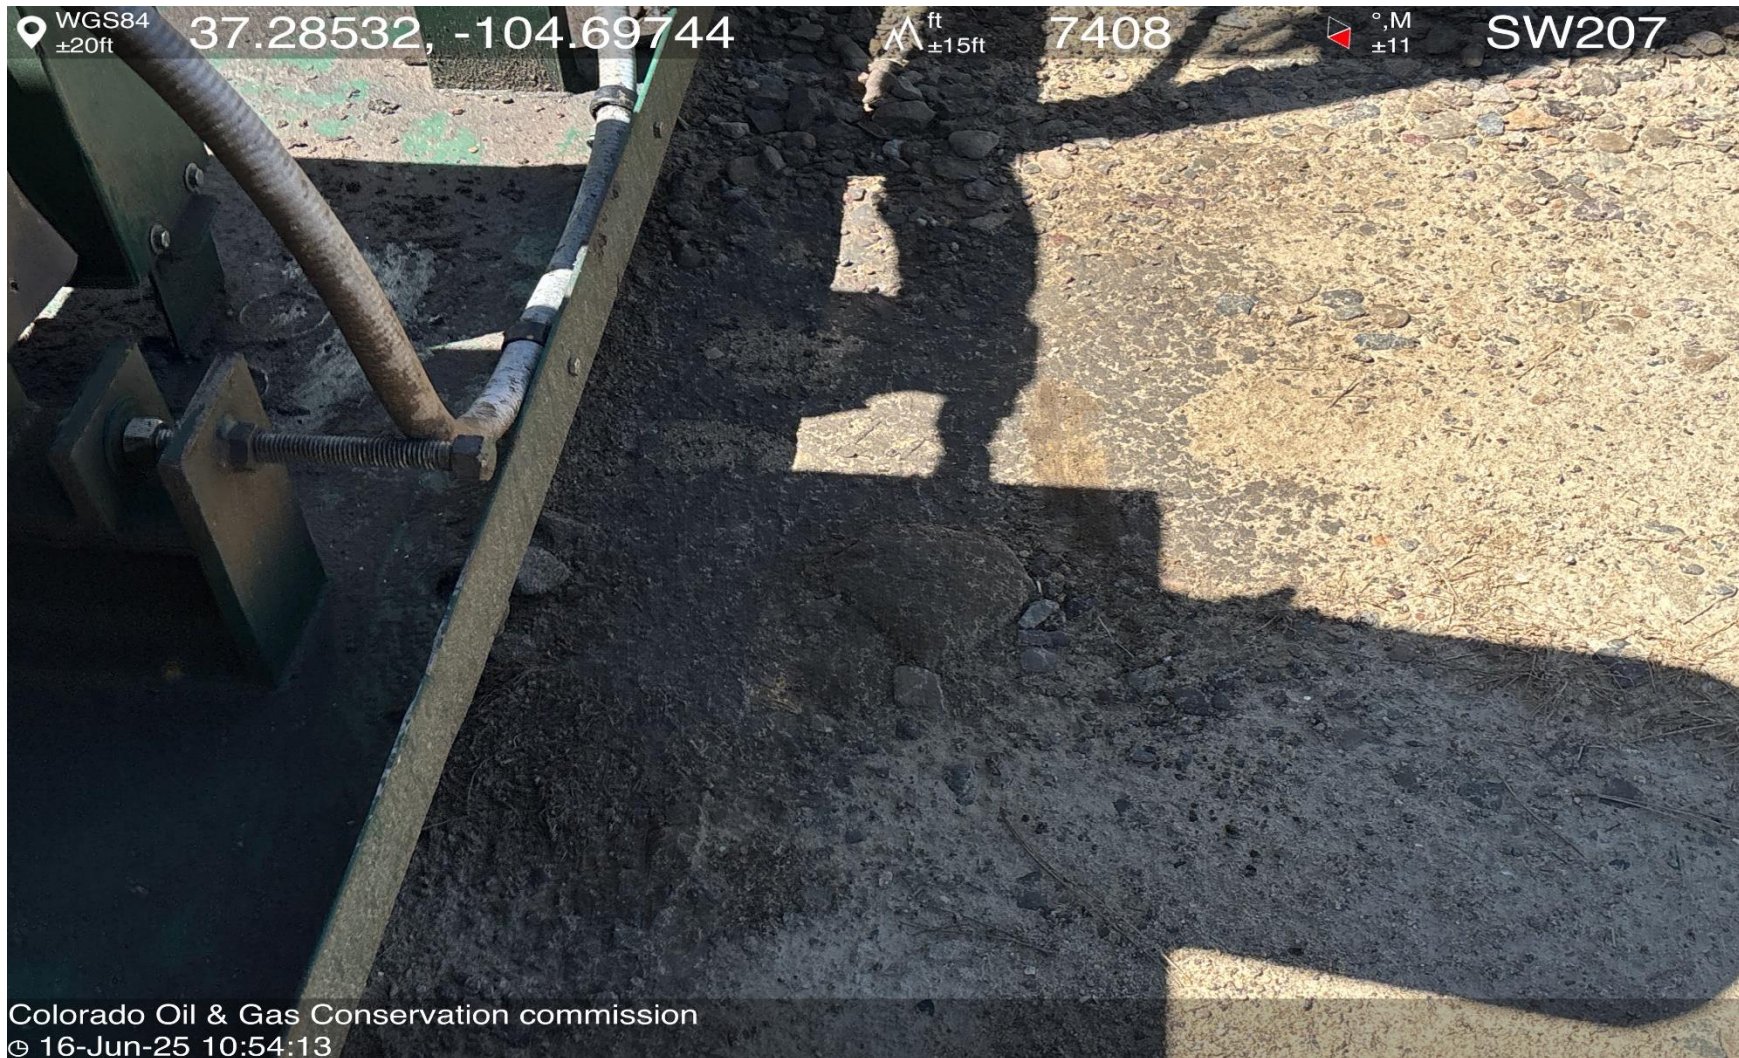
PHOTO 9: AREA OF IMPACTED SOIL AROUND COMPRESSOR SKID. Conduct maintenance on equipment, cleanup stained material and review self inspection processes. COMPLY WITH RULE 1002,(2).D. CA DATE 6-25-2025.

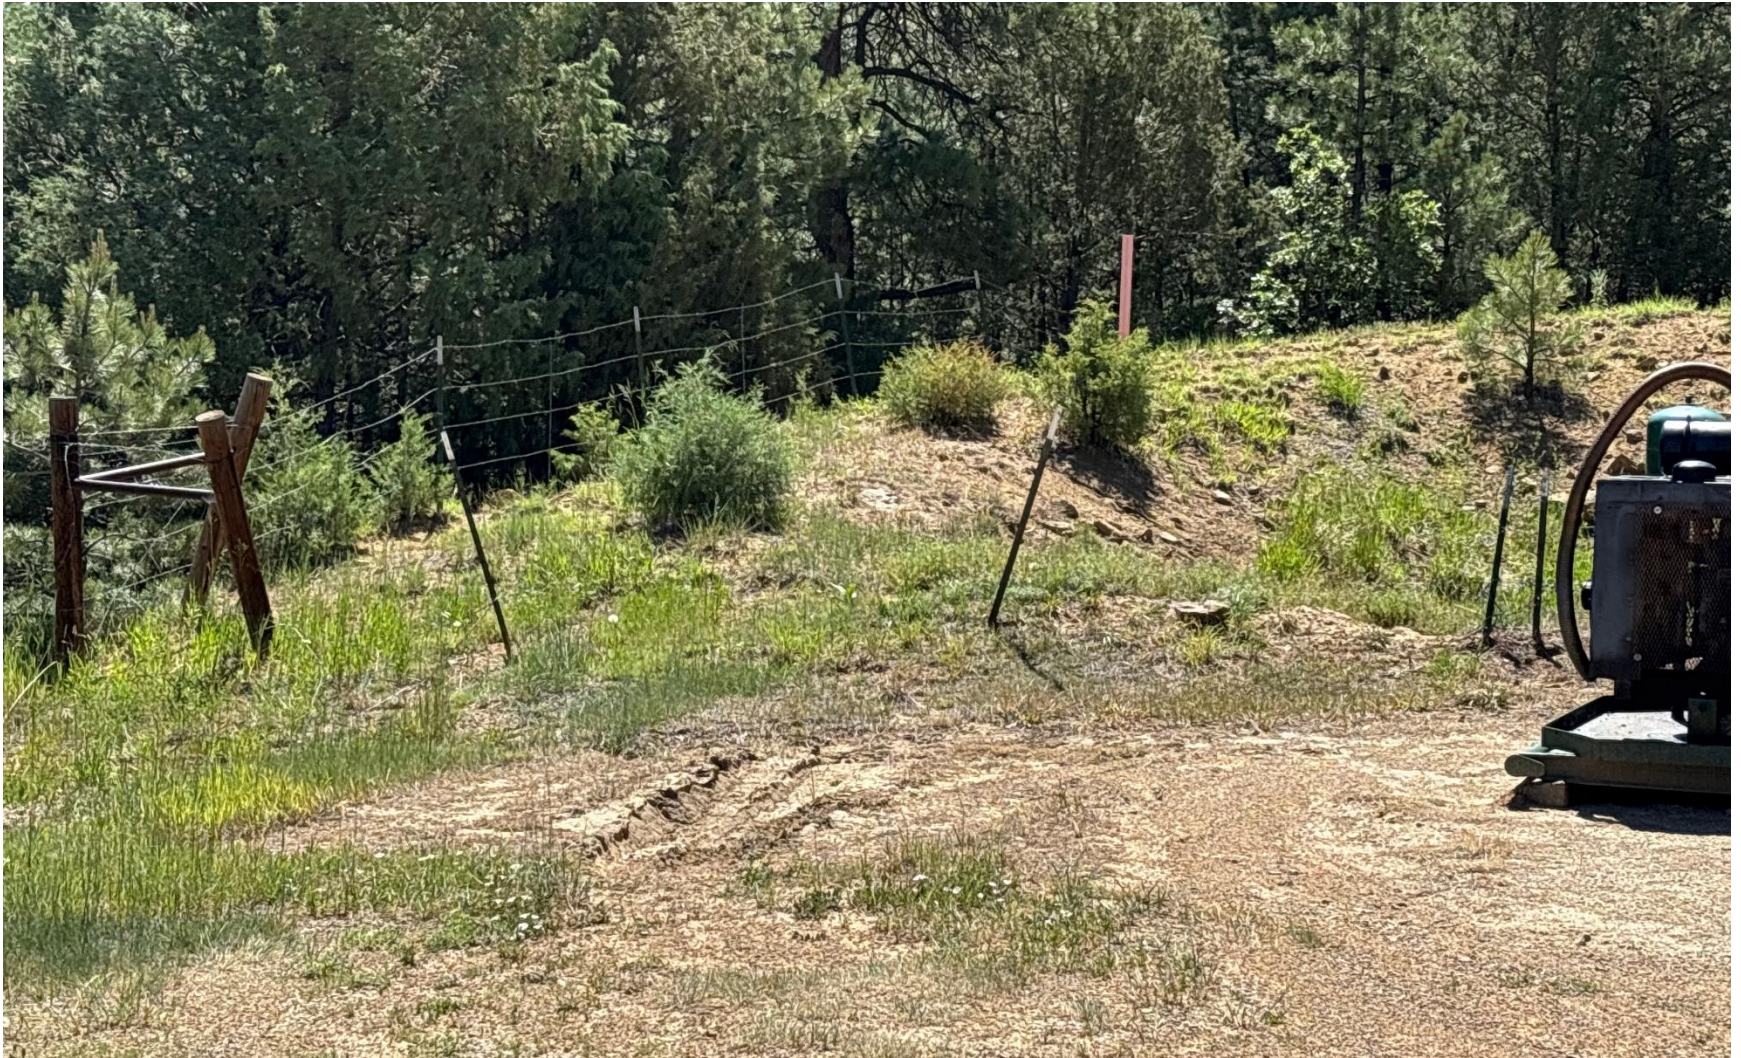
PHOTO 10: PART OF THE WIRES HAVE BEEN REMOVED FROM FENCE. REPAIR FENCE PER 1002 SERIES RULES. CA DATE 6-25-2025.
