ECMC
Environmental
Field Inspection

Suckla C#3 Spill
© 16-Jun-25 03:31:07 PM
ECMC Environmental Inspection

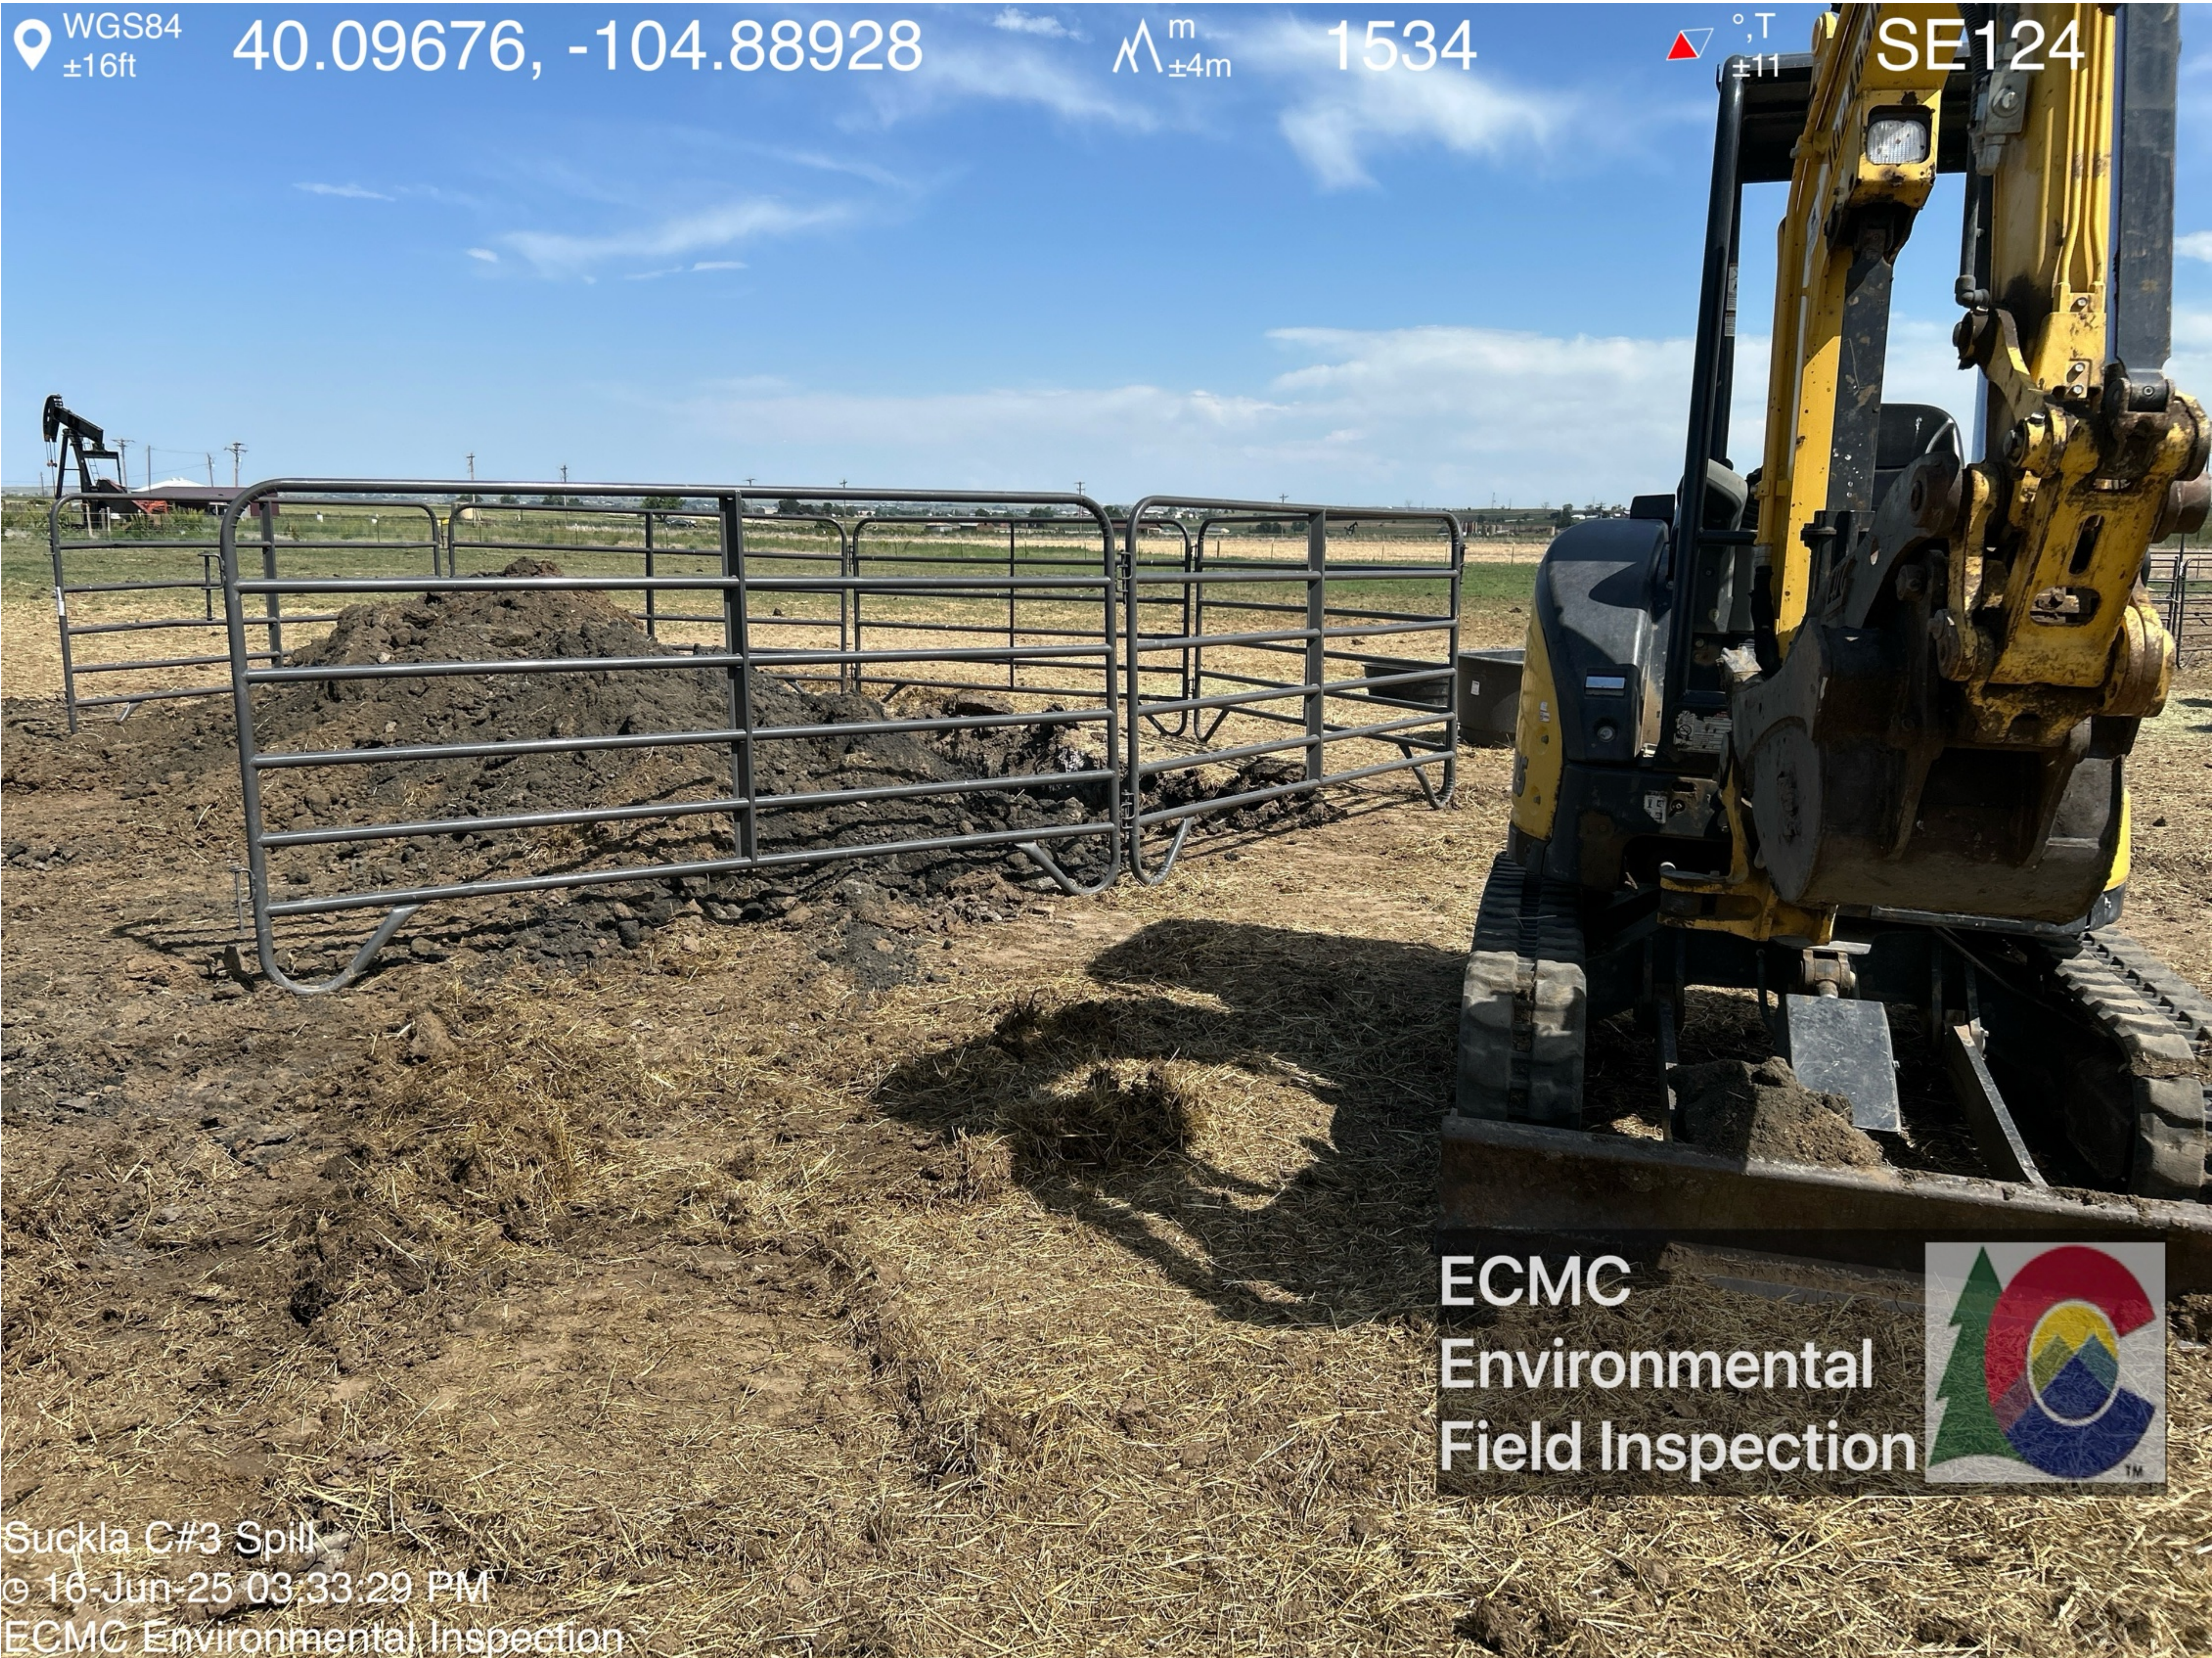
Photo taken adjacent to Operator equipment and the spill location. Horses are visible in the background. The pasture in which the spill was discovered remains in use. Metal fence panels from the pictured coral were moved by the Operator to encompass the spill area.

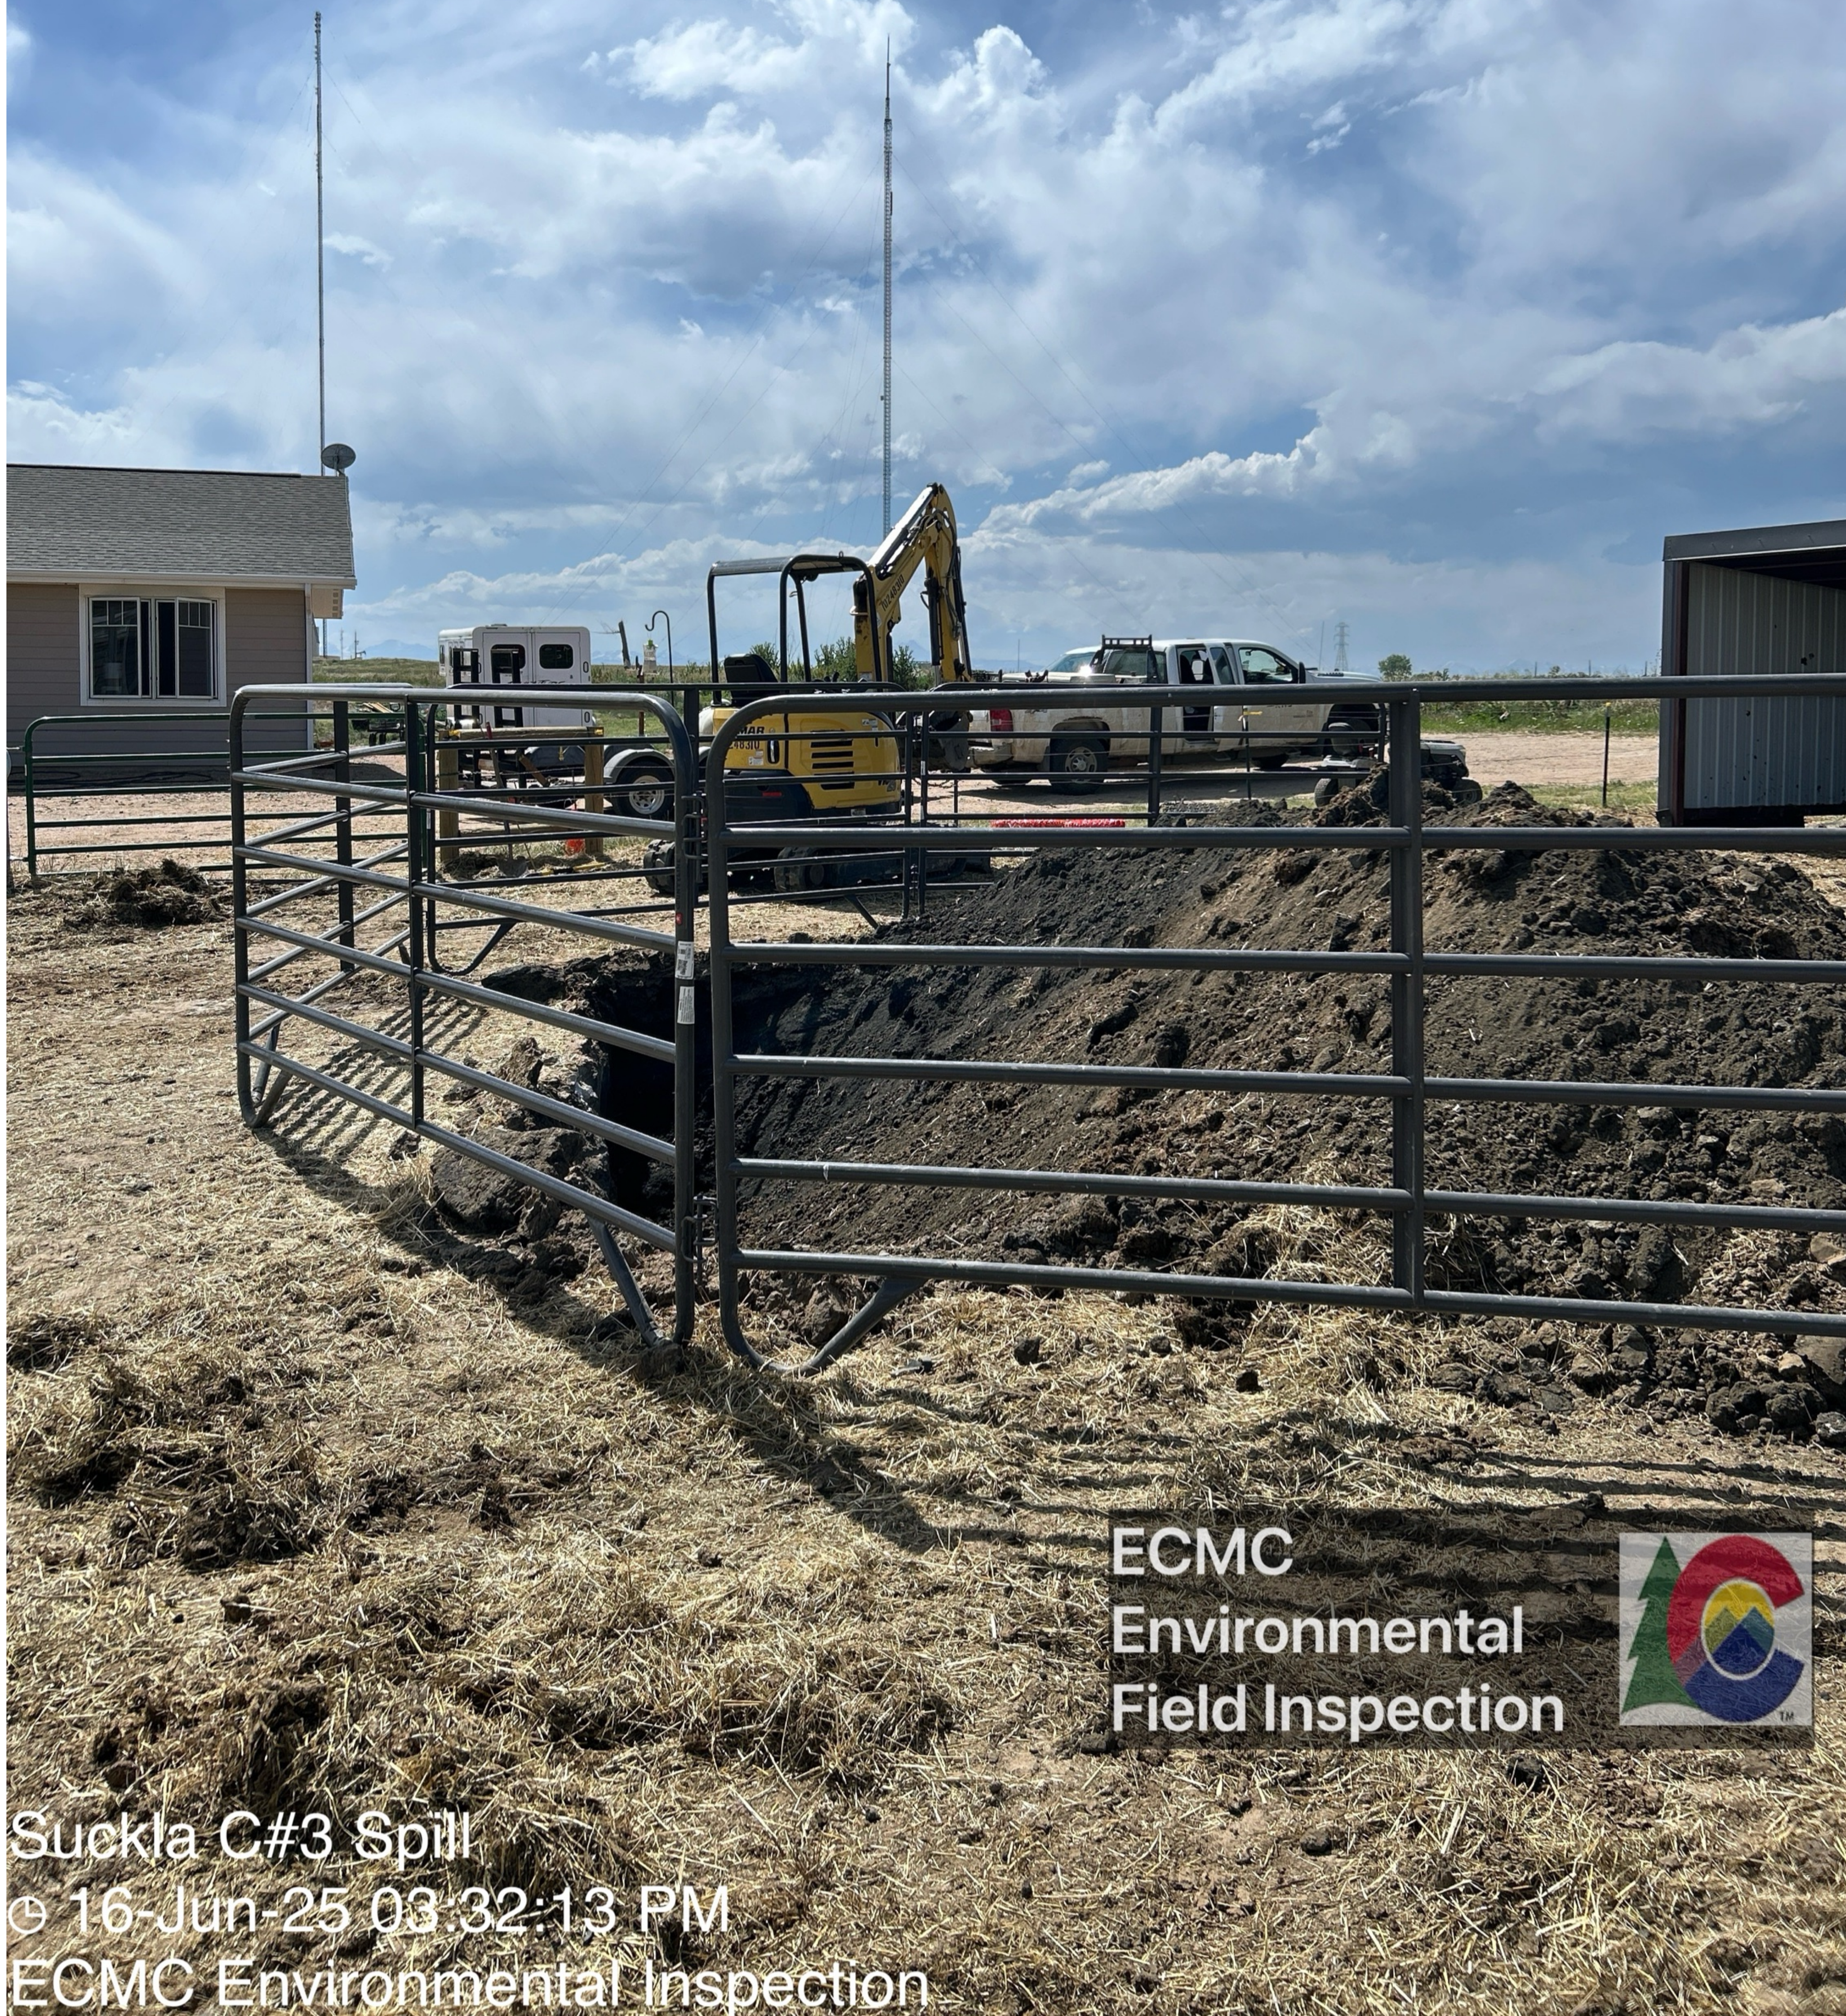
Suckla C#3 Spill
© 16-Jun-25 03:33:29 PM
ECMC Environmental Inspection

Operator personnel were in the process of installing metal panel fencing around the excavation. The excavation and stockpile were fully encompassed by the fencing at the conclusion of the inspection.

The pumping unit of the well associated with the spill (Suckla Farms C 3, API # 05-123-08882) is visible in the background at the left side of the photo.
