Facility 2 Consolidation
© 16-Jun-25 02:56:54 PM
ECMC Environmental Inspection

ECMC
Environmental
Field Inspection

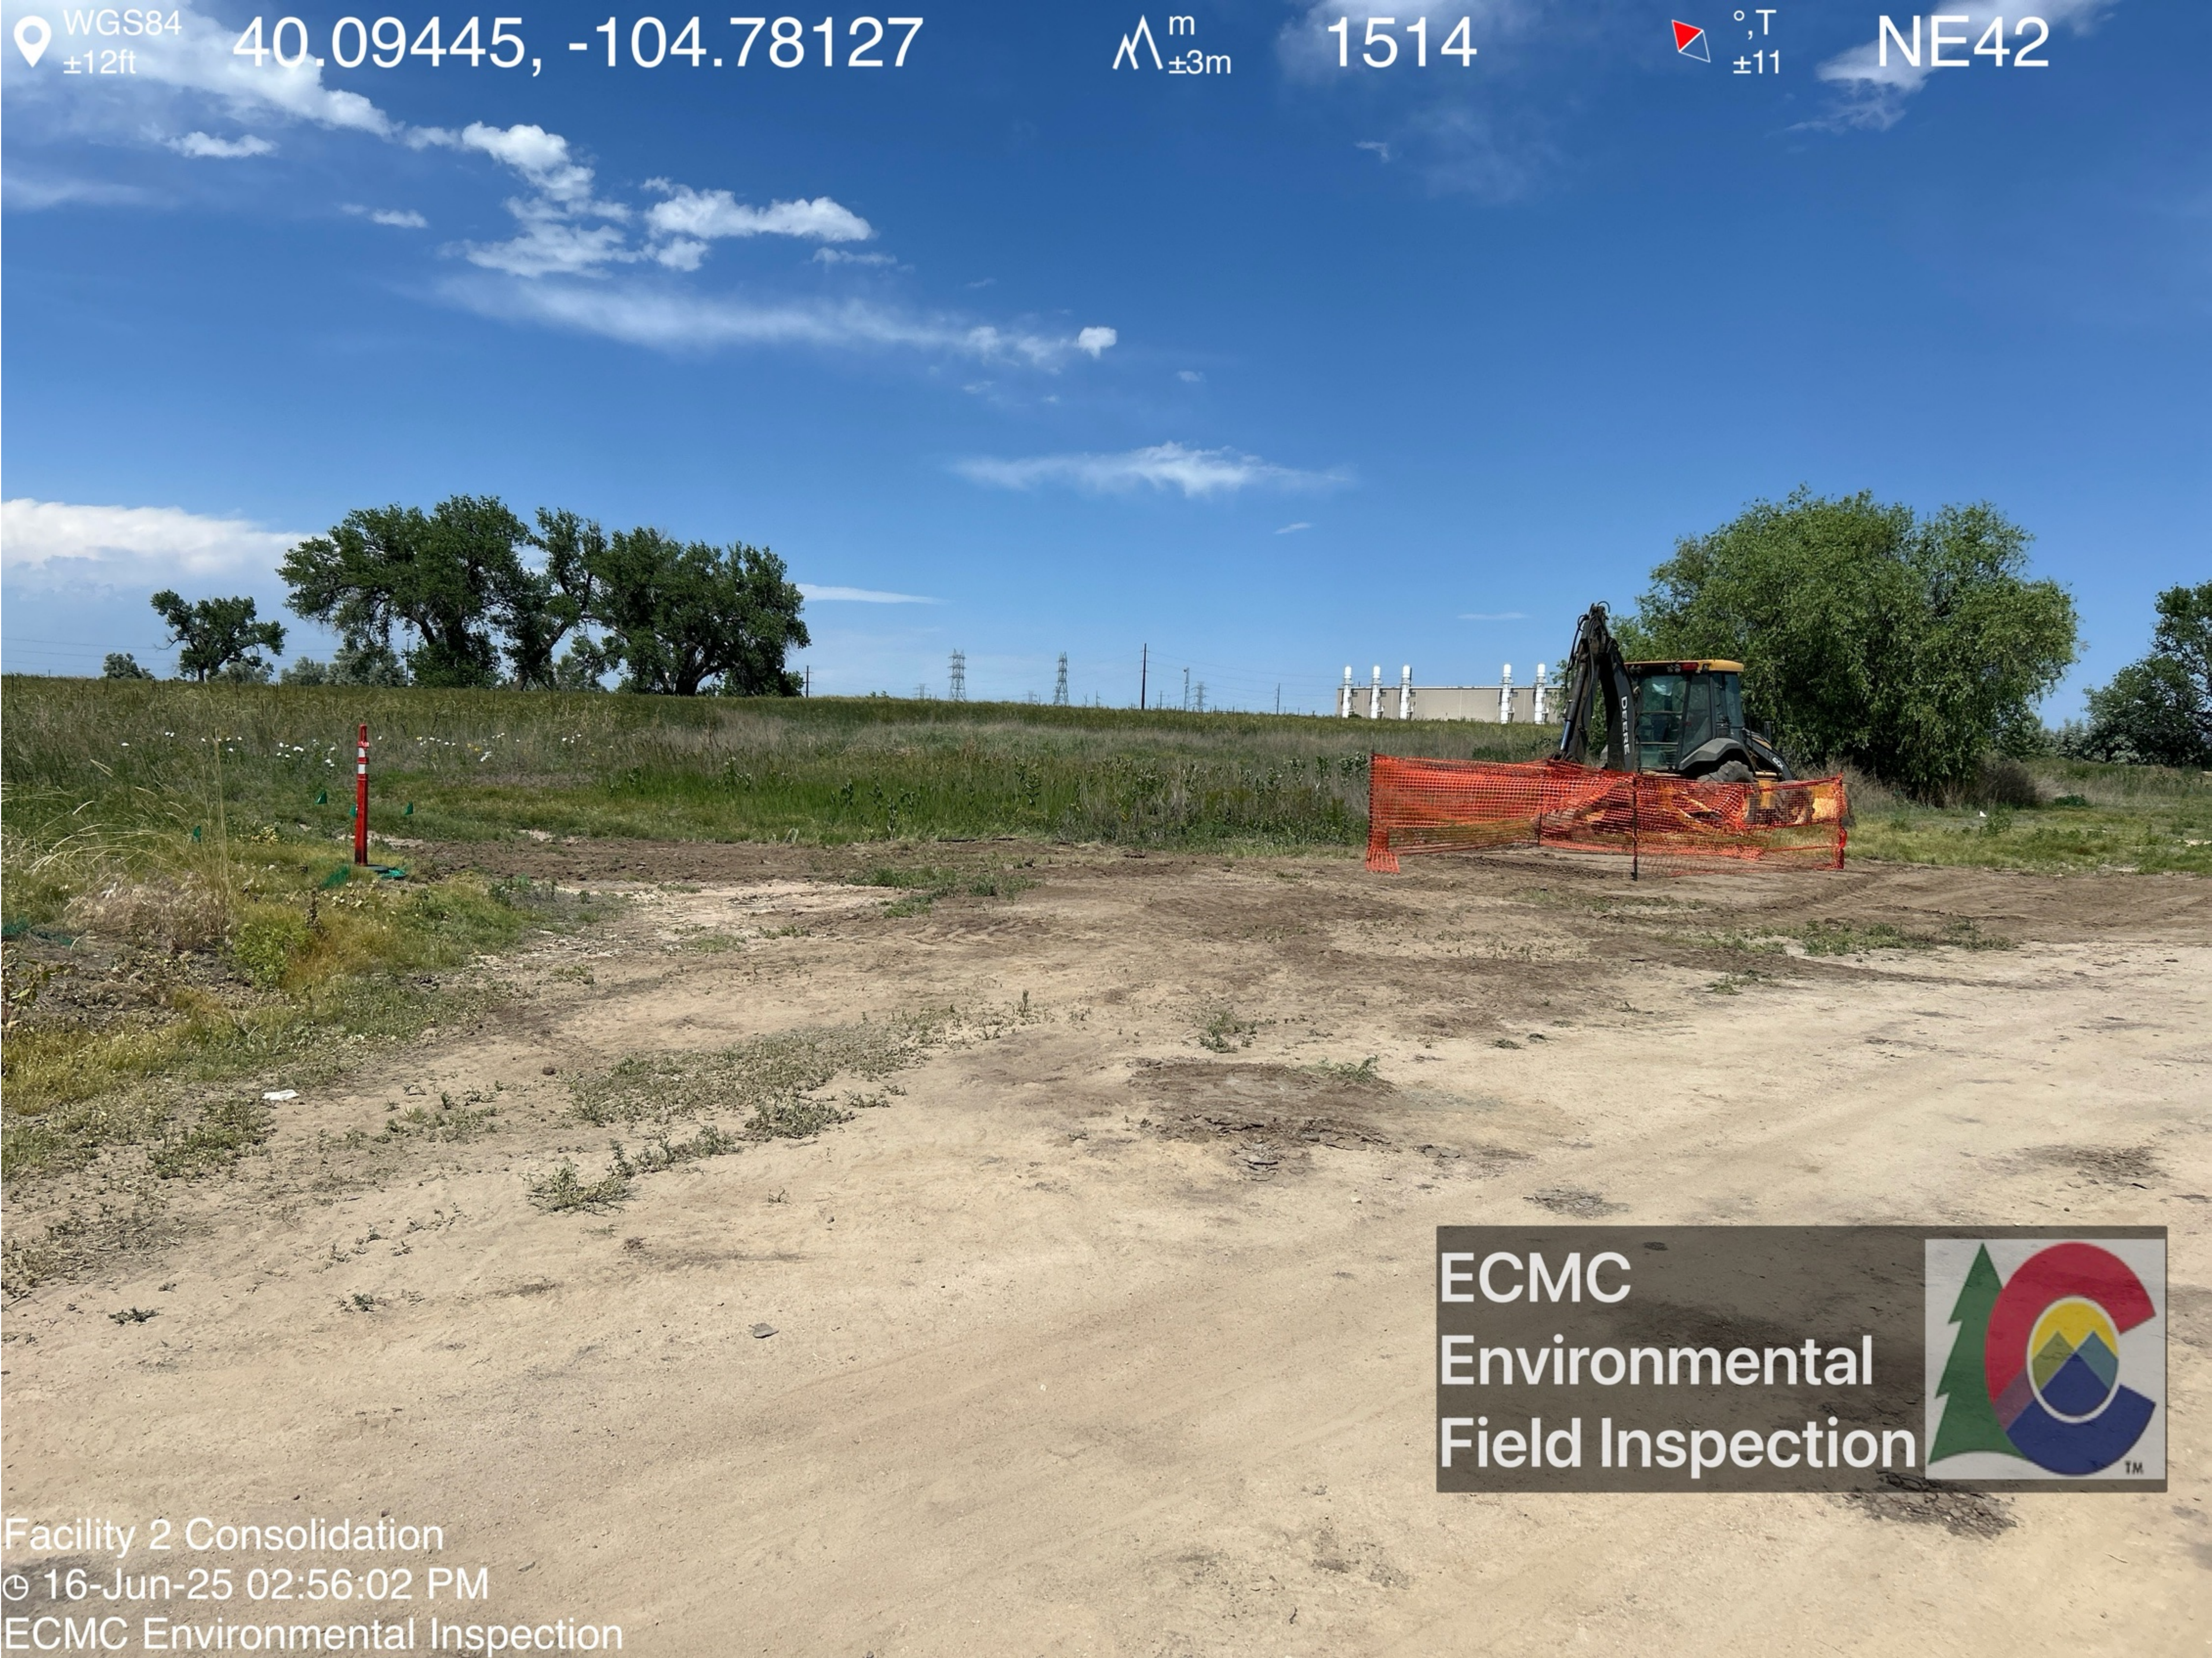
A scarped area with orange construction fencing and equipment is visible. No environmental impacts were visible on the surface in this area.

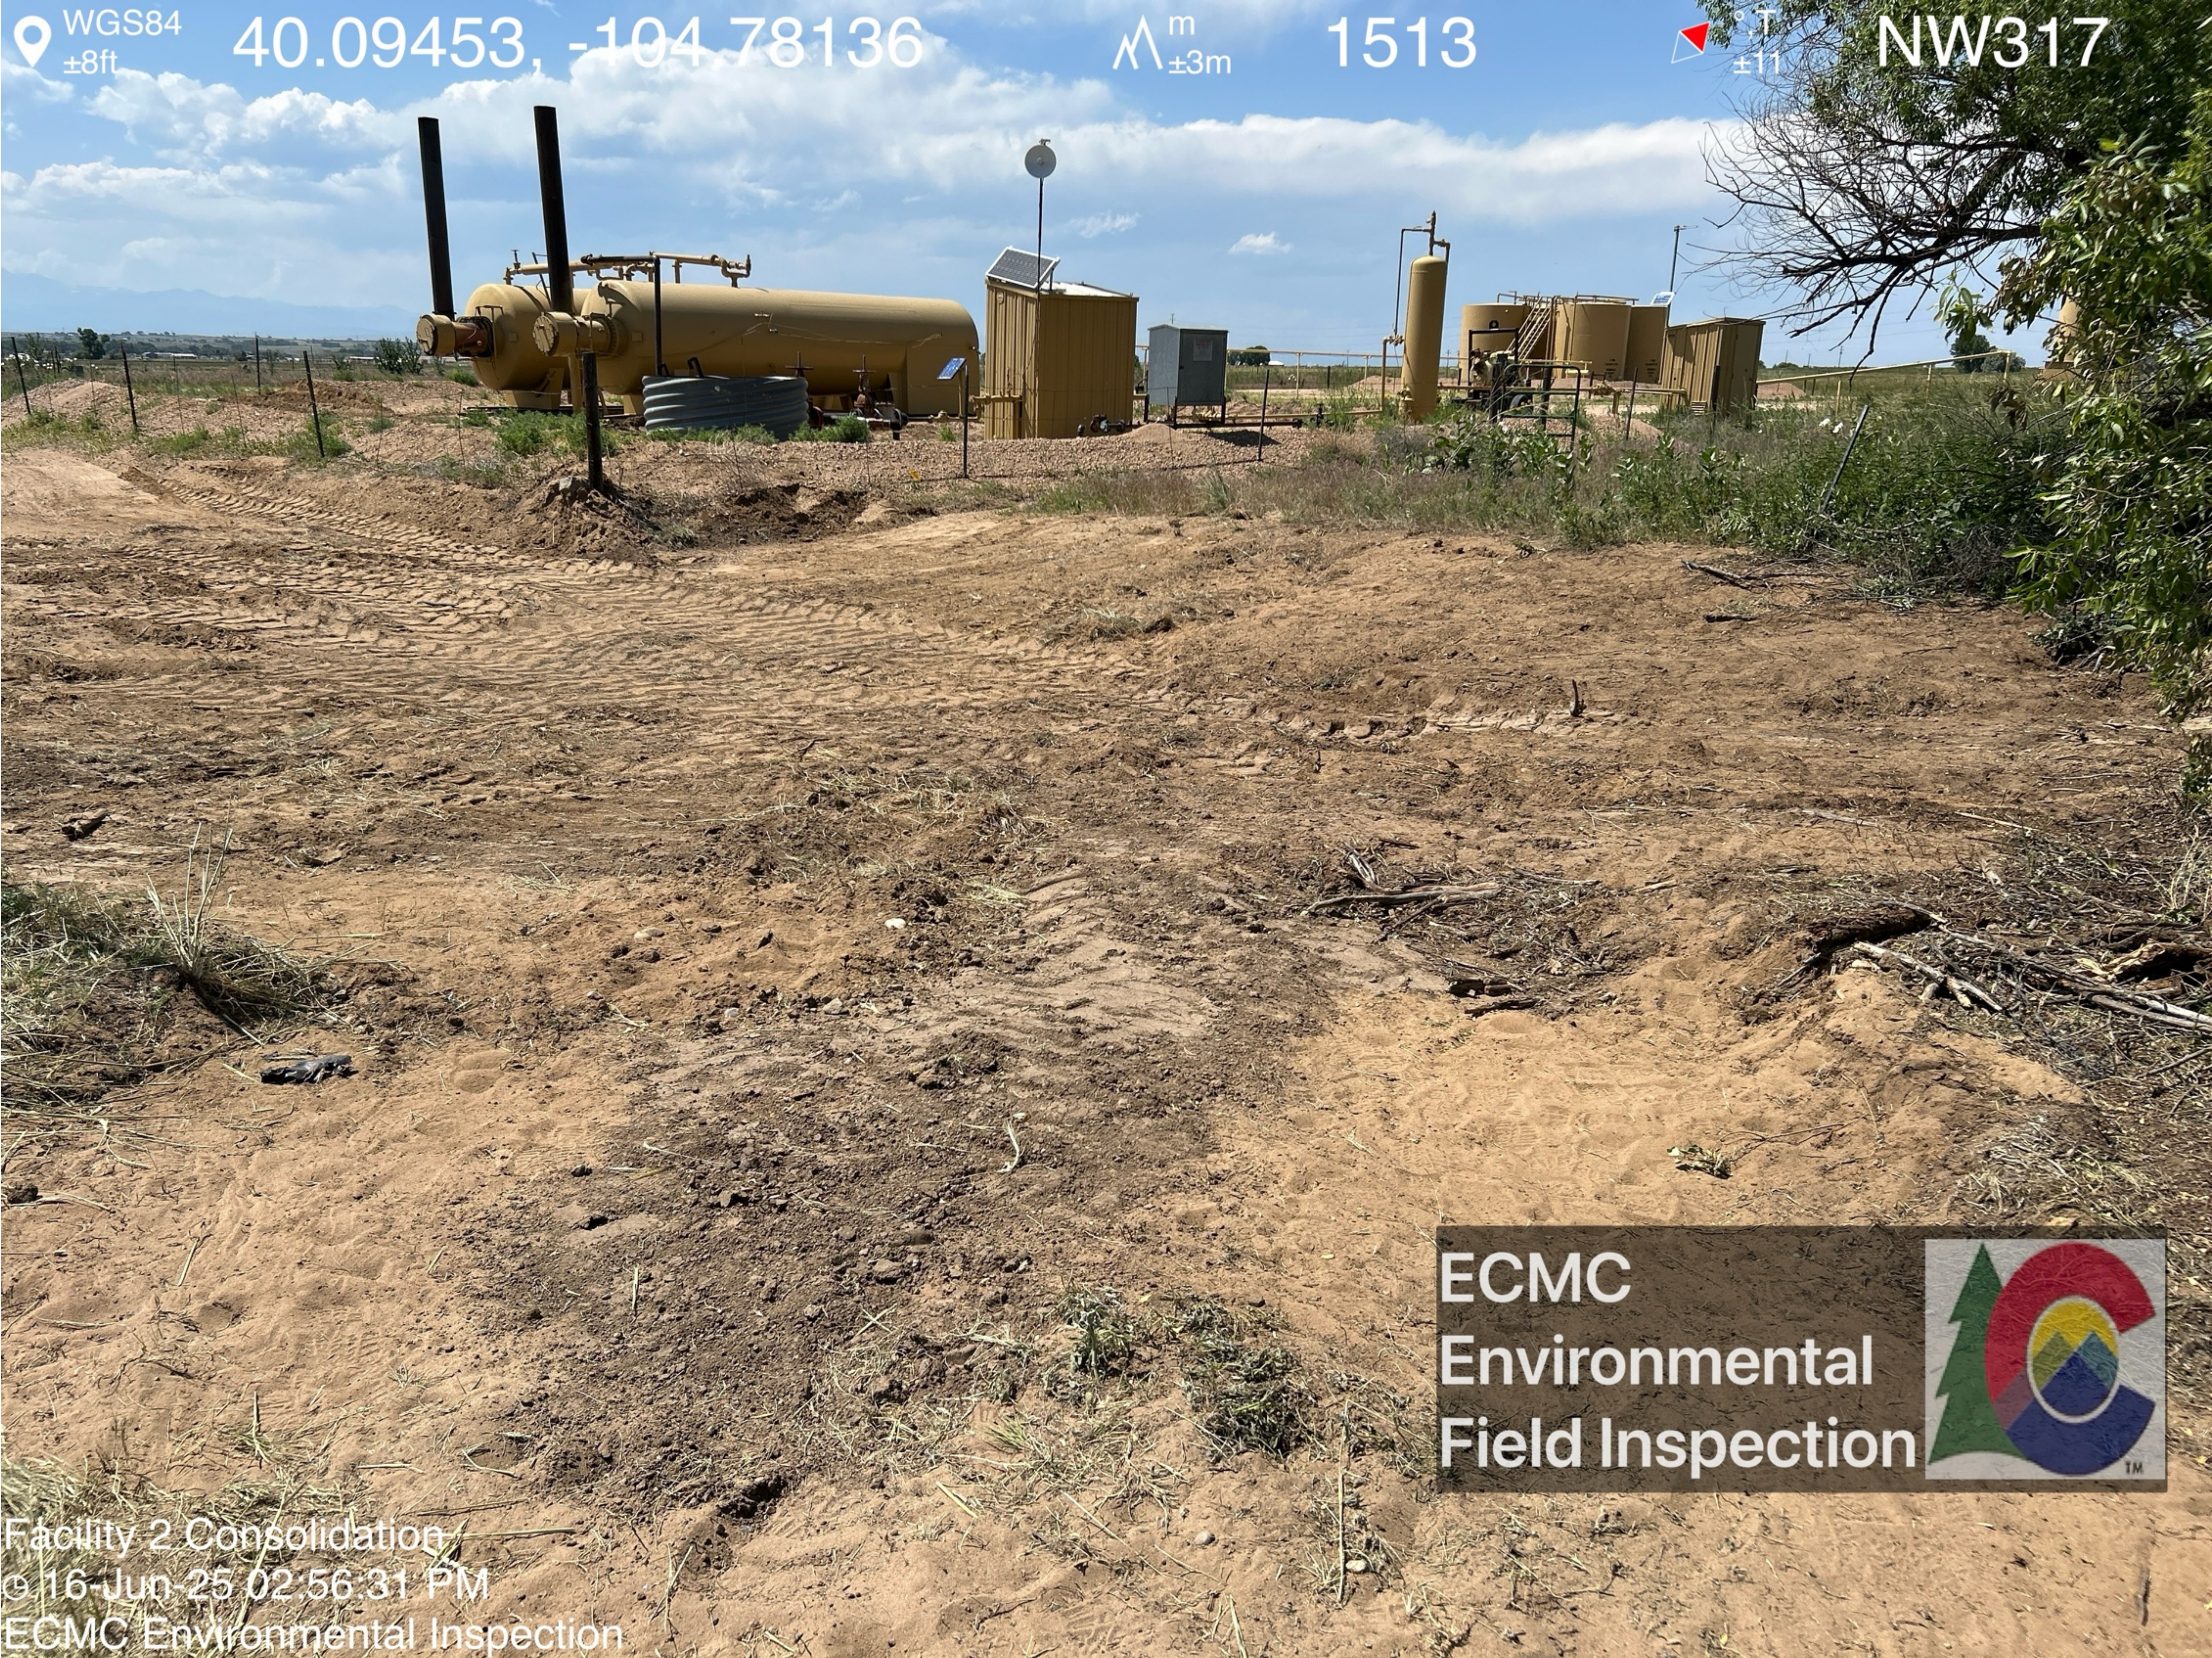
Approximate spill area. Excavations have been backfilled.

Multiple areas of stained soil are visible on the surface of the spill area. A petroleum hydrocarbon odor was observed when the stained soil was disturbed.

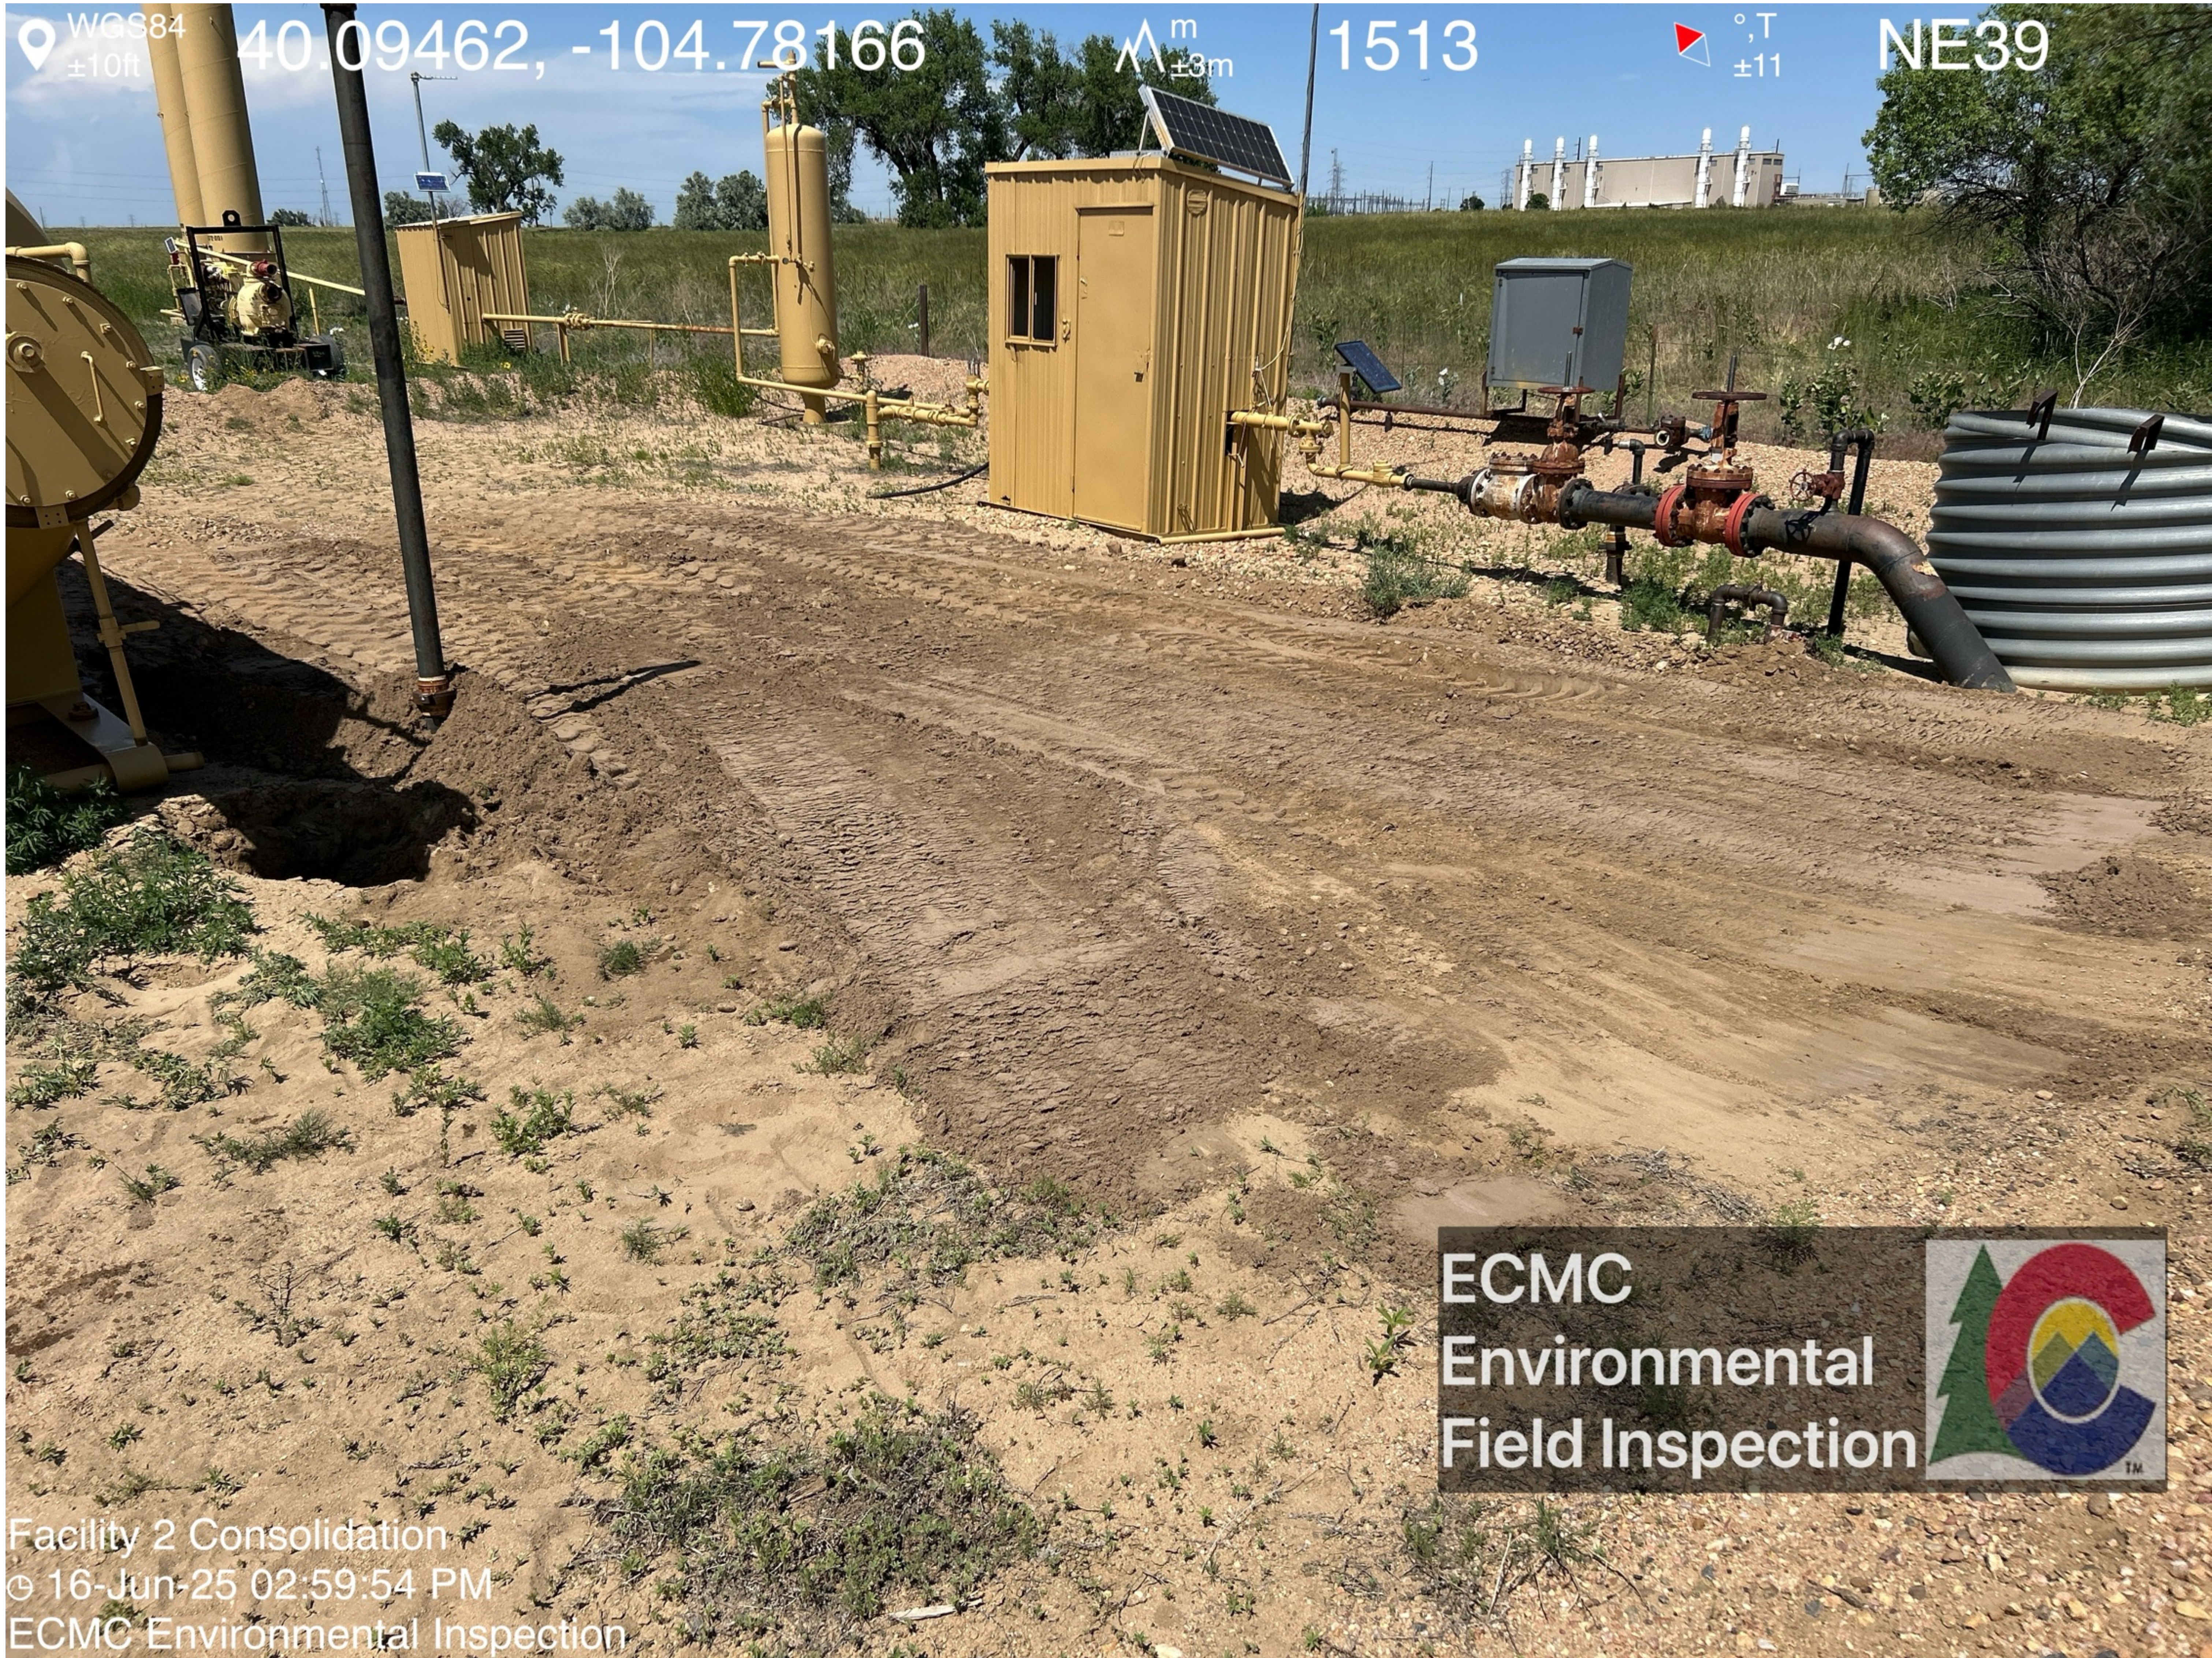
Approximate spill area.

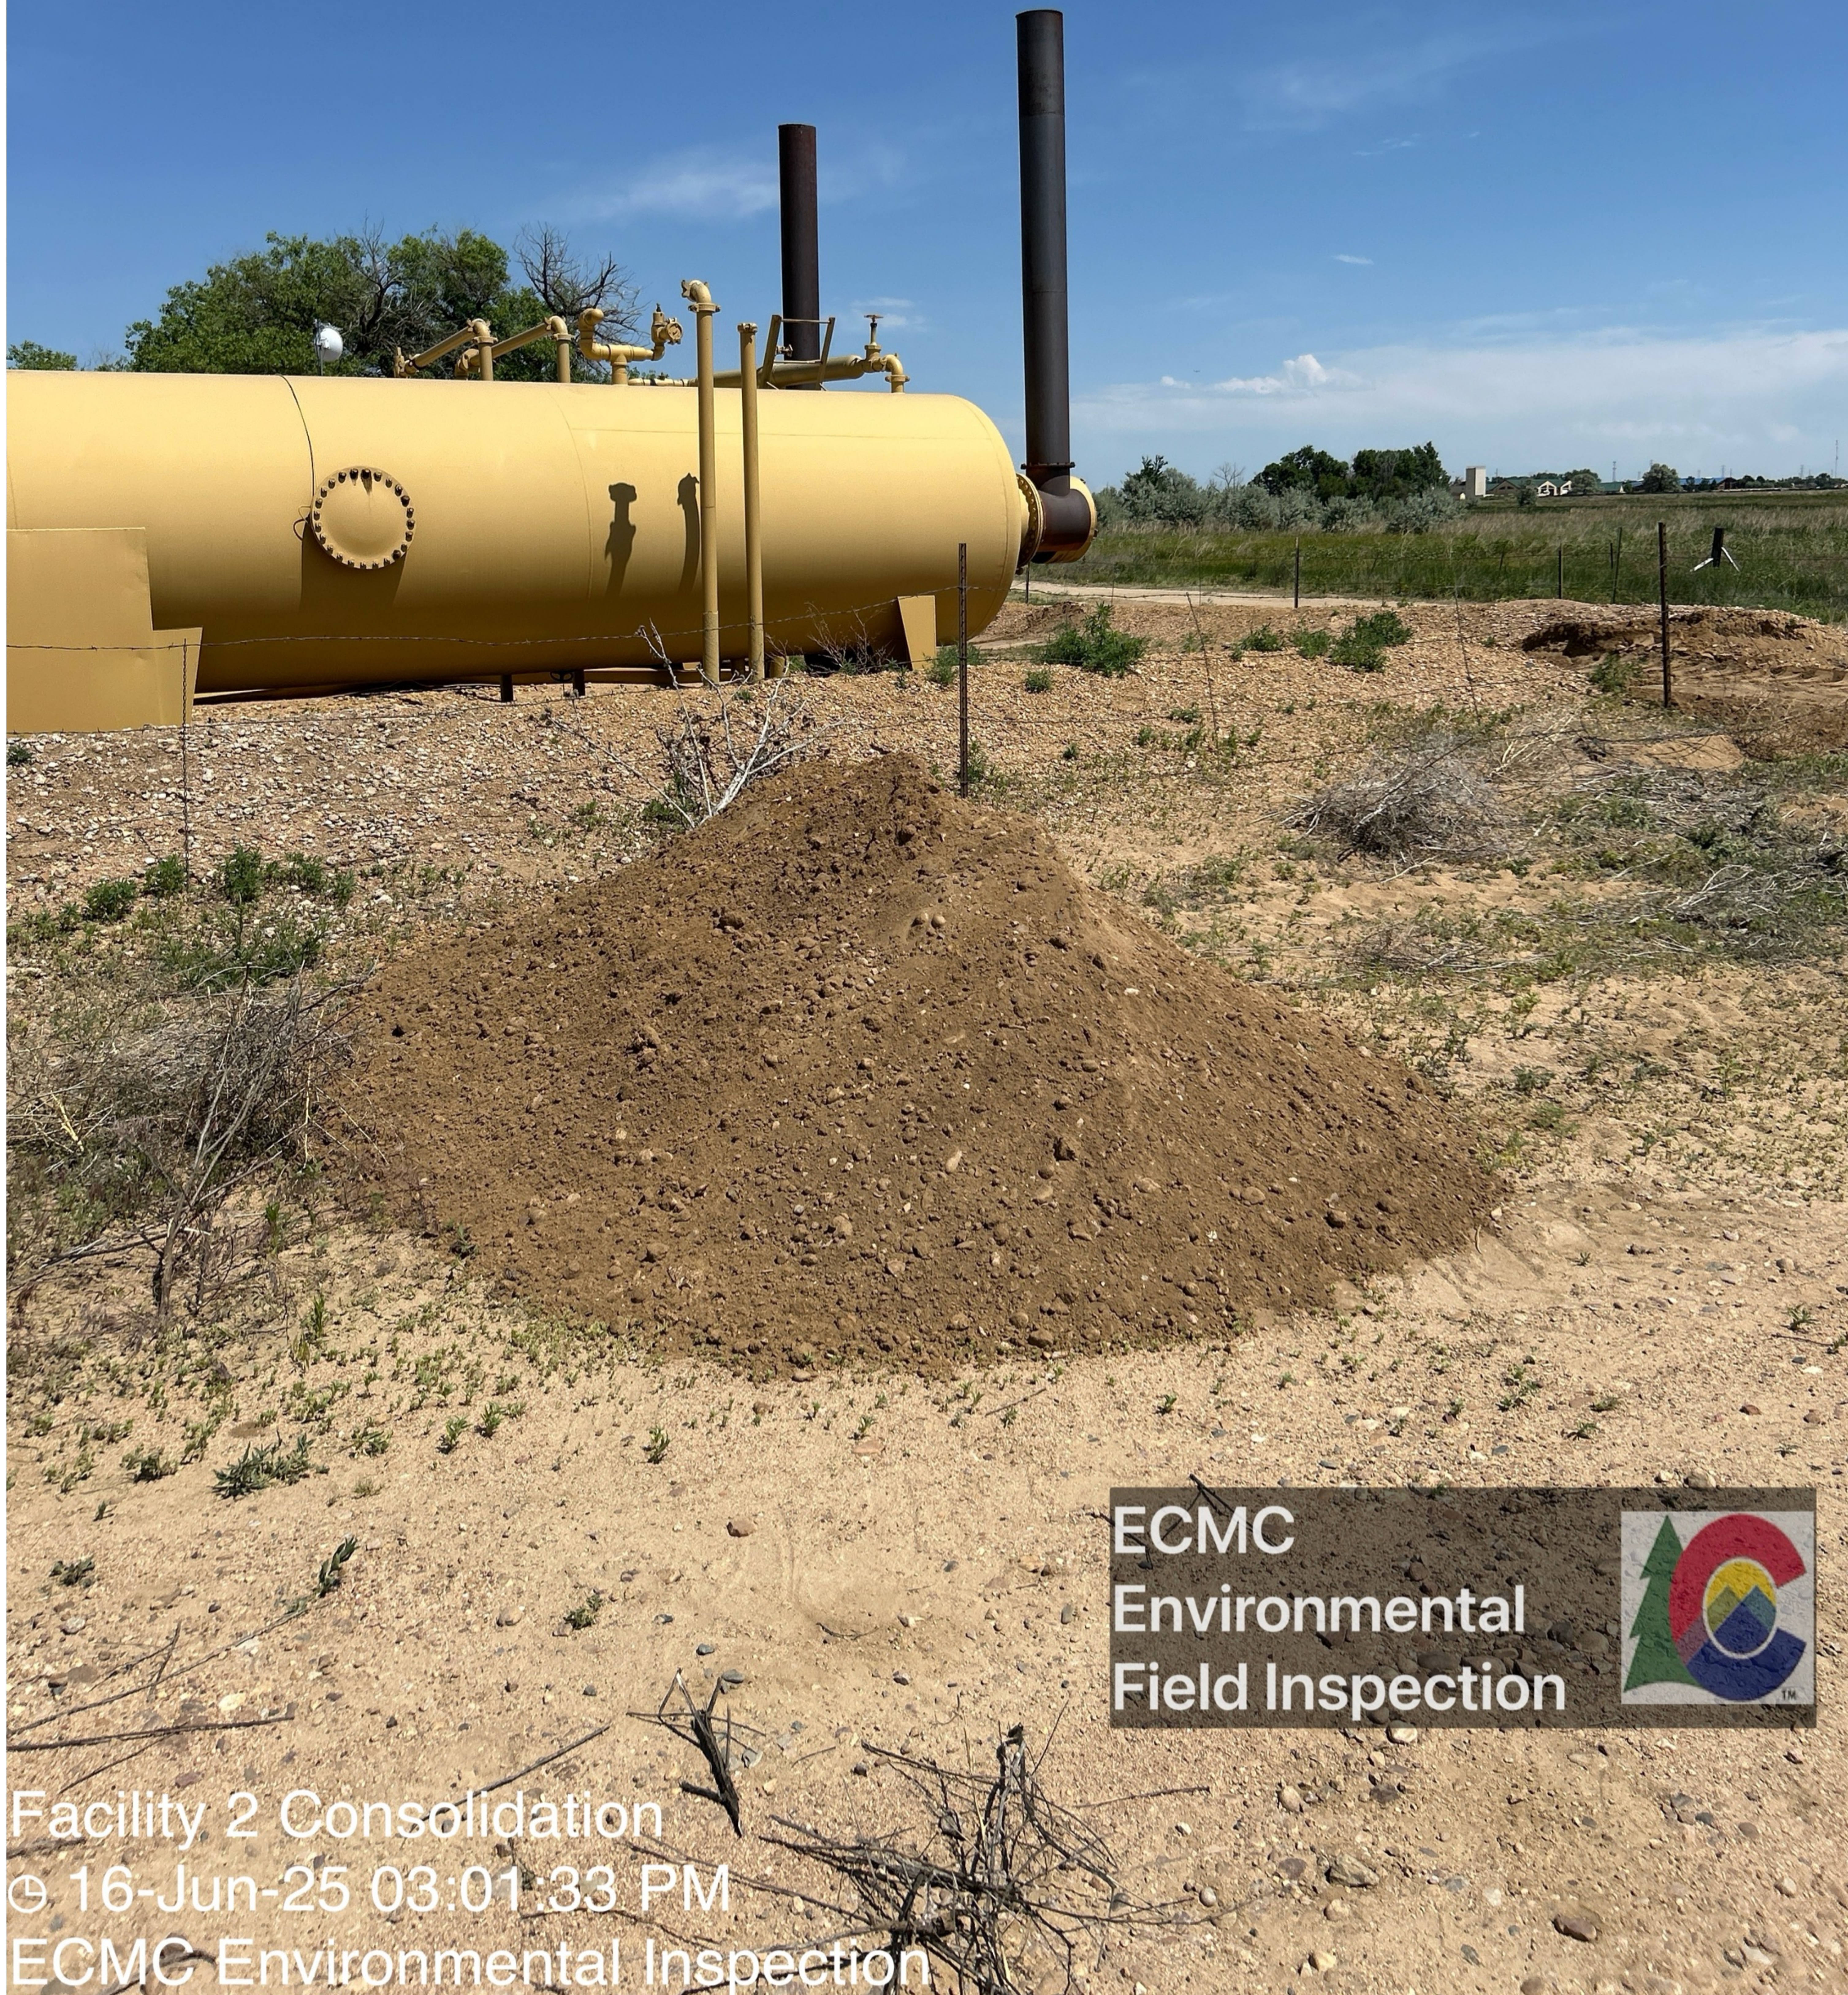
A small area of ground disturbance was visible adjacent to the eastern separator.
