## Inspection/Audit Photos

Location: TEP ROCKY MOUNTAIN LLC SG 44-23 PAD

Location ID: 429938

Date: 06/16/2025

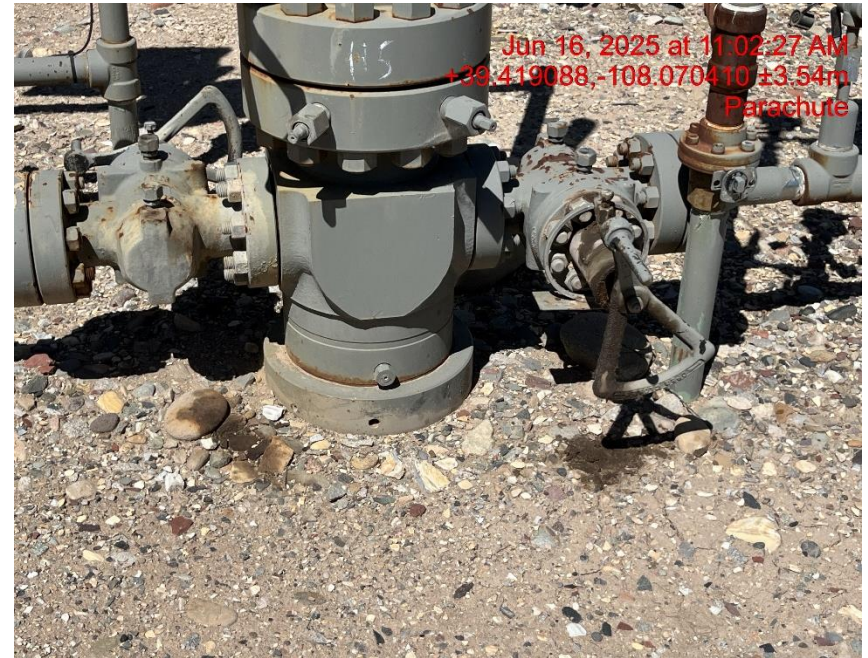
Photo # 8536 Staining

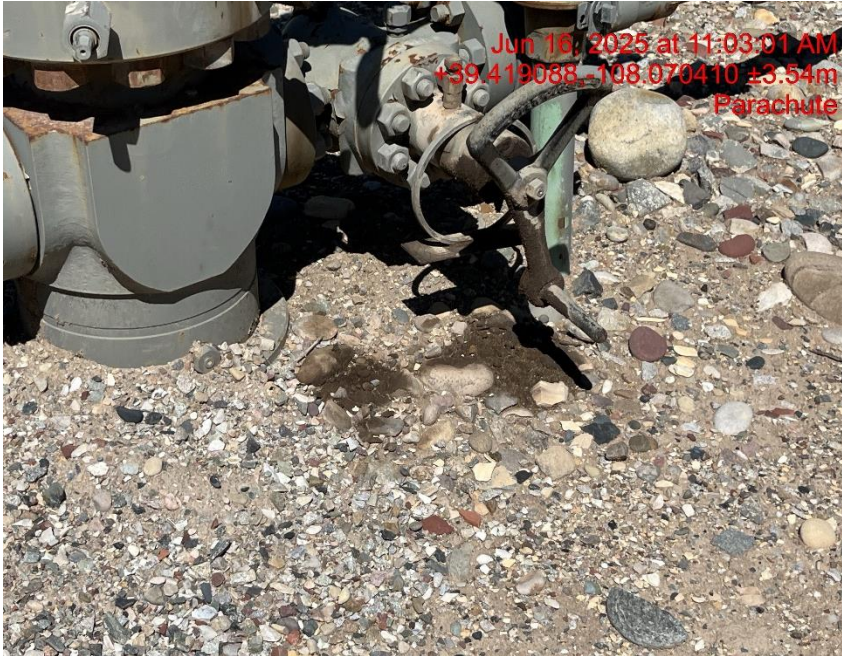
Photo # 8538 Staining

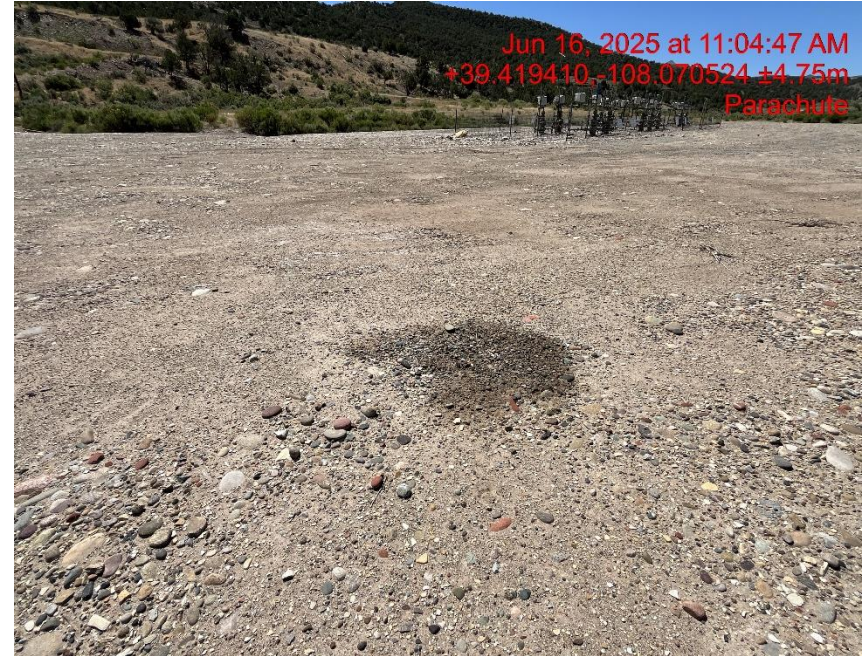
Photo # 8539 Staining

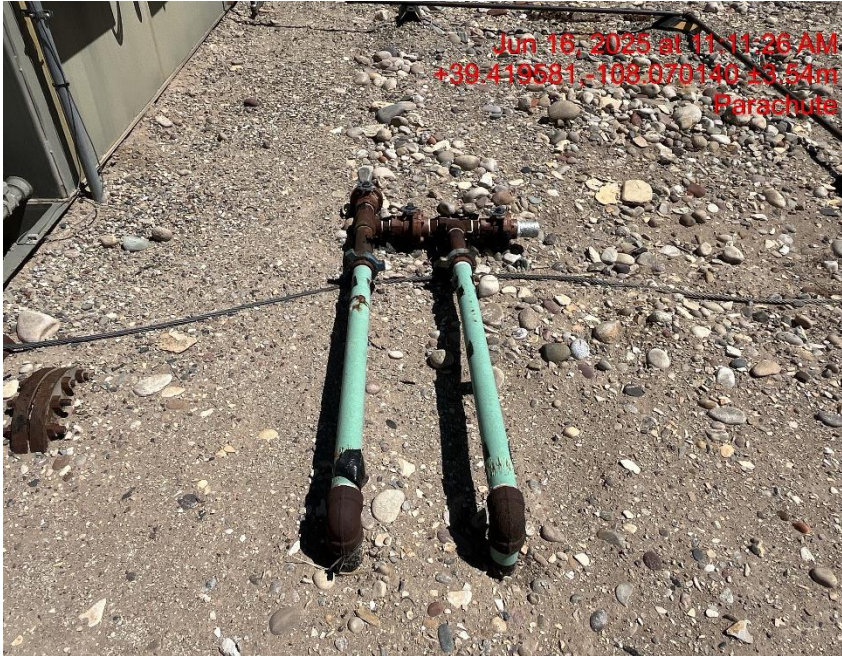
**Photo # 8543 Multiple unused flowlines do not comply with CECMC 600 & 1100 series rules**

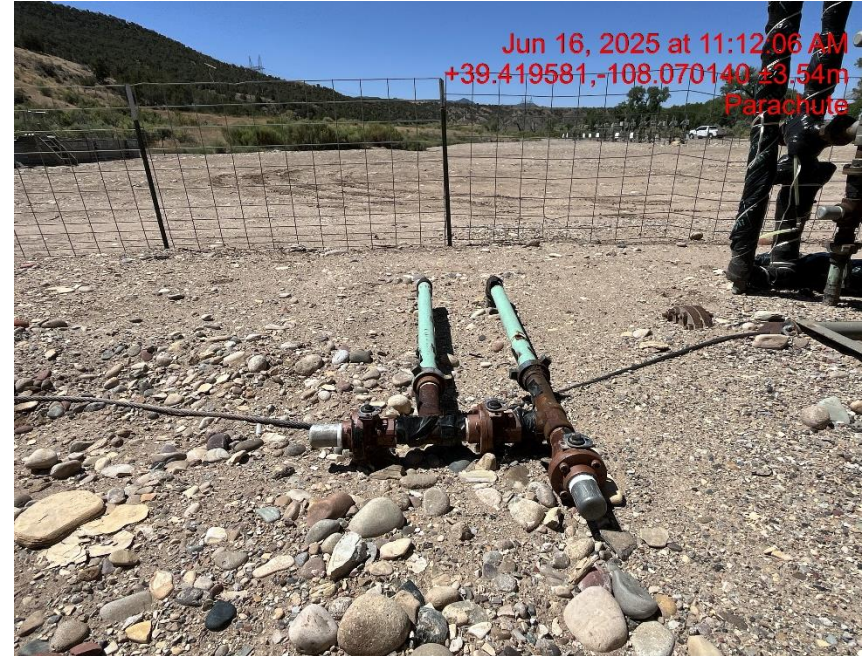
**Photo # 8545 Multiple unused flowlines do not comply with CECMC 600 & 1100 series rules**

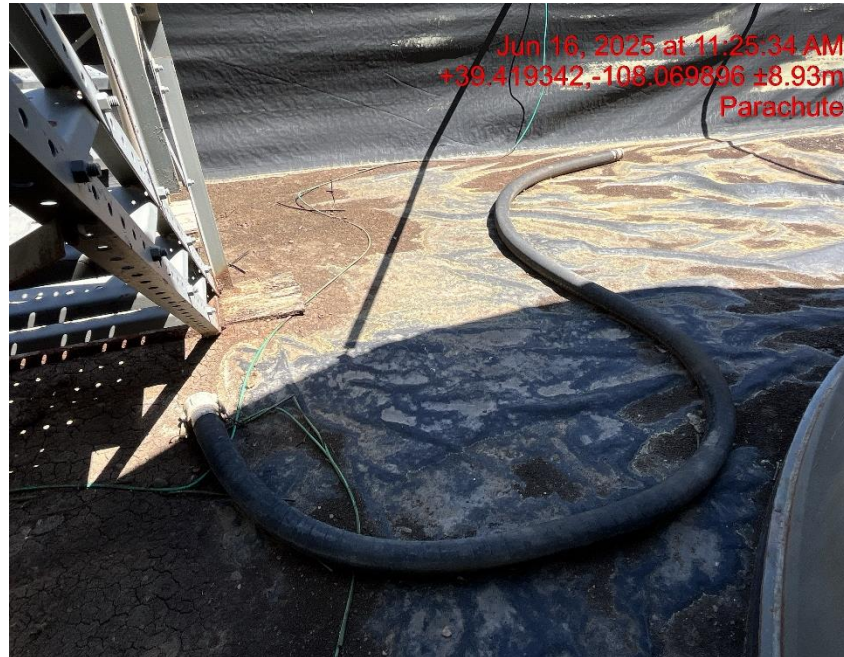
Photo # 8558 Unused hose
