**Inspection Photos**  
**Location: Frontera Unit Gas Plant**  
**Location ID: 480729, Spill ID 489242**

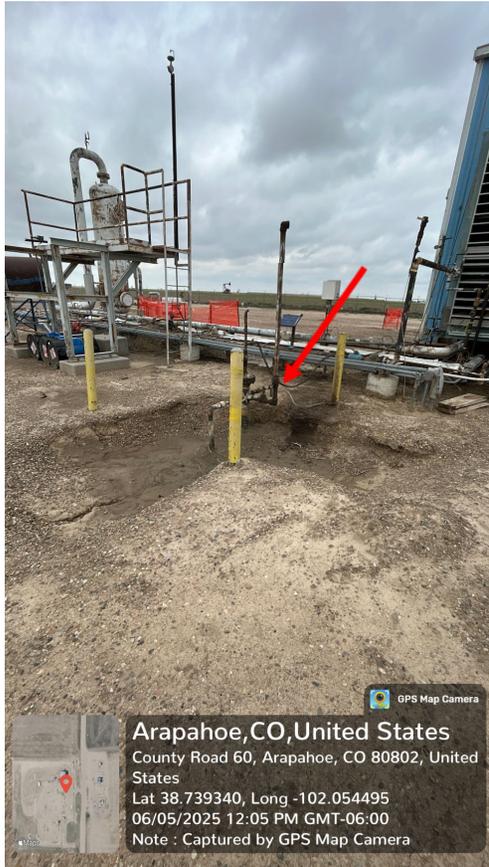
**Photo 2 – Spill Excavation**

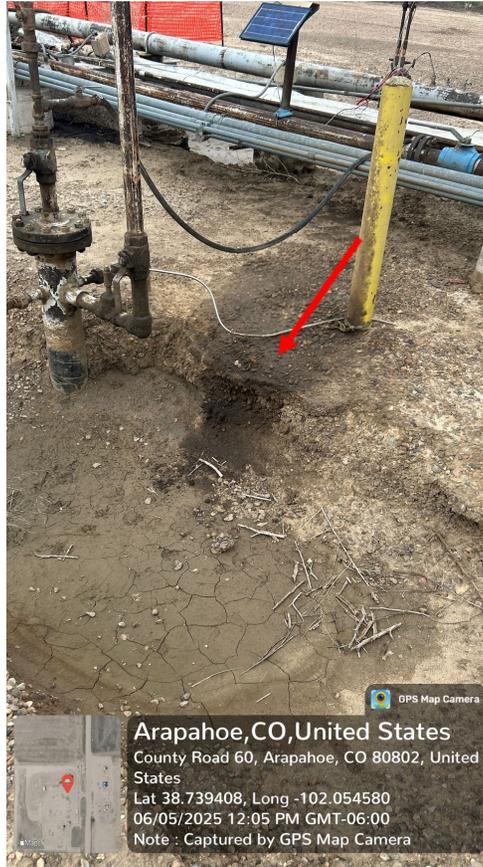
**Photo 3 – Stained soils**

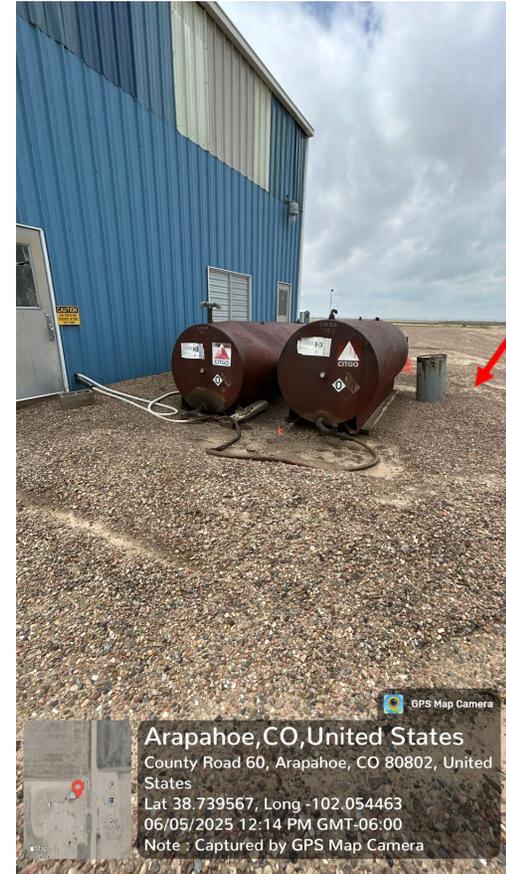
**Photo 4 – Inadequate Berming**

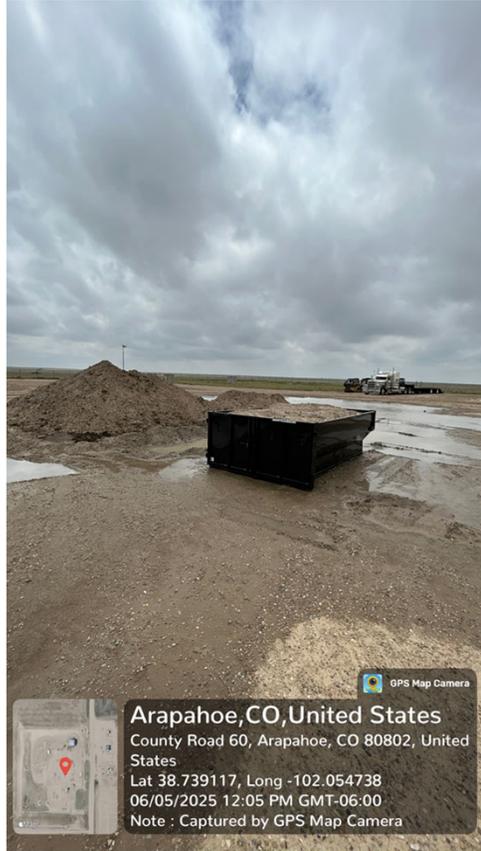
**Photo 5 – Stockpiles**

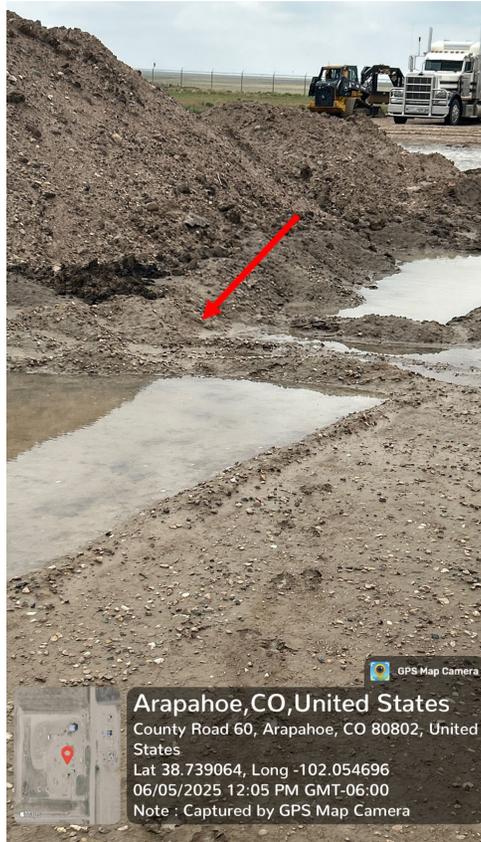
**Photo 6 – Inadequate earthen berms**

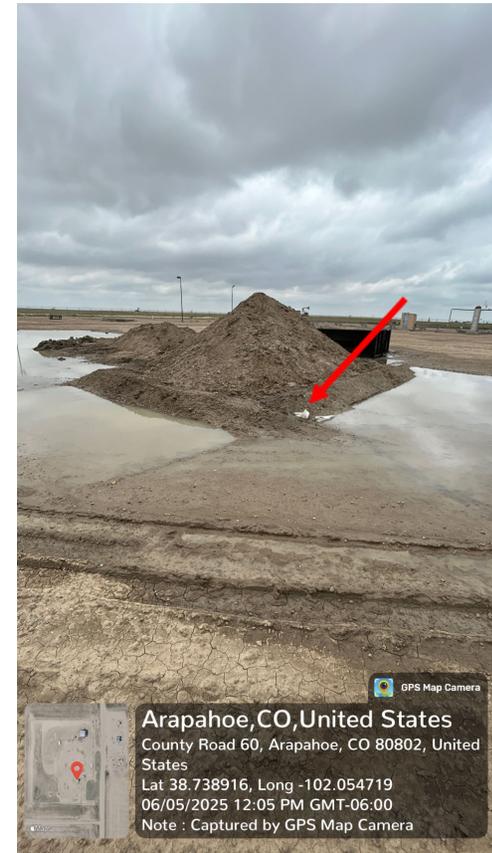
**Photo 7 – Compromised Liner**

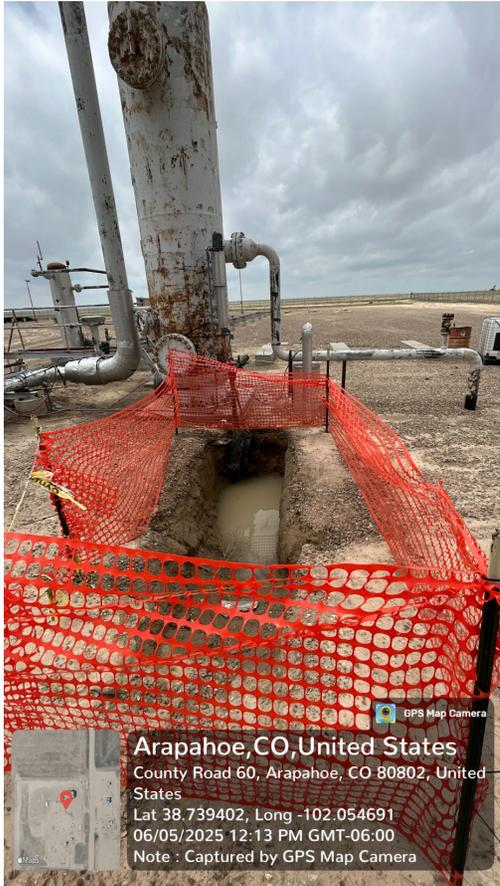
**Photo 8 – Open Excavation**

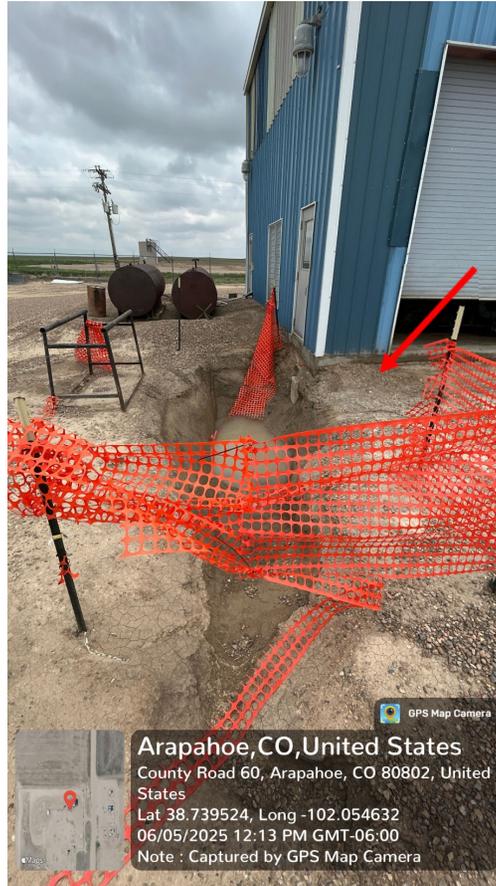
**Photo 9 – Inadequate  
fencing**

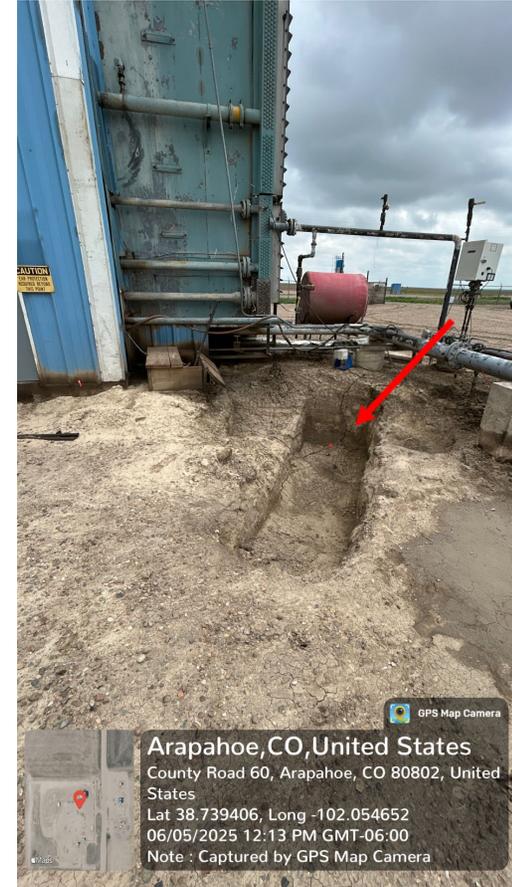
**Photo 10 – Open Excavation**
