Inspection Photos

LOC ID: 441082

Operator: DOVER ATWOOD CORPORATION

Inspection Date: 6/16/2025

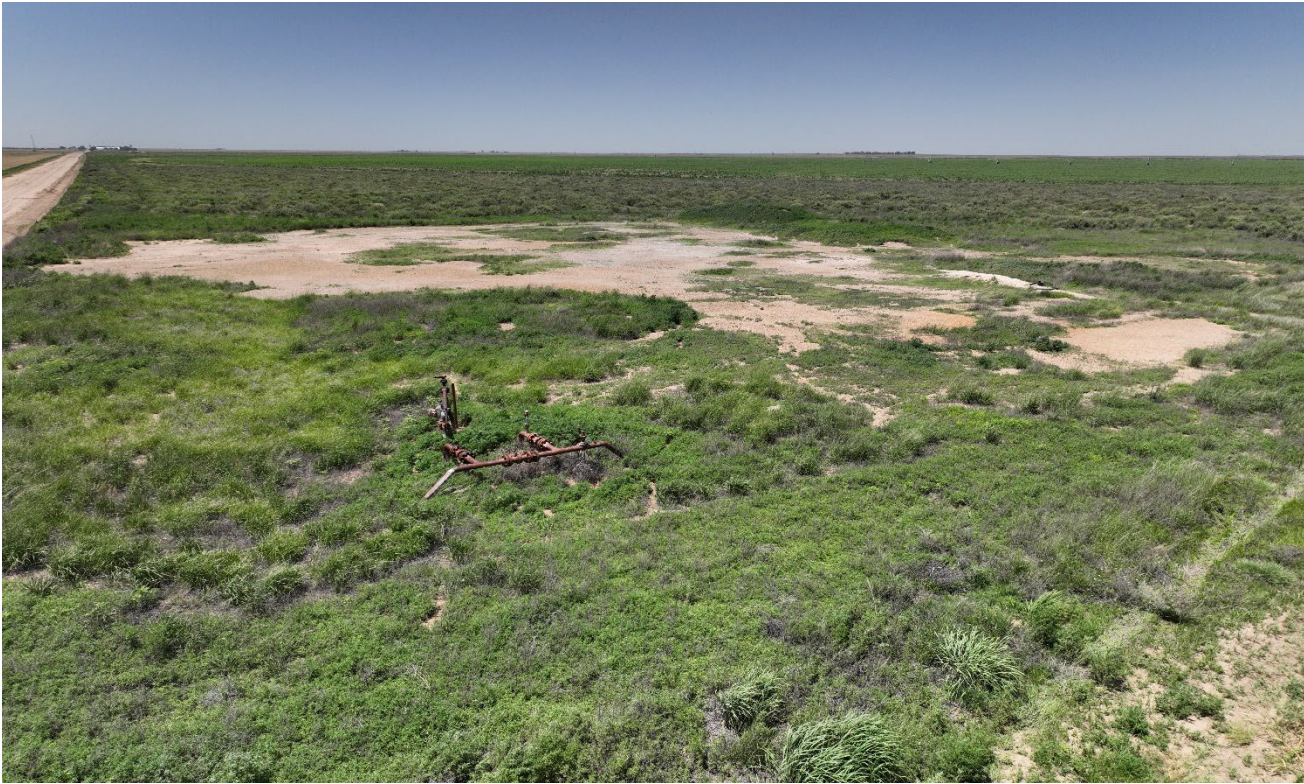
Photo 1. Drone aerial photo facing northwest toward the location. Much of the location consists of undesirable weeds and bare soils.

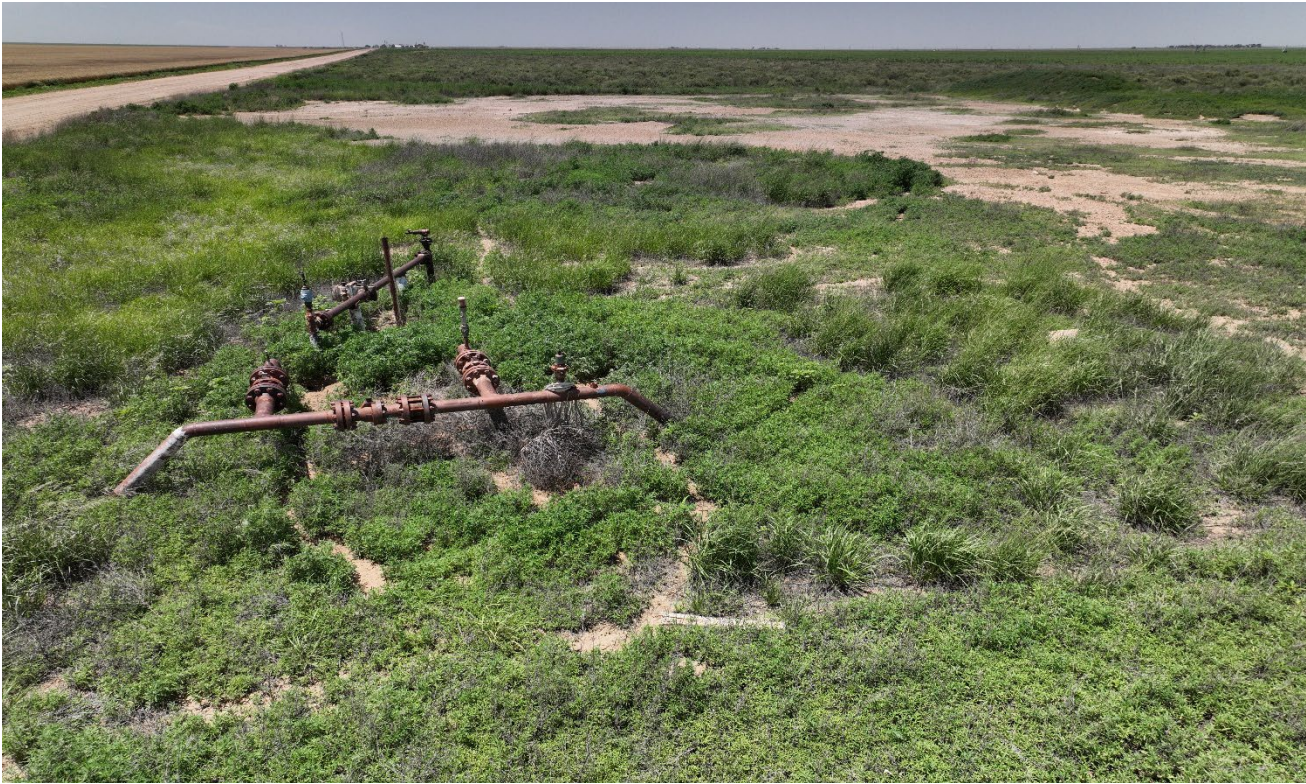
Photo 2. Drone aerial photo facing toward the flowline pipe that remains at the southeast corner. There is no signage posted at this equipment.

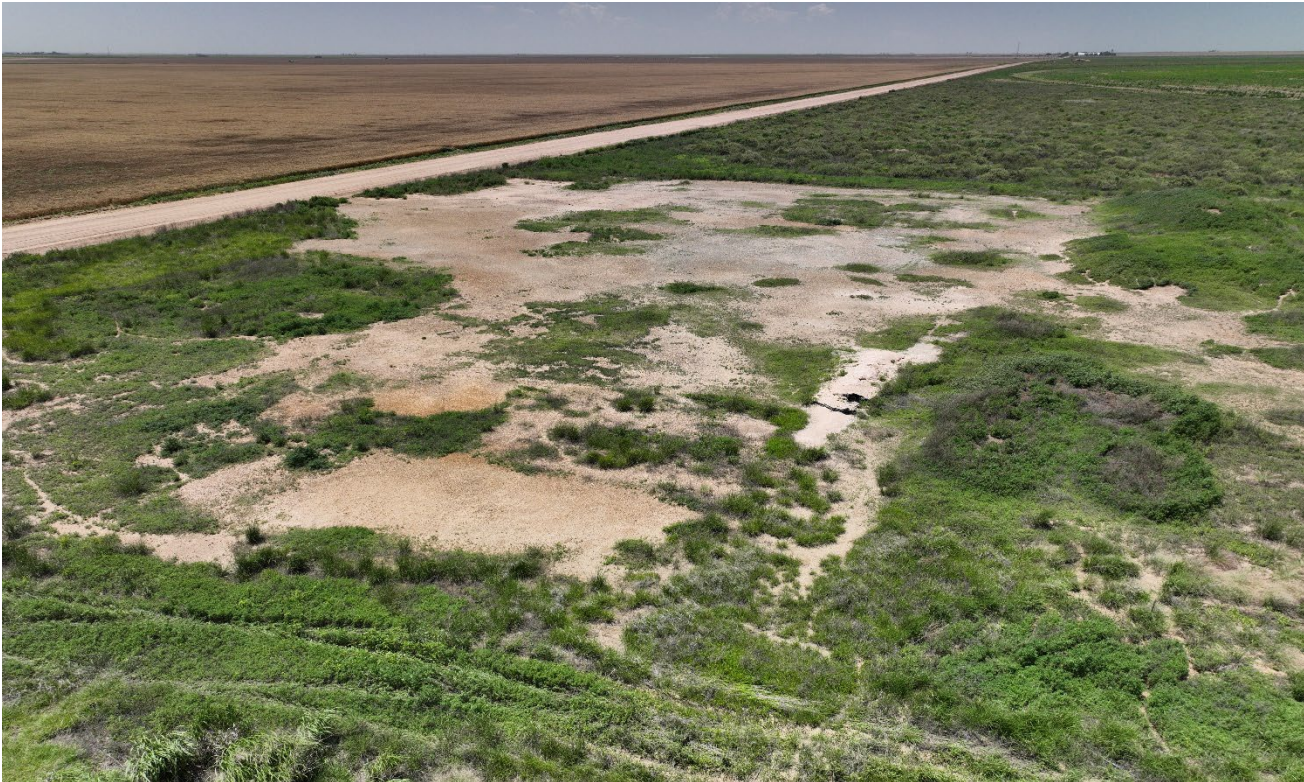
Photo 3. Drone aerial photo facing southwest toward the location. Much of the location consists of undesirable weeds and bare soils. It appears there are impacted soil from historical spills from the abandoned compressor station.

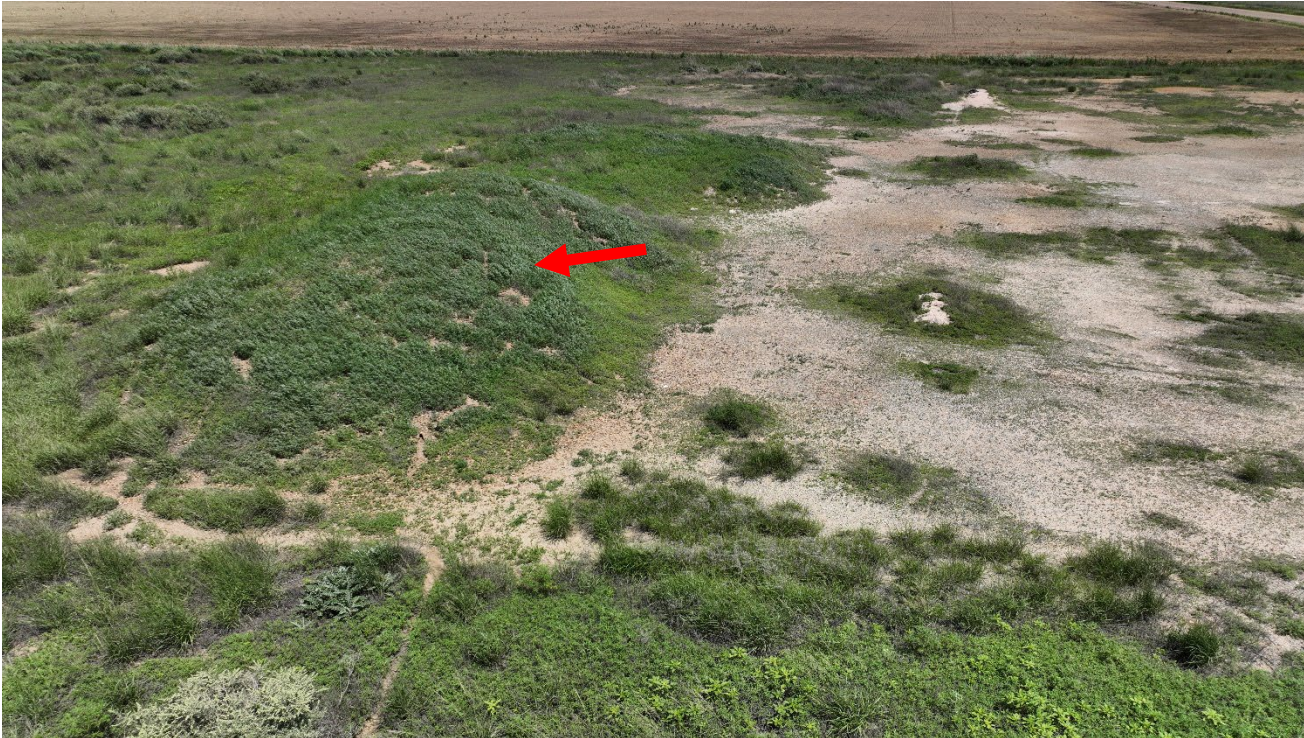
Photo 4. The red arrow points to the gravel pile that still remains at the northwest corner and is full of undesirable weeds (Kochia).

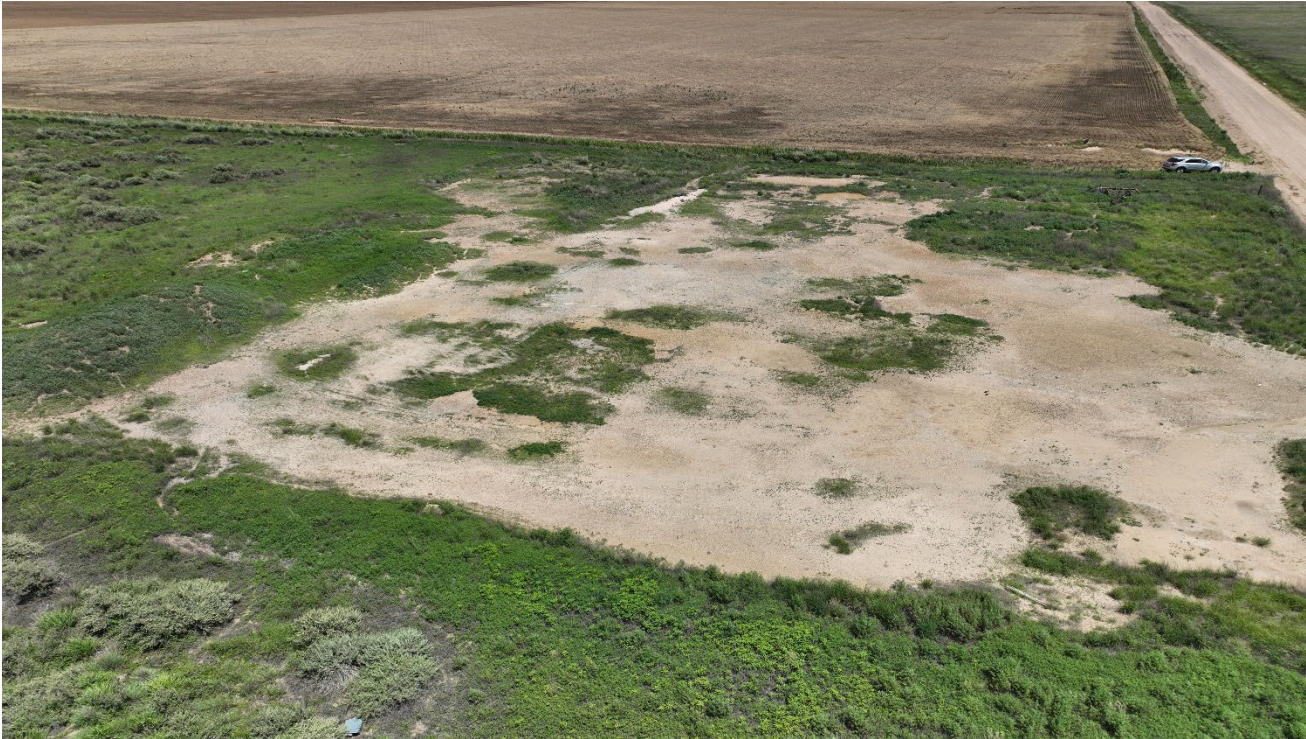
Photo 5. Drone aerial photo facing northeast toward the location. Area of disturbance is approximately 1 acre in size.

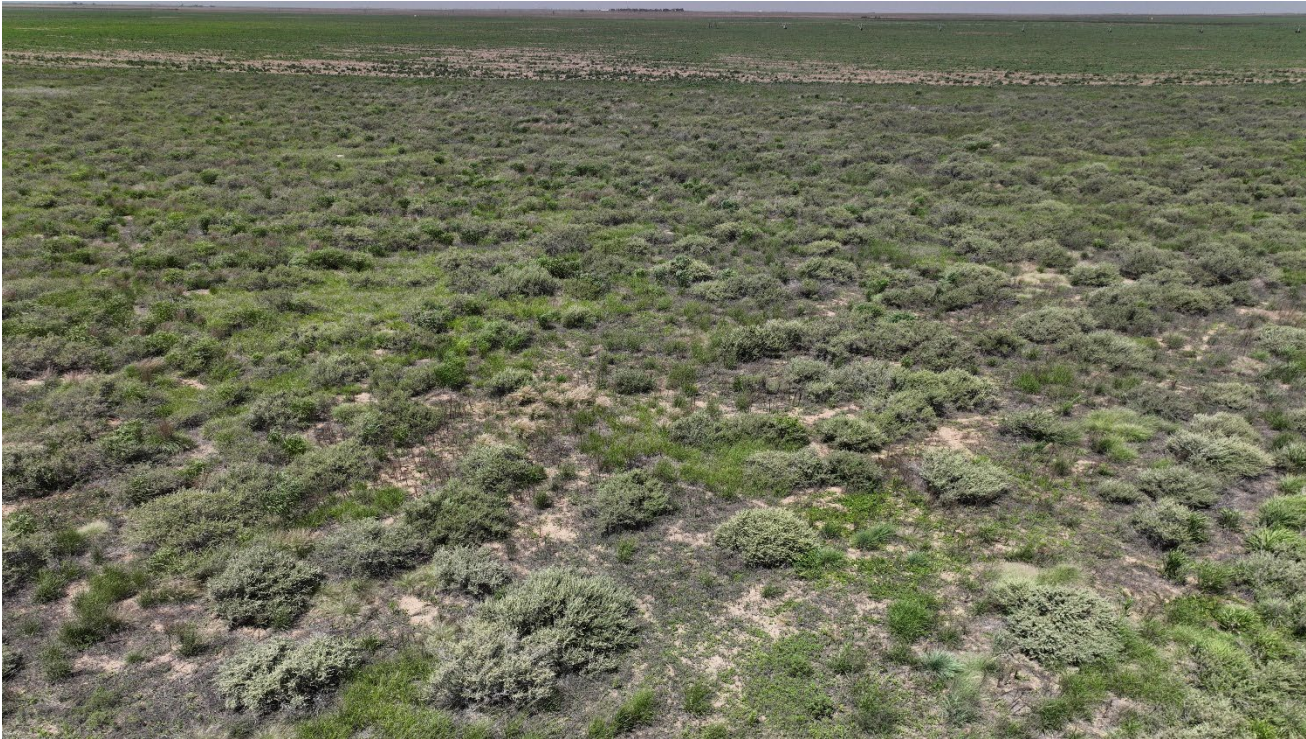
Photo 6. View of adjacent surrounding vegetation which consists of Fourwing salt brush community.

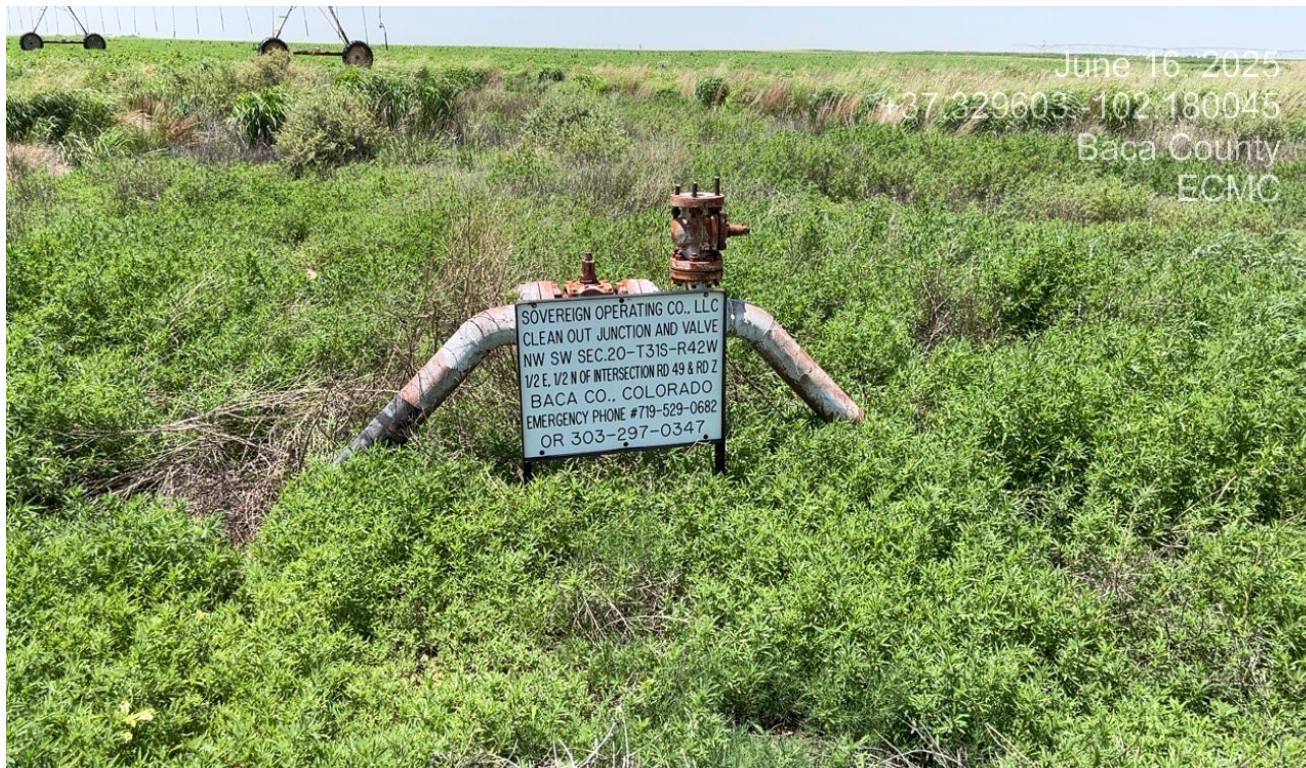
Photo 7. There was a cleanout junction 1850 ft. north of the pipeline previously observed. The cleanout junction is associated with the former gas compressor station and must be removed.
