Inspection Photos

API: 009-06573

Operator: INVESTMENT EQUIPMENT LLC

Inspection Date: 6/16/2025

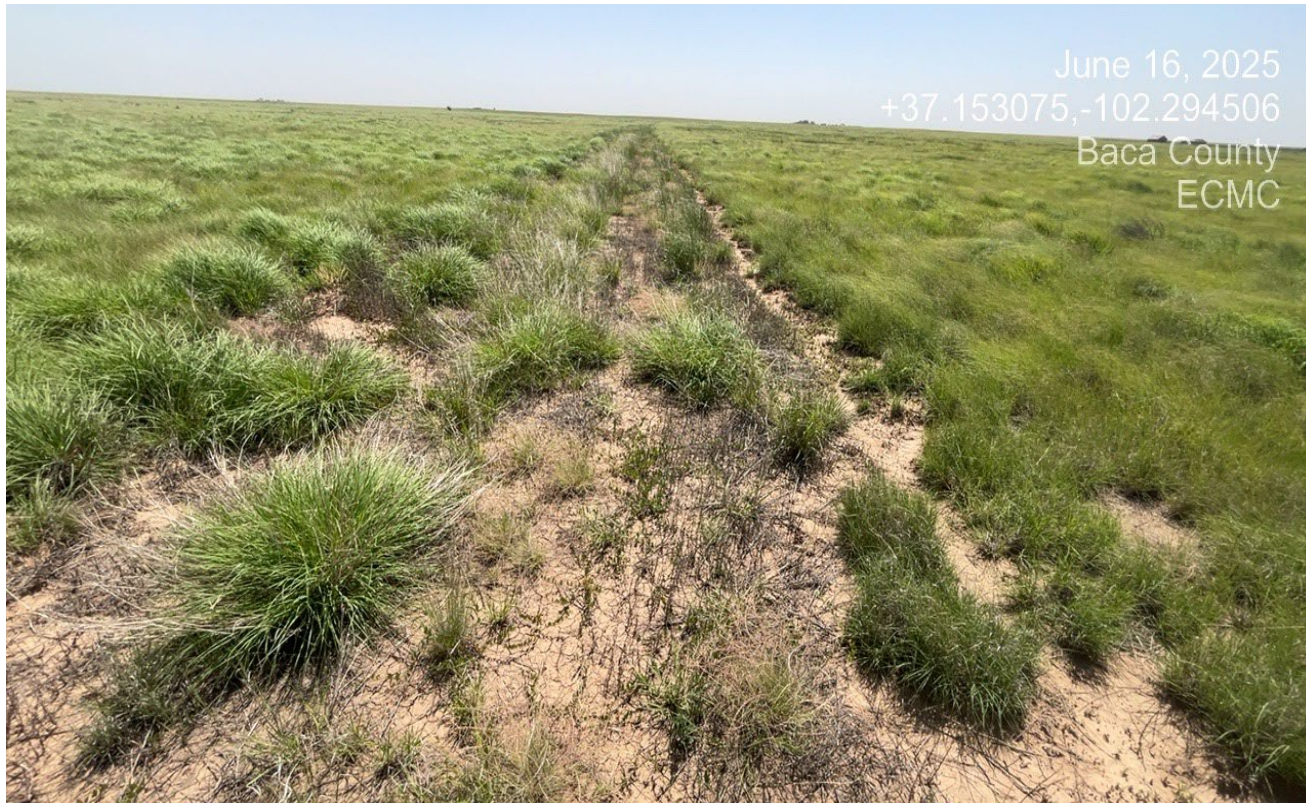
Photo 1. . Facing east along the former access road. The road has not fully established perennial vegetation and there are noxious weeds along the road.

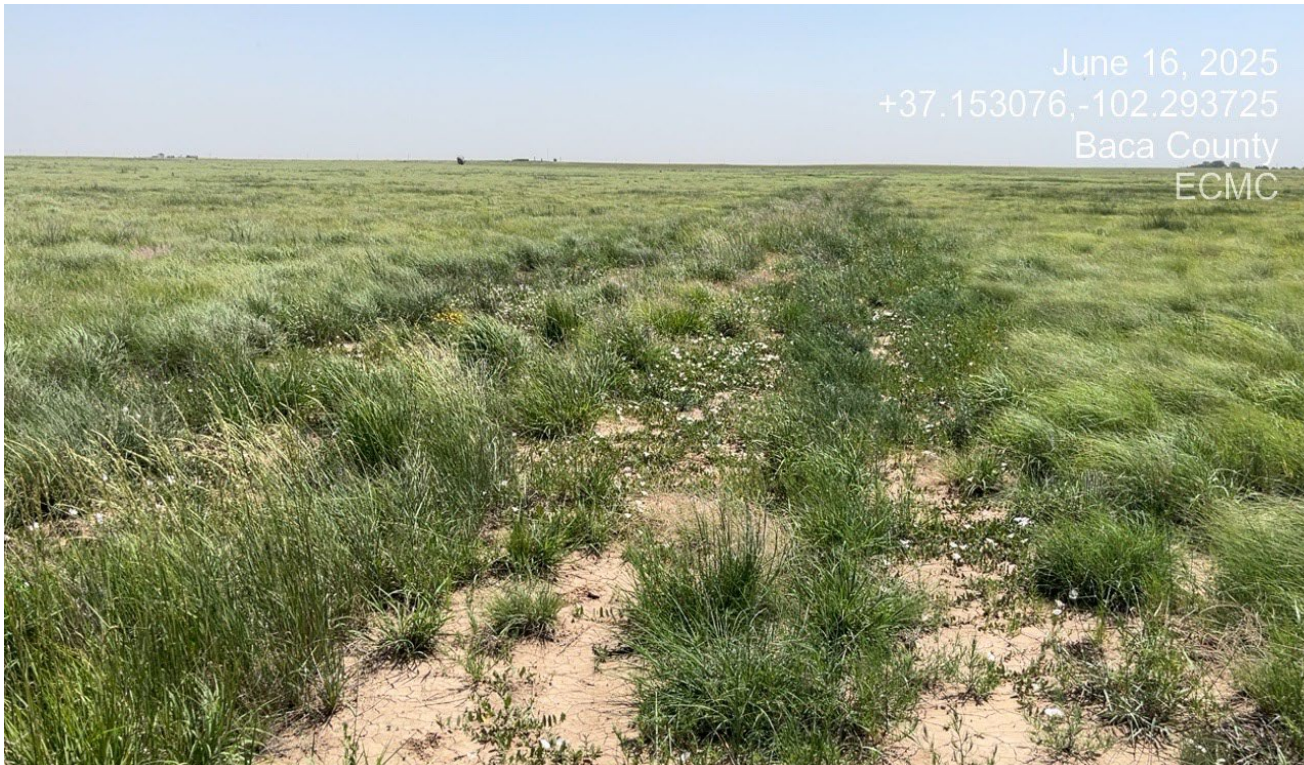
Photo 2. Facing east along the former access road. The road has not fully established perennial vegetation and there are noxious weeds along the road.

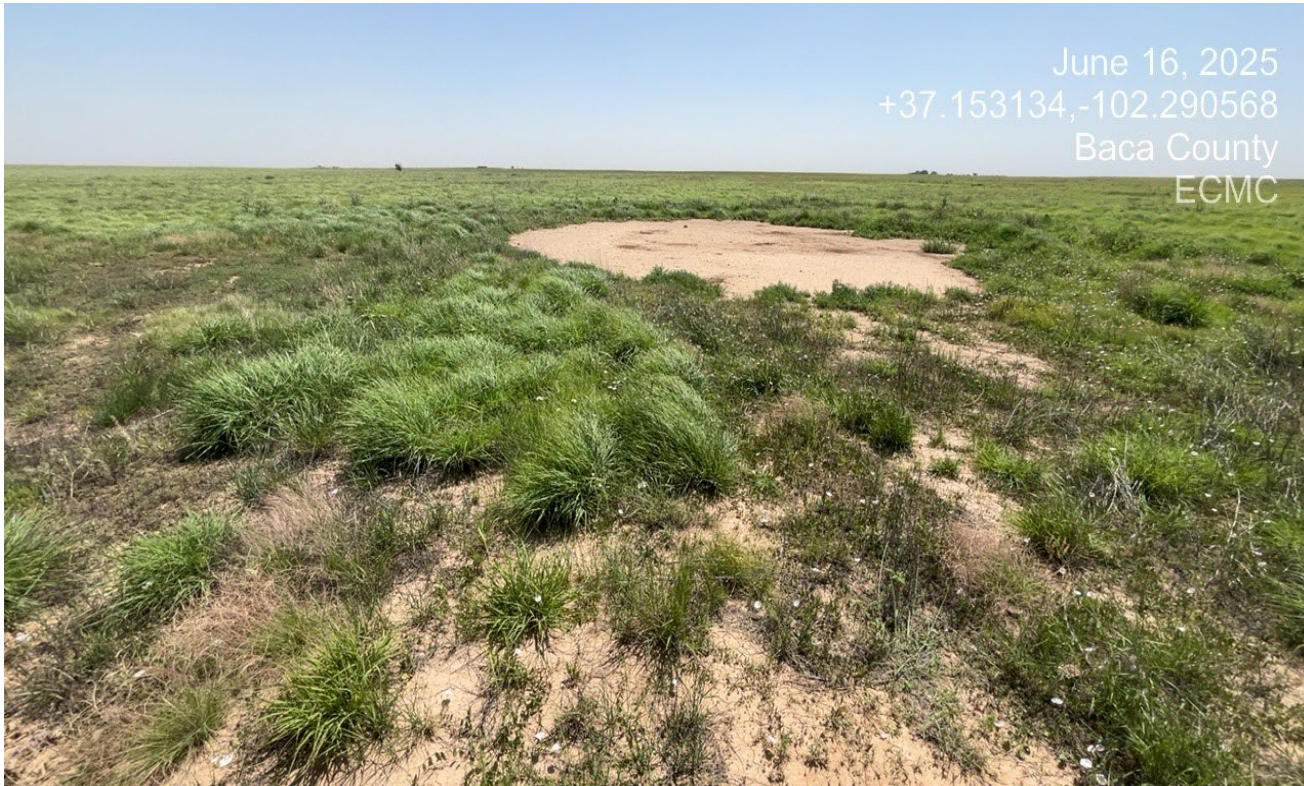
Photo 3. Facing east toward the abandoned wellsite. The location has not been reclaimed.

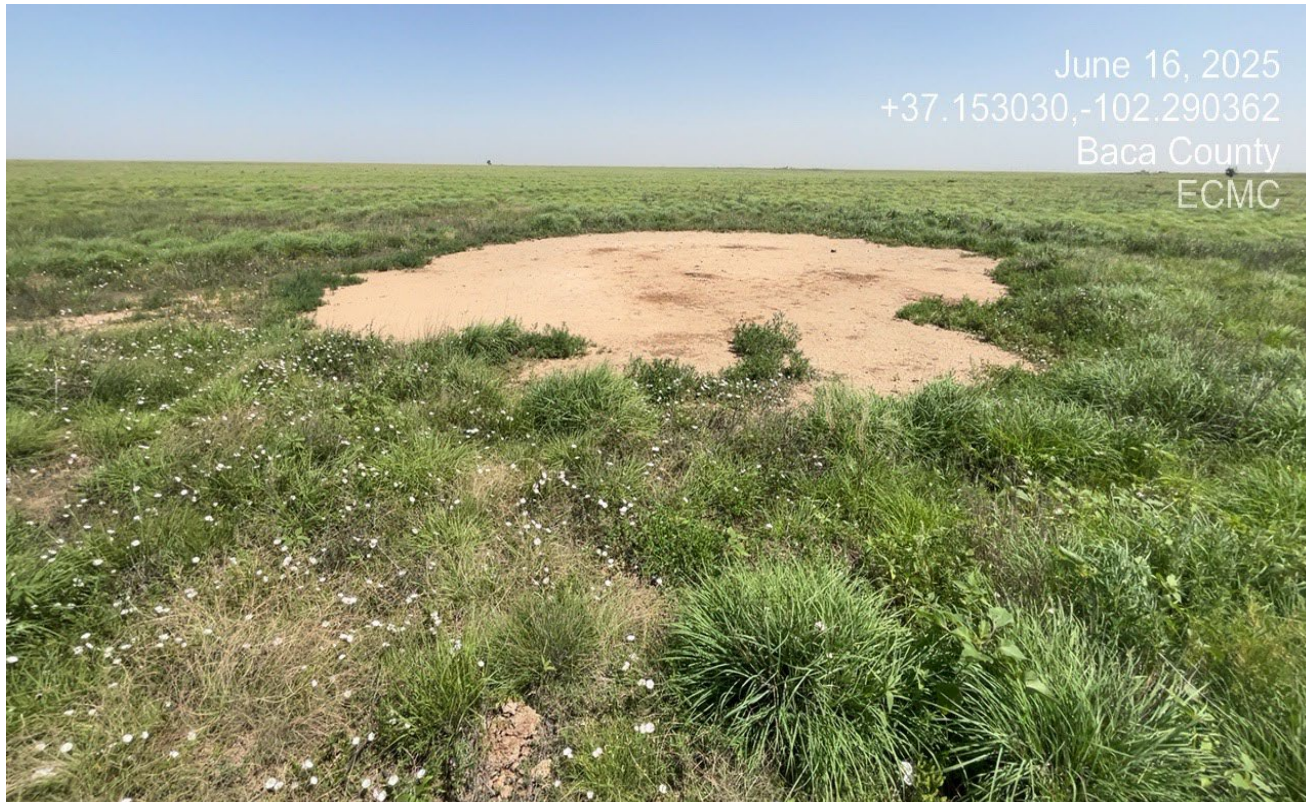
Photo 4. Facing north at the location. There is bare soil at the well site which appears to be impacts from a historic spill . This area is approximately 50'x50'. There are noxious weed throughout the location (Field bind weed – white flower).

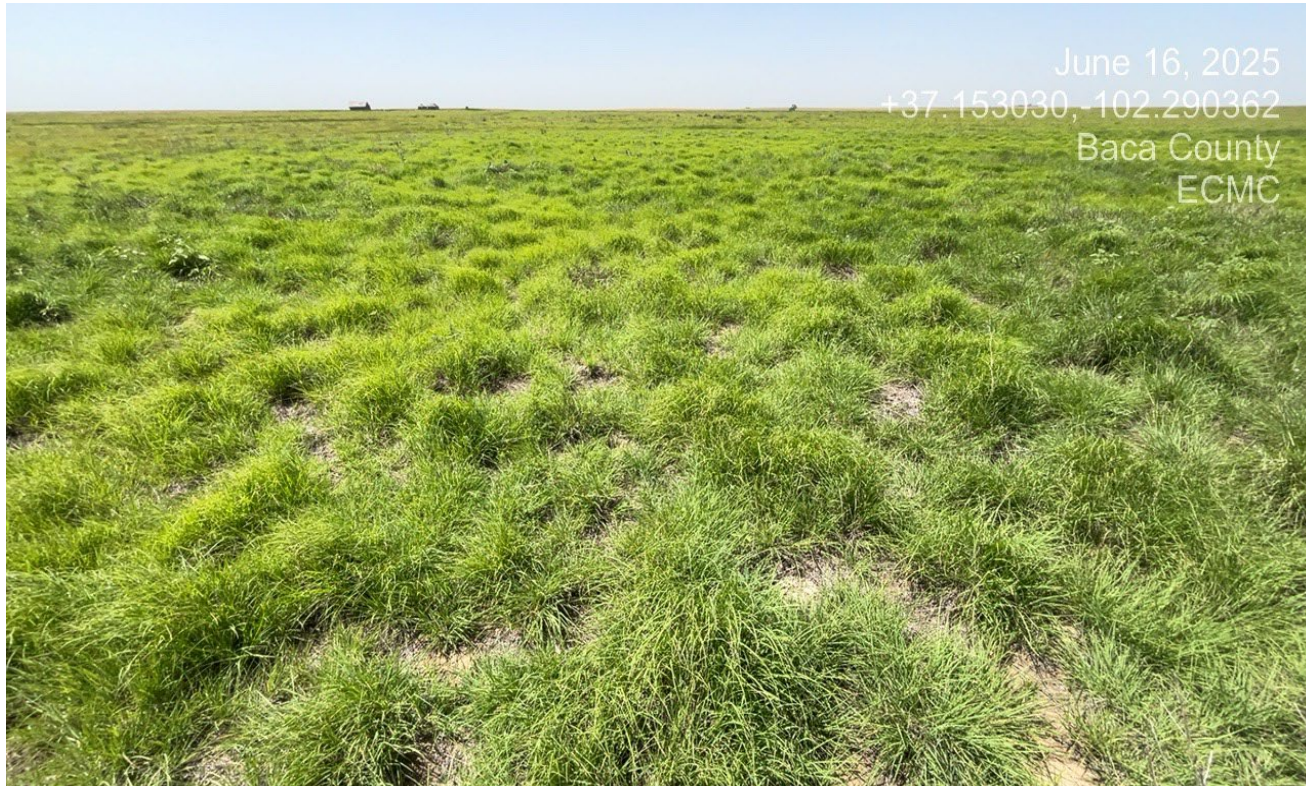
Photo 5. Facing south toward the surrounding reference area.
