Final Reclamation and Stormwater Inspection

June 16, 2025

Well Name: ERIE CHAMPLIN B UNIT #1

Inspection Document #: 718600688

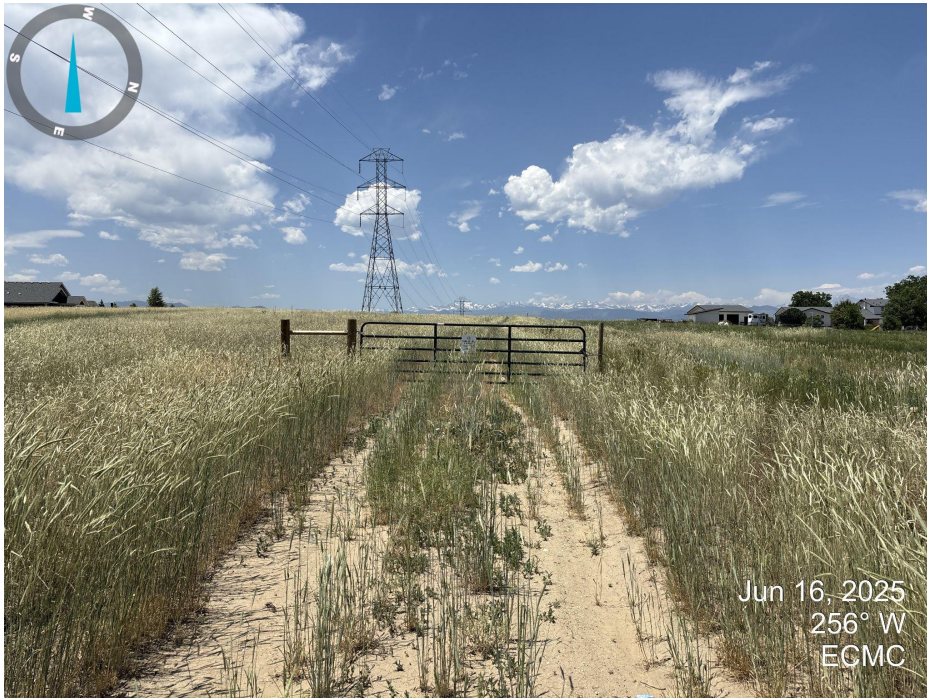
Photo 1. Looking west down the access road. A gate is installed.

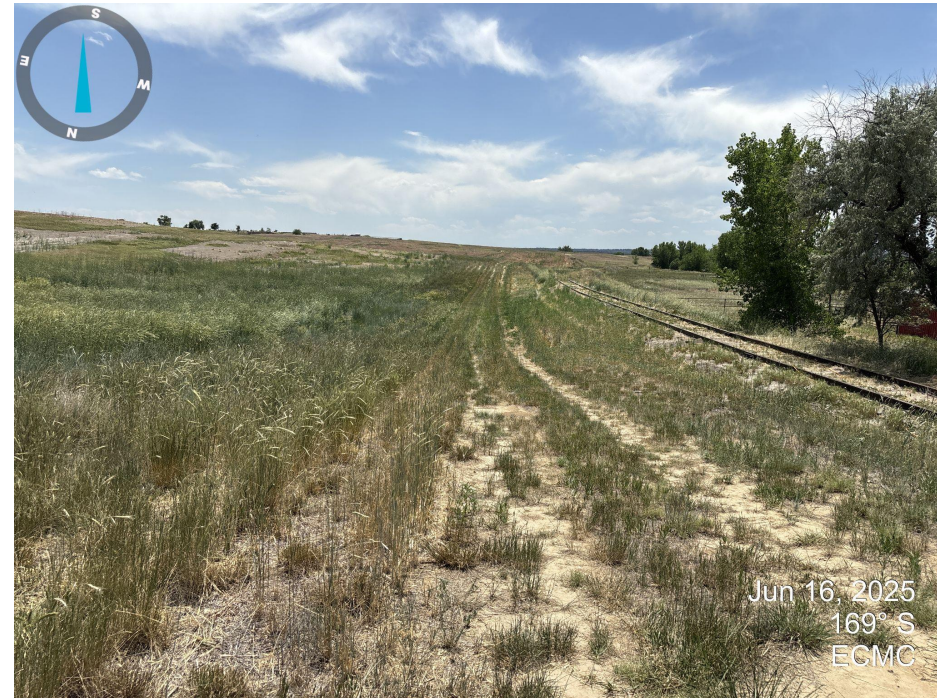
Photo 2. Picture taken at mid point of access road looking south towards location.

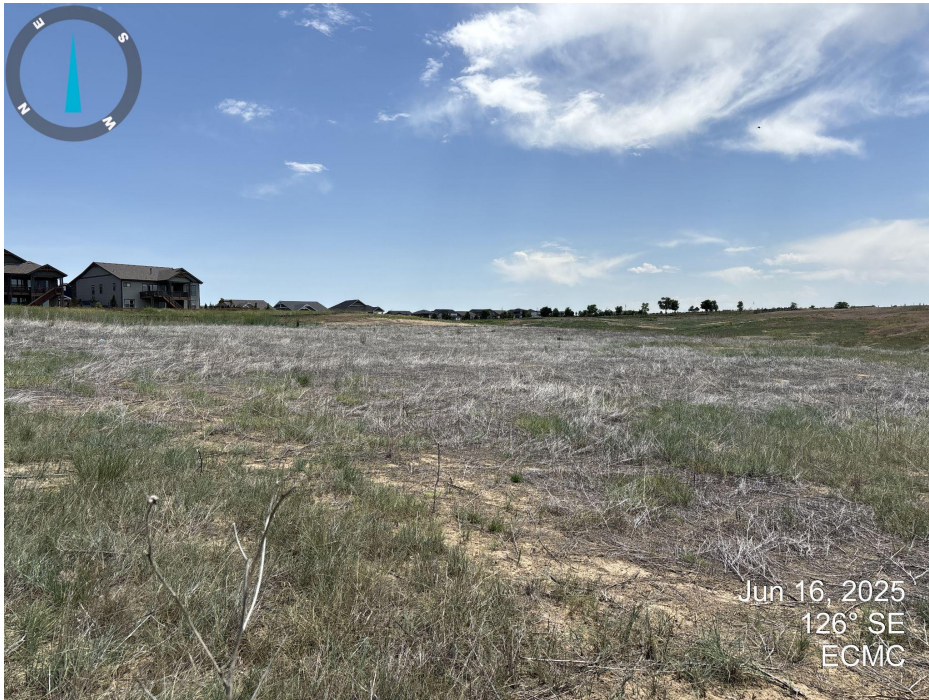
Photo 3. Looking southeast across the location. No oil and gas equipment remains. Undesirable weed Kochia is dominant throughout the location. Some desirable perennial vegetation is present.

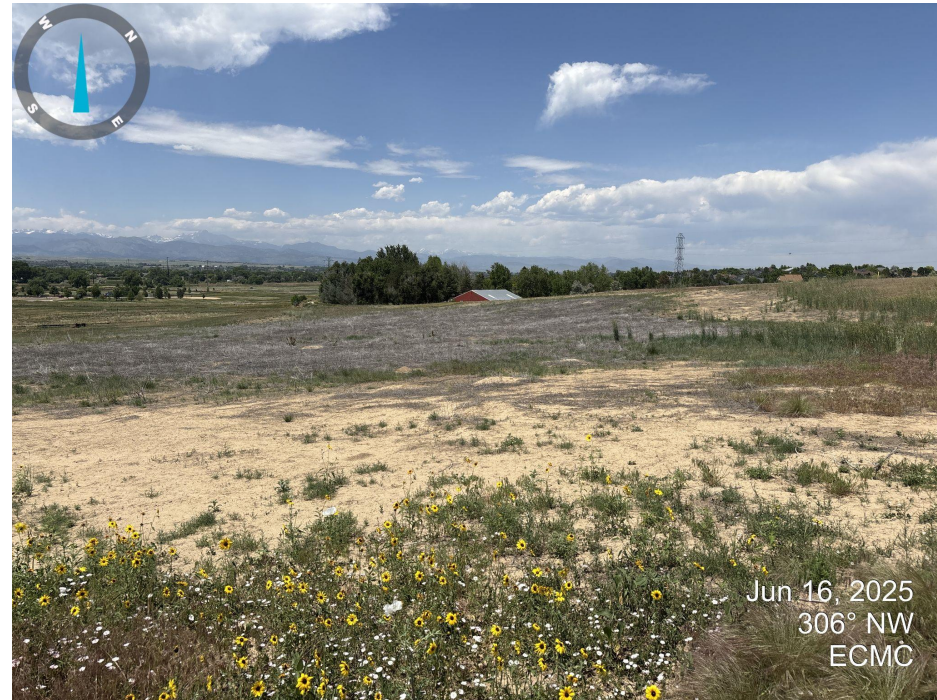
Photo 4. Looking northwest across the location. See photo 3 comments.

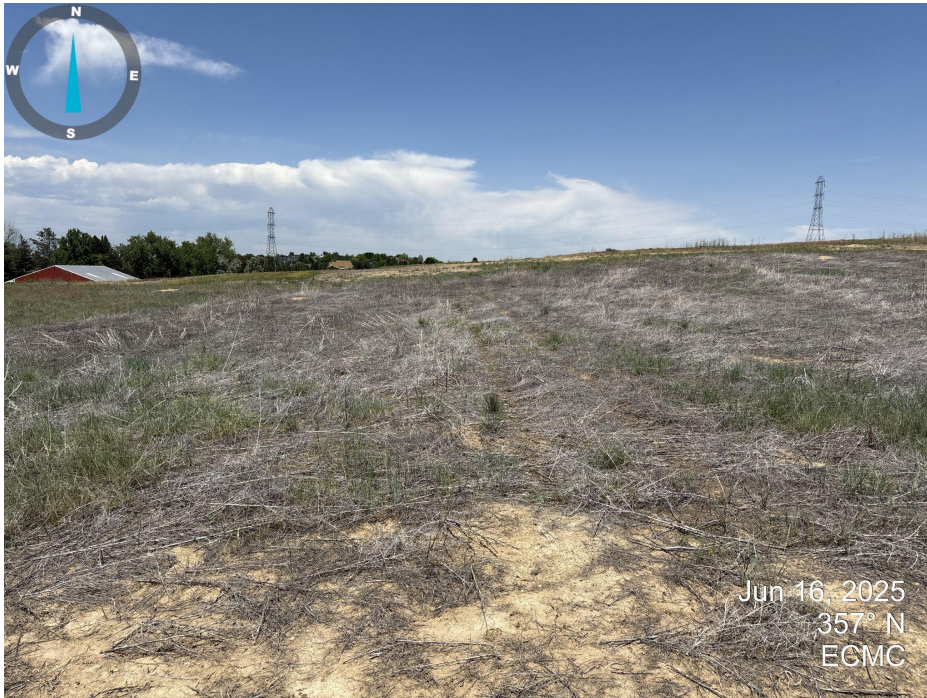
Photo 5. Looking north from the wellbore. Undesirable weed kochia is dominant throughout the location. Some desirable vegetation is present, but large areas of the location have little to no desirable vegetation establishment.

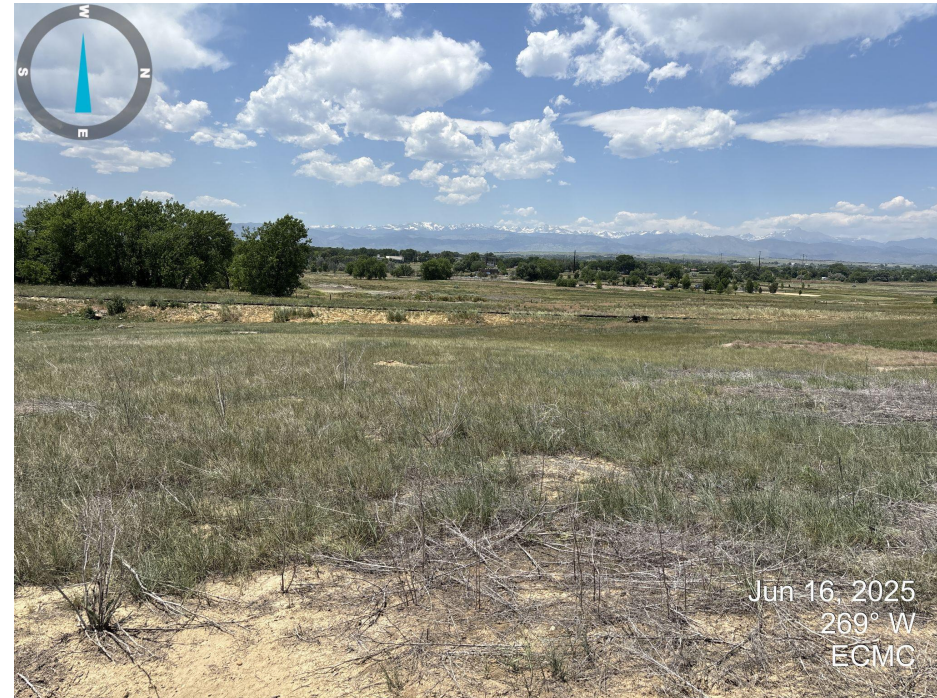
Photo 6. Looking west from the wellbore. See photo 5 comments.

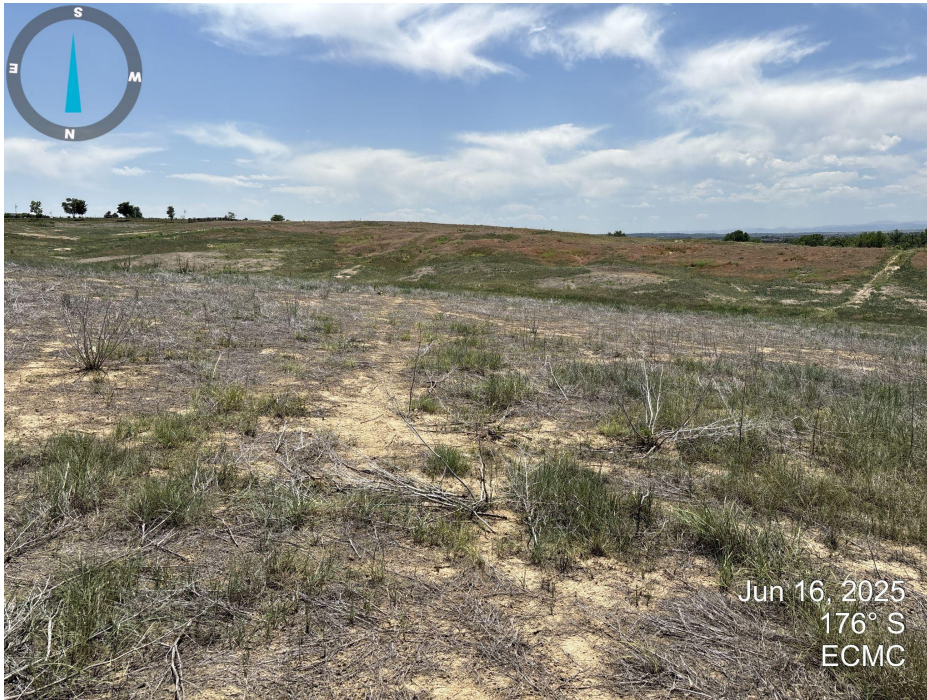
Photo 7. Looking south from the wellbore. See photo 5 comments.

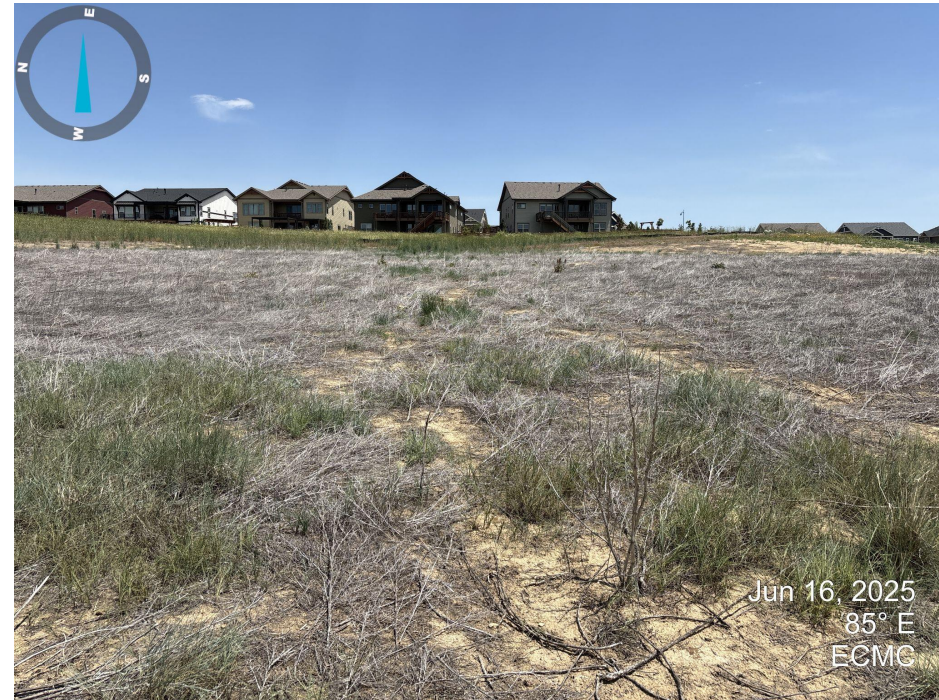
Photo 8. Looking east from the wellbore. See photo 5 comments.

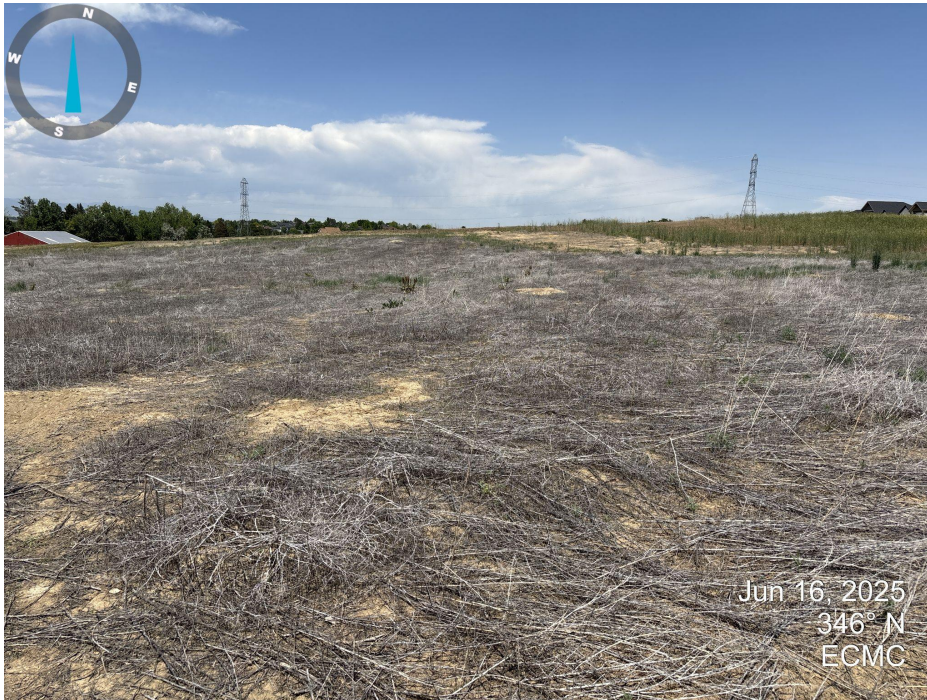
Photo 9. Looking north across the former tank battery on the north side of the location.

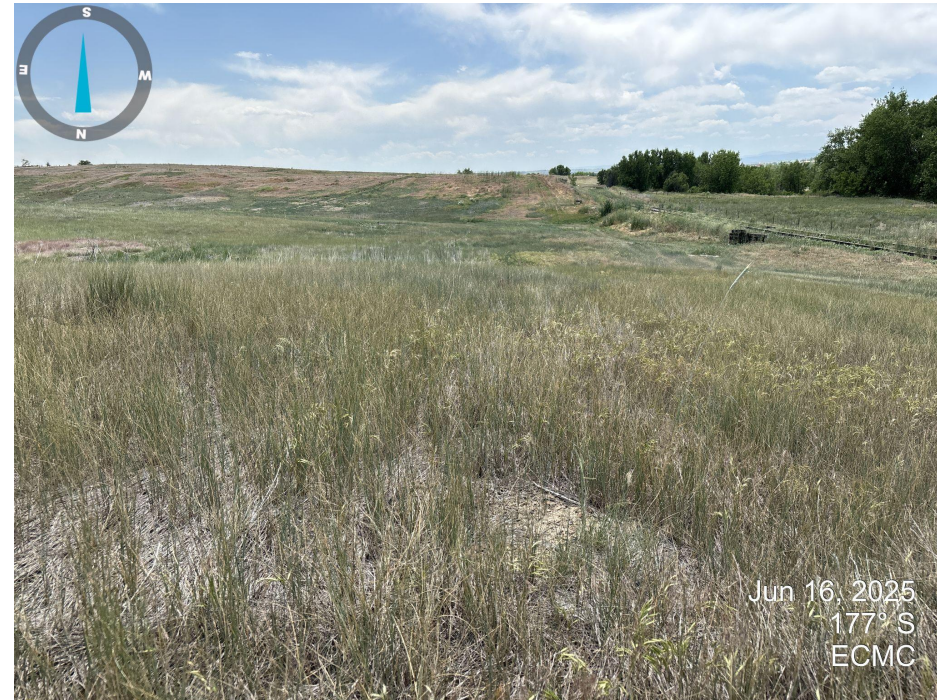
Photo 10. Reference vegetation to the west of the well location.

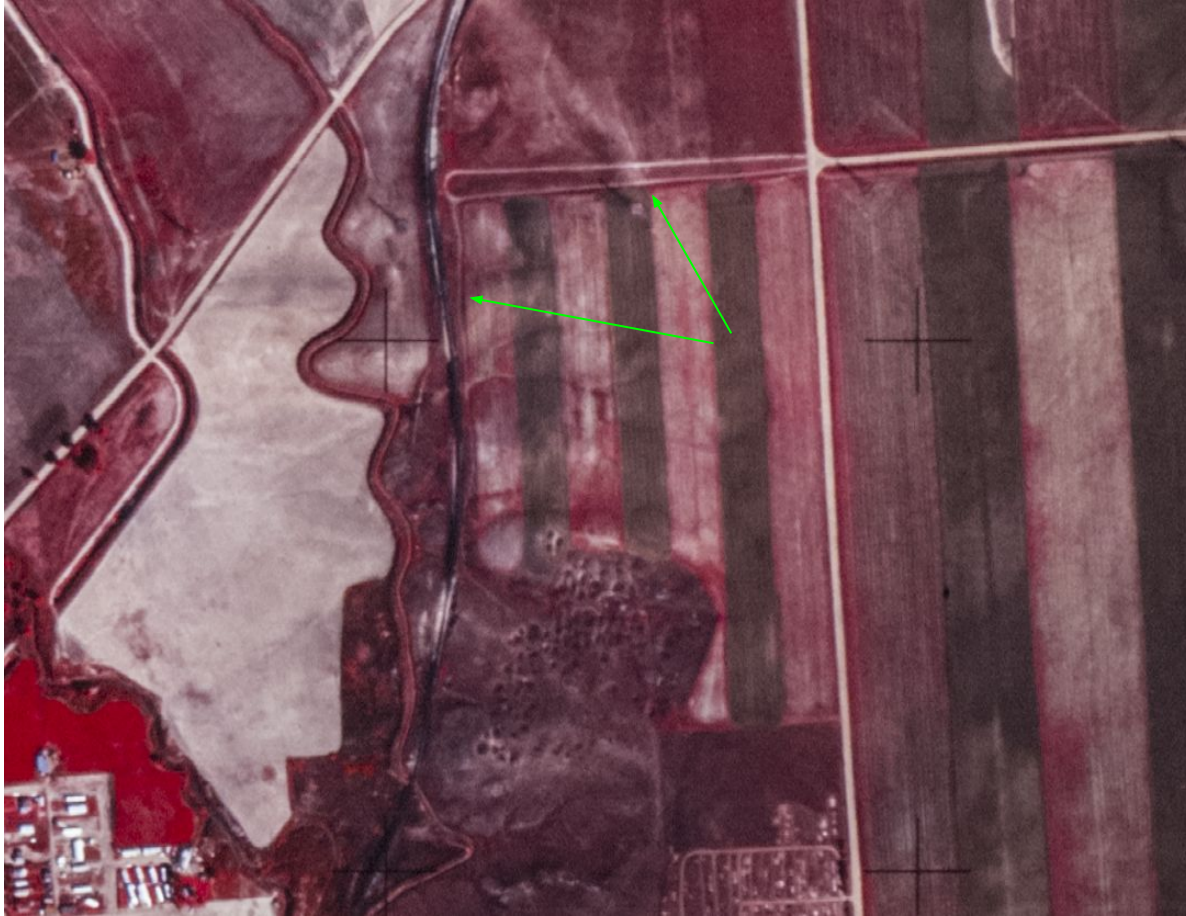
Photo 11. Aerial photo taken 09/21/1972. It appears the majority of the access road was pre existing prior to oil and gas development (green arrows).
