Inspection/Audit Photos

Location: TEP ROCKY MOUNTAIN LLC NOLTE 14-44 PAD

Location ID: 334568

Date: 06/17/2025

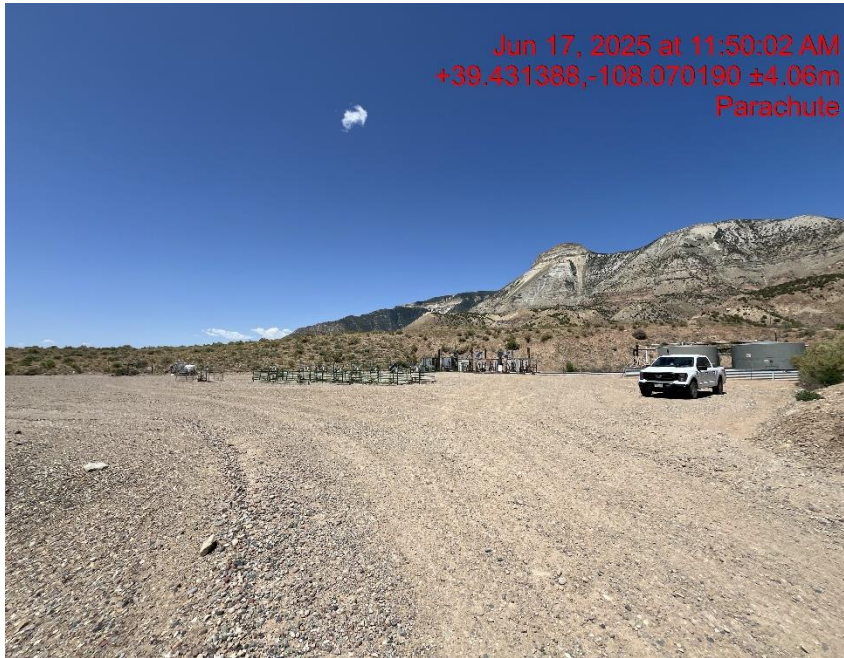
Photo # 8631 Entrance to location

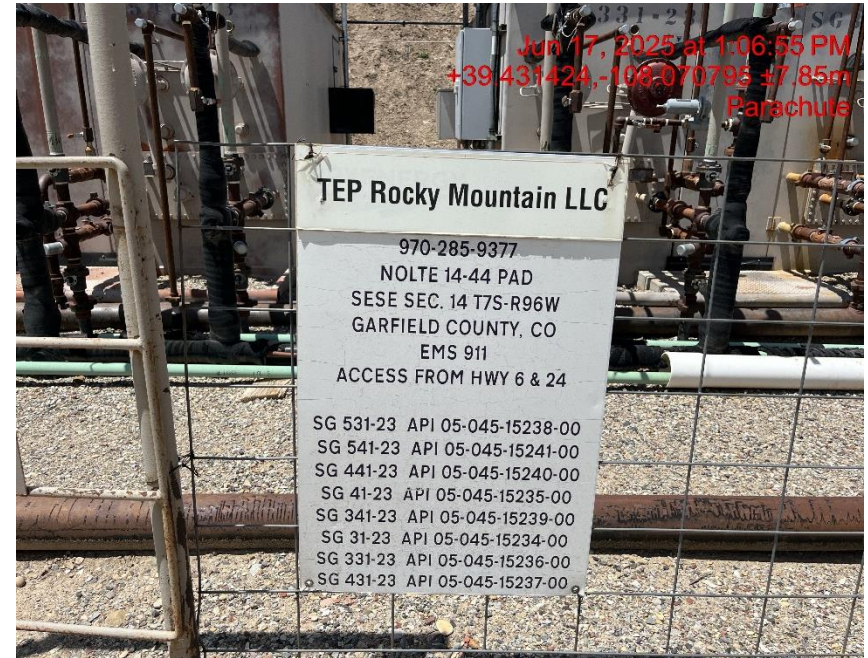
Photo # 8716 Battery sign lacks well info/not in compliance with CECMC rules

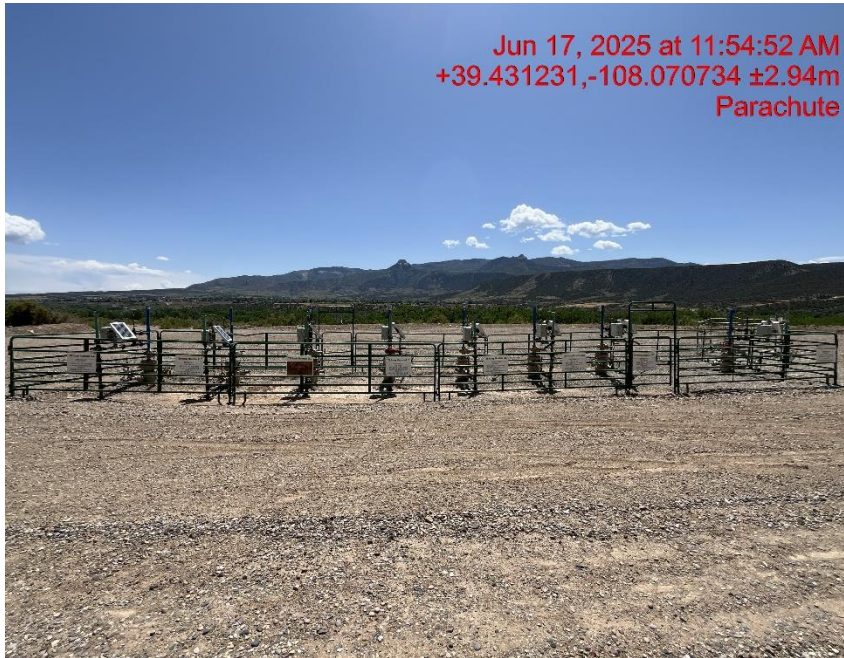
Photo # 8633 Location

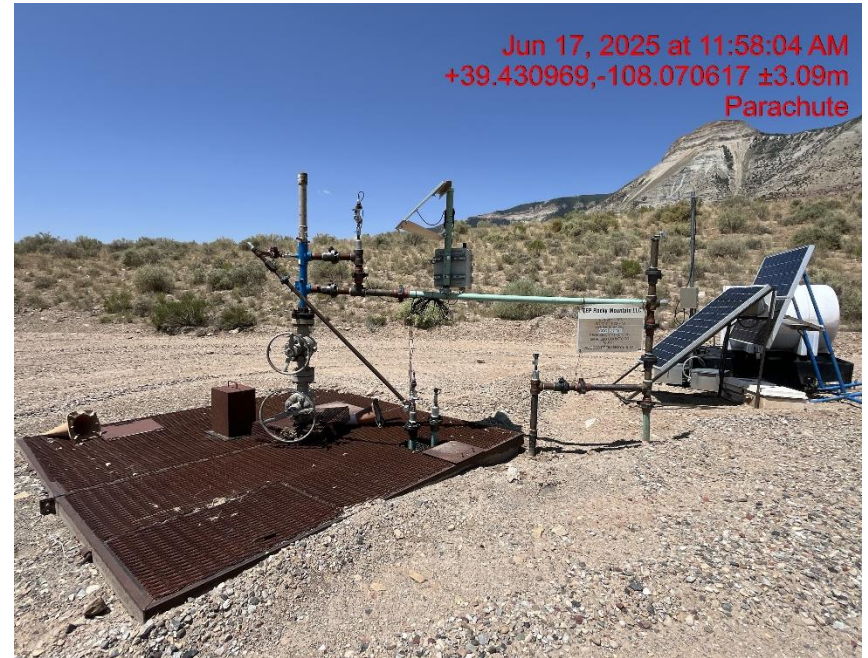
Photo # 8635 Location

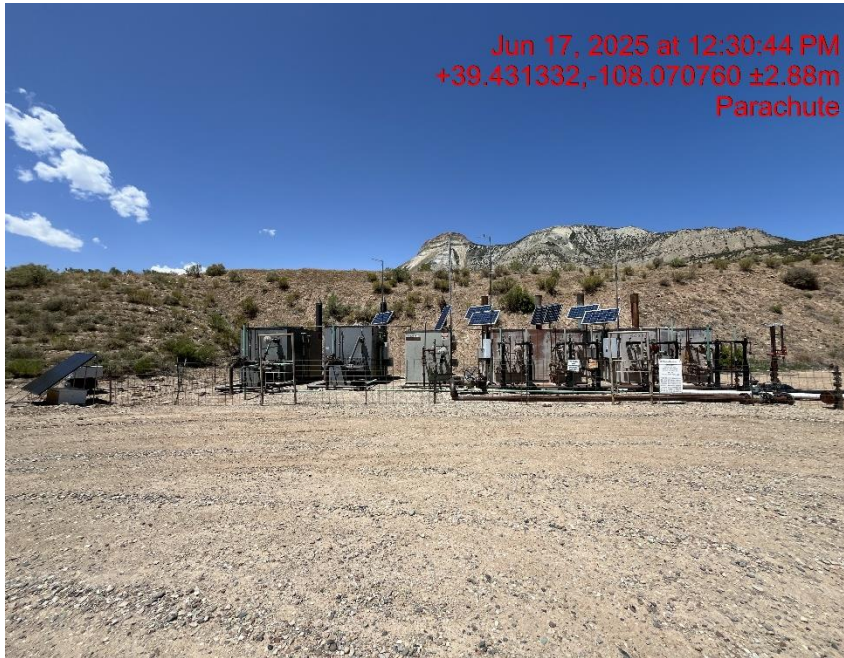
Photo # 8668 Location

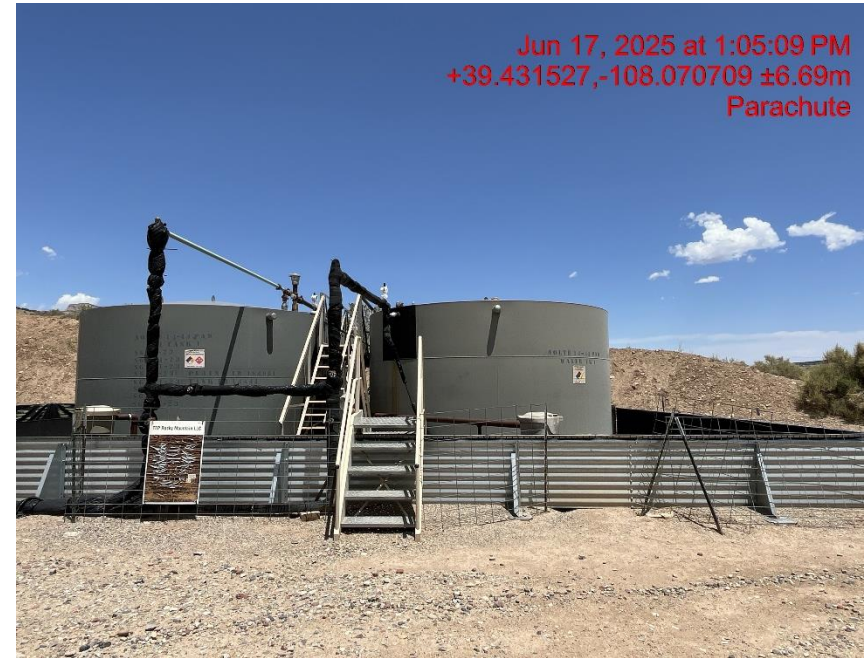
Photo # 8714 Location

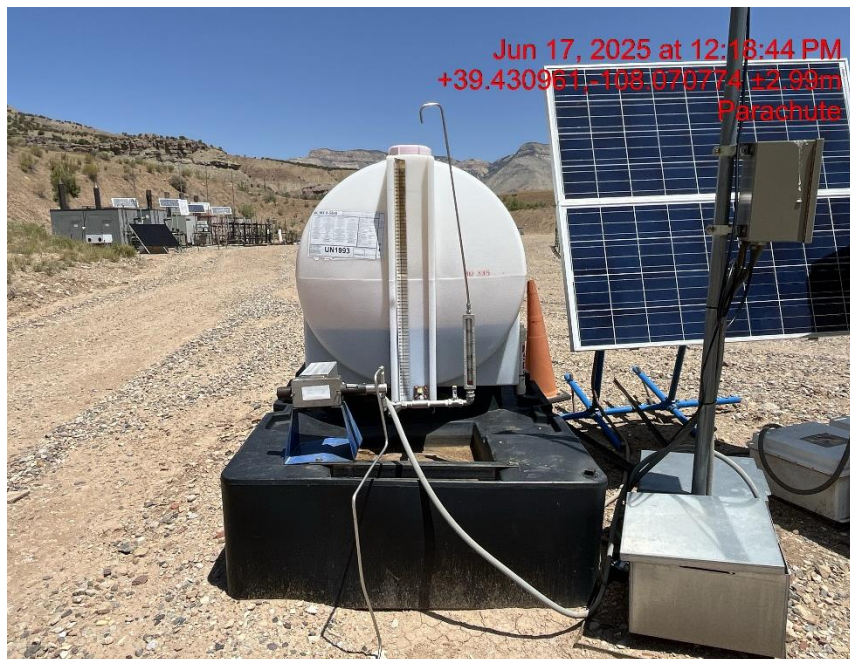
Photo # 8667 Chemical tank - Equipment does not appear to be in operators Form 2A or a Form 4 Sundry as required by CECMC rules.

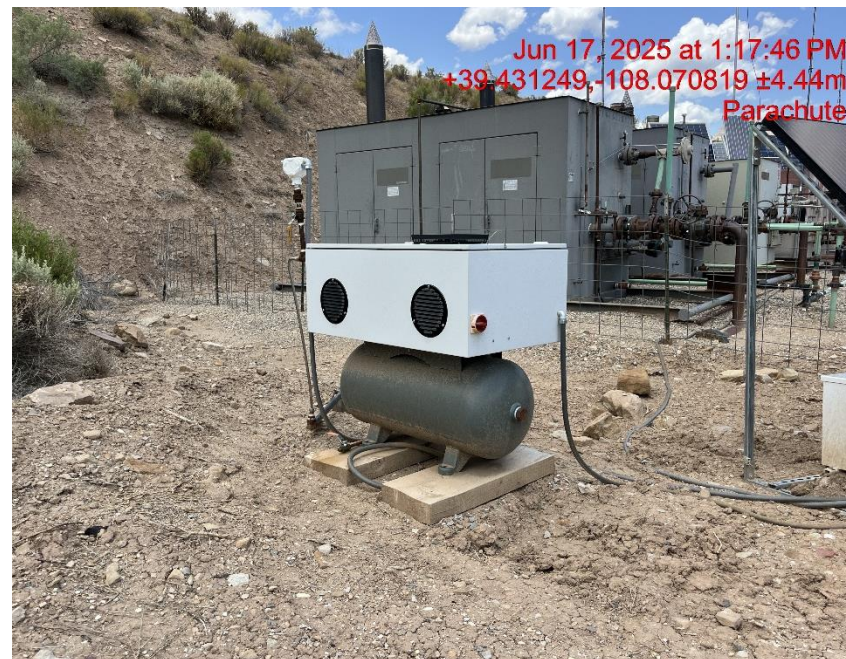
Photo # 8731 Air compressor - Equipment does not appear to be in operators Form 2A or a Form 4 Sundry as required by CECMC rules.

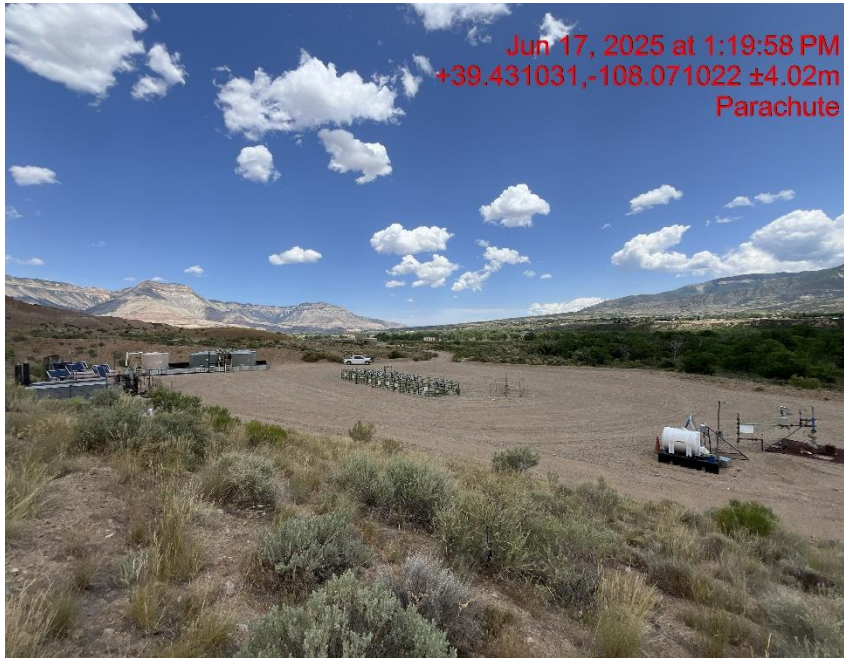
Photo # 8732 SW corner of location

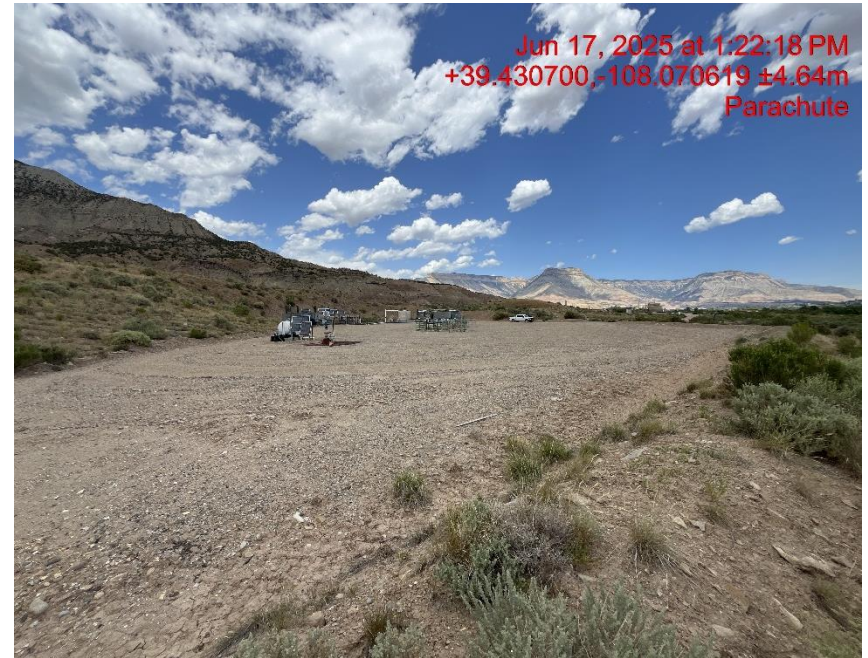
Photo # 8733 SE corner of location

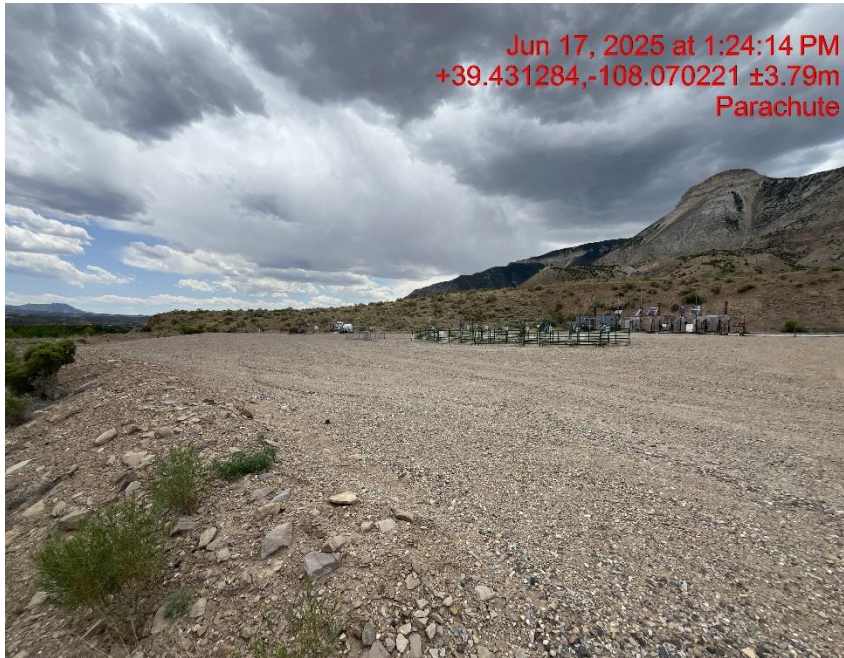
Photo # 8734 NE corner of location

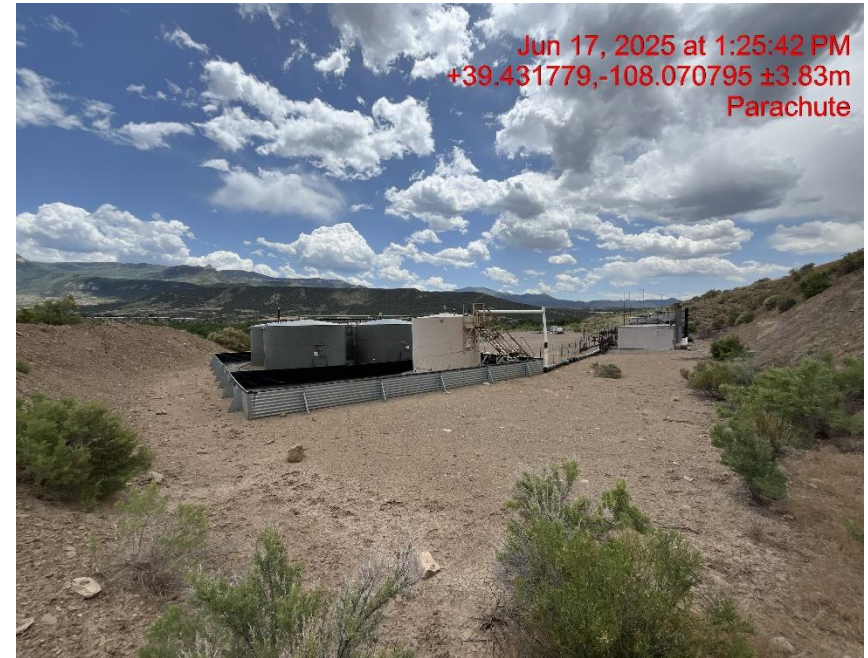
Photo # 8735 NW corner of location

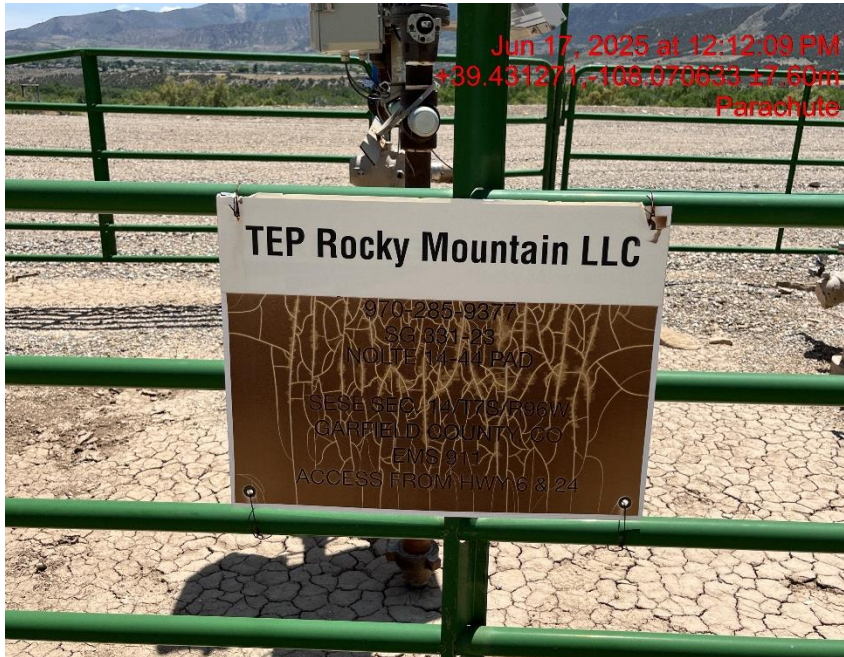
Photo # 8660 Wellhead sign is not legible

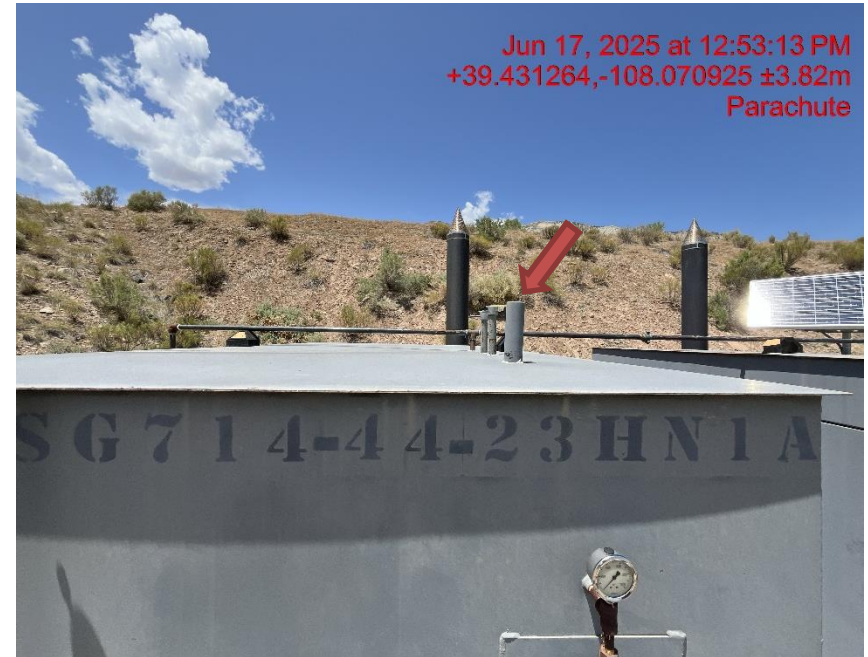
Photo # 8693 PRV vent line does not comply with CECMC pressure safety device rules

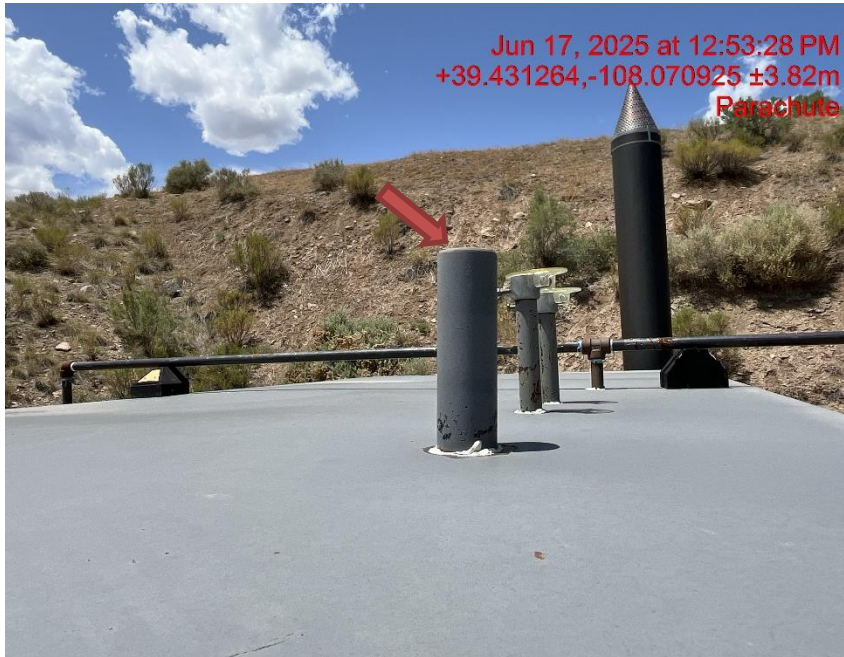
Photo # 8694 PRV vent line does not comply with CECMC pressure safety device rules

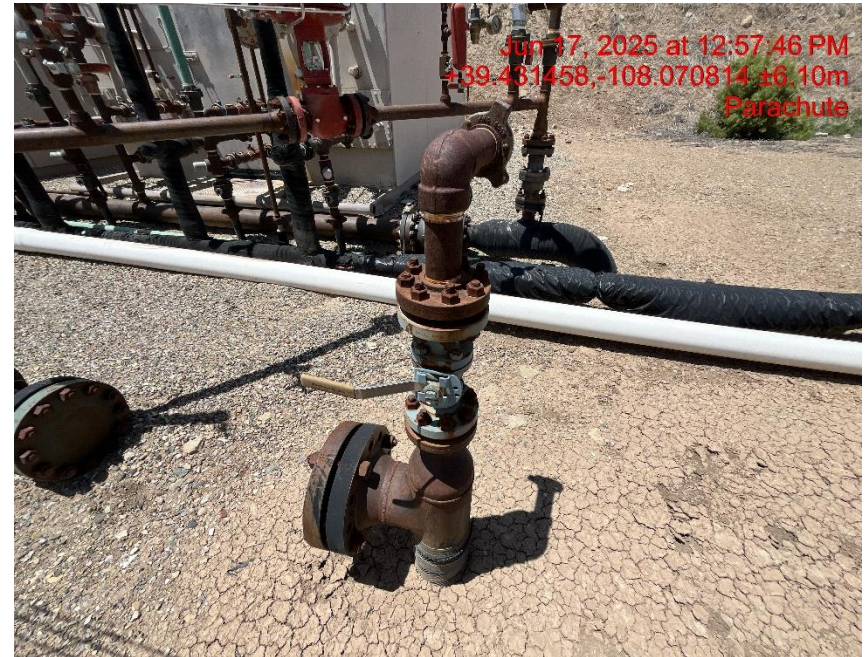
Photo # 8700 Unused flowline does not comply with CECMC 600 & 1100 series rules

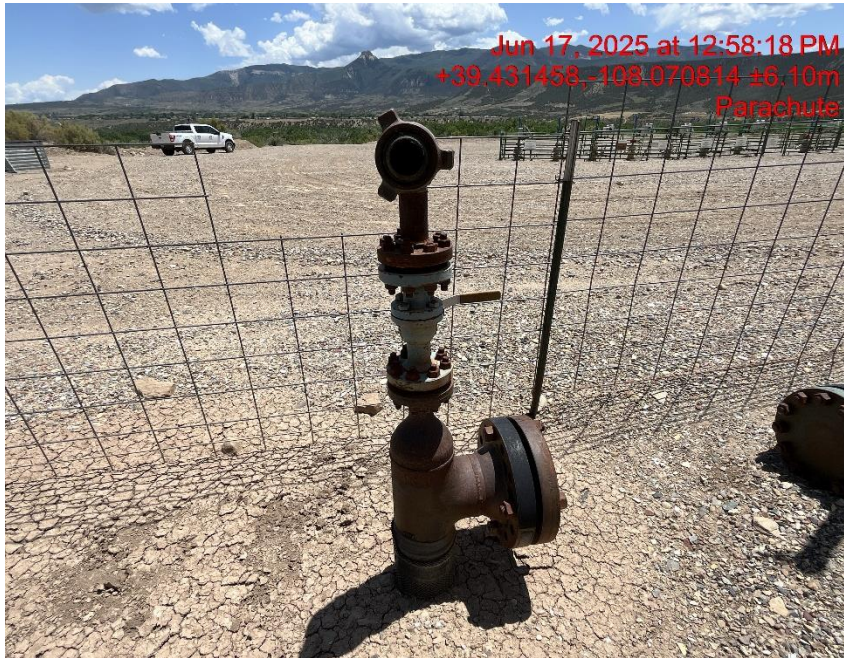
Photo # 8702 Unused flowline does not comply with CECMC 600 & 1100 series rules

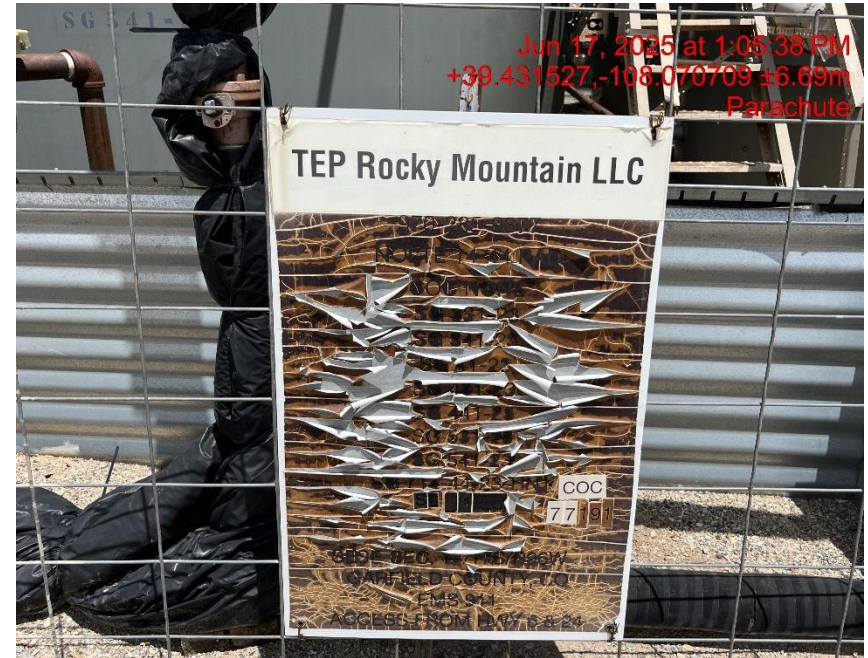
Photo # 8715 2ND Battery sign not legible

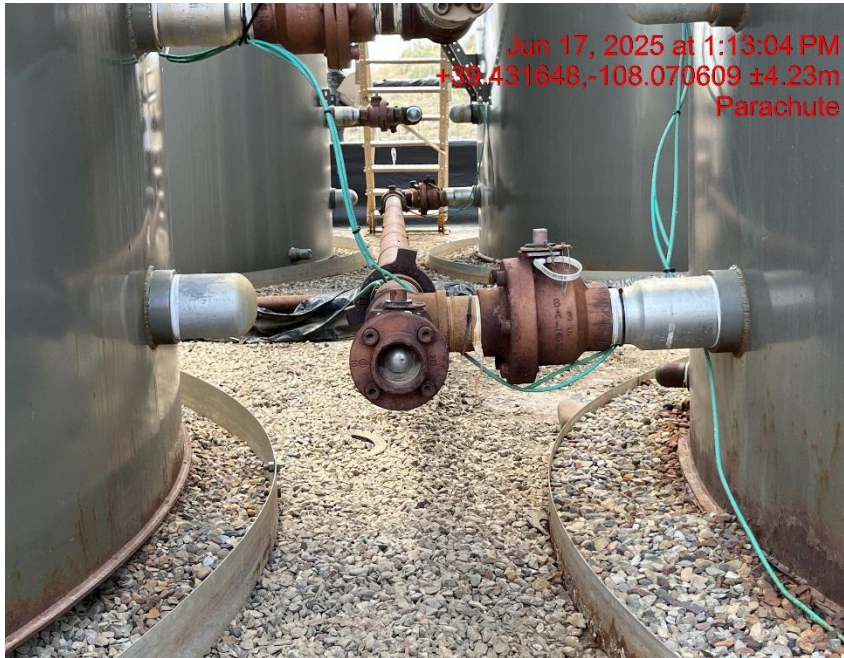
Photo # 8724 Open ended load line

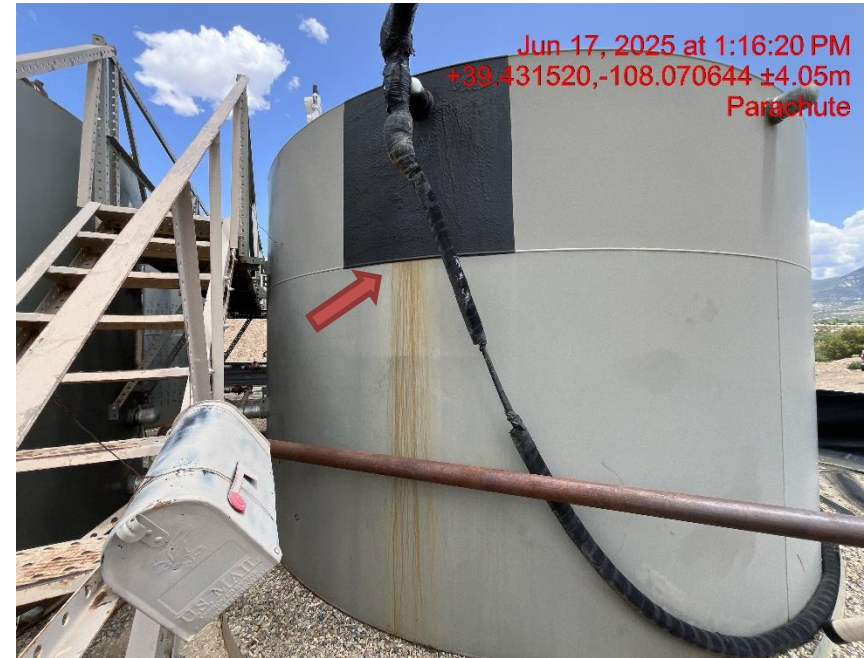
Photo # 8728 Suspected leaks on tank 1 production tank/tank appears to lack integrity

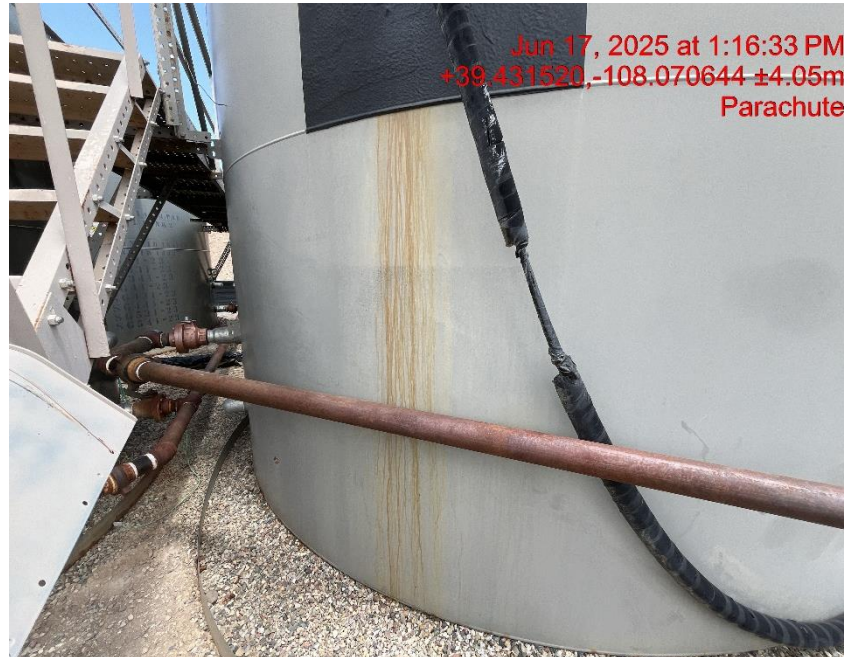
**Photo # 8730 Suspected leaks on tank 1 production
tank/tank appears to lack integrity**
