# LOWE B 2

## Photo Log

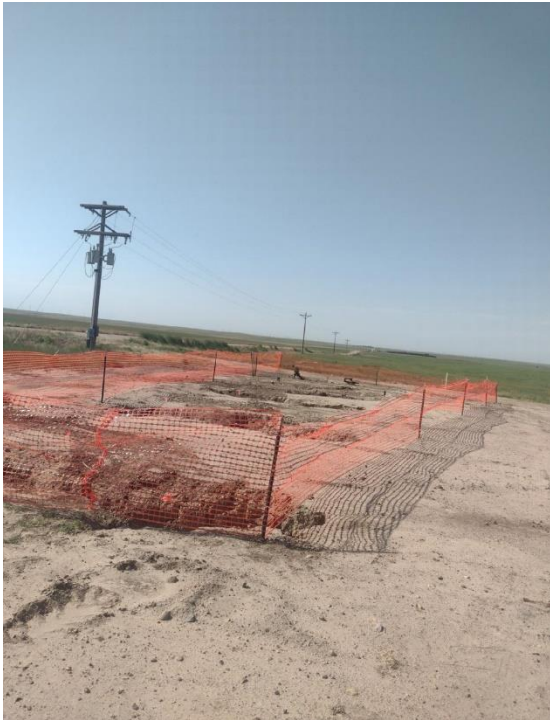
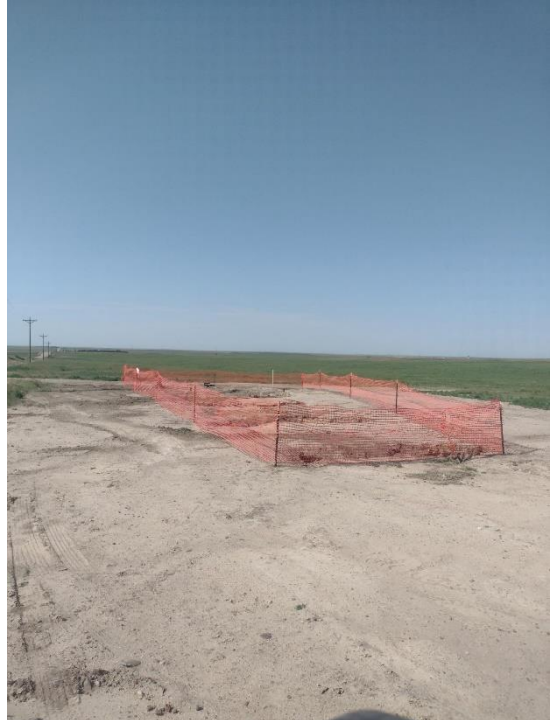
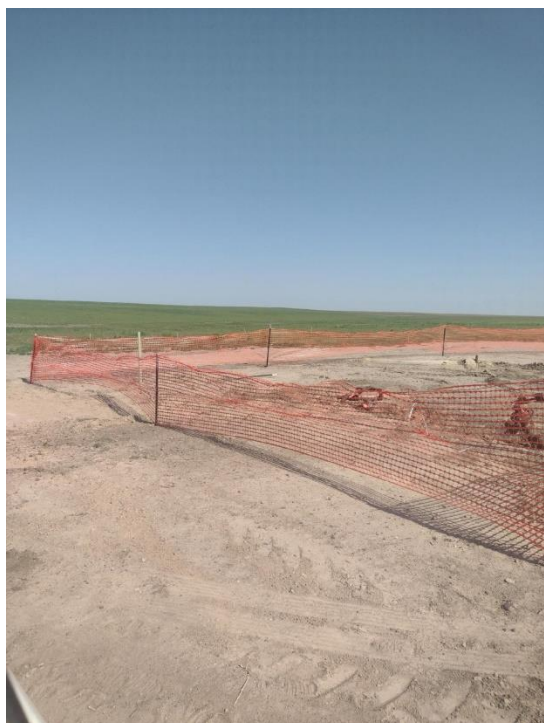
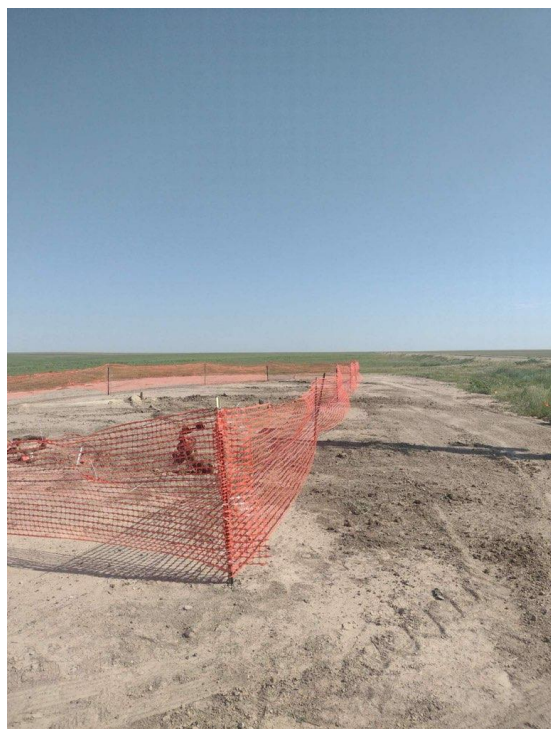
**Inspection Comment:** Fence posts with pieces of plastic tape have been installed at the excavations/trenches and depressions; no fencing was visible.

Photos are of fencing around the entire excavation around the tank battery

**Corrective Action Requested:** Secure access to excavation in accordance with Rule 913.b.(5).B.i and ECMC Guidance 913.b.(5)B i-v.

**Description of Compliance:** Fencing has been installed.
