Final Reclamation Inspection

Operator: NOBLE ENERGY INC - 100322

Location ID: 329909

Inspection Document #: 718800409

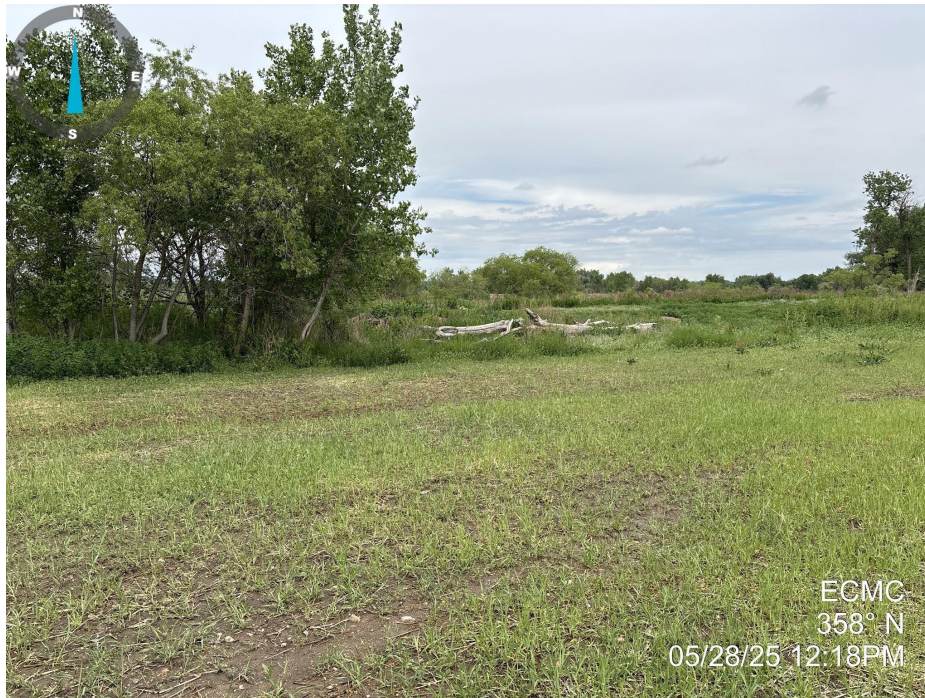
Photo 1. Photo taken from the well location, facing North. Photo illustrates that final reclamation activities have taken place, with evidence of drill row seeding and straw mulch, but vegetation has not yet established to Rule 1004 standards.

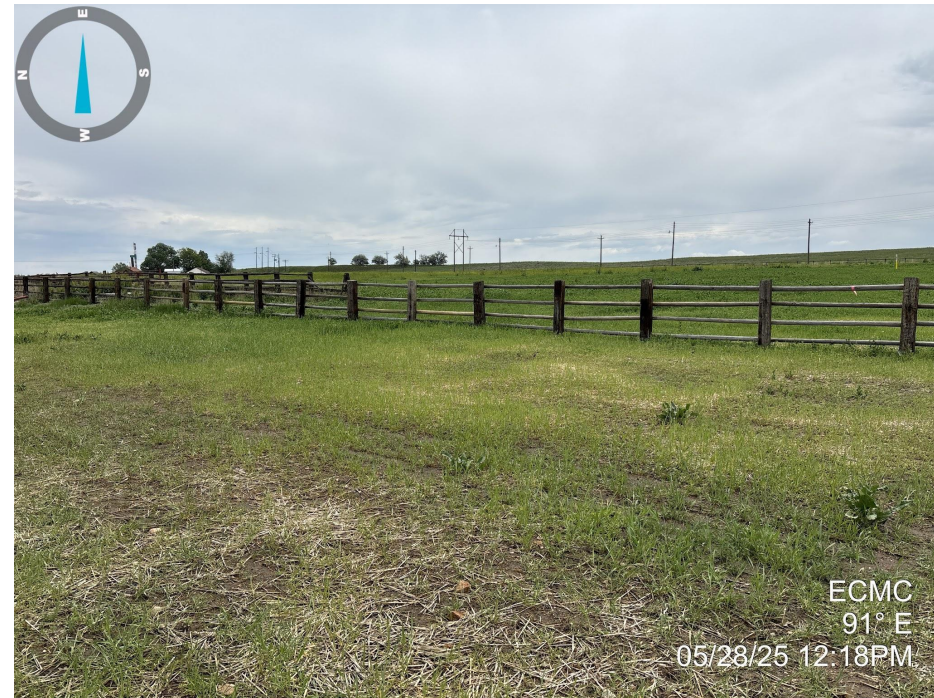
Photo 2. Photo taken from the well location, facing East. See comments under Photo 1.

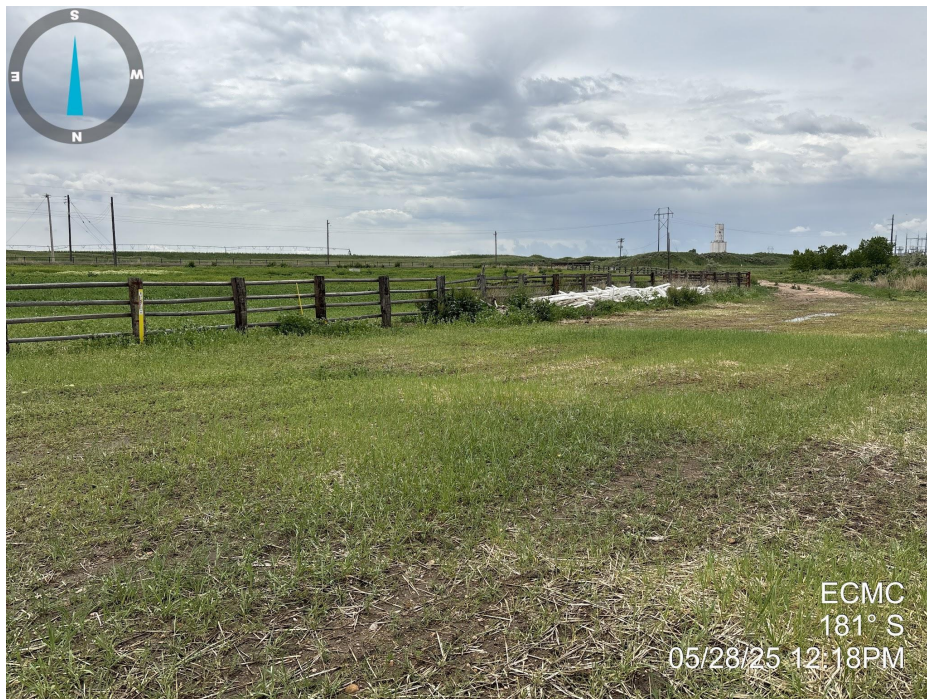
Photo 3. Photo taken from the well location, facing South. See comments under Photo 1.

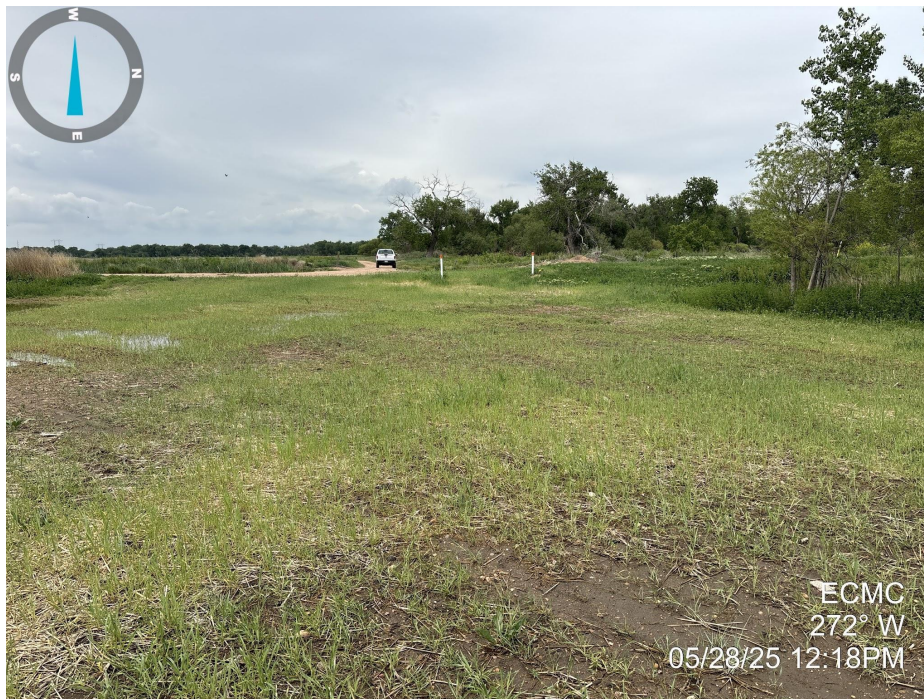
Photo 4. Photo taken from the well location, facing West. See comments under Photo 1.

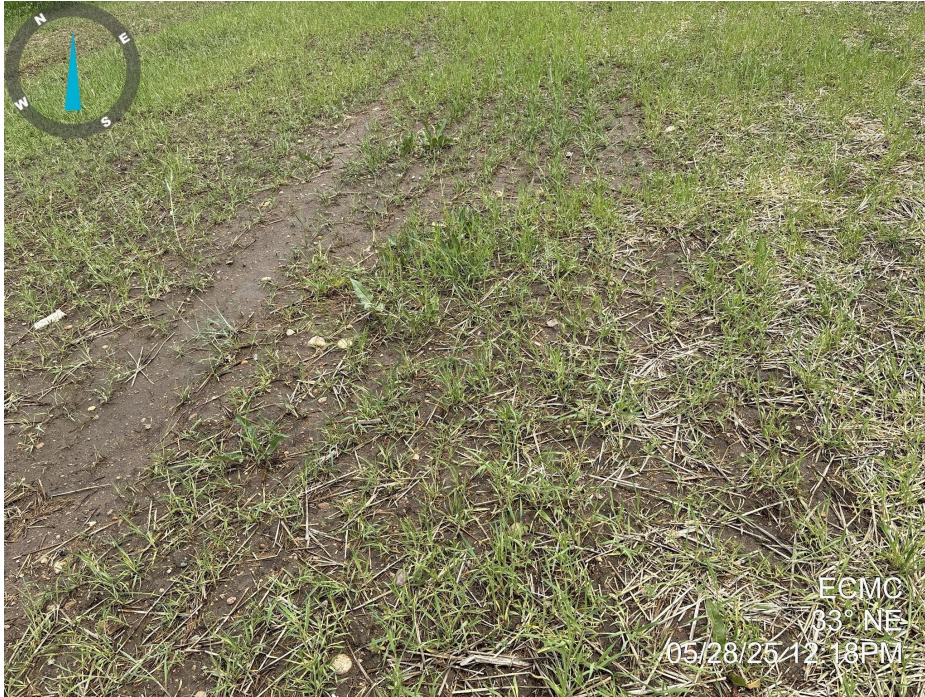
Photo 5. Photo taken of ground cover at the well location. Photo illustrates that final reclamation activities have taken place, but vegetation has not established to Rule 1004 standards.

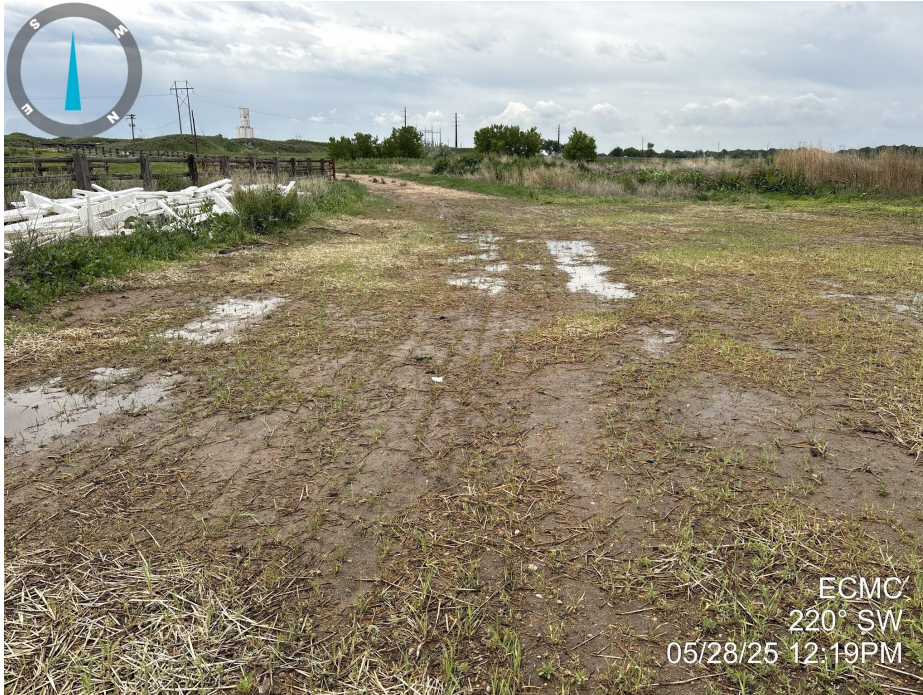
Photo 7. Photo taken of the access road, facing Southwest away from the location. Photo illustrates that final reclamation activities appear to have taken place, with evidence of drill row seeding and straw mulch, but vegetation has not established to Rule 1004 standards.

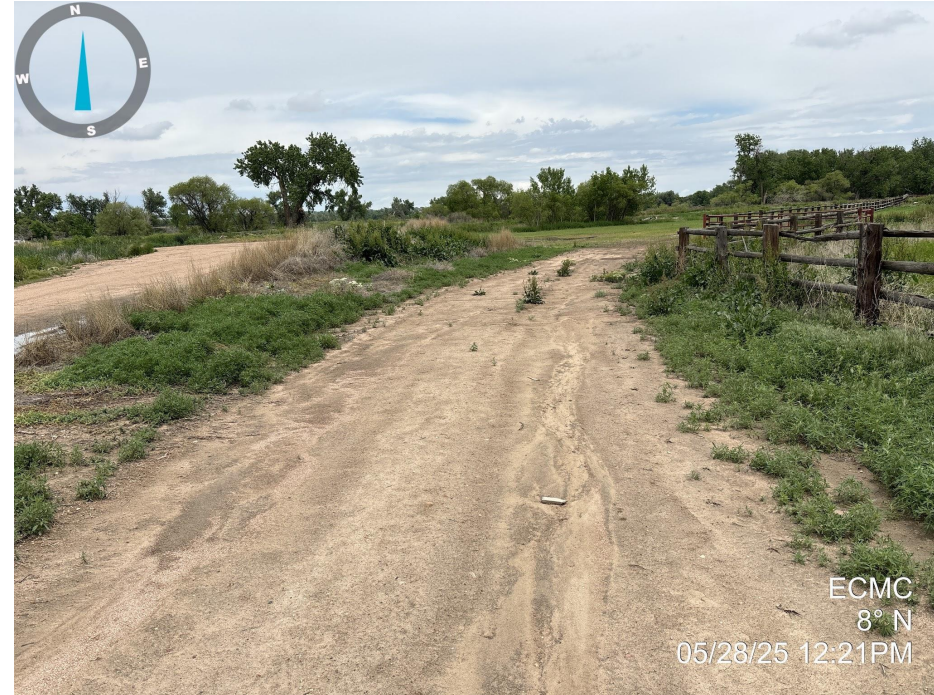
Photo 8. Photo taken of the entrance of the access road, facing North towards the location. Photo illustrates that bare ground remains along this portion of the access road.

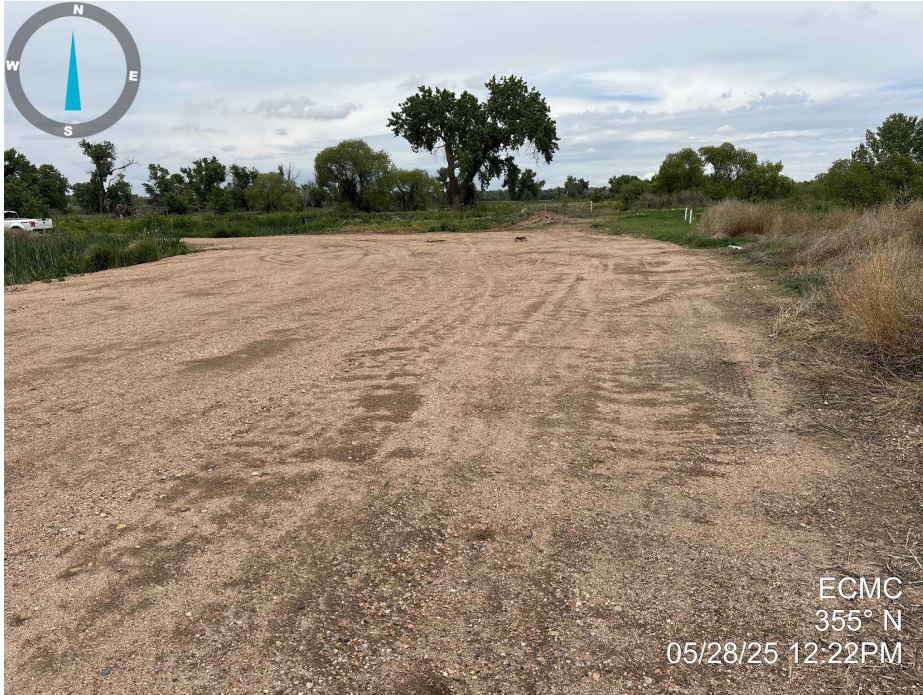
Photo 9. Photo taken of the tank battery location, facing North. Photo illustrates that final reclamation activities do not appear to have taken place as bare ground and gravel remain across the location.

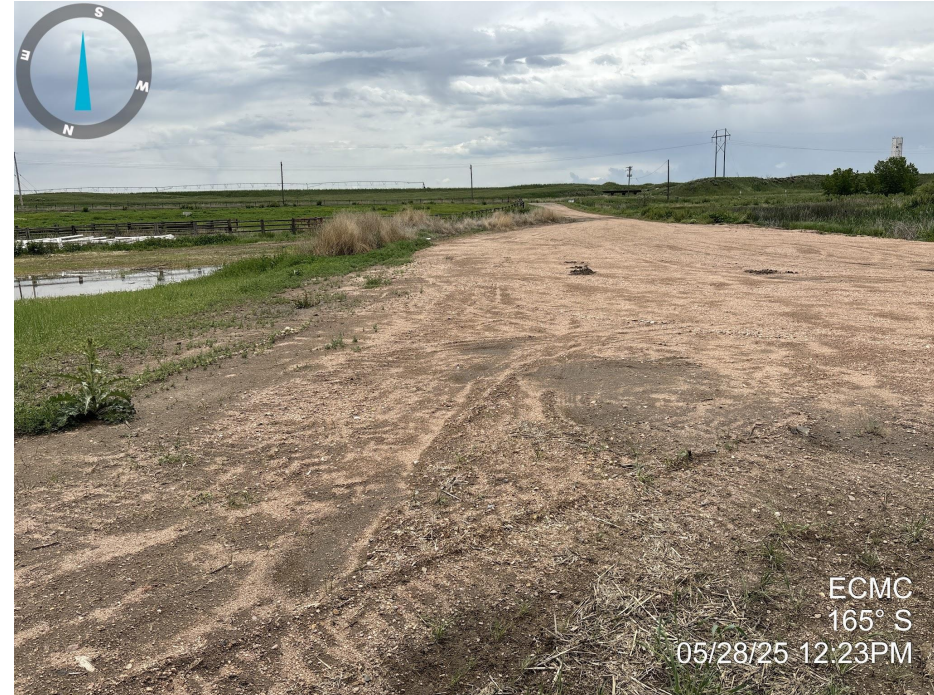
Photo 10. Photo taken of the tank battery location, facing South. See comments under Photo 9.

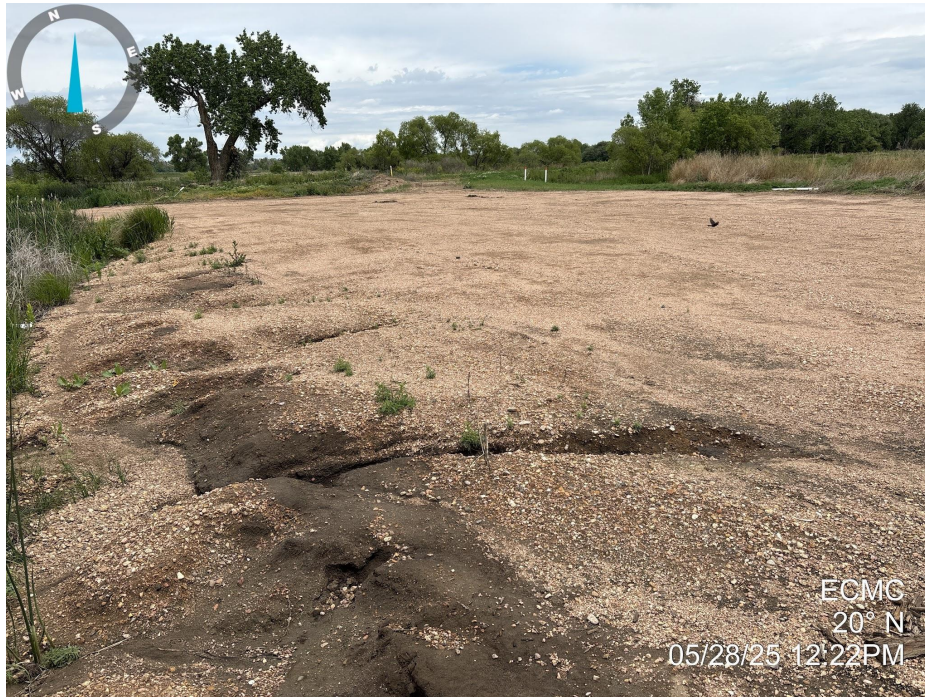
Photo 11. Photo taken of the access road, facing North towards the tank battery location. Photo illustrates stormwater erosion along the western portion of the access road.

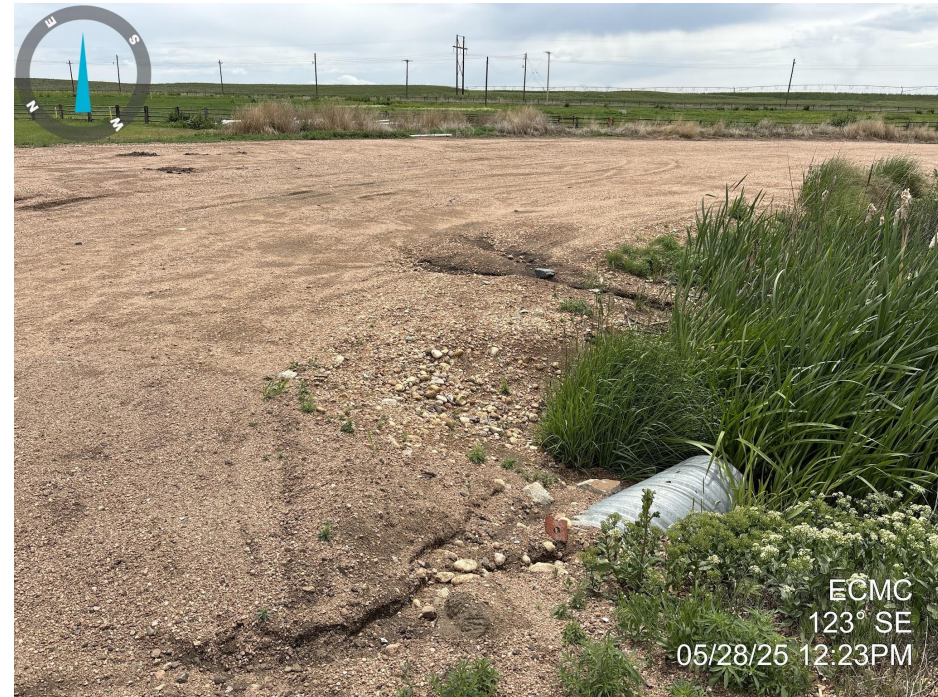
Photo 12. Photo taken of the access road adjacent to the tank battery location, facing Southeast. Photo illustrates erosion along the edge of the access road and around the culvert.
