NININGER 11-1-1645

Photo Log

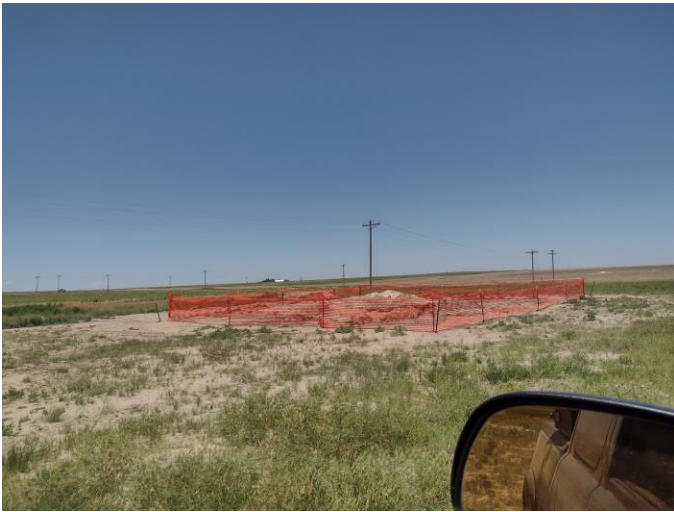
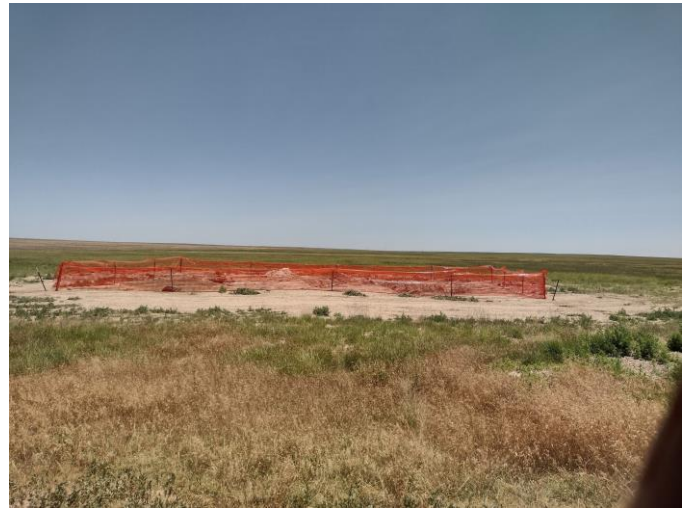
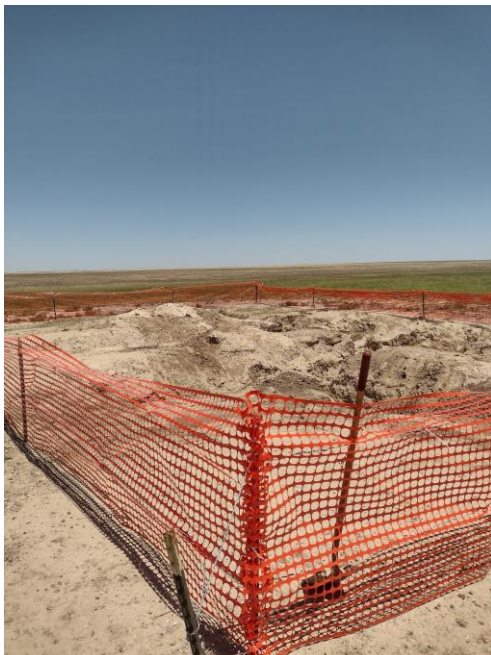
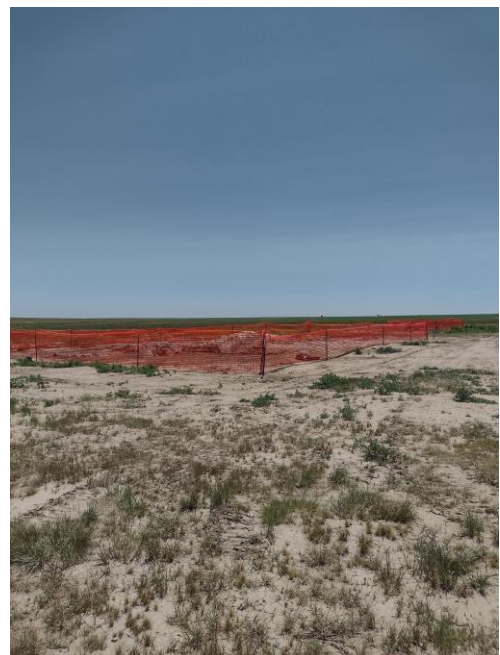
Inspection Comment: Fence posts and a single metal wire have been installed around one of the open excavations but do not adequately limit access.

Photos are fencing around the entire Nininger Tank Battery excavation.

Corrective Action Requested: Secure access to excavation in accordance with Rule 913.b.(5).B.i and ECMC Guidance 913.b.(5)B i-v.

Description of Compliance: Excavation area secured with fencing per Rule 913.b.(5)
