Final Reclamation Inspection

Operator: NOBLE ENERGY INC - 100322

Location ID: 331036

Inspection Photos
Location Name: DANIELS K-64N66W/5SESW
Location ID: 331036

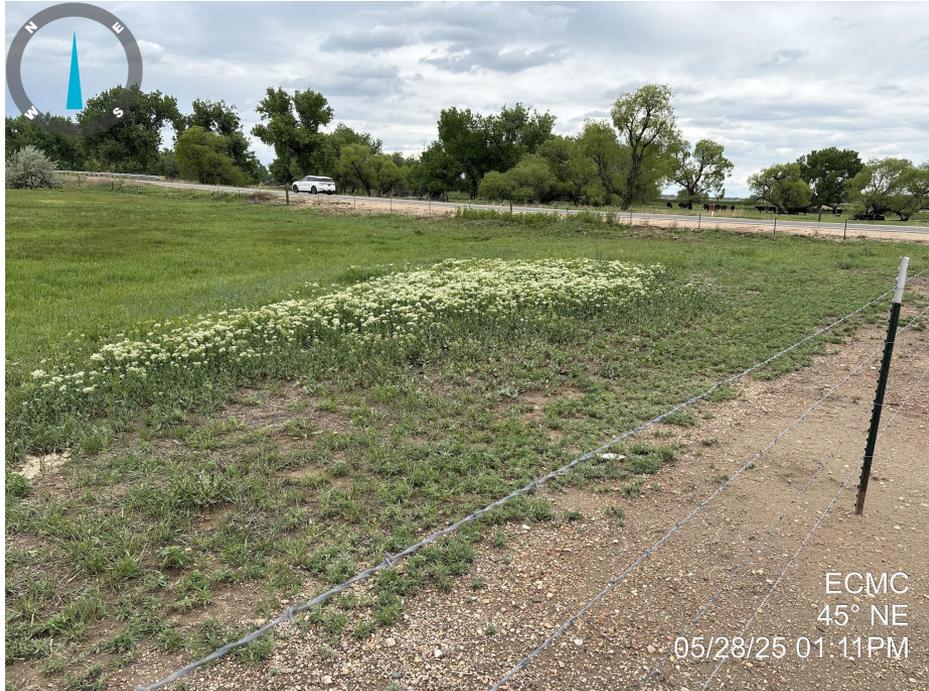
Photo 1. Photo taken of the tank battery location, facing Northeast. Photo illustrates that final reclamation activities have taken place, but vegetation has not established to Rule 1004 standards and the location is dominated by weedy annual vegetation.

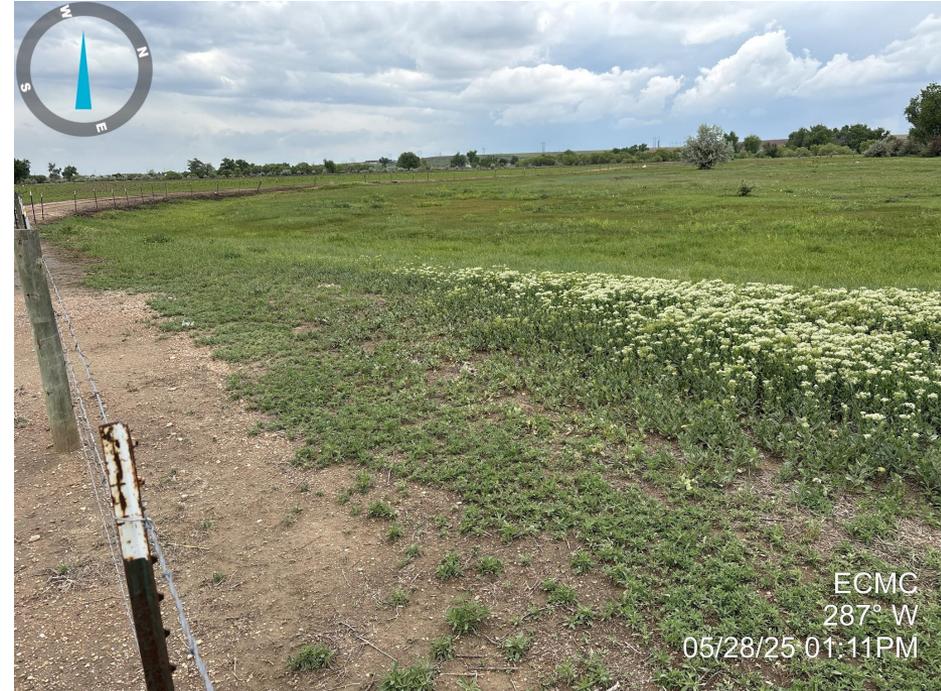
Photo 2. Photo taken of the tank battery location, facing West. See comments under Photo 1.

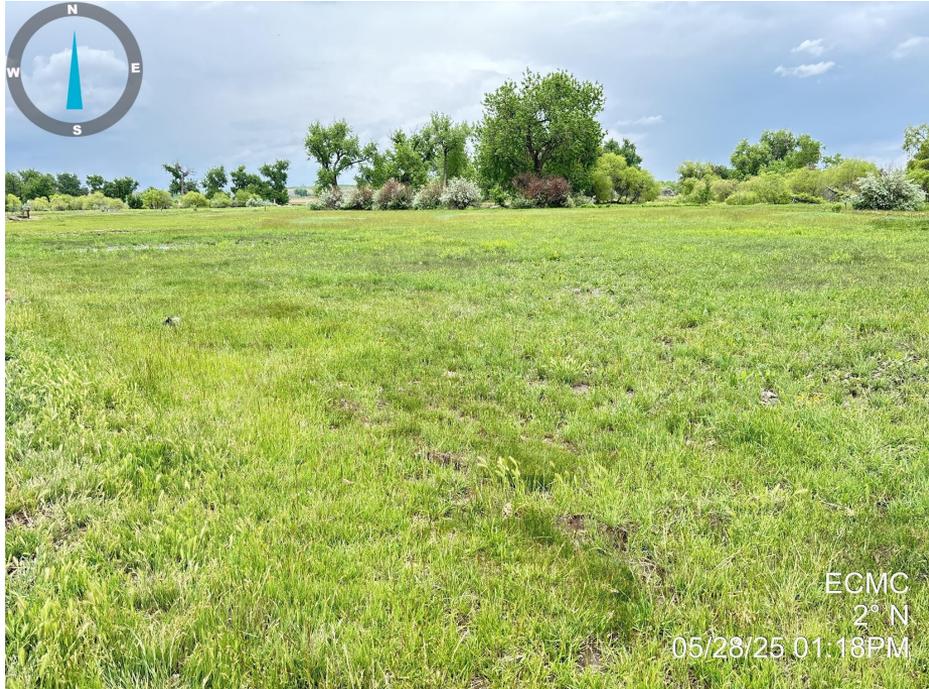
Photo 3. Photo taken from the multi-well location, from well API# 123-20058 (DANIELS K #5-14 X), facing North. Photo illustrates that the well location meets Rule 1004 standards.

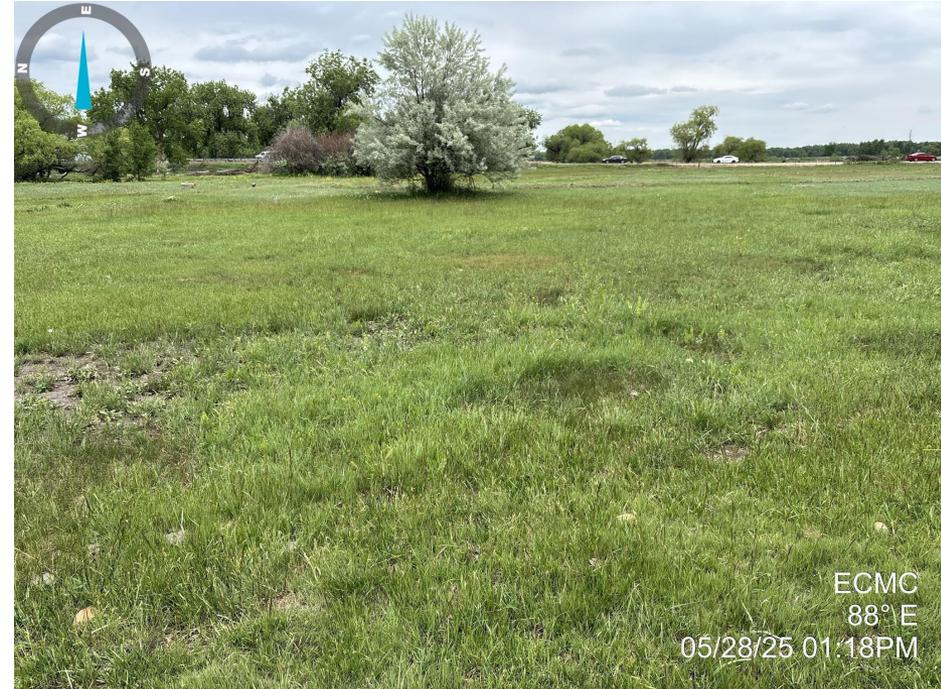
Photo 4. Photo taken from the well location, from well API# 123-20058 (DANIELS K #5-14 X), facing East. See comments under Photo 3.

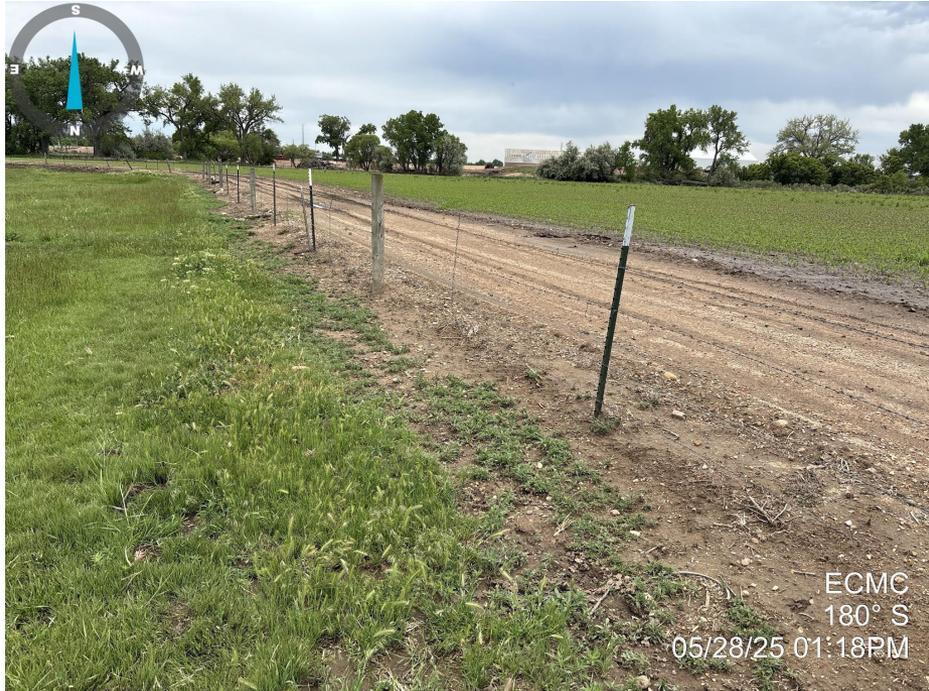
Photo 5. Photo taken from the multi-well location, from well API# 123-20058 (DANIELS K #5-14 X), facing South. See comments under Photo 3.

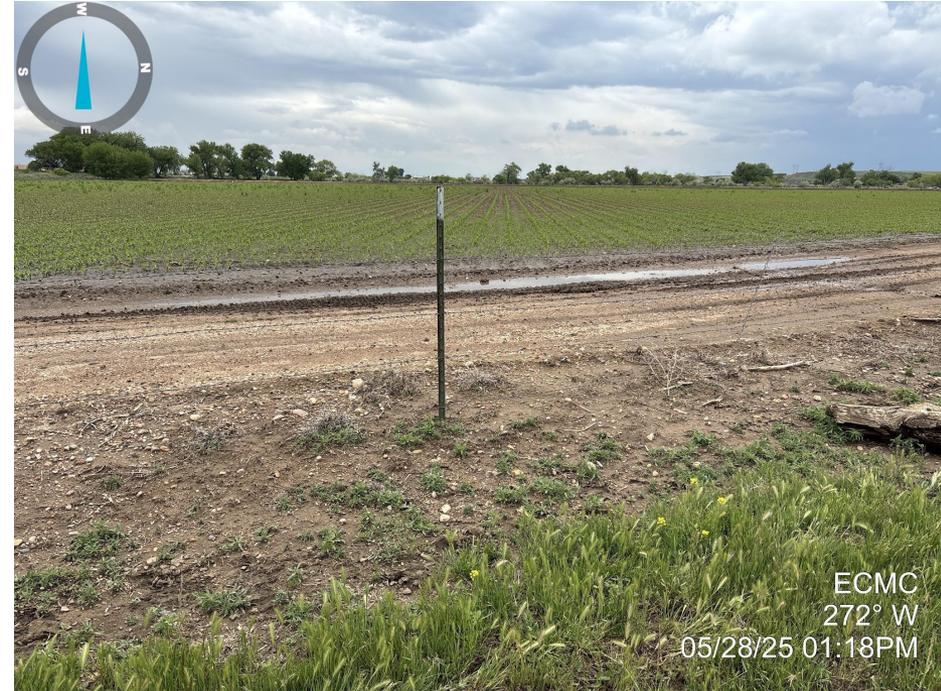
Photo 6. Photo taken from the multi-well location, from well API# 123-20058 (DANIELS K #5-14 X), facing West. See comments under Photo 3.

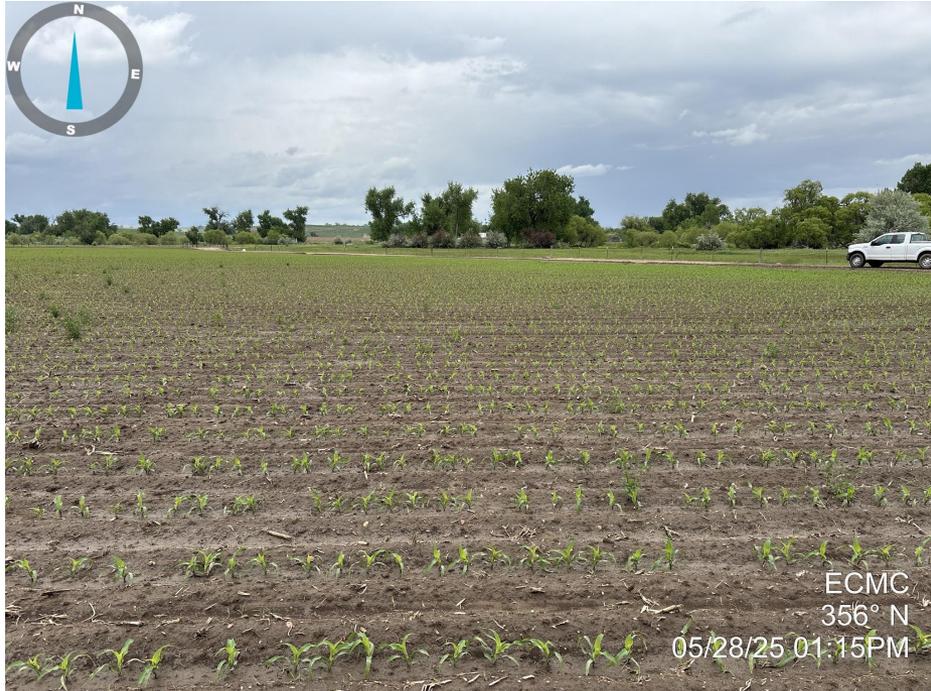
Photo 7. Photo taken from the multi-well location, from well API# 123-18028 (DANIELS #5-1416), facing South. Photo illustrates that the well location appears to meet Rule 1004 standards and a future inspection will be conducted during the appropriate reproductive stage.

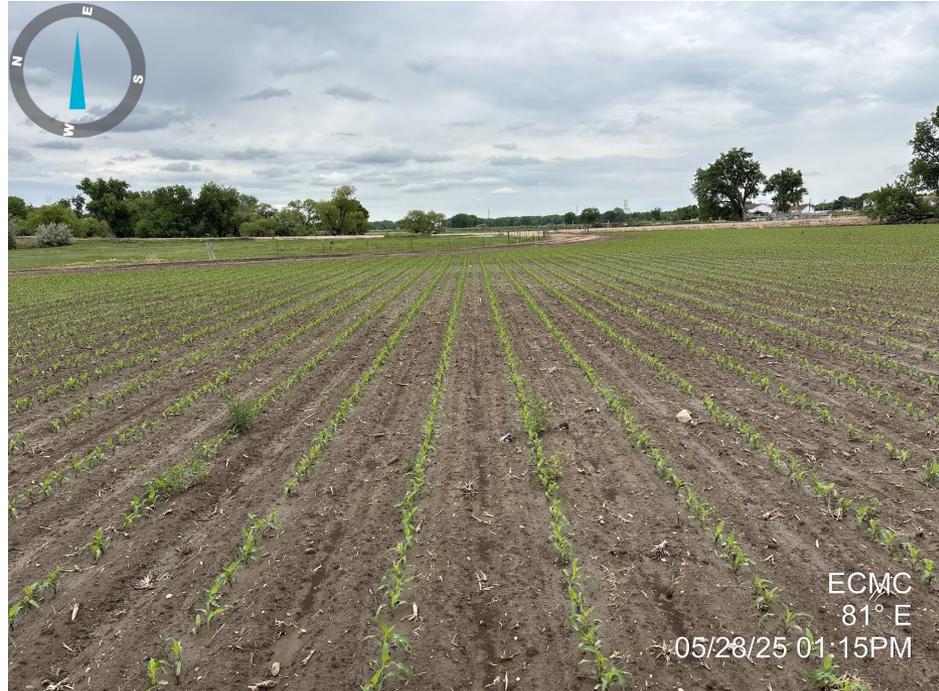
Photo 8. Photo taken from the multi-well location, from well API# 123-18028 (DANIELS #5-1416), facing West. See comments under Photo 7.

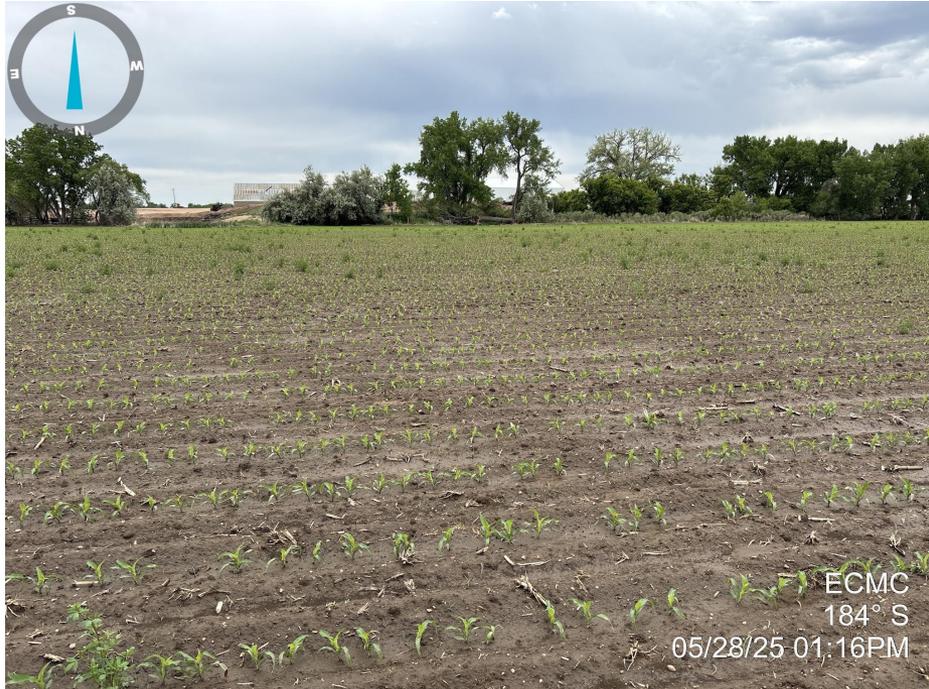
Photo 9. Photo taken from the multi-well location, from well API# 123-18028 (DANIELS #5-1416), facing South. See comments under Photo 7.

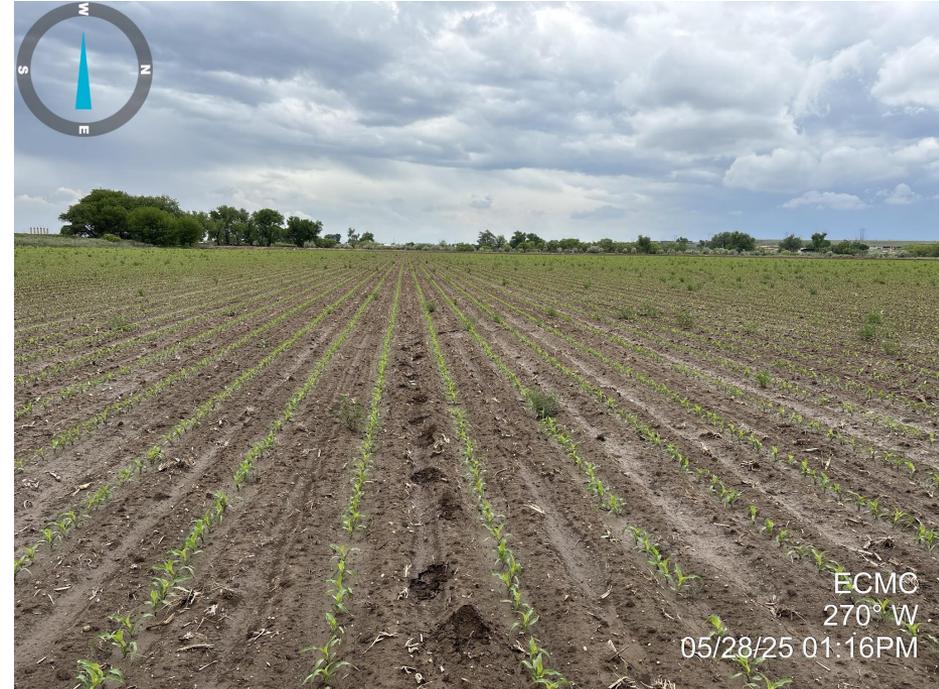
Photo 10. Photo taken from the multi-well location, from well API# 123-18028 (DANIELS #5-1416), facing West. See comments under Photo 7.

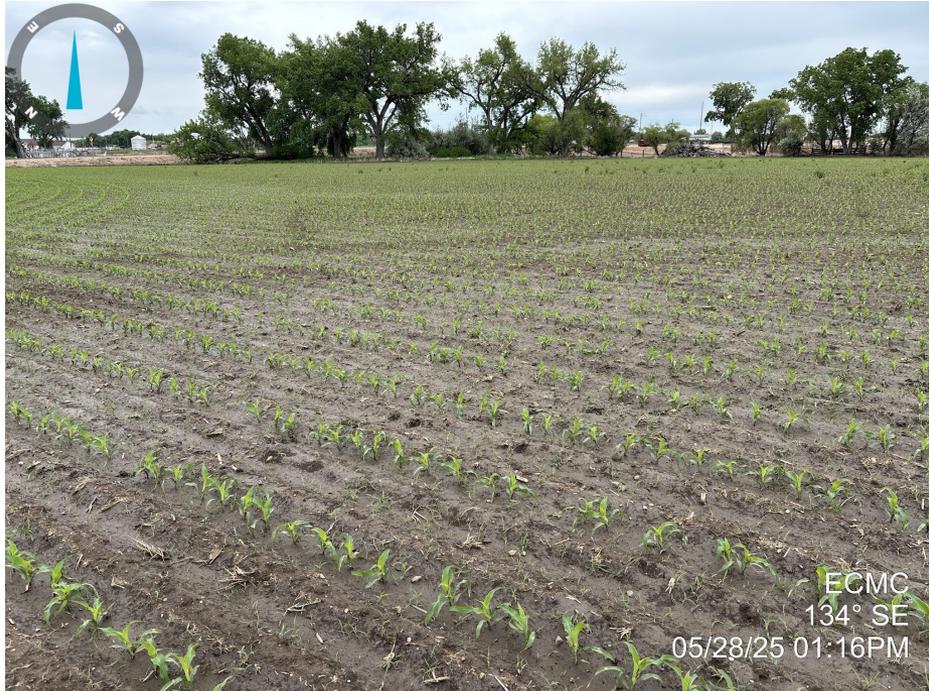
Photo 11. Photo taken of the reference area for well API# 123-18028 (DANIELS #5-1416), east of the well location, facing Southeast.

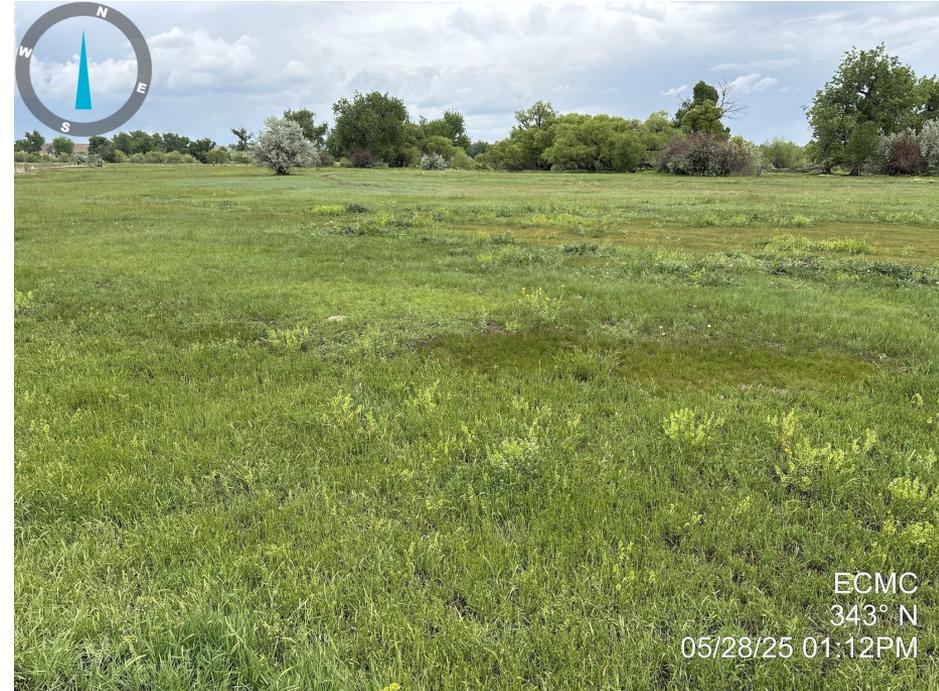
Photo 12. Photo taken of the reference area, west of the tank battery location, facing North. Photo illustrates perennial grass vegetation.
