**ECMC  
Environmental  
Field Inspection**

ECMC Environmental Inspection

**Burrows**

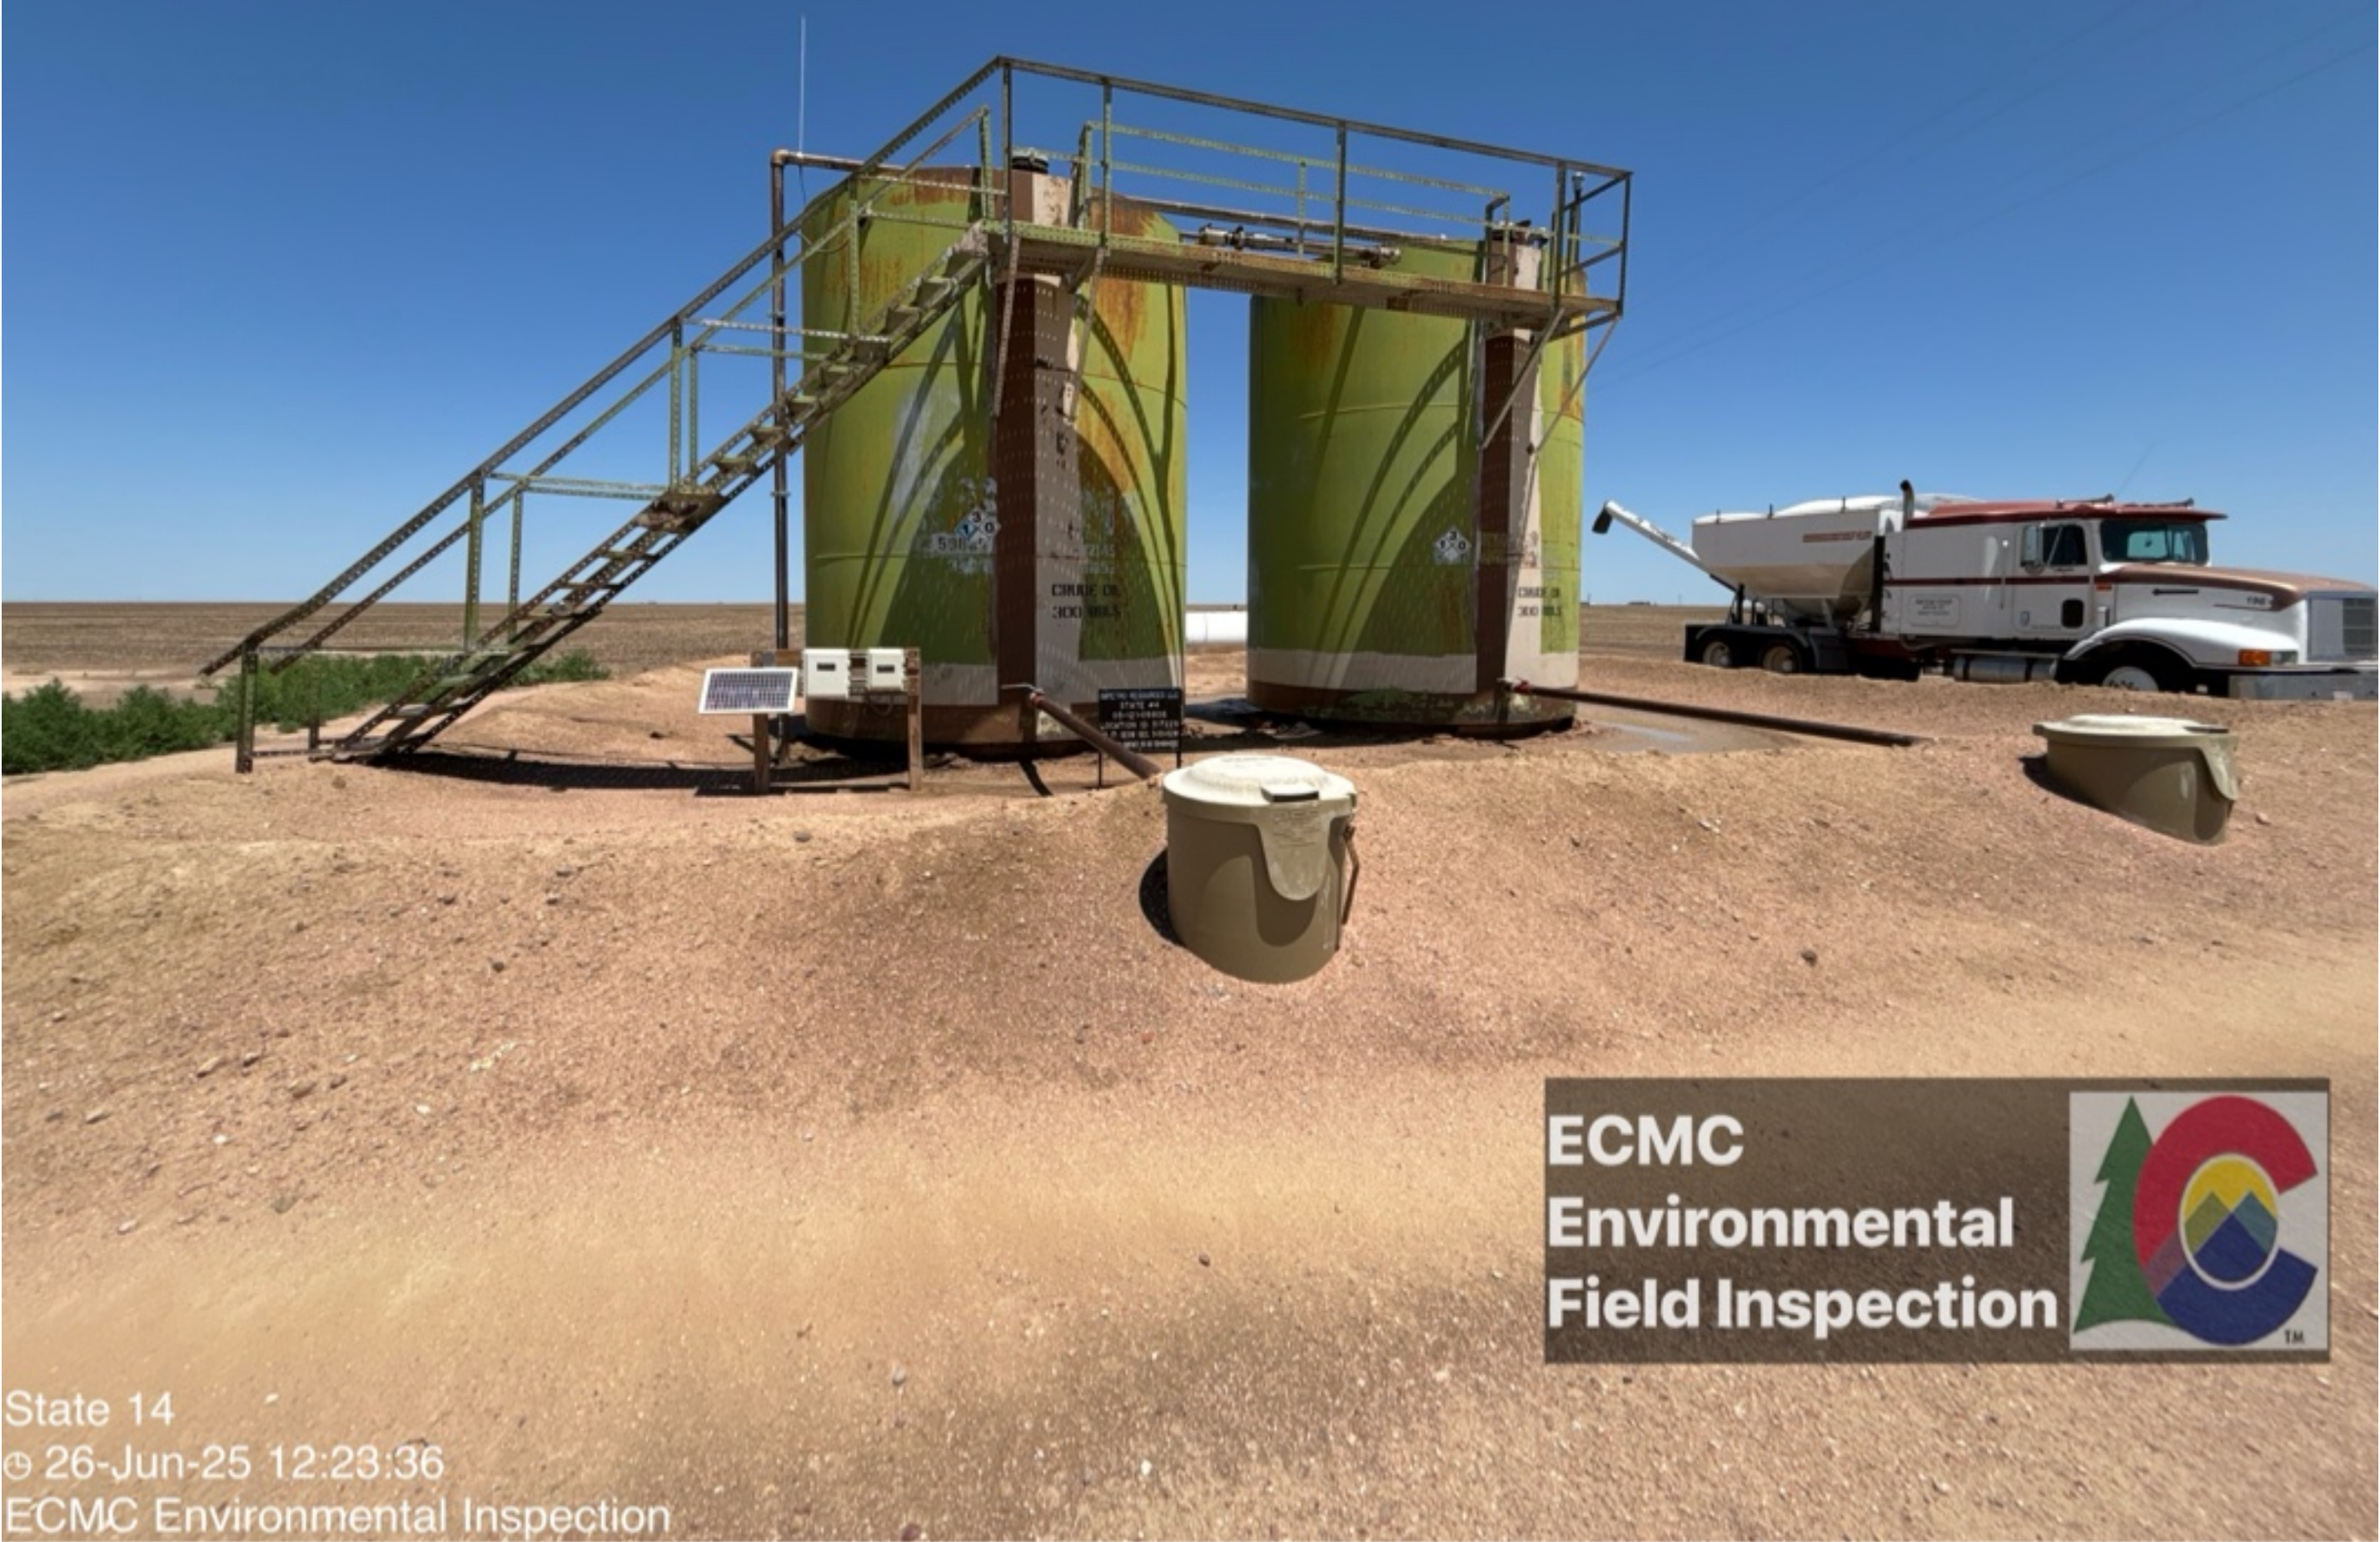
Weeds  
Faded NFPA placards  
Rusted/pitted 300 bbl steel crude oil ASTs  
Inadequate secondary containment. Earthen secondary containment berm(s) is(are) not adequately sized to contain volume of the largest tank plus freeboard allowance.  
Earthen secondary containment berm(s) is(are) not sufficiently impervious to contain spills/releases.

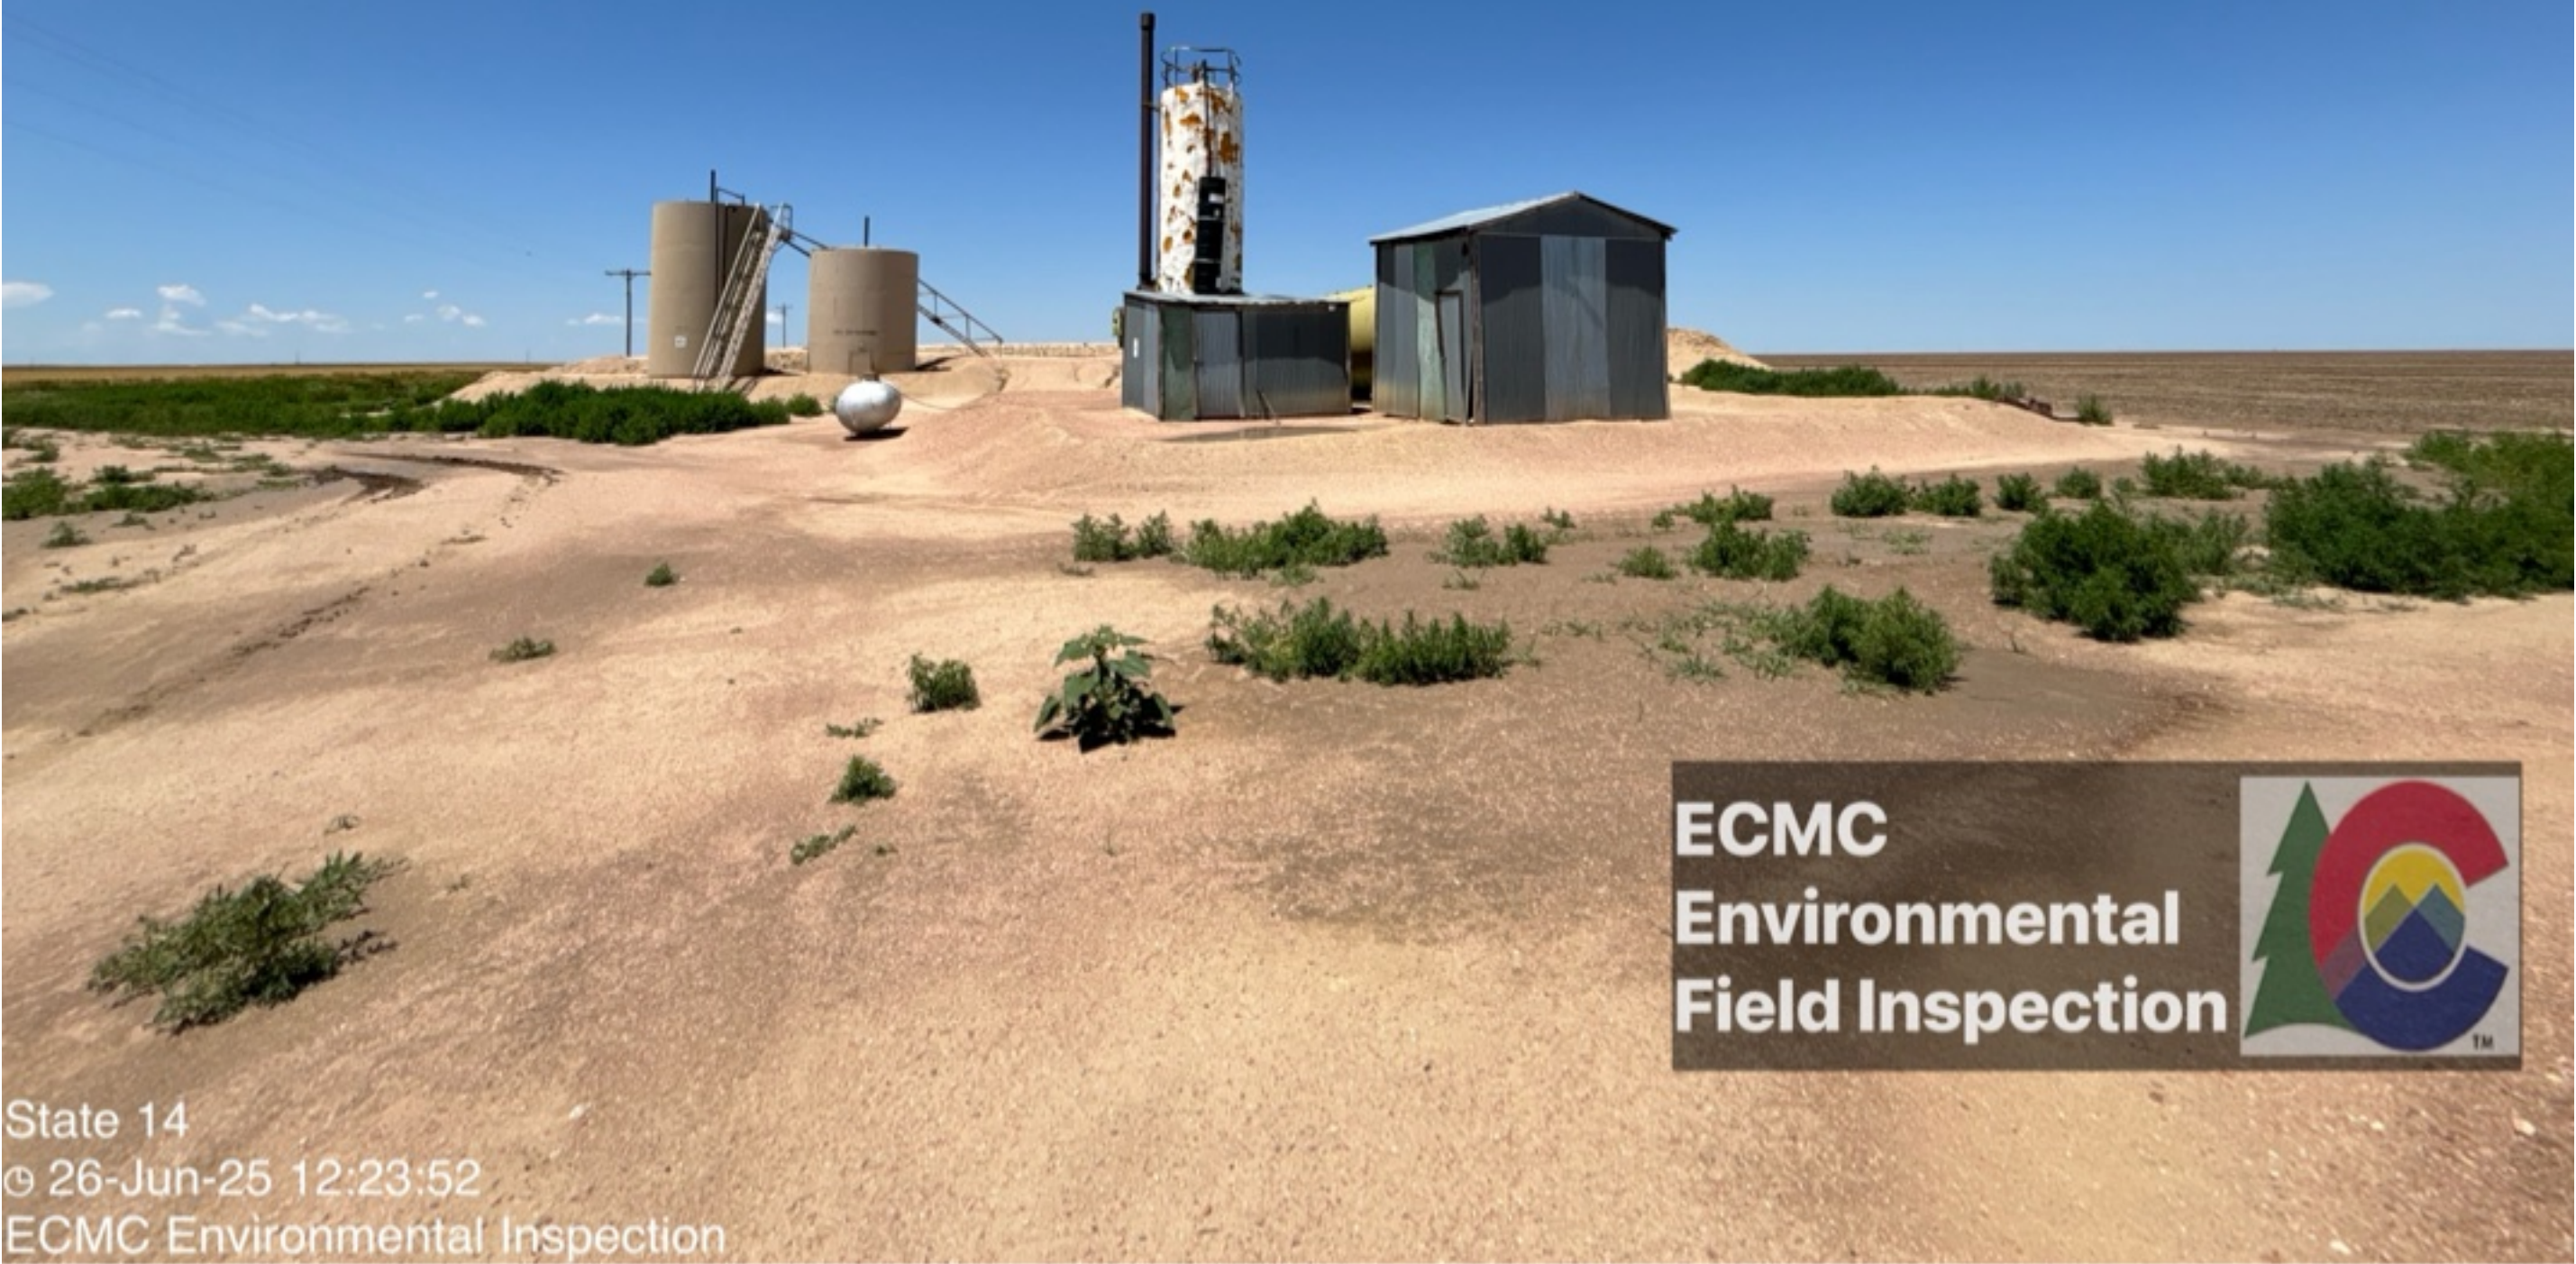
Weeds  
Inadequate secondary containment. Earthen secondary containment berm(s) is(are) not adequately sized to contain volume of the largest tank plus freeboard allowance.  
Earthen secondary containment berm(s) is(are) not sufficiently impervious to contain spills/releases.

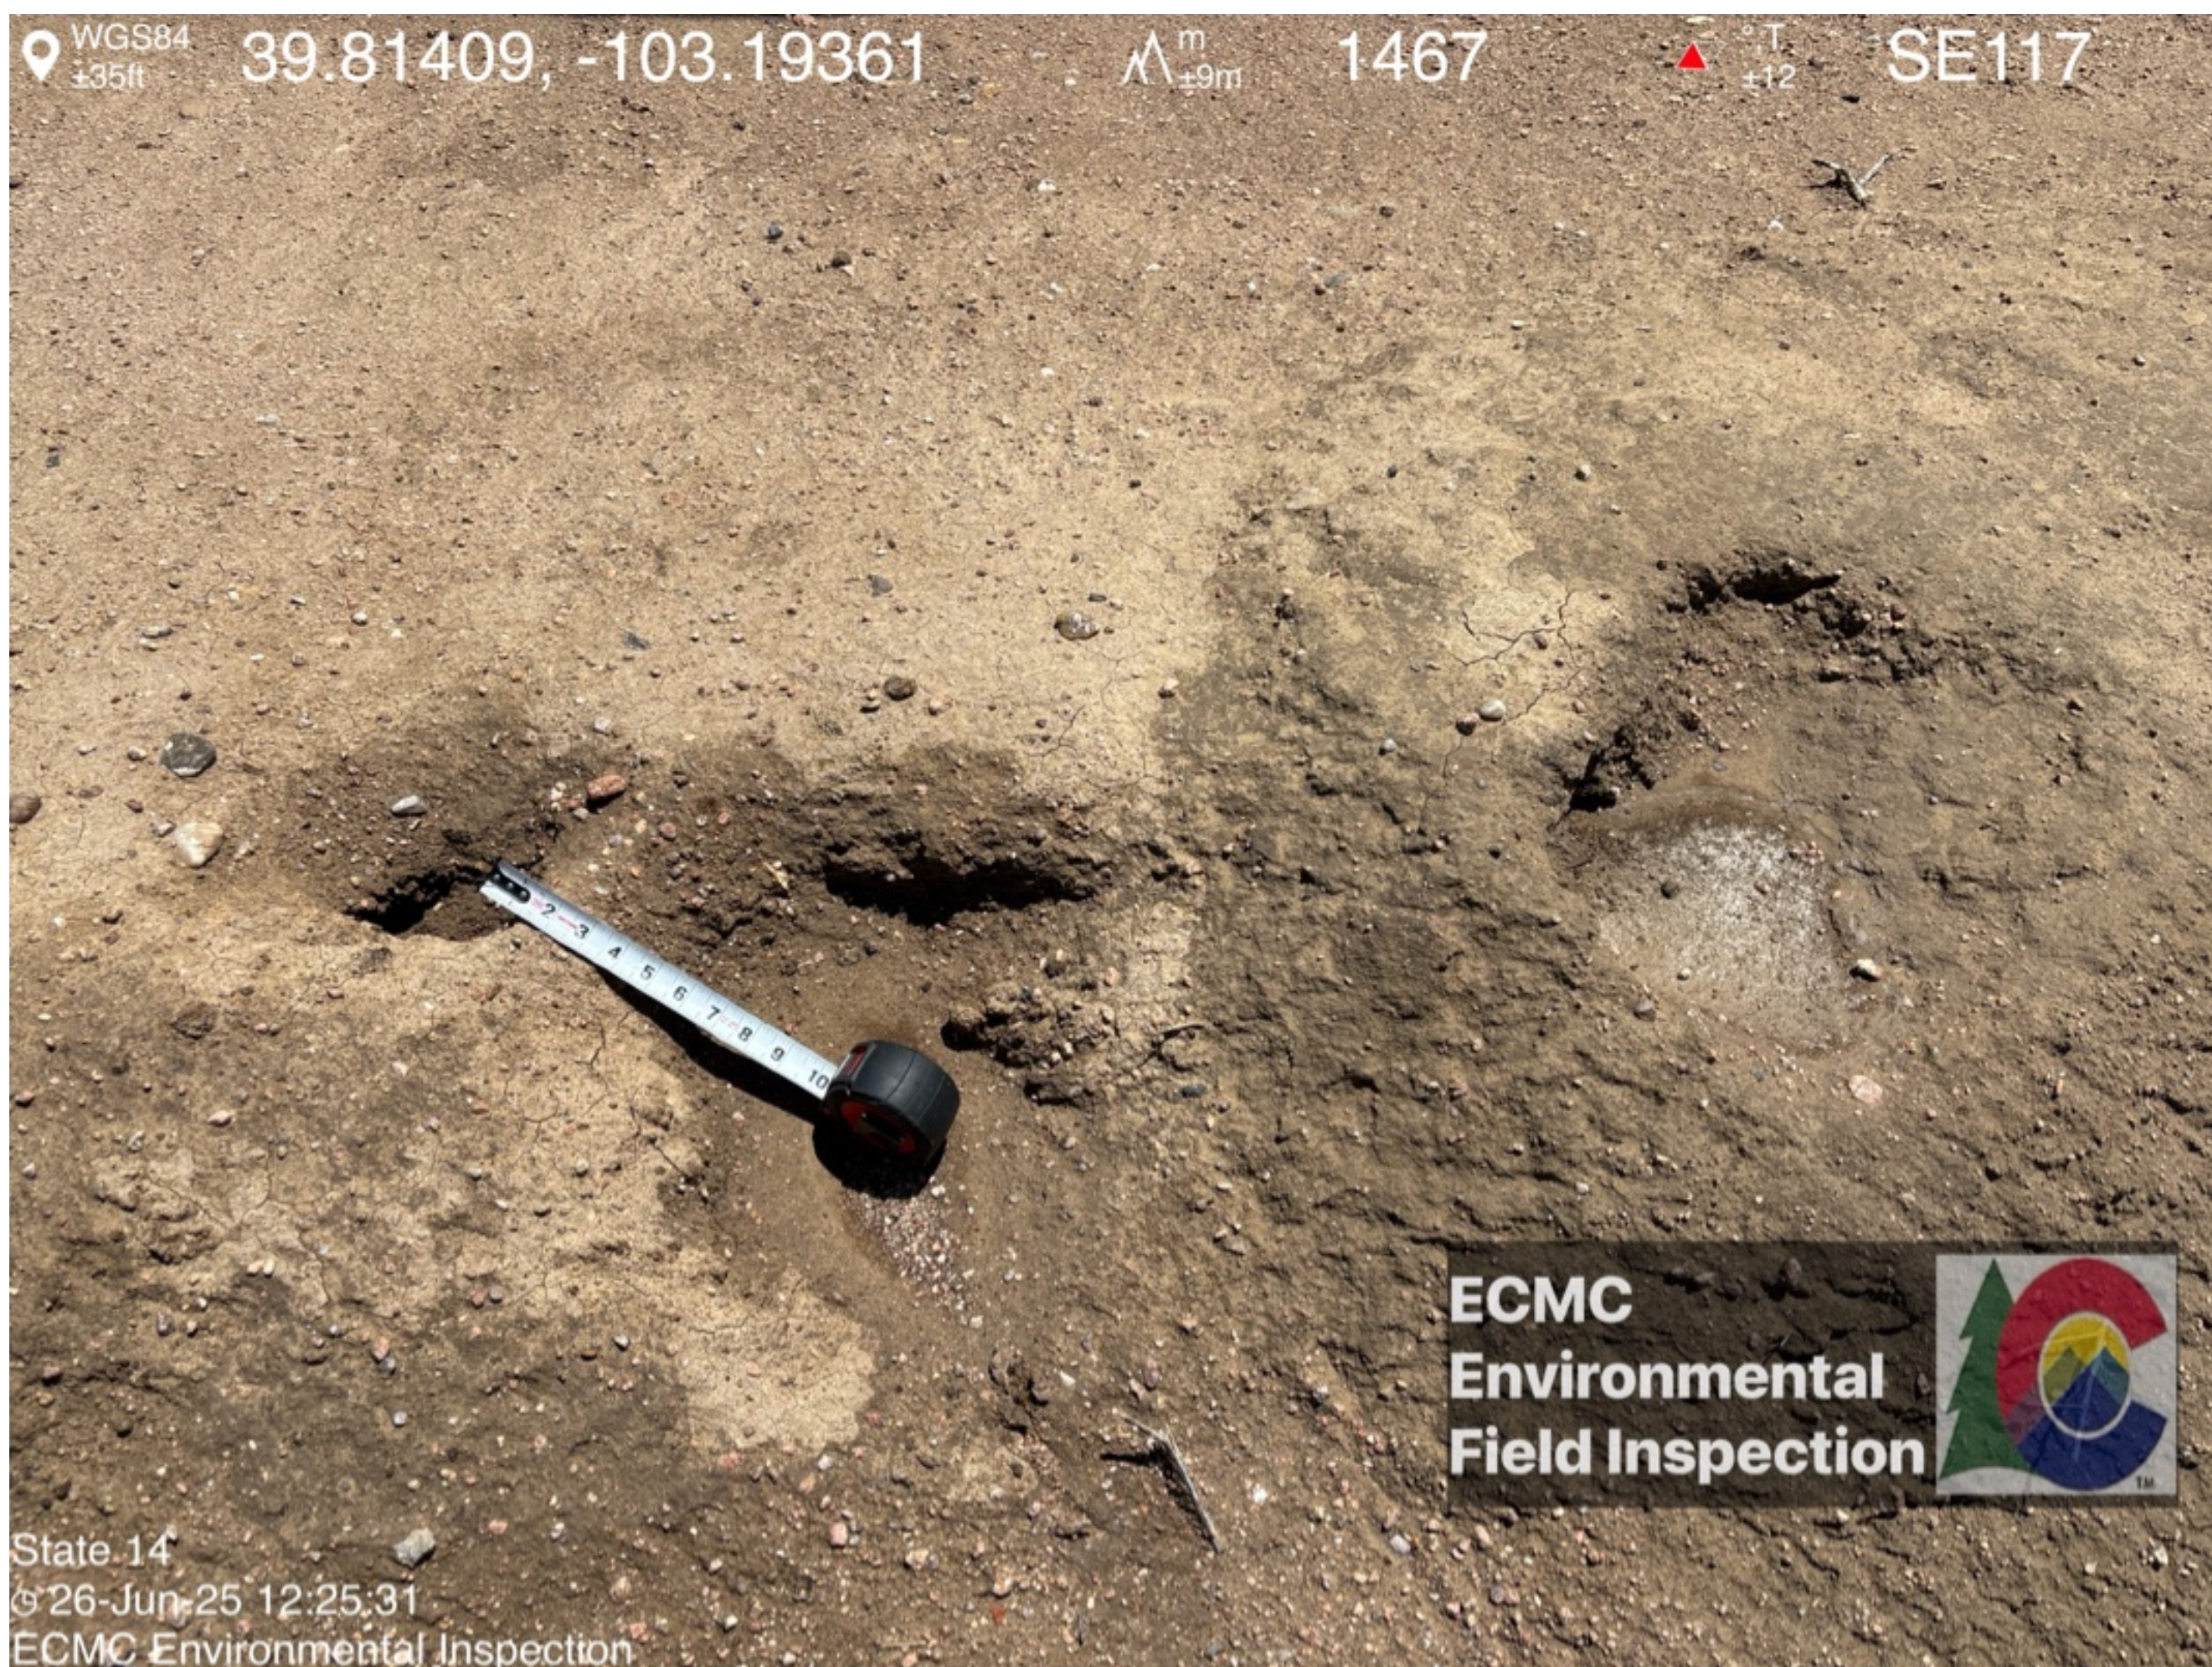
Inadequate secondary containment. Earthen secondary containment berm(s) is(are) not adequately sized to contain volume of the largest tank plus freeboard allowance.  
Earthen secondary containment berm(s) is(are) not sufficiently impervious to contain spills/releases.

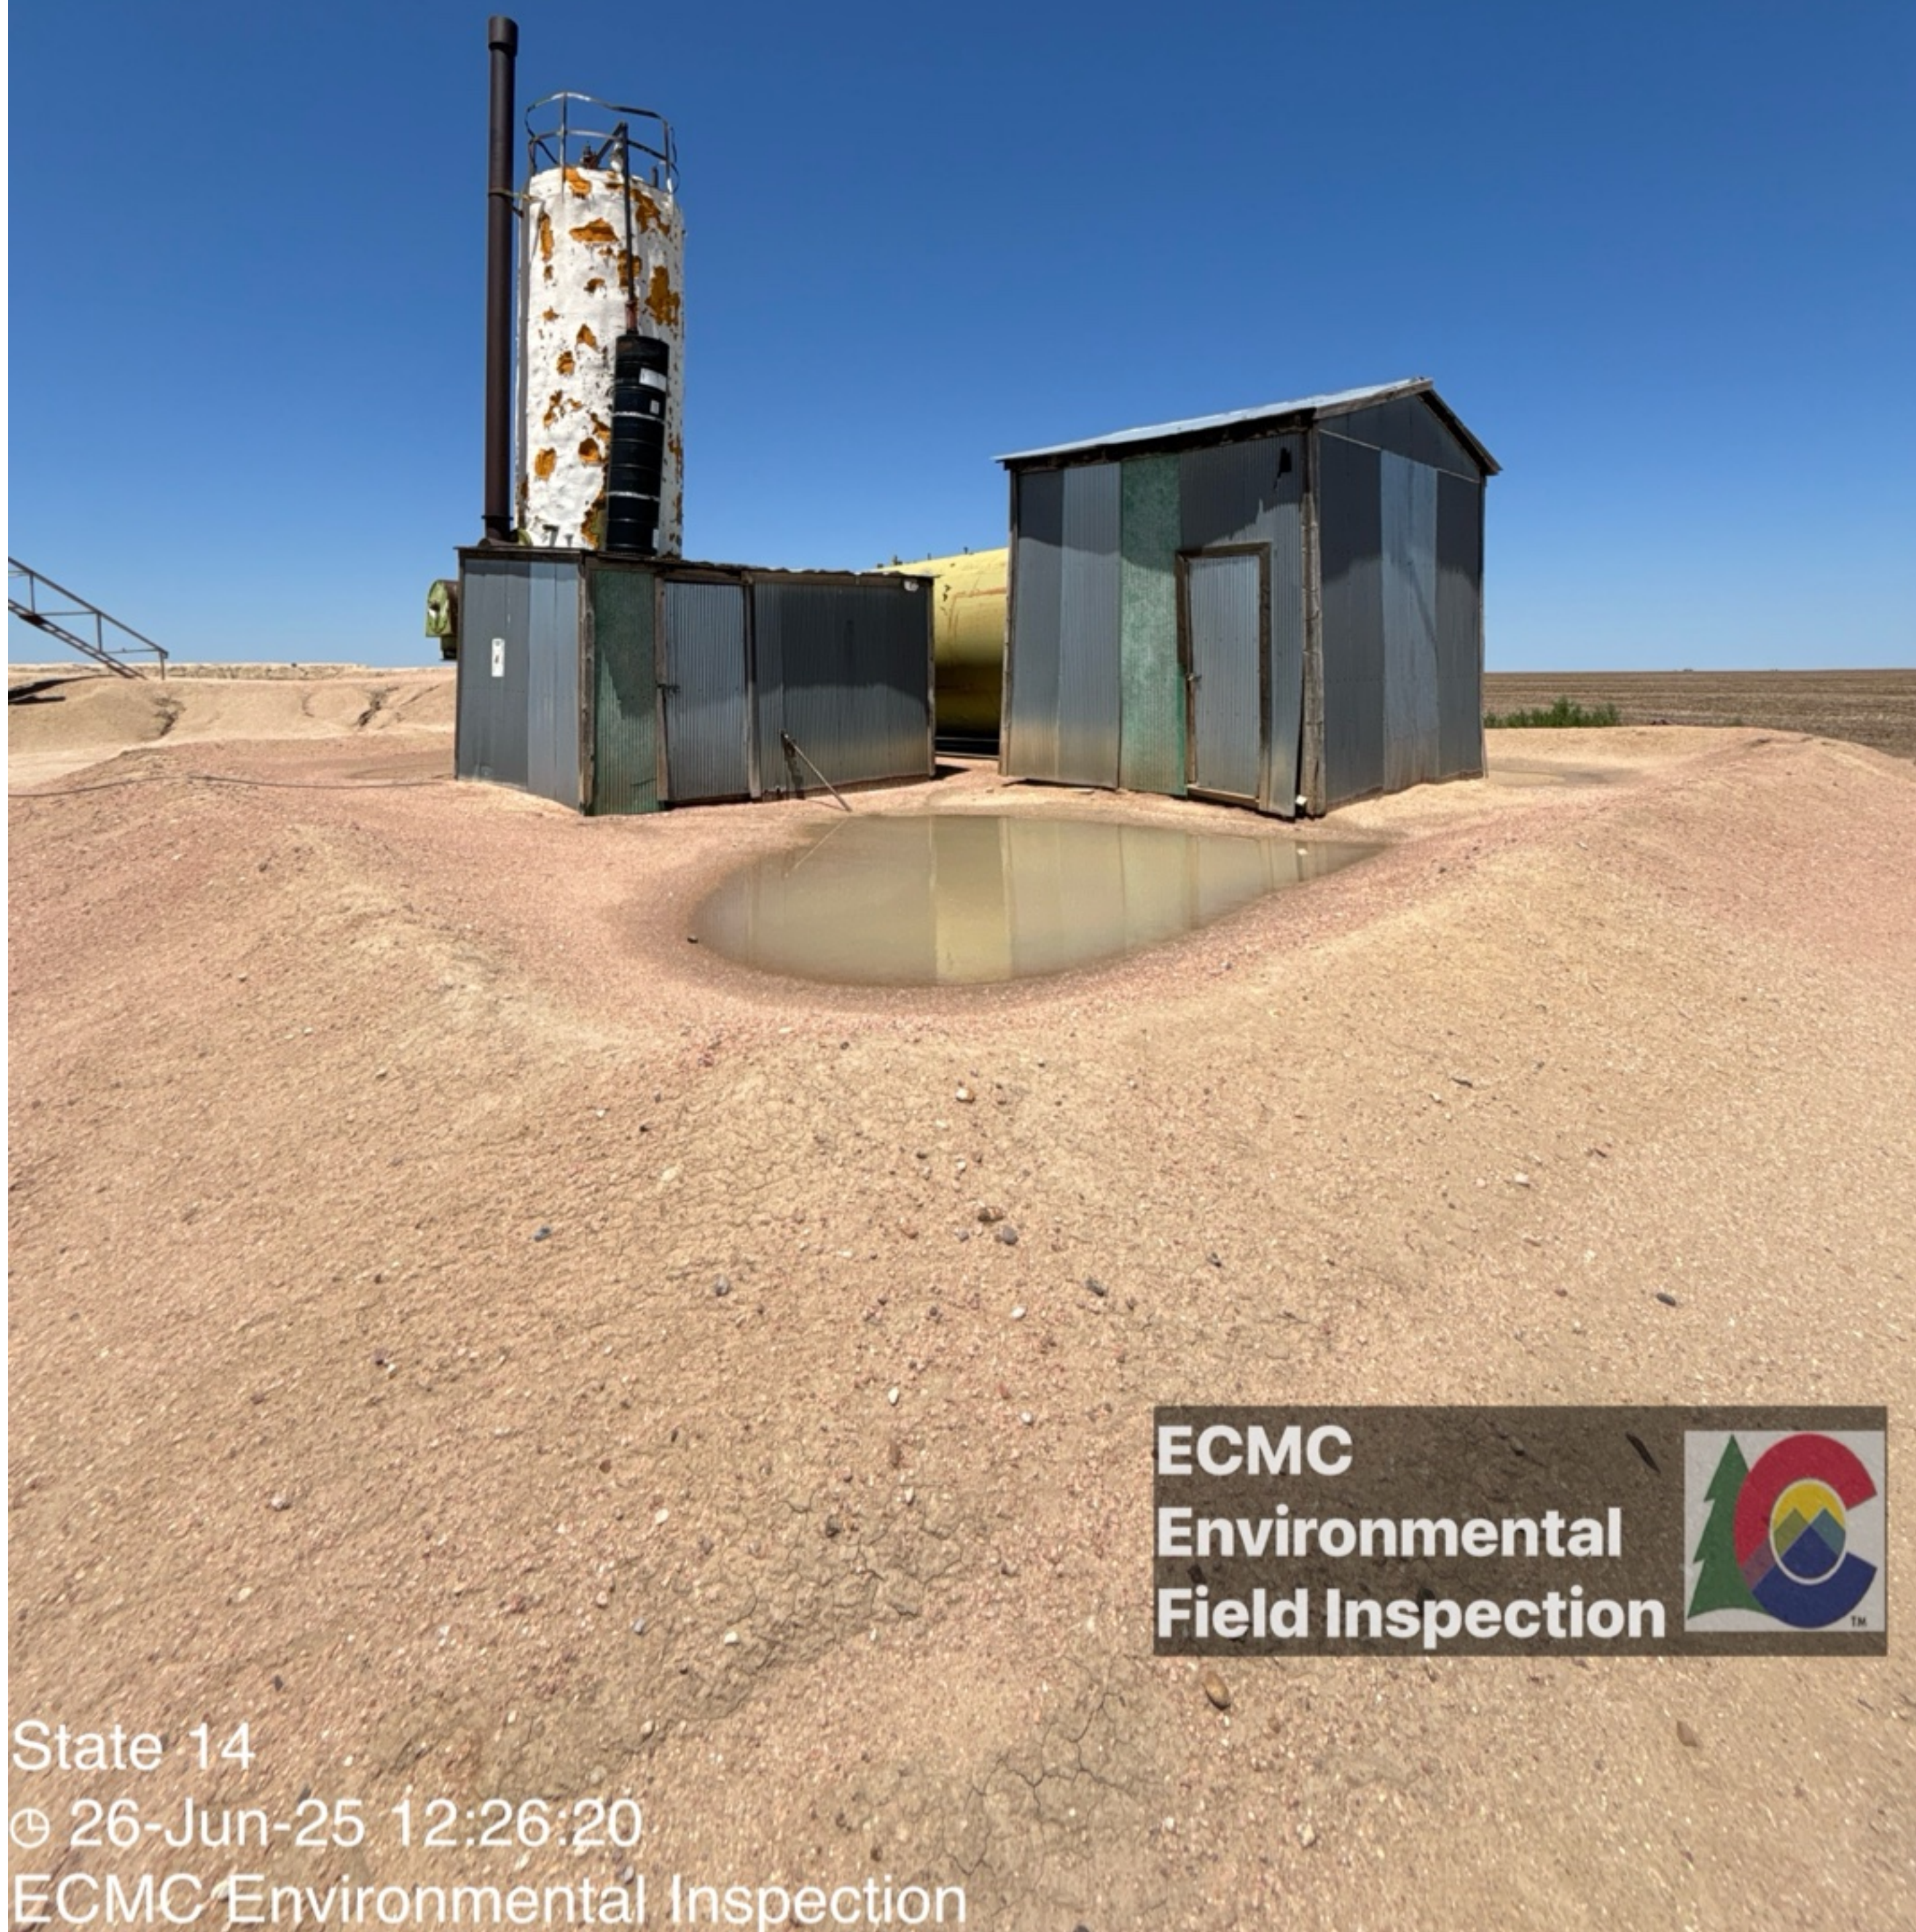
Earthen secondary containment berm(s) is(are) not adequate to contain volume of the largest tank plus freeboard allowance.  
Earthen secondary containment berm(s) is(are) not sufficiently impervious to contain spills/releases.

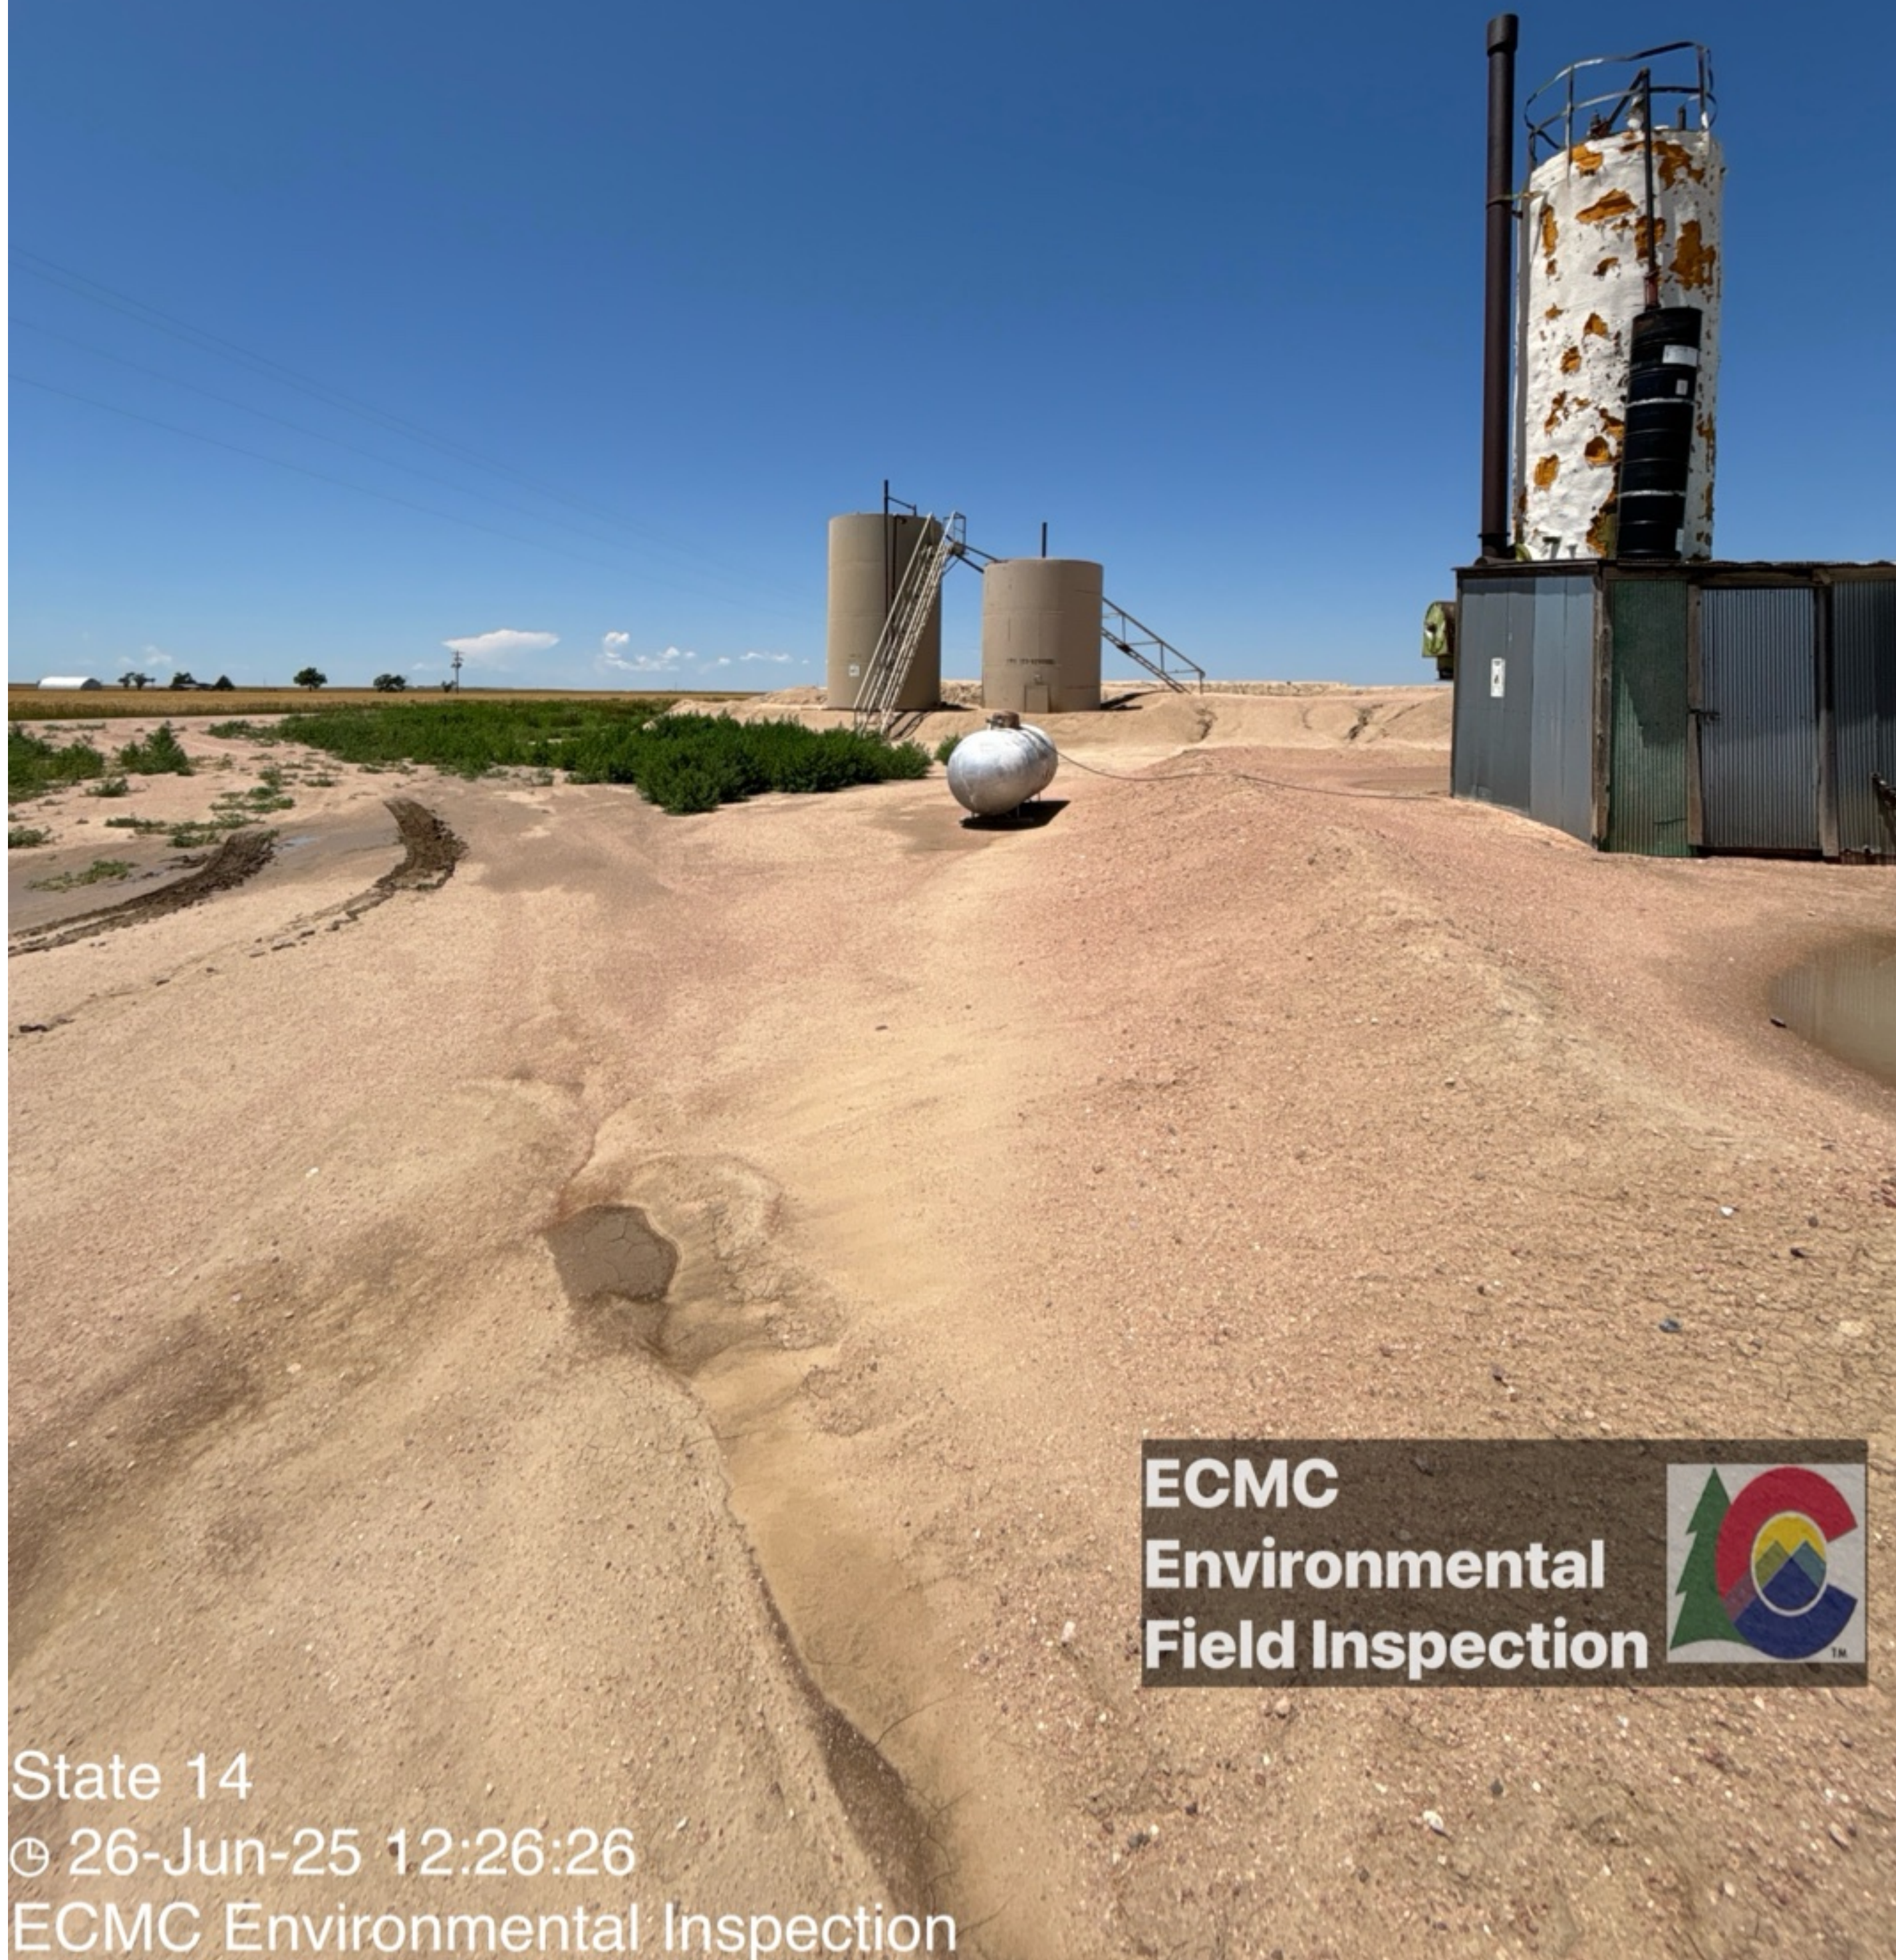
Weeds  
Erosion

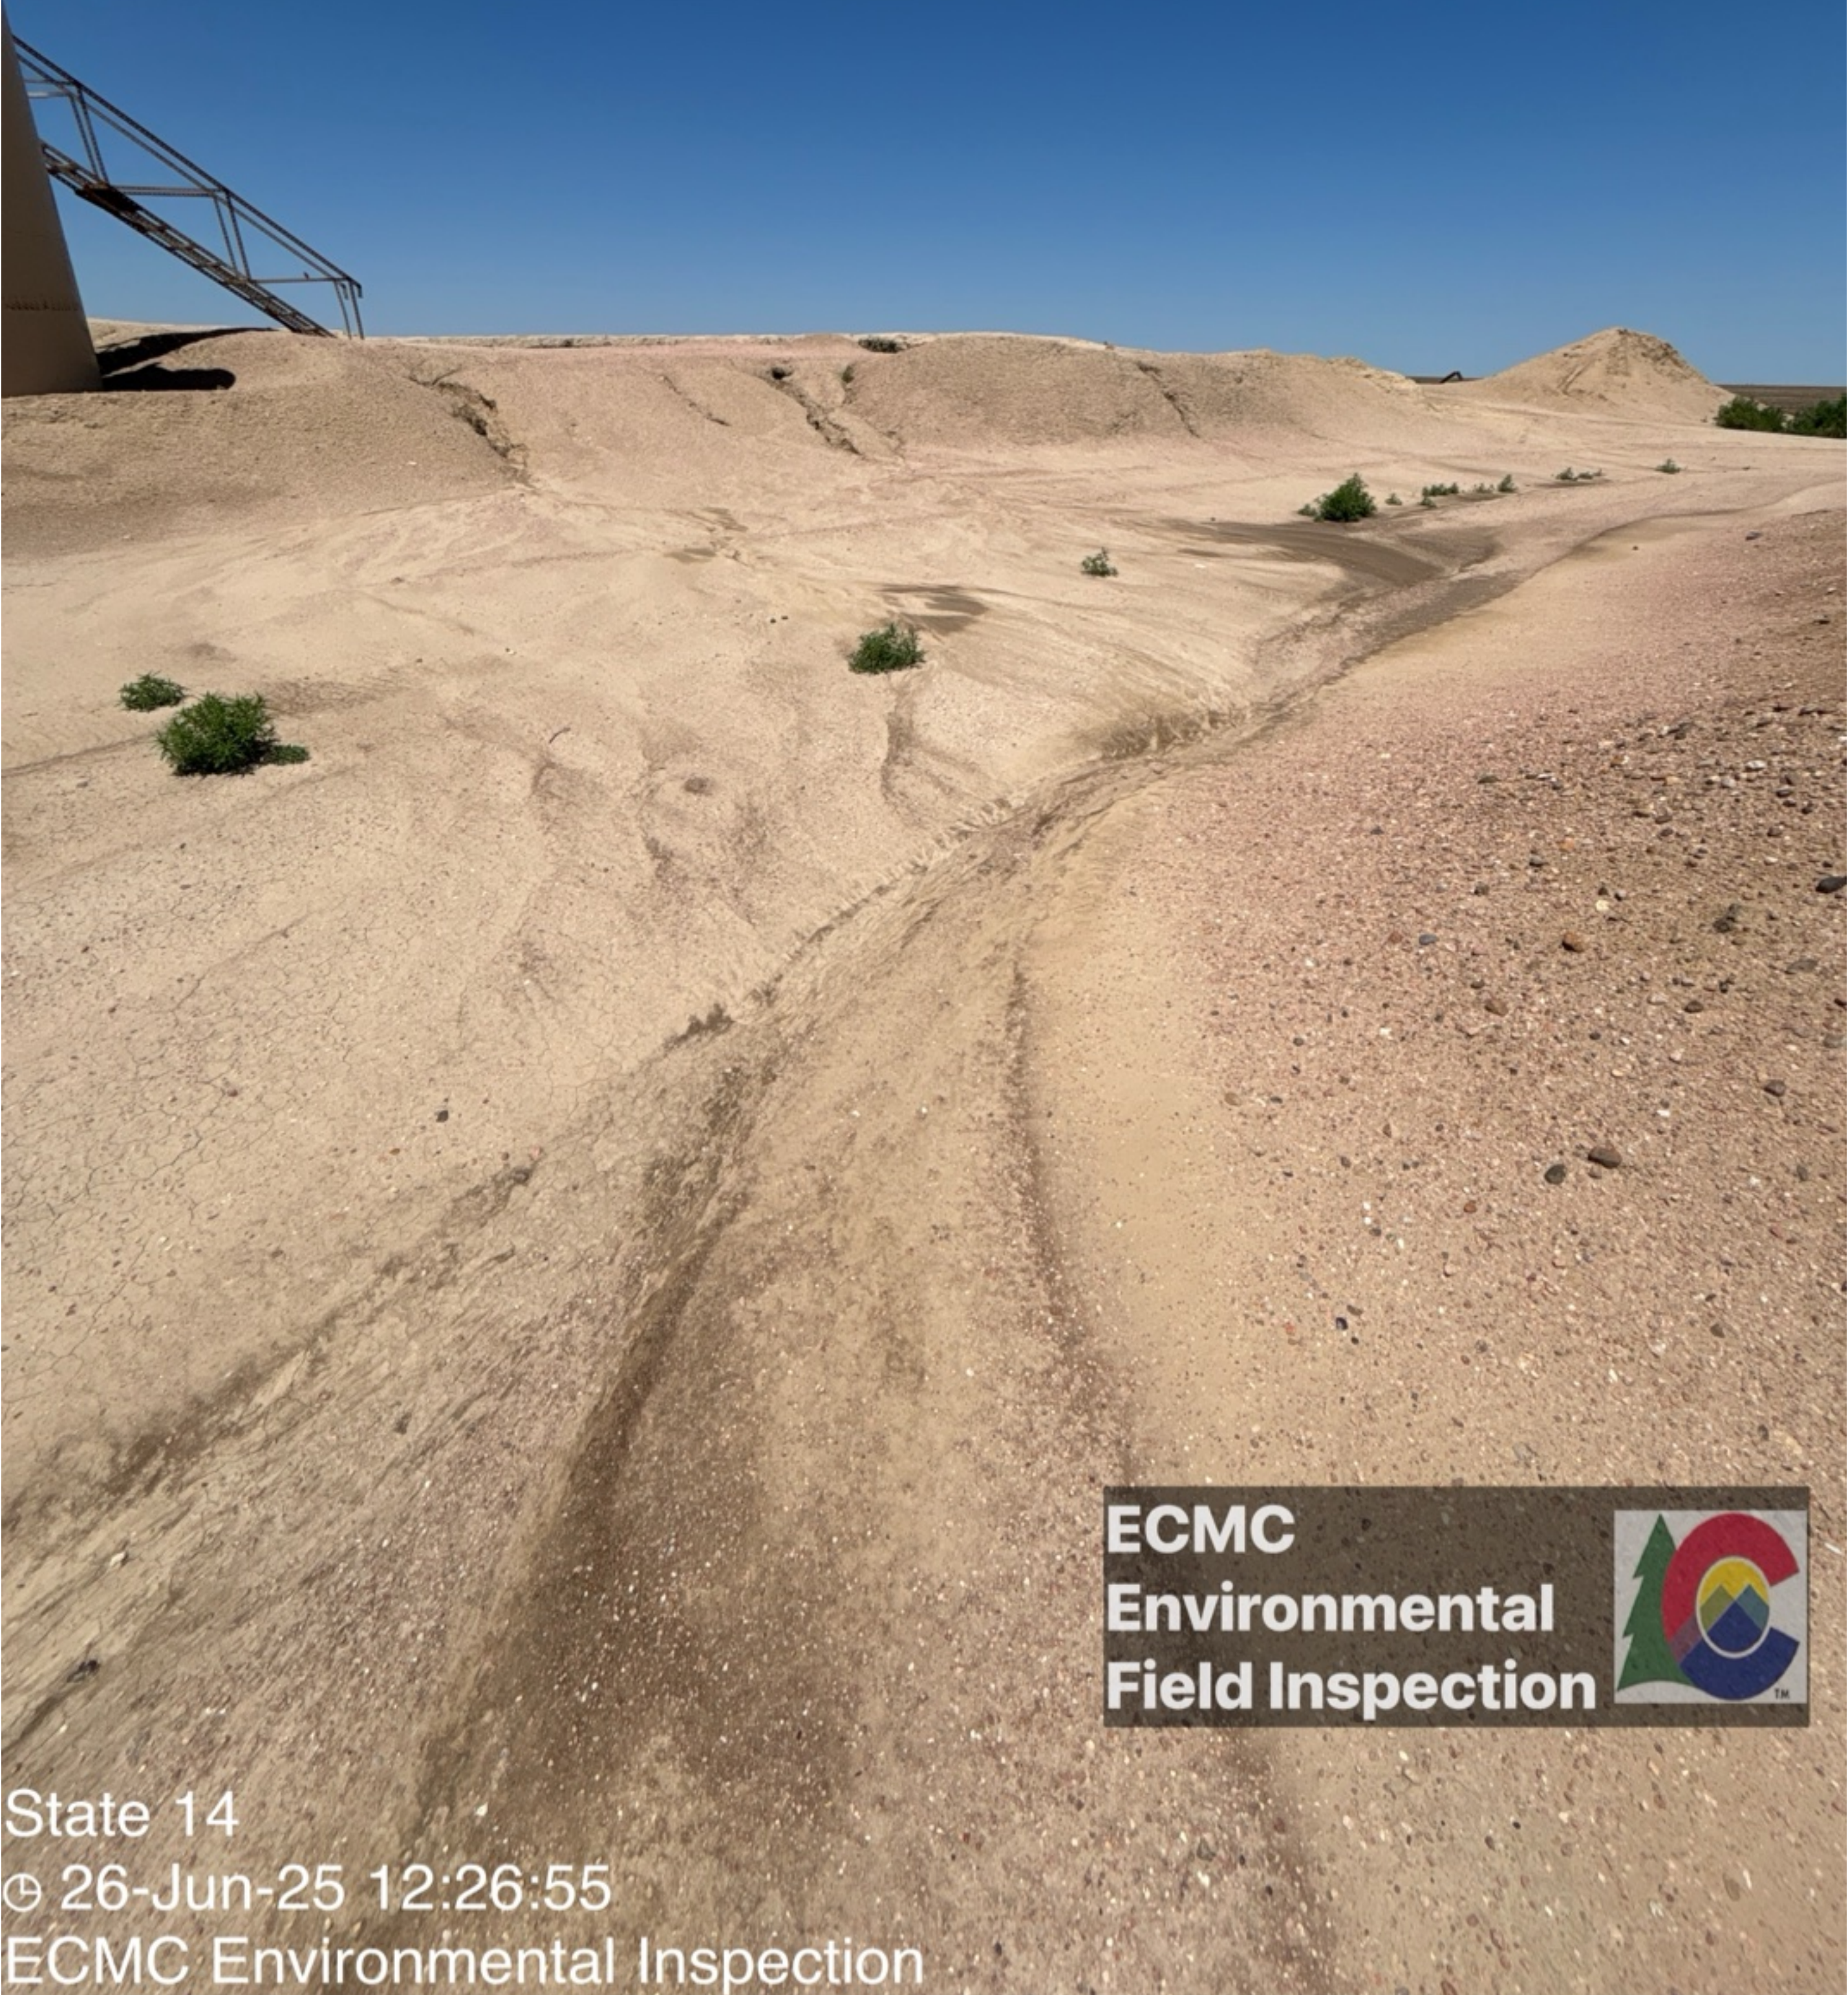
Weeds  
Erosion - Sediment transport  
Unknown stockpile - No Stormwater BMPs/signage
