**ECMC  
Environmental  
Field Inspection**

ECMC Environmental Inspection

**Burrows**

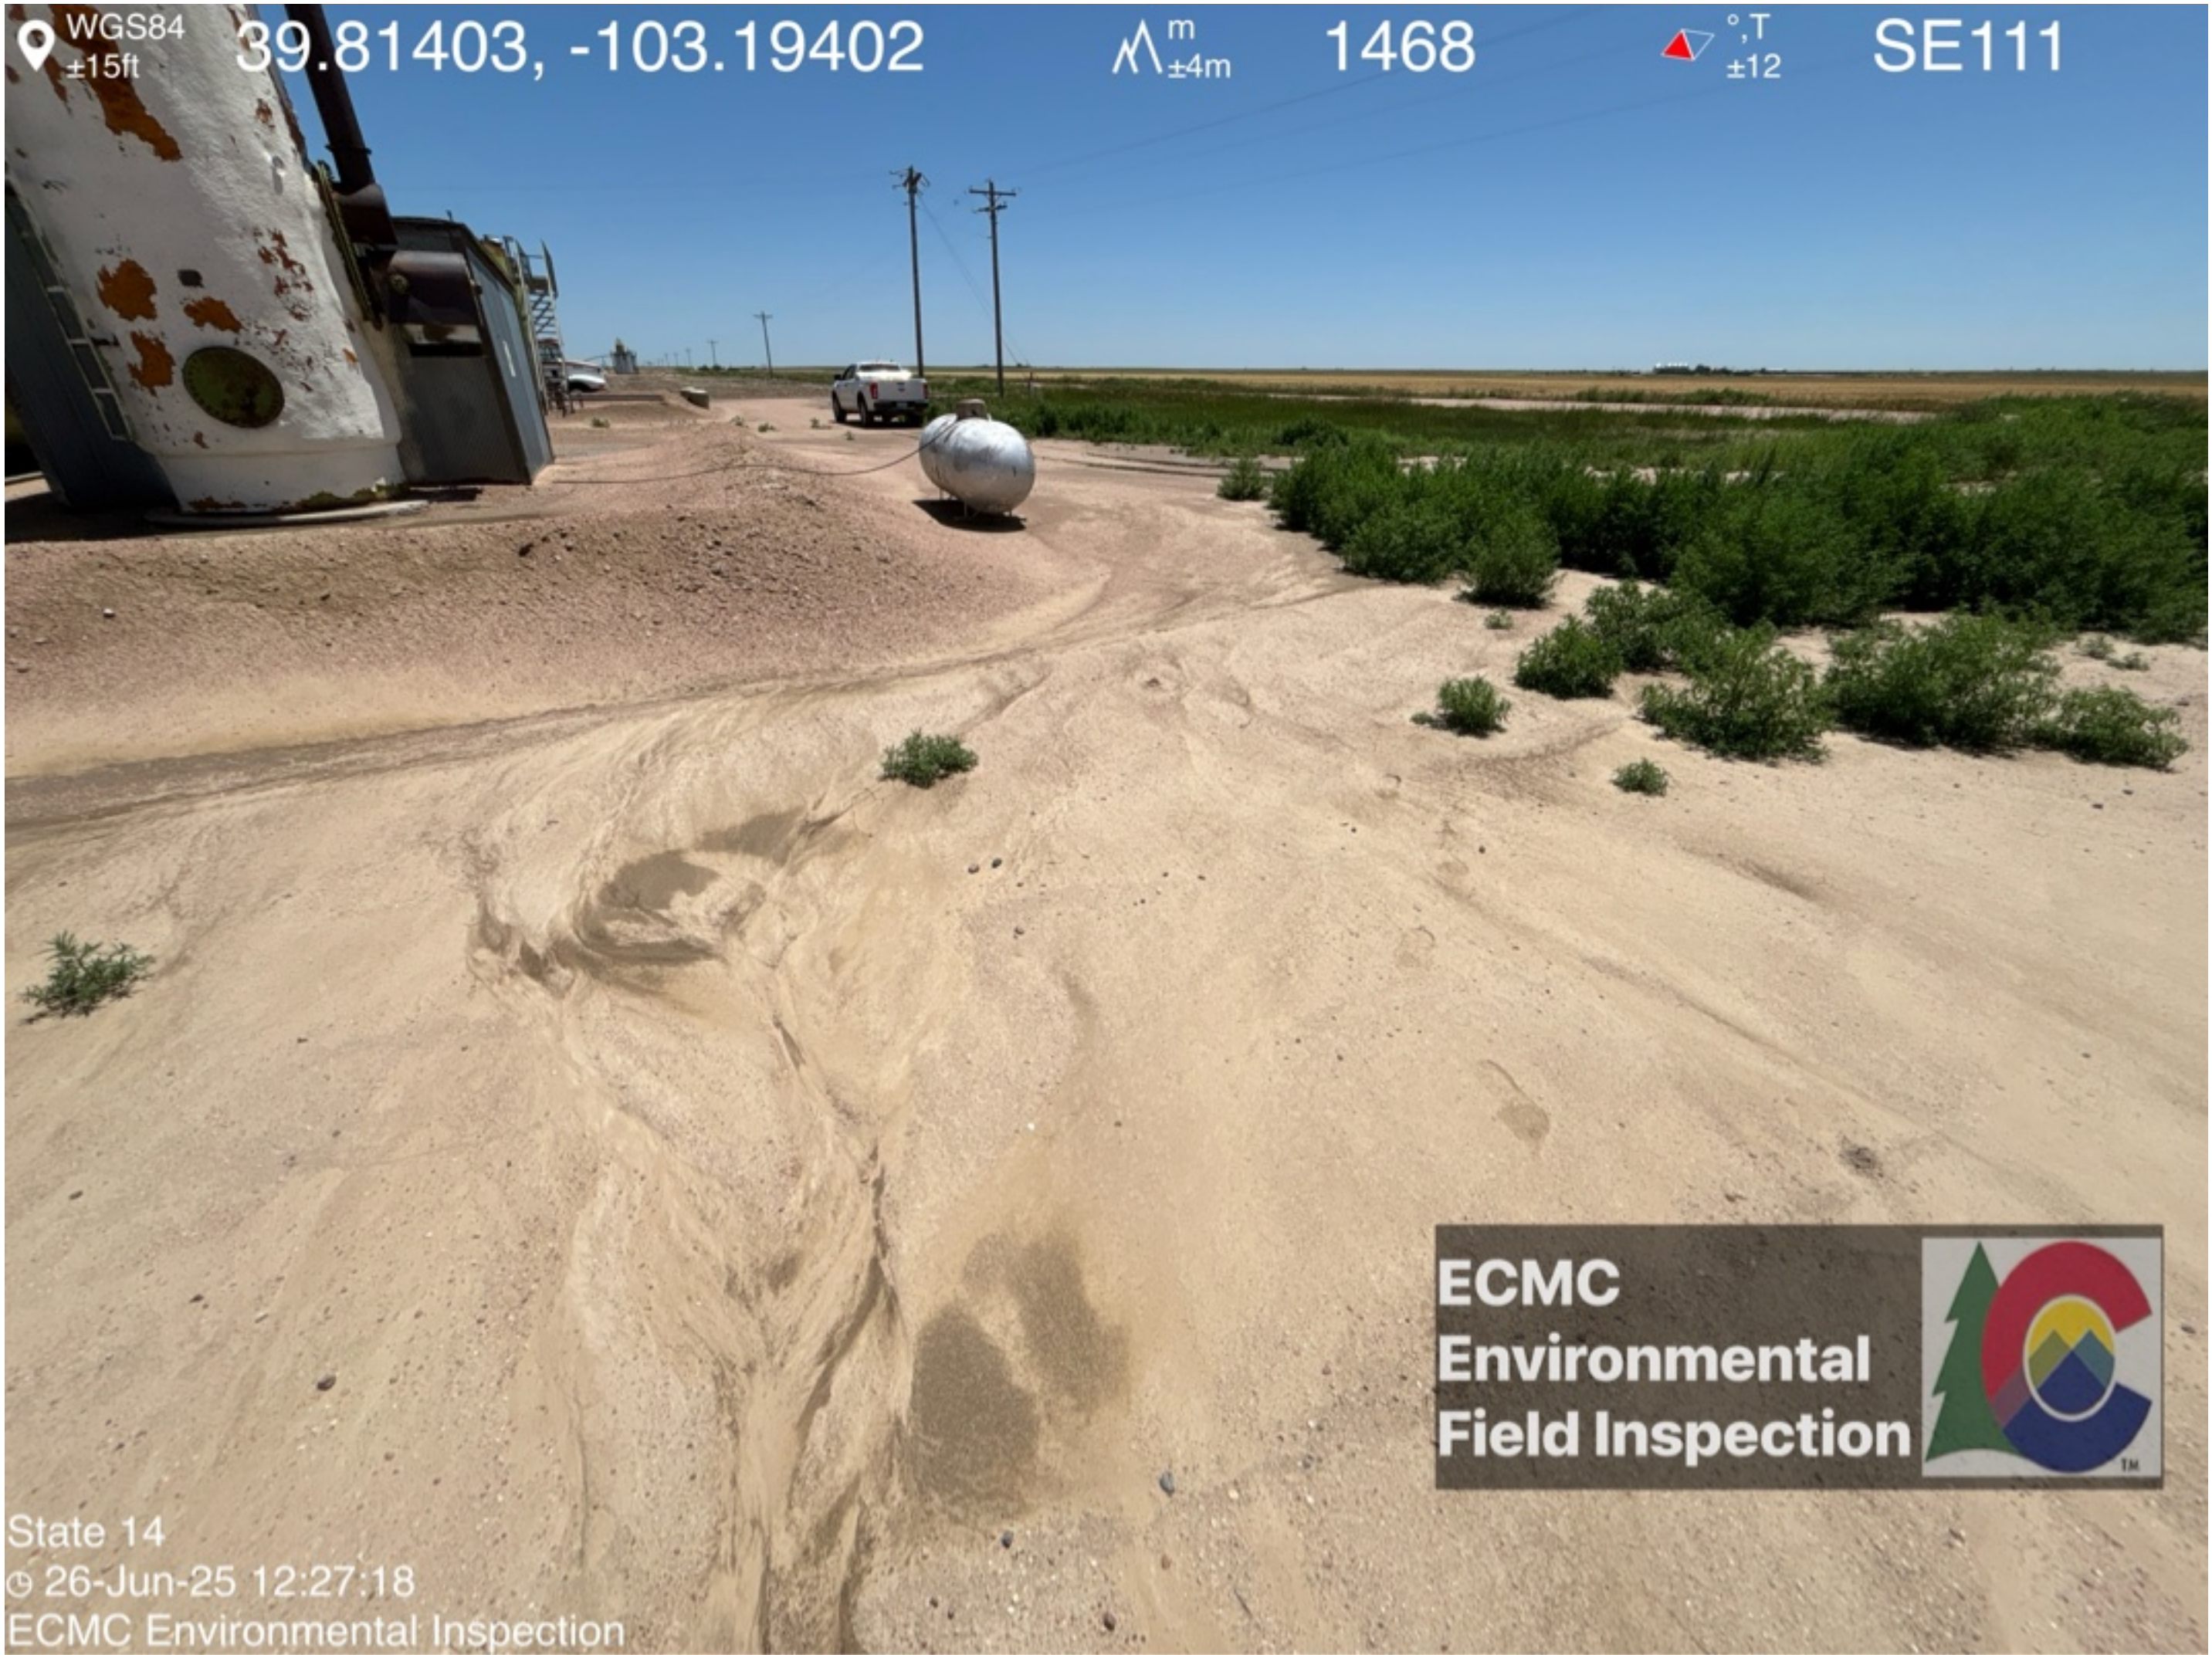
Weeds  
Erosion - Sediment transport

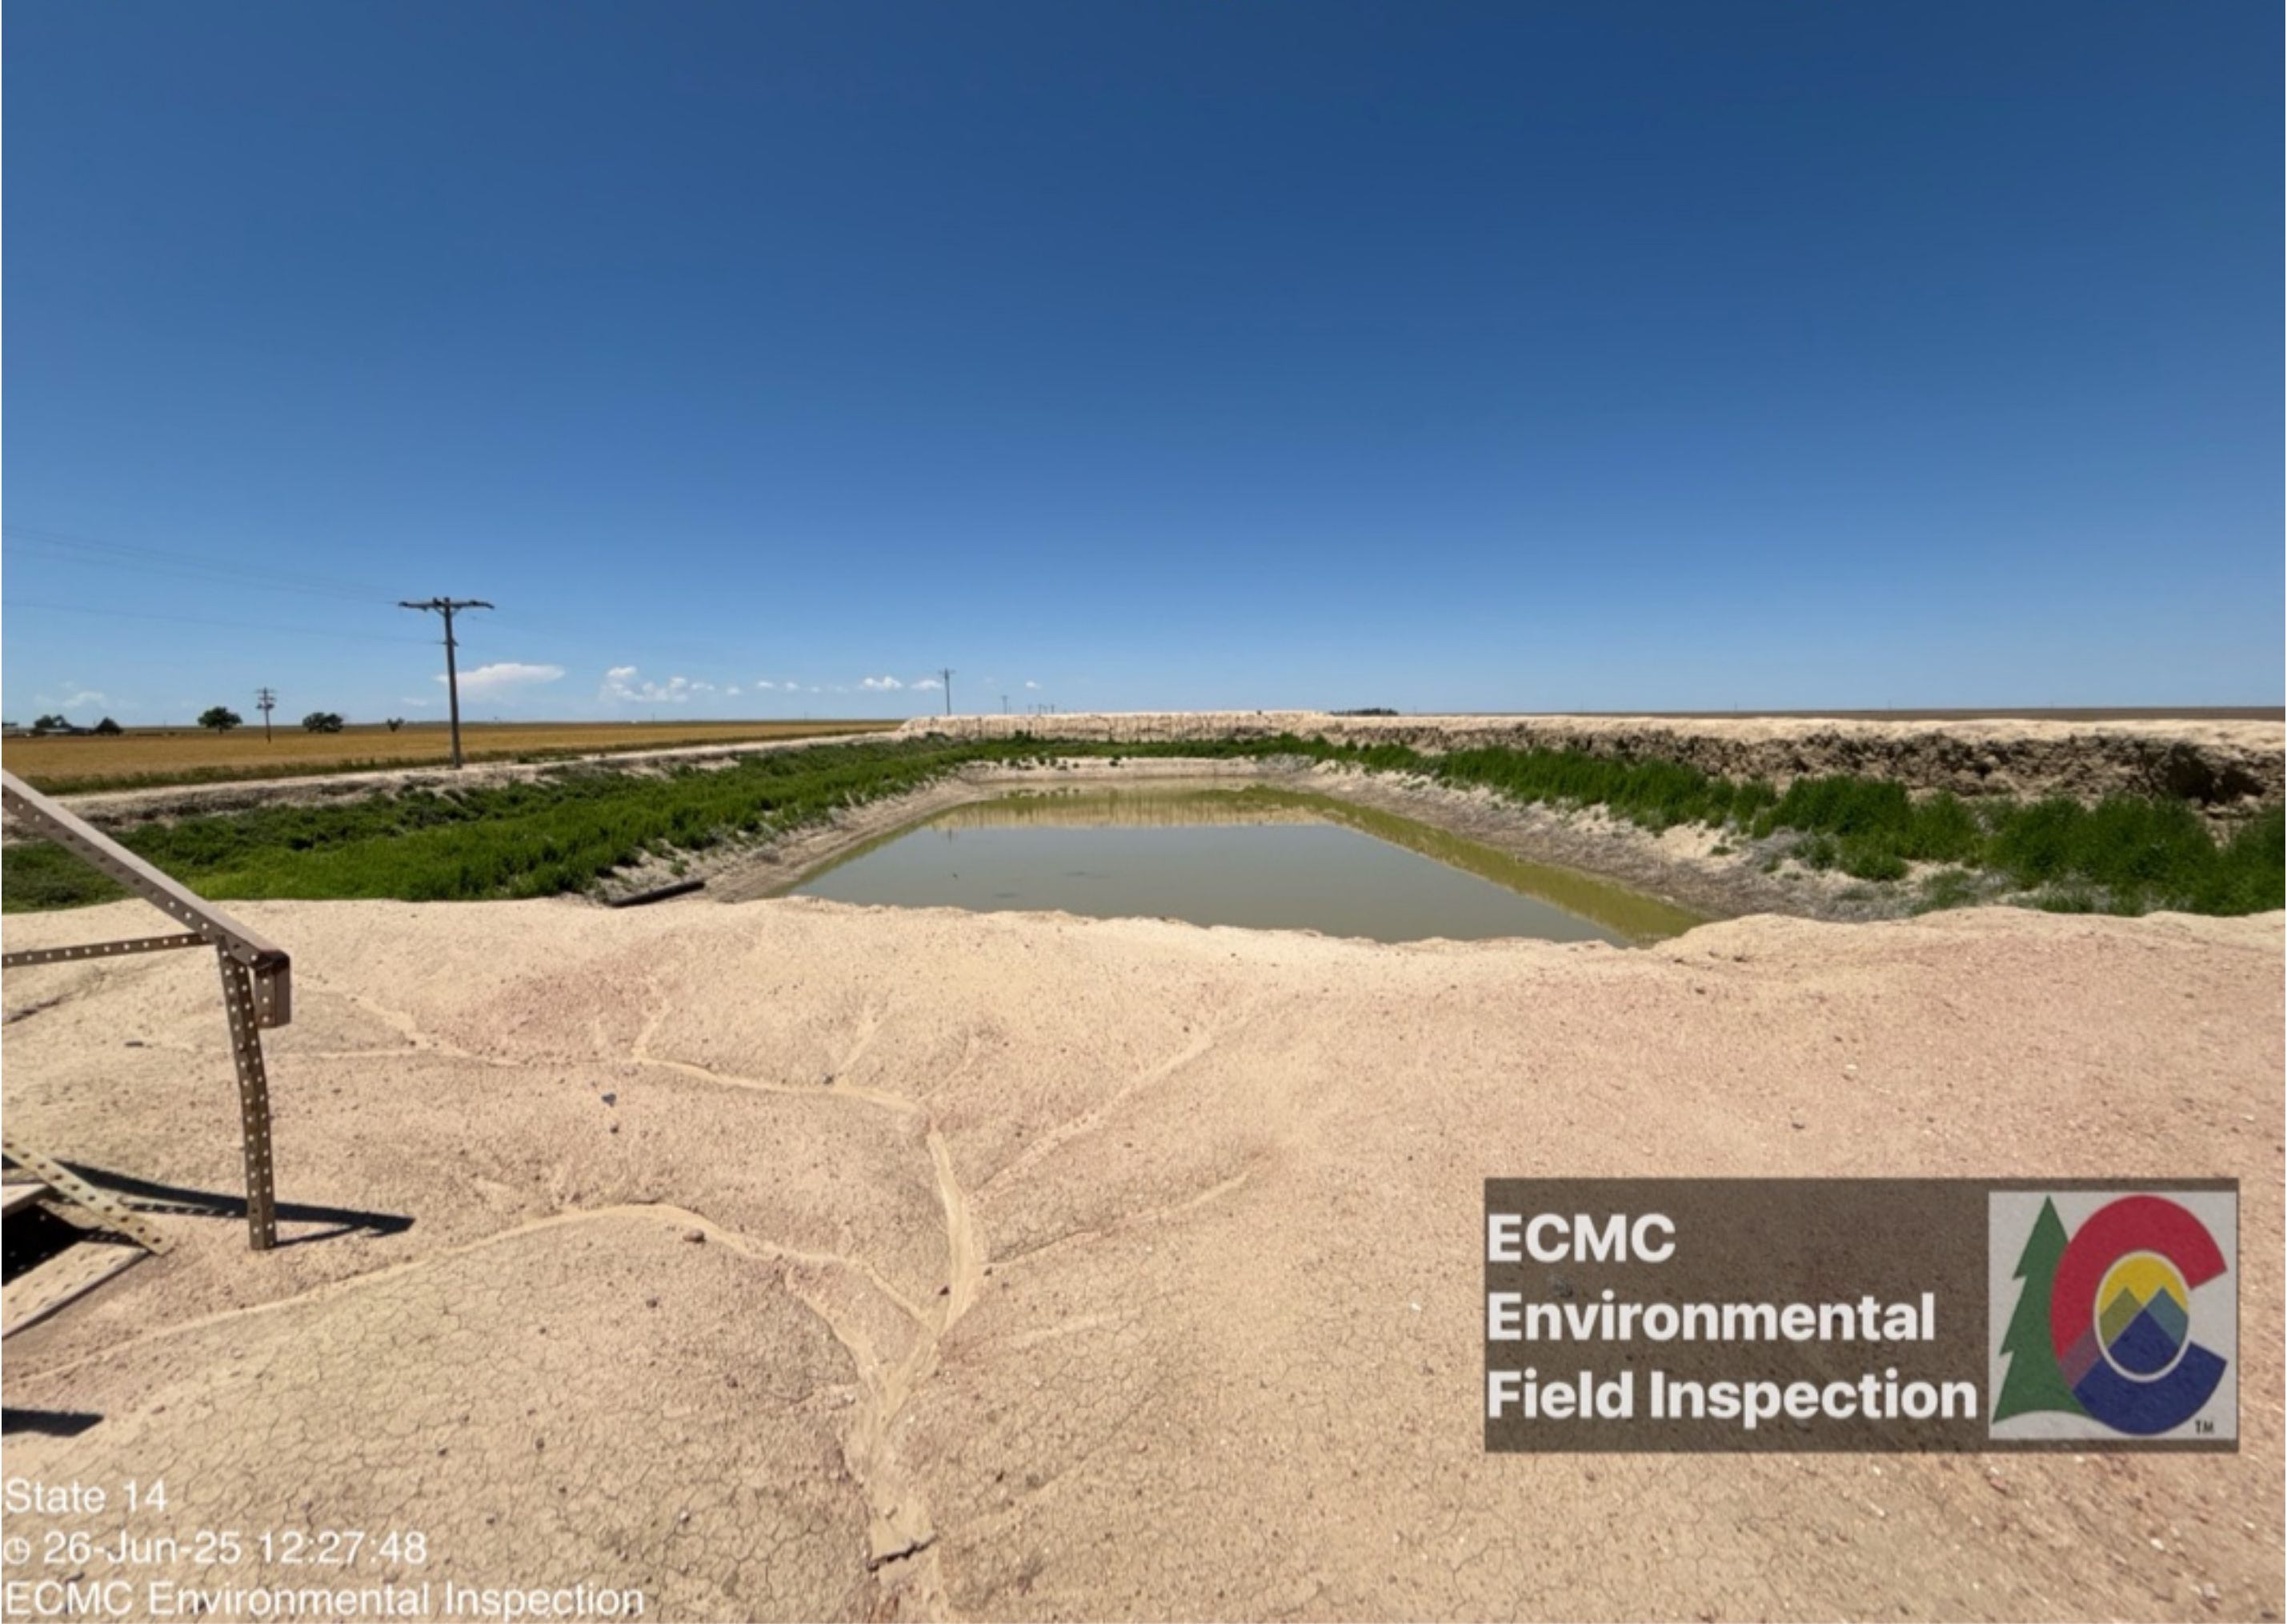
Weeds  
Pit  
Rill erosion

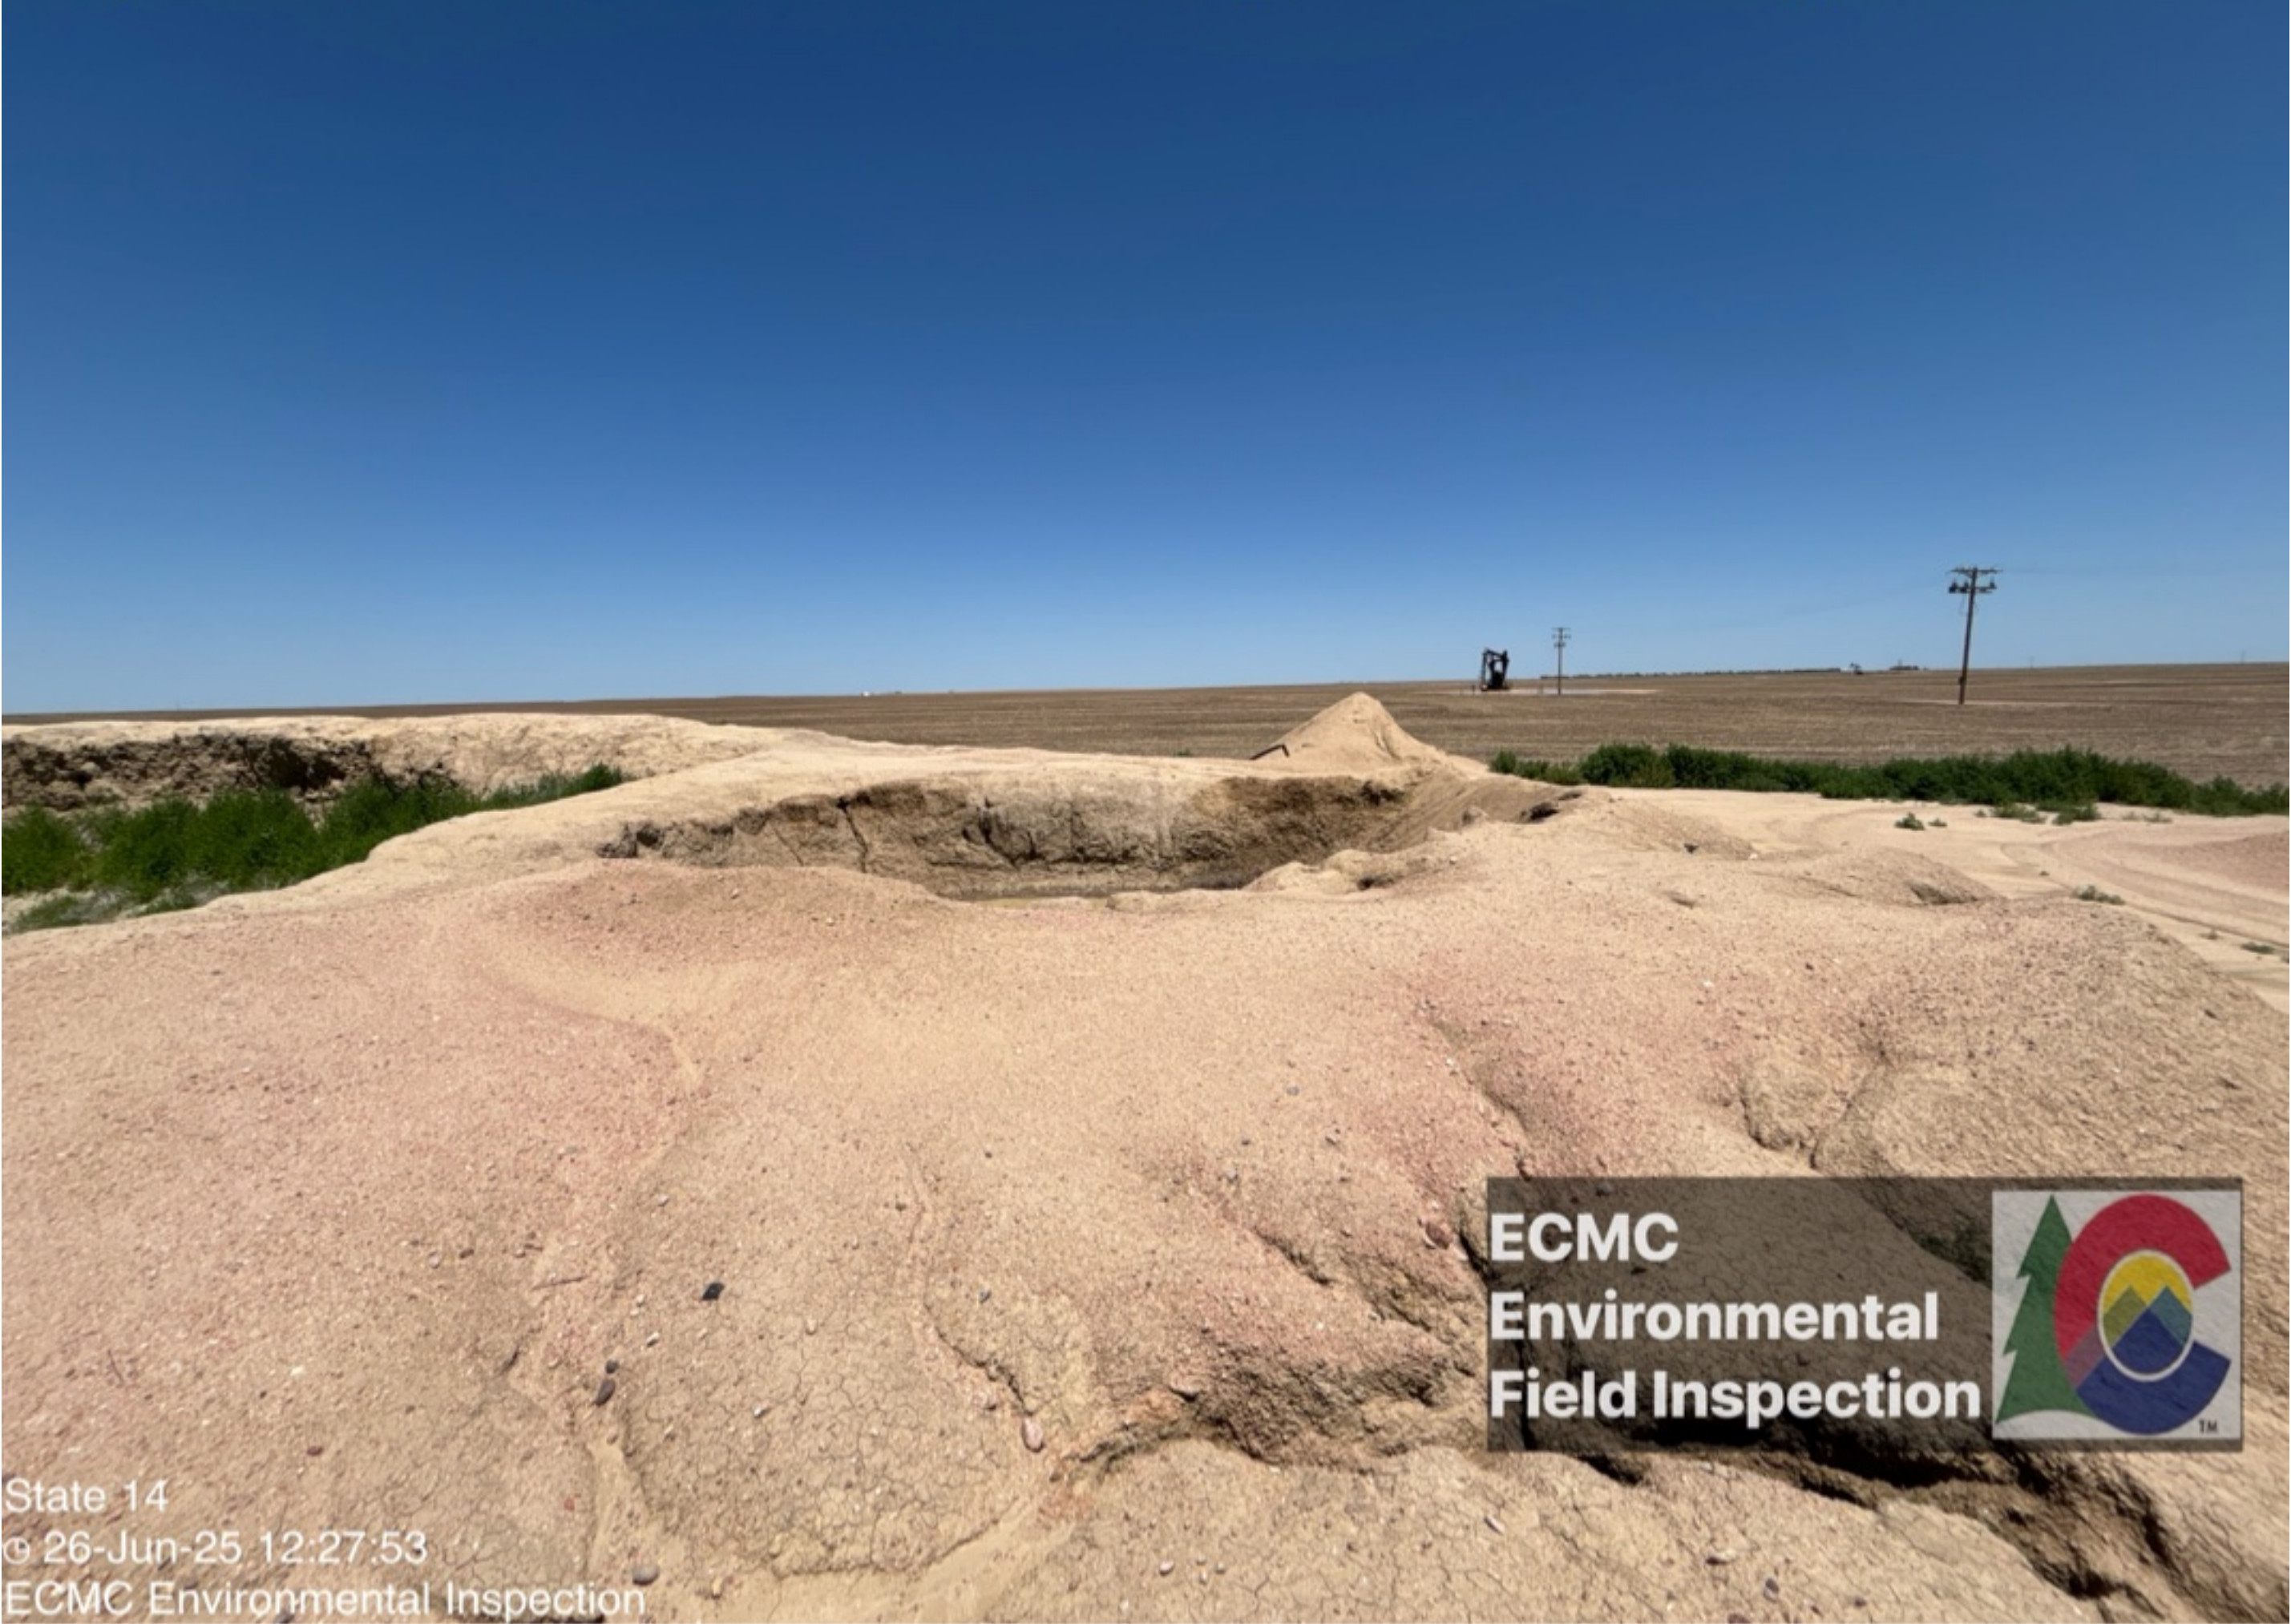
Weeds  
Unknown - Open excavation/Former Pit. Stained soil observed along sidewalls.  
Erosion & transport of sediment off location

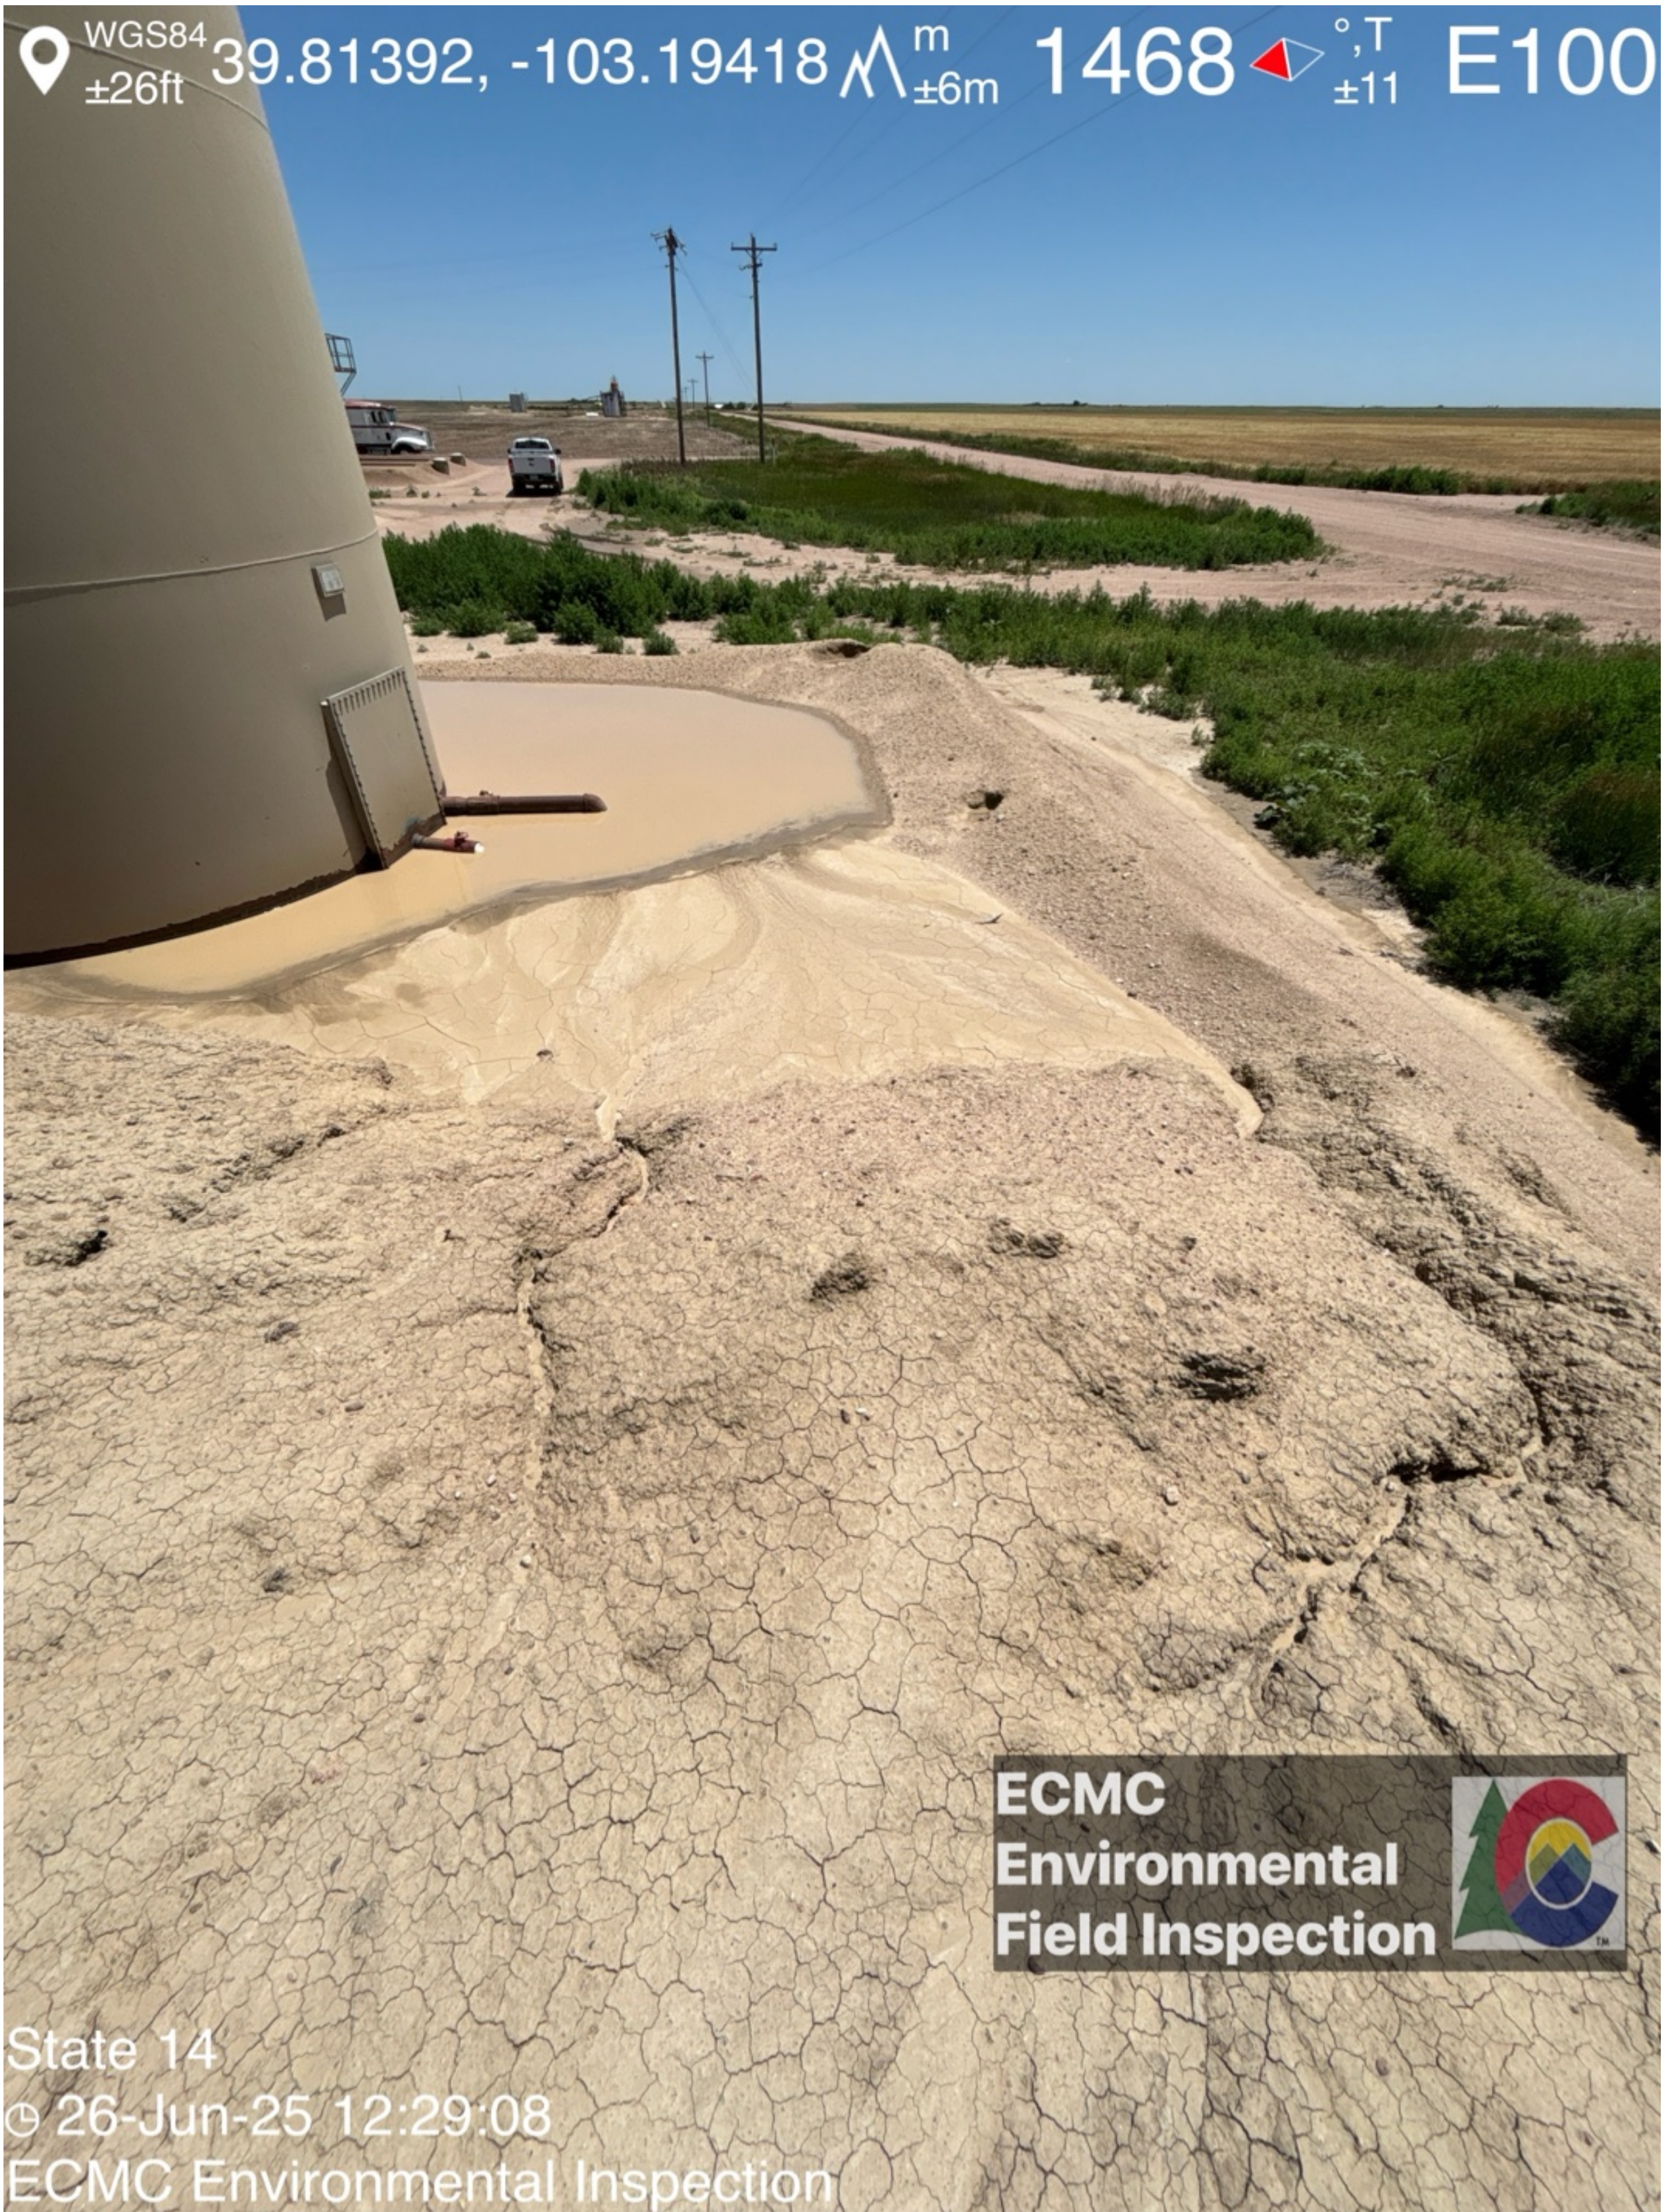
Weeds  
Erosion - Sediment transport off location  
Earthen secondary containment berm(s) is(are) not adequate to contain volume of the largest tank plus freeboard allowance.  
Earthen secondary containment berm(s) is(are) not sufficiently impervious to contain spills/releases.

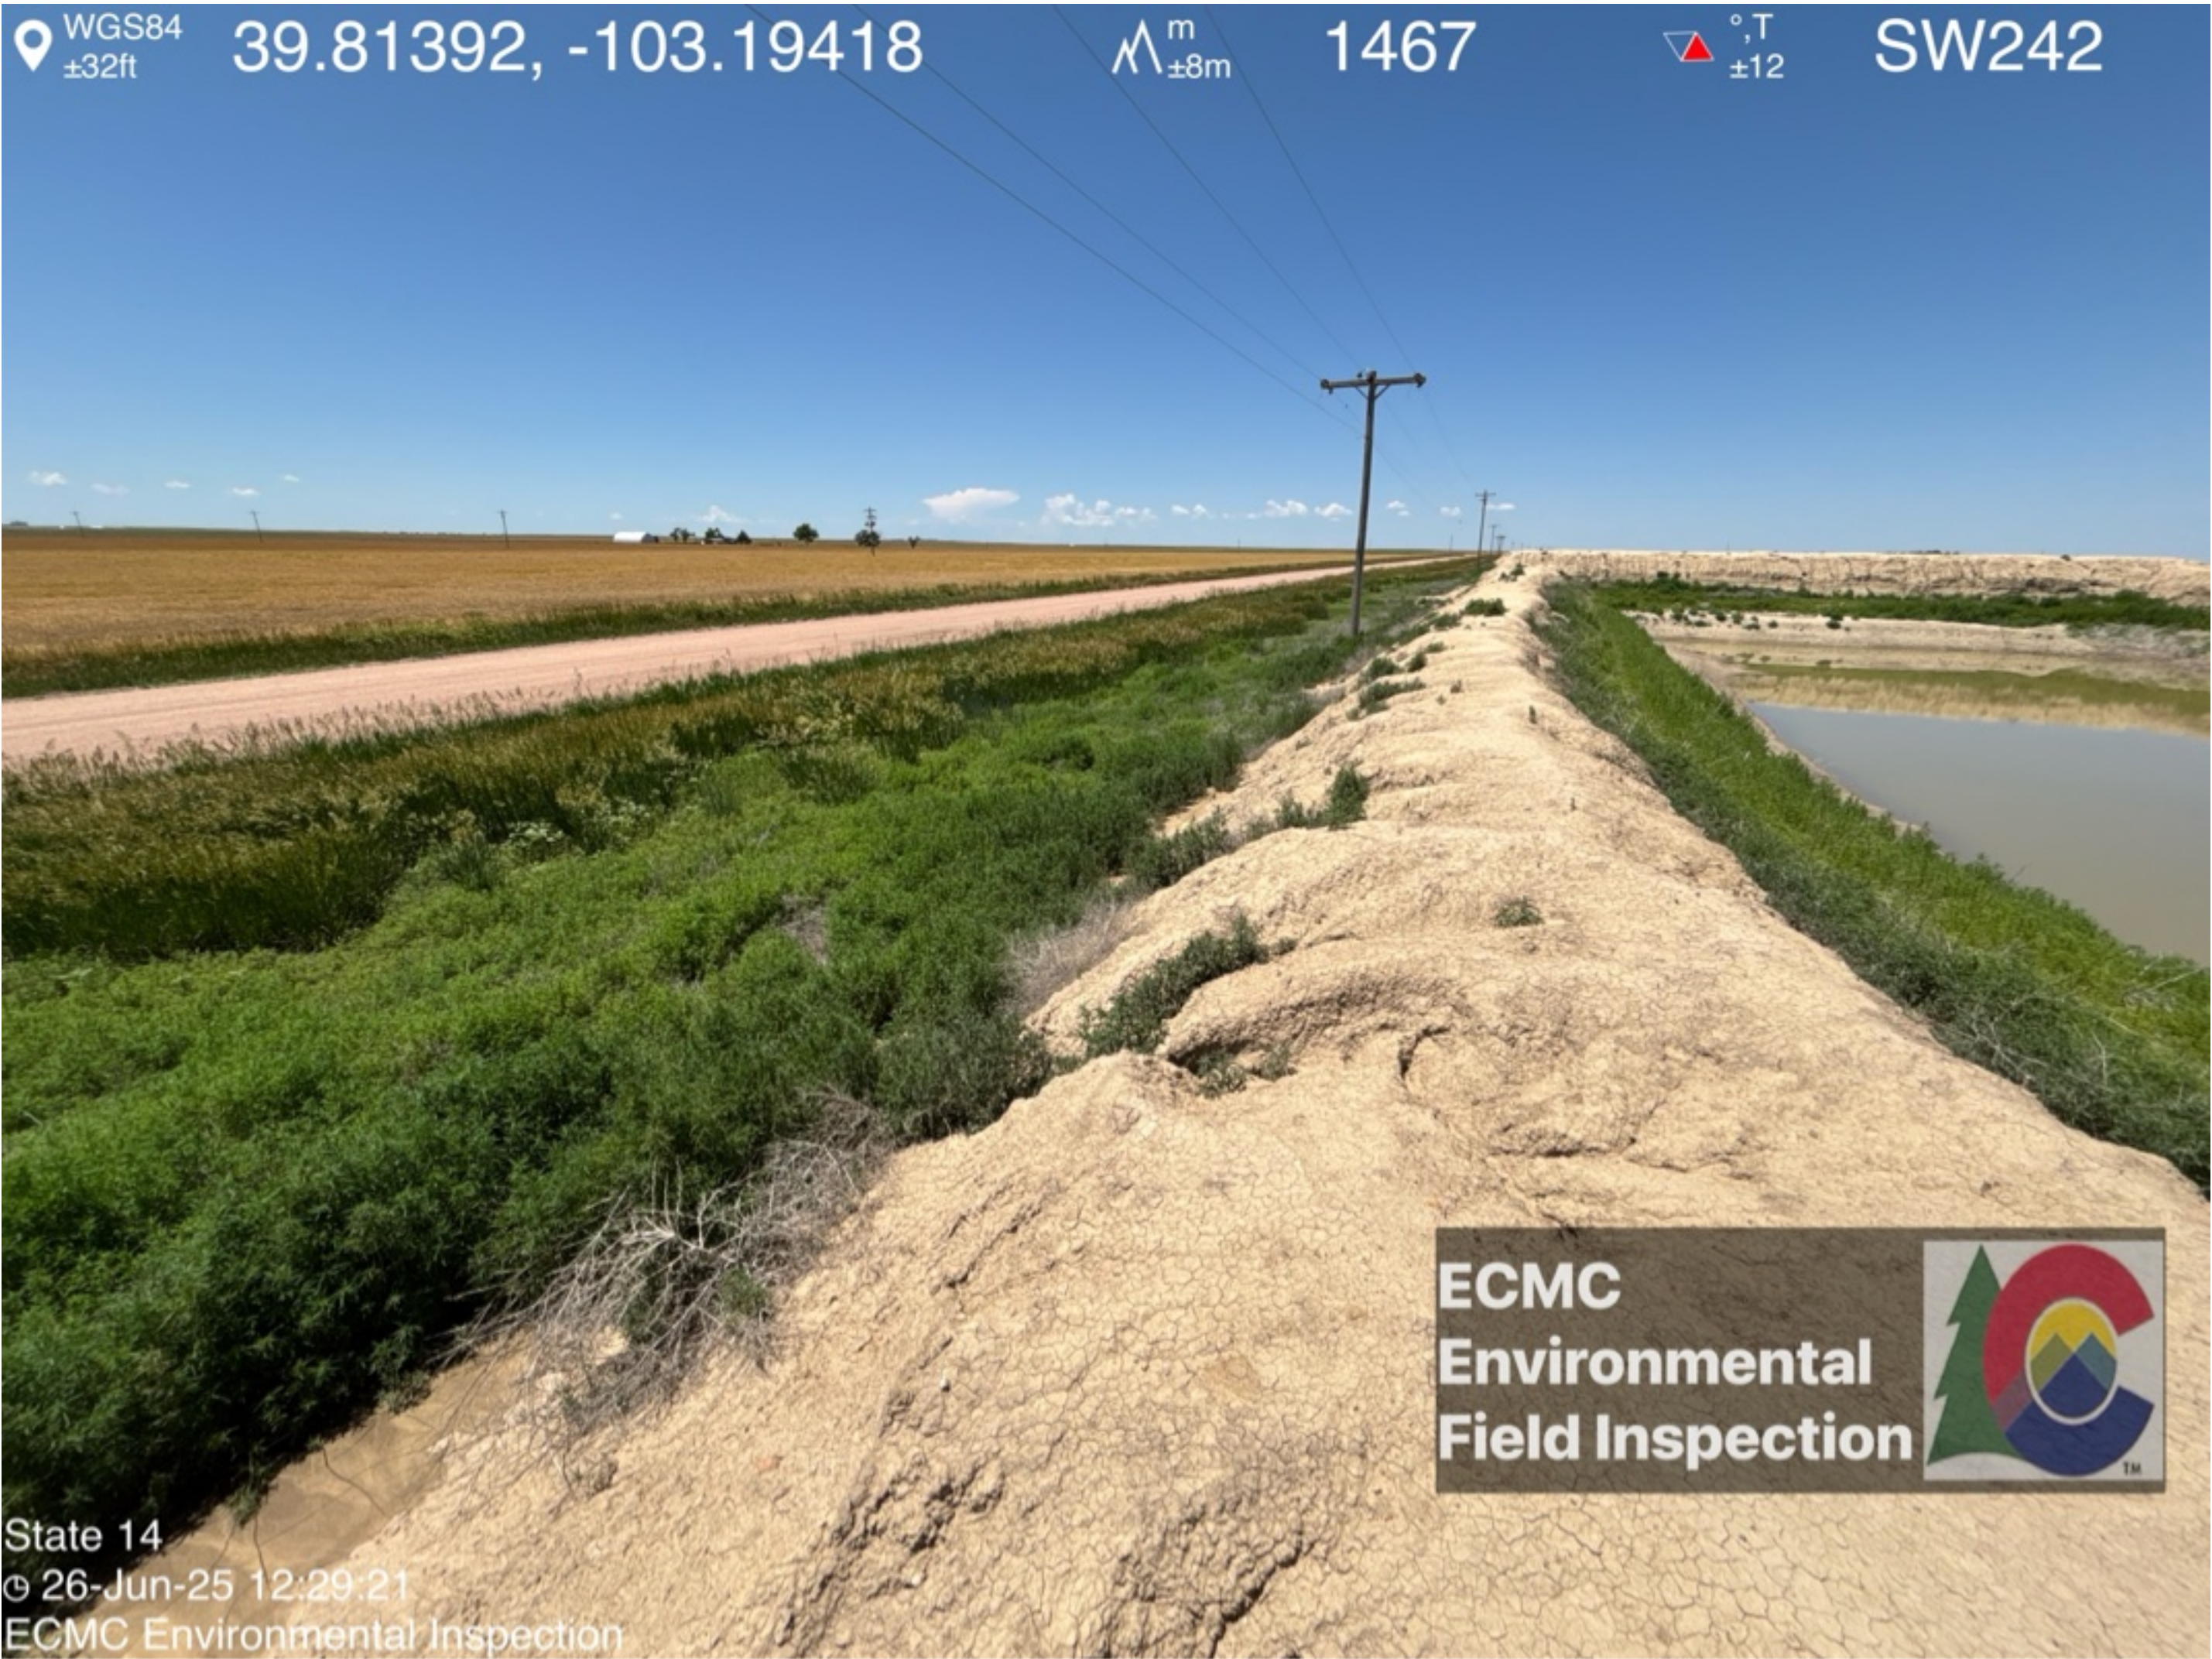
Weeds  
Erosion of the earthen pit - Sediment transport off location.

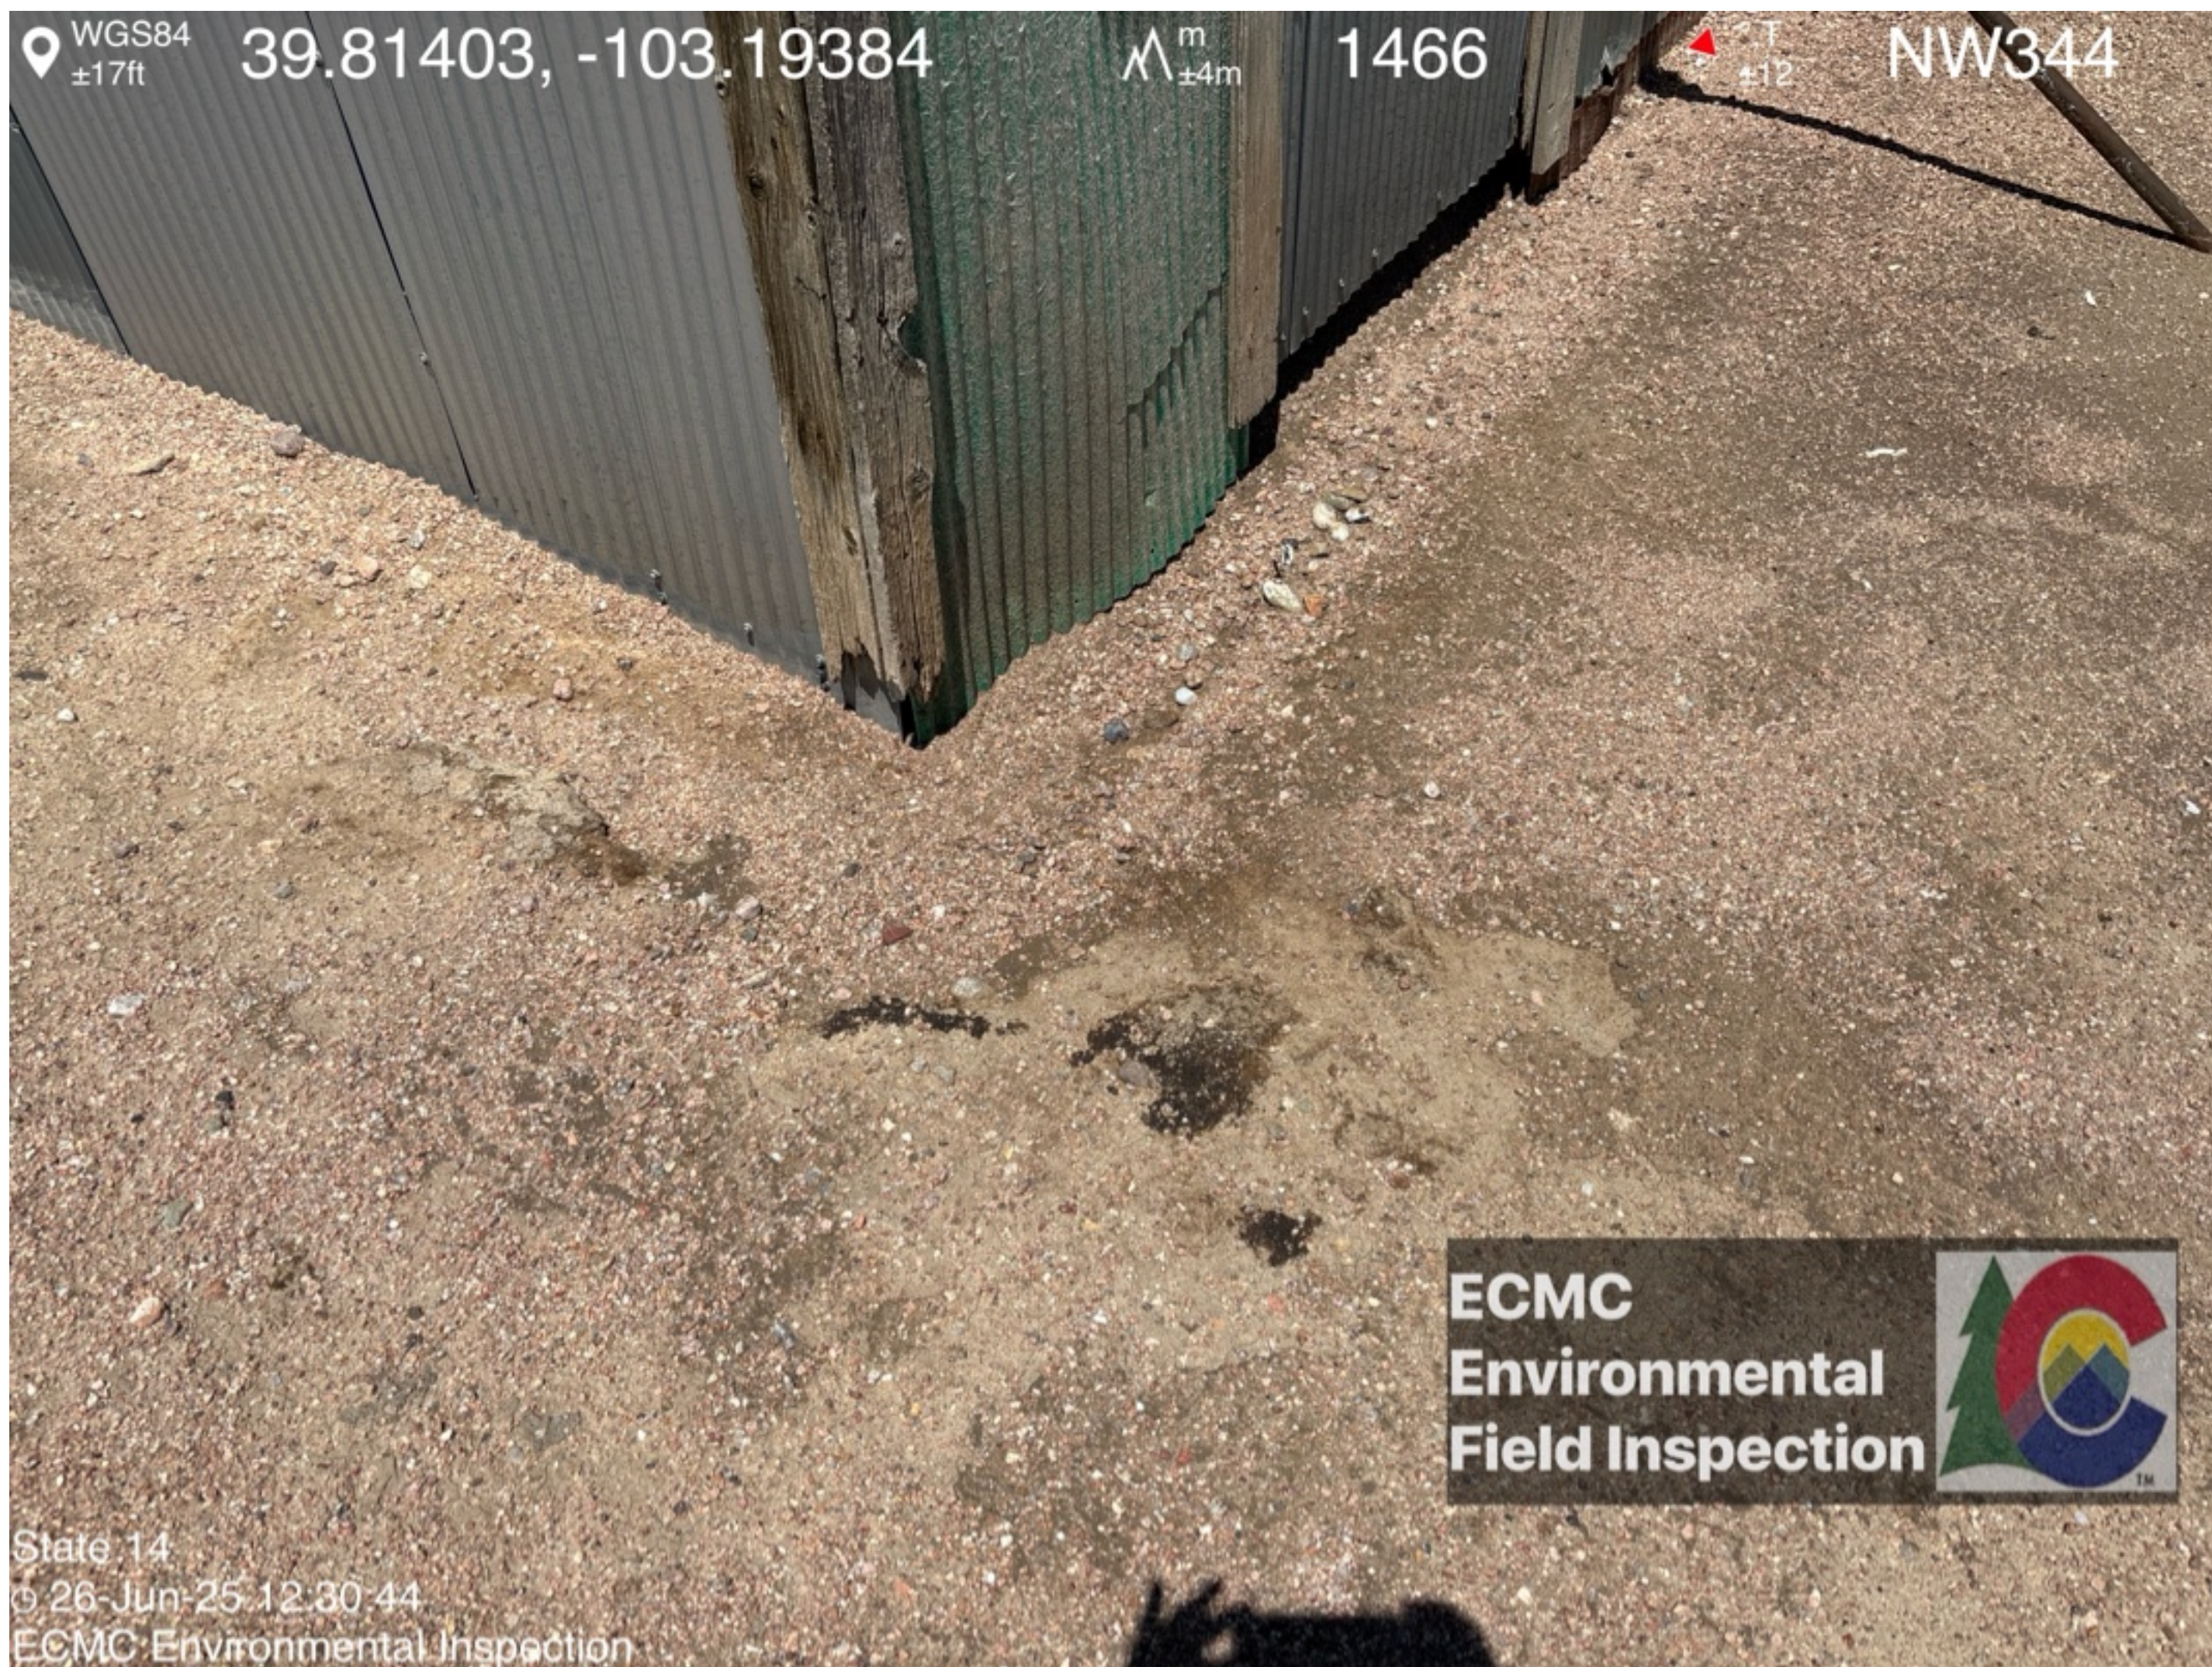
Stained soil observed outside heater treater shed
