**ECMC  
Environmental  
Field Inspection**

ECMC Environmental Inspection

**Burrows**

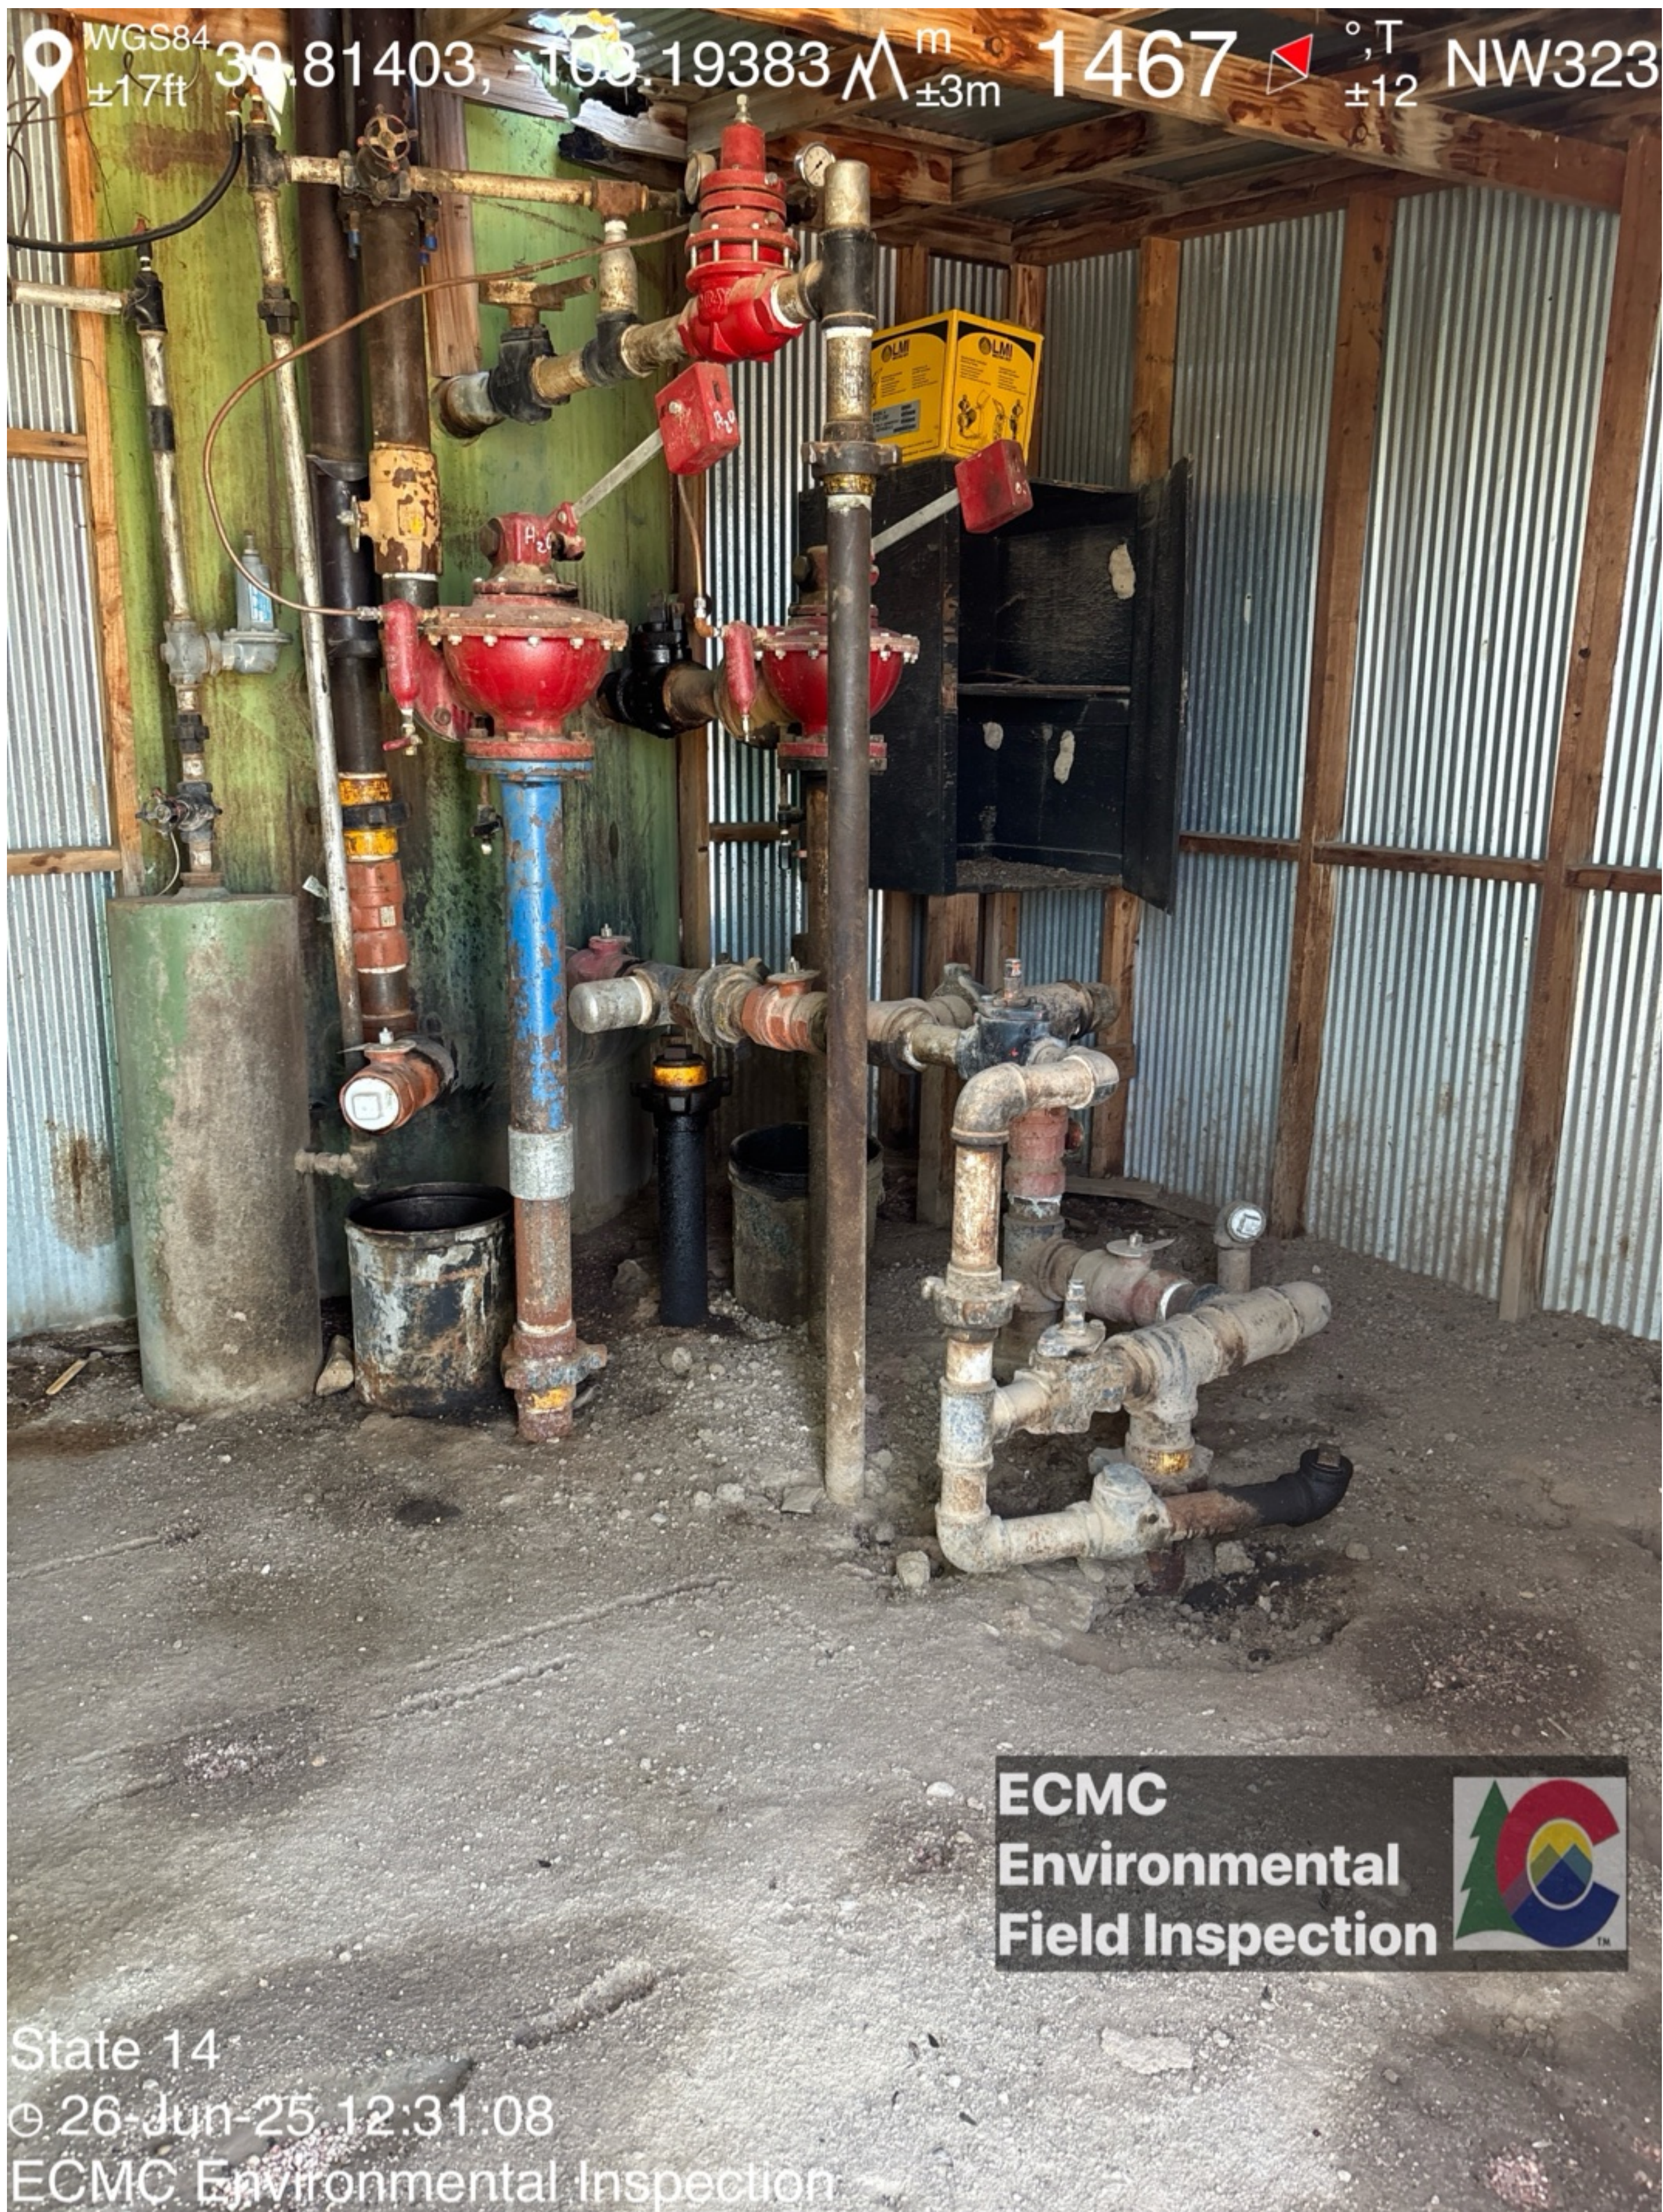
Stained soil observed within heater treater shed

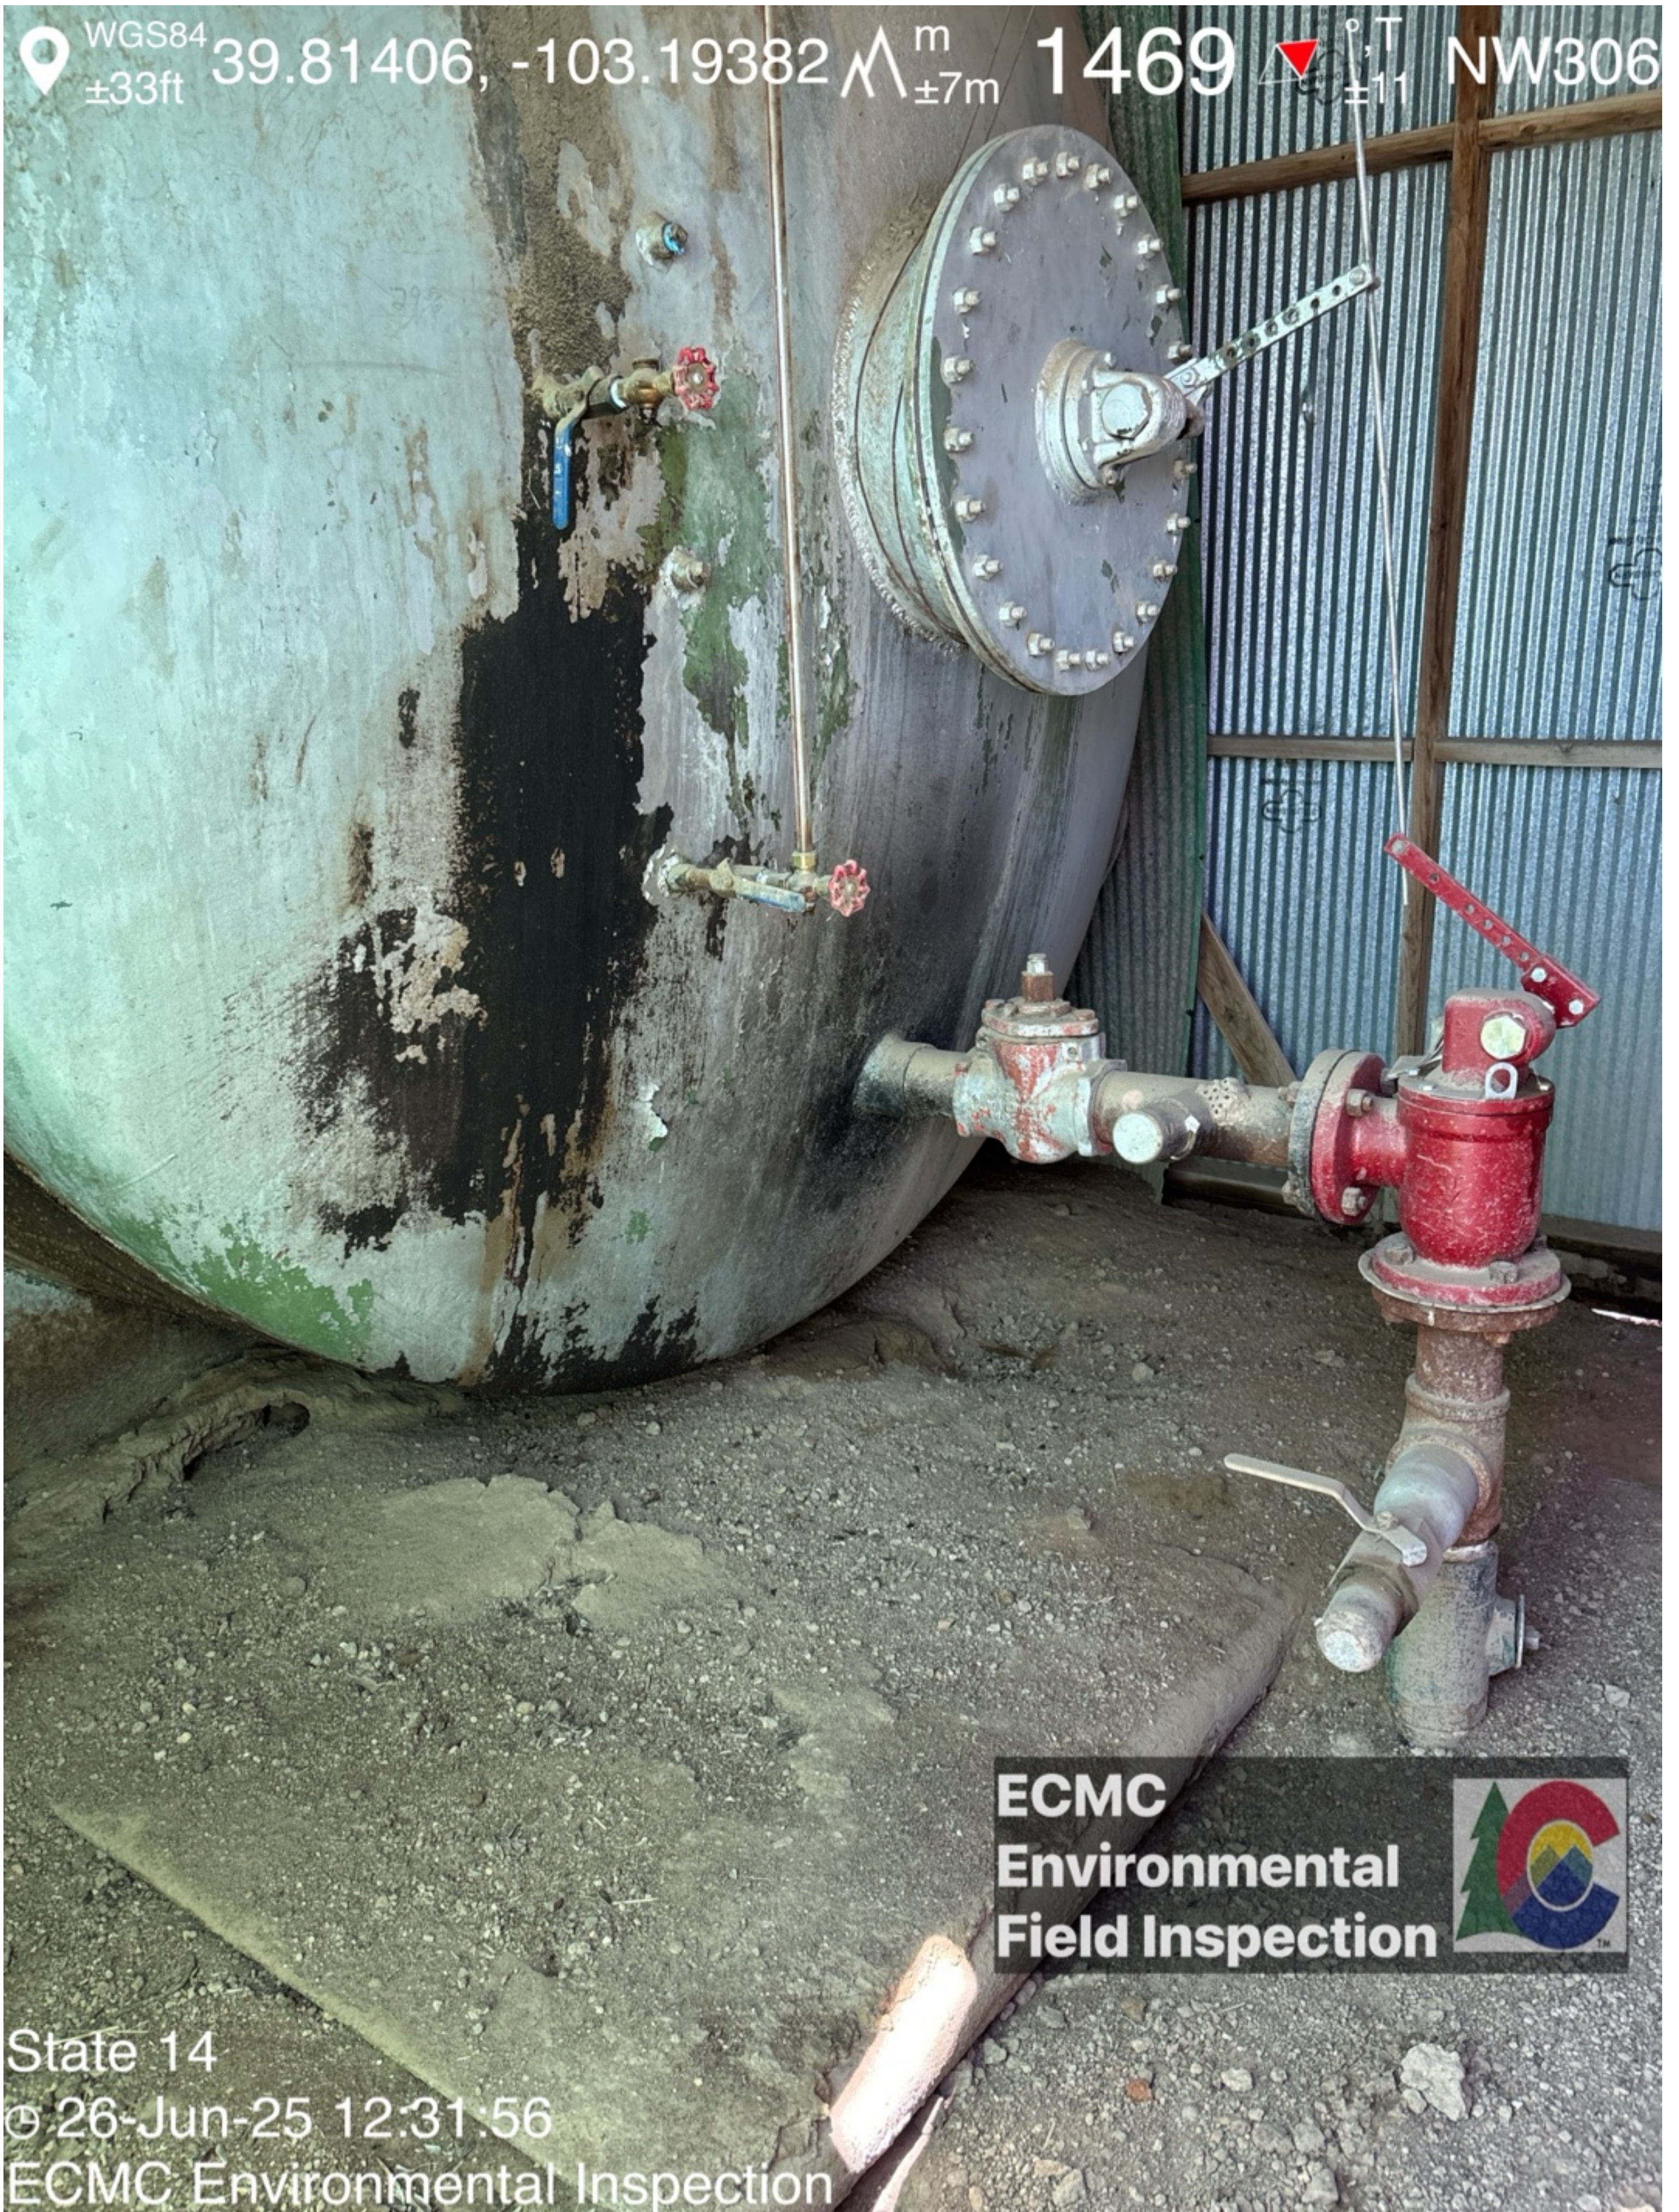
Stained soil observed within FWKO shed

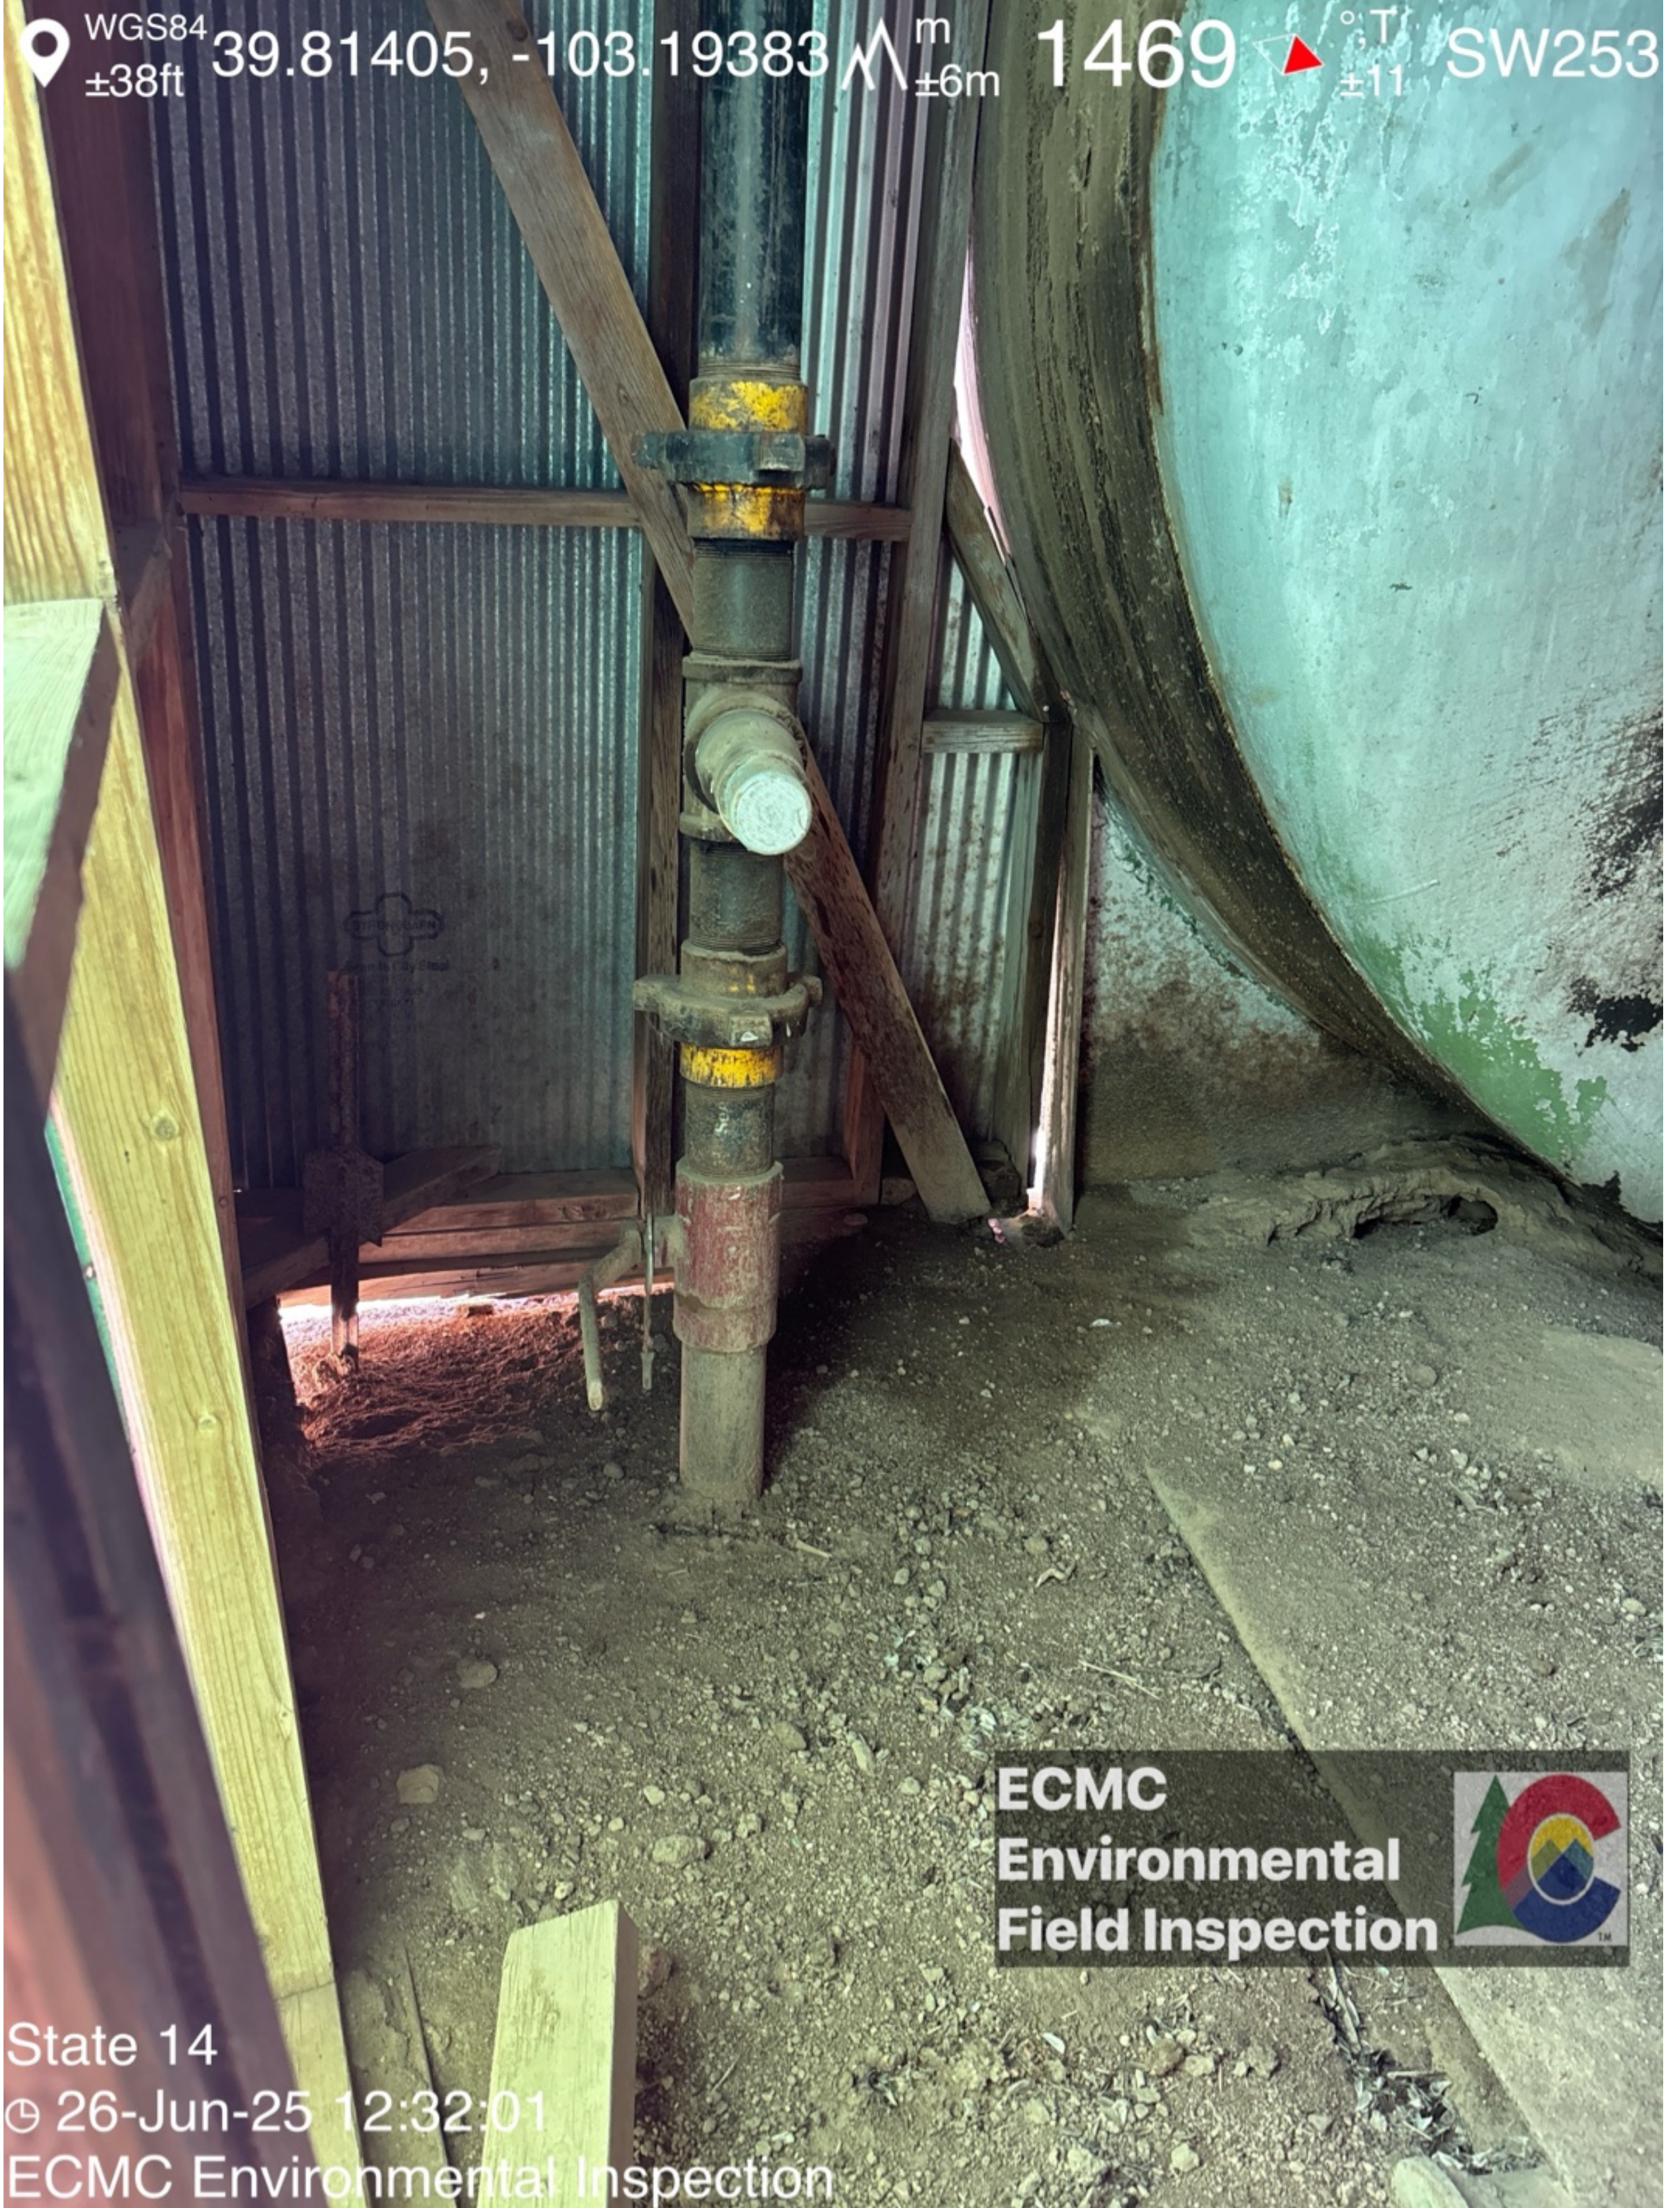
Staining soil observed within FWKO shed

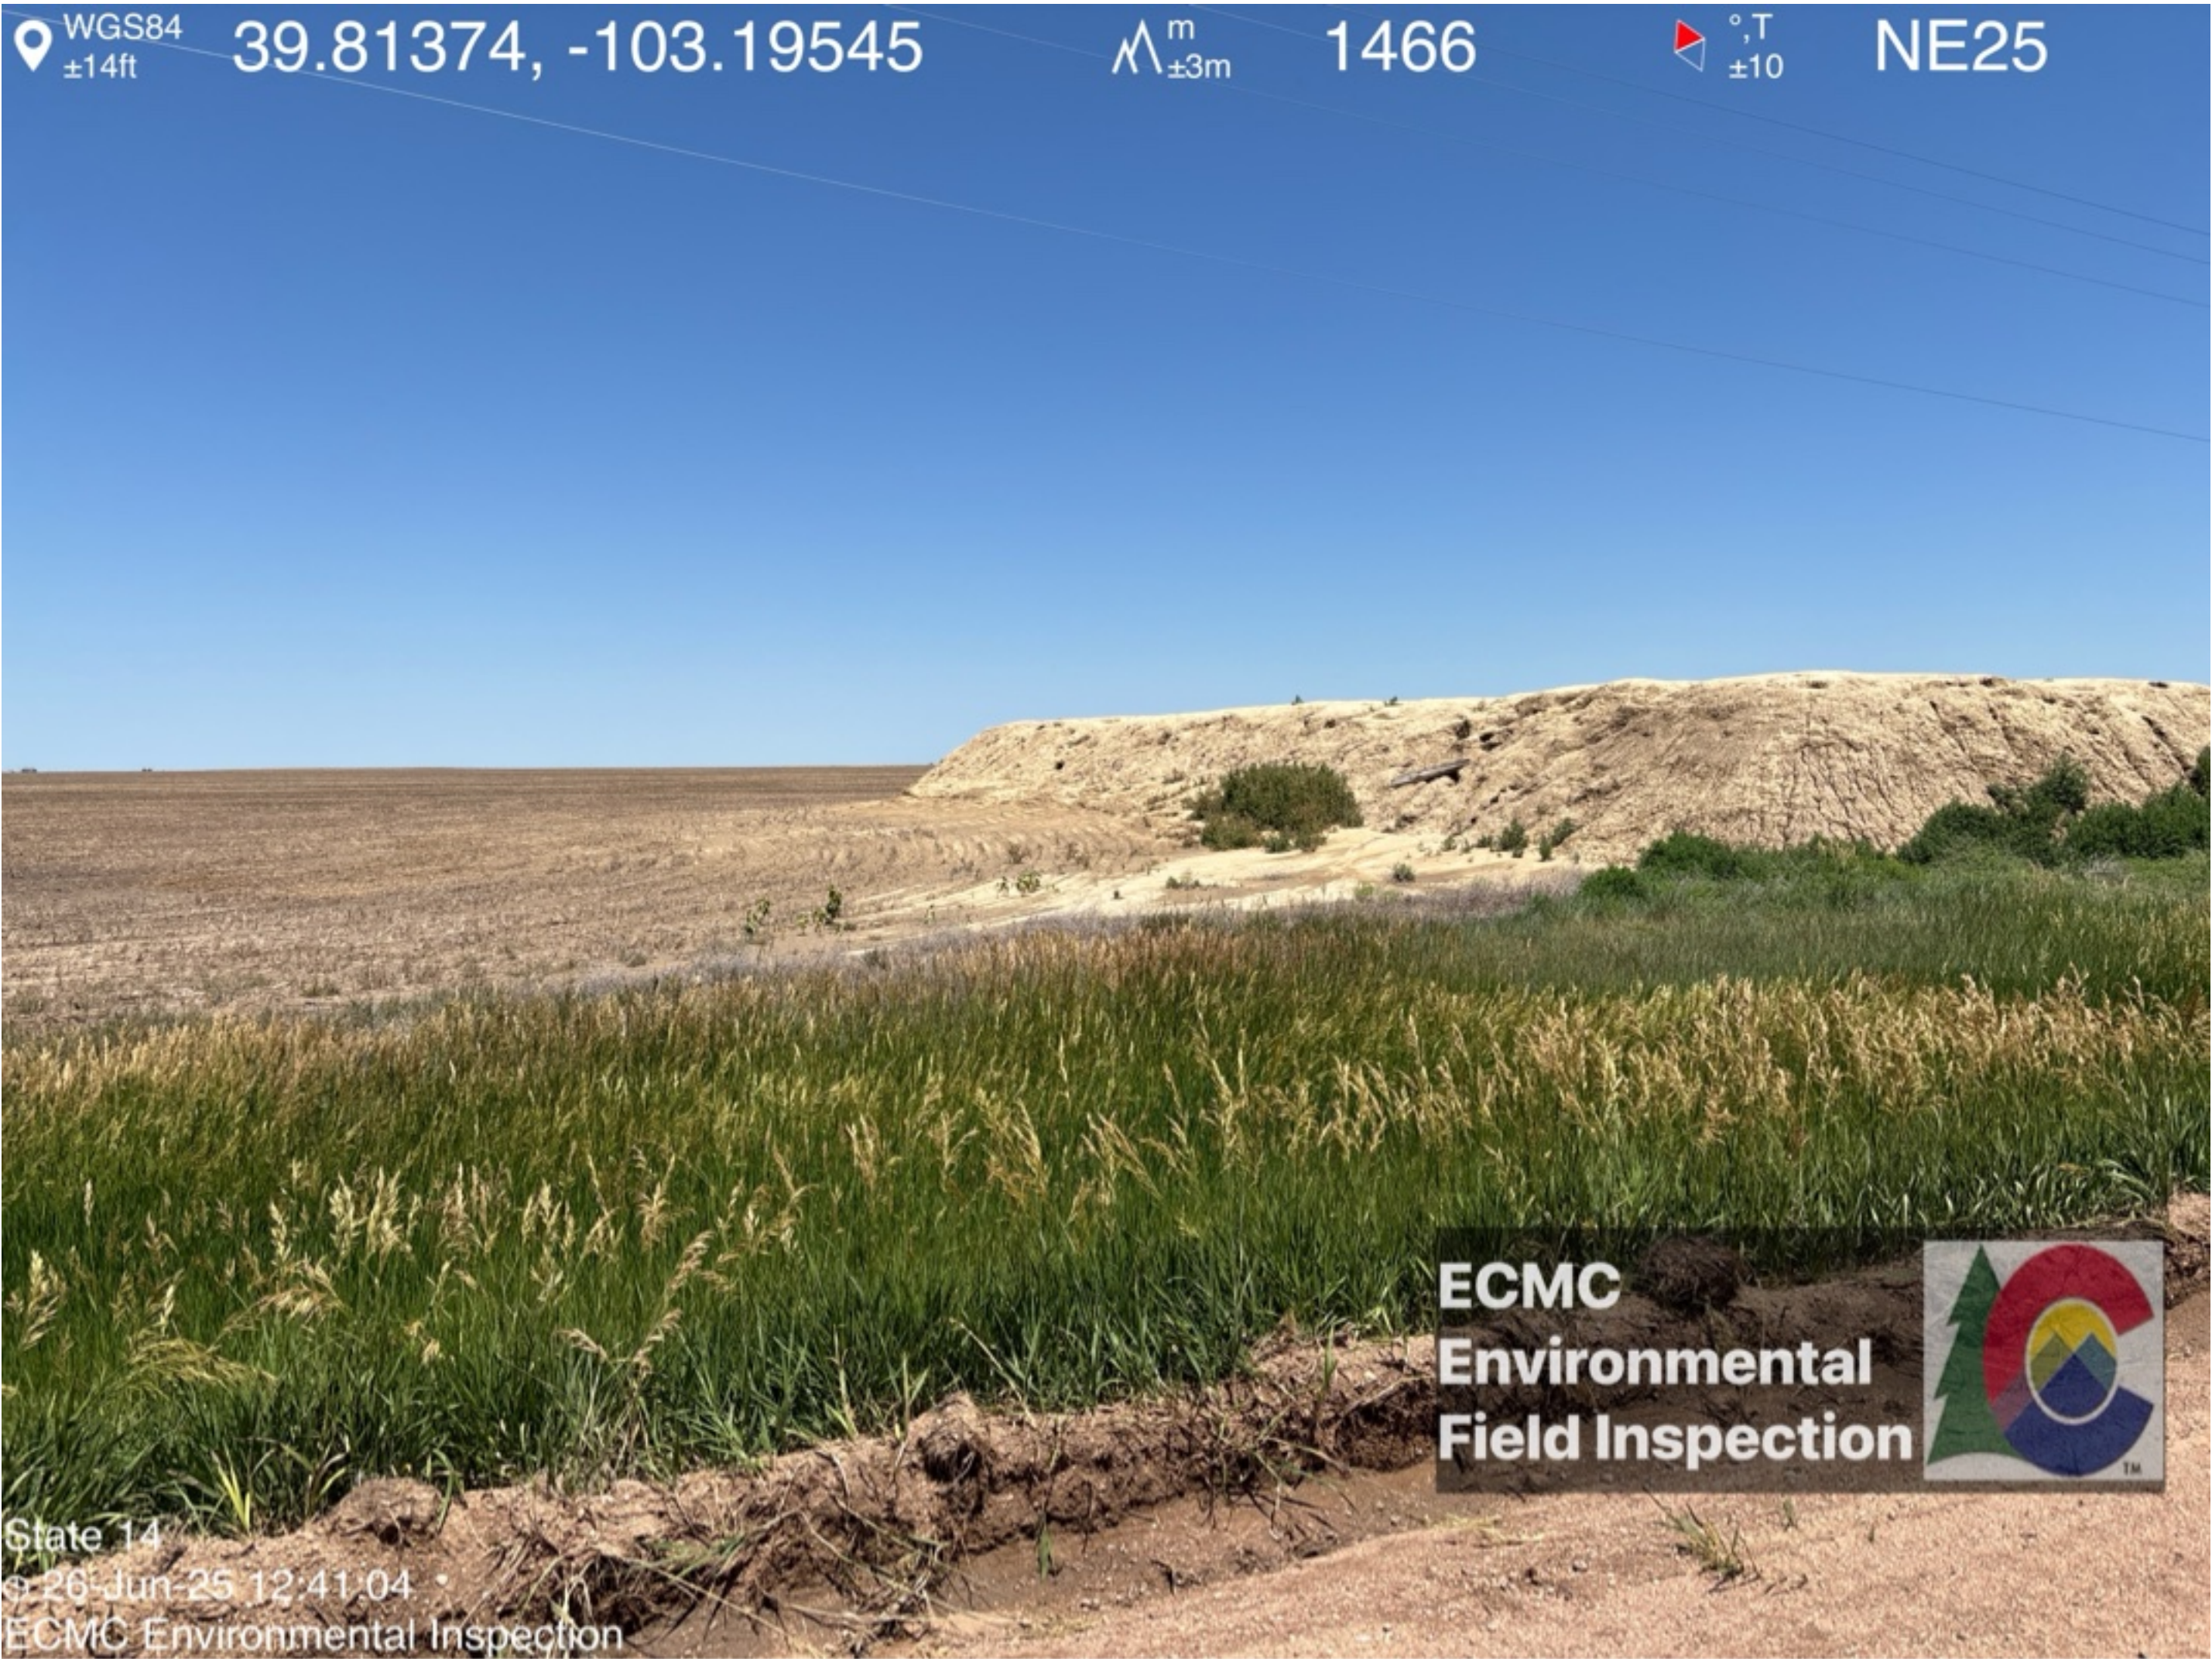
Weeds  
Erosion - Sediment transport off location
