ECMC
Environmental
Field Inspection

Arikaree Creek SWD 1 Tank Battery
© 26-Jun-25 13:27:08
ECMC Environmental Inspection

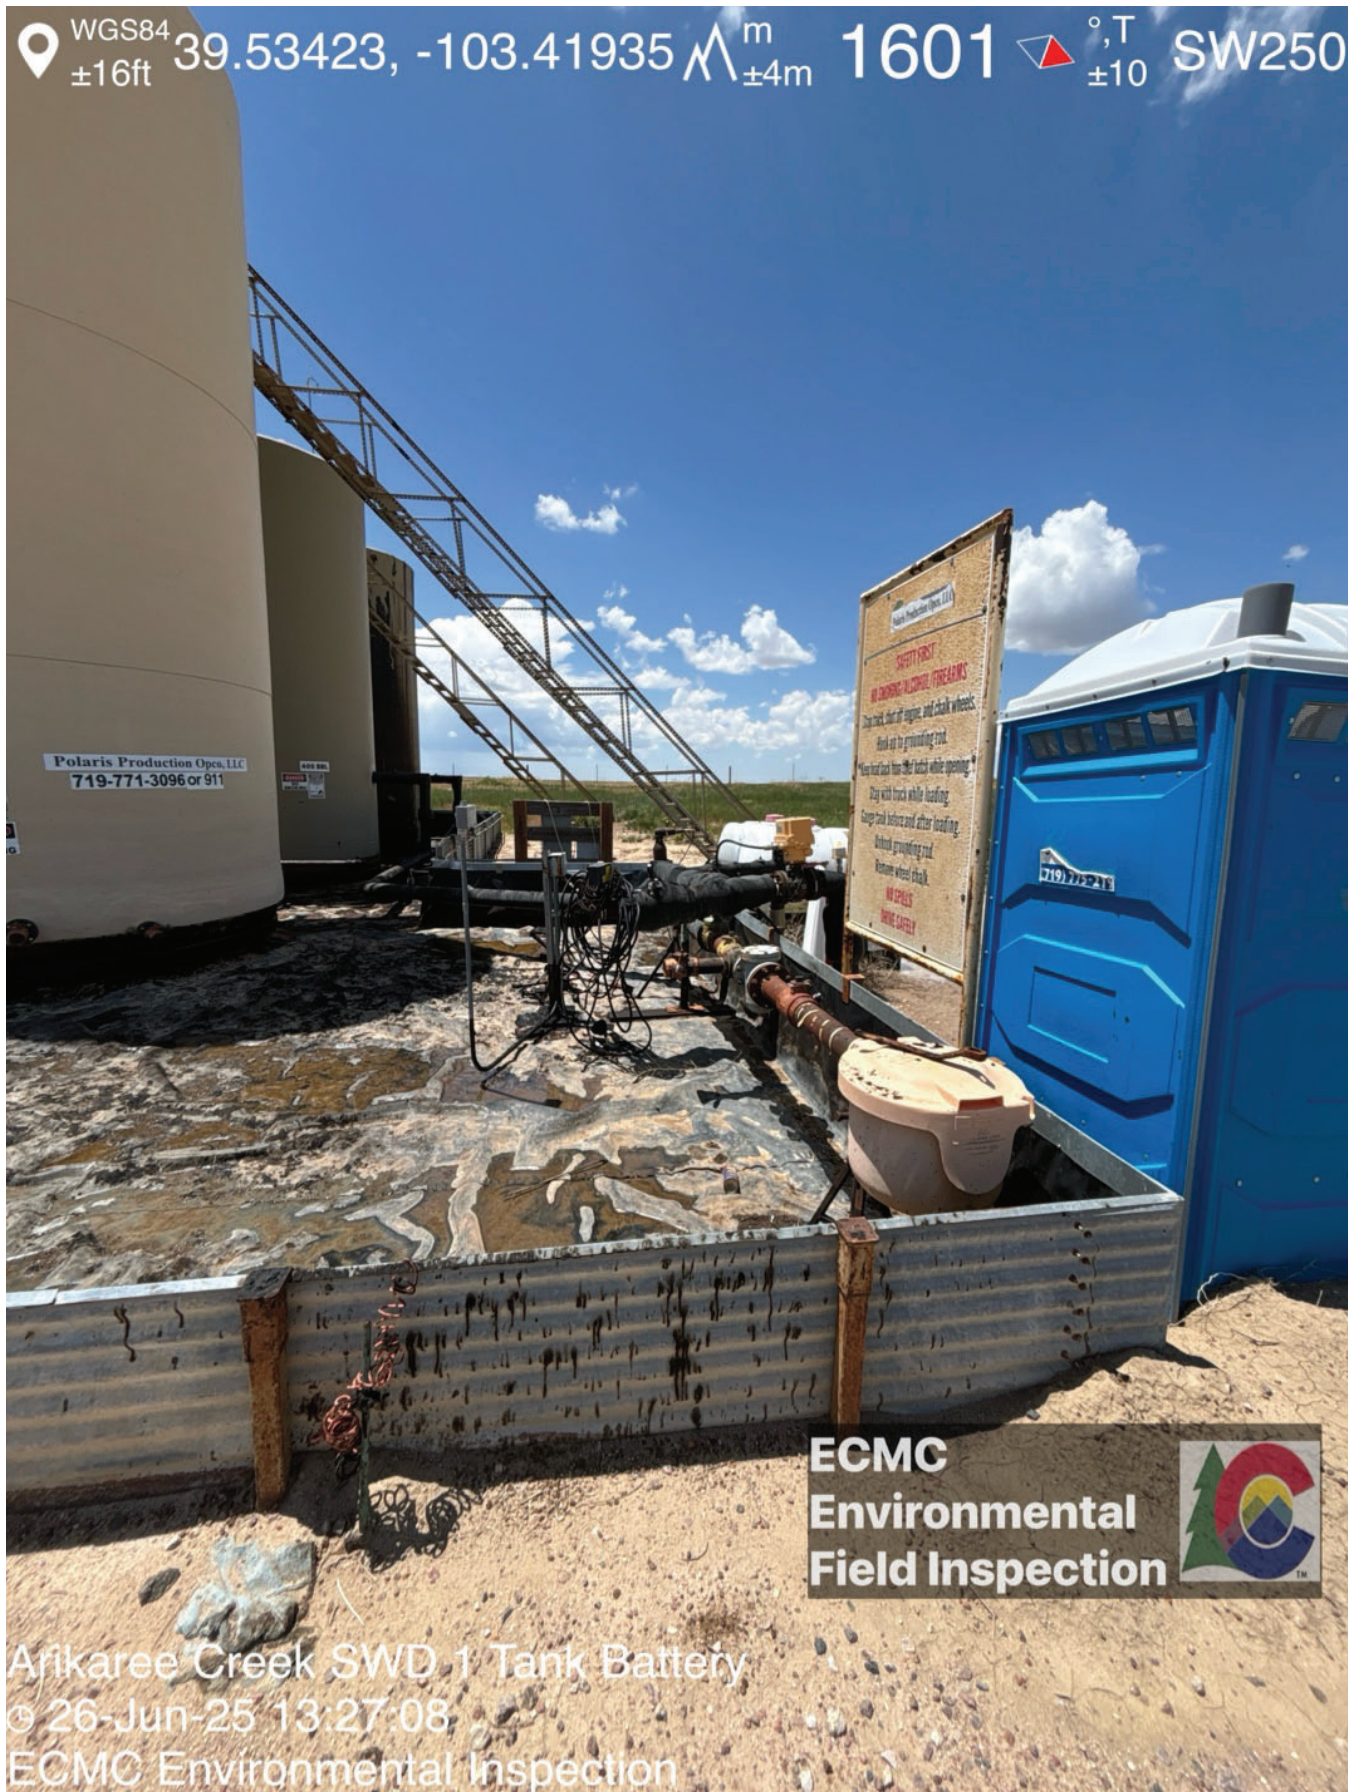
Oil/spray/staining inside and outside secondary containment (Spill ID 488212)

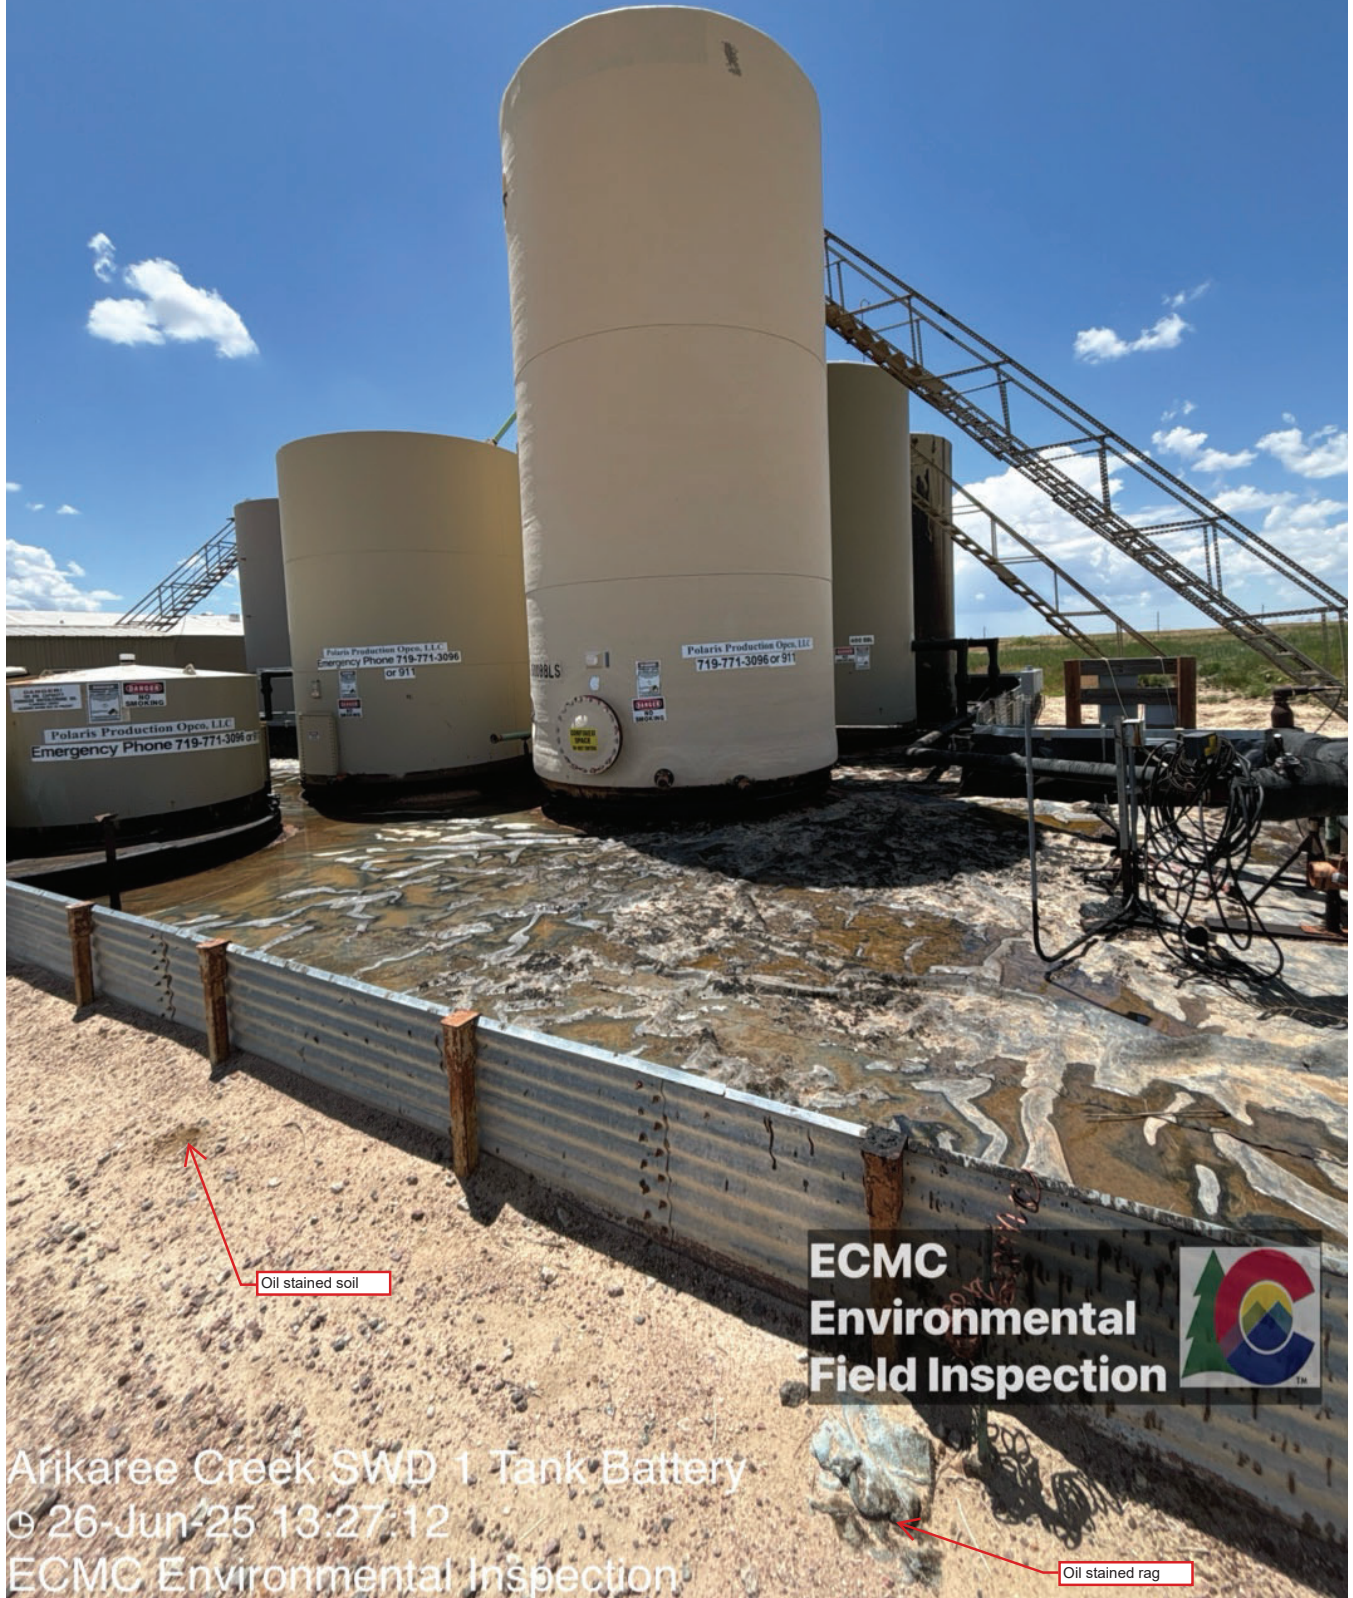
Oil/spray/staining inside and outside secondary containment (Spill ID 488212)

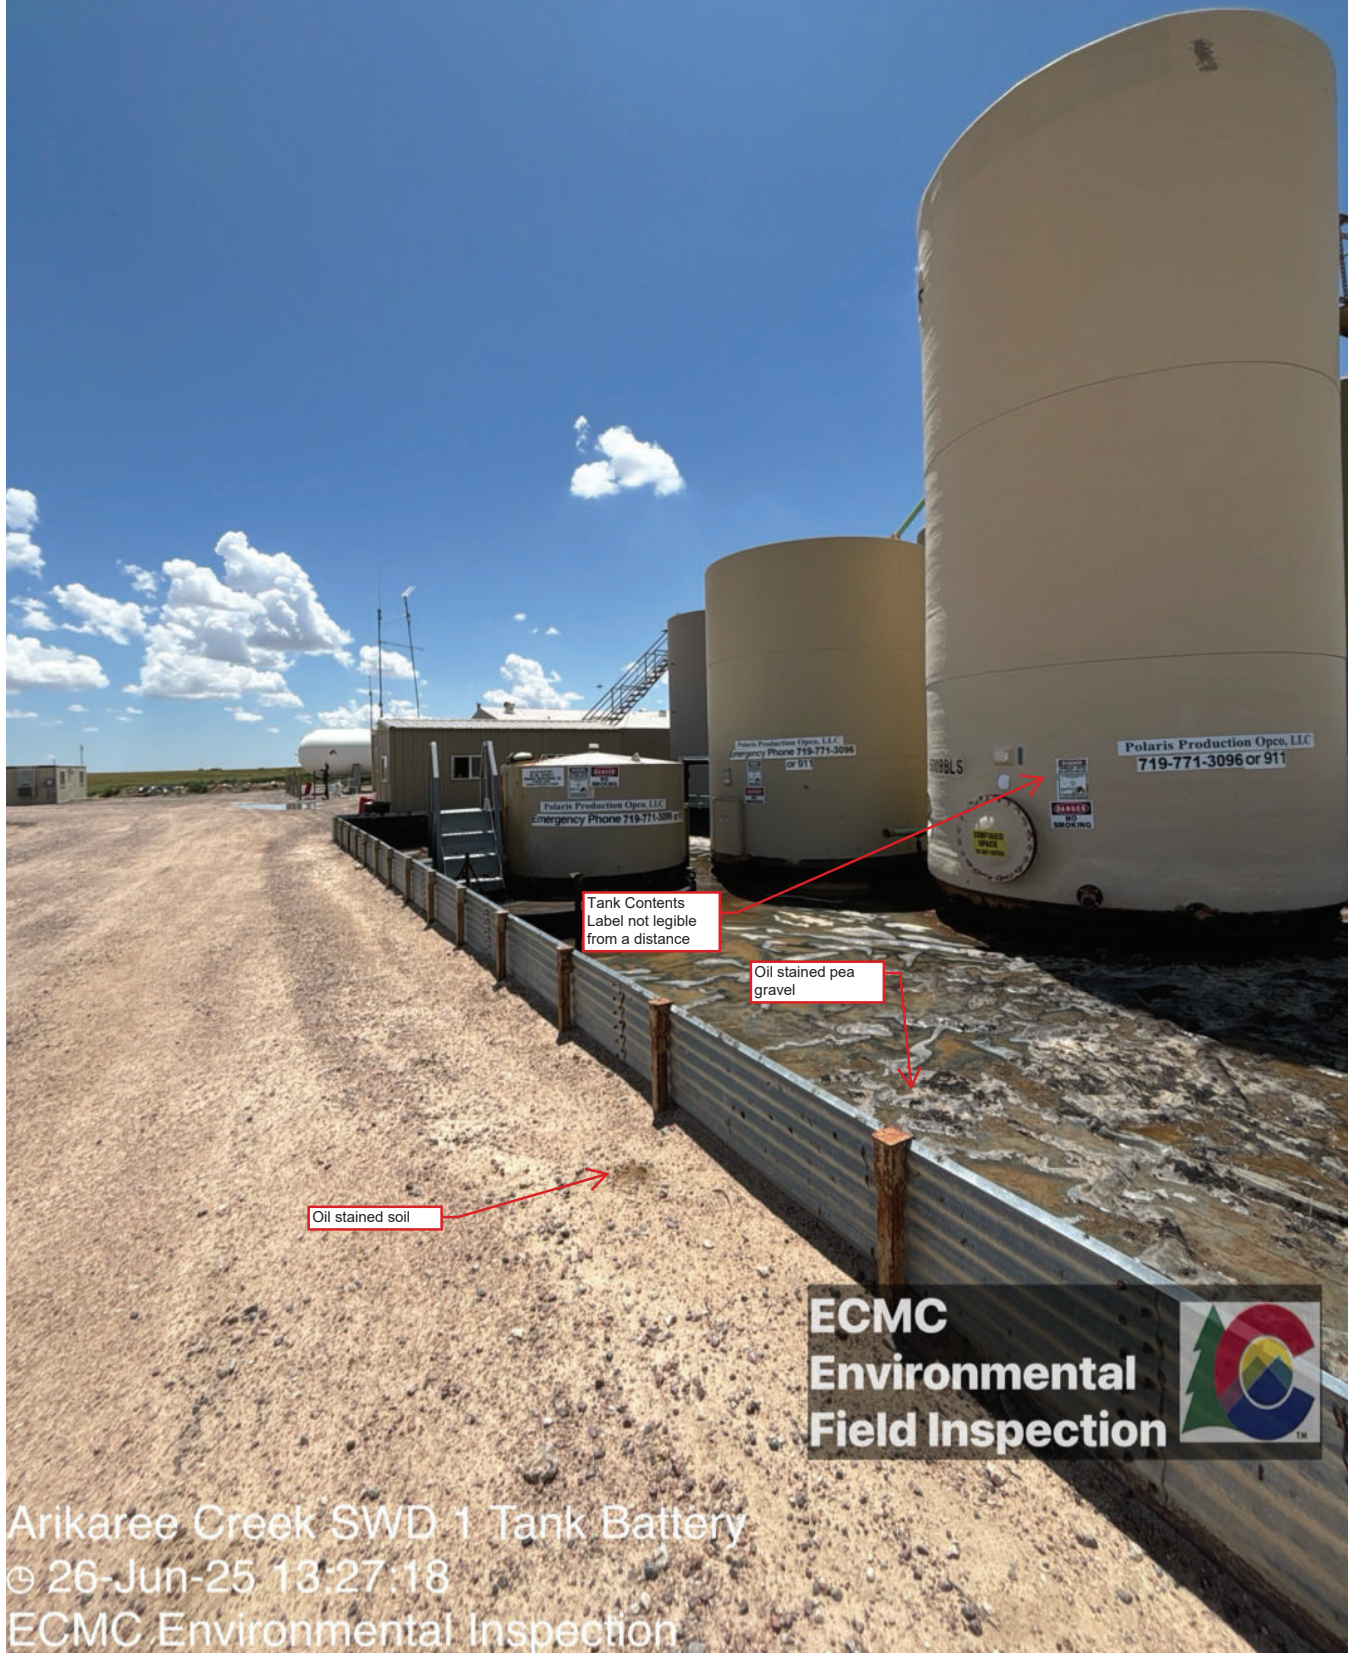
Tank Contents
Label not legible
from a distance

Oil stained pea
gravel

Oil stained soil

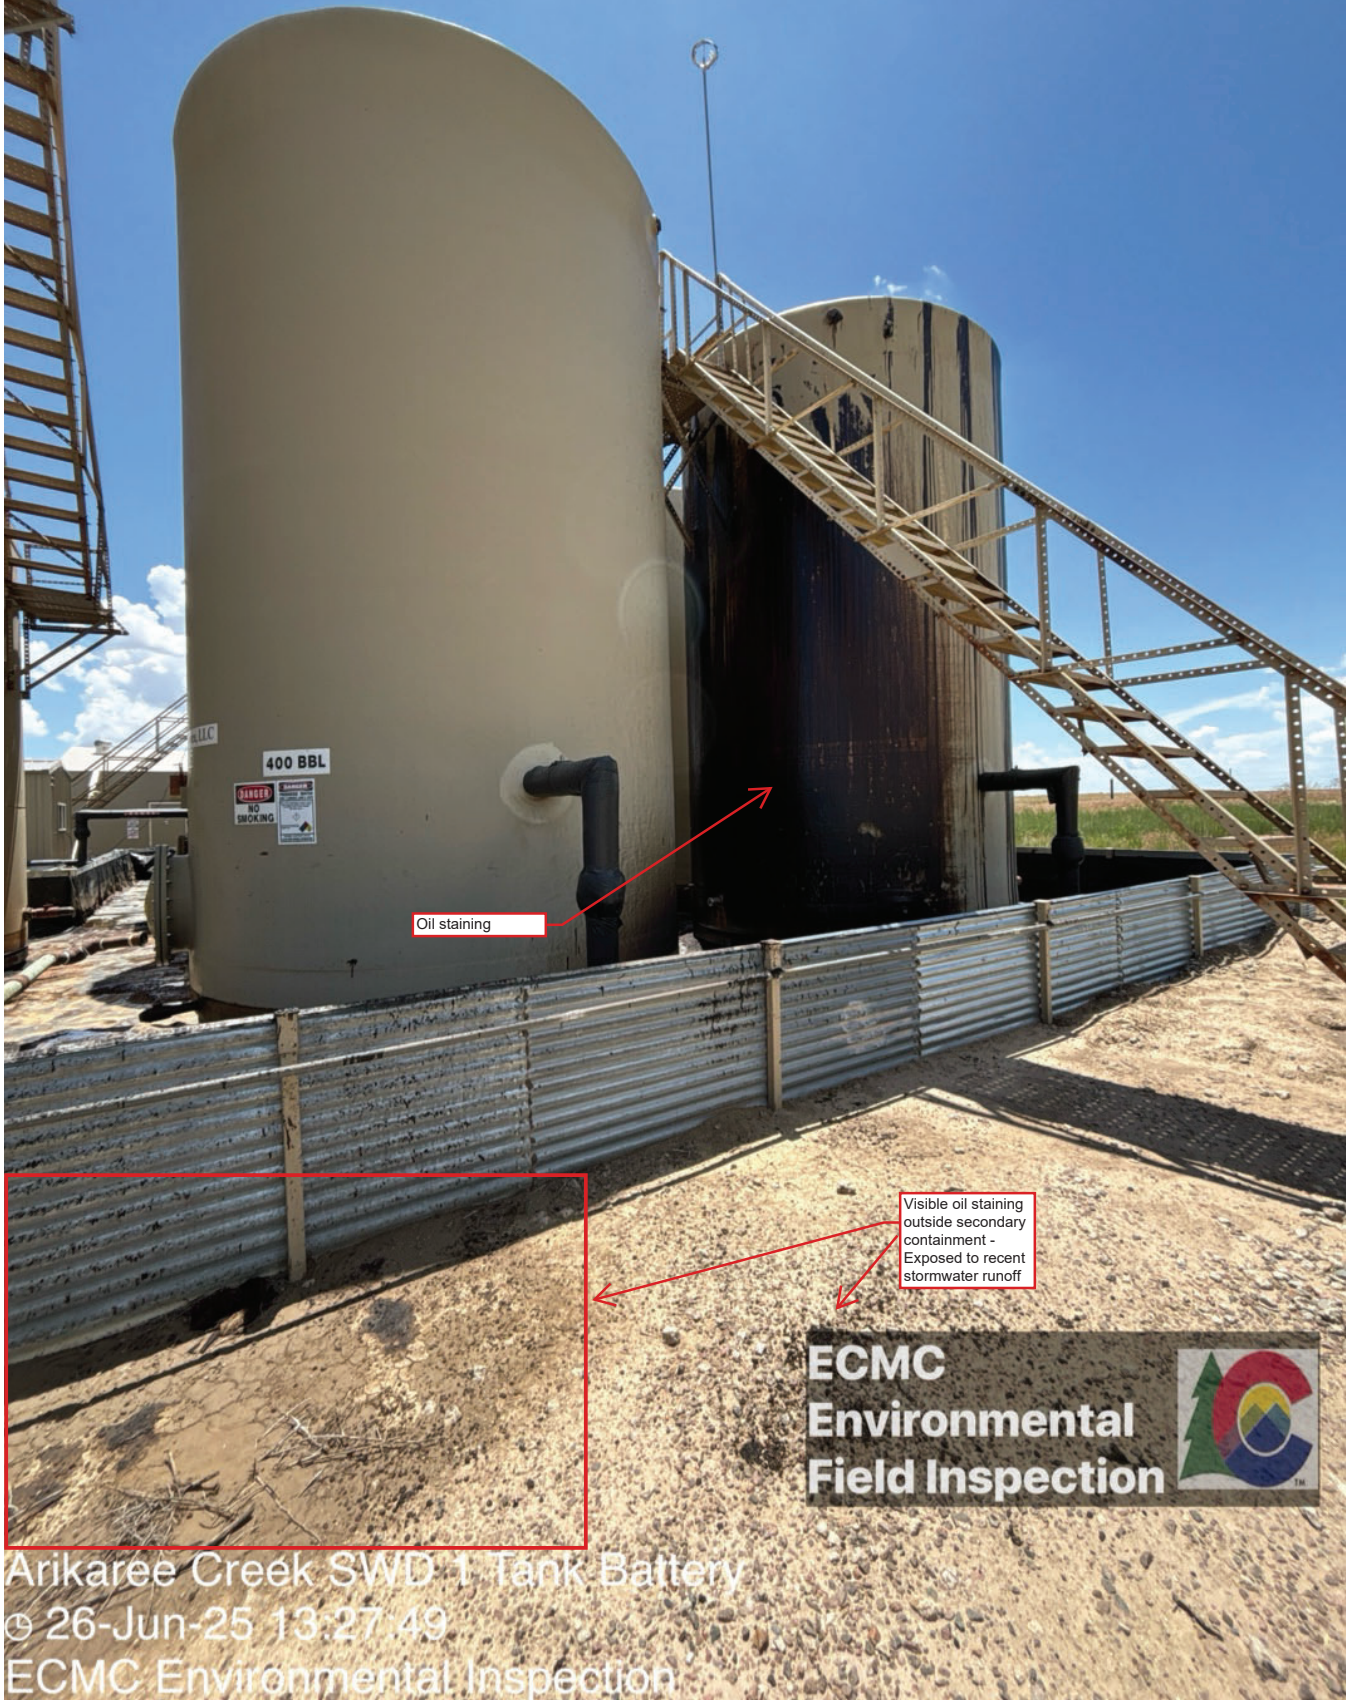
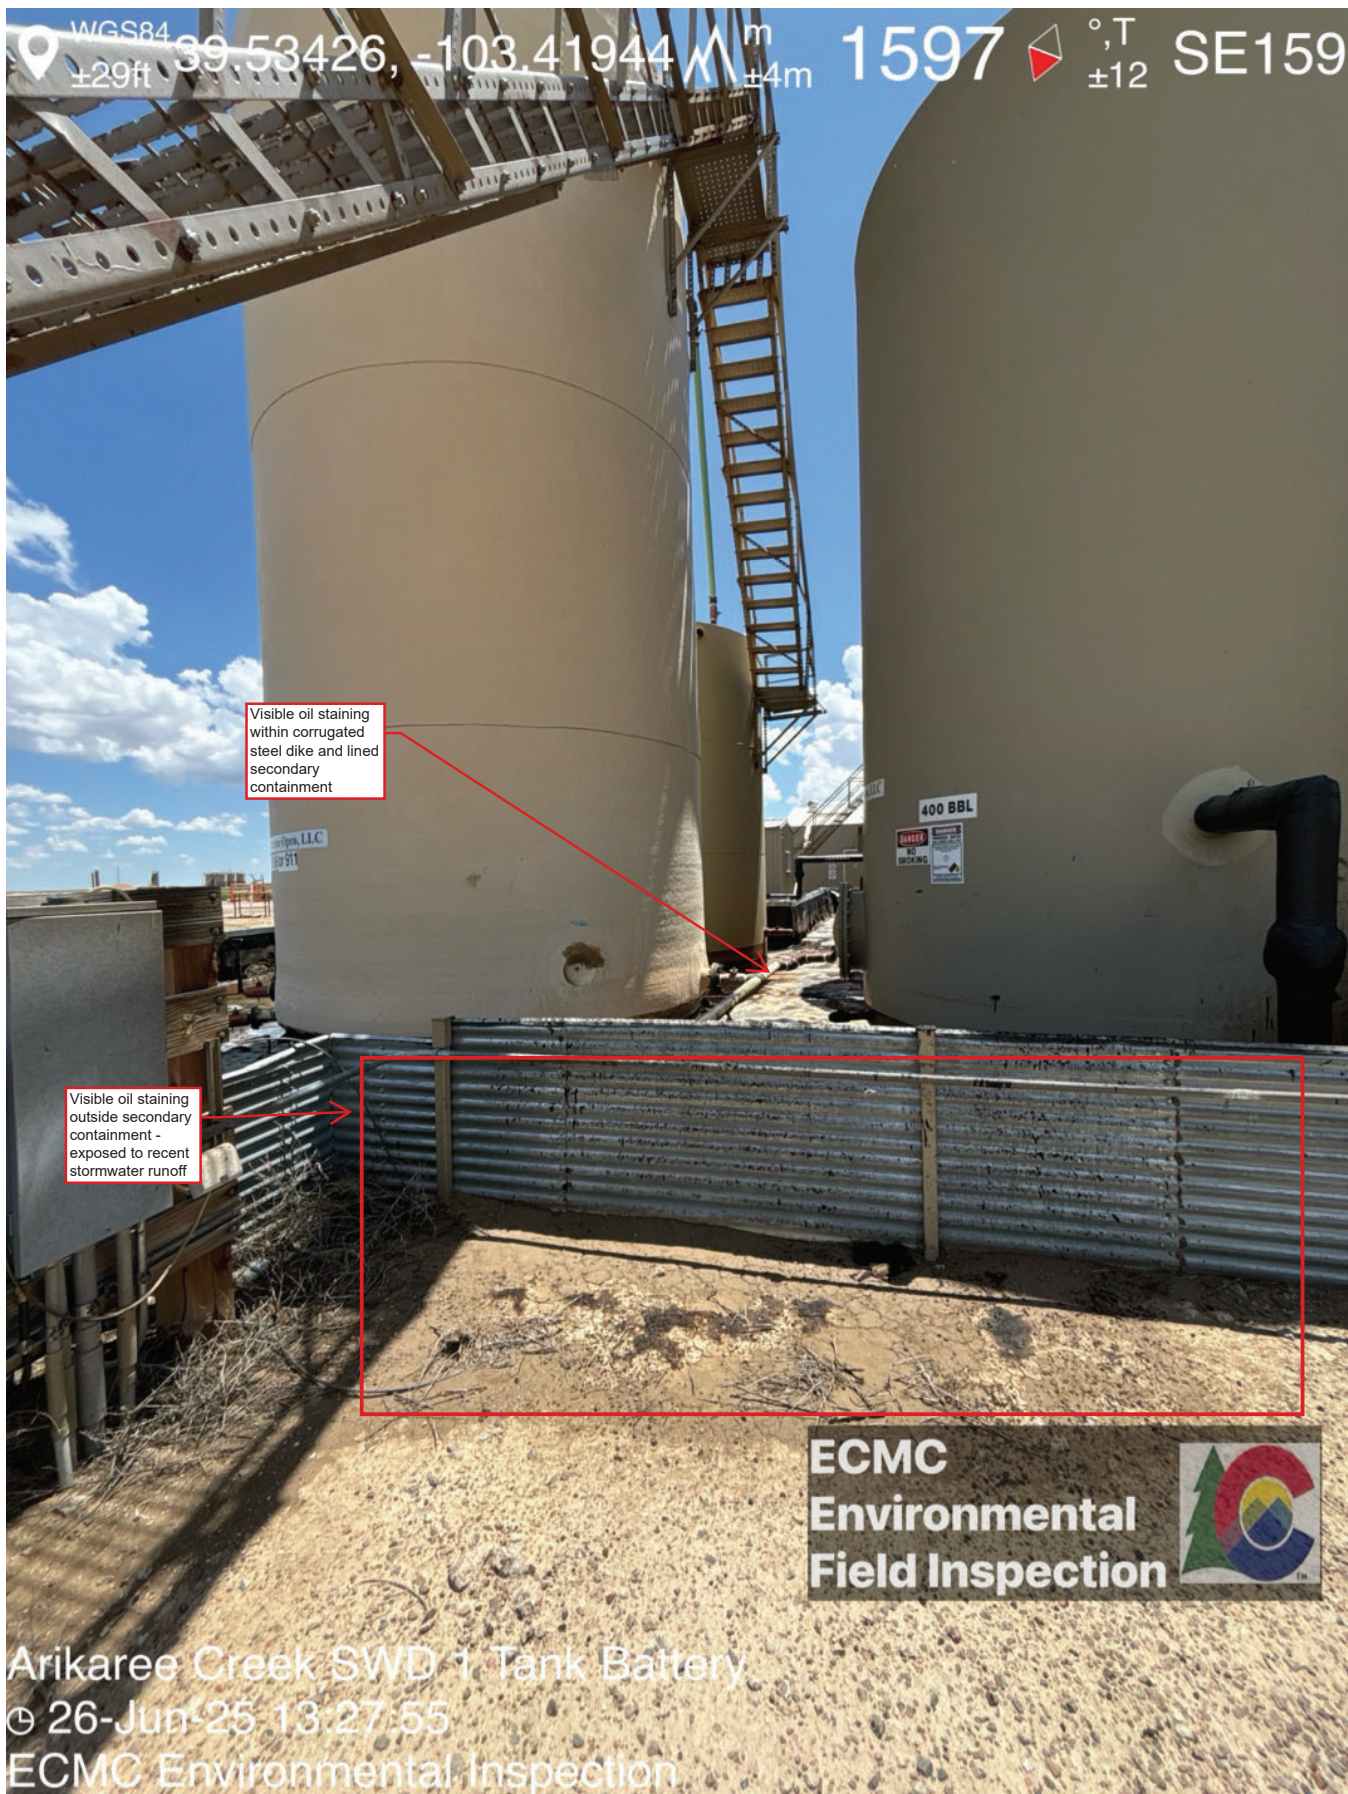
Visible oil staining
within corrugated
steel dike and lined
secondary
containment

Visible oil staining
outside secondary
containment -
exposed to recent
stormwater runoff

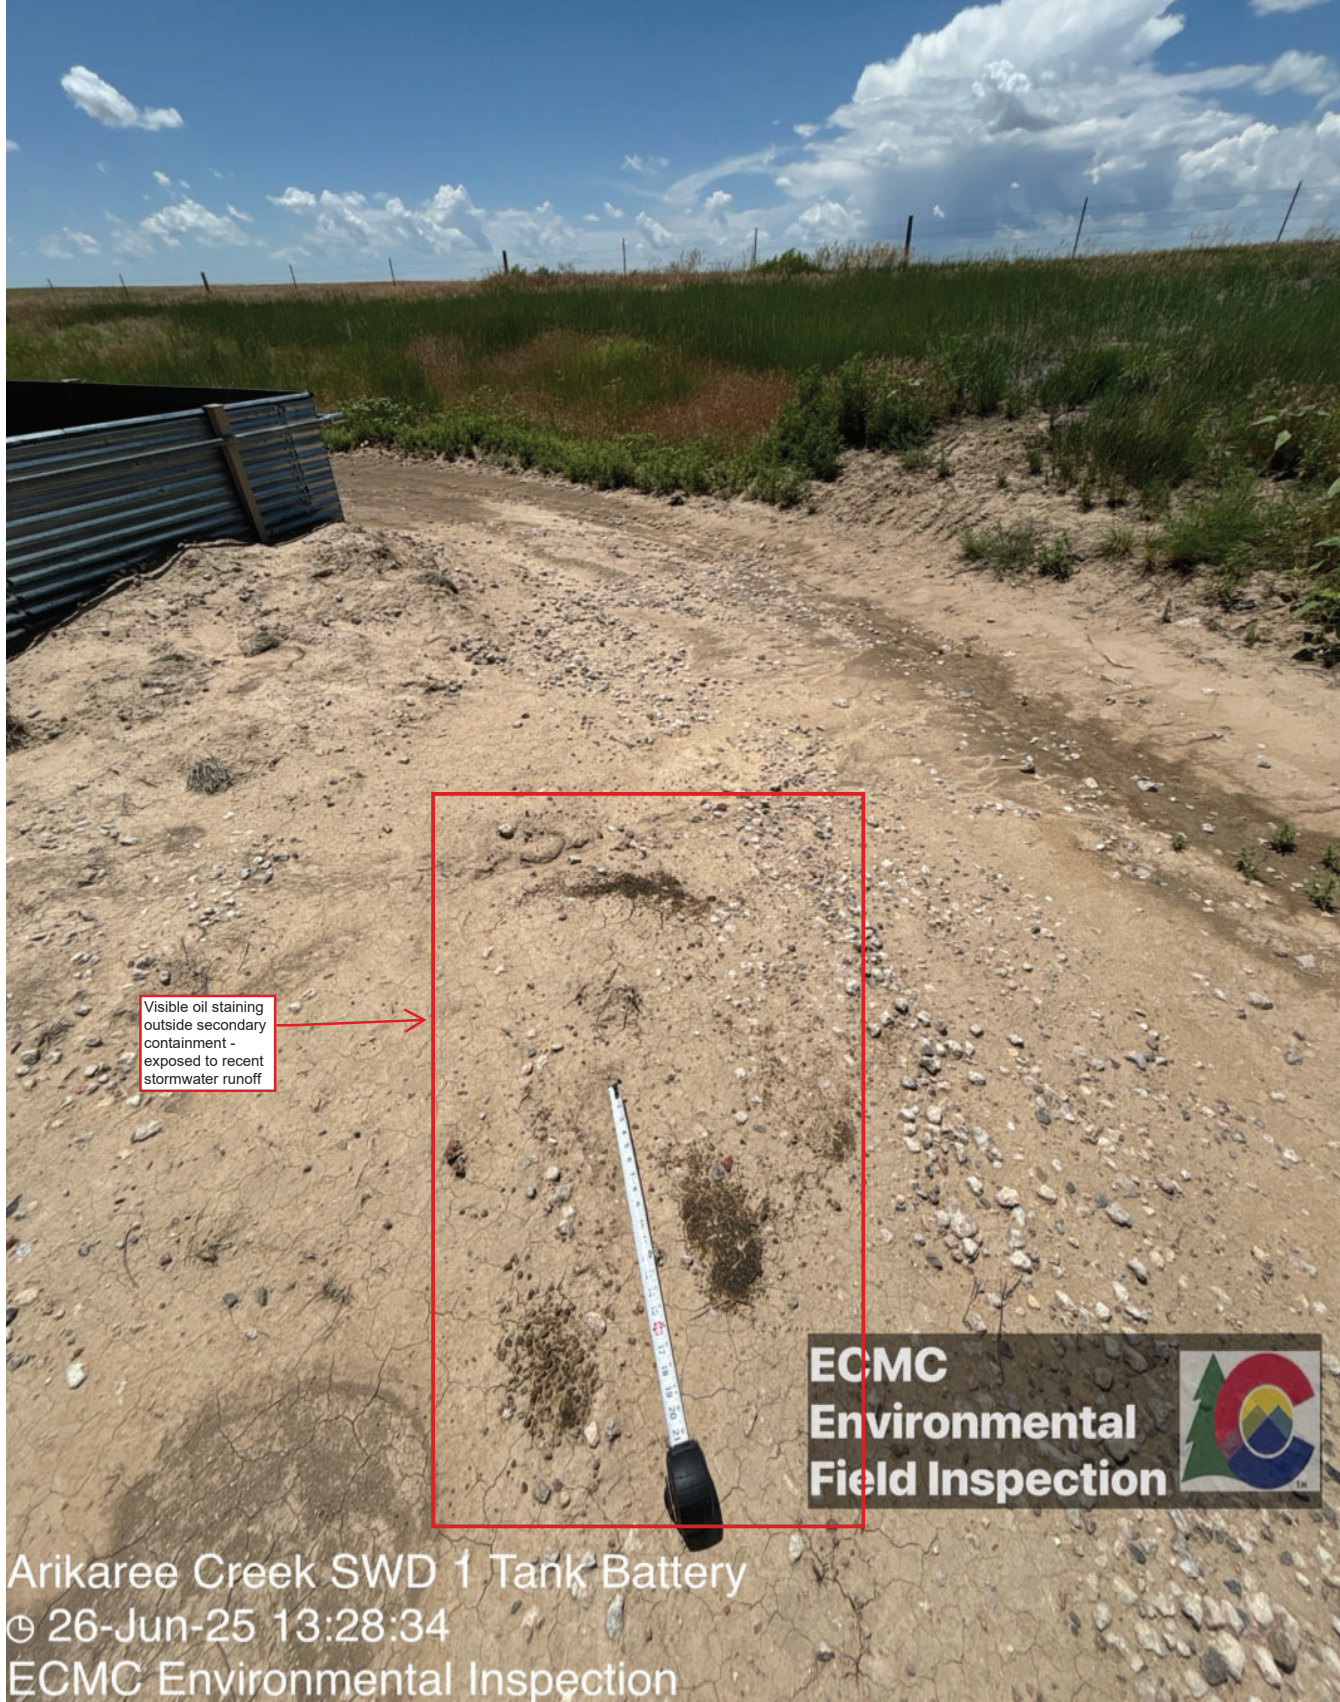
Weeds

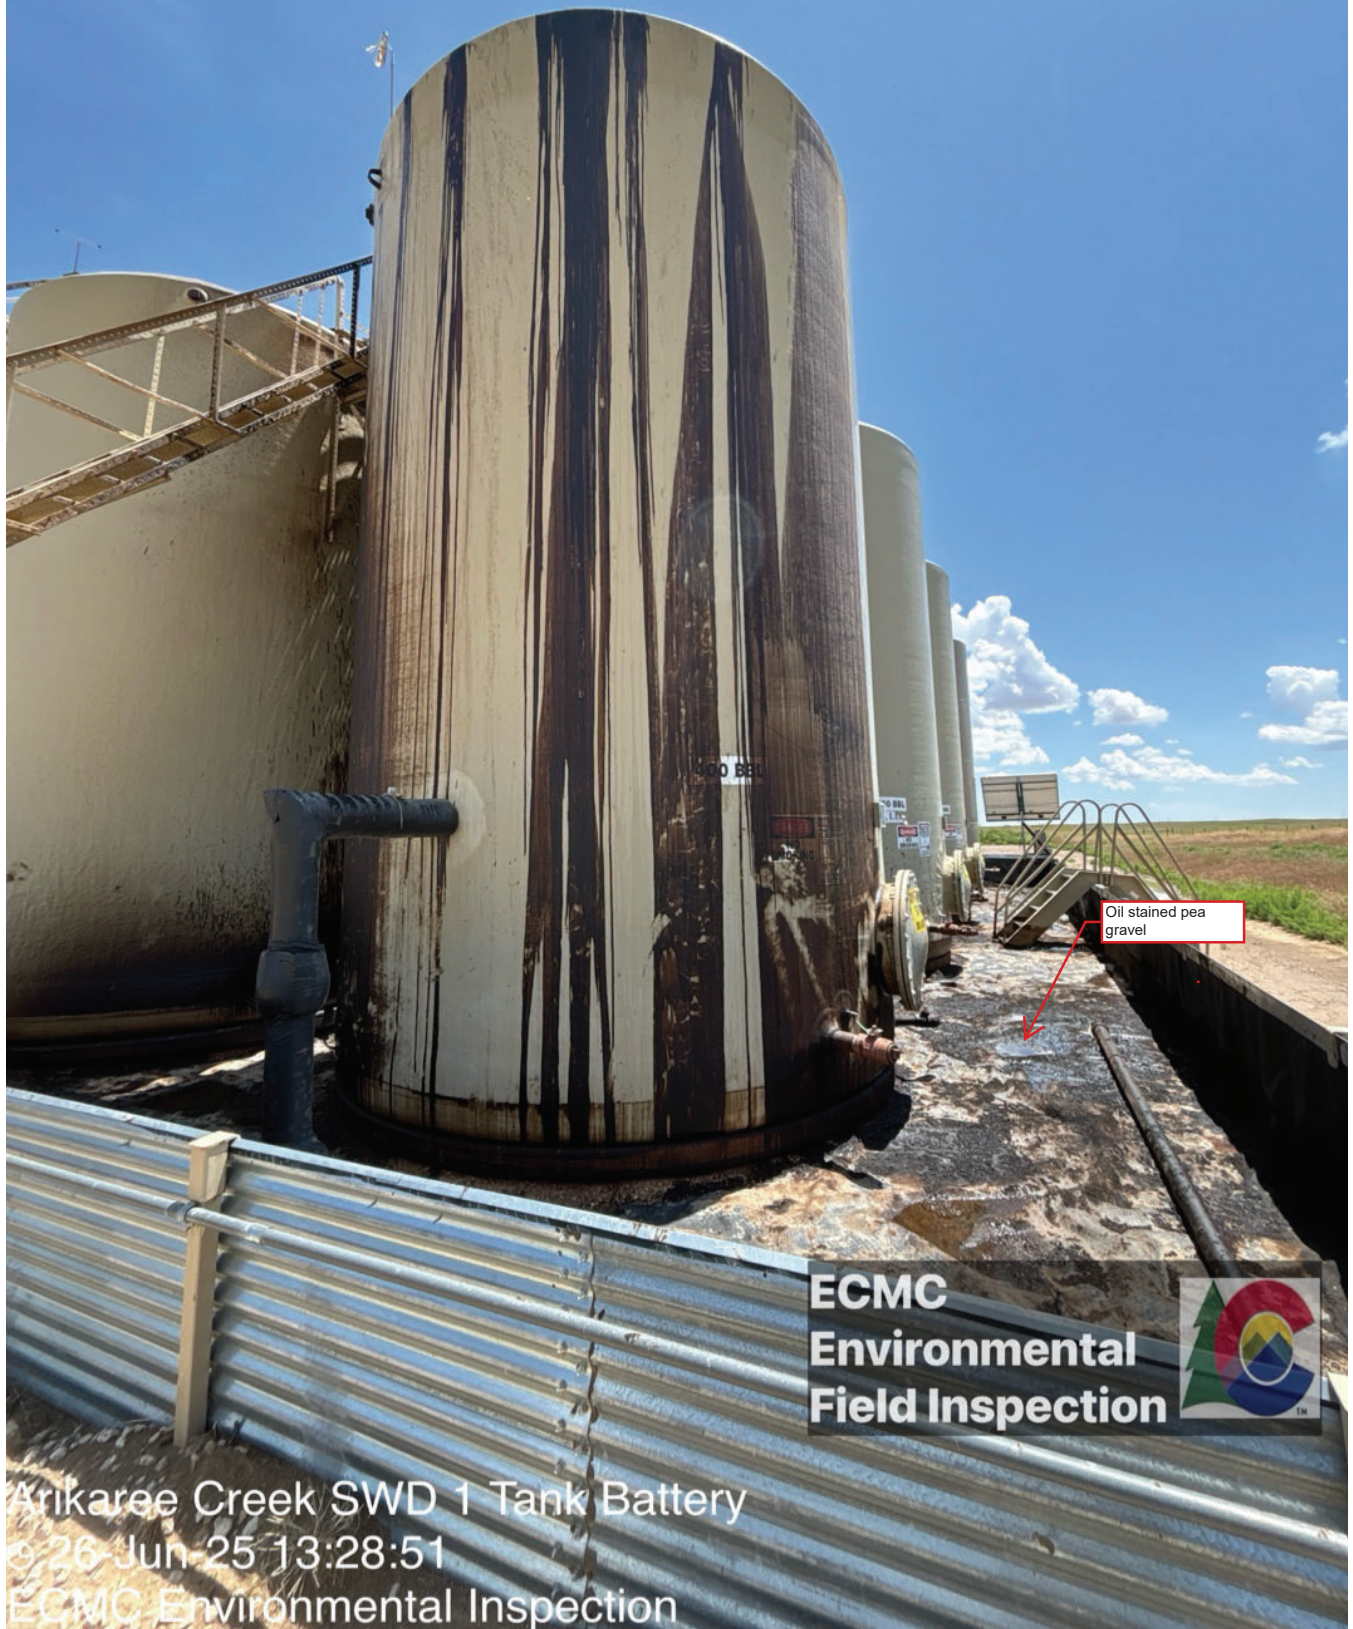
Visible oil staining throughout tank battery equipment within corrugated steel dike and lined secondary containment

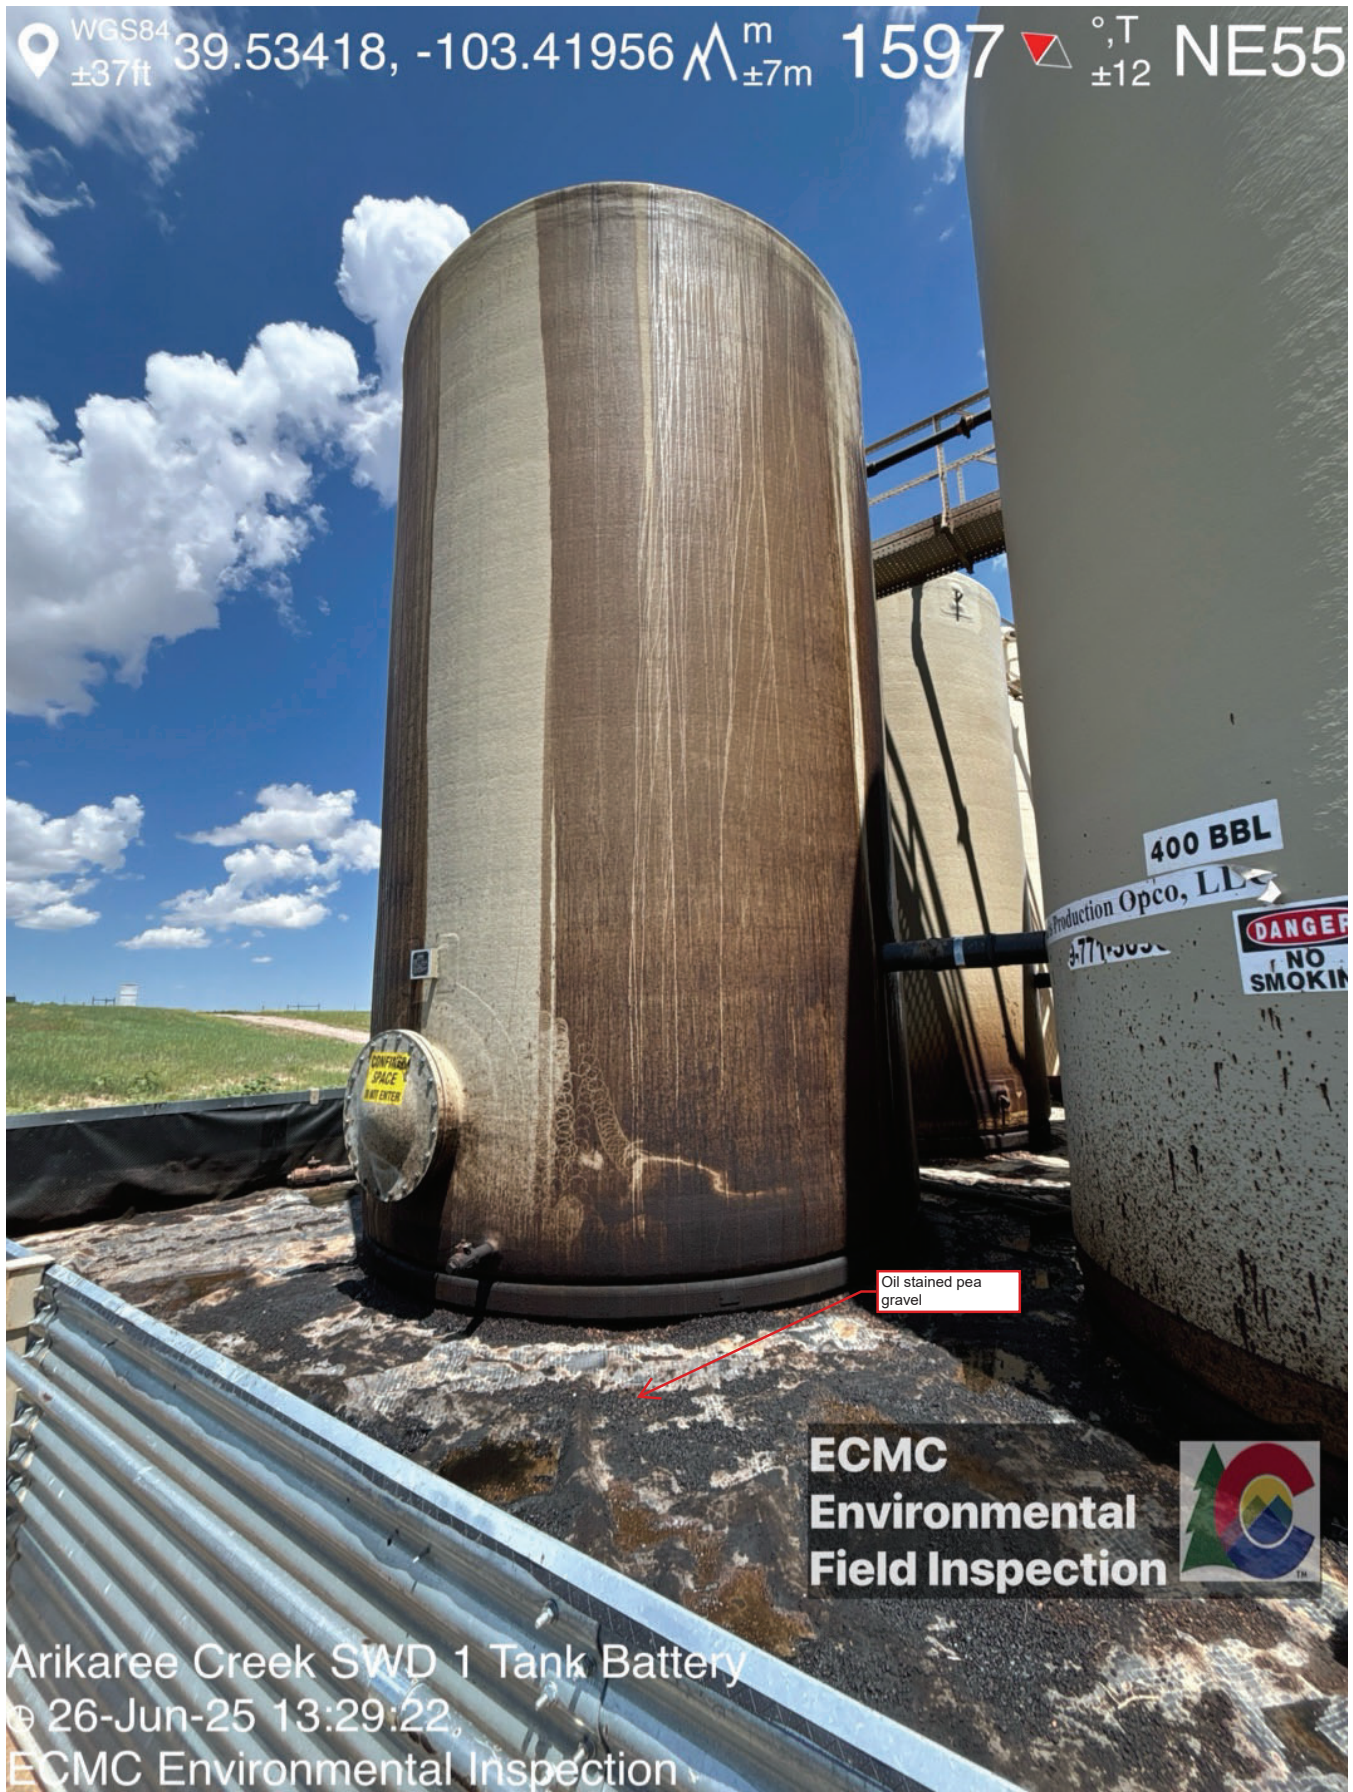
Visible oil staining throughout tank battery equipment within corrugated steel dike and lined secondary containment

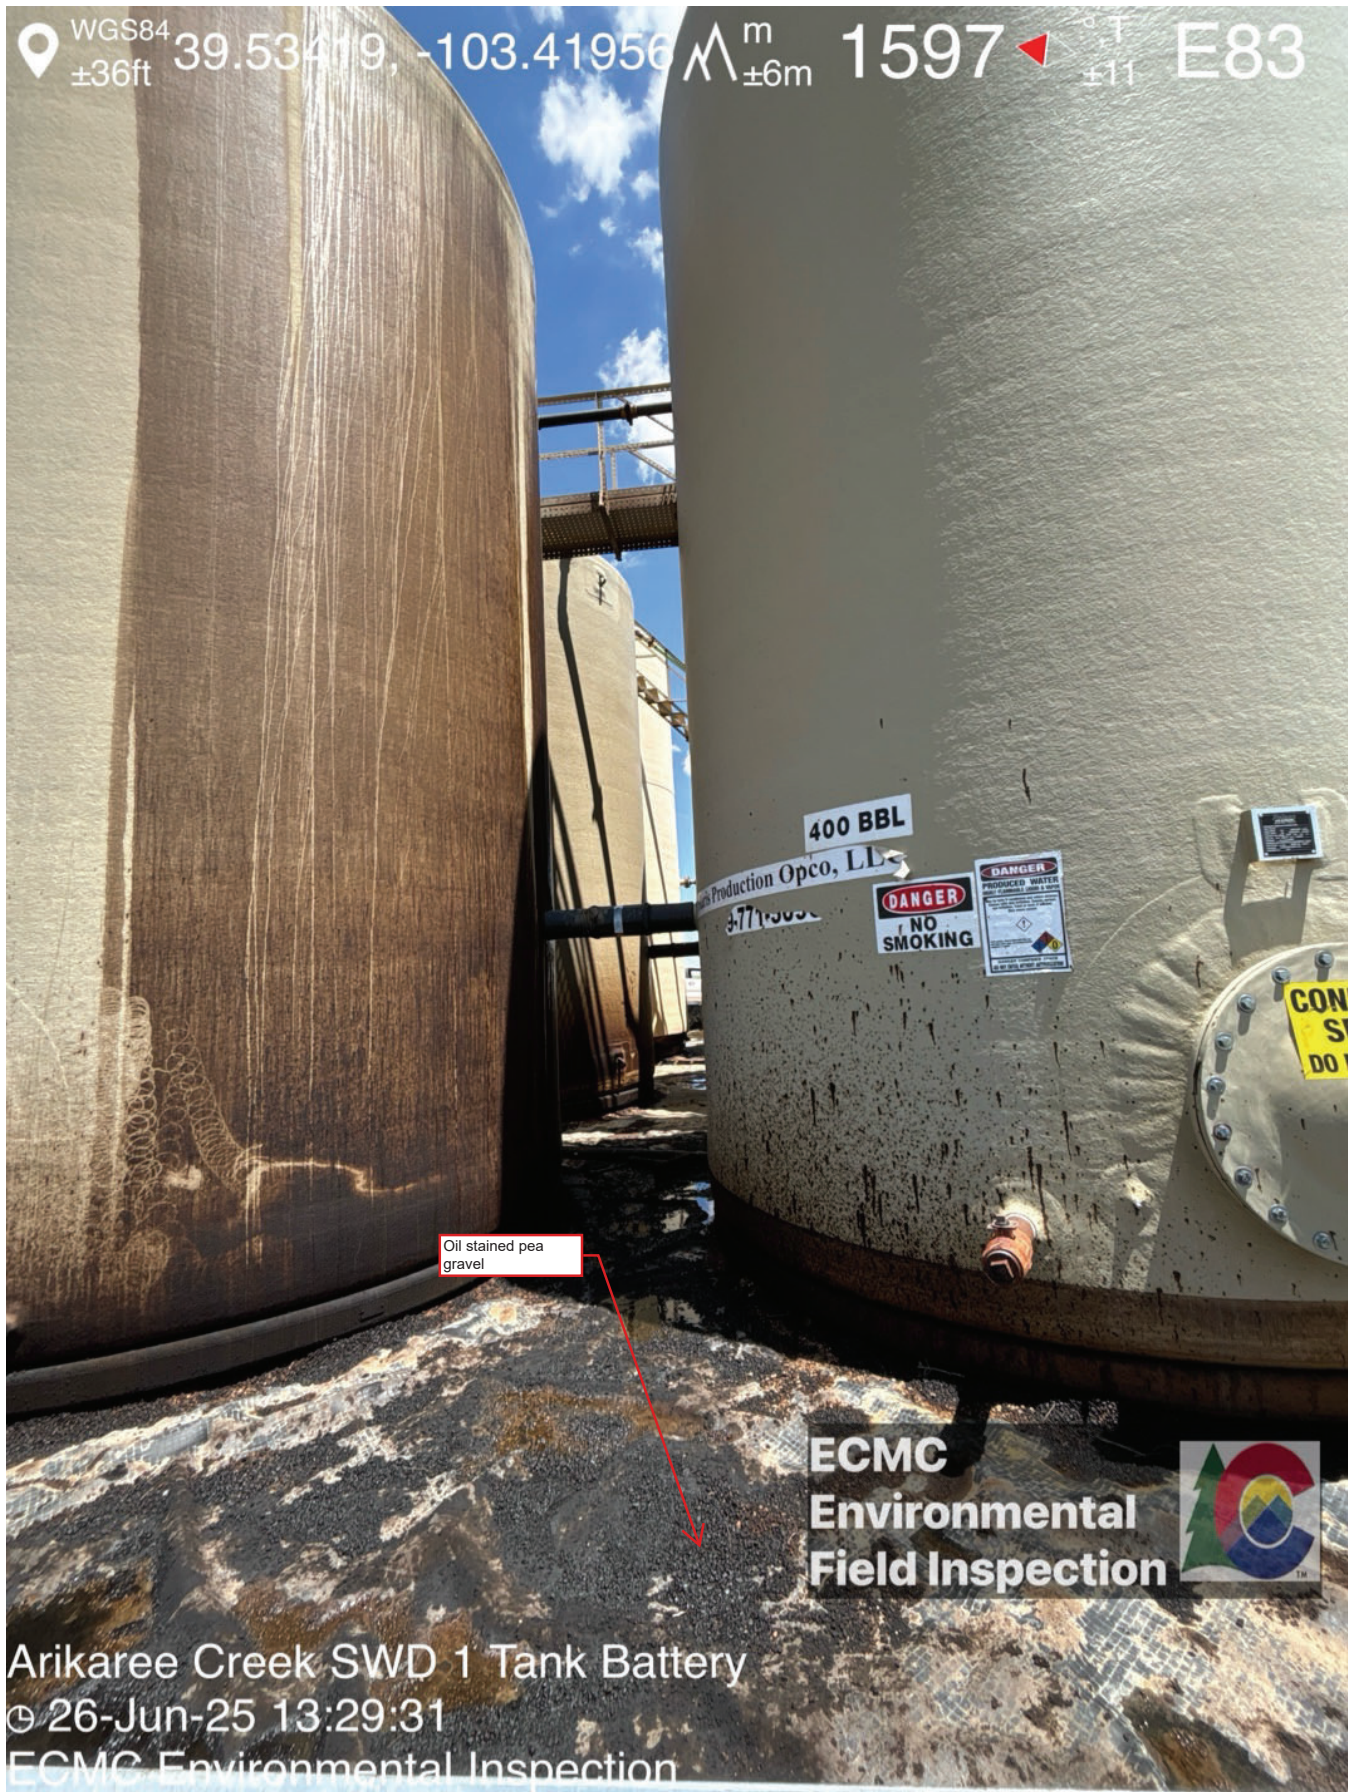
Oil stained pea
gravel

Visible oil staining throughout tank battery equipment within corrugated steel dike and lined secondary containment
