ECMC
Environmental
Field Inspection

Arikaree Creek SWD 1 Tank Battery
© 26-Jun-25 13:27:08
ECMC Environmental Inspection

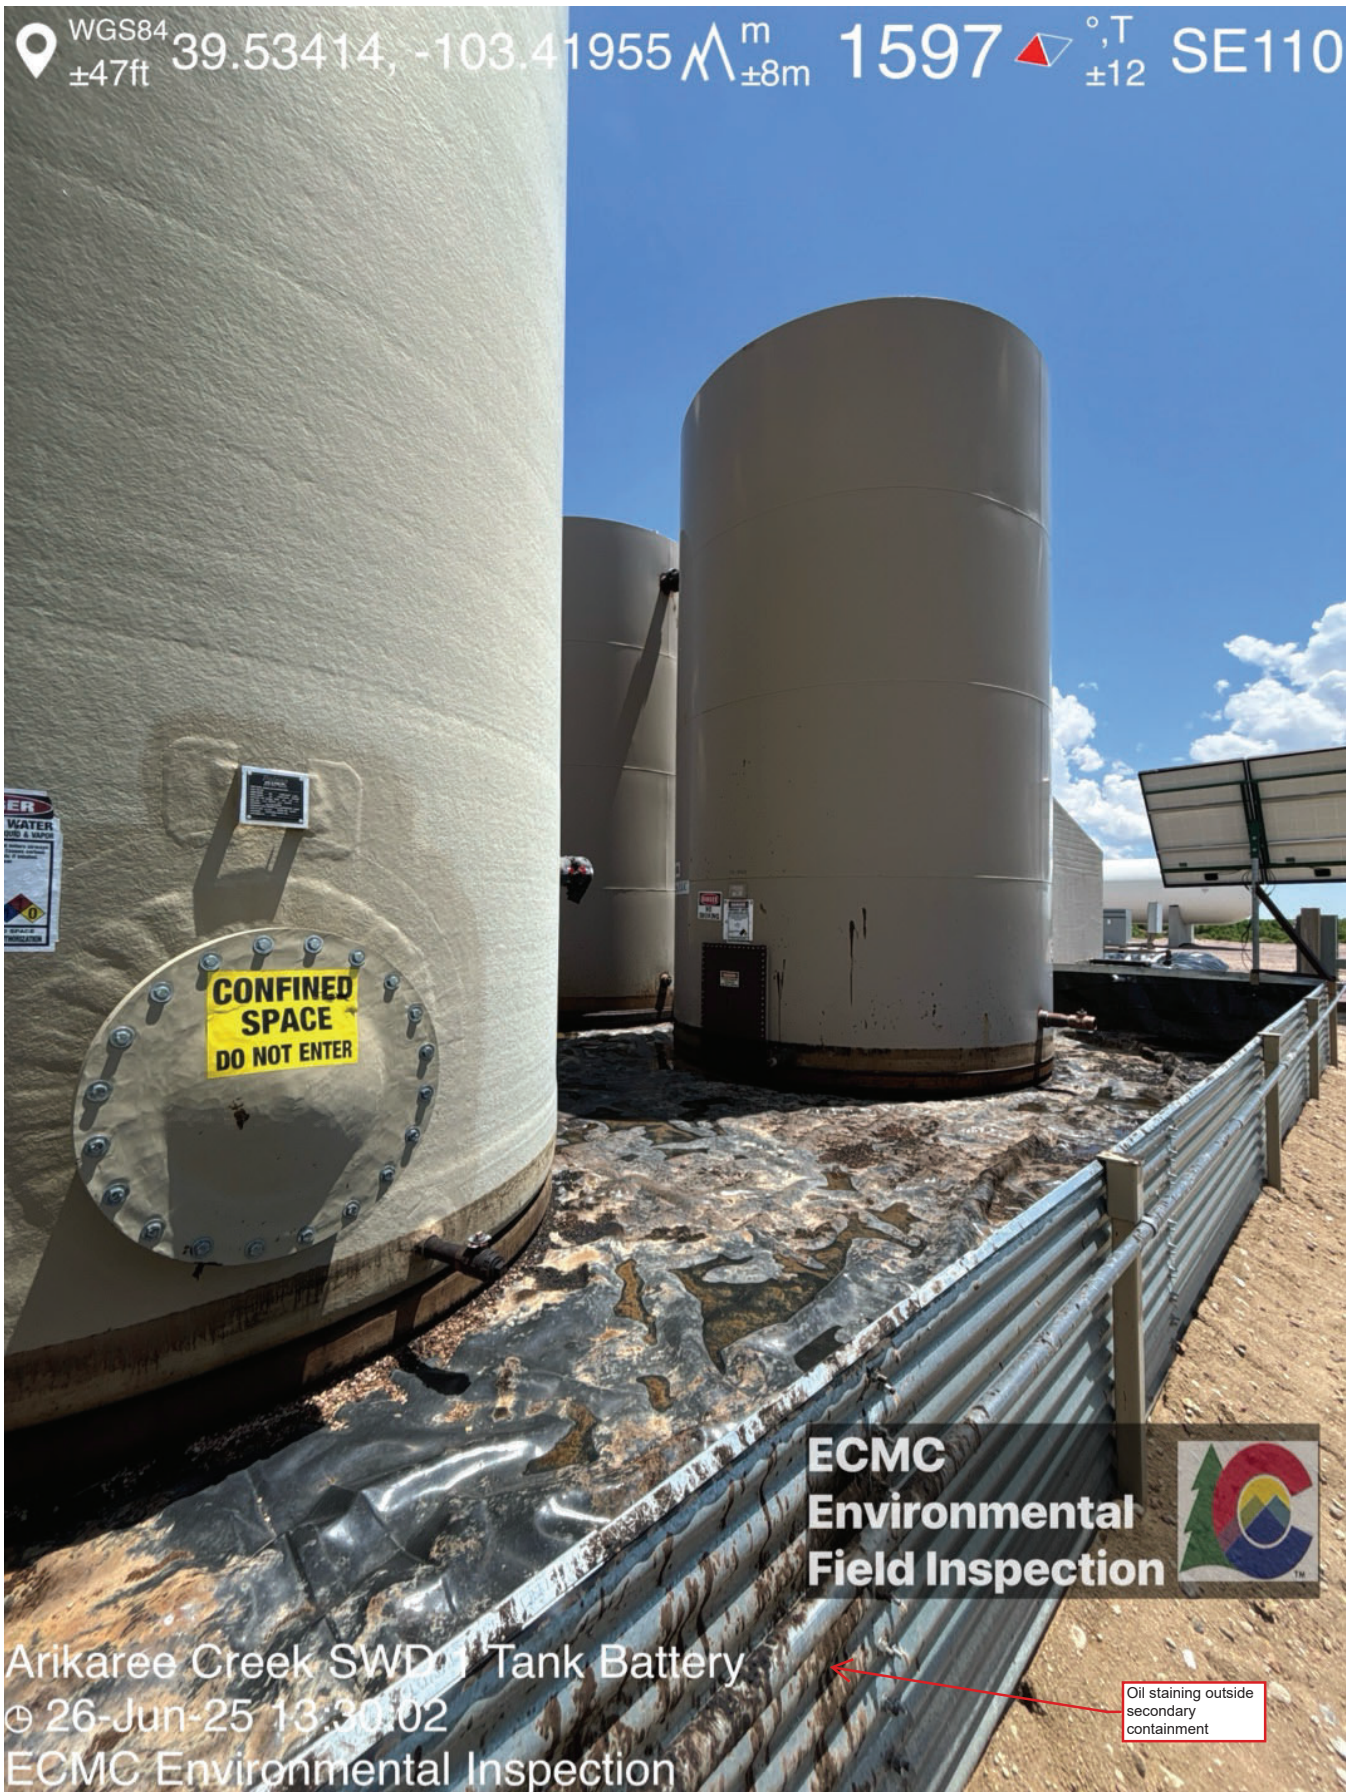
Oil staining outside
secondary
containment

Visible oil staining throughout tank battery equipment within corrugated steel dike and lined secondary containment

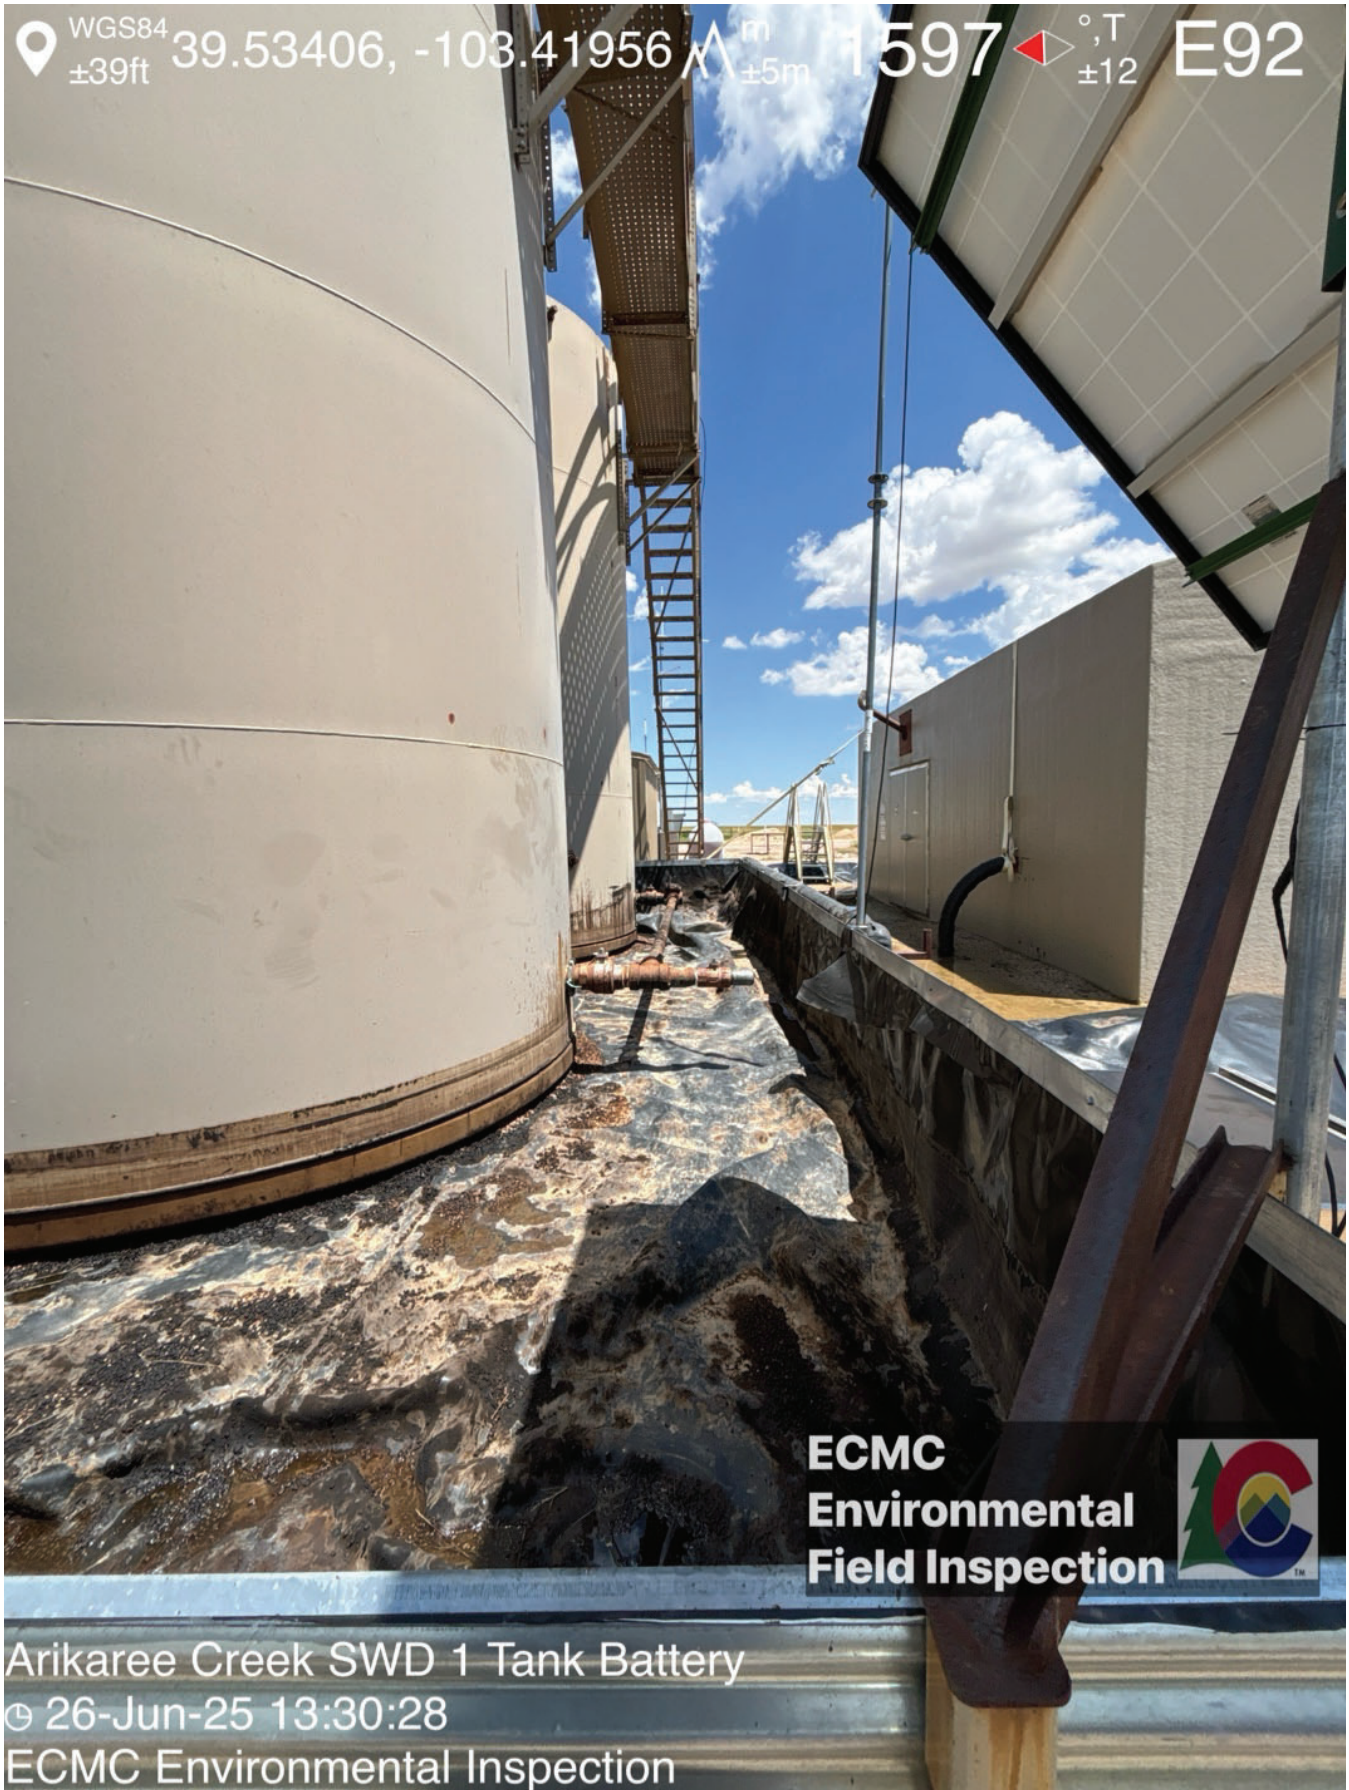
Visible oil staining throughout tank battery equipment within corrugated steel dike and lined secondary containment

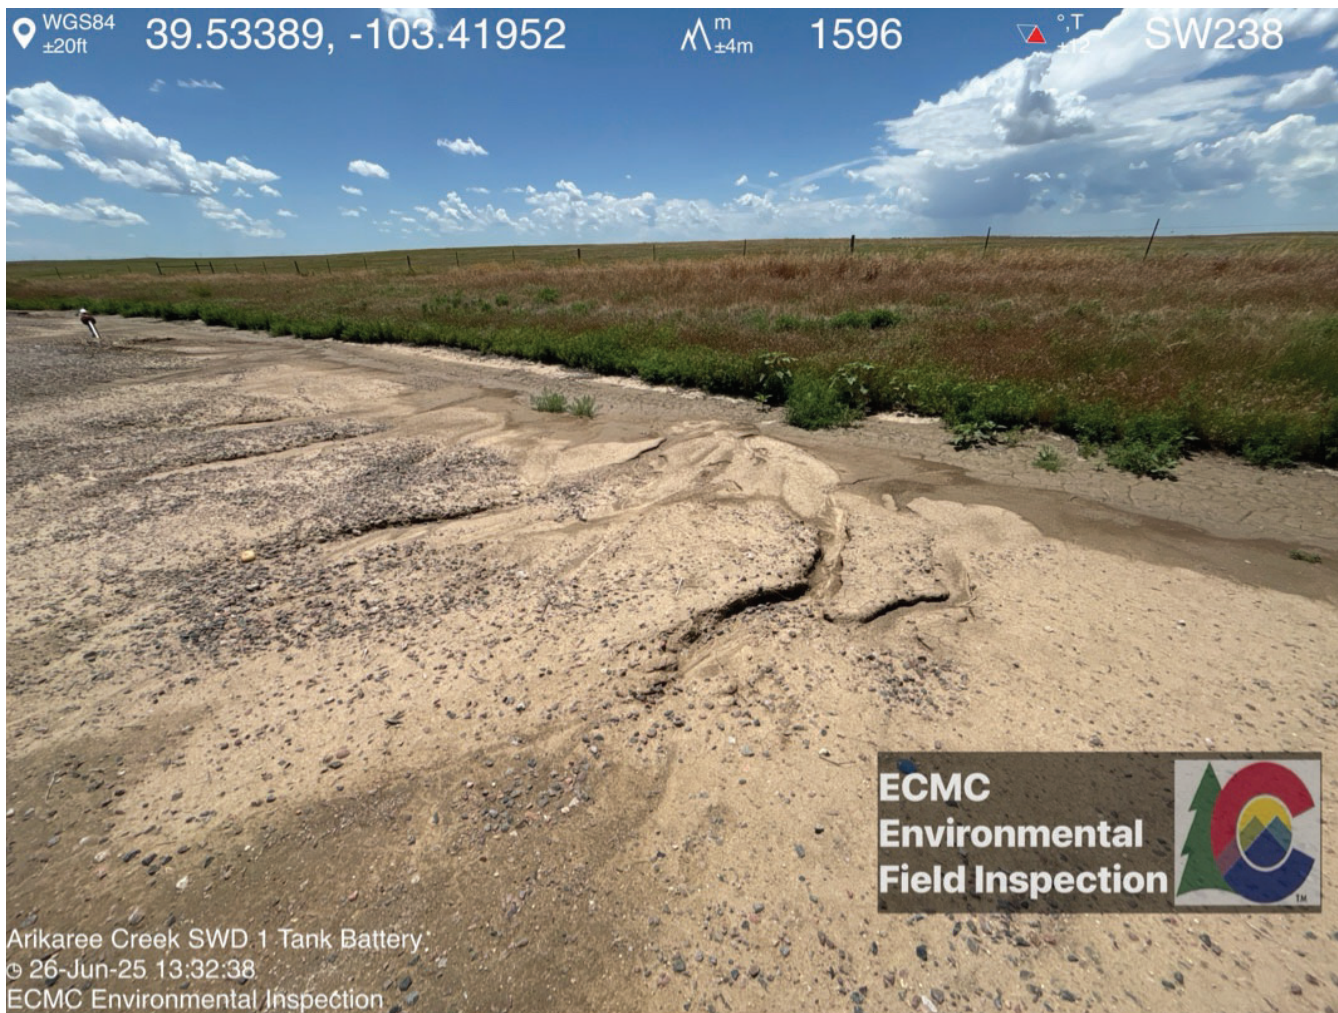
Stormwater erosion. Rill formation.
Weeds.

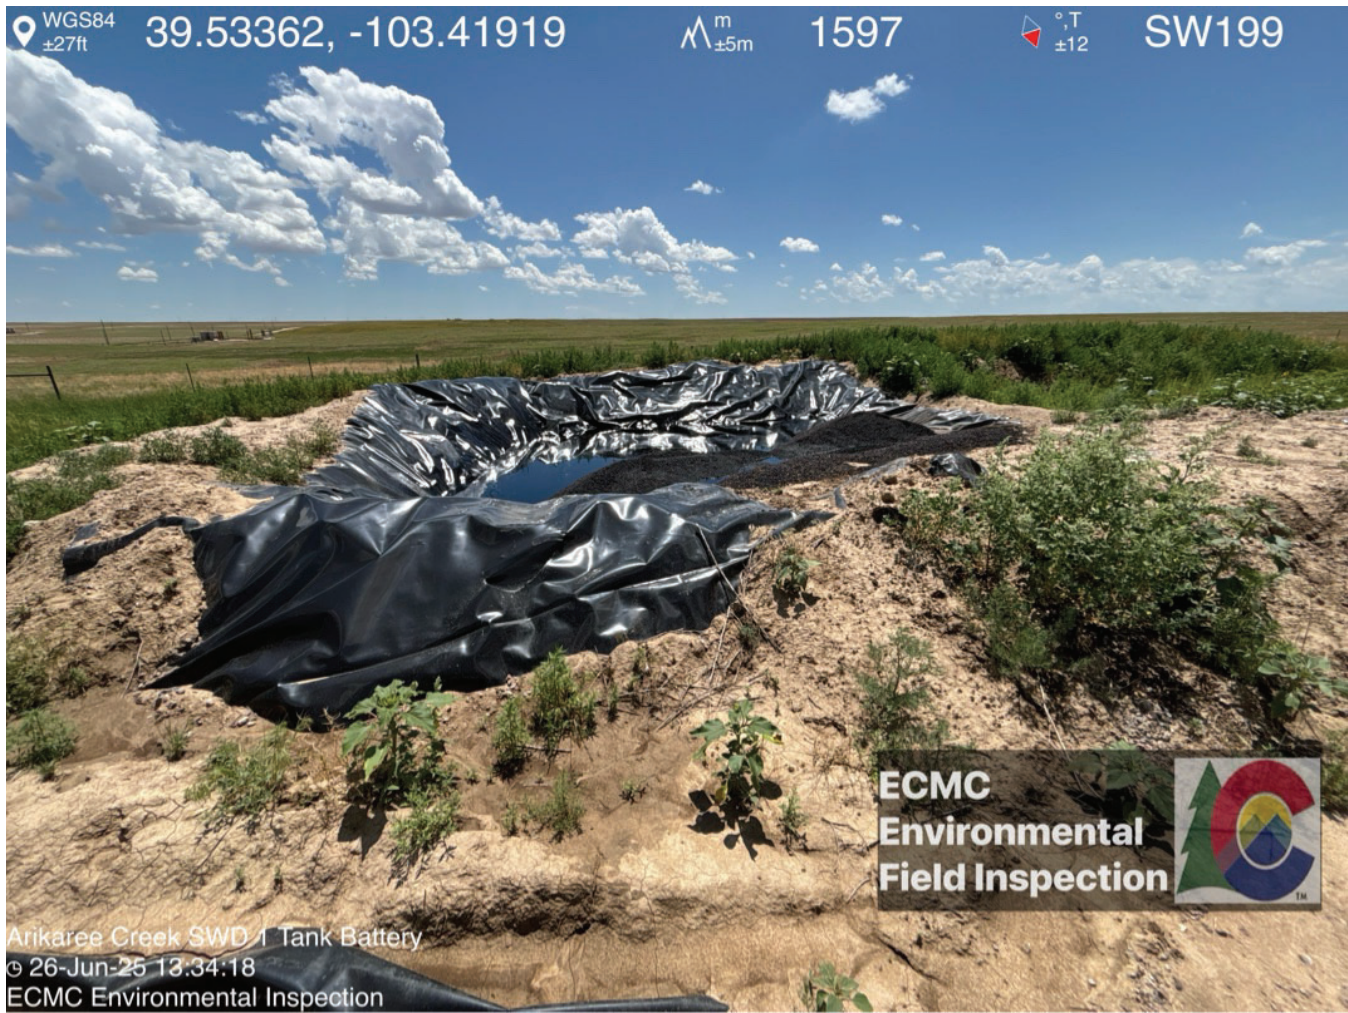
E&P waste stockpiled in bermed and lined containment
Weeds

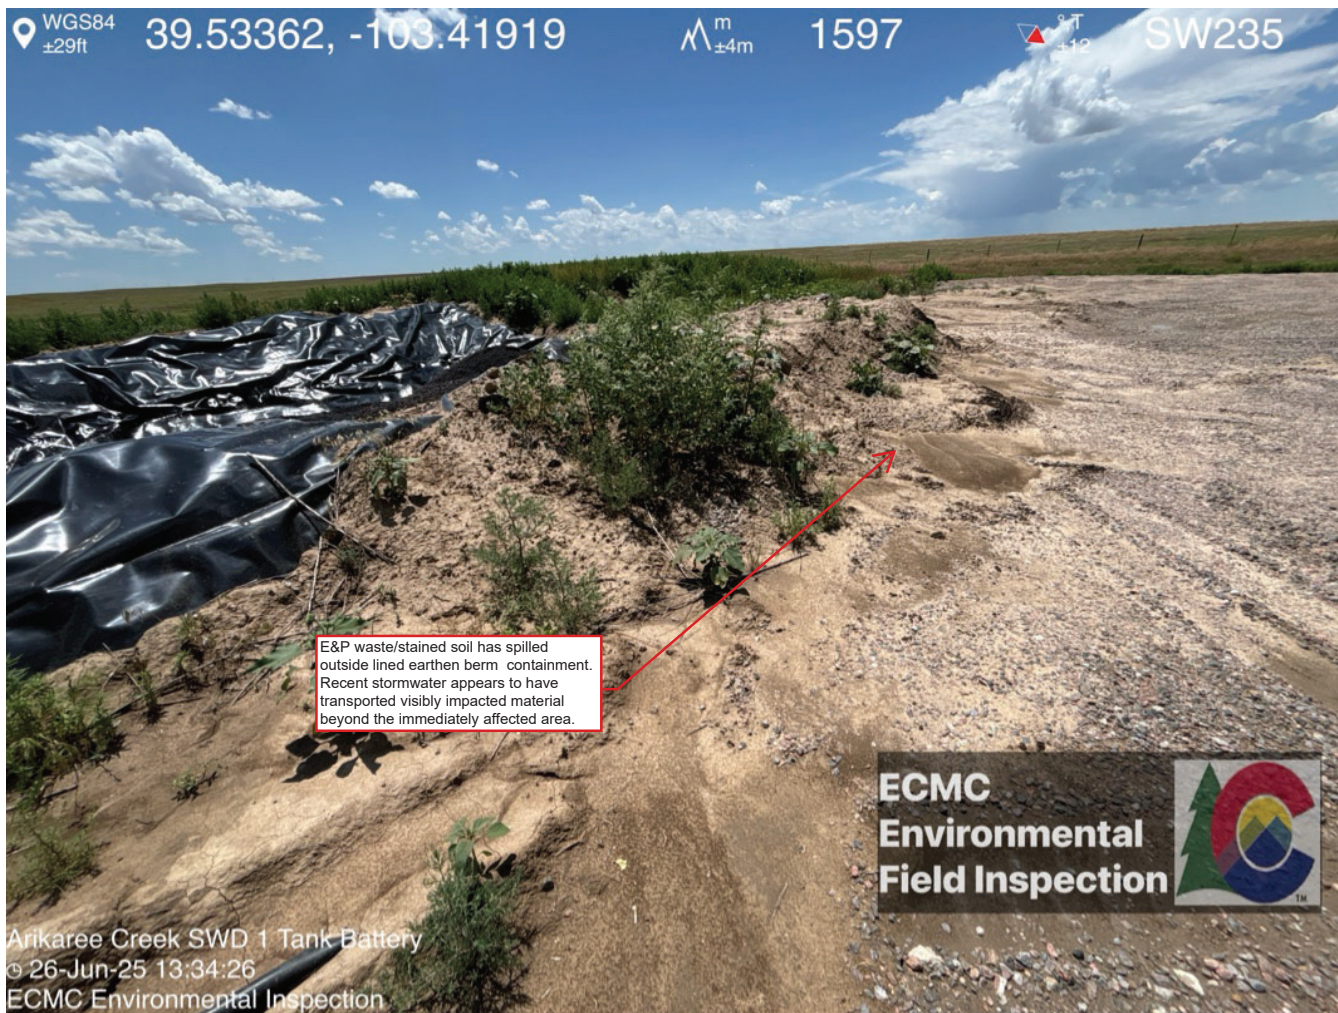
E&P waste/stained soil has spilled outside lined earthen berm containment. Recent stormwater appears to have transported visibly impacted material beyond the immediately affected area.

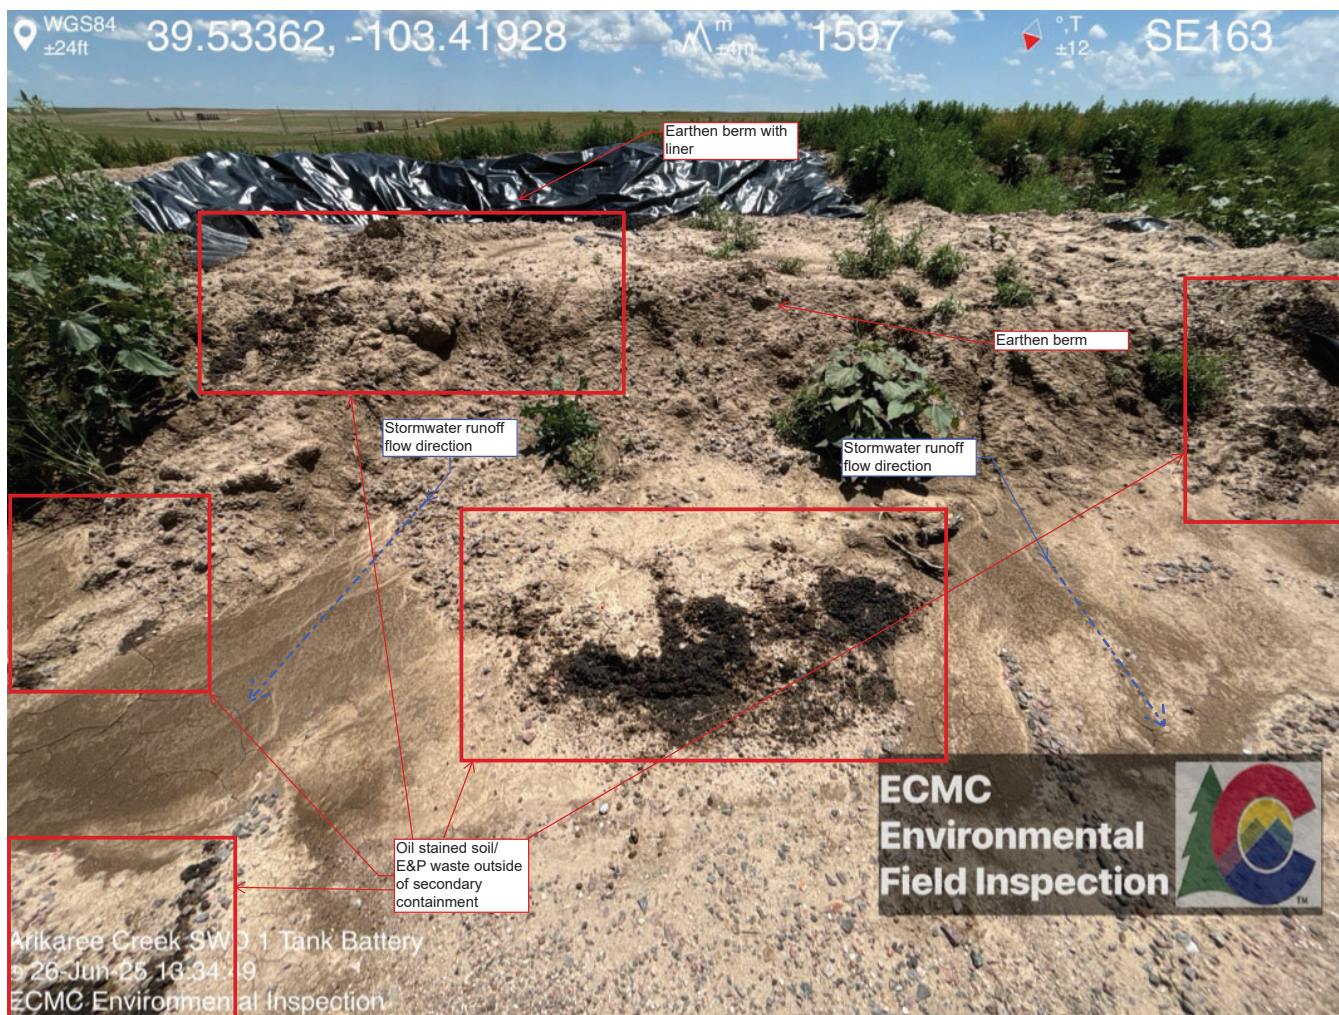
E&P waste stockpiled in bermed and lined containment
 E&P waste has spilled outside of secondary containment - recent stormwater runoff appears to have transported E&P waste beyond the immediate area.
 Weeds

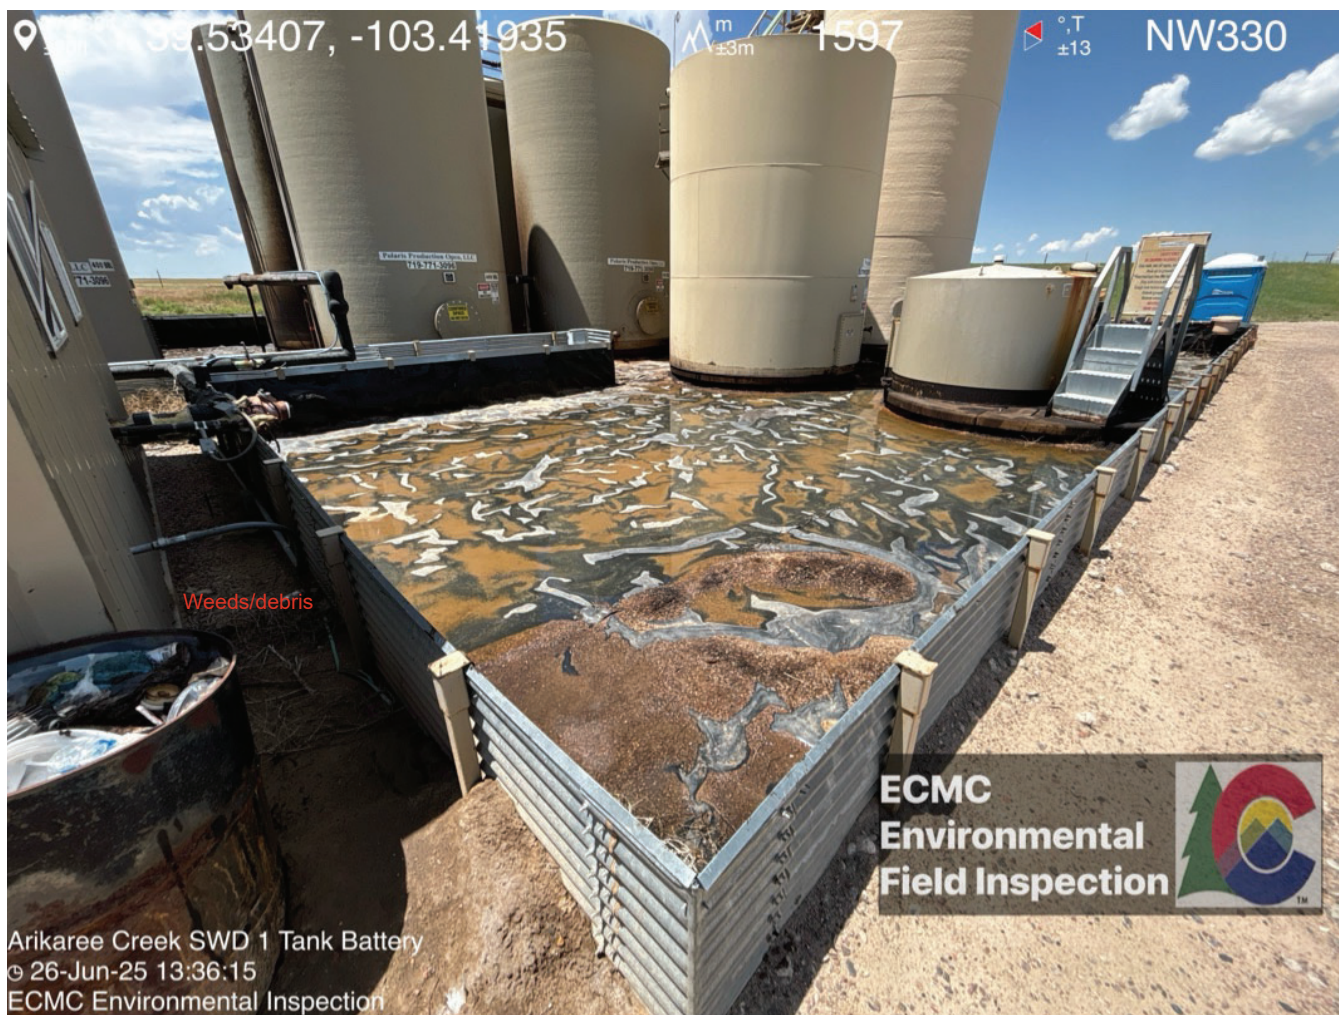
Visible oil staining throughout tank battery equipment within corrugated steel dike and lined secondary containment

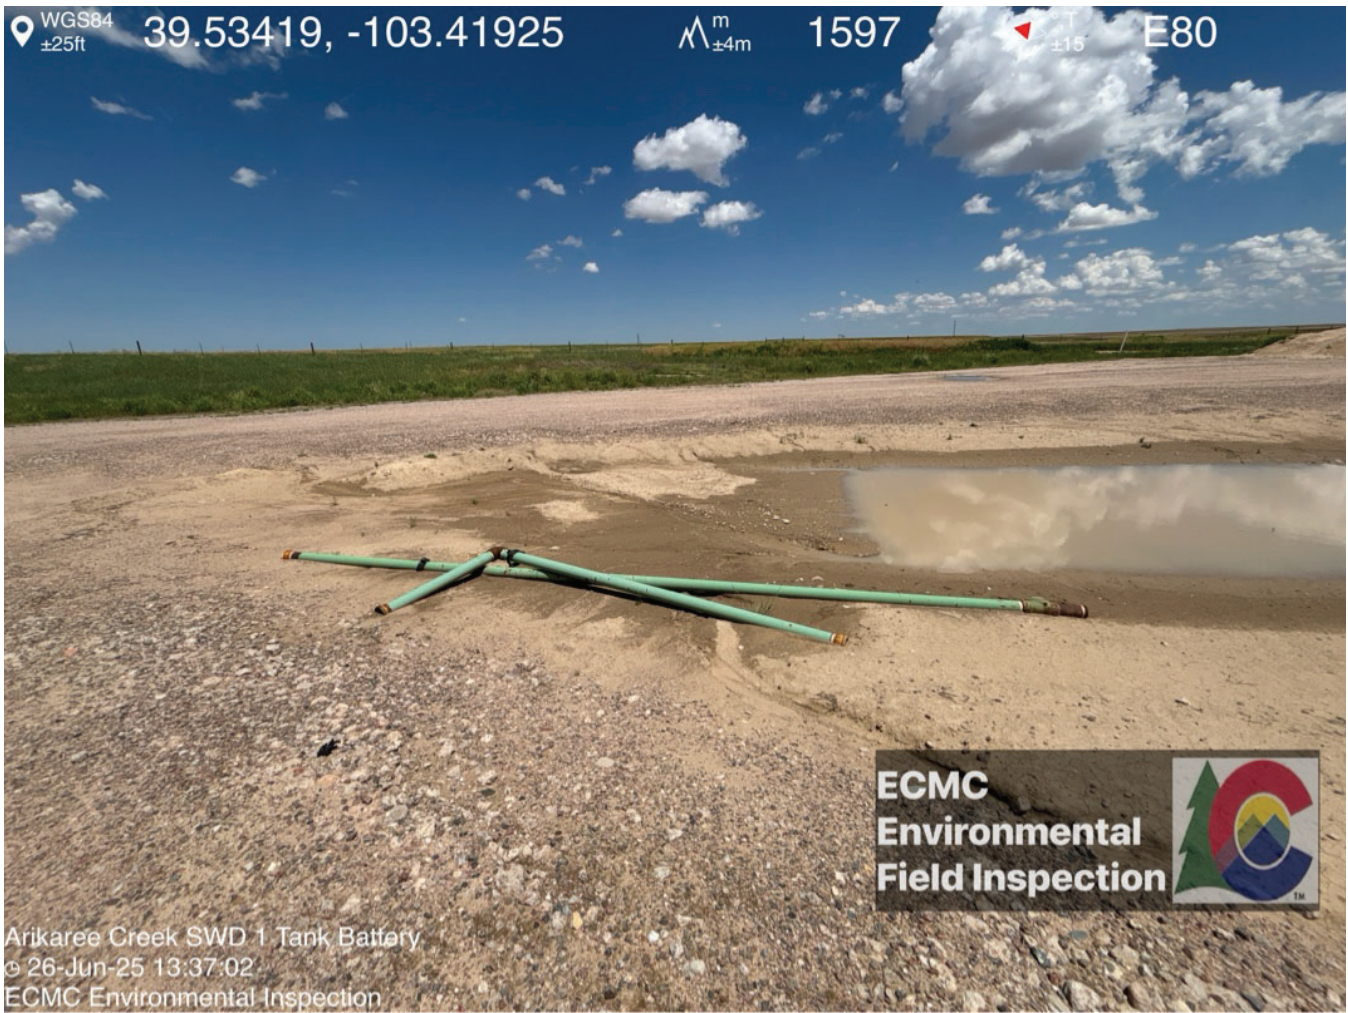
Unused equipment

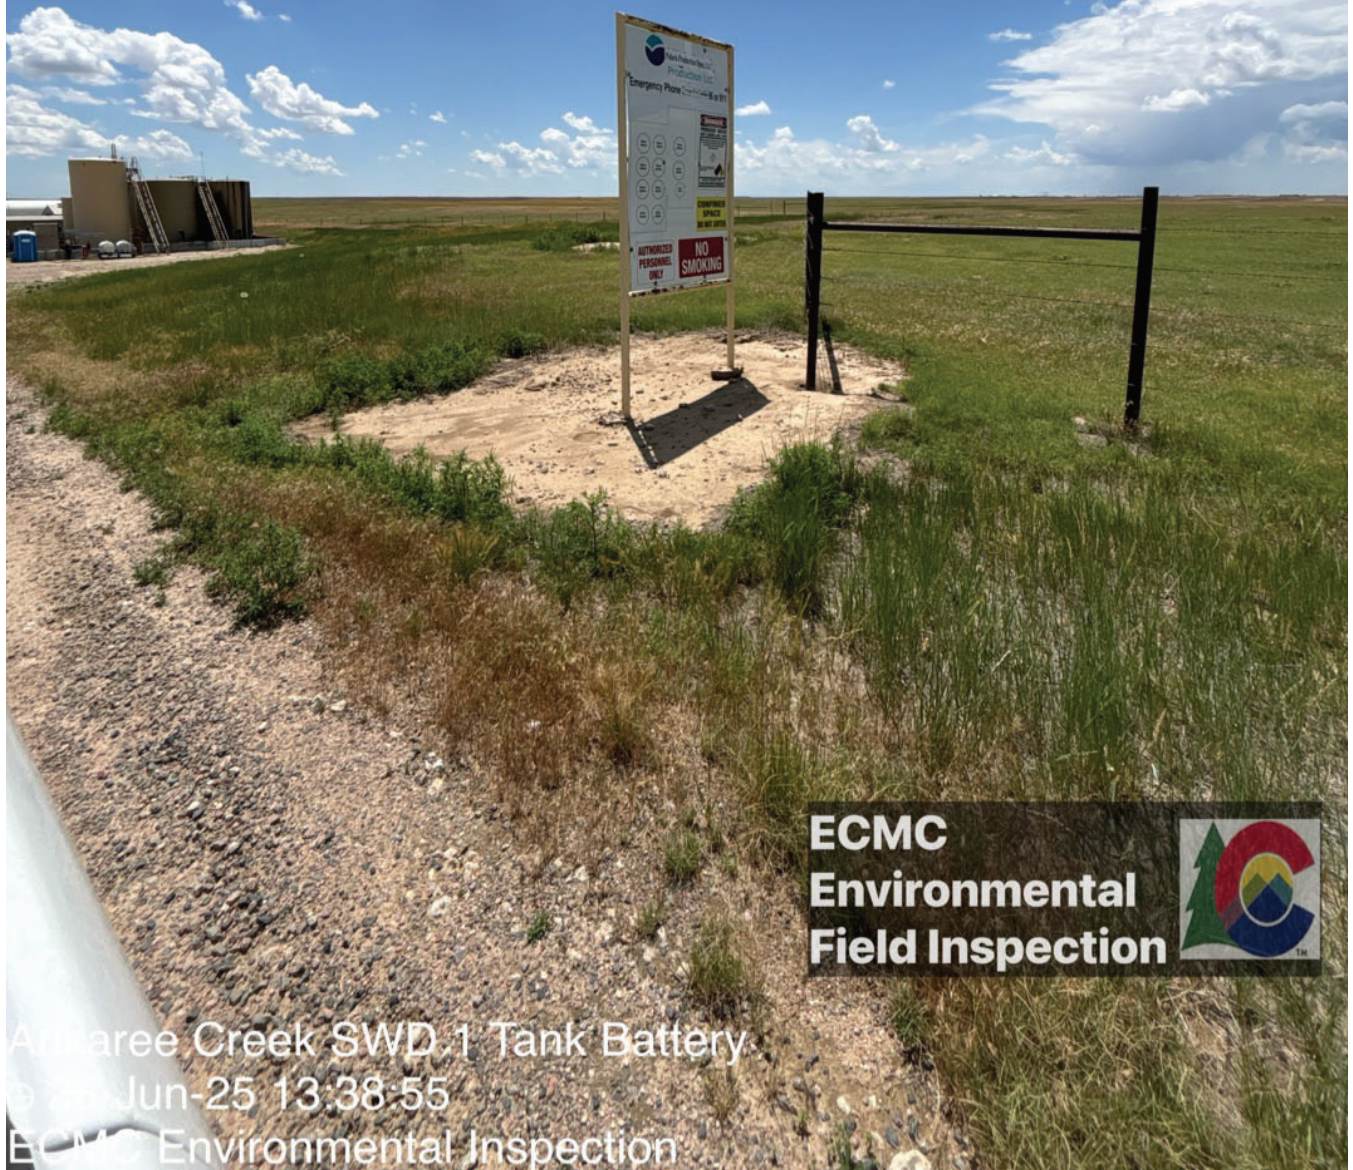
Signage at entrance - Note: all AST contents labelled produced water
