# Inspection Photos

**Operator:** QB ENERGY OPERATING LLC

**Location ID:** 334855

**Inspection Doc:** 719200013

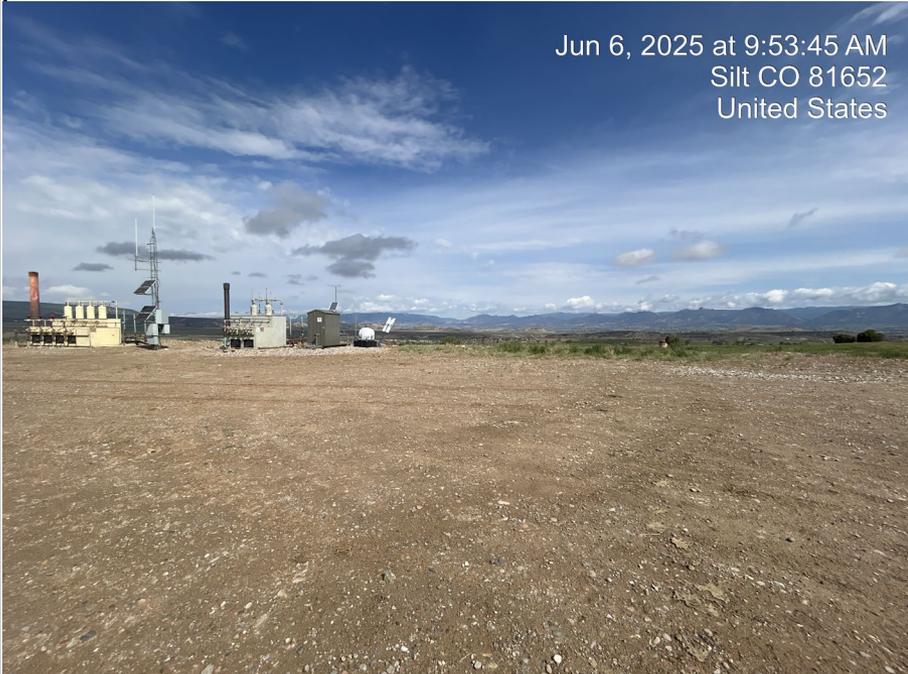
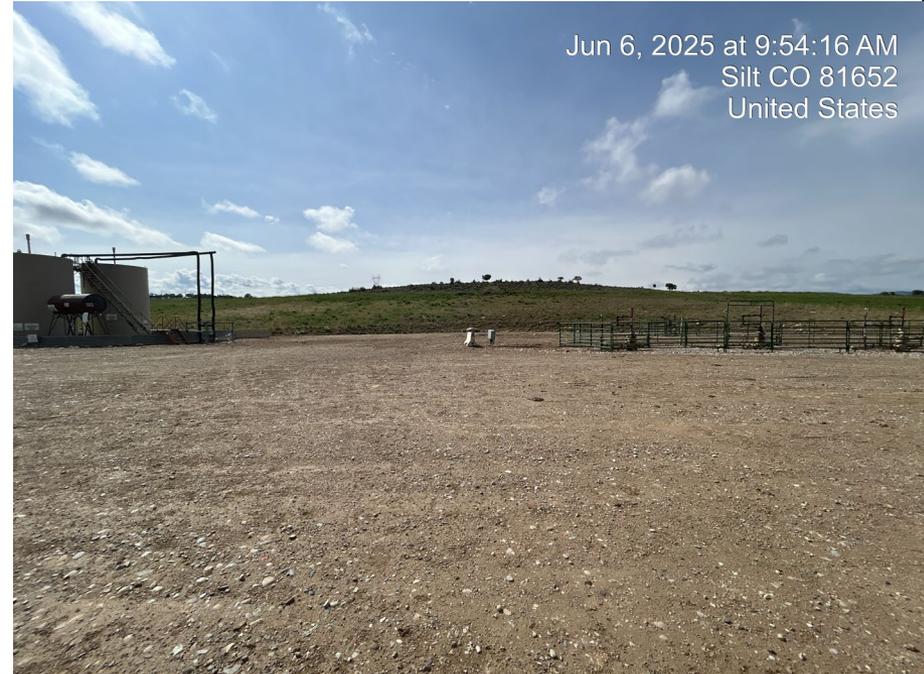
**Photo 1:** Photos taken from the central portion of the Location and provide an overview of the Location looking north and south, respectively.

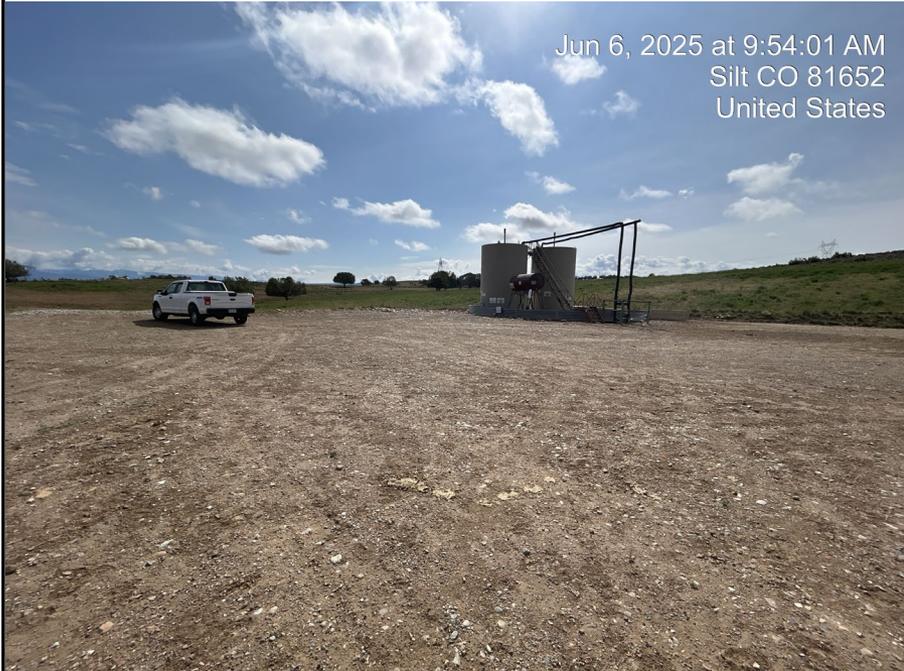
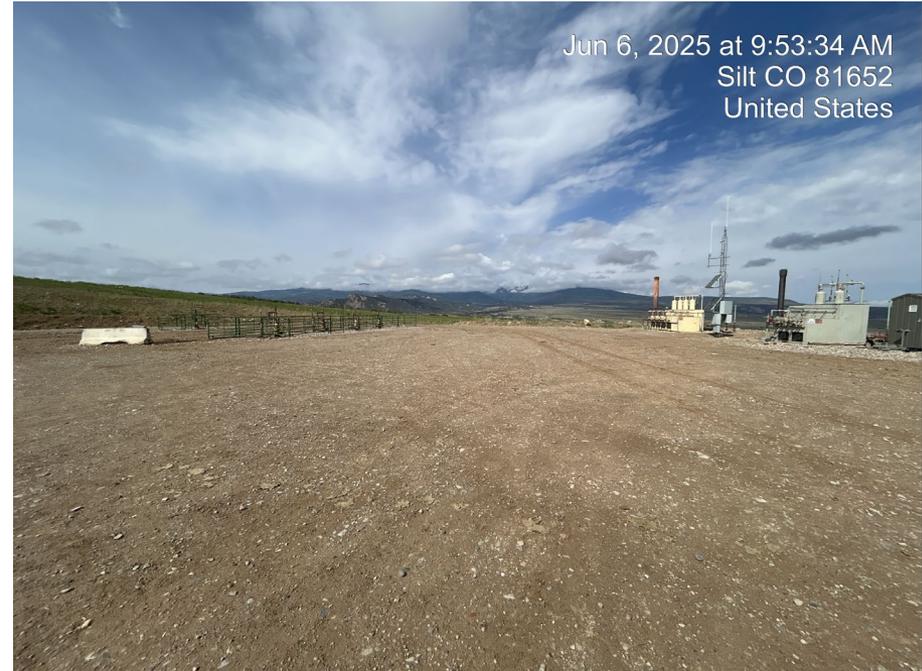
**Photo 2:** Photos taken from the central portion of the Location and provide an overview of the Location looking east and west, respectively.

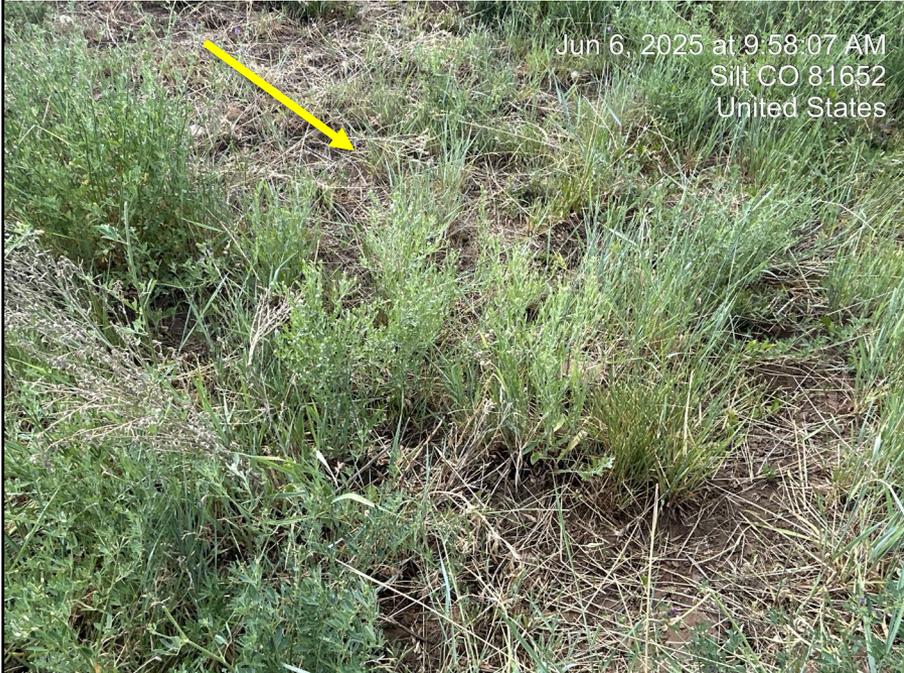
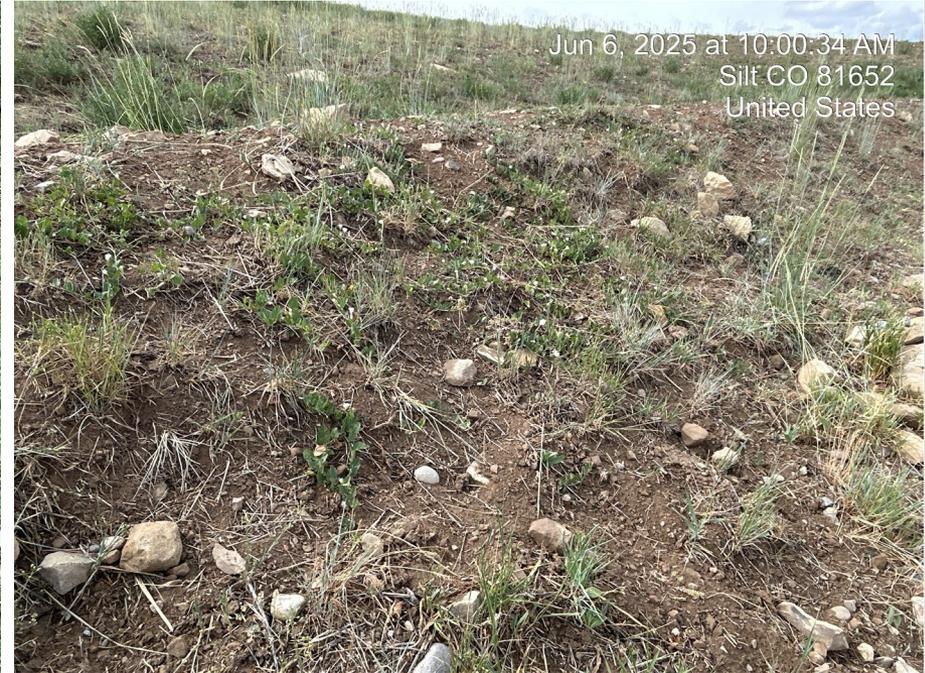
**Photo 4:** Photo example of undesirable plant species that have established on the southern portion of the Location. Russian knapweed and cheatgrass have established at the edges of the interim areas.

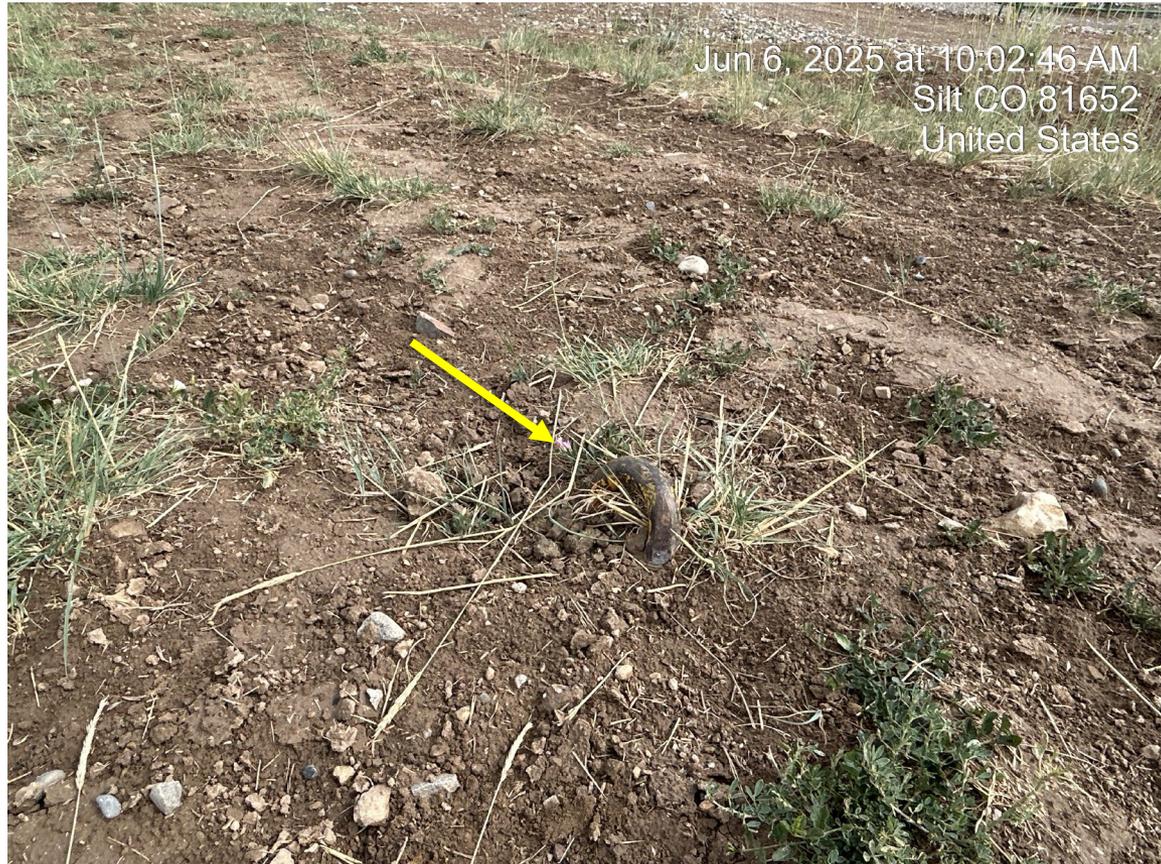
**Photo 5:** An unused guy-line anchor was observed on the western portion of the site. Marking or removal is required.

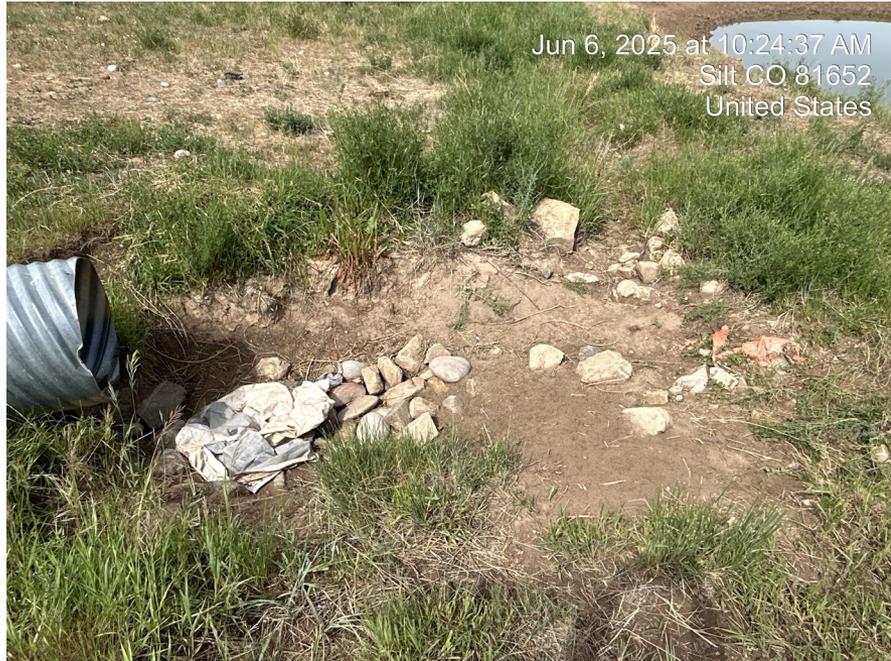
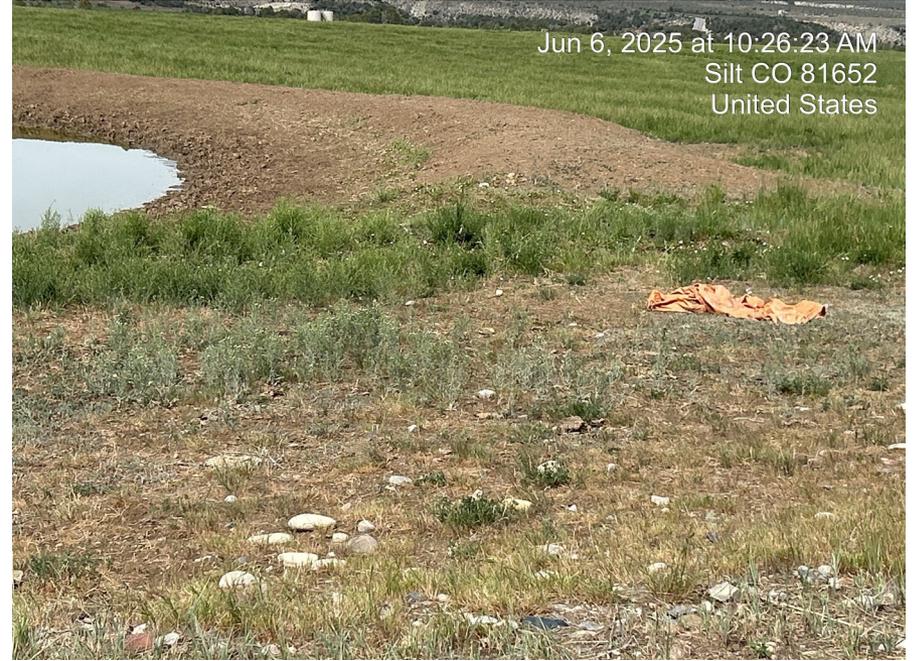
**Photo 6:** Debris located in the culvert and near the access road. Removal is required.

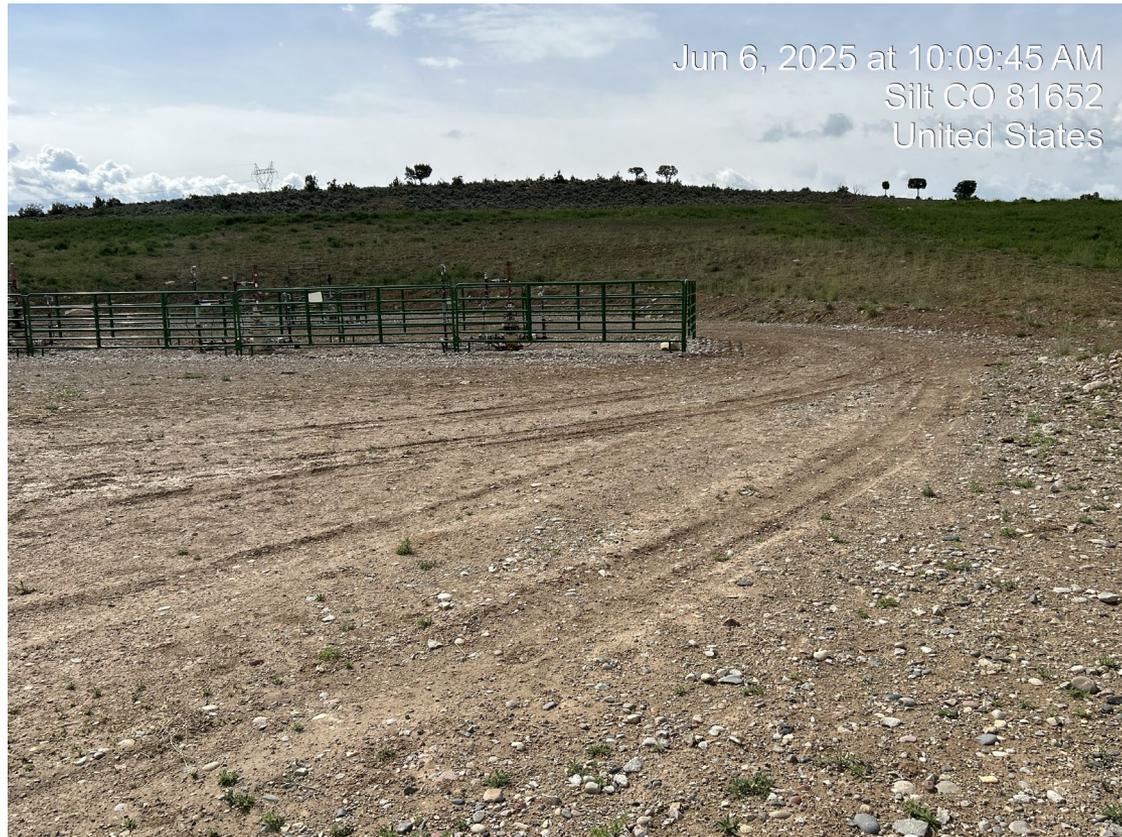
**Photo 7:** Photos showing an example of light sediment tracking observed on the western portion of the Location. Gravel has not been applied to the entire pad. BMP's show signs of disrepair; maintenance is advised.
