Inspection/Audit Photos

Location Name: QB ENERGY OPERATING LLC SHAEFFER 12-14B (012) Pad

Location #: 334650

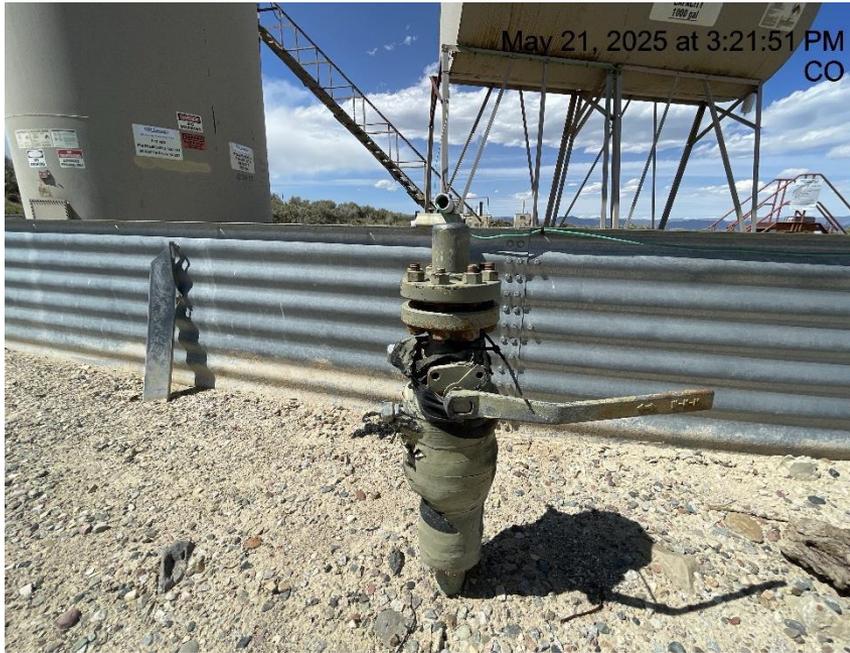
Photo # 2213 From inspection/audit 708906562 conducted on 05/21/2025 Unused flowline lacks lockout tagout (OOSLAT)

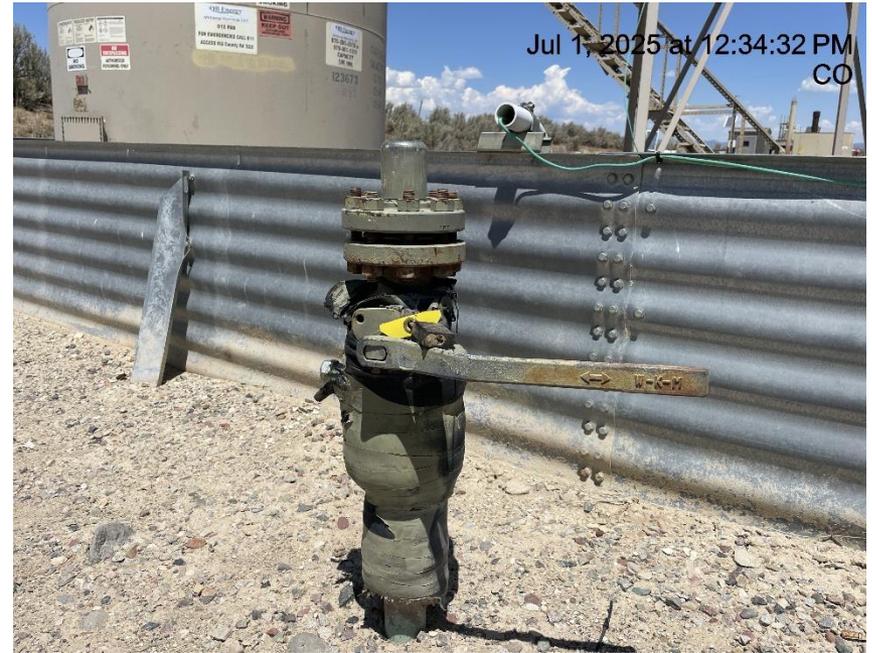
Photo # 9150 Unused flowline lacks tag/not in compliance with CECMC rules

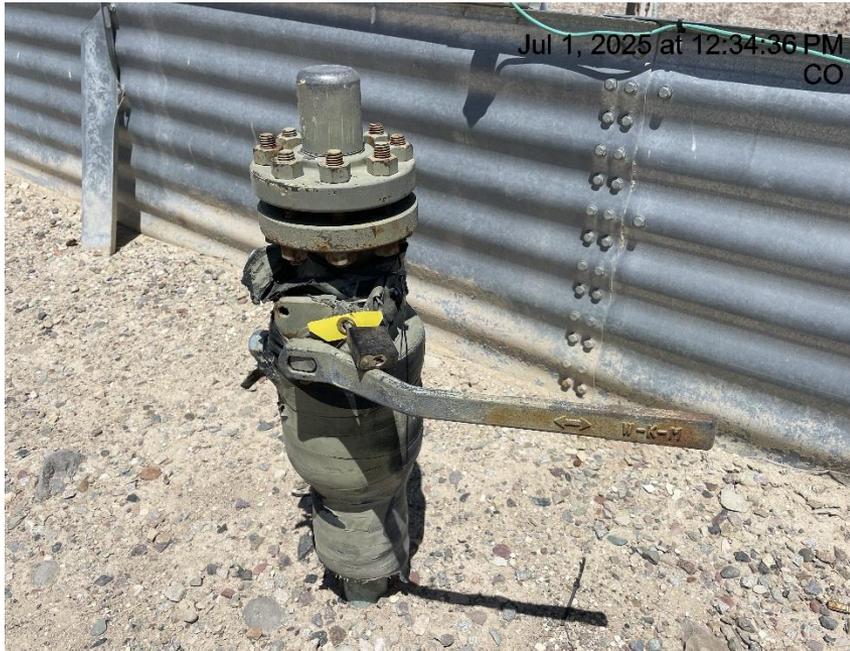
Photo # 9151 Unused flowline lacks tag/not in compliance with CECMC rules

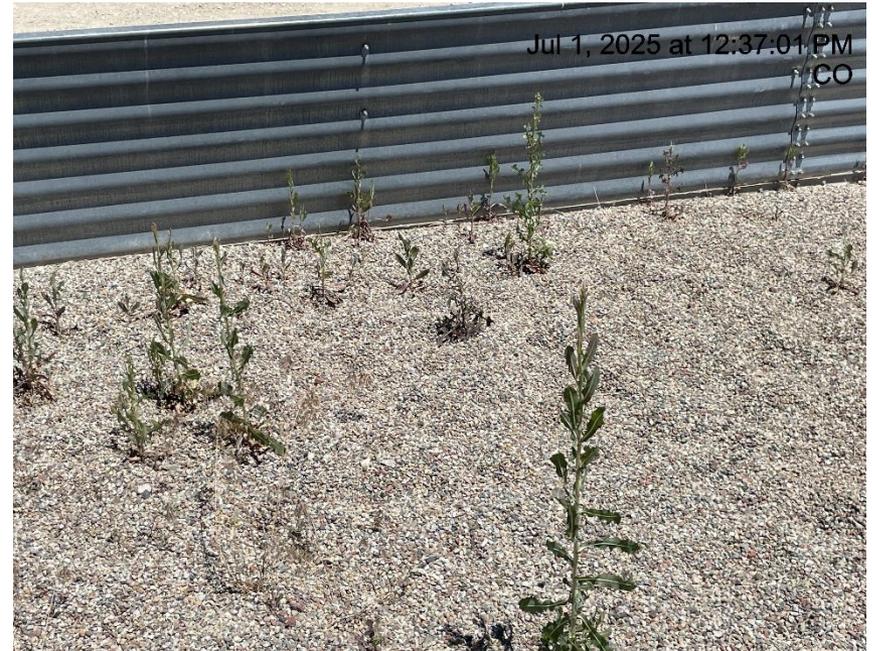
Photo # 9152 Weeds in secondary containment

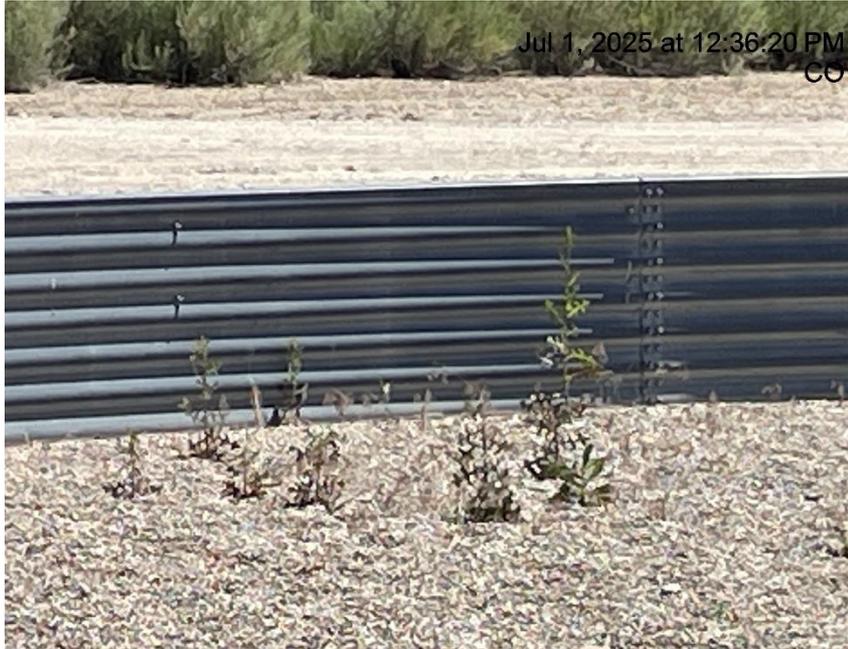
Photo # 9153 Weeds in secondary containment
