## Inspection/Audit Photos

Location: QB ENERGY OPERATING LLC PL35NW PAD

Location ID: 424424

Date: 07/1/2025

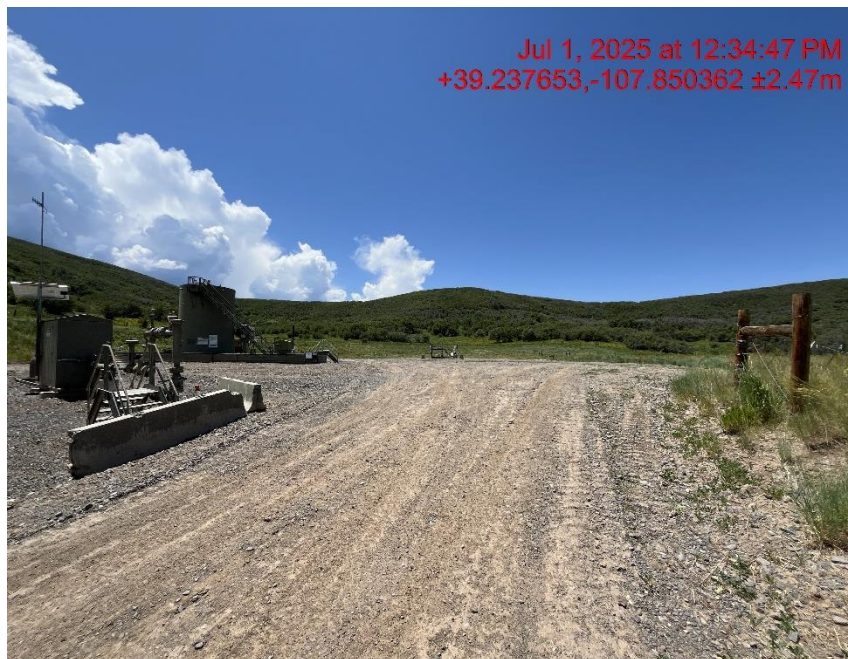
Photo # 9232 Entrance to location

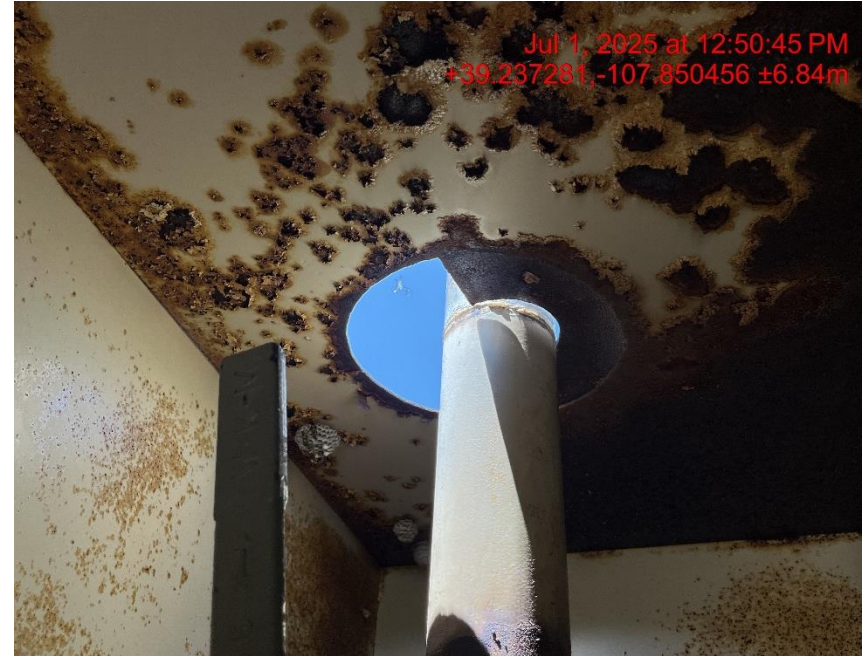
Photo # 9247 Hole in separator building/wildlife hazard/available for entry by wildlife

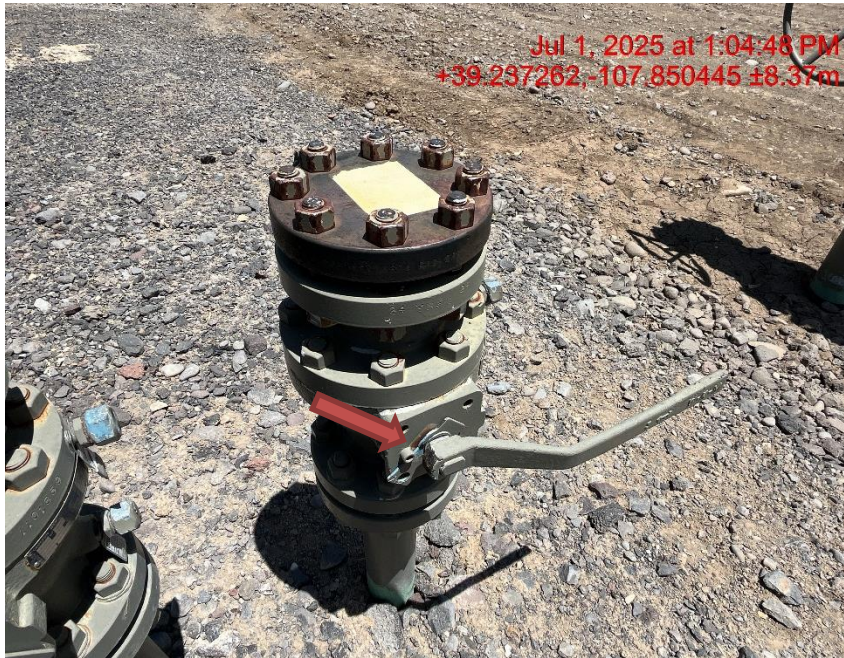
Photo # 9256 Unused flowline does not comply with CECMC 600 & 1100 series rules

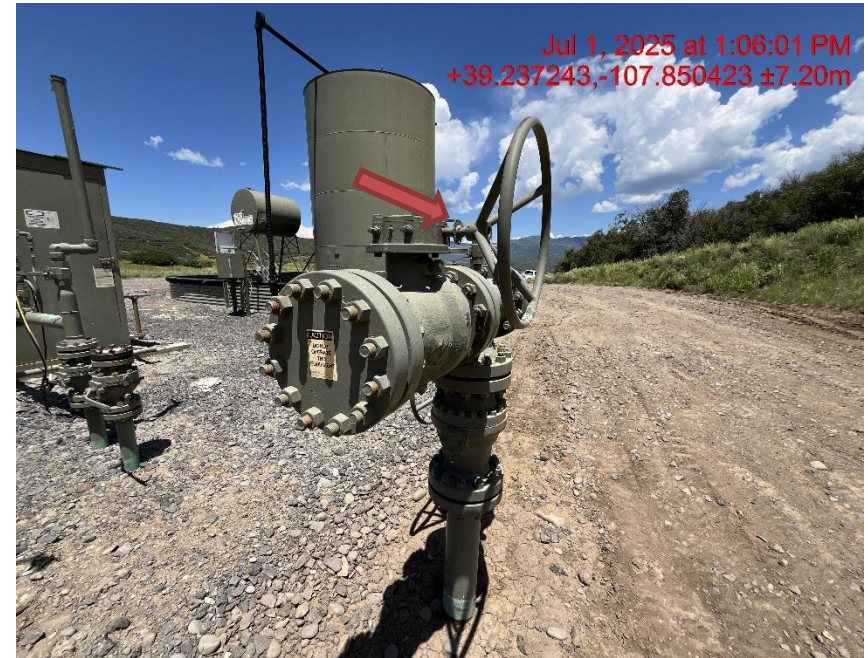
Photo # 9257 Unused flowline does not comply with CECMC 600 & 1100 series rules

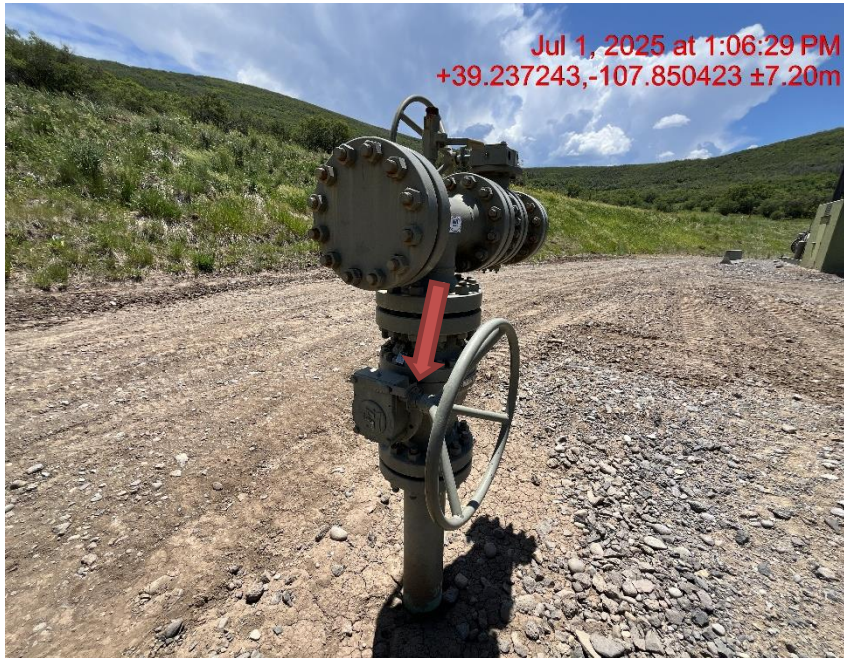
**Photo # 9259 Unused flowline does not comply with CECMC 600 & 1100 series rules**

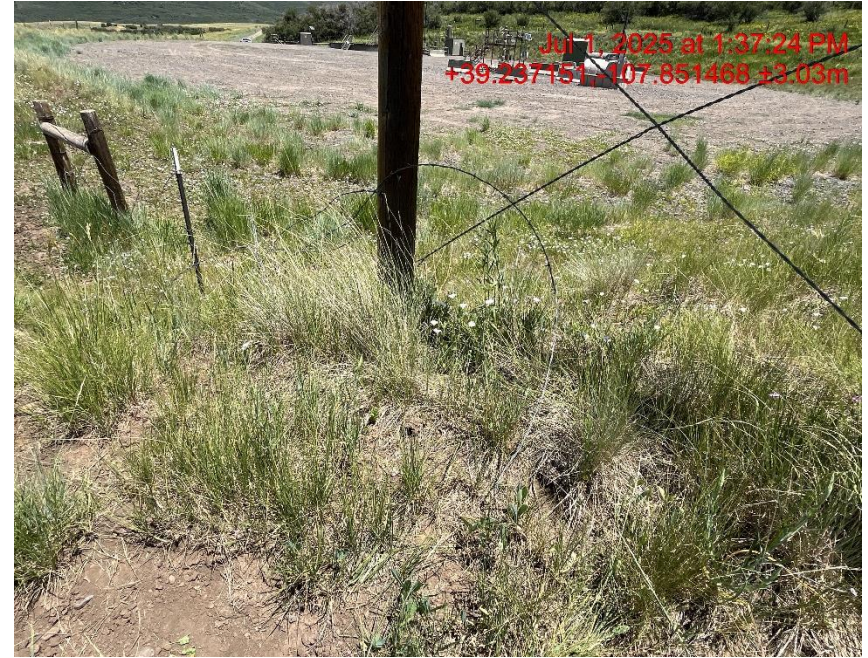
**Photo # 9288 Loose barbed wire fencing/wildlife hazard**

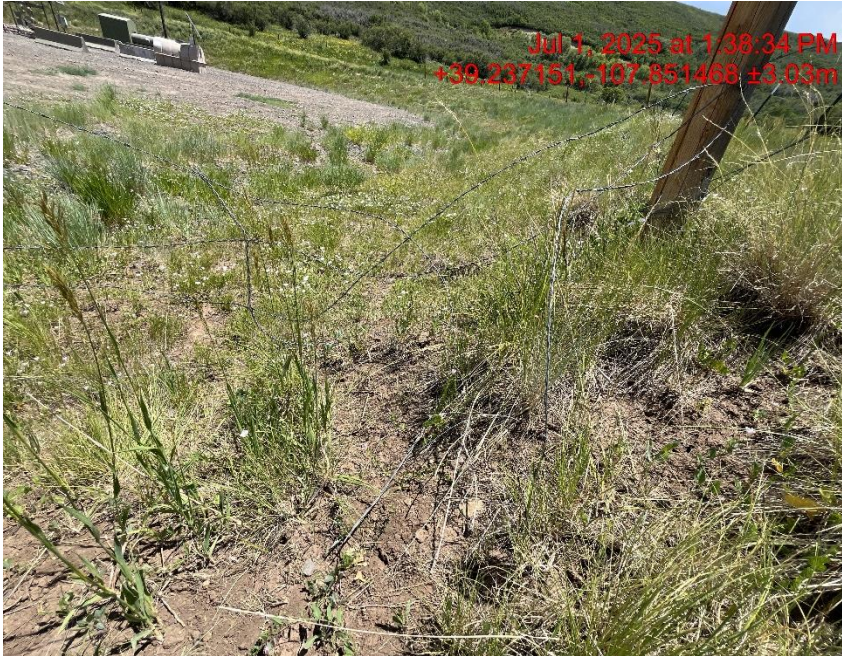
Photo # 9290 Loose barbed wire fencing/wildlife hazard

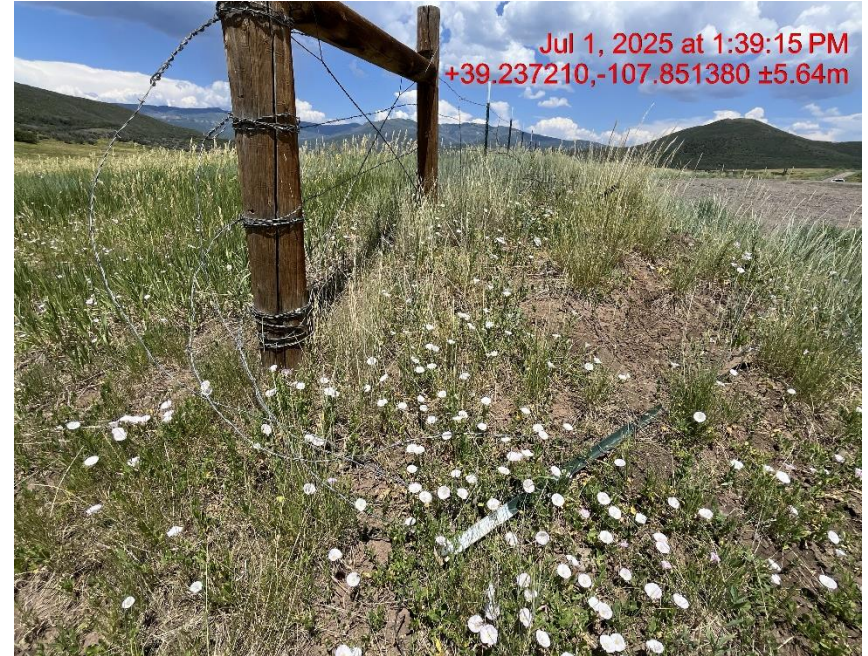
Photo # 9292 Loose barbed wire fencing/wildlife hazard

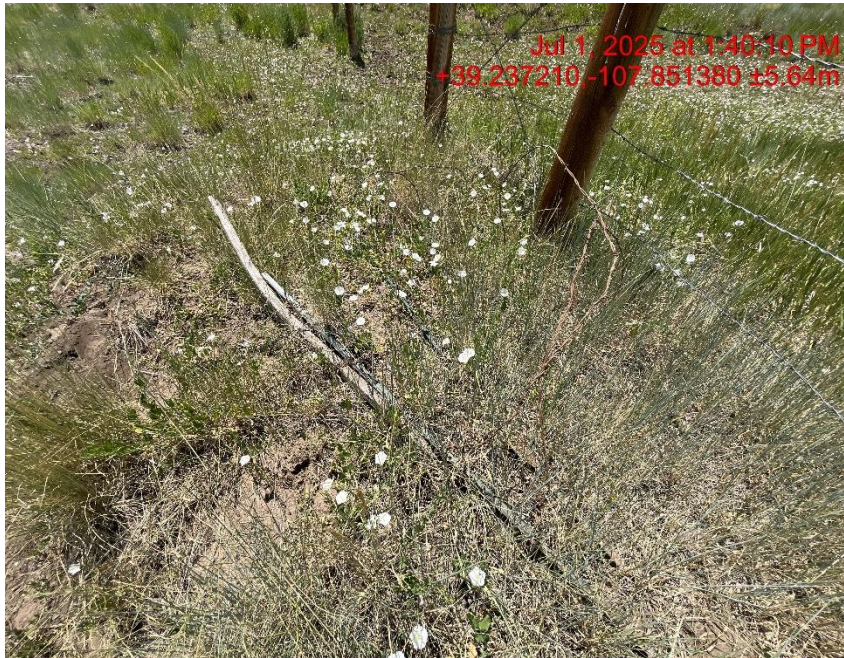
Photo # 9294 Loose barbed wire fencing/wildlife hazard

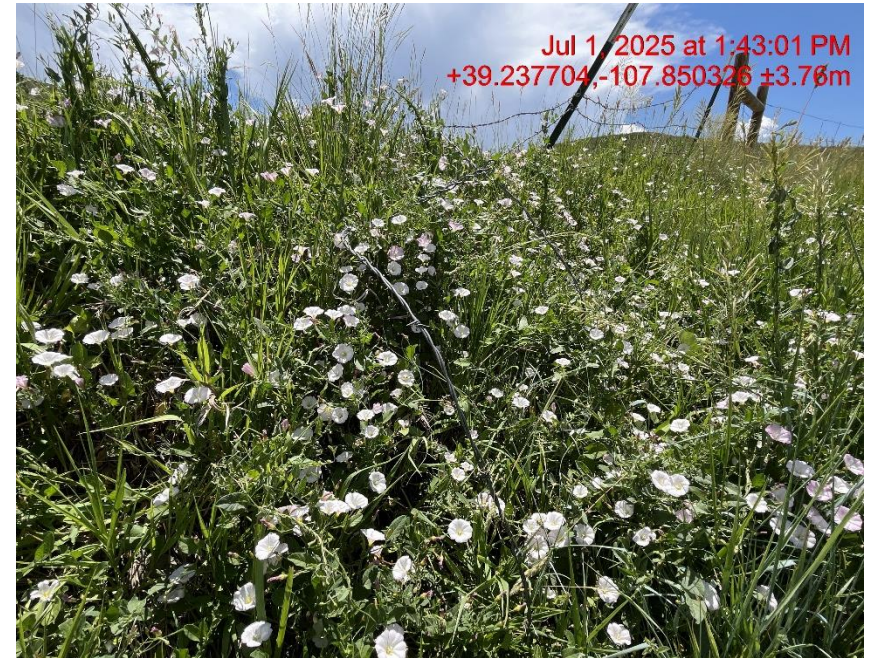
Photo # 9299 Loose barbed wire fencing/wildlife hazard

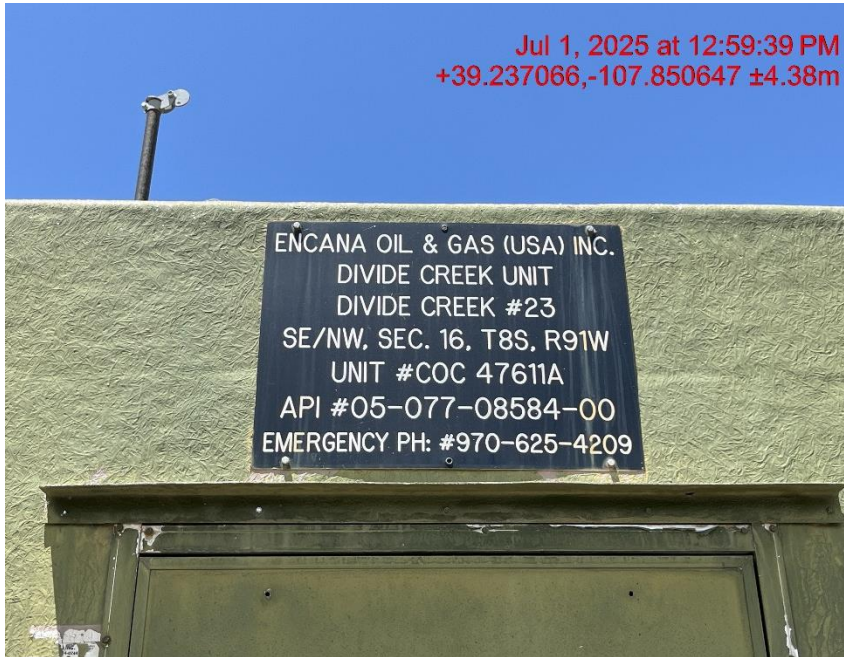
Photo # 9254 Sign on dehydrator building is inaccurate

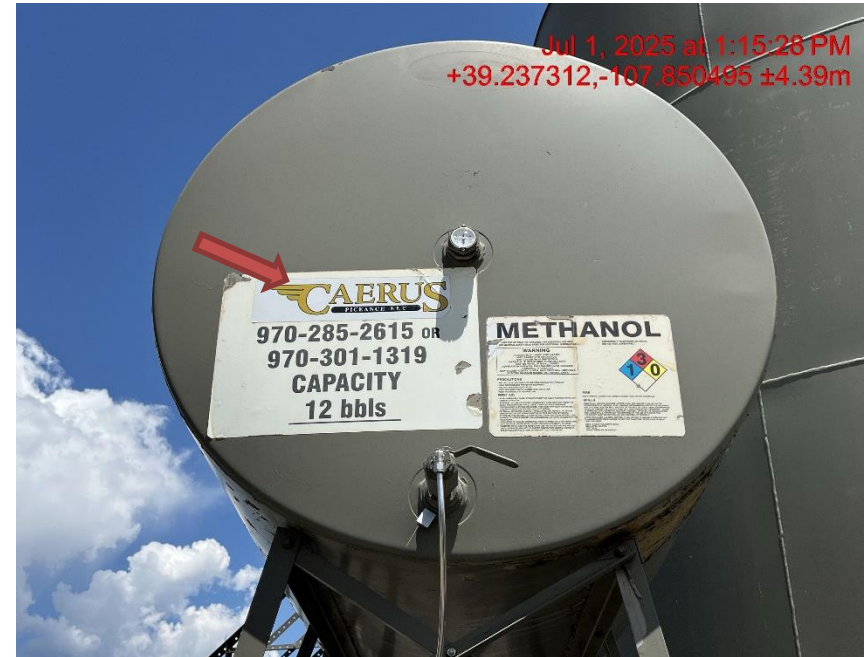
Photo # 9271 Label on methanol tank has incorrect operator name
