Final Reclamation Inspection

Operator: NOBLE ENERGY INC - 100322

Location ID: 329078

Inspection Photos
Location Name: HSR-MERRITT #11-34A
Location ID: 329078

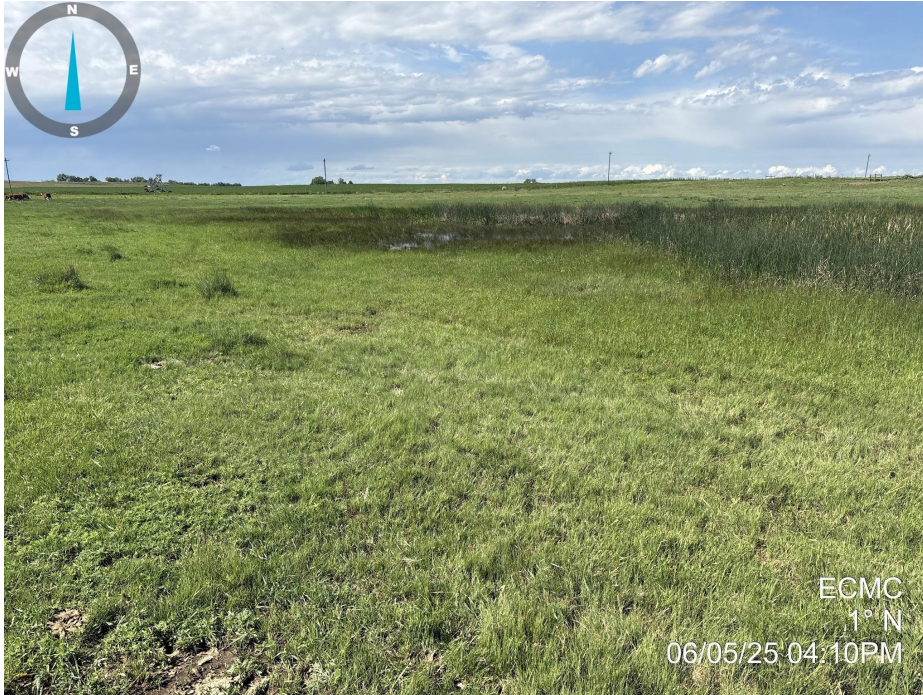
Photo 1. Photo taken from the well location, facing North. Photo illustrates that vegetation has not established to Rule 1004 standards on the location as there is bare ground and weedy annual vegetation, including cheatgrass (*Bromus tectorum*).

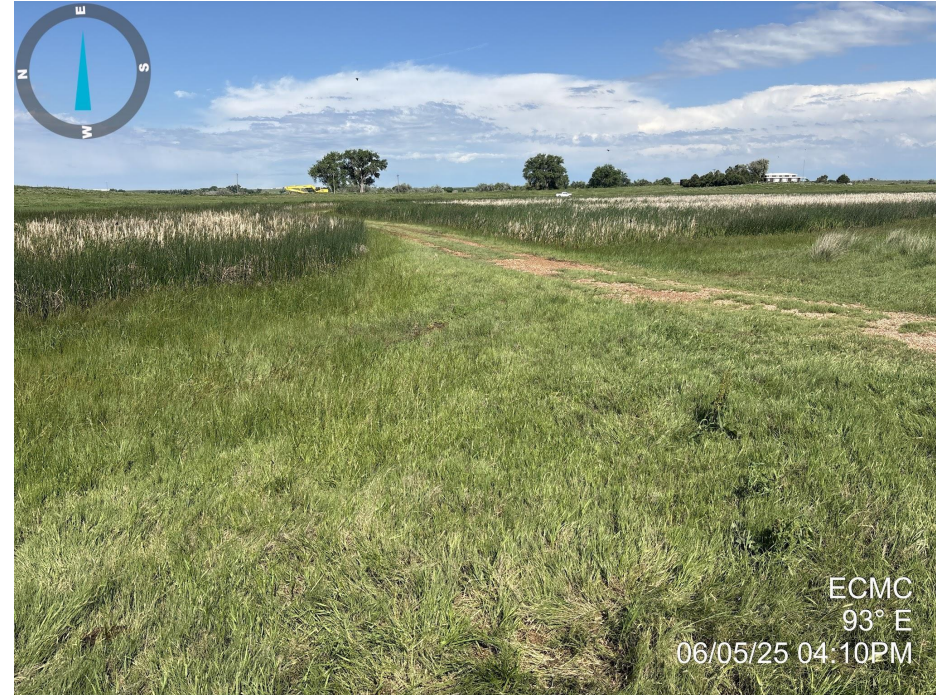
Photo 2. Photo taken from the well location, facing East. See comments under Photo 1.

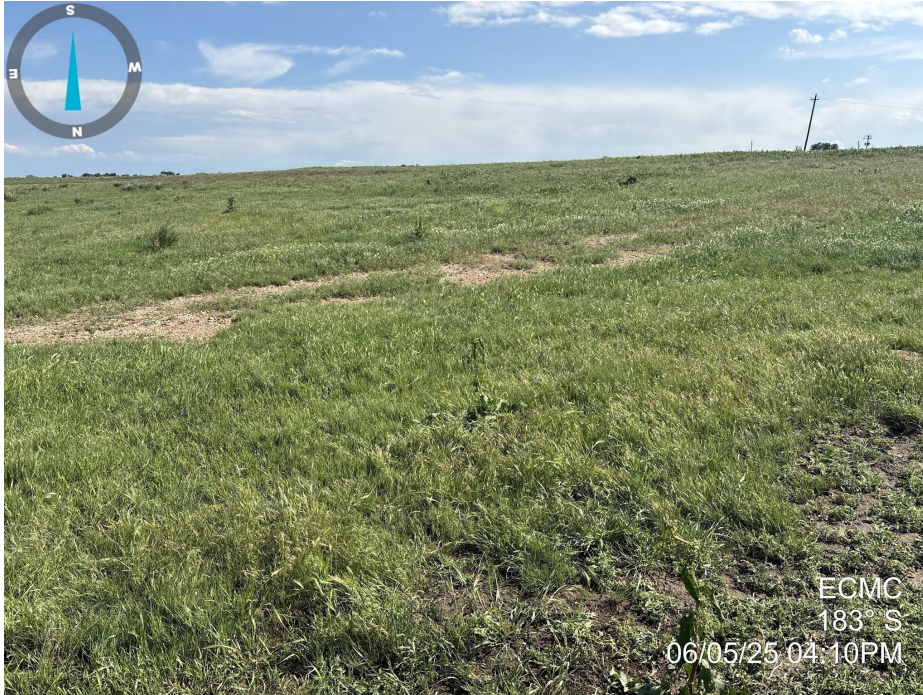
Photo 3. Photo taken from the well location, facing South. See comments under Photo 1.

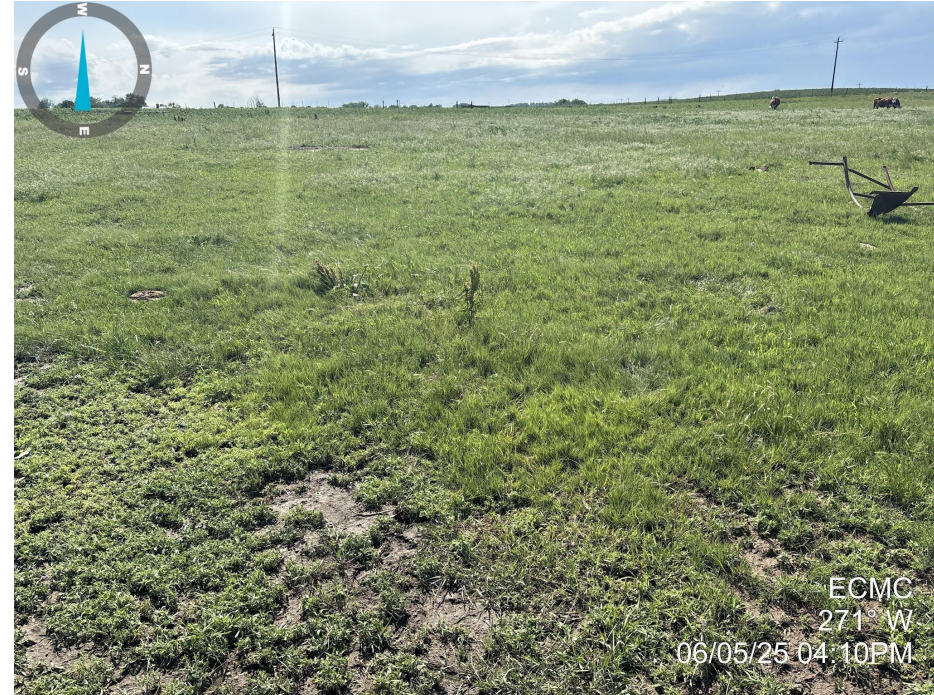
Photo 4. Photo taken from the well location, facing West. See comments under Photo 1.

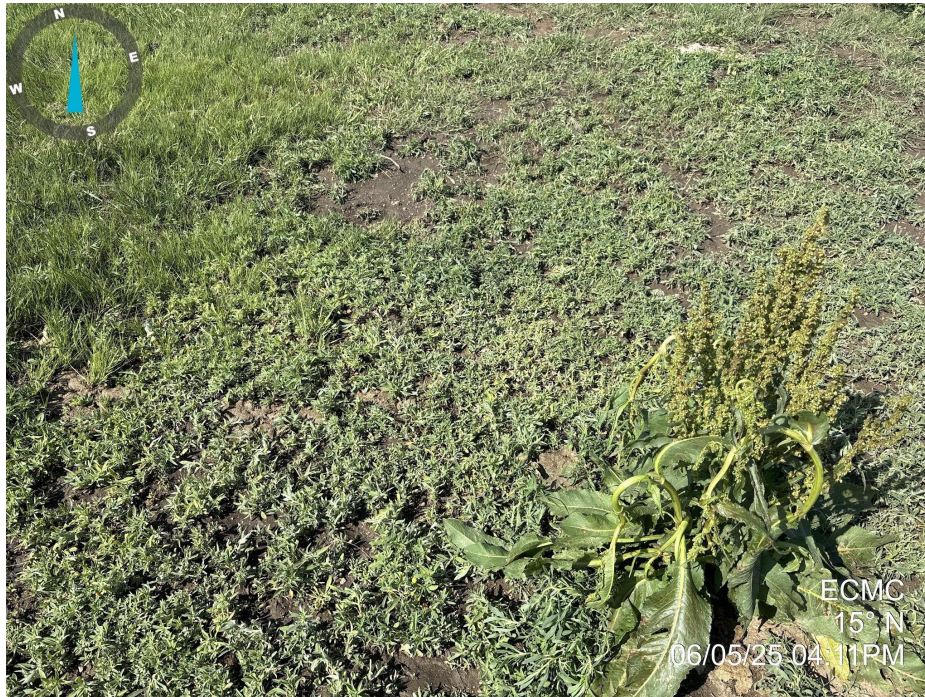
Photo 5. Photo taken of ground cover at the well location. Photo illustrates weedy annual vegetation including kochia (*Bassia scoparia*).

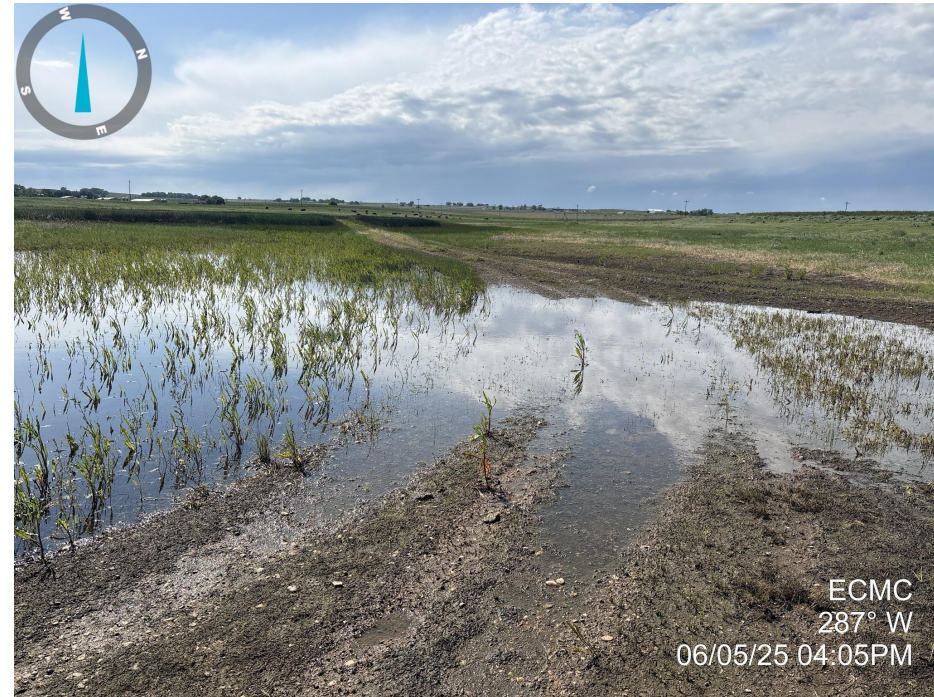
Photo 6. Photo taken of the access road to the well location, facing west. Photo illustrates that final reclamation activities have not taken place and gravel and bare ground remain along the road. Flooding is present across the access road from the adjacent wetland area.

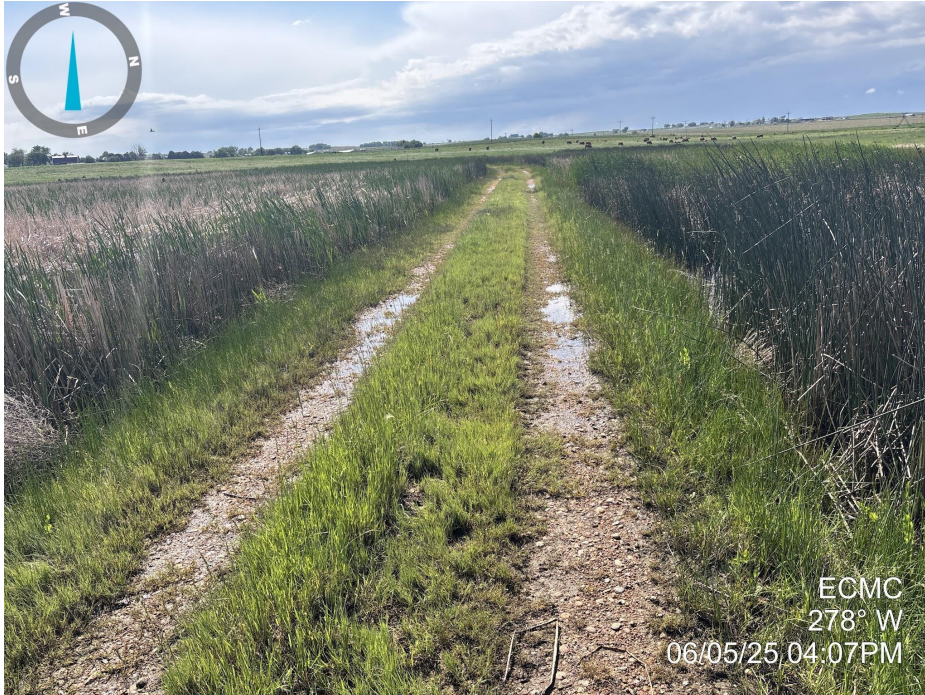
Photo 7. Photo taken of the access road to the well location, facing west towards the well location. Photo illustrates that final reclamation activities have not taken place and gravel and bare ground remain along the road.

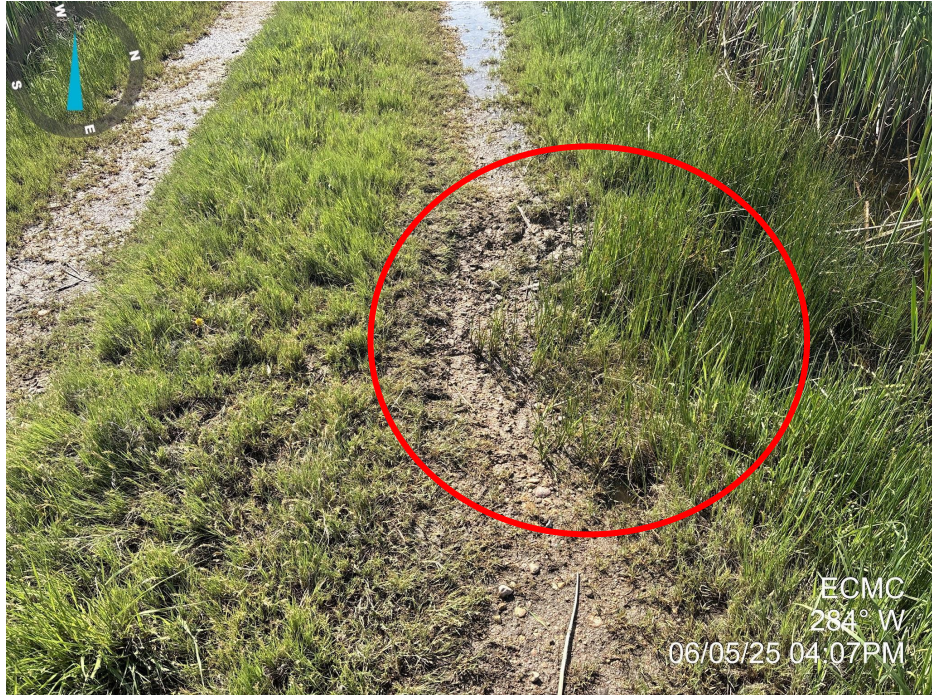
Photo 8. Photo taken of the access road. Photo illustrates stormwater erosion (highlighted in red circle) along a portion of the road.

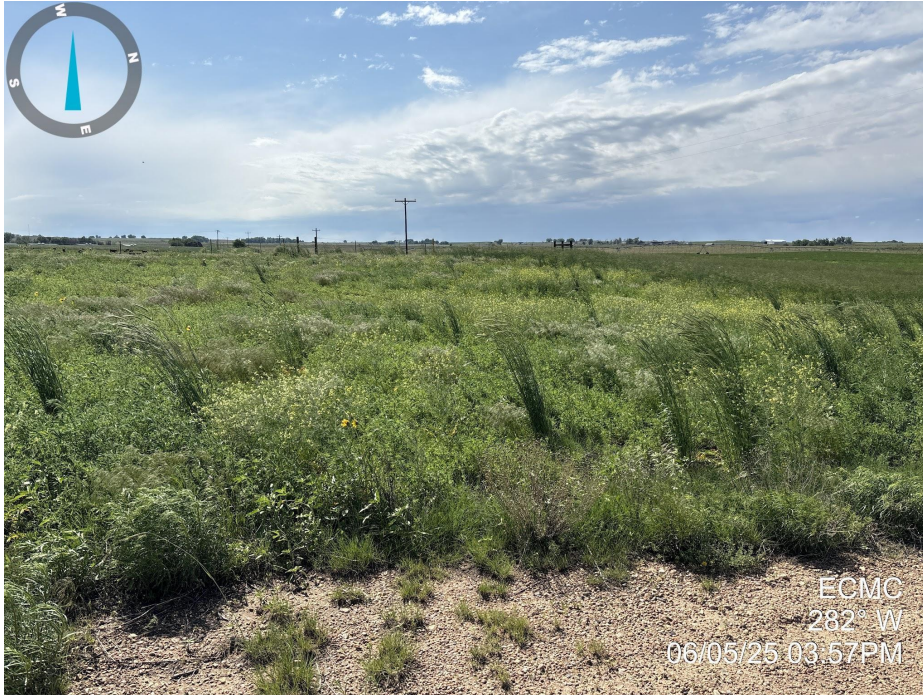
Photo 9. Photo taken of the tank battery location, facing West. Photo illustrates the location does not meet Rule 1004 standards as it is dominated by weedy, annual vegetation.

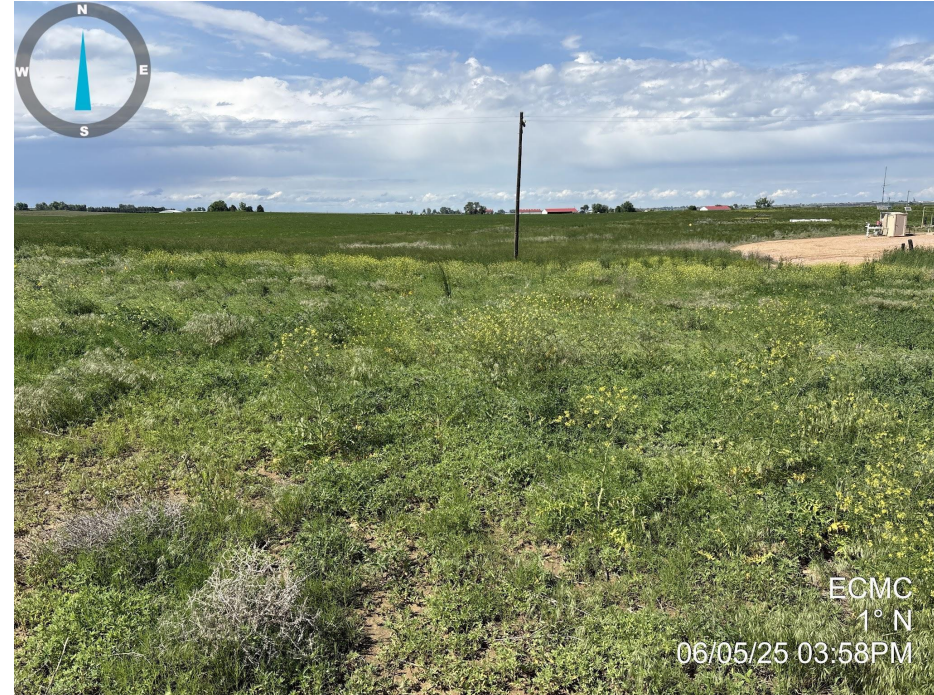
Photo 10. Photo taken of the tank battery location, facing North. See comments under Photo 9.

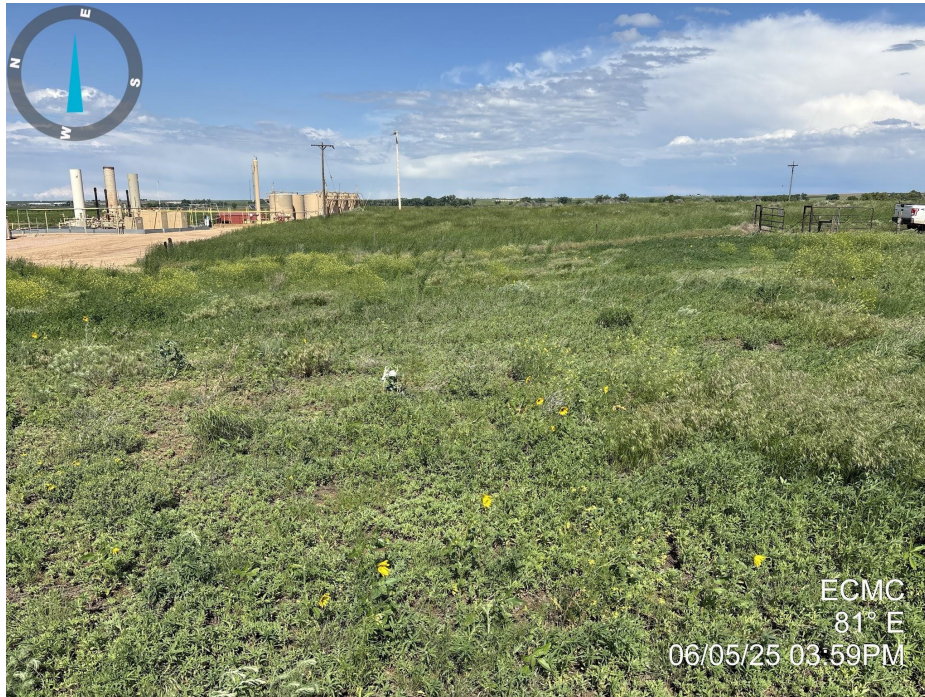
Photo 11. Photo taken of the tank battery location, facing East. See comments under Photo 9.

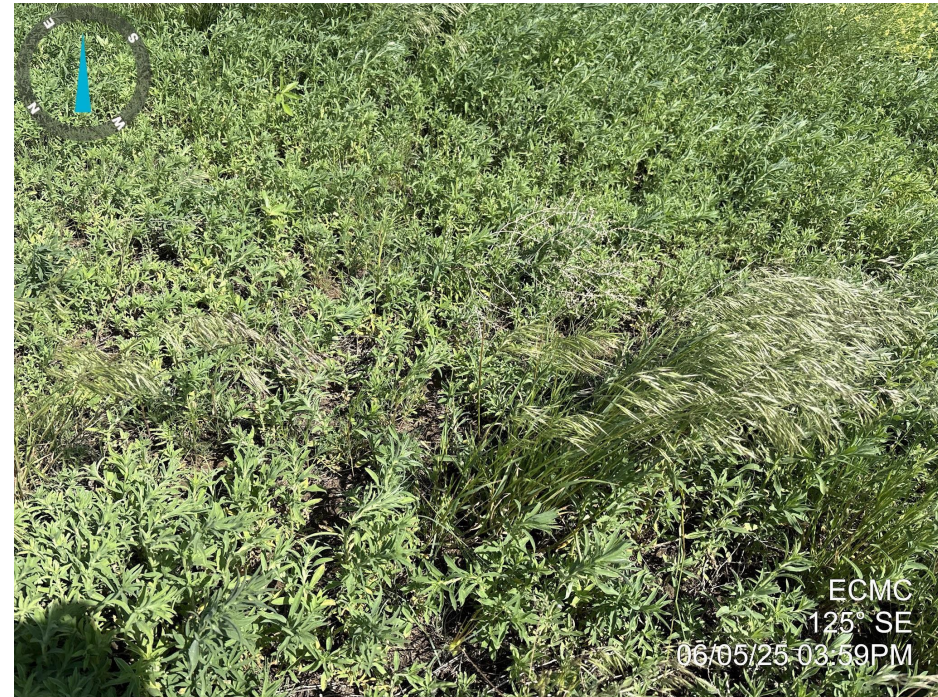
Photo 12. Photo taken ground cover at the tank battery location. Photo illustrates weedy annual vegetation including cheatgrass (*Bromus tectorum*), a List C Noxious Weed species, and kochia (*Bassia scoparia*).

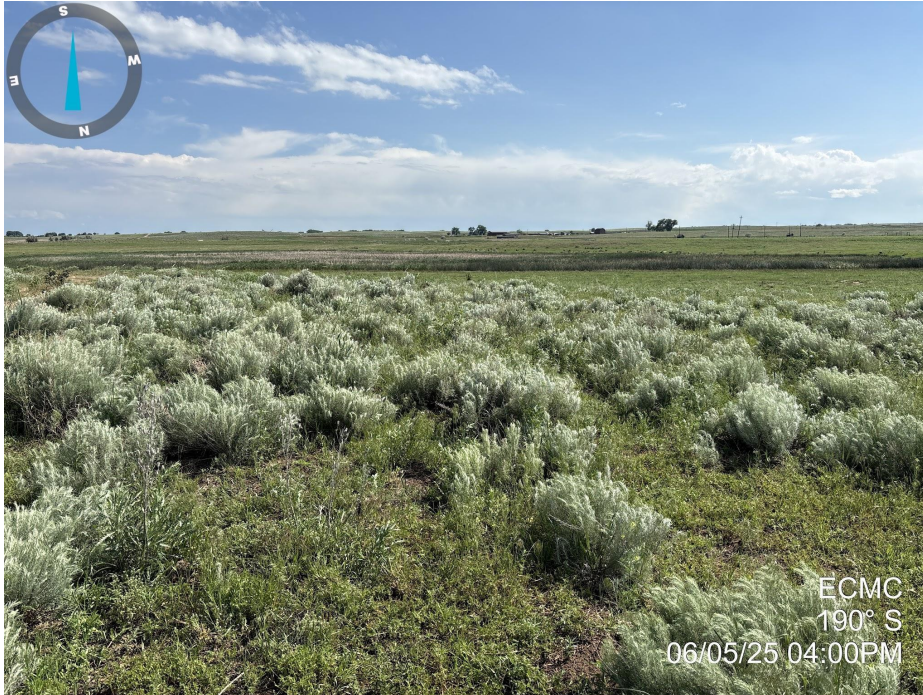
Photo 13. Photo taken of the reference area to the tank battery, south of the location, facing South. Photo illustrates perennial grass vegetation with some cheatgrass (*Bromus tectorum*) encroachment, and sand sagebrush (*Artemisia filifolia*).

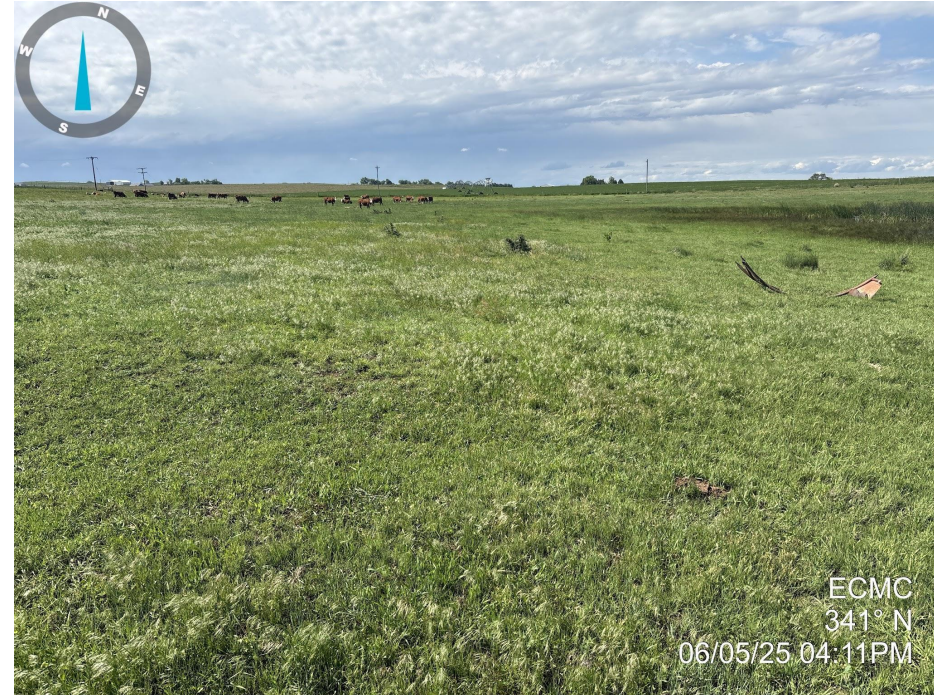
Photo 14. Photo taken of the reference area for the well location, west of the location, facing North. Photo illustrates perennial grass vegetation with cheatgrass.
