Inspection Photos

Loc: 488238

Operator: BNL (ENTERPRISE) INC

Inspection Date: 7/2/2025

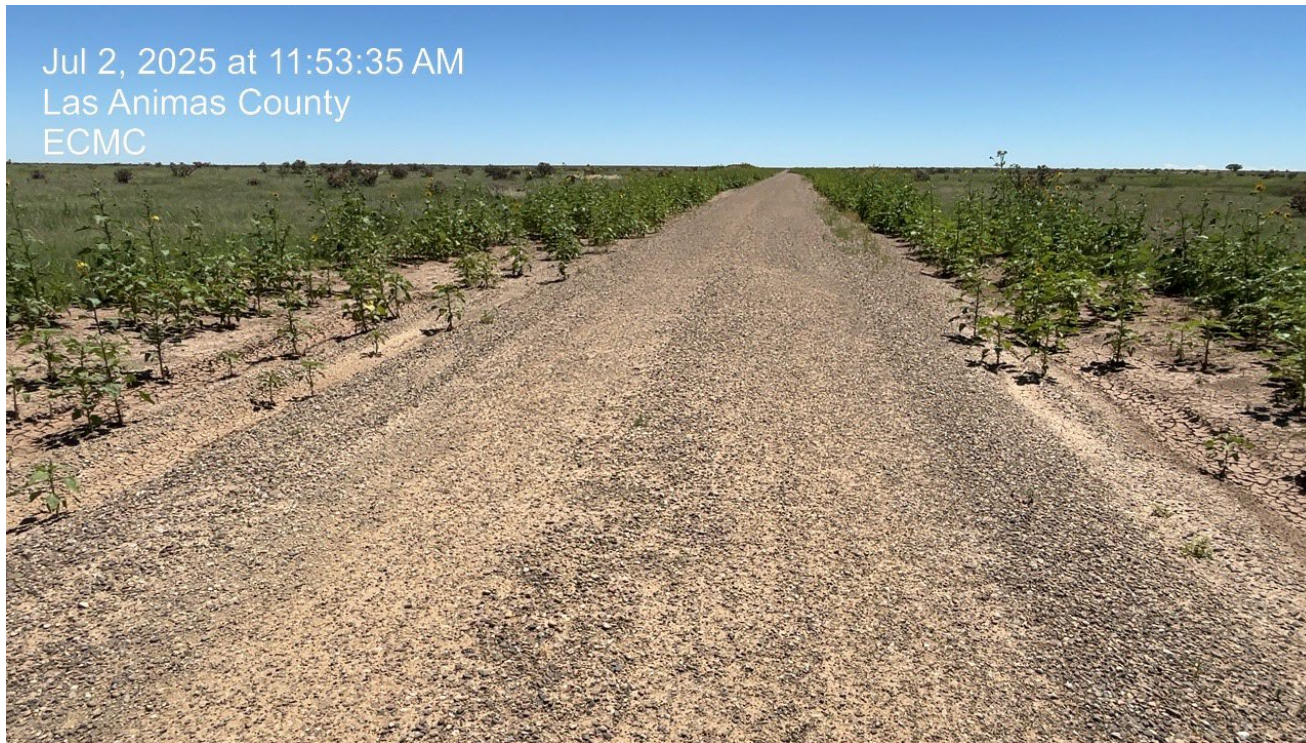
Photo 1. Facing east at the beginning of the access road.

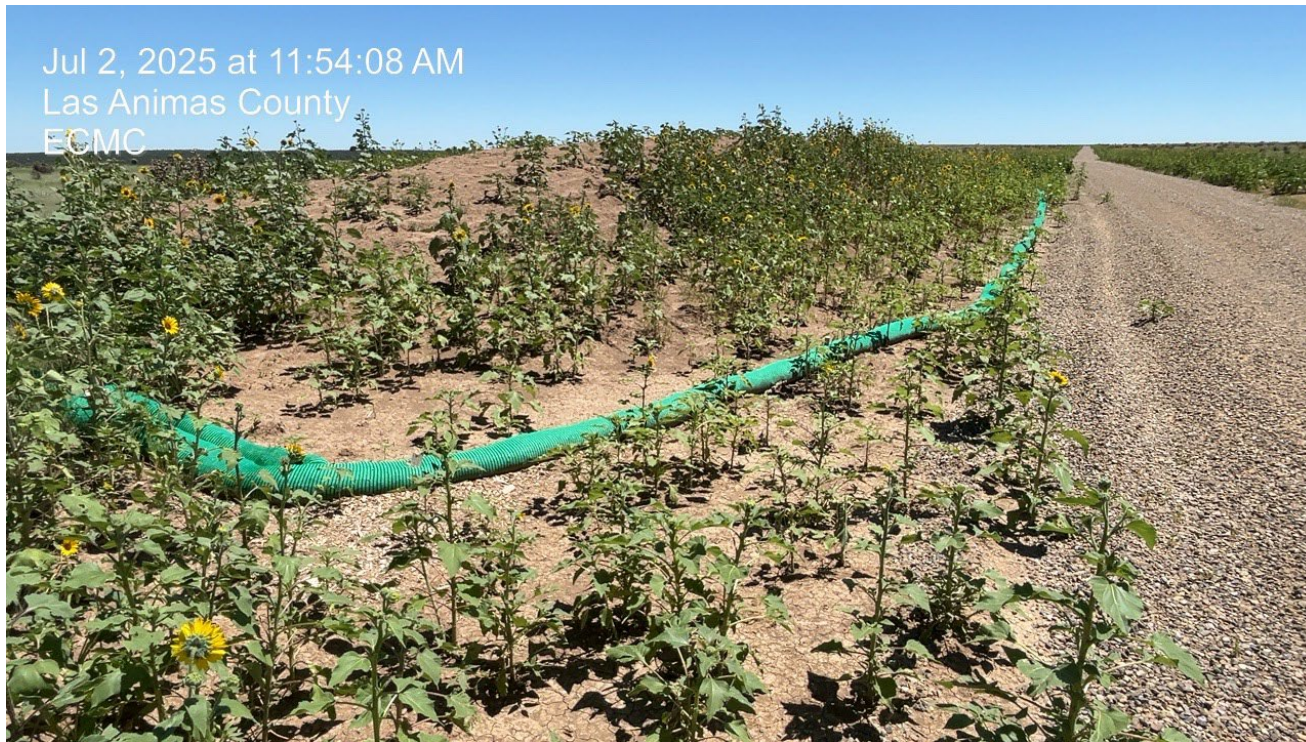
Photo 2. The topsoil piles stored along the road will need to be seeded for long term stabilization with perennial vegetation. The annual sunflowers that have naturally grown are not sufficient for long term stabilization.

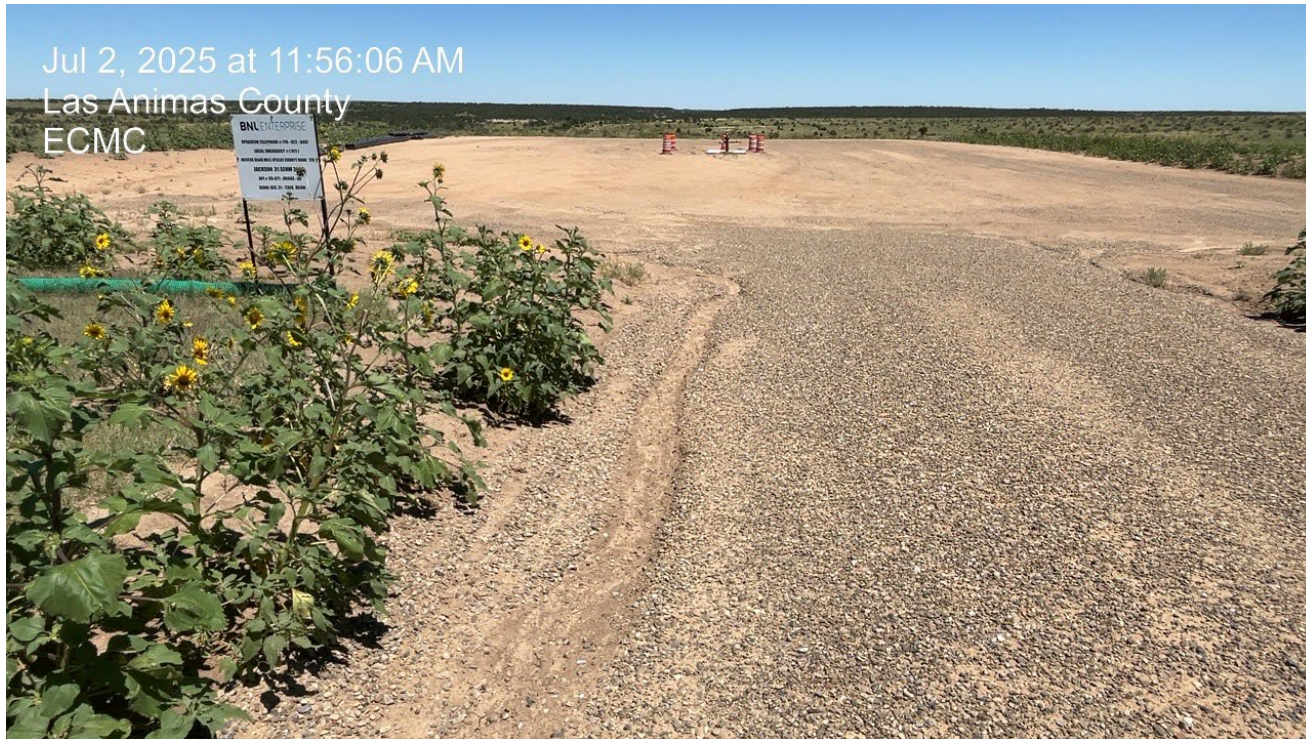
Photo 3. Facing north toward the wellsite location.

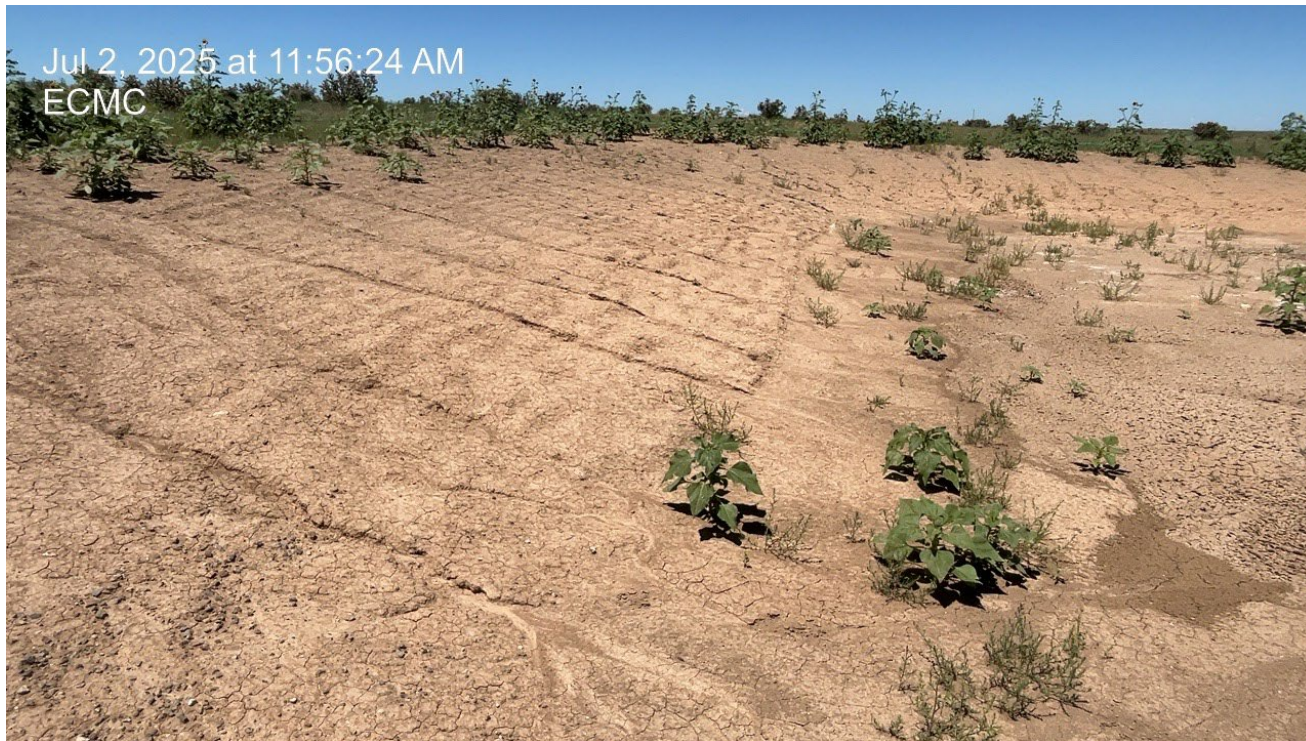
Photo 4. The cut slope of the location is not stabilized and is beginning to erode.

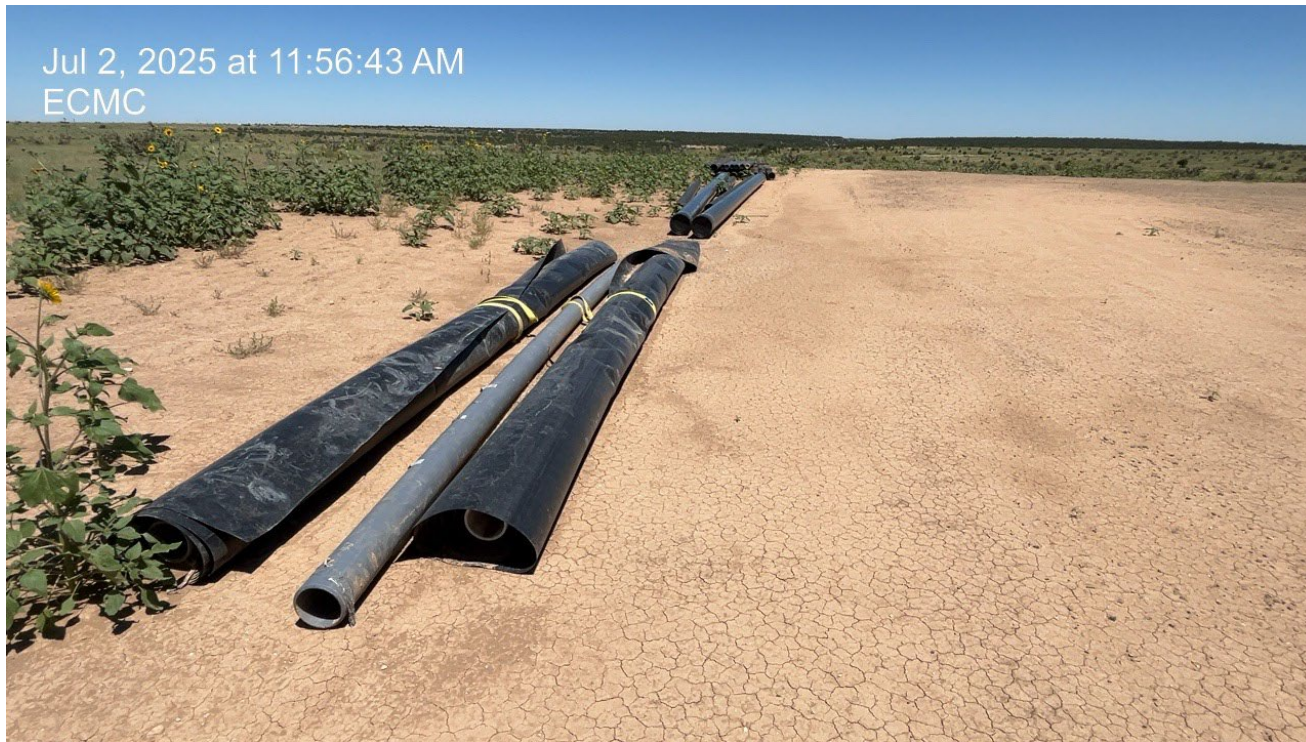
Photo 5. There is unused piupe and liner that needs to be removed.

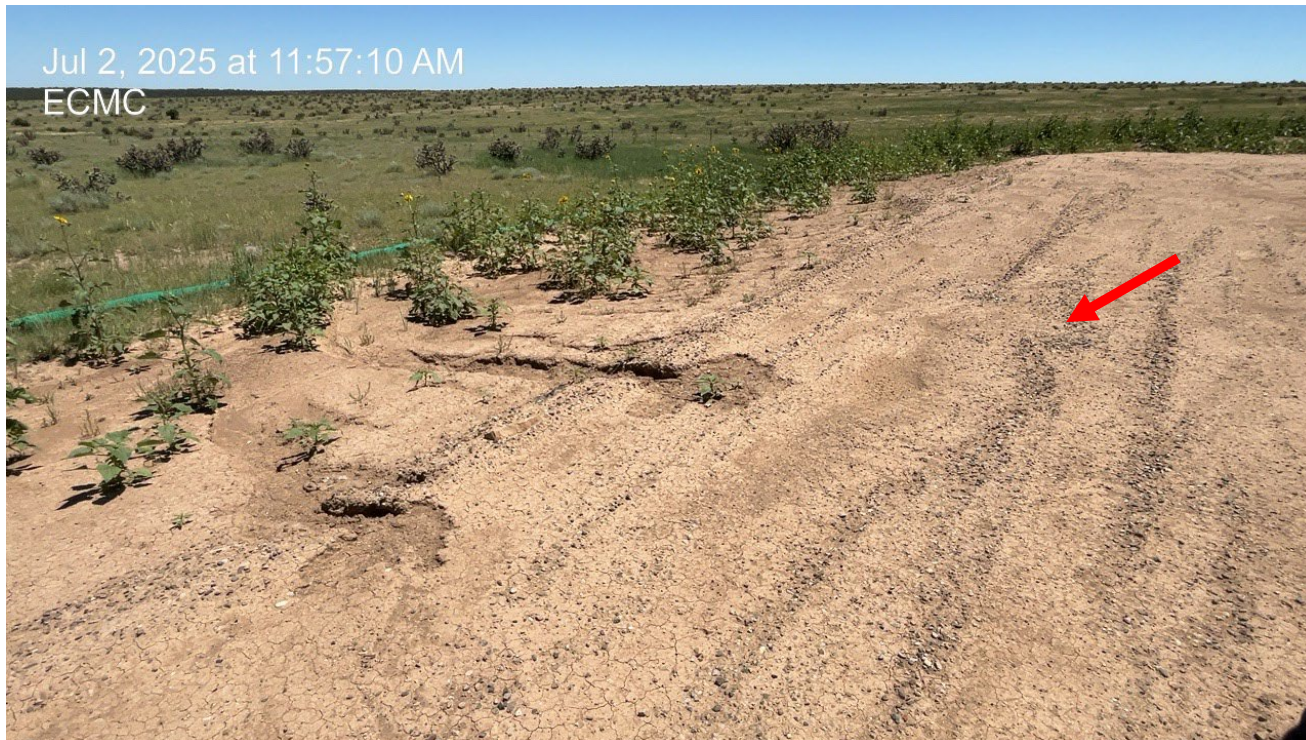
Photo 6. The fill slope of the location is not stabilized and is beginning to erode.

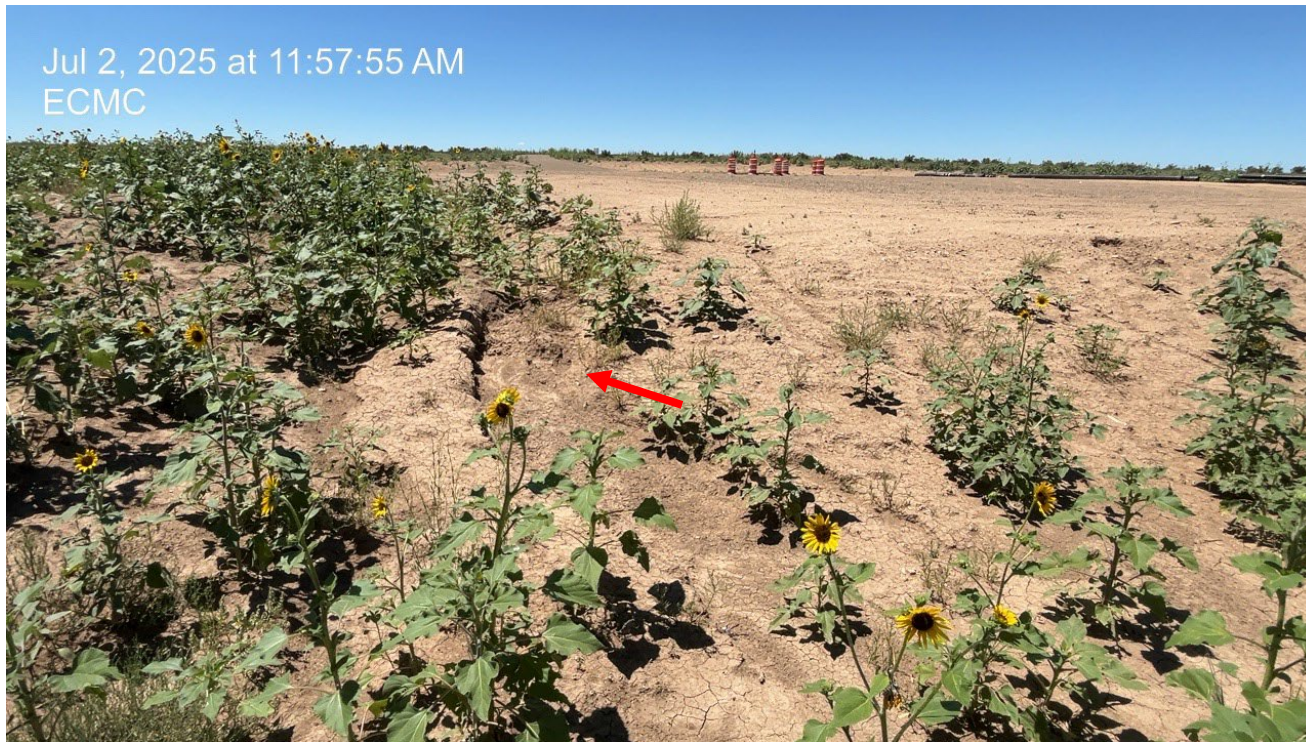
Photo 7. The entire location slopes to this northeast corner and there are insufficient BMP's to prevent erosion and offsite sediment transport. There is erosion occurring shown at red arrow.

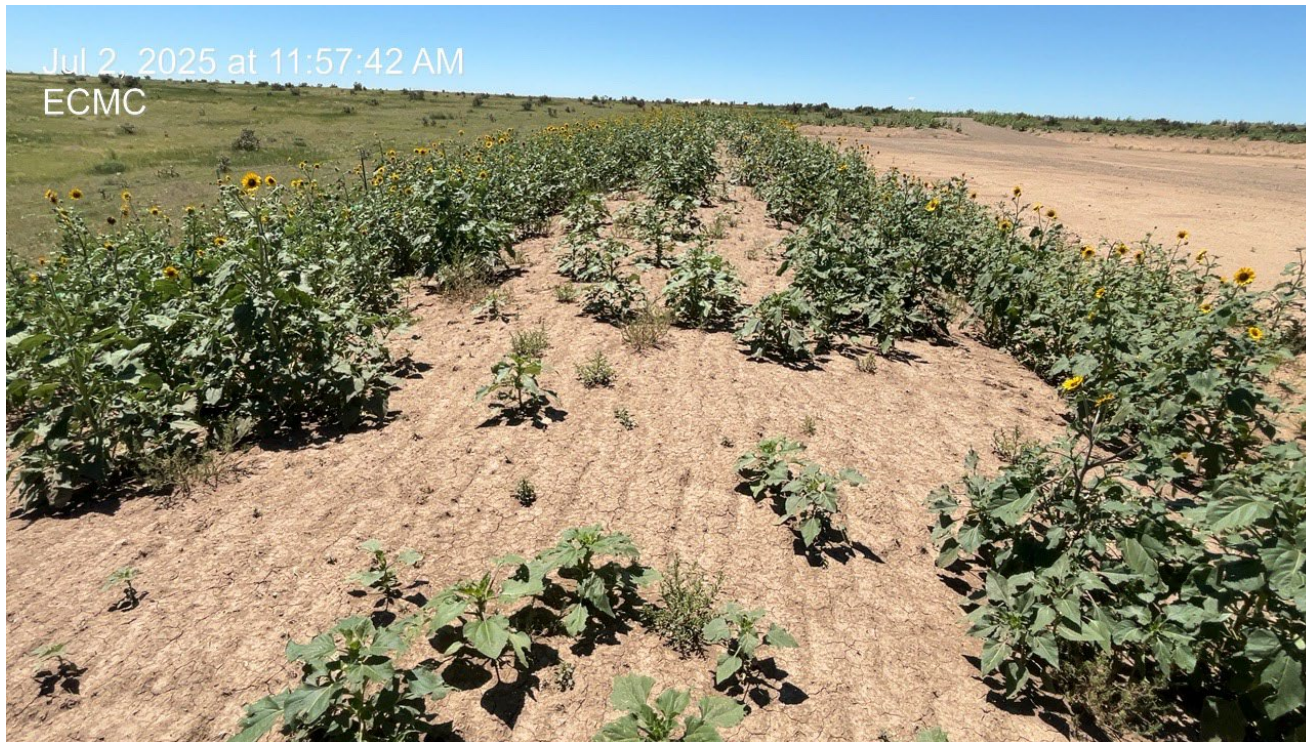
Photo 8. The topsoil pile at the east side of the location will need to be seeded and stabilized if stored for longer than 6 month since construction.
