Inspection/Audit Photos

Location: LARAMIE ENERGY LLC Currier 26-15 PAD

Location ID: 334528

Date: 07/1/2025

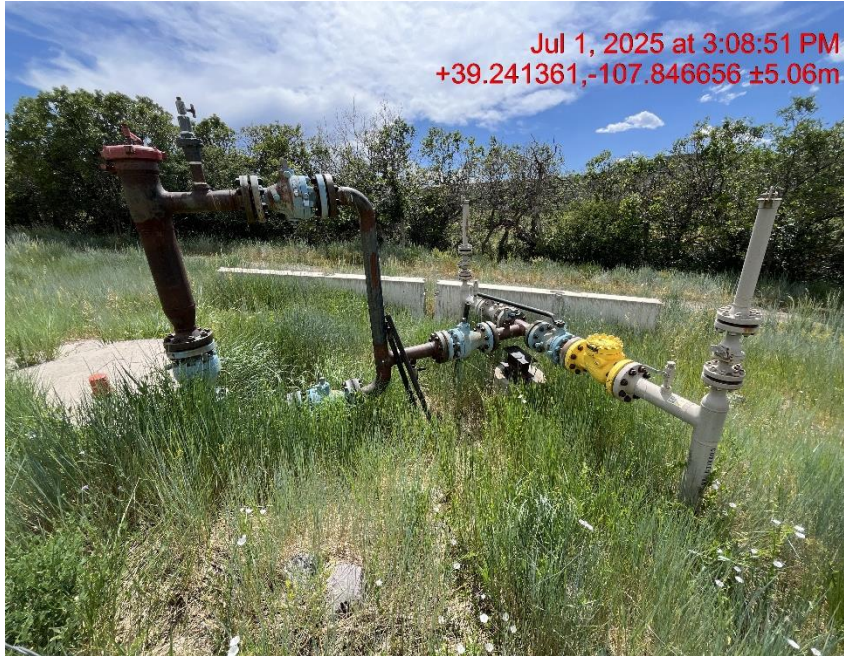
Photo # 9402 Location - Weeds/undesirable plant species surrounding production equipment constitutes a fire hazard

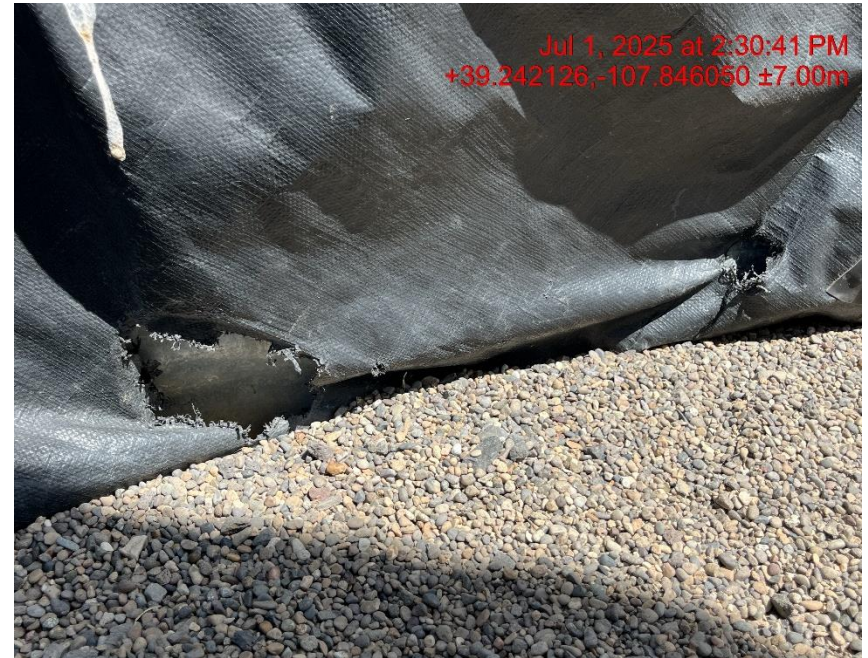
Photo # 9343 Multiple holes in secondary containment liner/liner needs maintenance

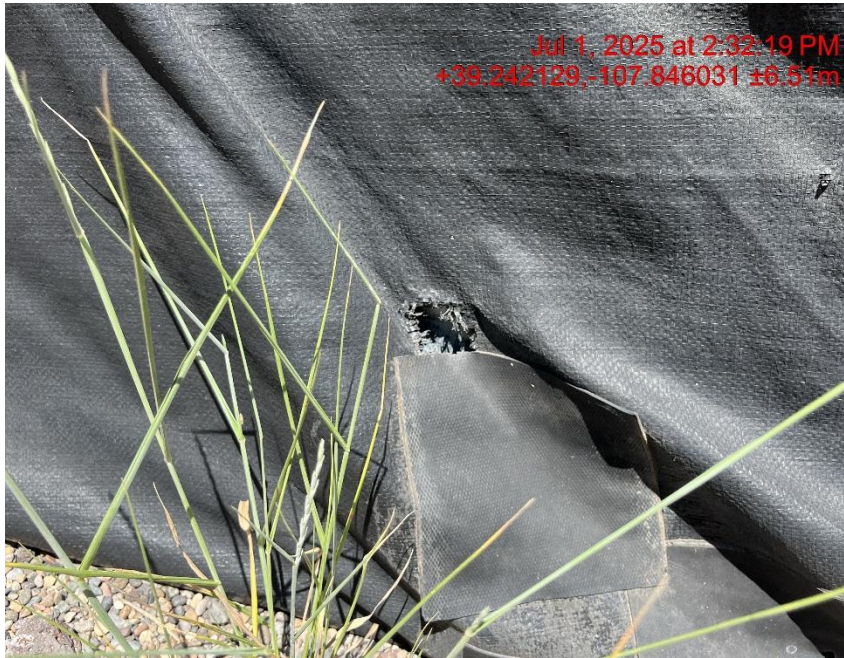
Photo # 9345 Multiple holes in secondary containment liner/liner needs maintenance

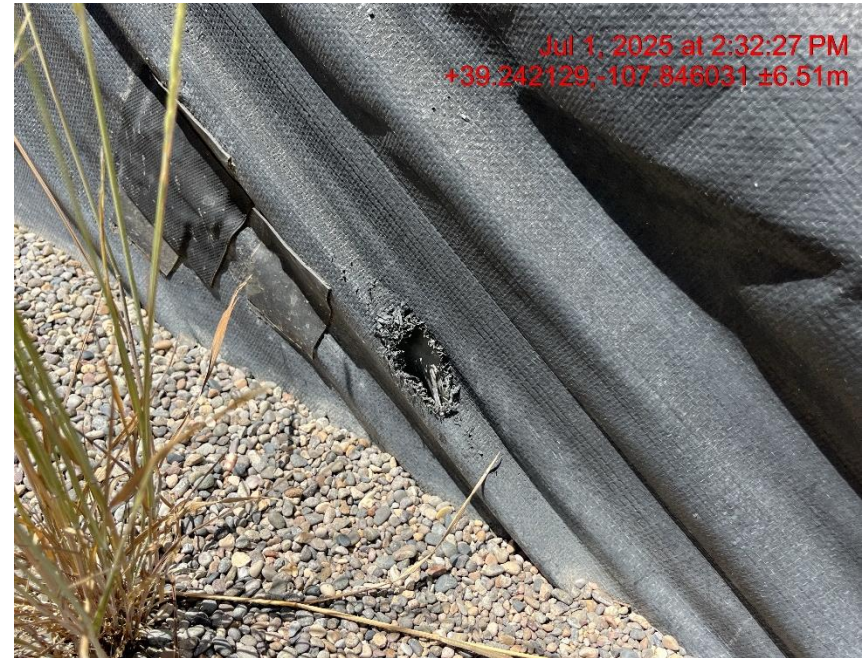
Photo # 9346 Multiple holes in secondary containment liner/liner needs maintenance

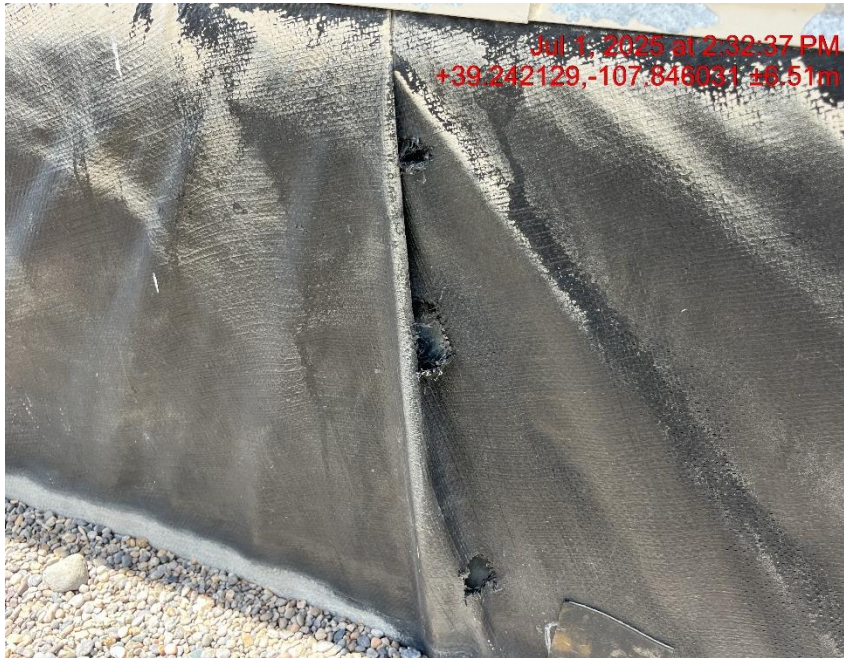
Photo # 9347 Multiple holes in secondary containment liner/liner needs maintenance

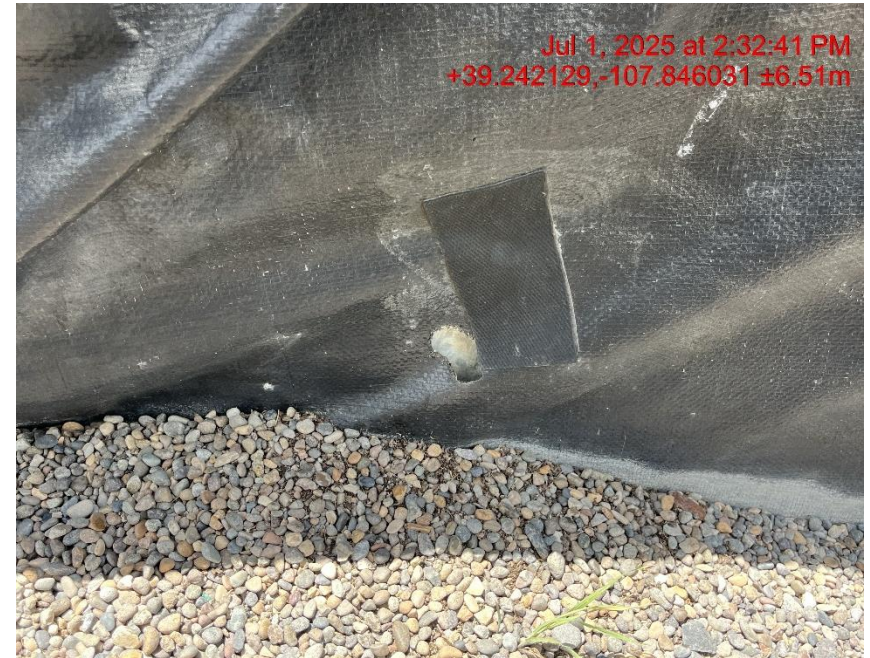
Photo # 9348 Multiple holes in secondary containment liner/liner needs maintenance

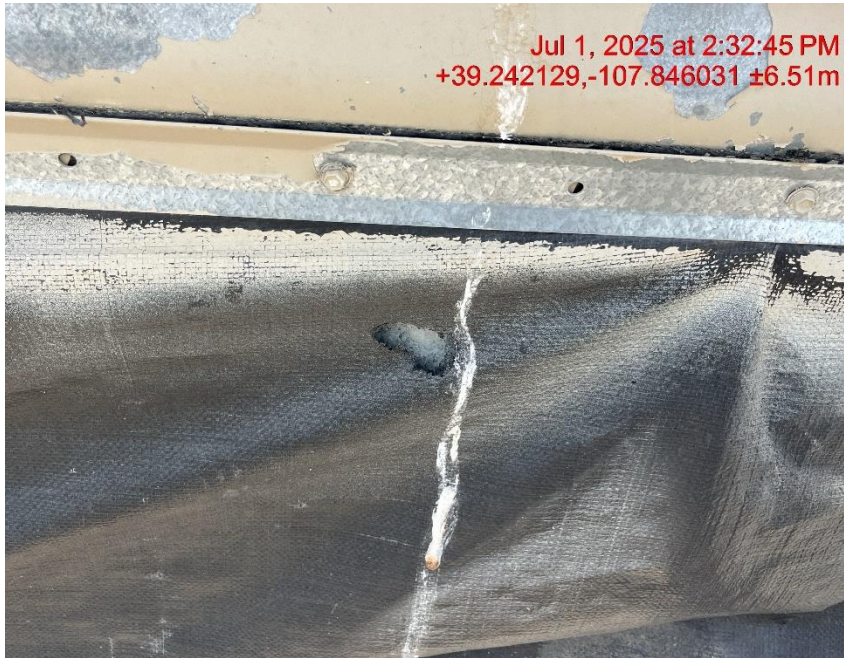
Photo # 9349 Multiple holes in secondary containment liner/liner needs maintenance

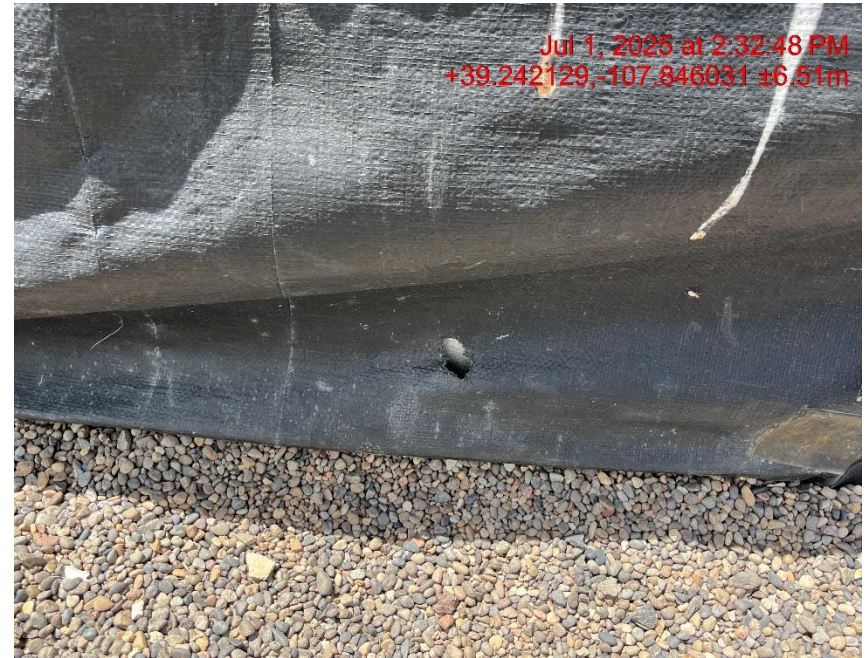
Photo # 9350 Multiple holes in secondary containment liner/liner needs maintenance

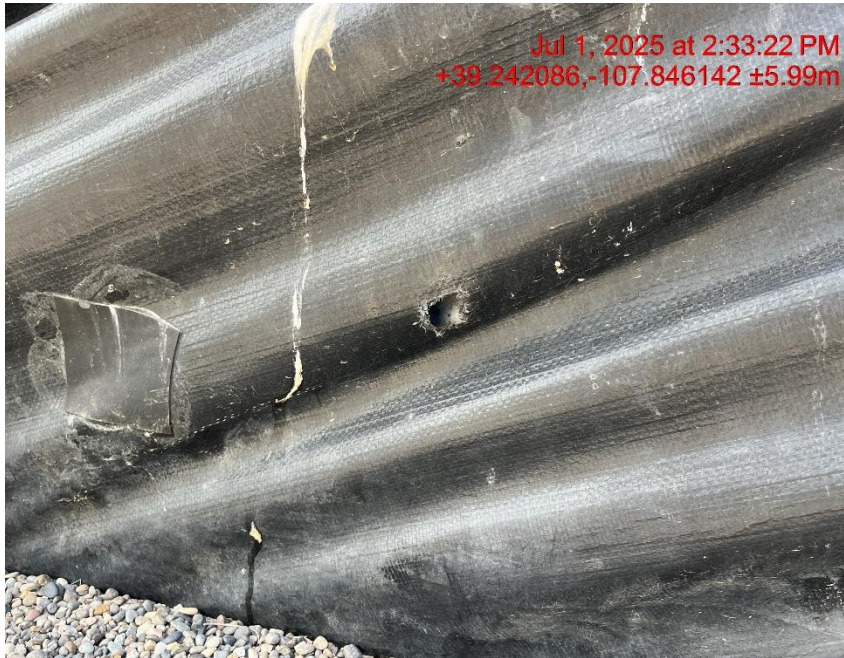
Photo # 9353 Multiple holes in secondary containment liner/liner needs maintenance

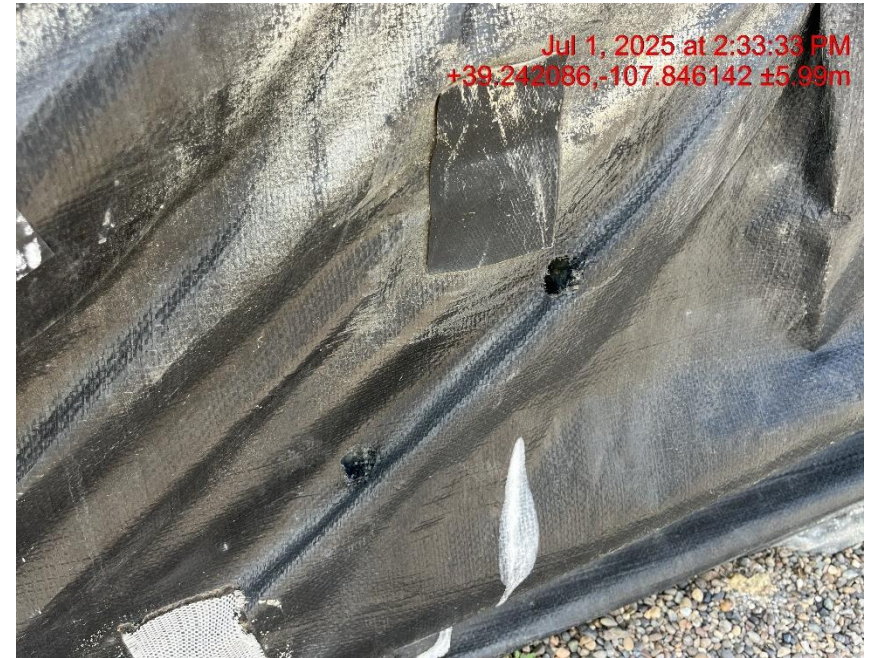
Photo # 9354 Multiple holes in secondary containment liner/liner needs maintenance

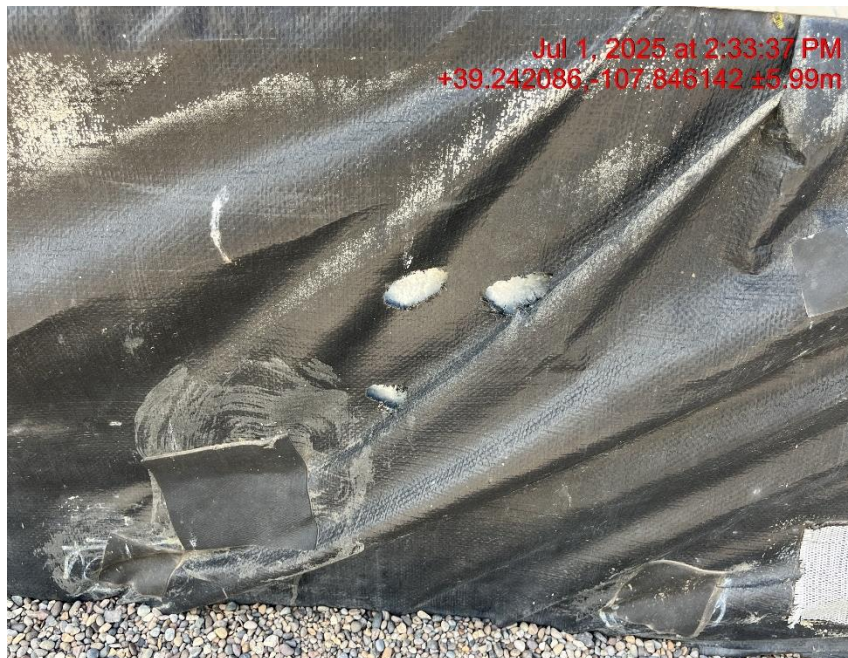
Photo # 9355 Multiple holes in secondary containment liner/liner needs maintenance

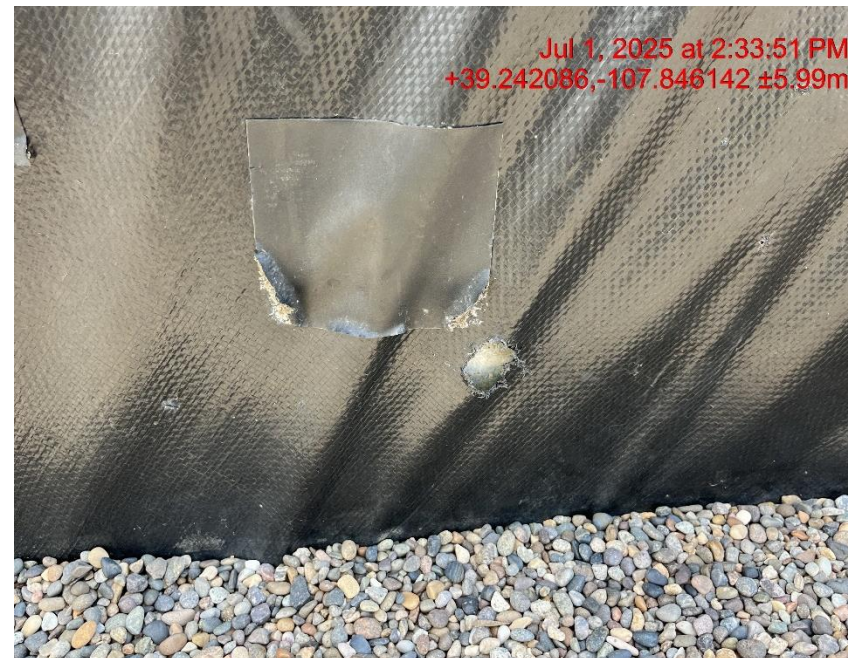
Photo # 9356 Multiple holes in secondary containment liner/liner needs maintenance

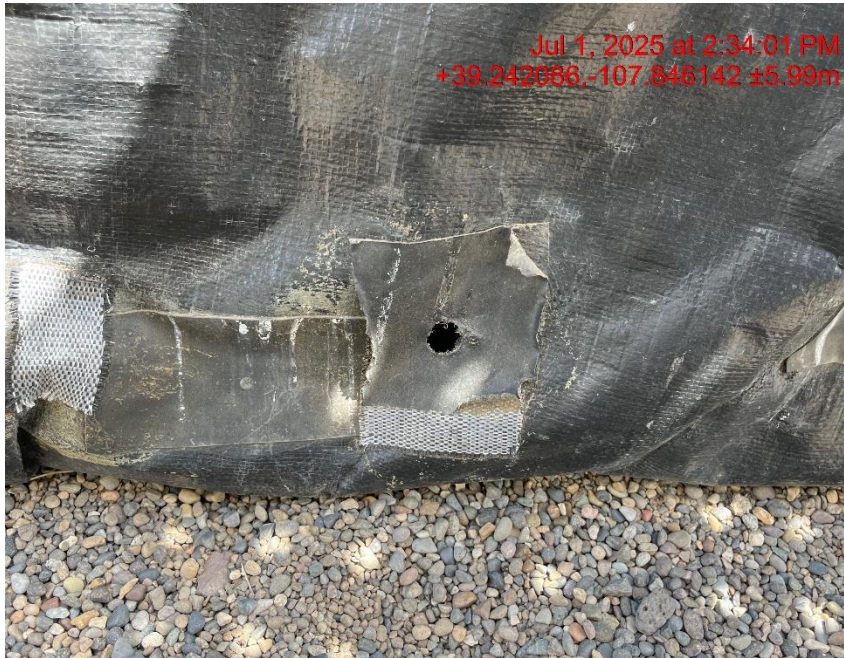
Photo # 9357 Multiple holes in secondary containment liner/liner needs maintenance

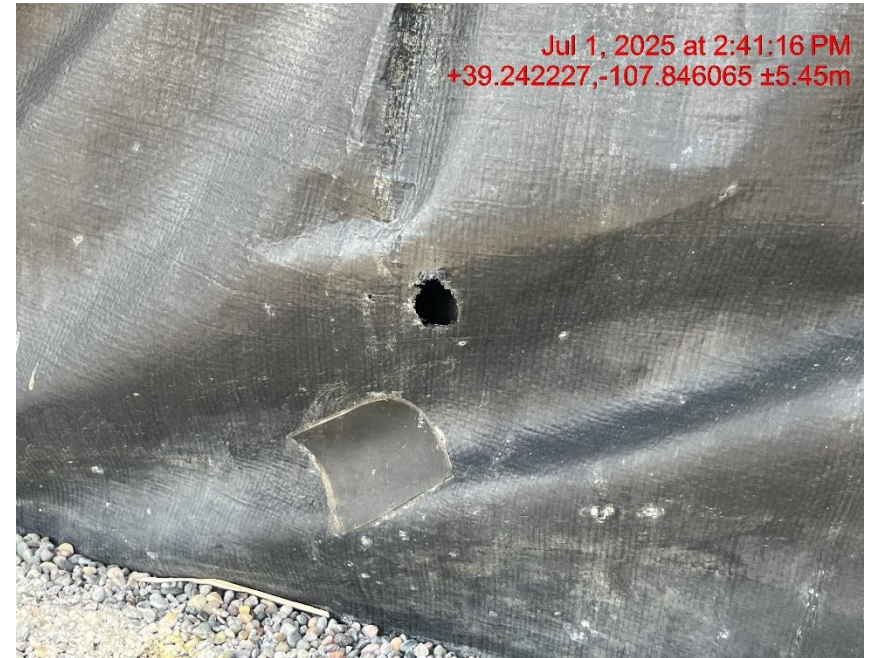
Photo # 9366 Multiple holes in secondary containment liner/liner needs maintenance

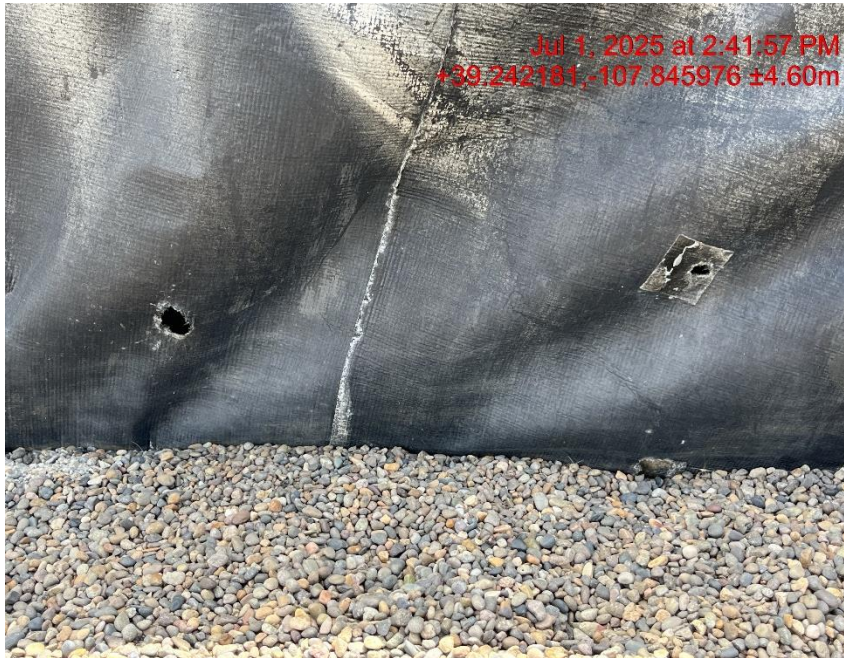
Photo # 9367 Multiple holes in secondary containment liner/liner needs maintenance

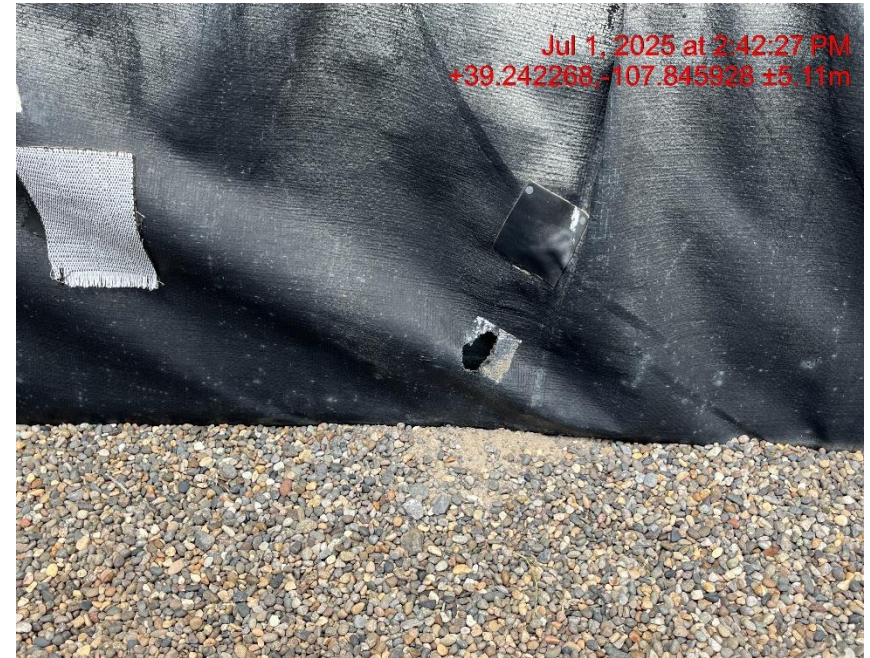
Photo # 9368 Multiple holes in secondary containment liner/liner needs maintenance

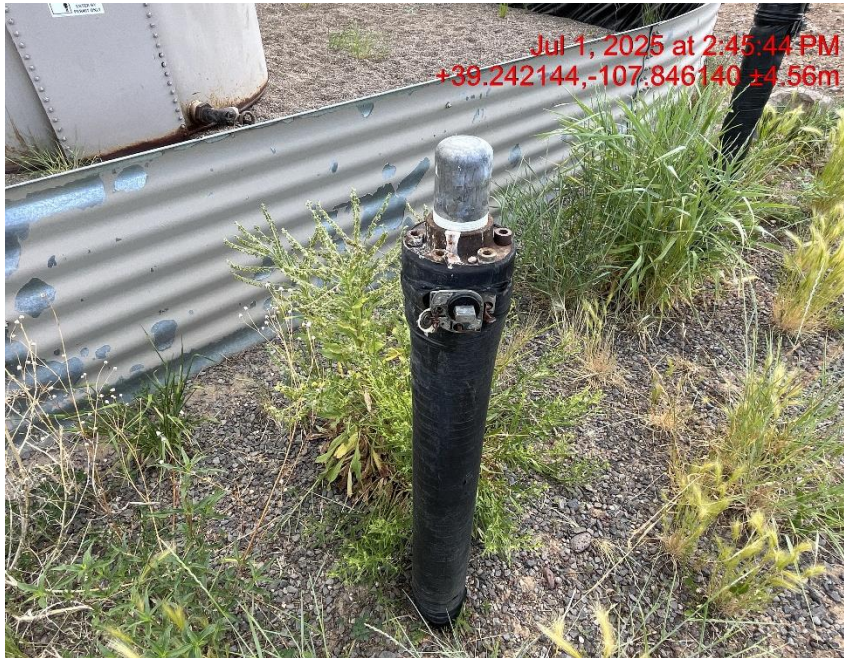
Photo # 9371 Unused flowline does not comply with CECMC 600 & 1100 series rules

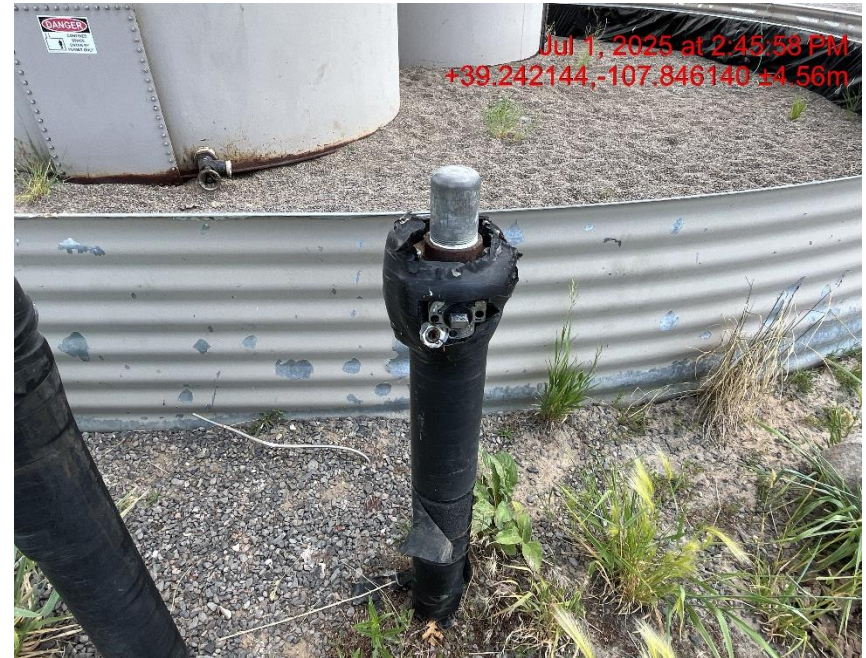
Photo # 9372 Unused flowline does not comply with CECMC 600 & 1100 series rules

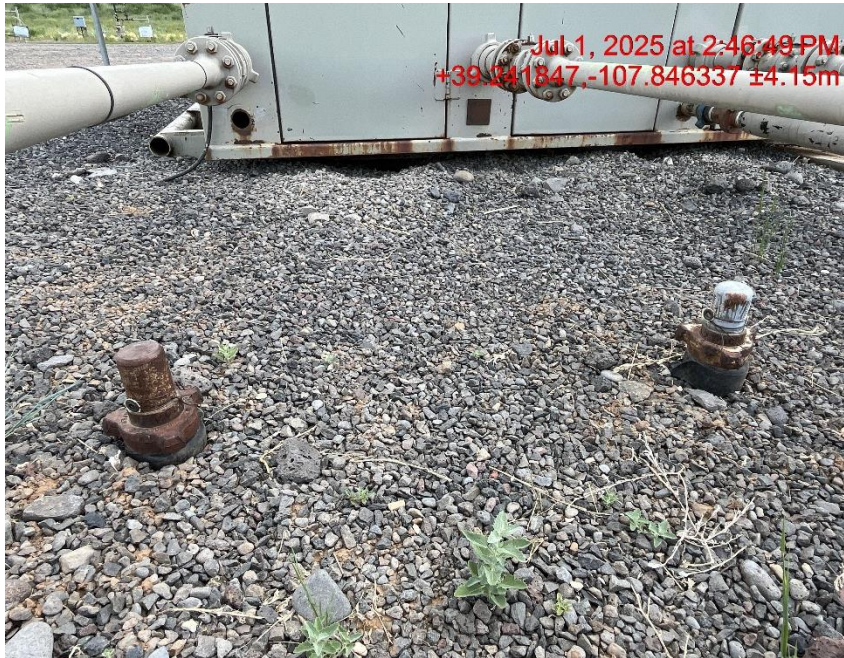
Photo # 9373 Multiple unused flowlines do not comply with CECMC 600 & 1100 series rules

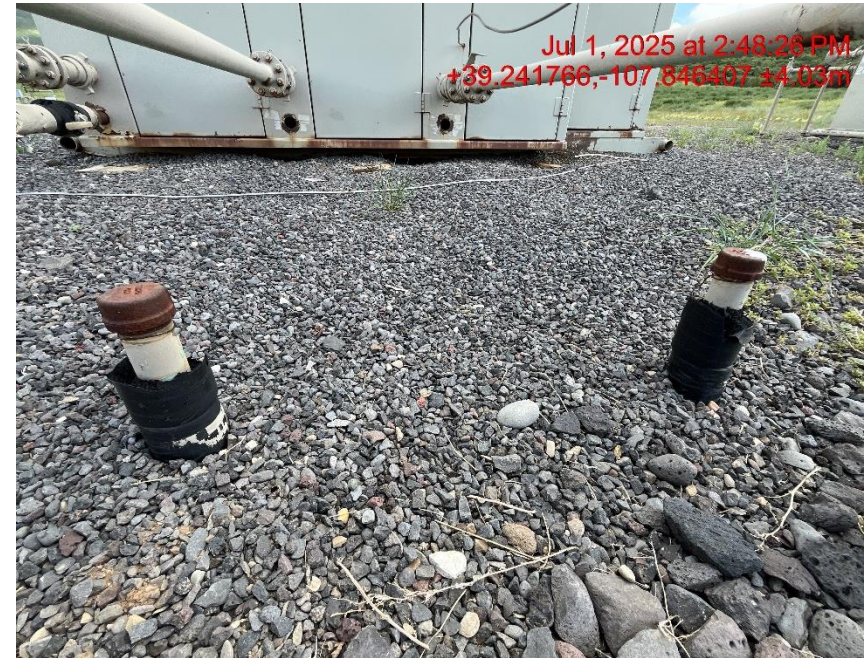
Photo # 9374 Multiple unused flowlines do not comply with CECMC 600 & 1100 series rules

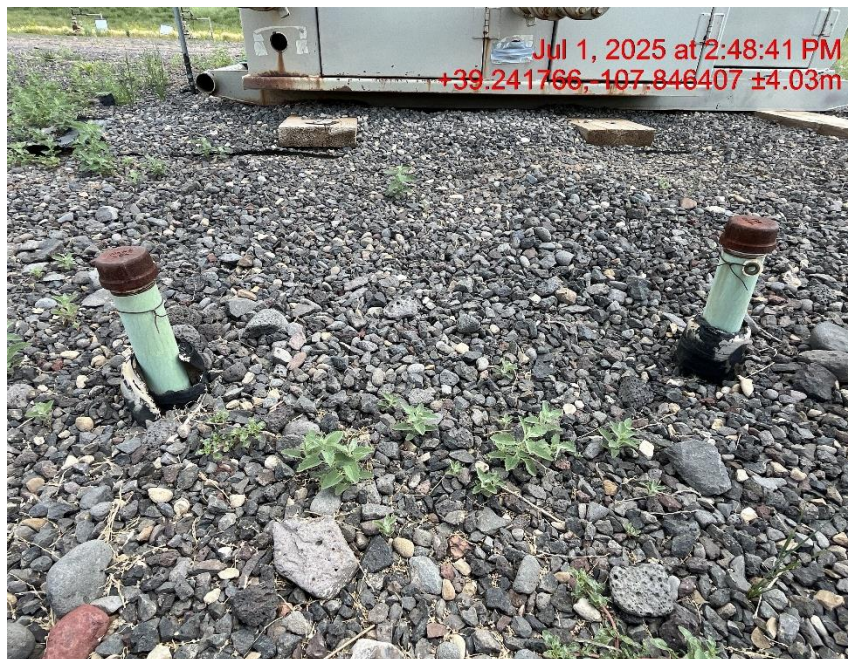
Photo # 9375 Multiple unused flowlines do not comply with CECMC 600 & 1100 series rules

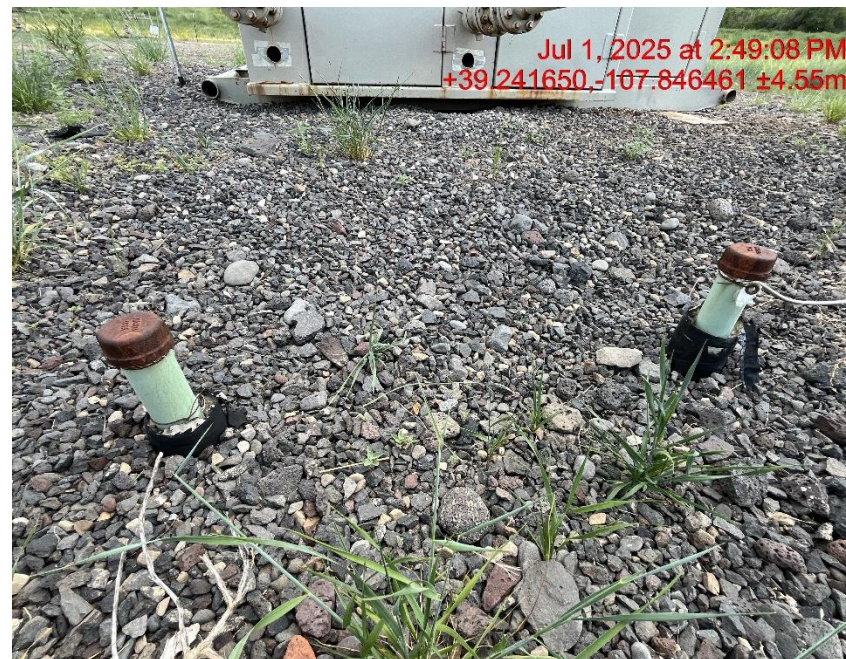
Photo # 9376 Multiple unused flowlines do not comply with CECMC 600 & 1100 series rules

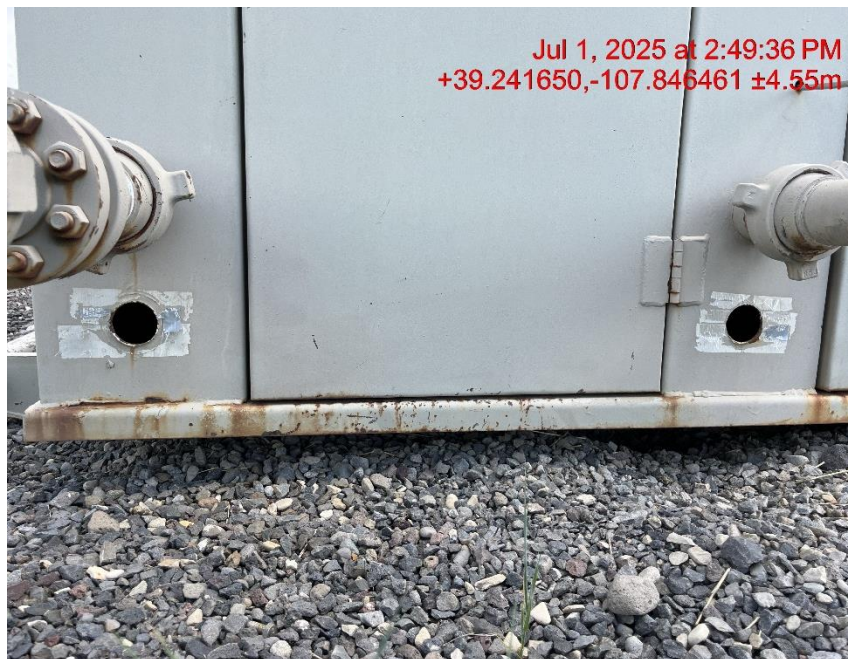
Photo # 9377 Multiple holes in separator buildings open to wildlife/ available for entry by wildlife

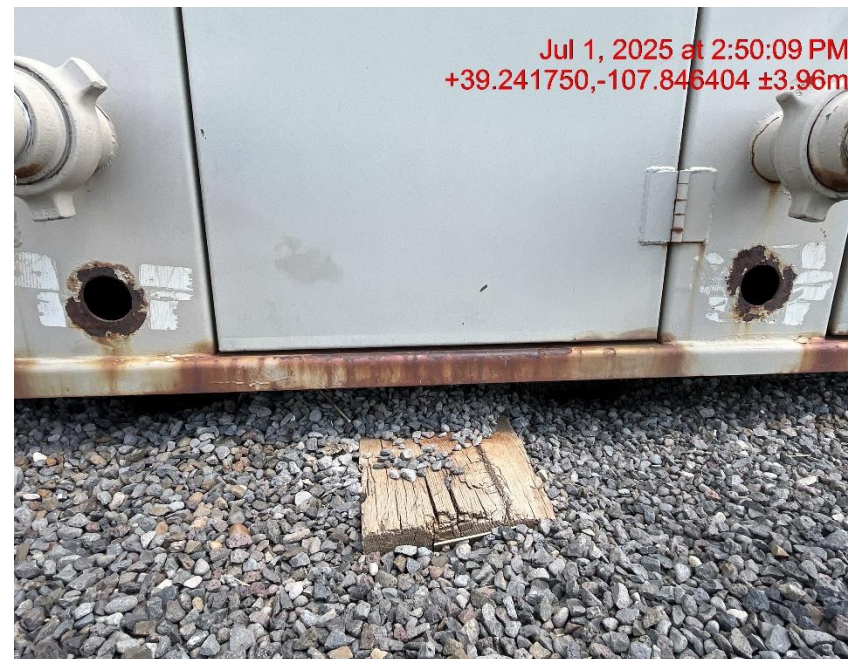
Photo # 9378 Multiple holes in separator buildings open to wildlife/ available for entry by wildlife

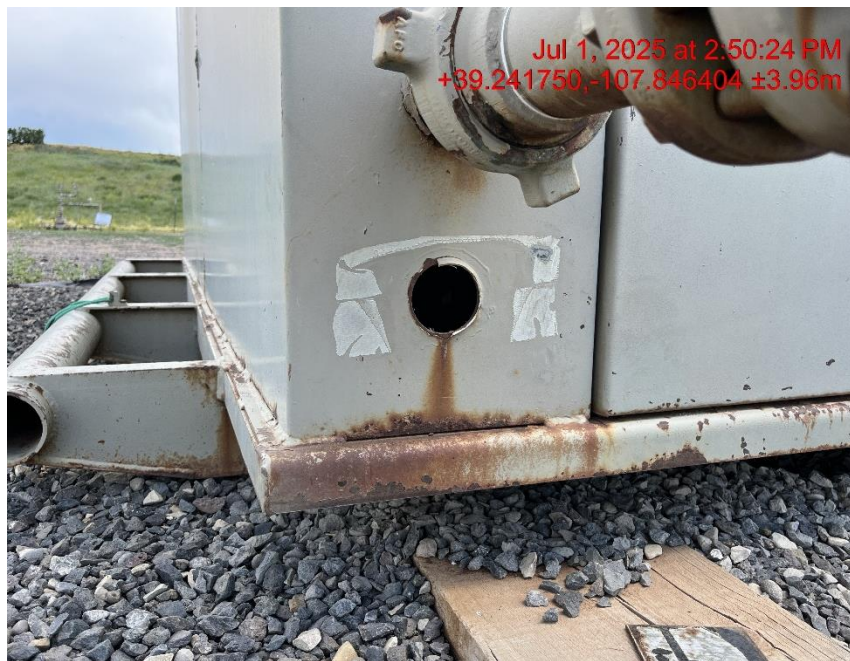
Photo # 9379 Hole in separator building/wildlife hazard/available for entry by wildlife

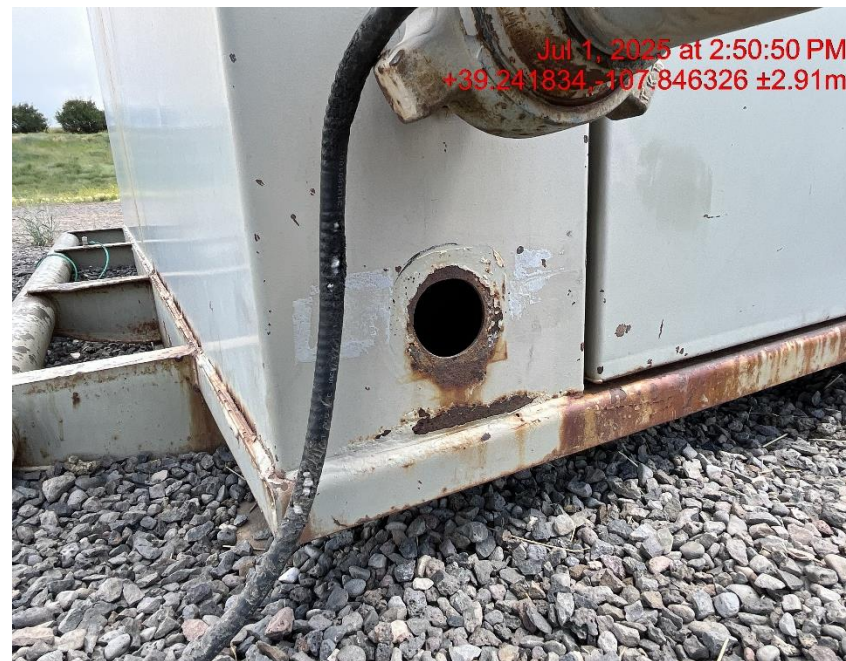
Photo # 9380 Hole in separator building/wildlife hazard/available for entry by wildlife

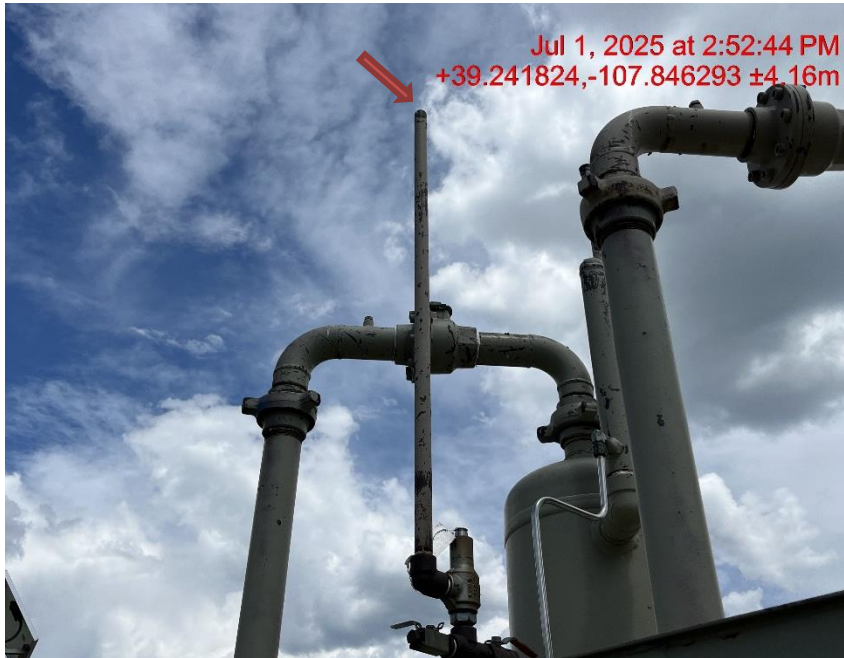
Photo # 9381 PRV vent line does not comply with CECMC pressure safety device rules

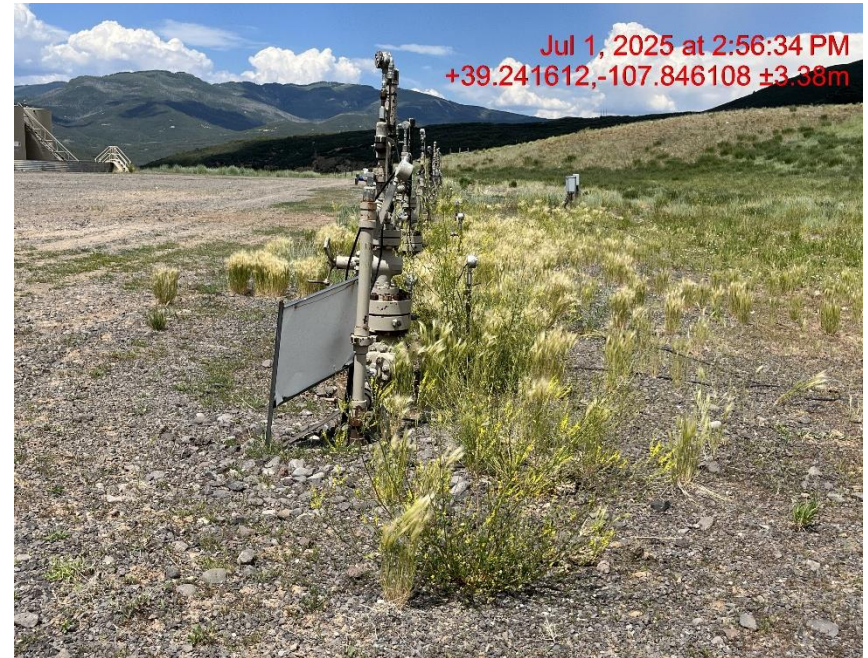
Photo # 9384 Weeds/undesirable plant species surrounding production equipment constitutes a fire hazard

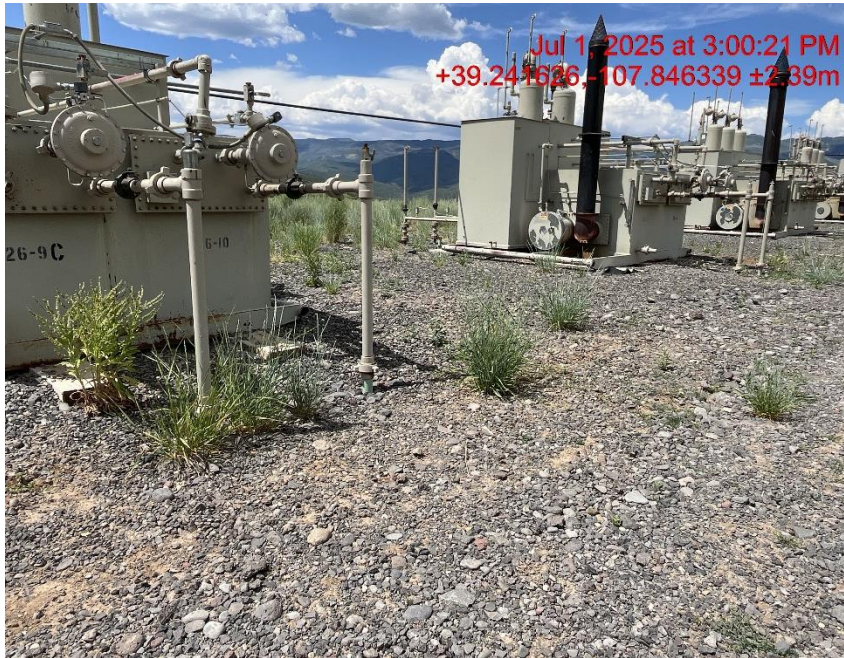
Photo # 9387 Weeds/undesirable plant species surrounding production equipment constitutes a fire hazard

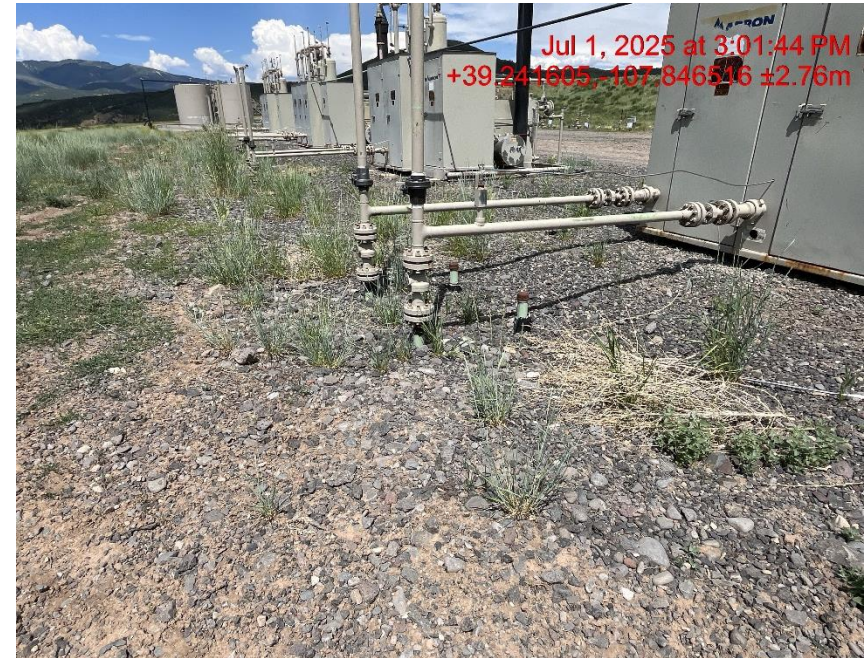
Photo # 9389 Weeds/undesirable plant species surrounding production equipment constitutes a fire hazard

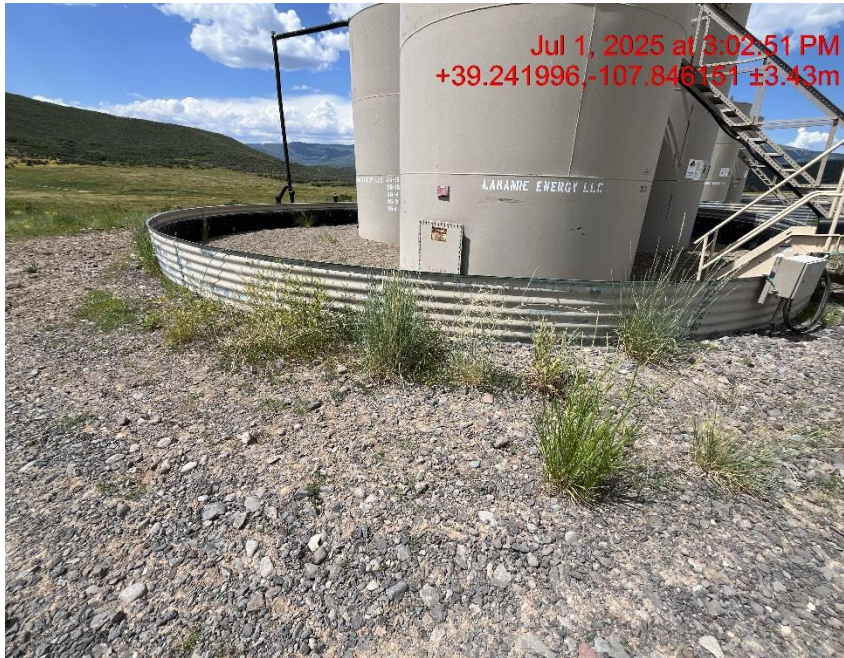
Photo # 9392 Weeds/undesirable plant species surrounding production equipment constitutes a fire hazard

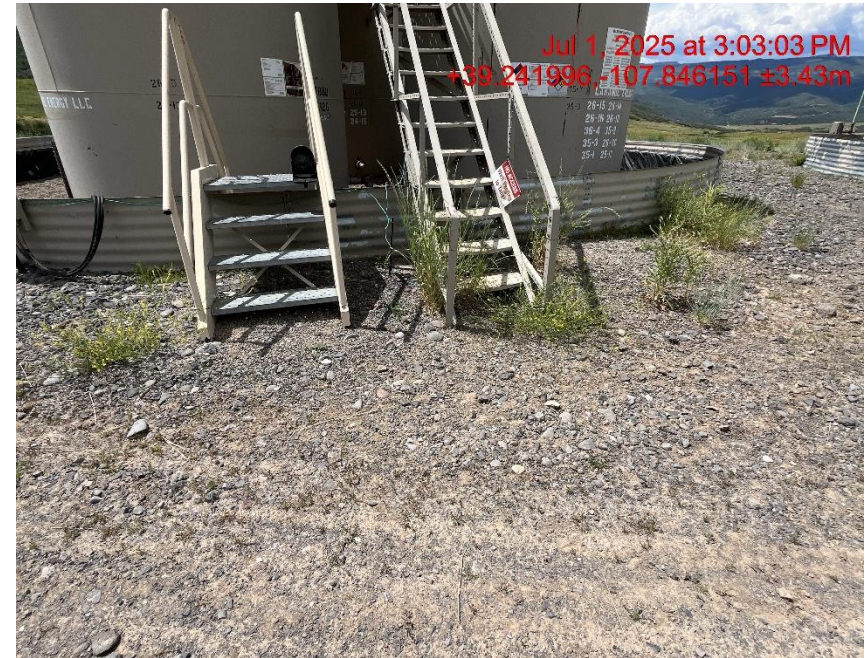
Photo # 9393 Weeds/undesirable plant species surrounding production equipment constitutes a fire hazard

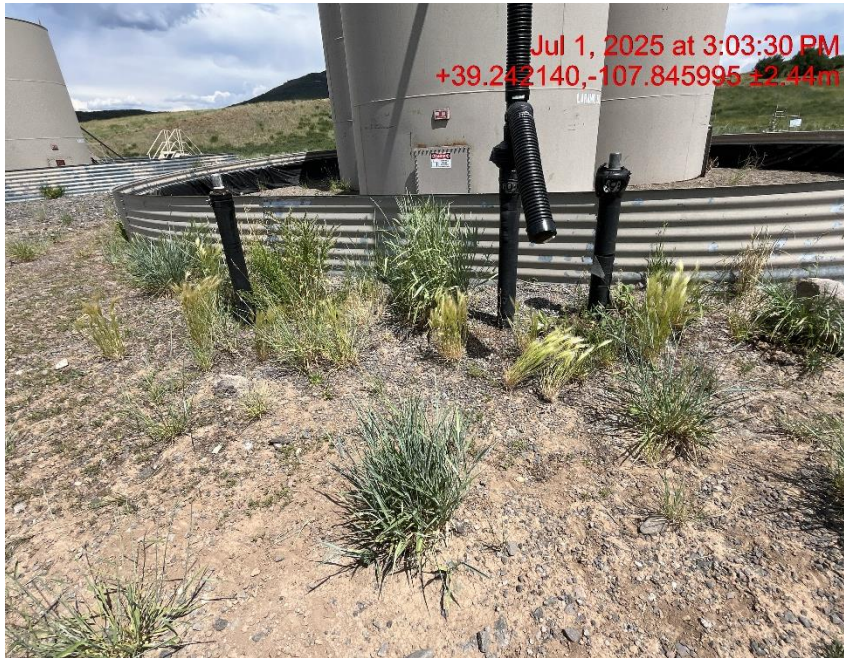
Photo # 9395 Weeds/undesirable plant species surrounding production equipment constitutes a fire hazard

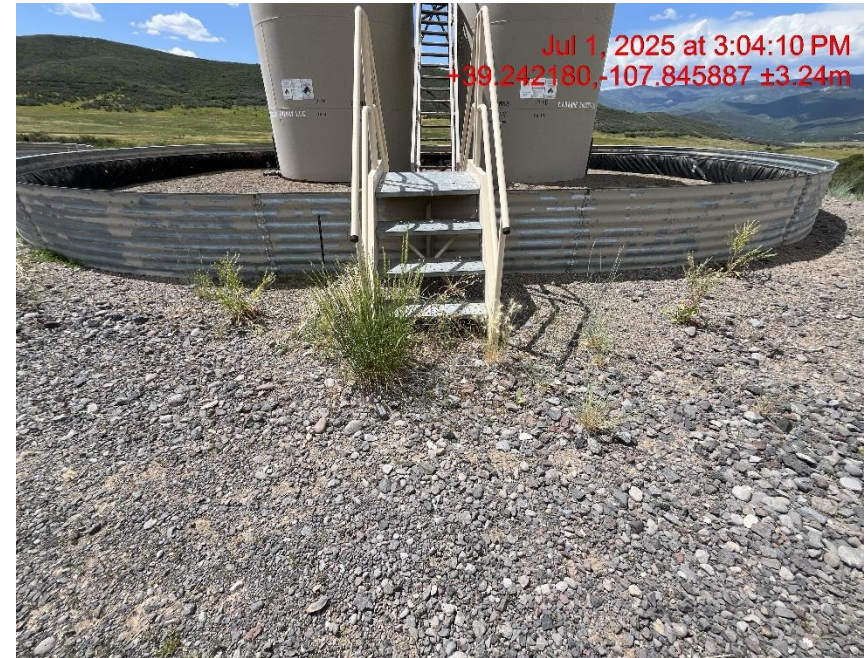
Photo # 9396 Weeds/undesirable plant species surrounding production equipment constitutes a fire hazard

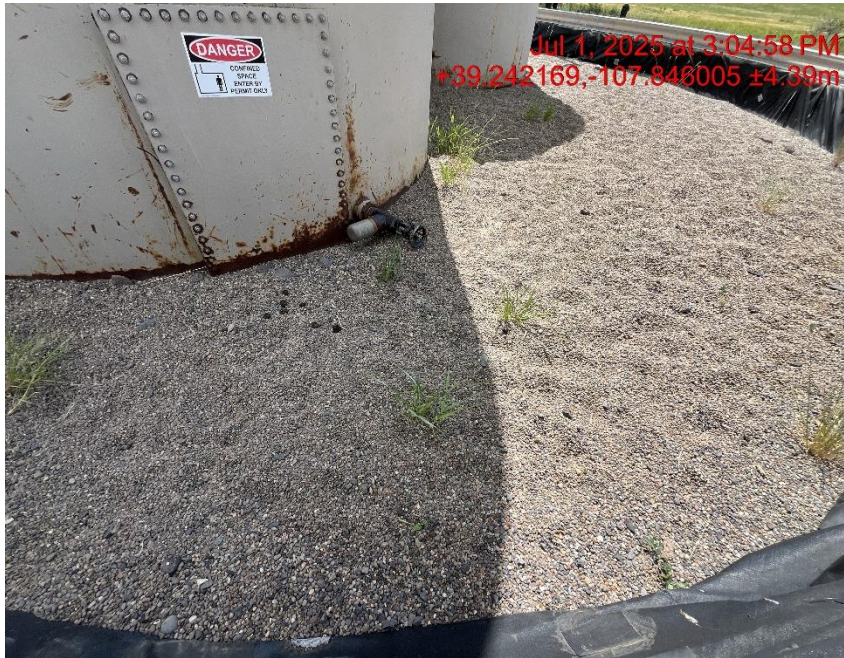
Photo # 9398 Weeds/undesirable plant species surrounding production equipment constitutes a fire hazard

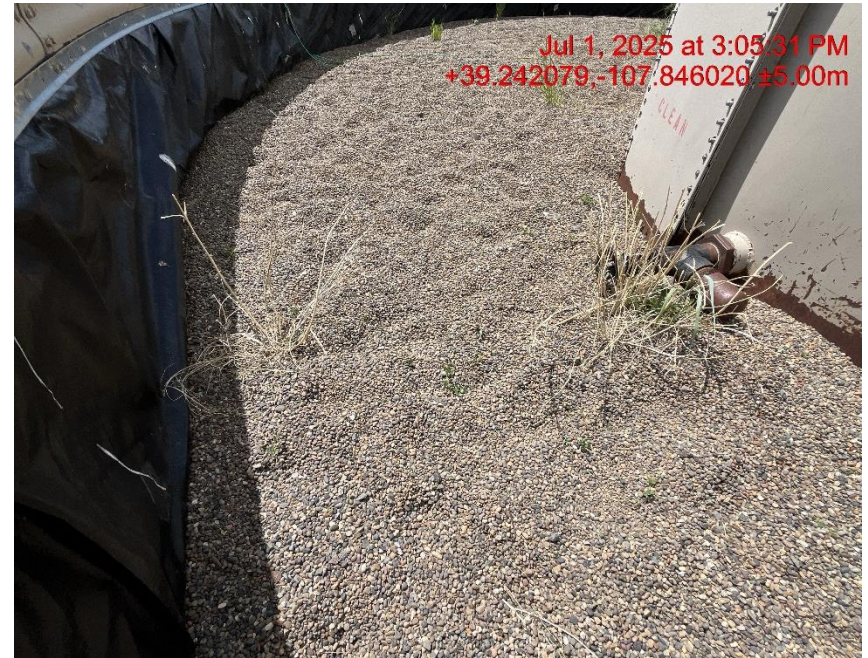
Photo # 9399 Weeds/undesirable plant species surrounding production equipment constitutes a fire hazard

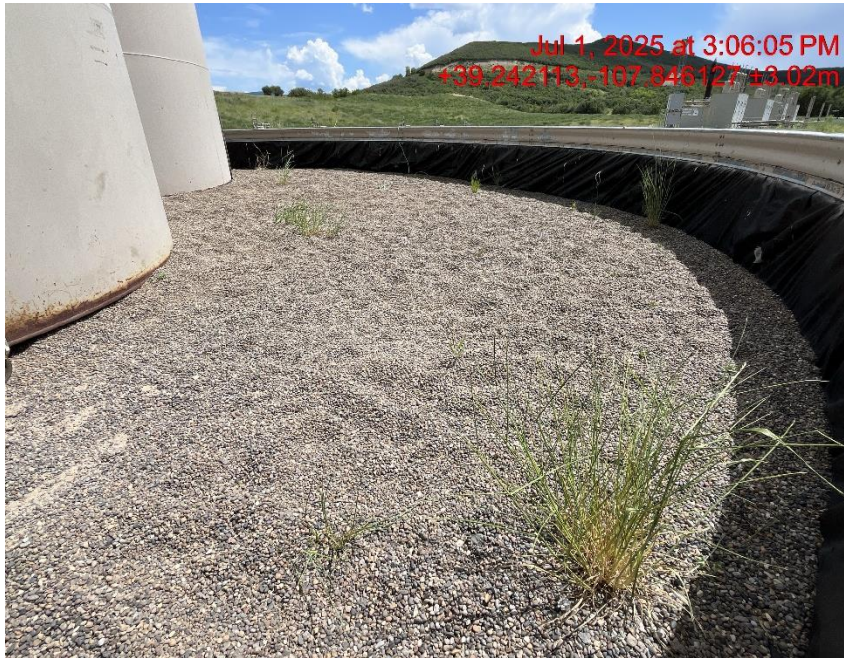
Photo # 9400 Weeds/undesirable plant species surrounding production equipment constitutes a fire hazard

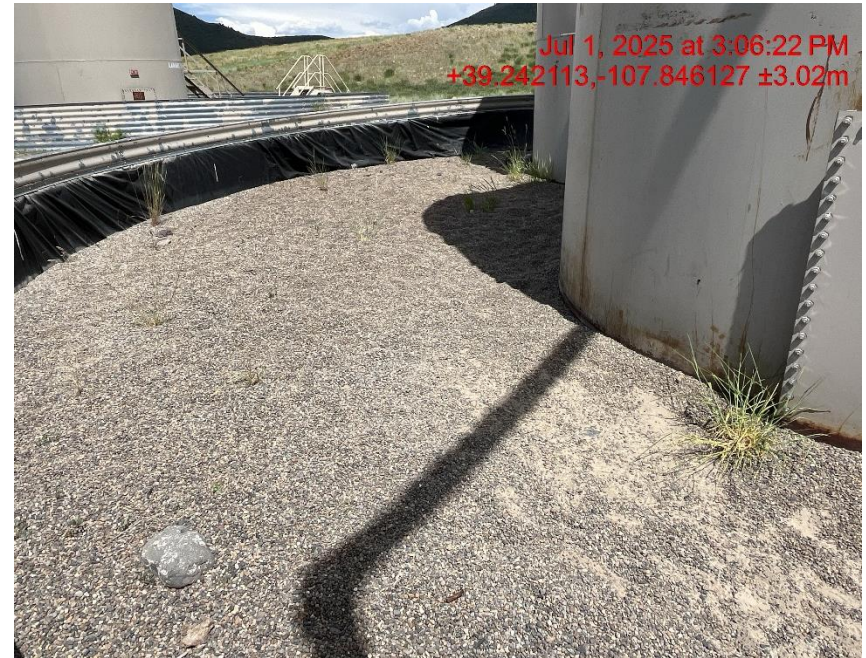
Photo # 9401 Weeds/undesirable plant species surrounding production equipment constitutes a fire hazard
