Stormwater Inspection

July 1, 2025

Operator: NOBLE ENERGY INC - #100322

Location ID: 483510

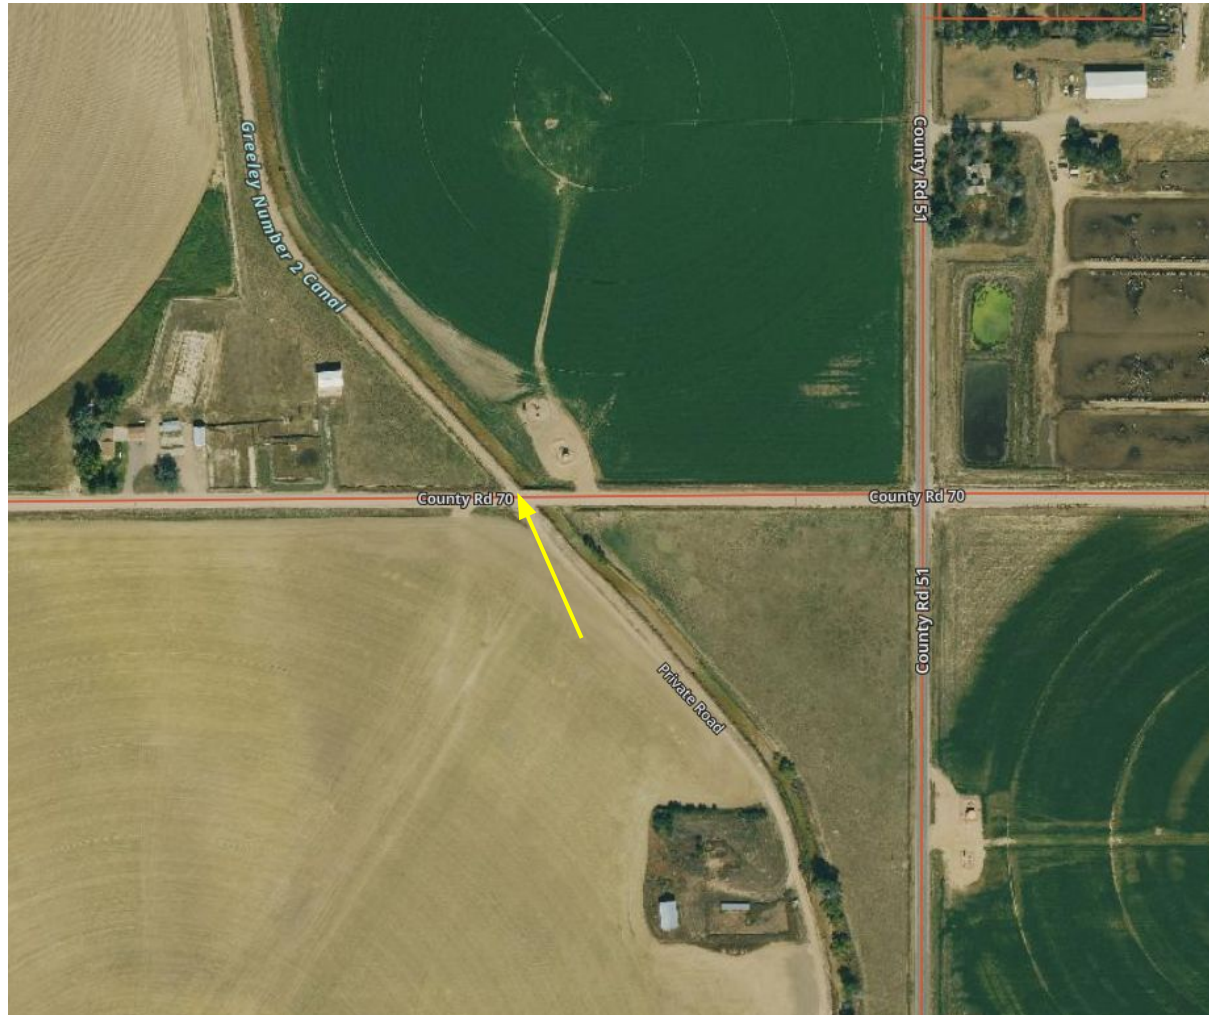
Photo 1. Aerial imagery illustrates an area along the Greeley #2 Canal road & CR 70 with stormwater compliance issues (yellow arrow). See Photos 2-3.

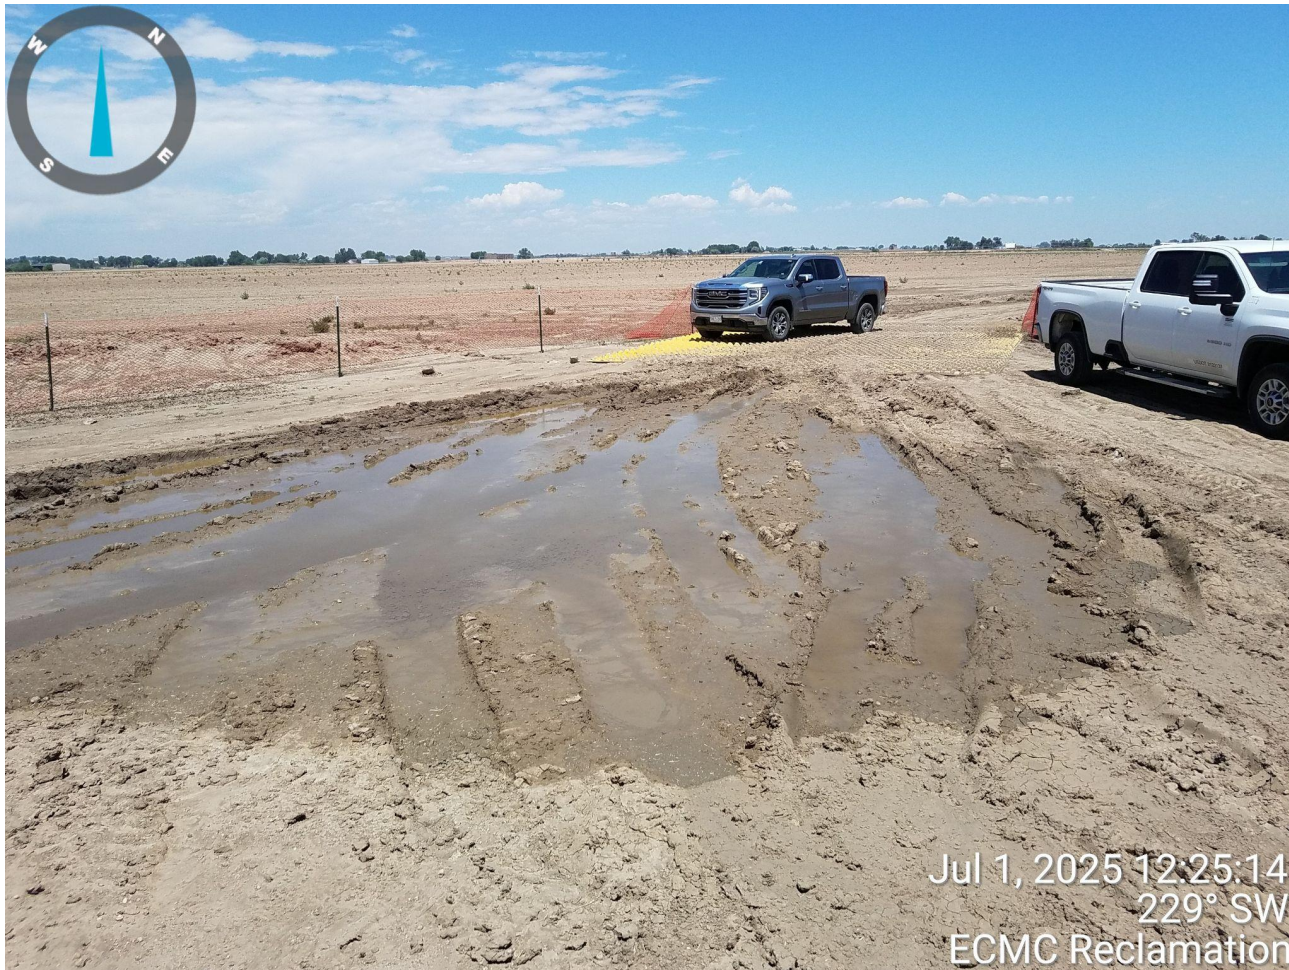
Photo 2. Photo taken from the entrance of the Greeley #2 Canal road, facing North. Photo illustrates what appears to be stormwater run-on from County Road 70. Operator has a vehicle tracking device BMP in need of maintenance (yellow mat); however, this BMP alone is not sufficient to prevent vehicle track out onto County Road 70.

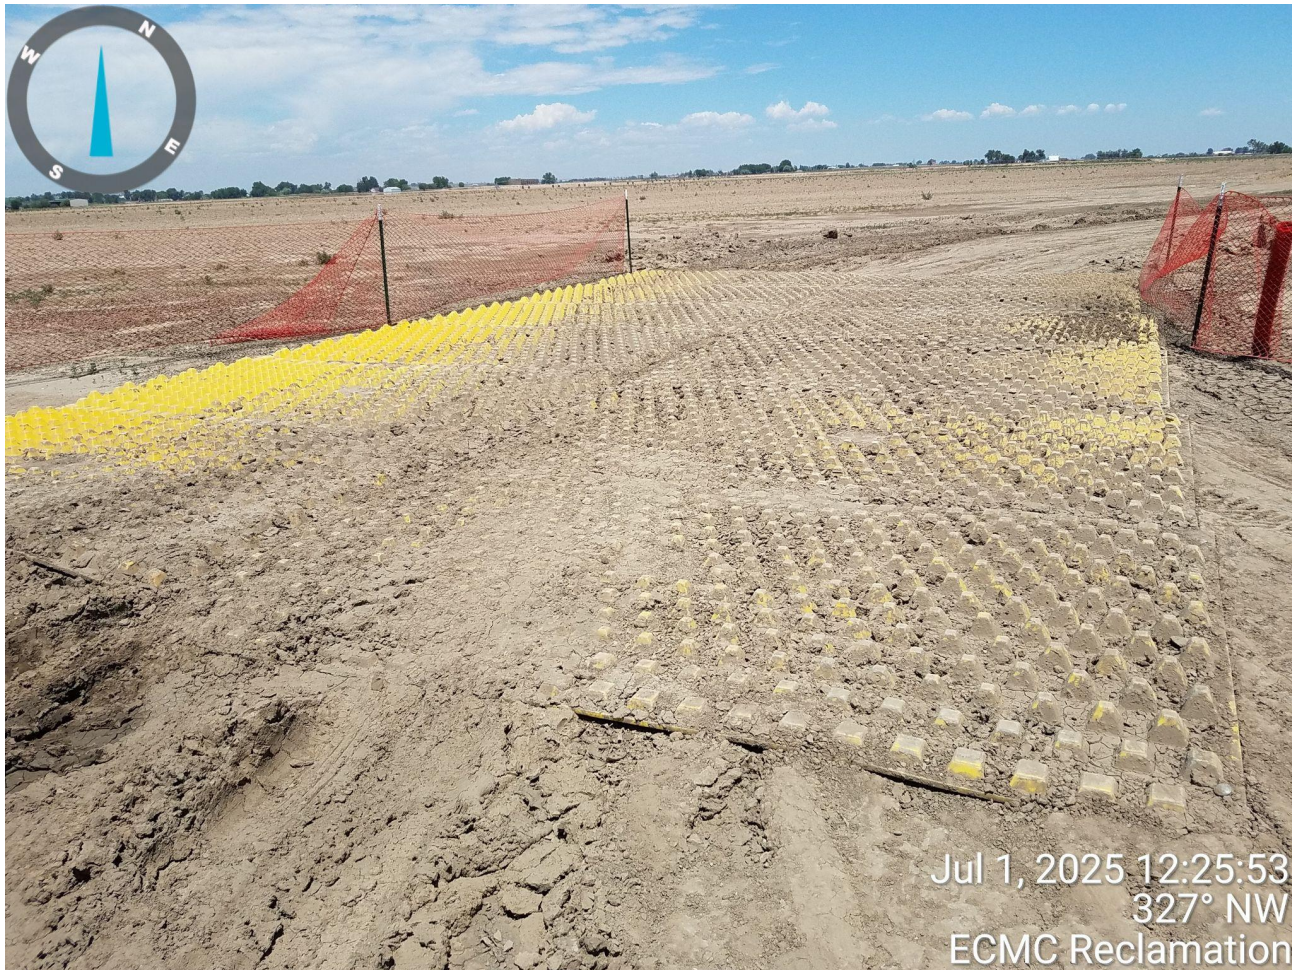
Photo 3. Close up photo taken from the vehicle tracking device BMP in need of maintenance (yellow mat).

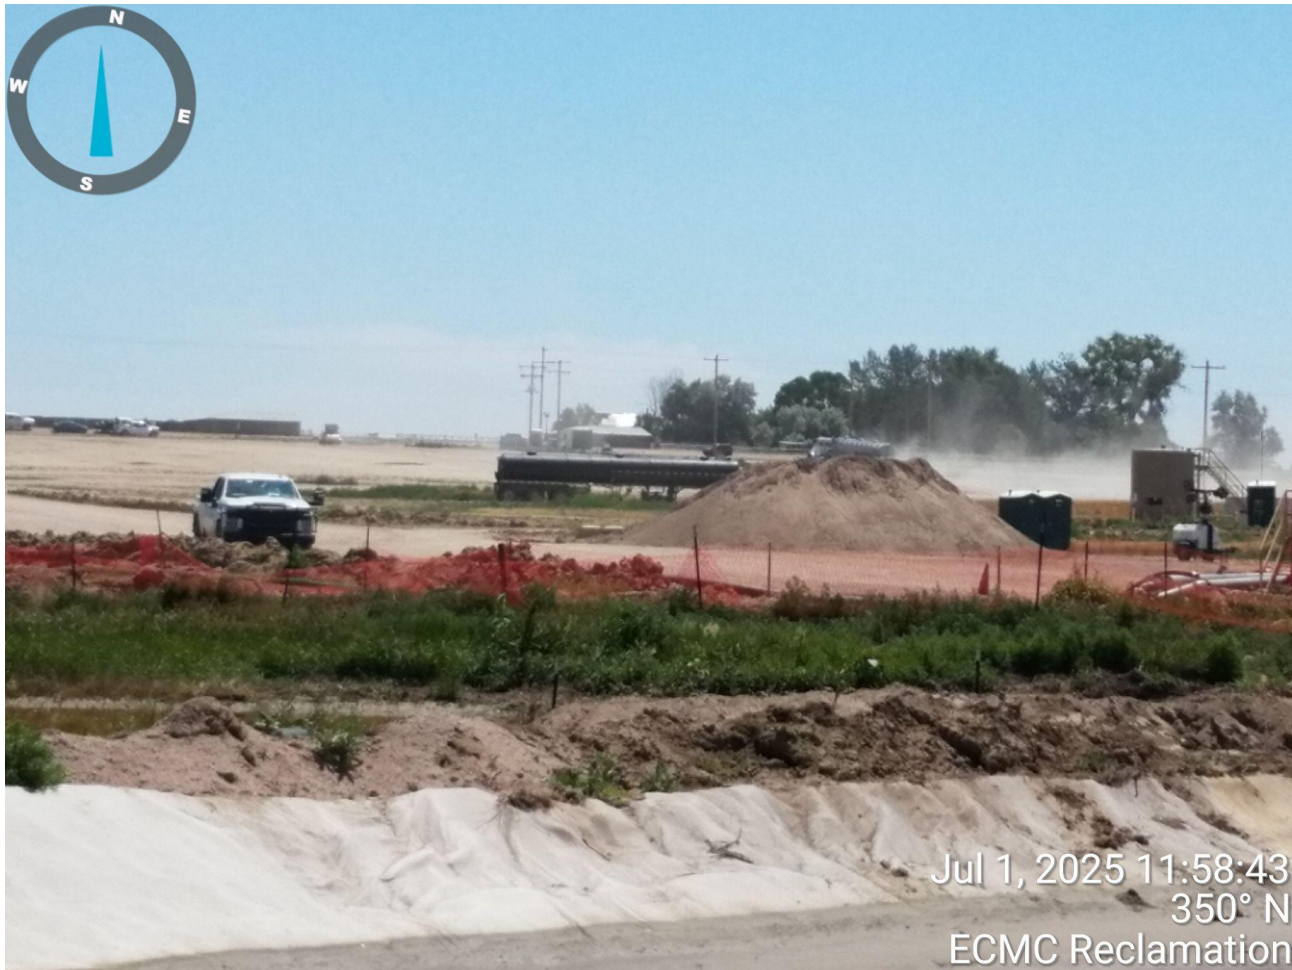
Photo 4. Photo taken from an Operator service truck along a portion of the main location access road, facing East. Photo illustrates fugitive dust from the service truck which needs to be controlled.

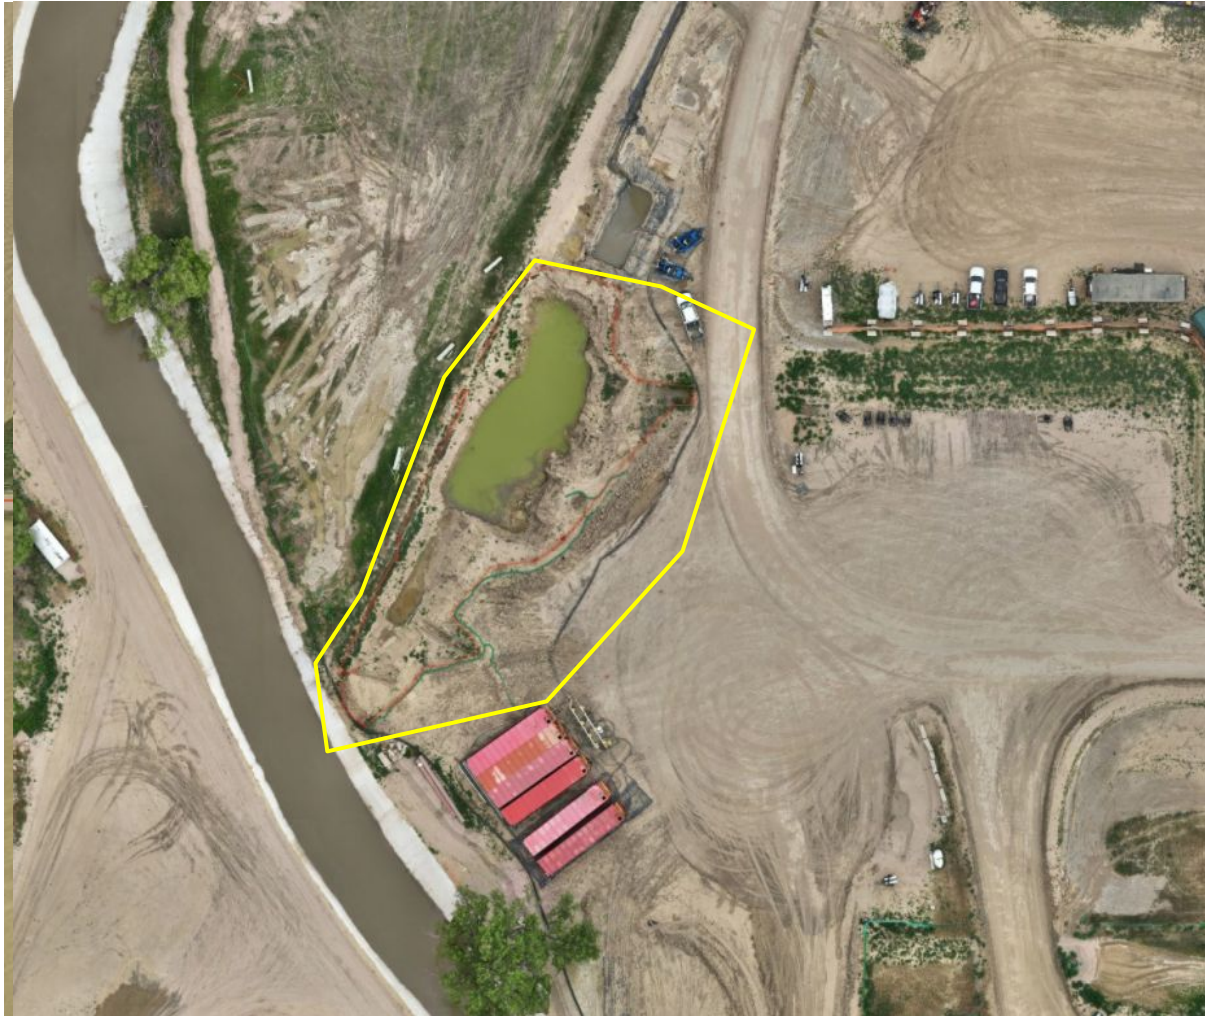
Photo 5. ECMC drone aerial imagery illustrates the emergency pit areas (yellow area). The southern emergency pit area has insufficient BMPs around unconsolidated bermed material. See Photo 6.

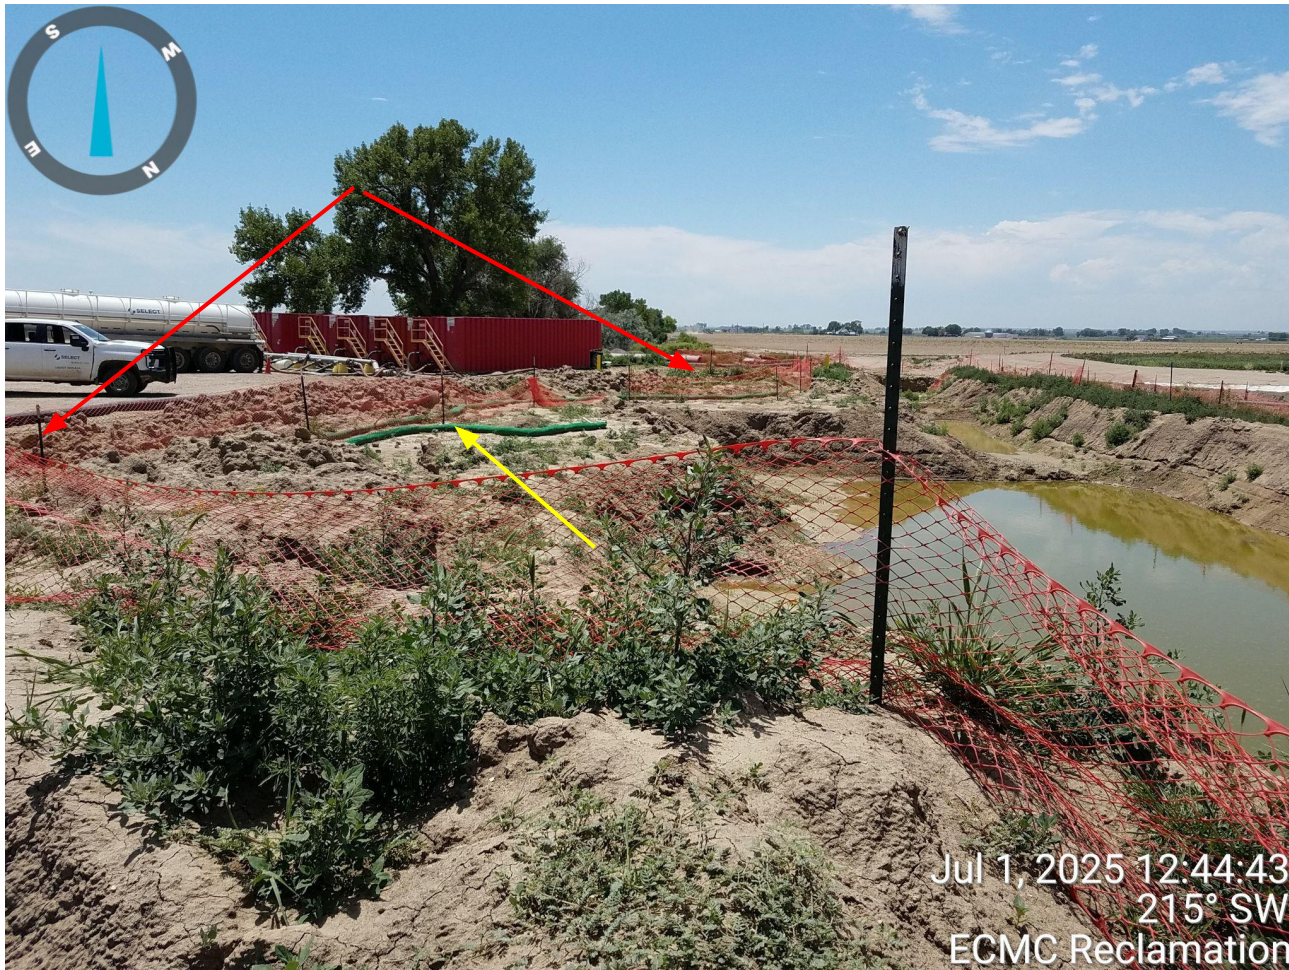
Photo 6. Photo taken from the southern emergency pit, facing South. Operator has a filtrex BMP along portions of the interior unconsolidated berm material that are not in proper functioning condition (yellow arrow) but no BMP along the exterior unconsolidated berm material (red arrows).

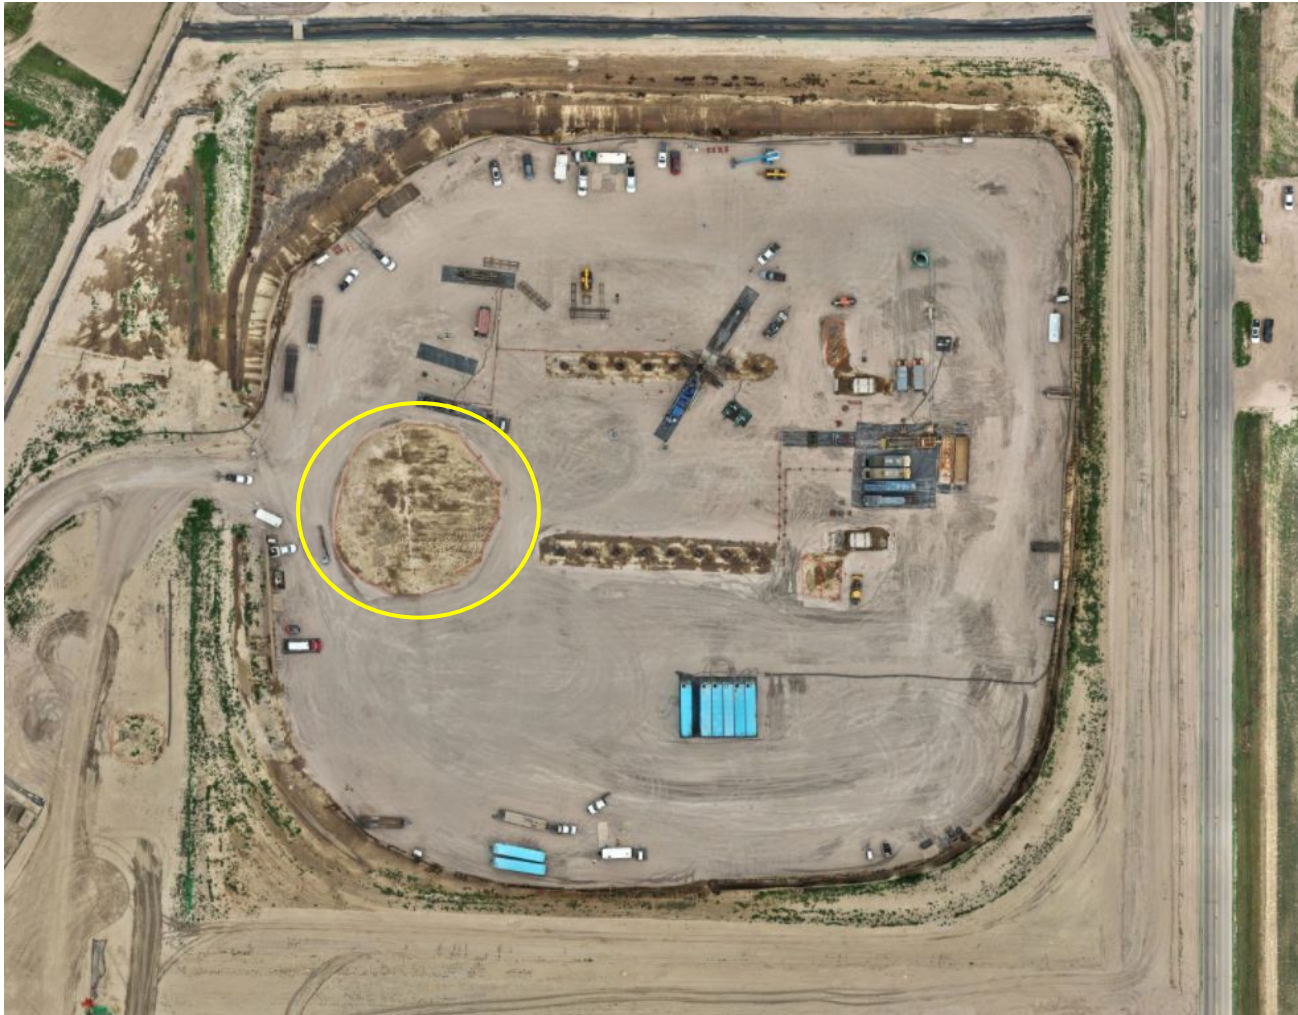
Photo 7. ECMC drone aerial imagery illustrates a wildlife exclusion area (yellow circle) to protect an active Killdeer nest. See Photo 8.

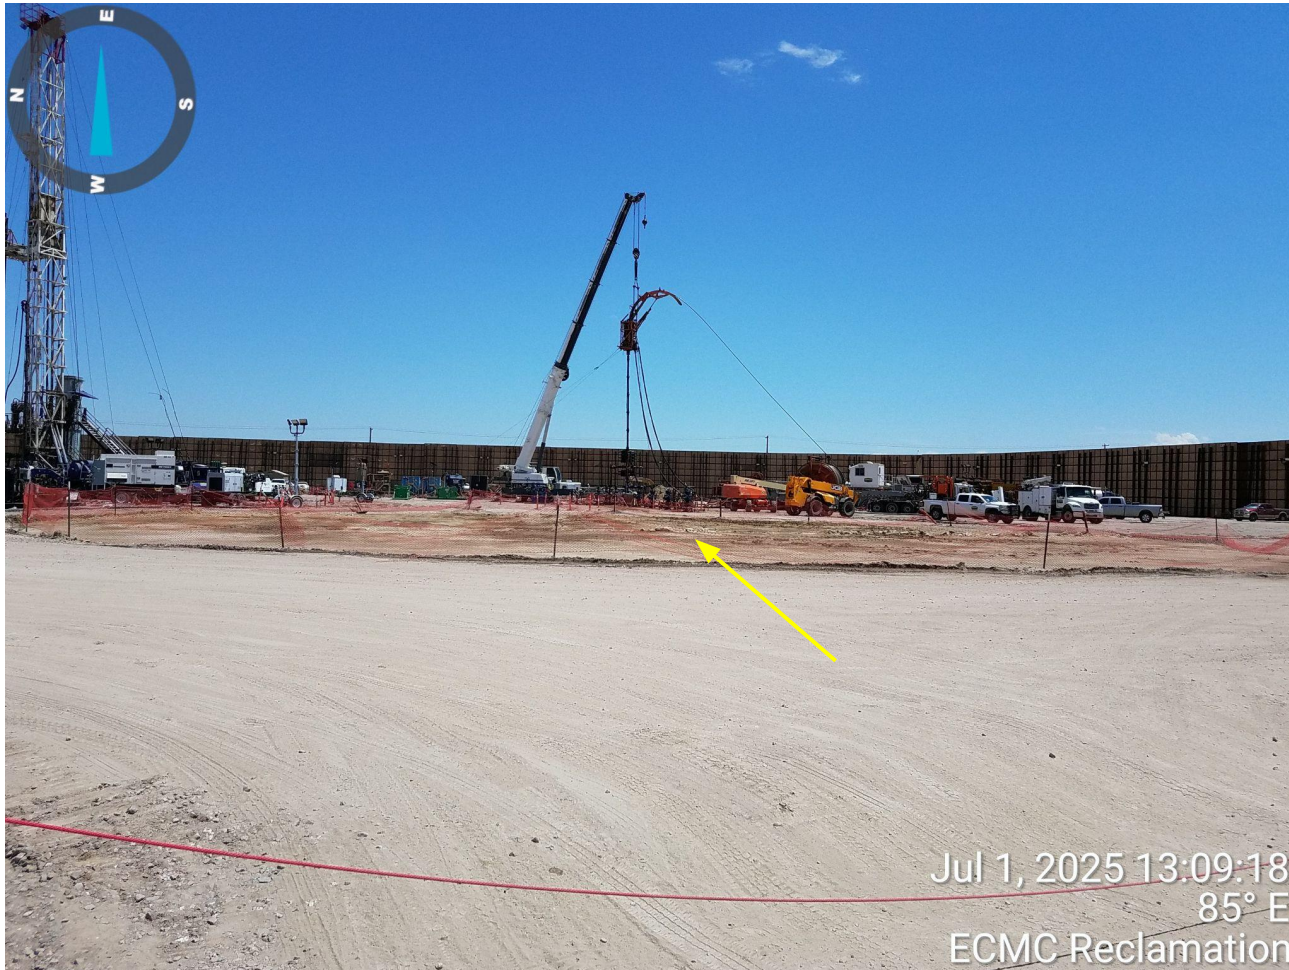
Photo 8. Photo taken from the entrance of the location, facing East. Photo illustrates a wildlife exclusion area to protect an active Killdeer nest (yellow arrow) during active operations.

Note- ~3" of impacted material was removed, excluding the 50' radius Killdeer nest, prior to work-over rig operations; however, the E&P waste source material has not been removed.

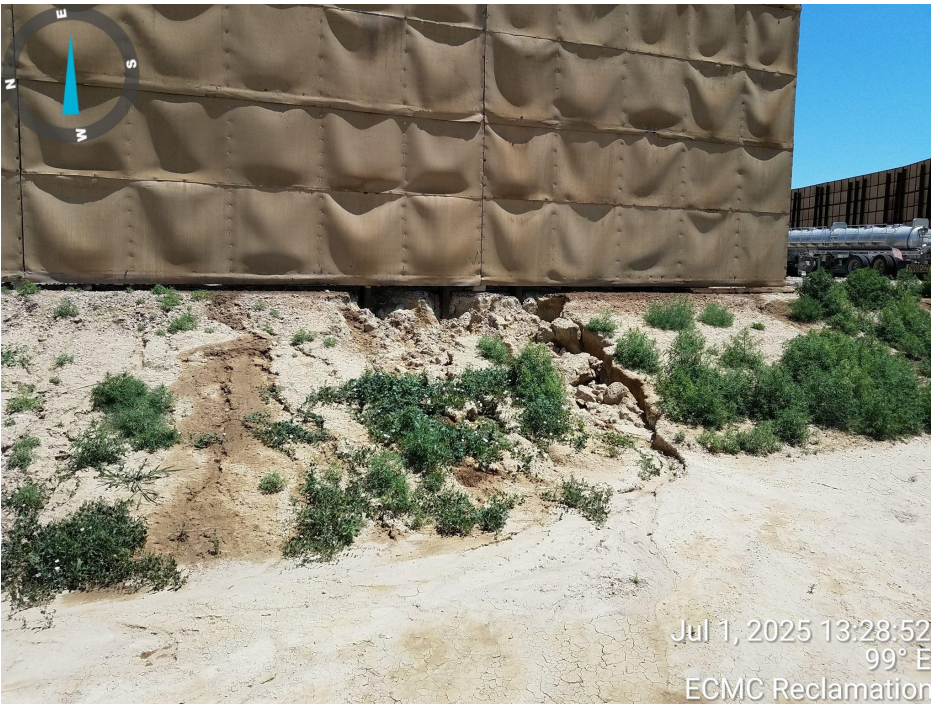
Photo 9. Photo taken from the southwestern fill slope of location, facing East. Photo illustrates gully erosion that was believed to be caused by the initial incident back in April 2025 per information from an Operator representative. Operator has failed to conduct stormwater repairs.

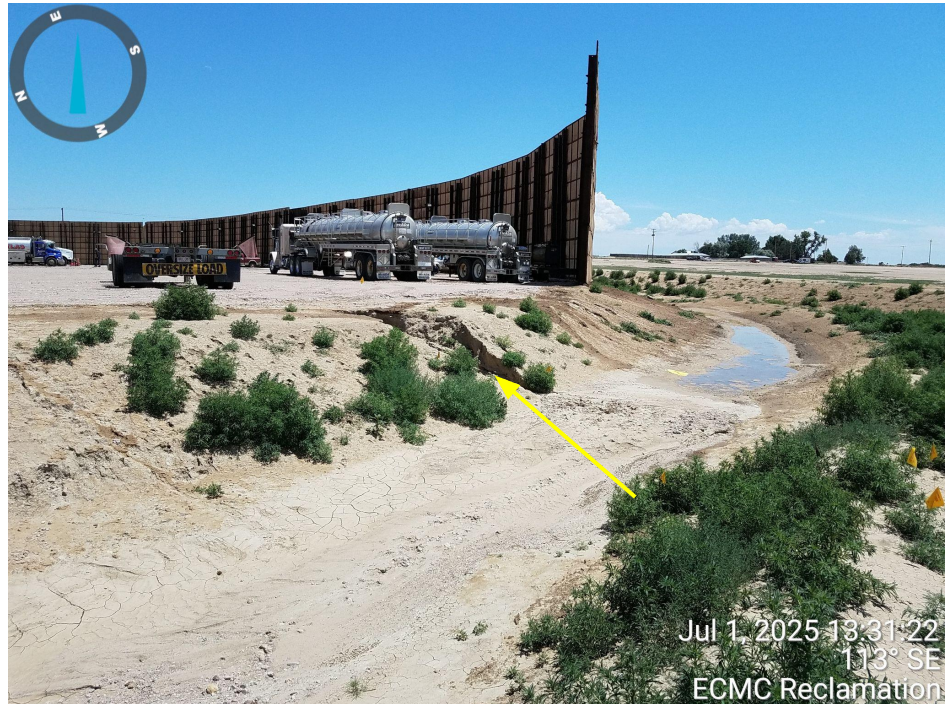
Photo 10. Photo taken from another portion of the southwestern fill slope of location, facing East. See comments under Photo 9.

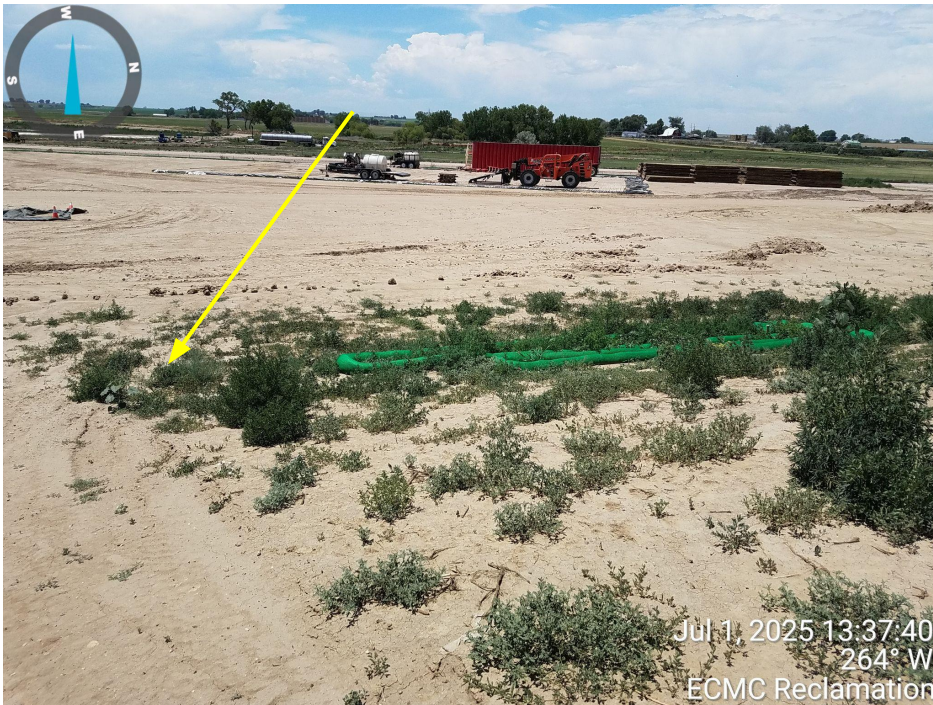
Photo 11. Photo taken from the southwestern perimeter of location along the topsoil stockpile, facing West. Photo illustrates Operator has failed to implement perimeter stormwater BMPs for the topsoil stockpile (yellow arrow).

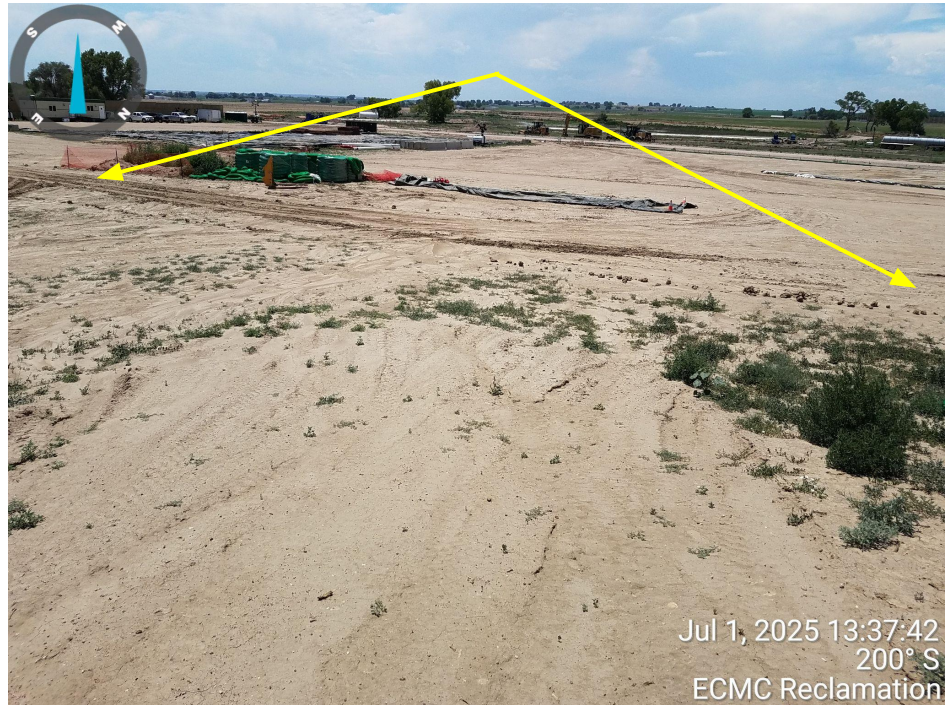
Photo 12. Photo taken from the southwestern perimeter of location along the topsoil stockpile, facing South. Photo illustrates stormwater erosion along the topsoil stockpile without implementing perimeter stormwater BMPs for the topsoil stockpile (yellow arrows).

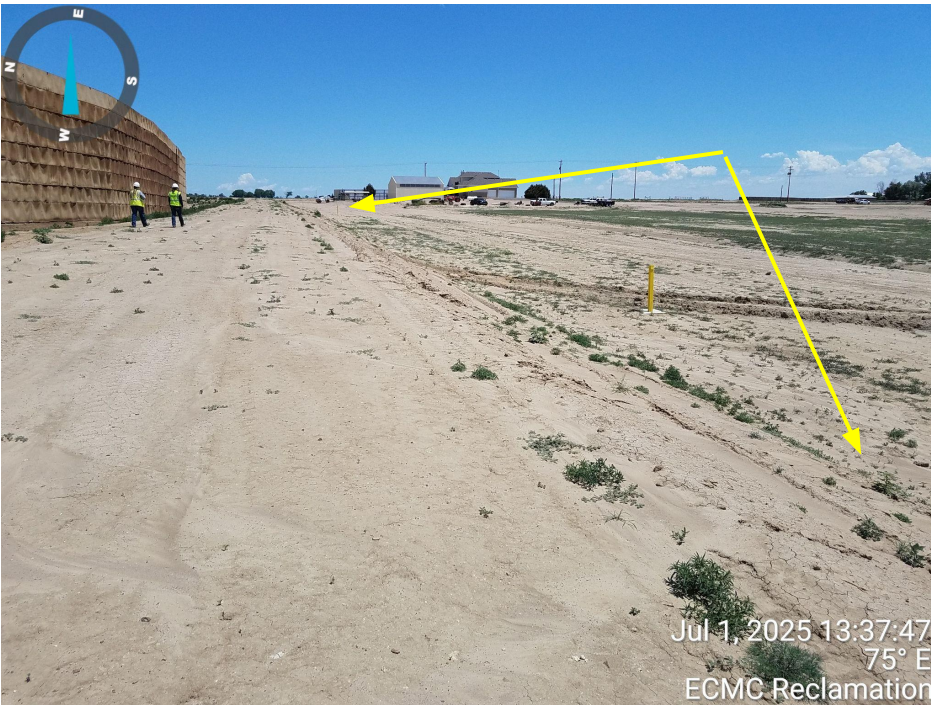
Photo 13. Photo taken from the southwestern perimeter of location along the topsoil stockpile, facing East. See comments under Photo 12.

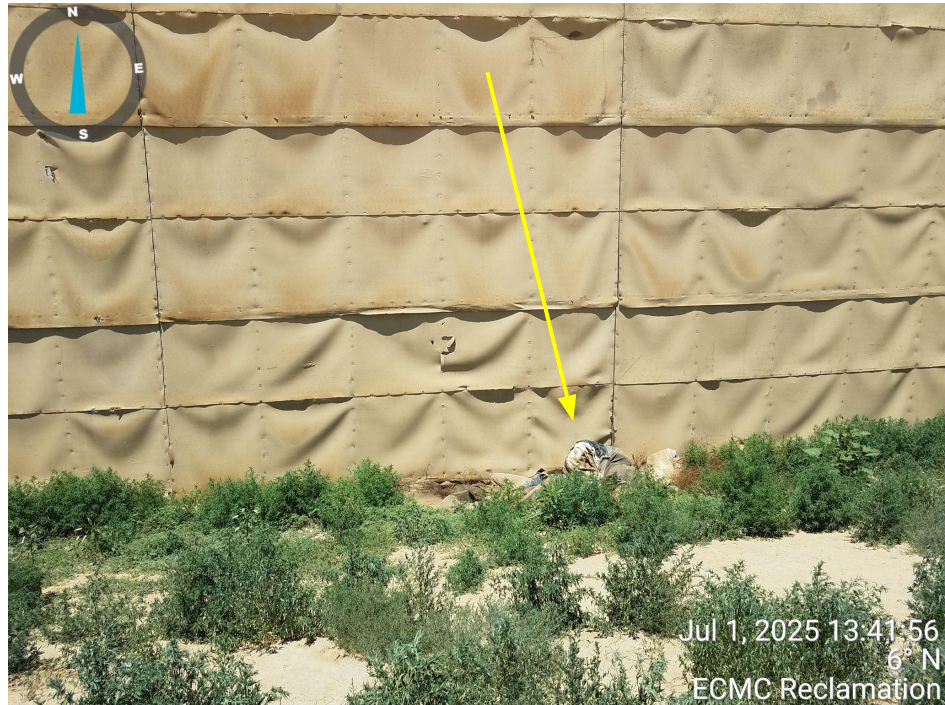
Photo 14. Photo taken from the southern exterior sound wall, facing North. Photo illustrates debris/trash along the base of the sound wall.

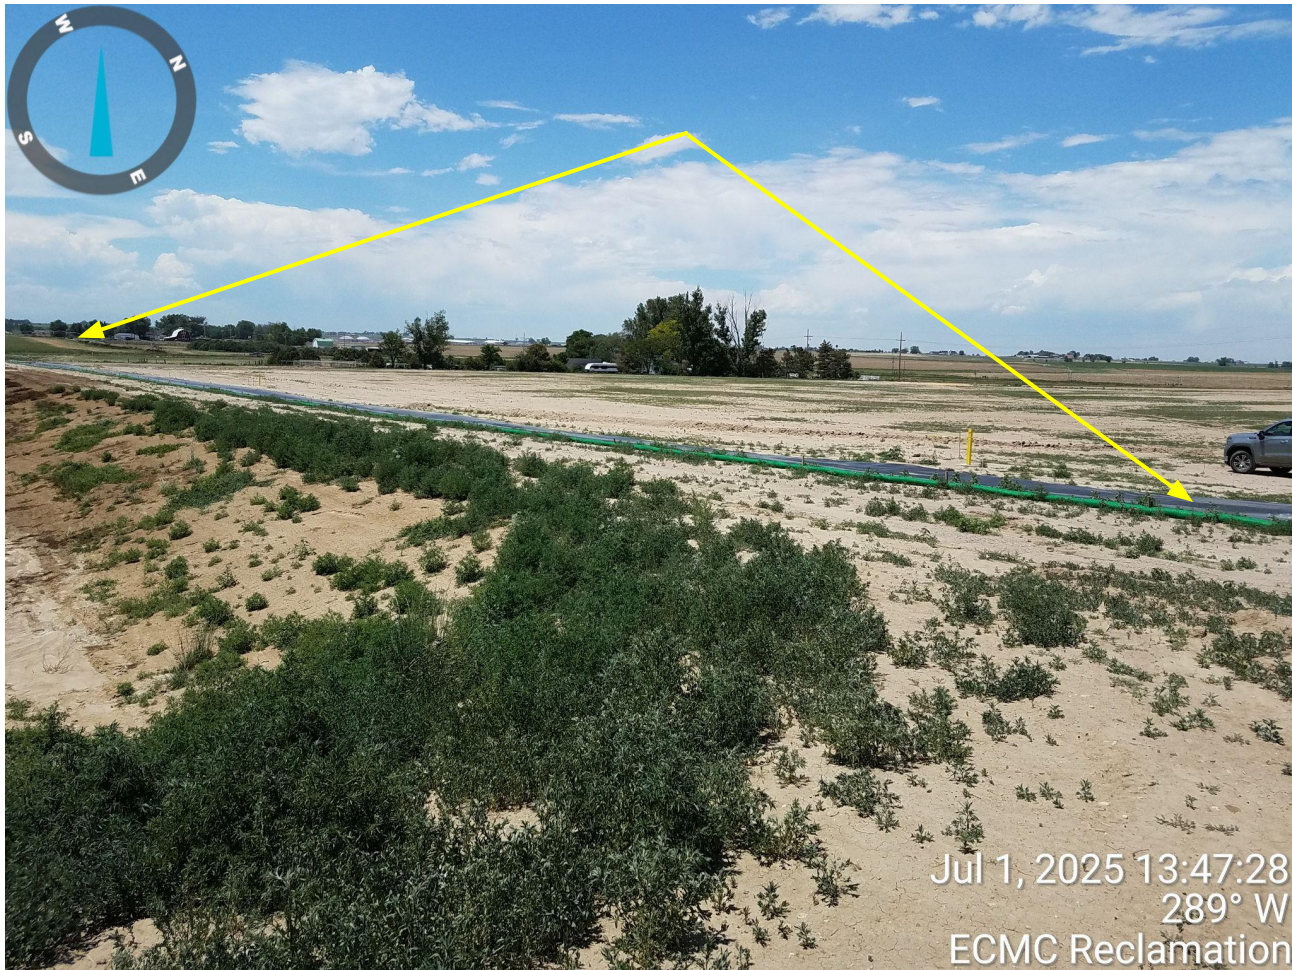
Photo 15. Photo taken from the northeastern perimeter of location, facing Northwest. Photo illustrates filter wattle BMPs (yellow arrows) have been installed along an irrigation ditch and appear to be in proper functioning condition.

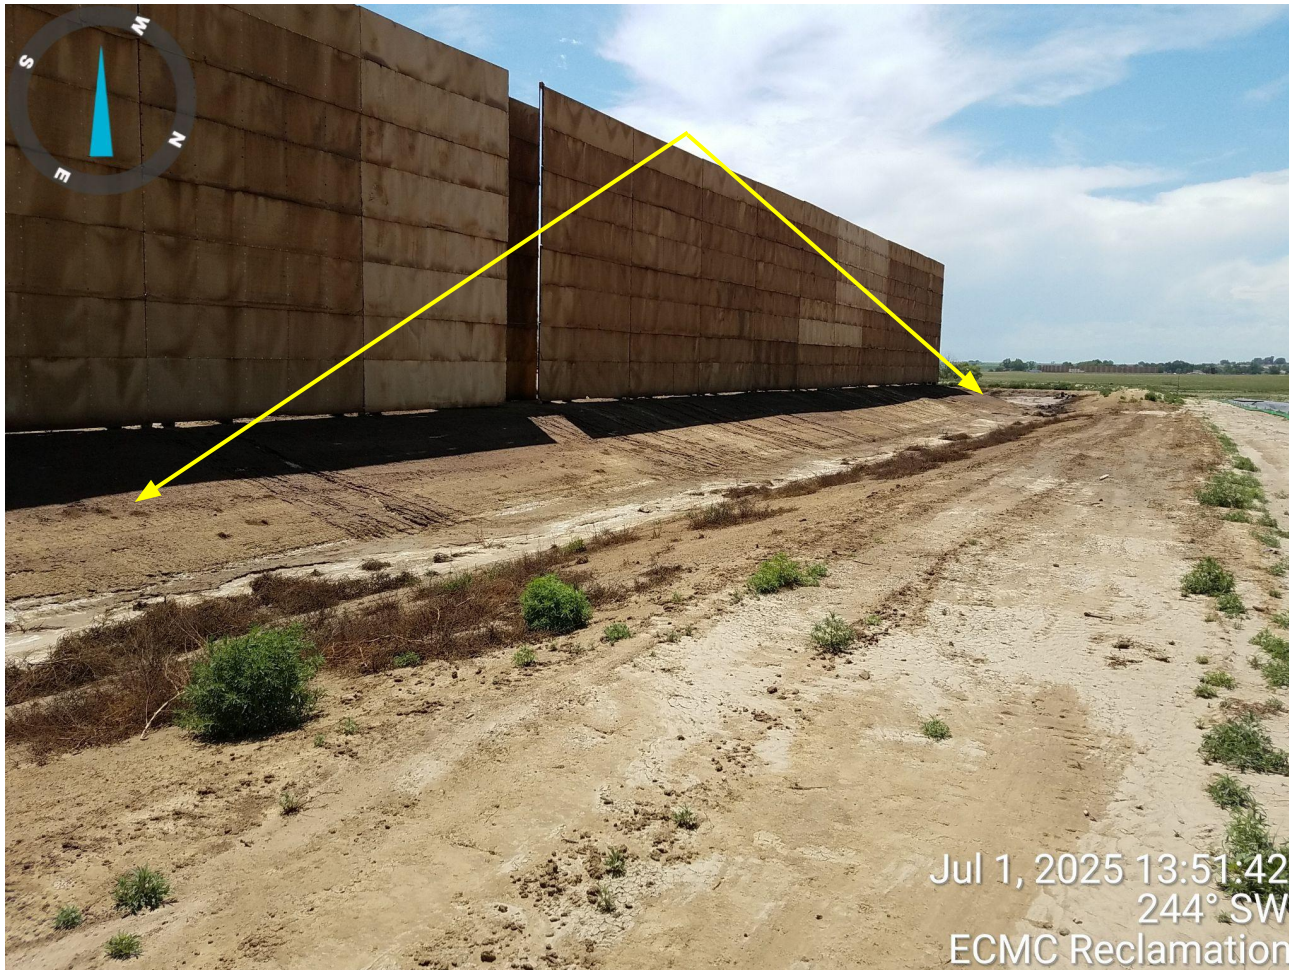
Photo 16. Photo taken from the northern fill slope of location, facing West. Photo illustrates rill erosion that was believed to be caused by the initial incident back in April 2025 per information from an Operator representative. Operator has failed to conduct stormwater repairs.

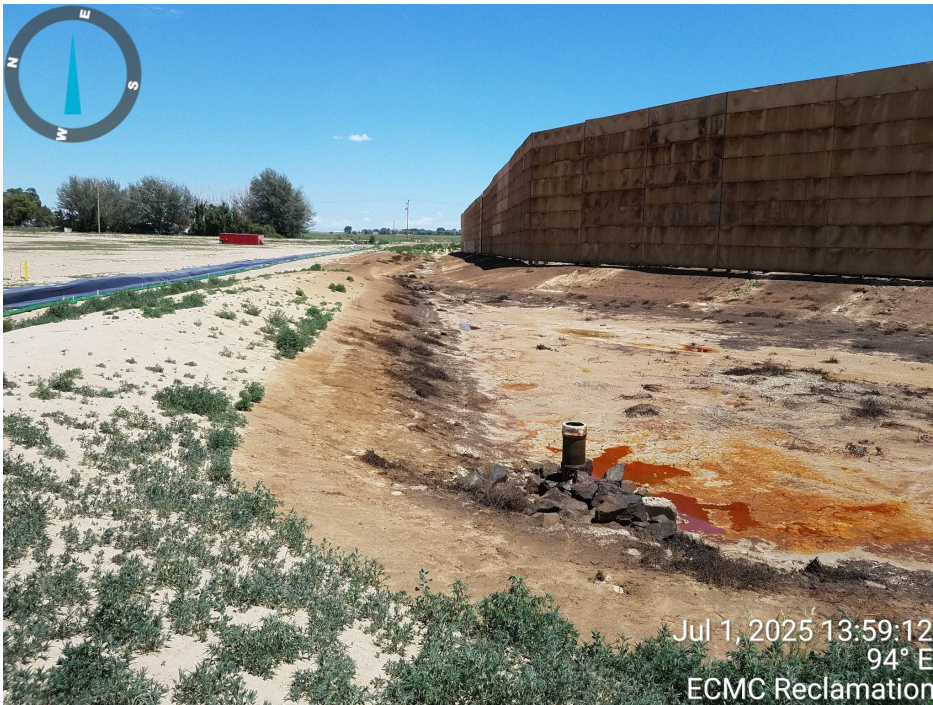
Photo 17. Photo taken from the northeastern perimeter of location, facing East. Photo illustrates a detention pond with impacted material. The PVC standpipe outlet has been capped. See Photo 18.

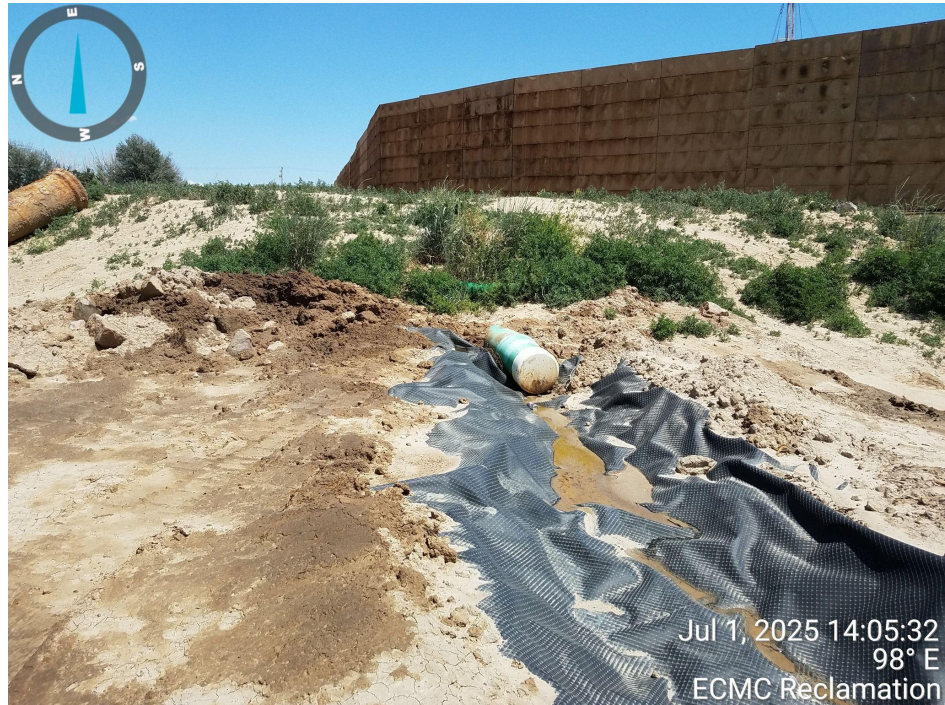
Photo 18. Photo taken from the PVC standpipe outlet, facing East. Photo illustrates the outlet has been capped to prevent the discharge of E&P waste mixed with stormwater discharge.

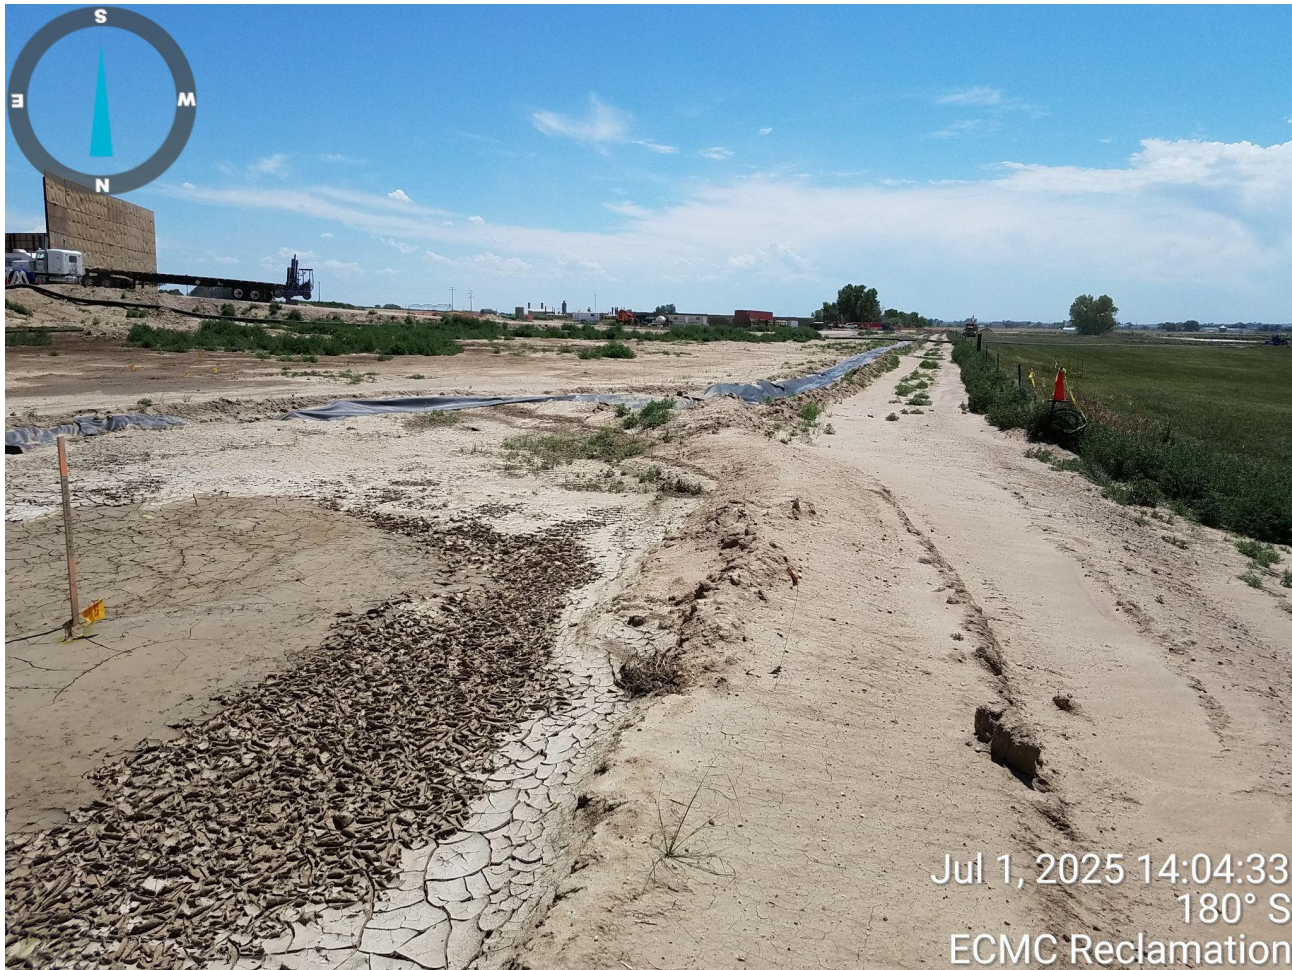
Photo 19. Photo taken west of the northwestern perimeter of location, facing South. Photo illustrates the Operator has failed to implement perimeter stormwater control BMPs.
