## LOWE 1-2 R

### Photo Log

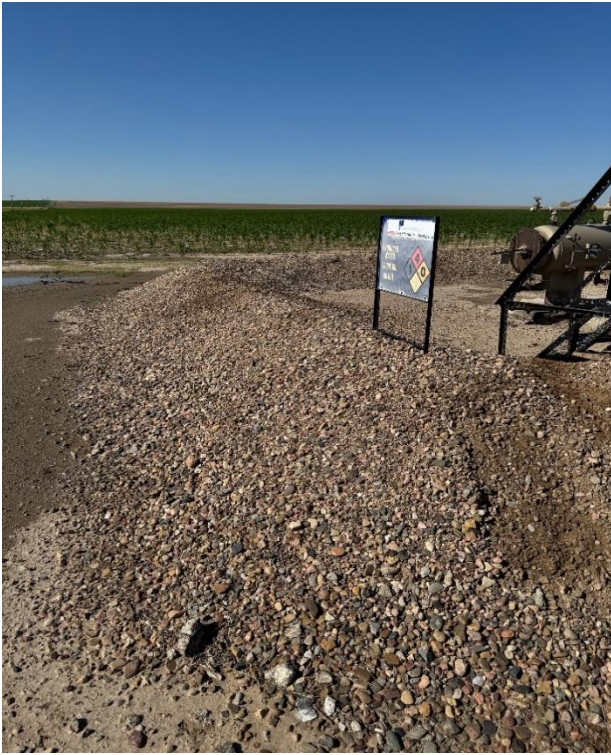
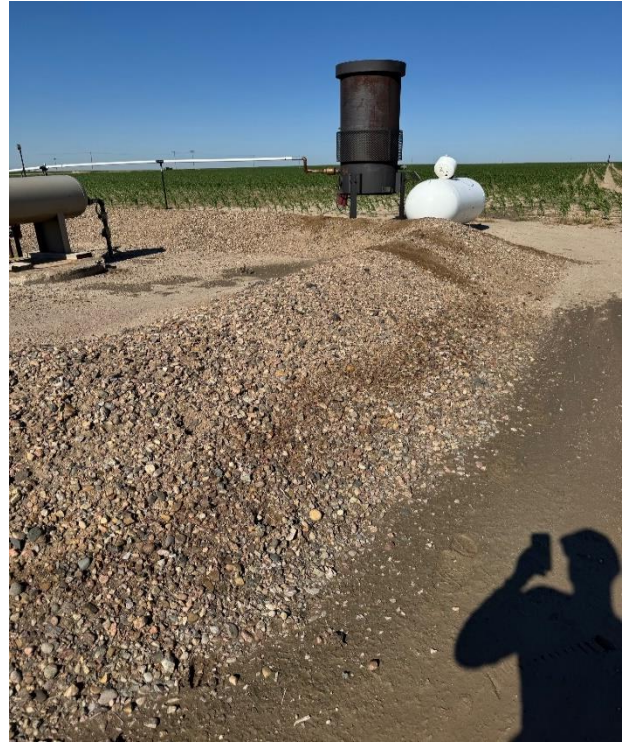
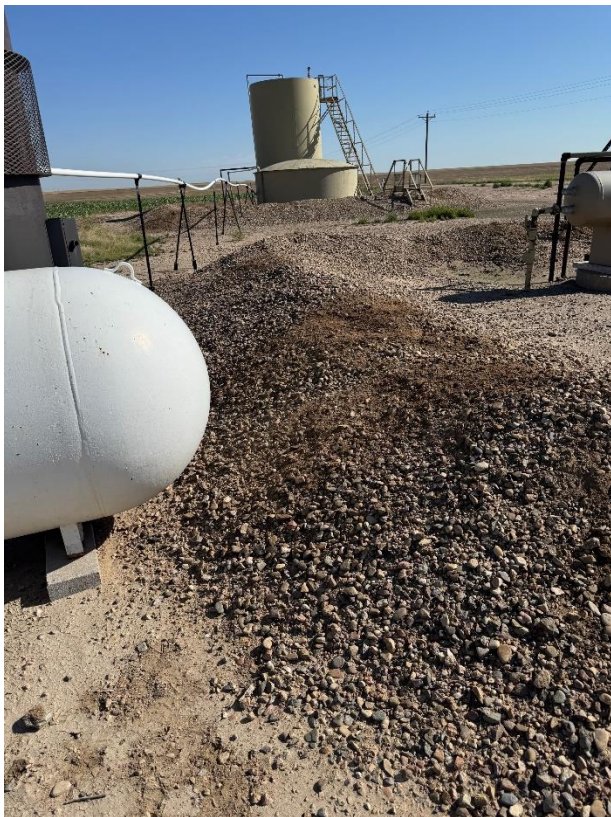
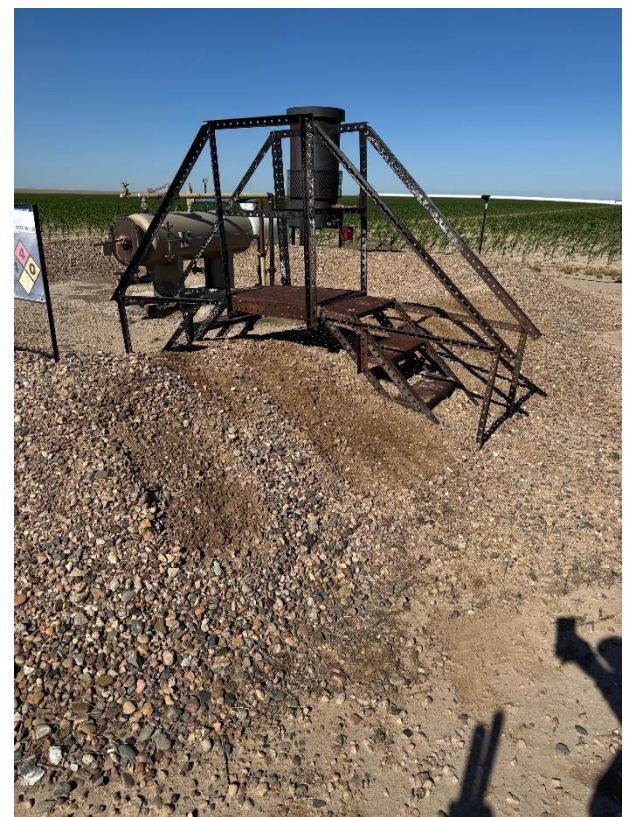
**Inspection Comment:** Animal burrows were visible in multiple areas of the shared production tank and produced water vessel containment berm, and at the separator containment berm.

**Corrective Action Requested:** Repair or install berms or other secondary containment devices per Rule 603.o

**Description of Compliance:** Berms were repaired and brought into compliance.
