TEP KP 11-16 Location ID: 335557

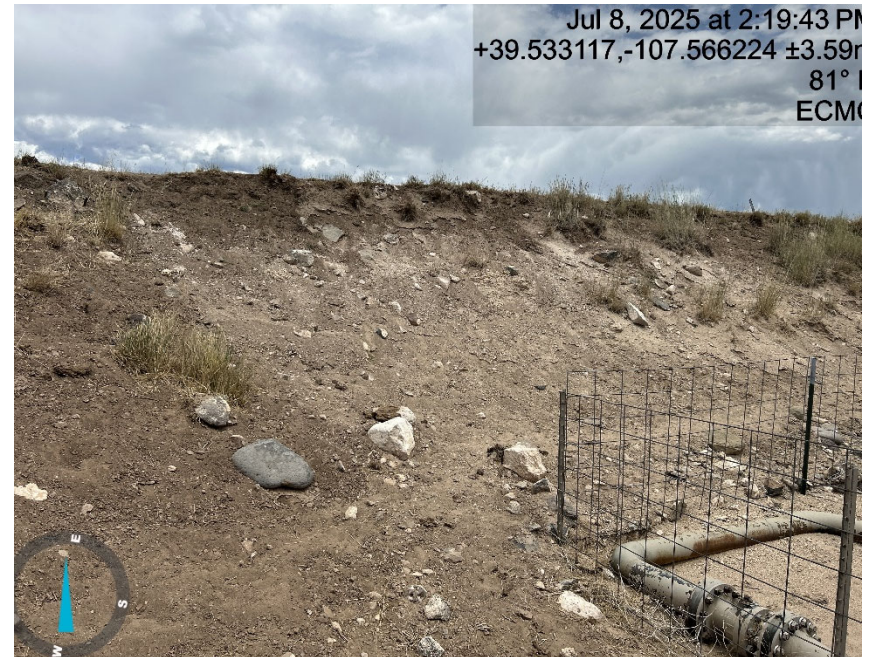
Cut slope lacks stabilization

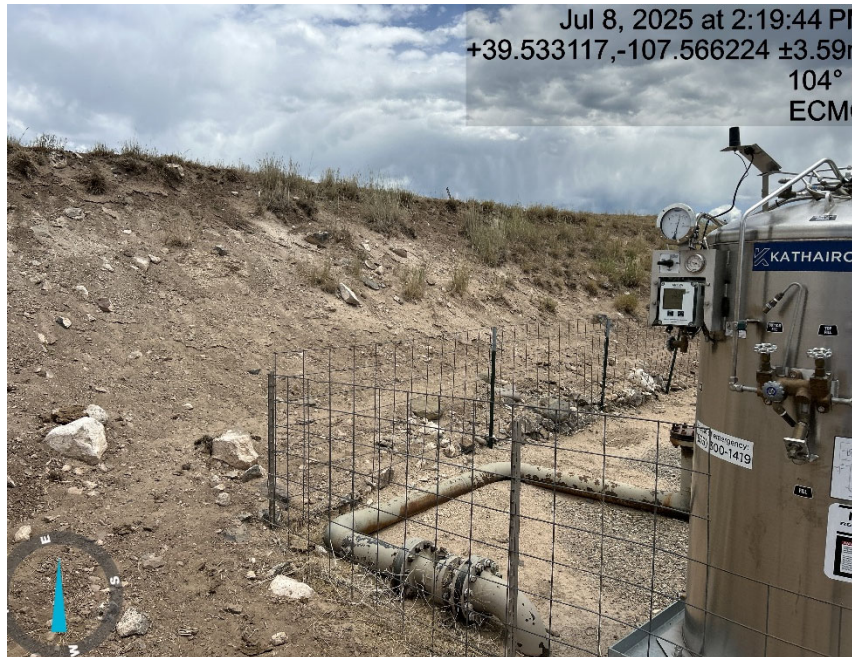
Cut slope lacks stabilization

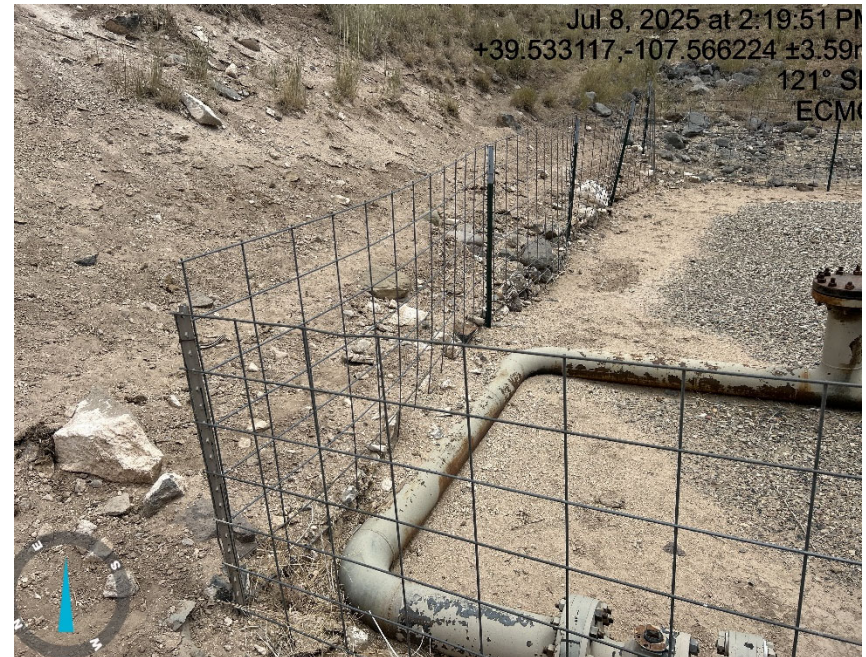
Sediment from cut slope erosion
