## Inspection/Audit Photos

Location Name: TEP ROCKY MOUNTAIN LLC CSF 33B-07-07-91 Pad

Location # 335051

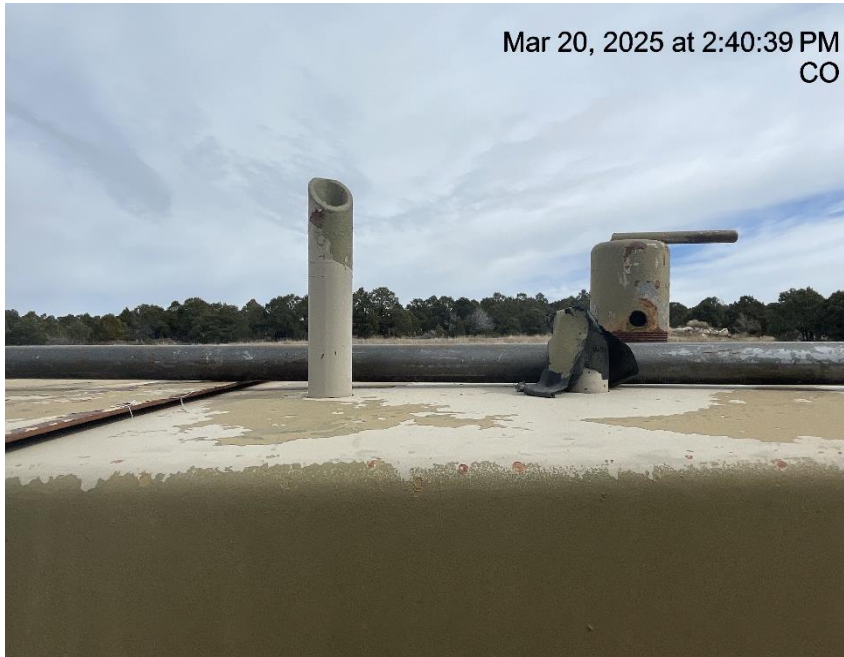
**Photo # 6182 From inspection/audit 708906074 conducted on 03/20/2025 PRV vent line on separator does not comply with CECMC pressure safety device rules**

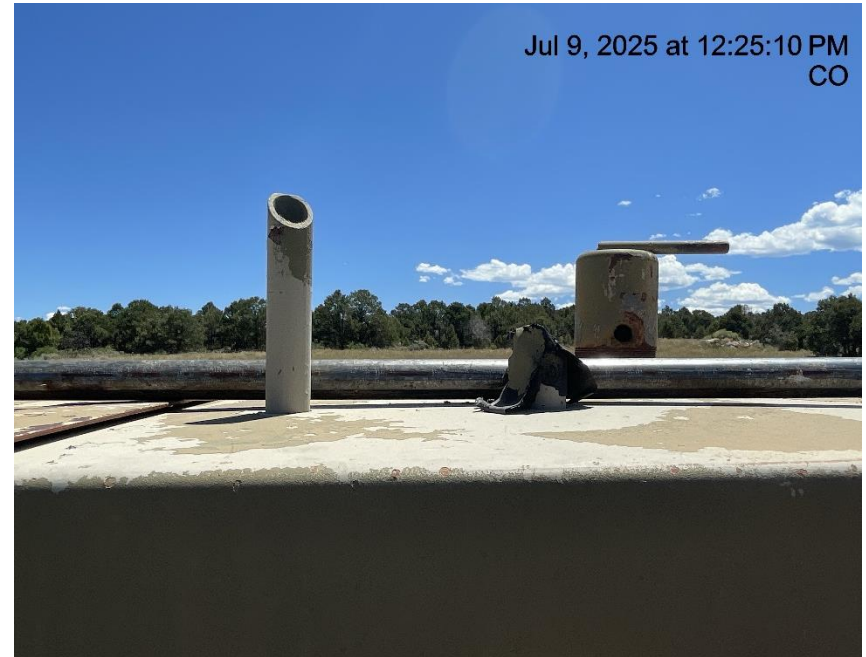
**Photo # 293 PRV vent line on separator does not comply with CECMC pressure safety device rules**

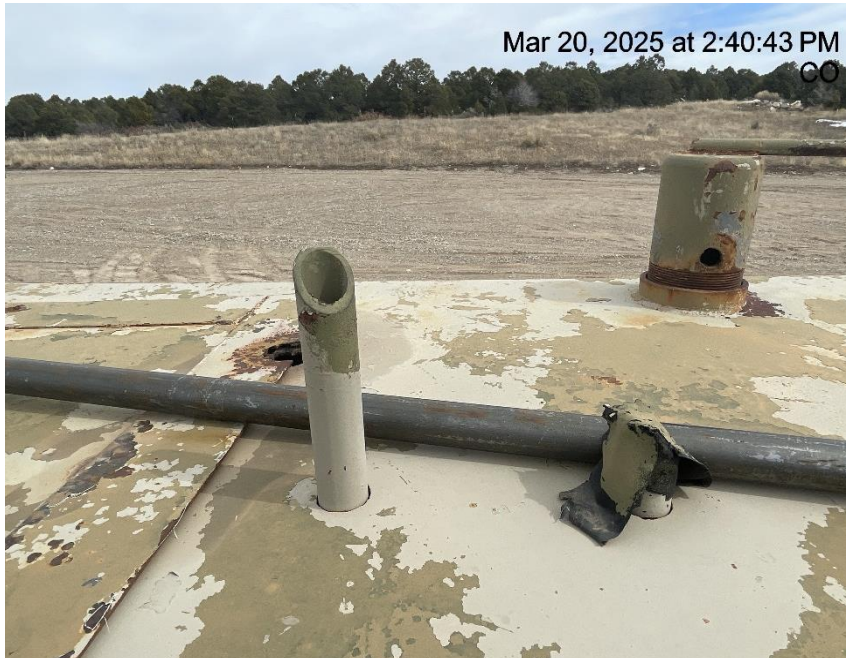
**Photo # 6183 From inspection/audit 708906074 conducted on 03/20/2025 PRV vent line on separator does not comply with CECMC pressure safety device rules**

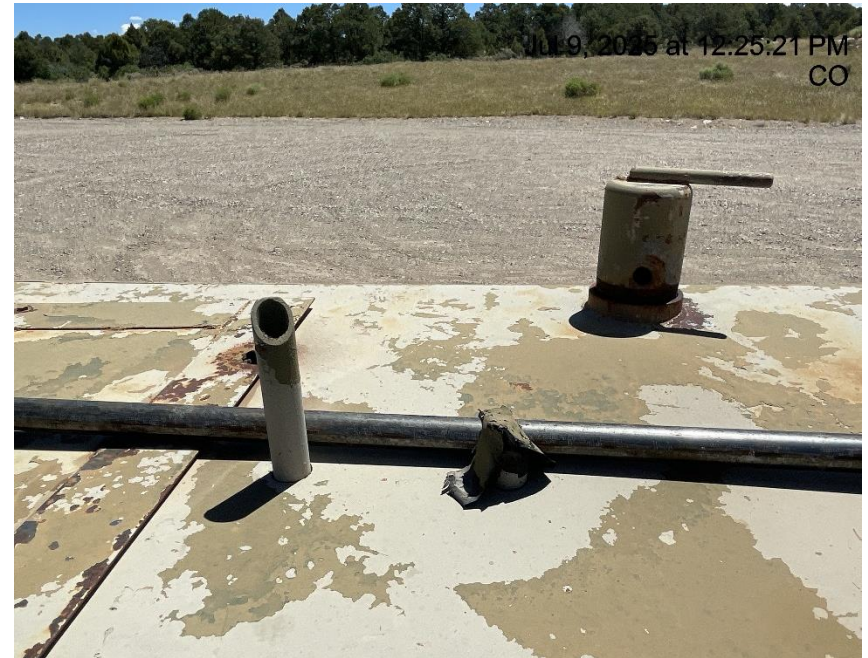
**Photo # 294 PRV vent line on separator does not comply with CECMC pressure safety device rules**

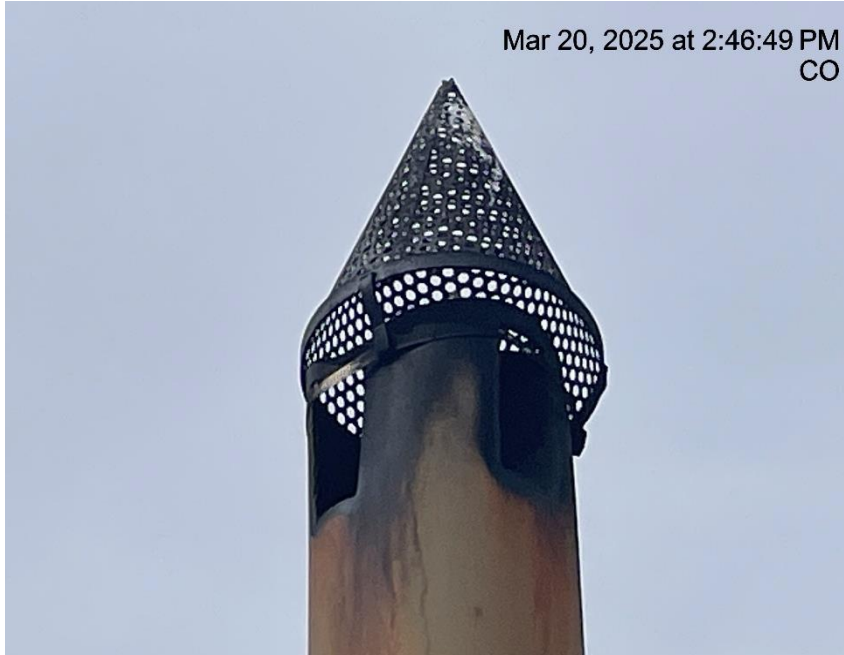
**Photo # 6184 From inspection/audit 708906074 conducted on 03/20/2025 Bird protection on separator insufficient /burner stack available for entry by wildlife/wildlife hazard**

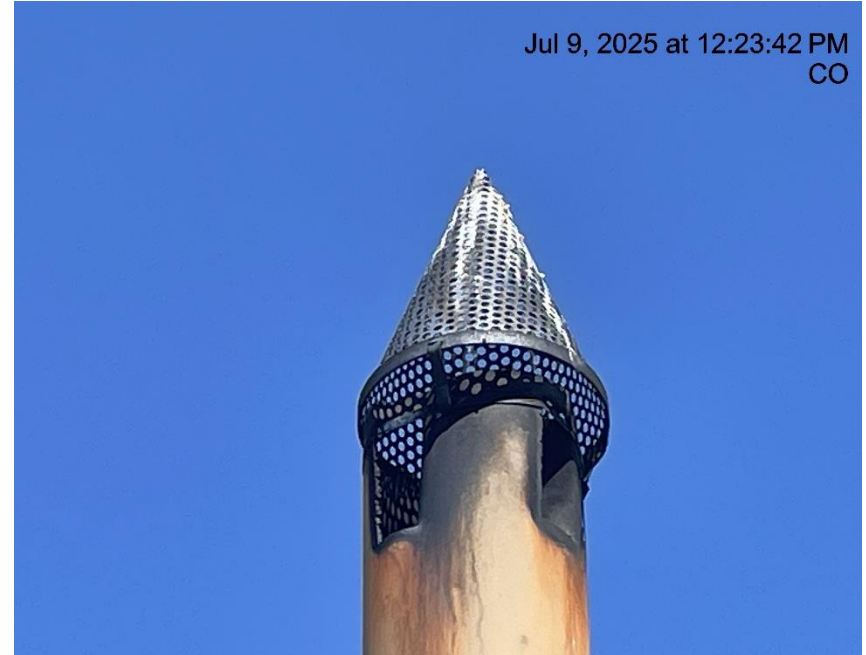
**Photo # 295 Bird protection on separator insufficient /burner stack available for entry by wildlife/wildlife hazard**

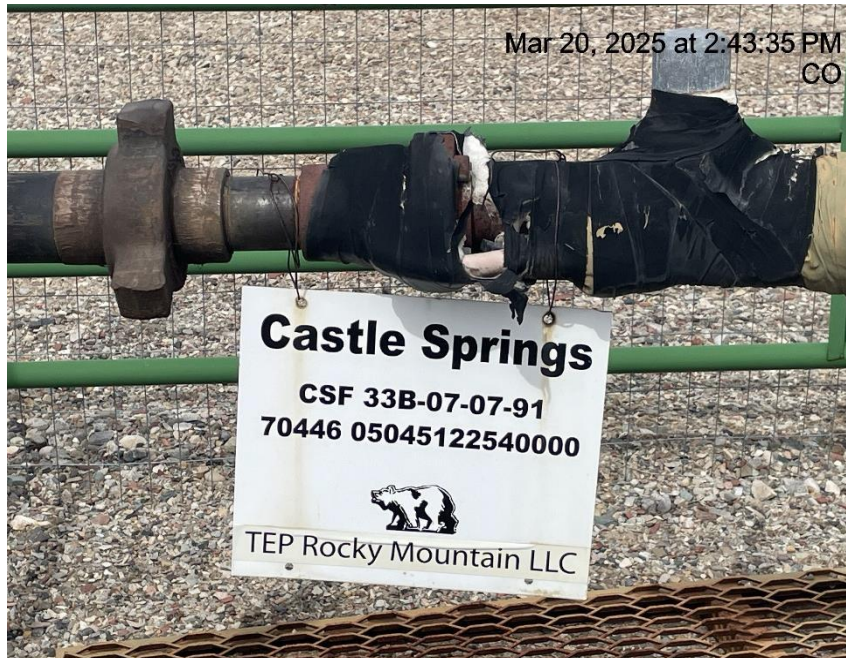
Photo # 6185 From inspection/audit 708906074 conducted on 03/20/2025 Wellhead sign lacks required information

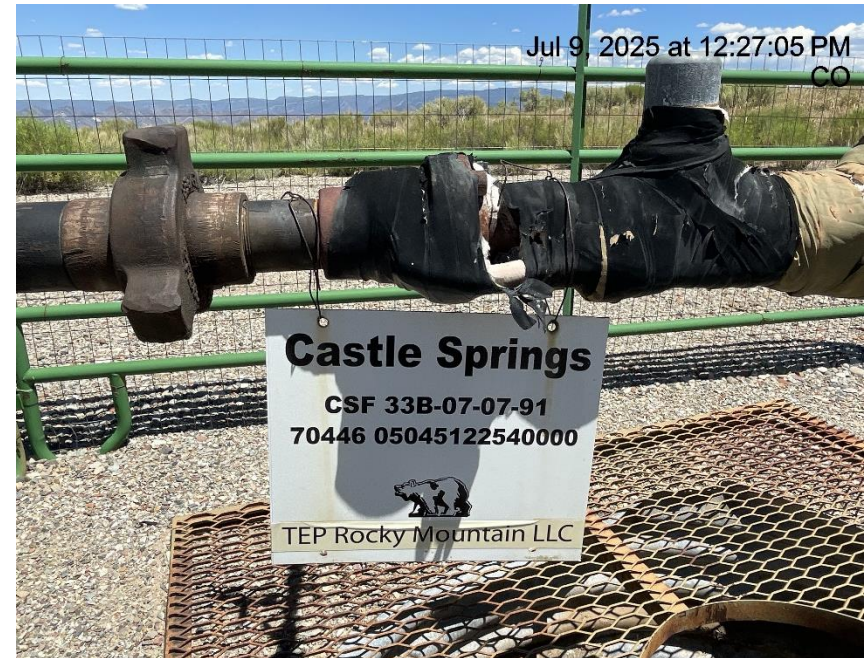
Photo # 296 Wellhead sign lacks required information
