Final Reclamation and Stormwater Inspection

July 2, 2025

Operator: KERR MCGEE OIL & GAS ONSHORE LP - 47120

Well Name: MILLER X #31-03

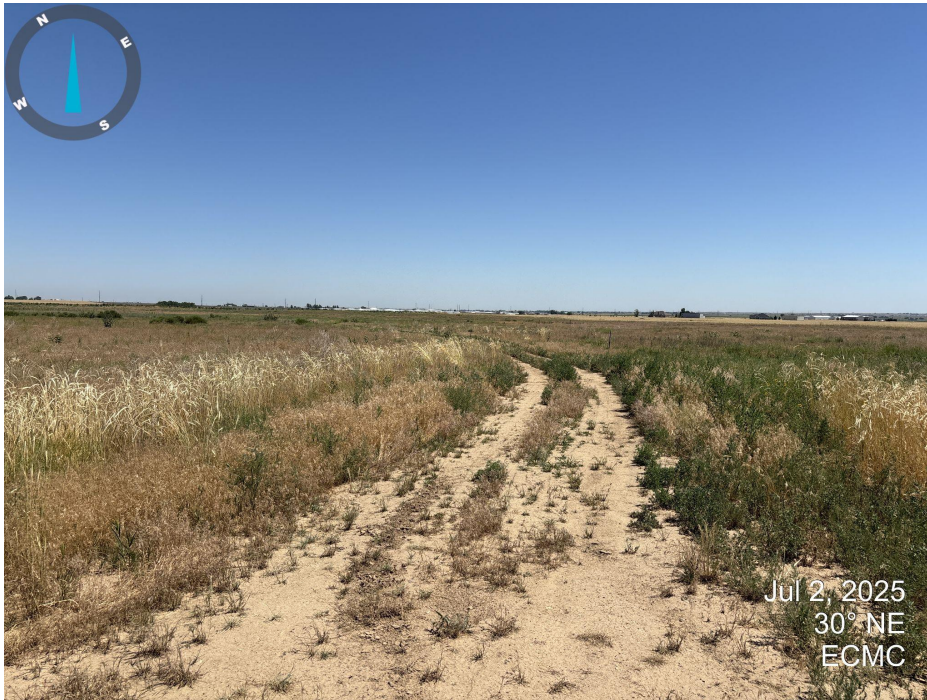
Photo 1. Picture taken at the entrance of the access road. The access road remains bare soil. The soil on the access road is more compacted than surrounding soil.

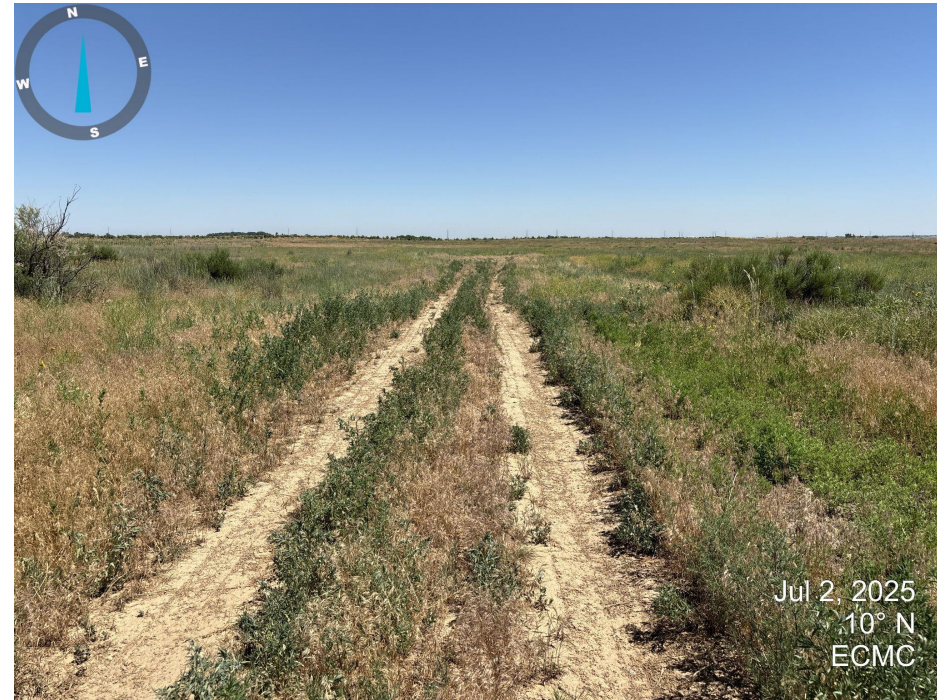
Photo 2. Looking north down the access road to the midpoint. It appears that reclamation such as drill seeding may have been conducted on the access road. Vegetation on the access road is primarily undesirable weed kochia and list C noxious weed cheatgrass. Germination of desirable plant species was not observed at the time of inspection.

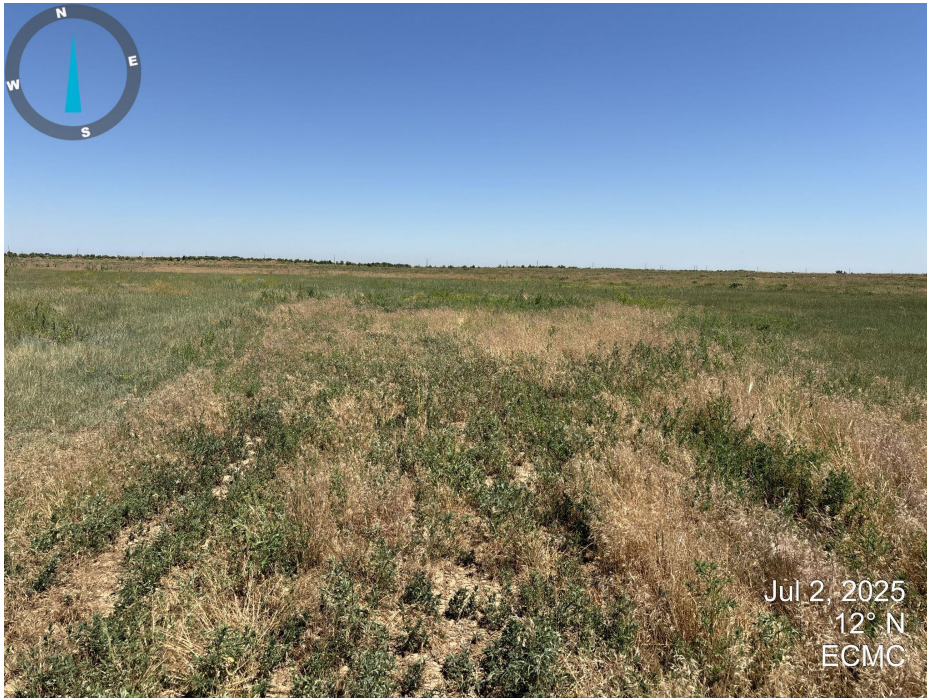
Photo 3. Looking north across the wellbore. No oil and gas equipment remains. Vegetation around the wellbore is primarily undesirable weed kochia and list C noxious weed cheatgrass.

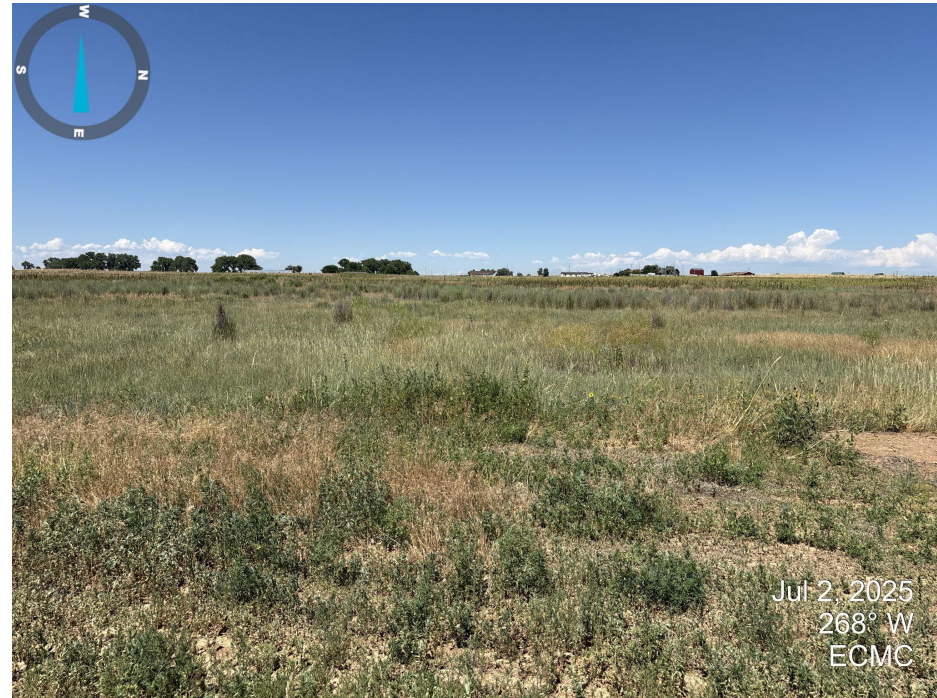
Photo 4. Looking west from wellbore. See photo 3 comments.

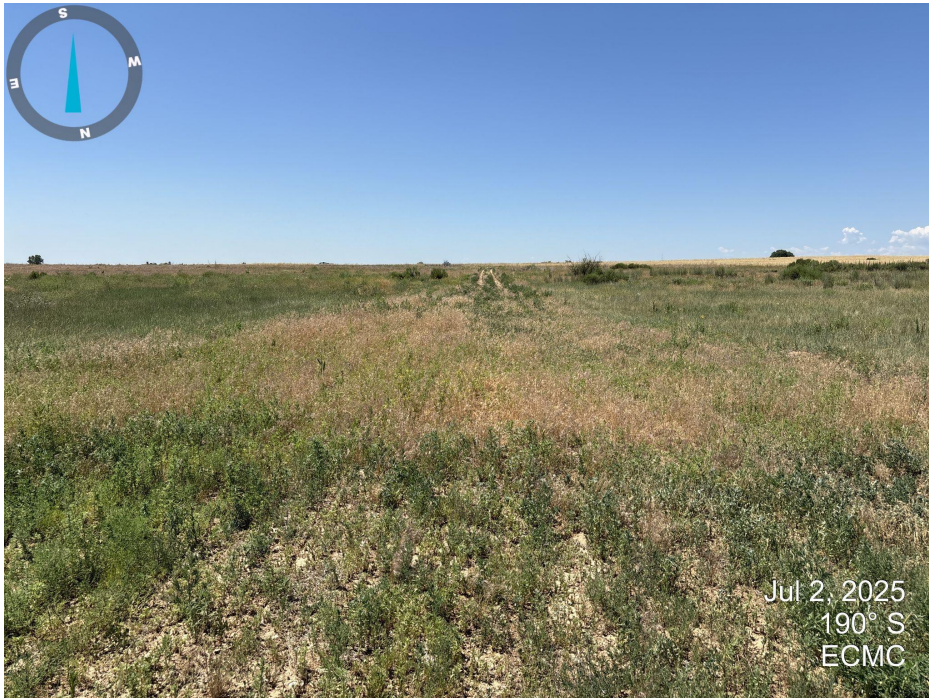
Photo 5. Looking south from wellbore. See photo 3 comments.

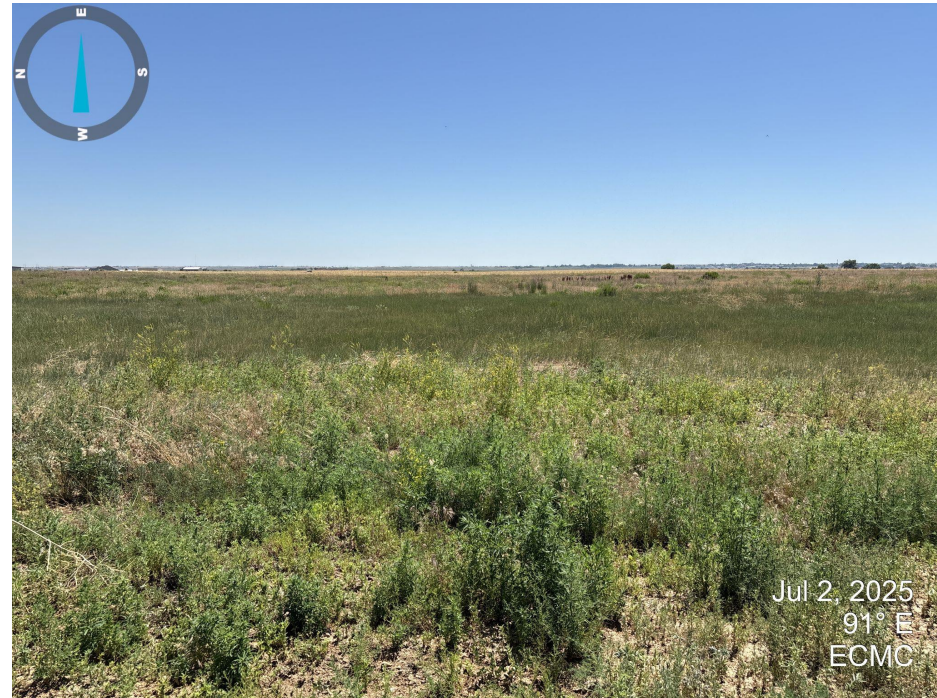
Photo 6. Looking east from wellbore. The former interim area appears to have desirable vegetation establishment. The difference in vegetative coverage can be seen in this picture.

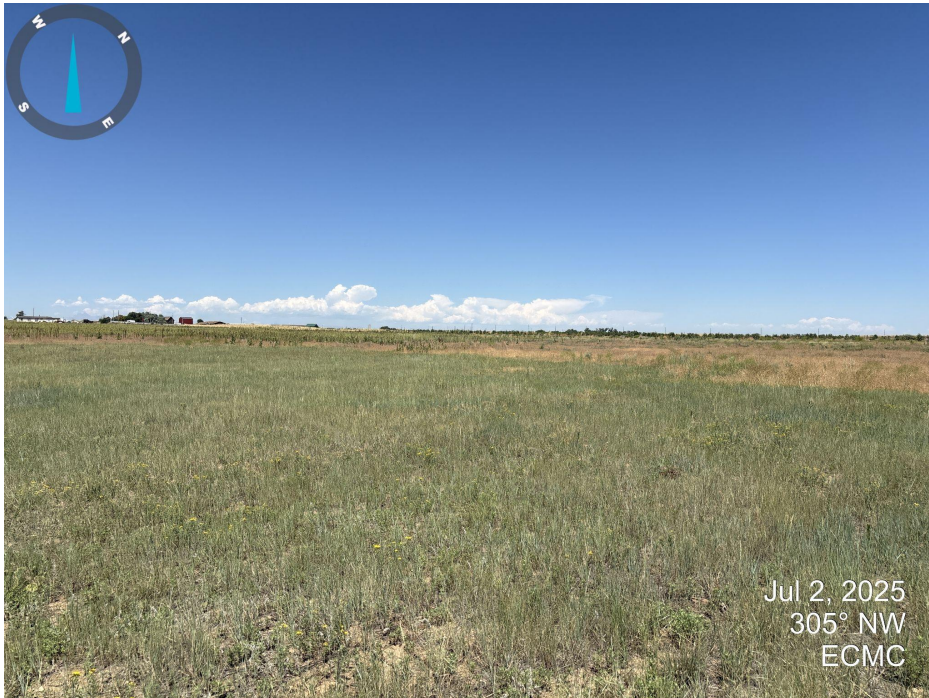
Photo 7. Picture taken on the east side of the interim disturbance area.

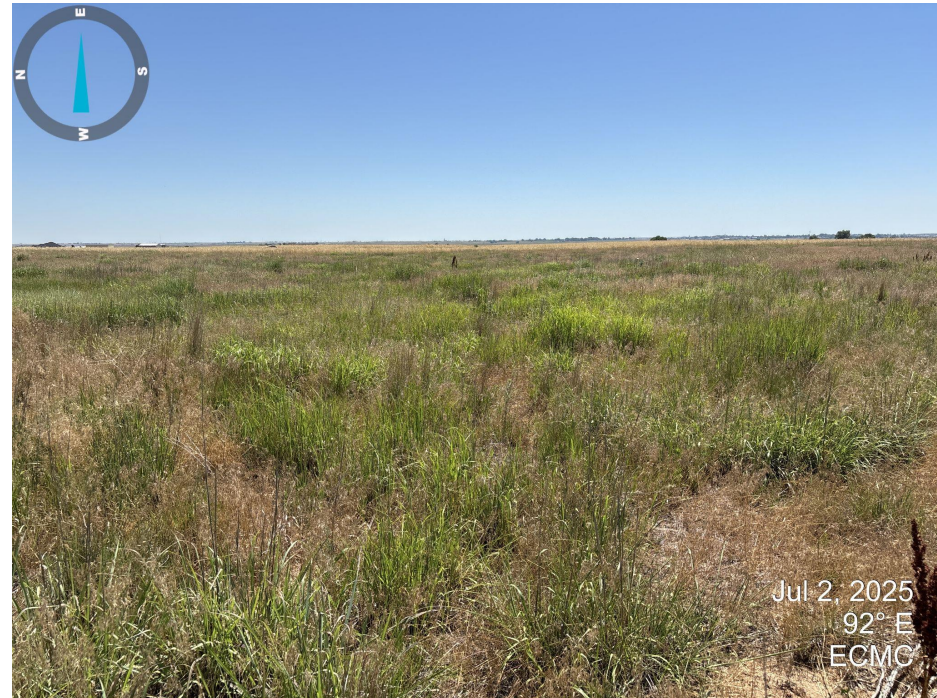
Photo 8. Reference vegetation to the east of well location.

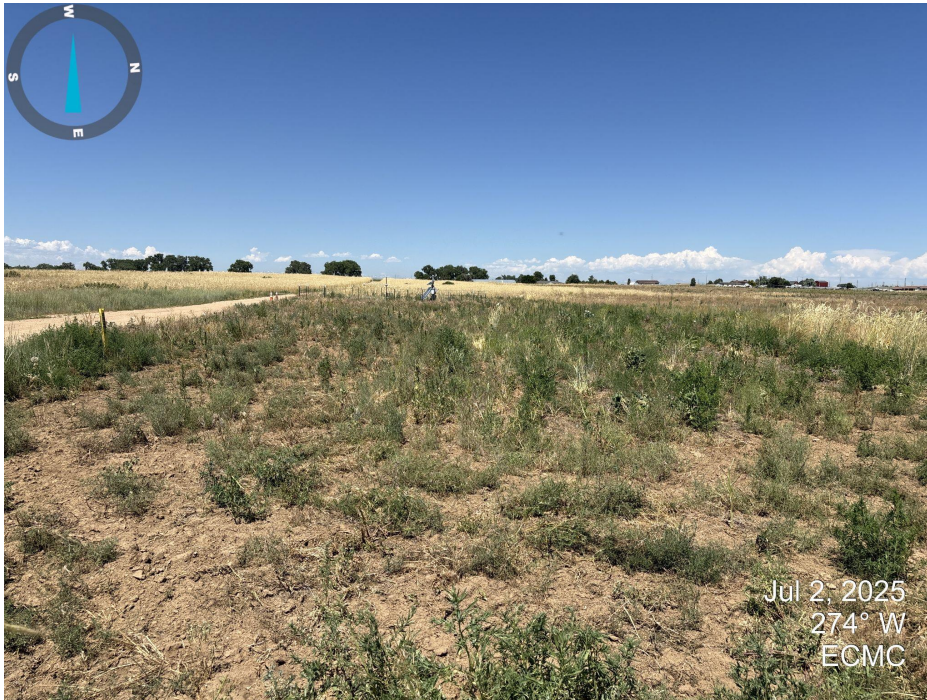
Photo 9. Looking west across the former tank battery from the east side. Vegetation on location is primarily undesirable weeds such as kochia, russian thistle and list C noxious weed cheatgrass. A weather station is present on location.

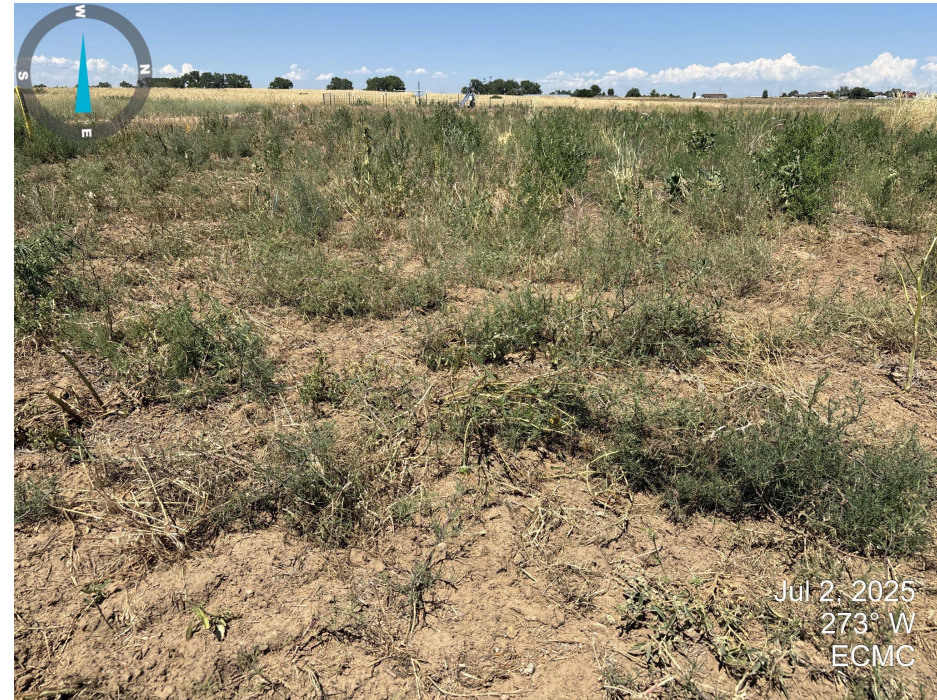
Photo 10. Picture taken on the east side of location. Illustrating vegetation and ground conditions. Activity such as excavations or tilling may have occurred on location.

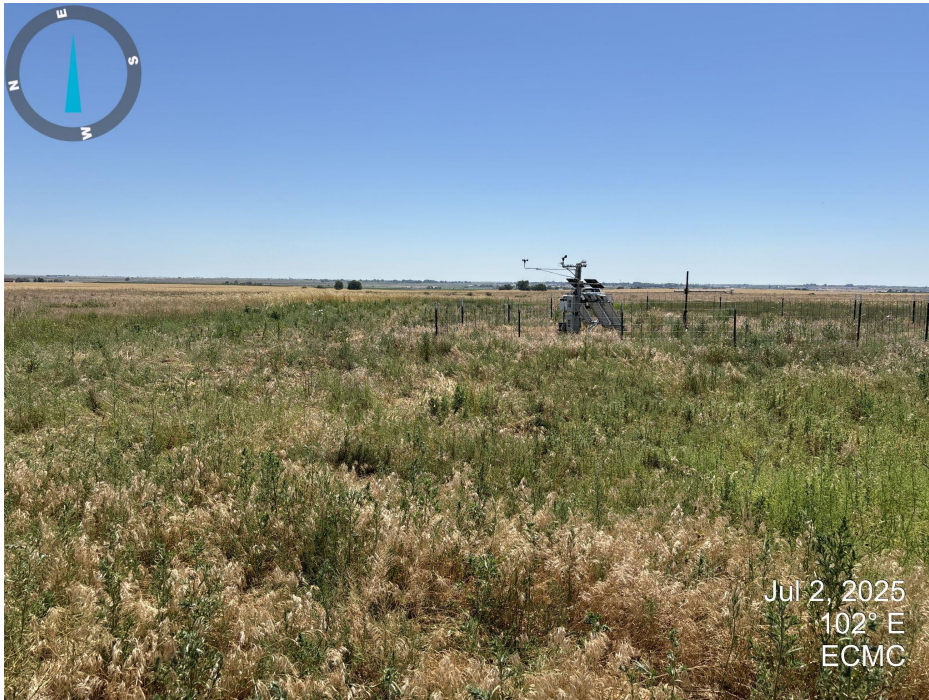
Photo 11. Looking east from the west side of the location. See photo 9 comments.

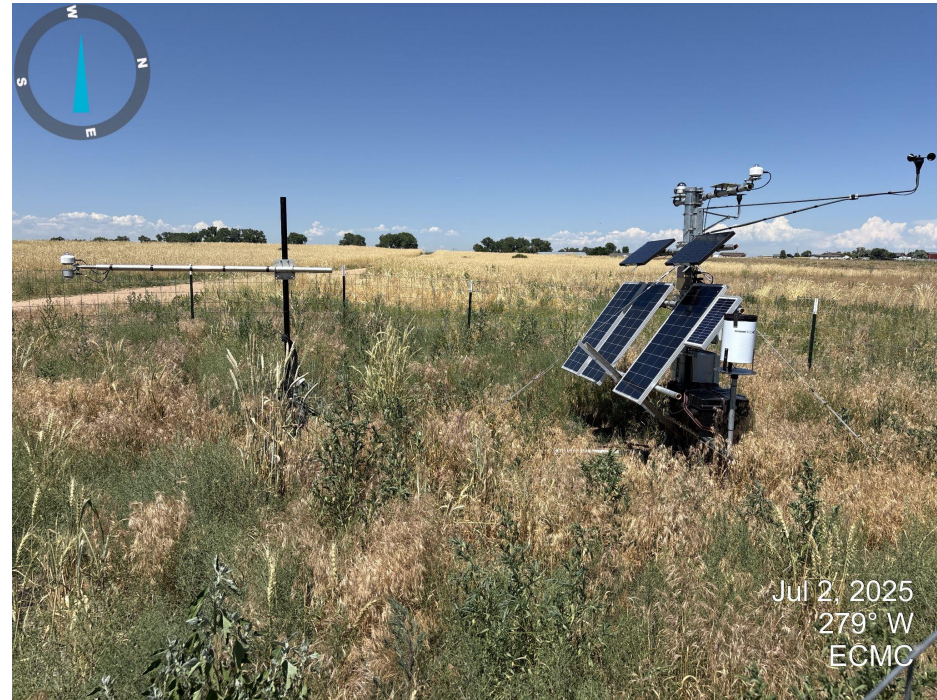
Photo 12. Picture taken on the west side of location. A section of the location is fenced off and monitoring equipment is present.
