Inspection Photos

Operator: LARAMIE ENERGY LLC #10433

Location ID: 487592

Inspection Doc: 718100633

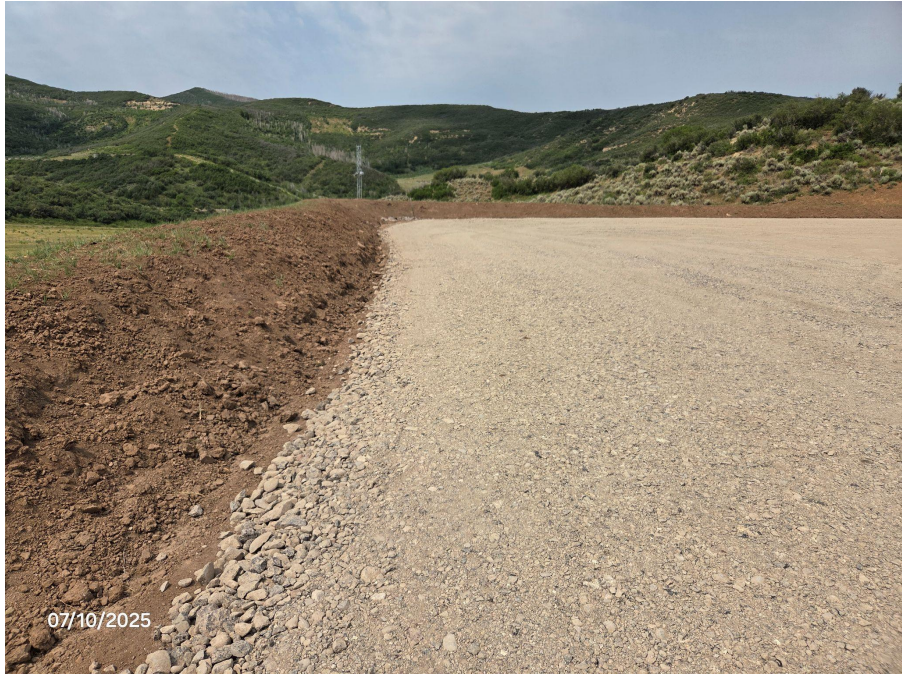
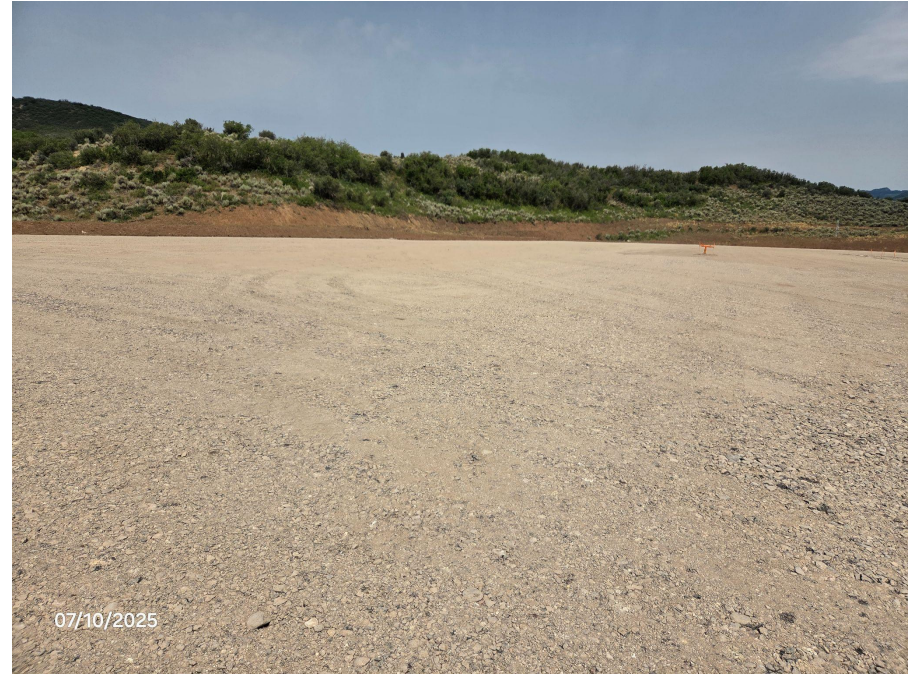
Photo 1: Photos 1-2 taken from the south end of the Location. Photos provide an overview of the Location from west, northwest, northeast to east.

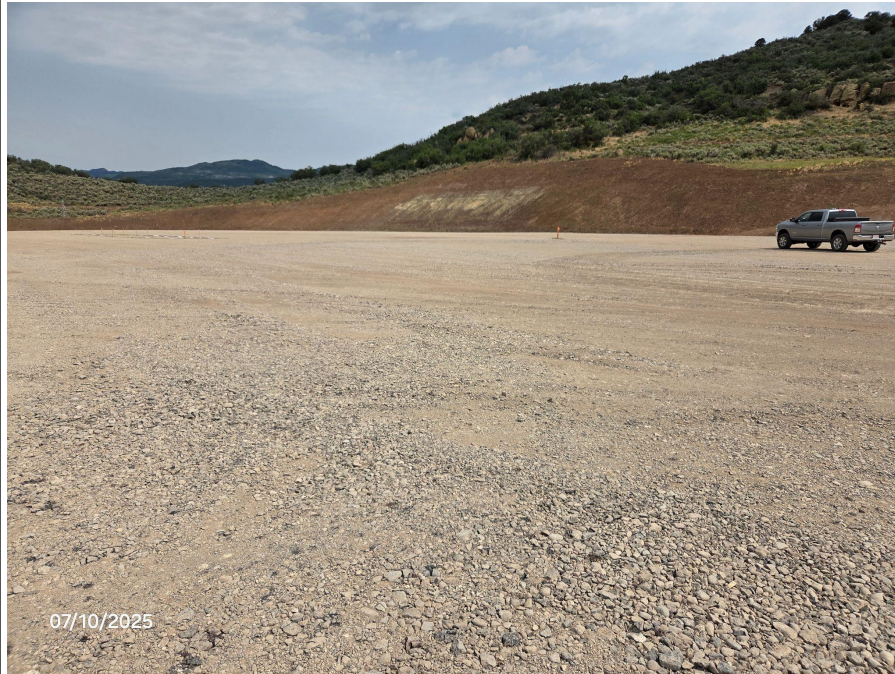
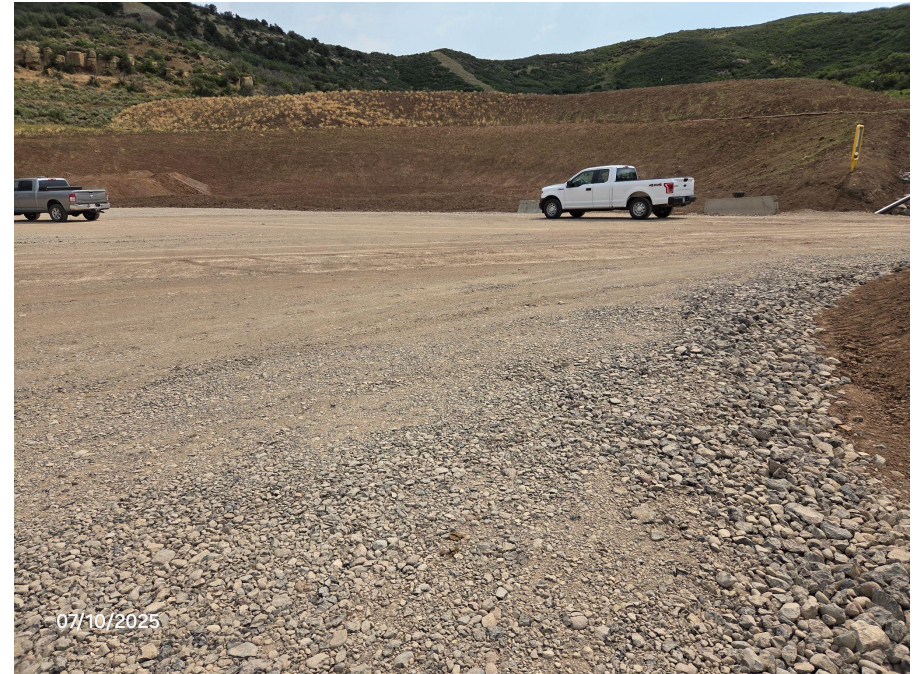
Photo 2: See comments under photo 1.

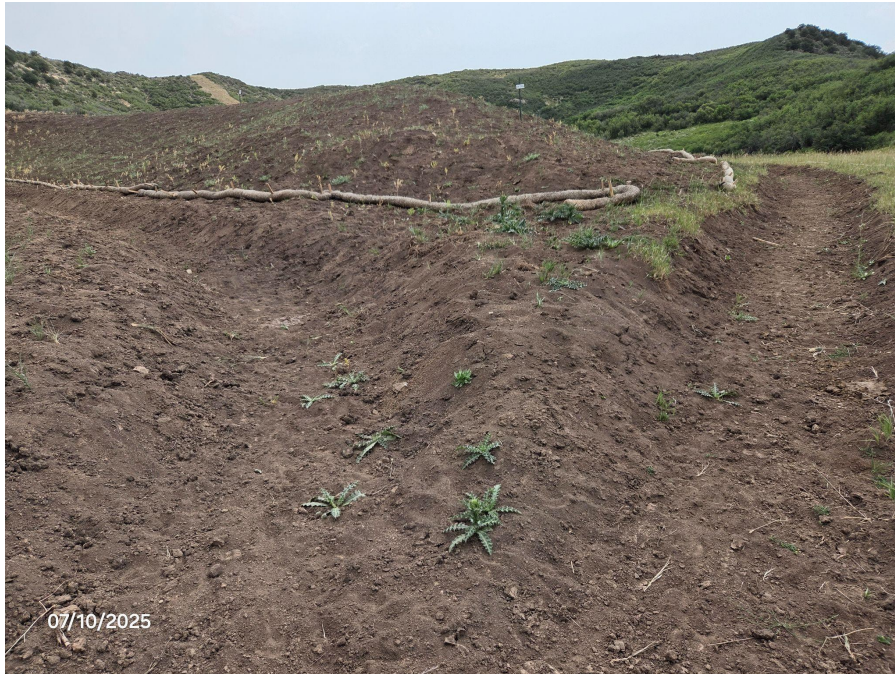
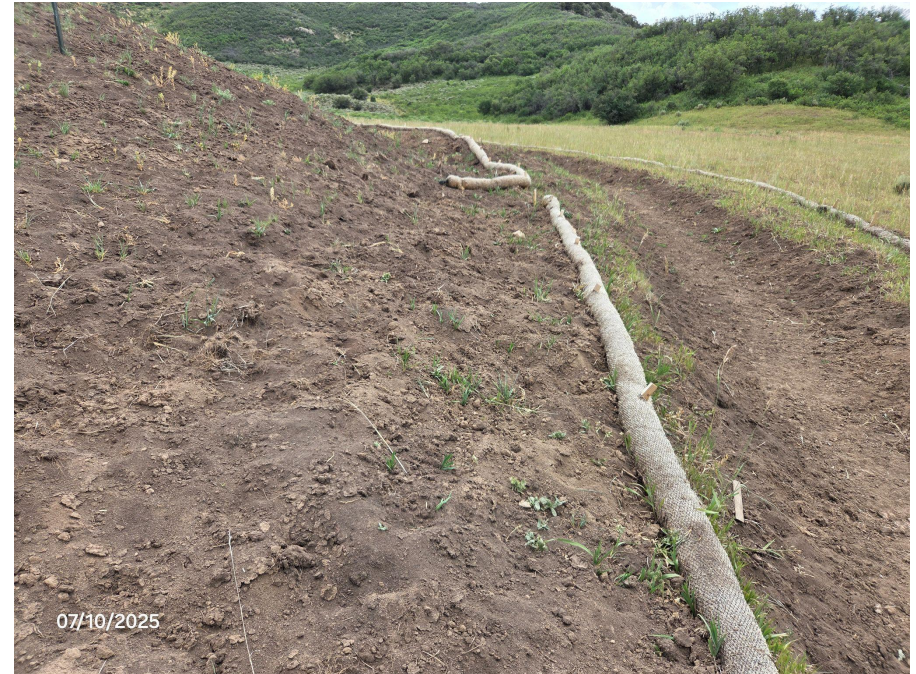
Photo 3: Photos taken from the topsoil stockpile on the east end of the Location. Photos examples showing erosion logs along the perimeter of the stockpile have not been maintained.

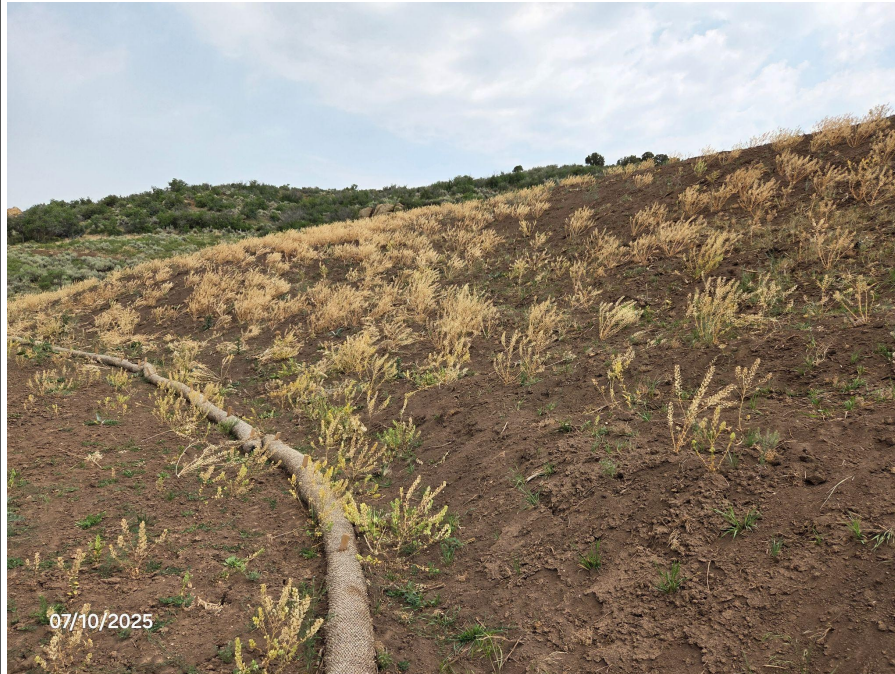
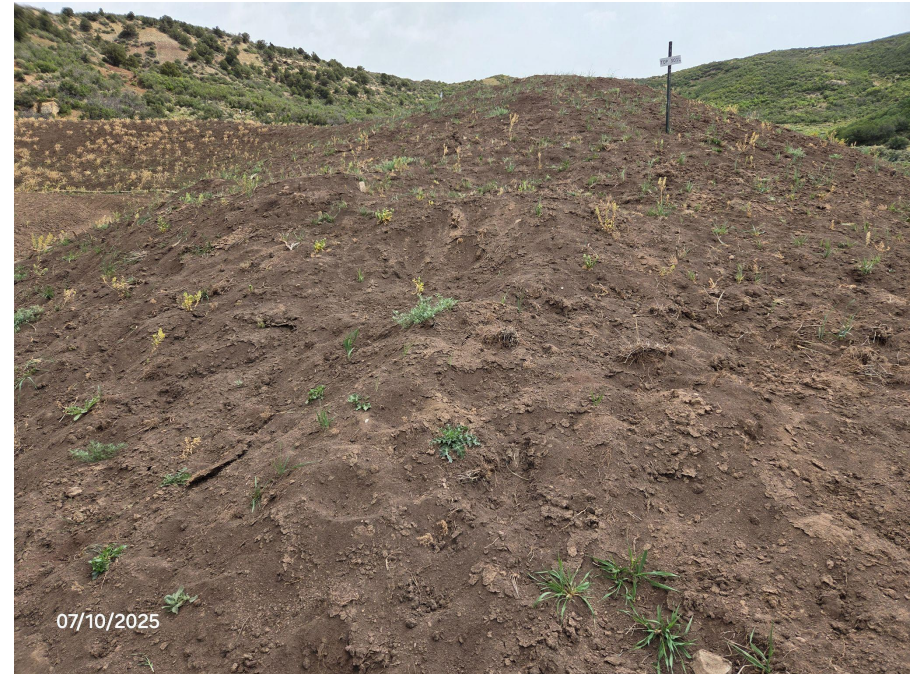
Photo 4: Photos taken from the topsoil stockpile on the east end of the Location. BMPs to protect the topsoil from wind and water erosion remain missing or insufficient; soils remain predominantly bare and lack stabilization. Erosion/Degradation evident.

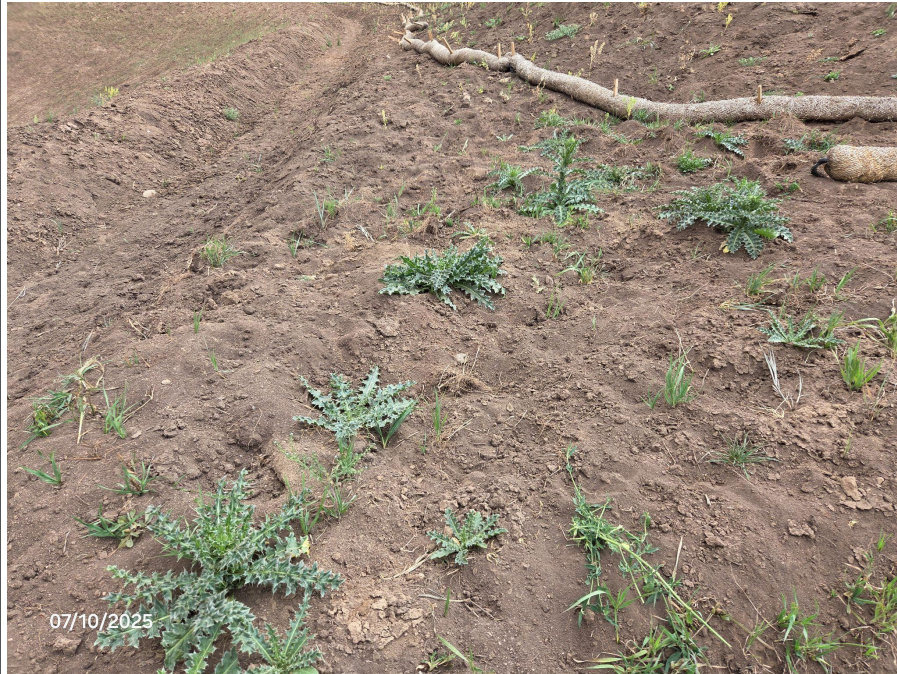
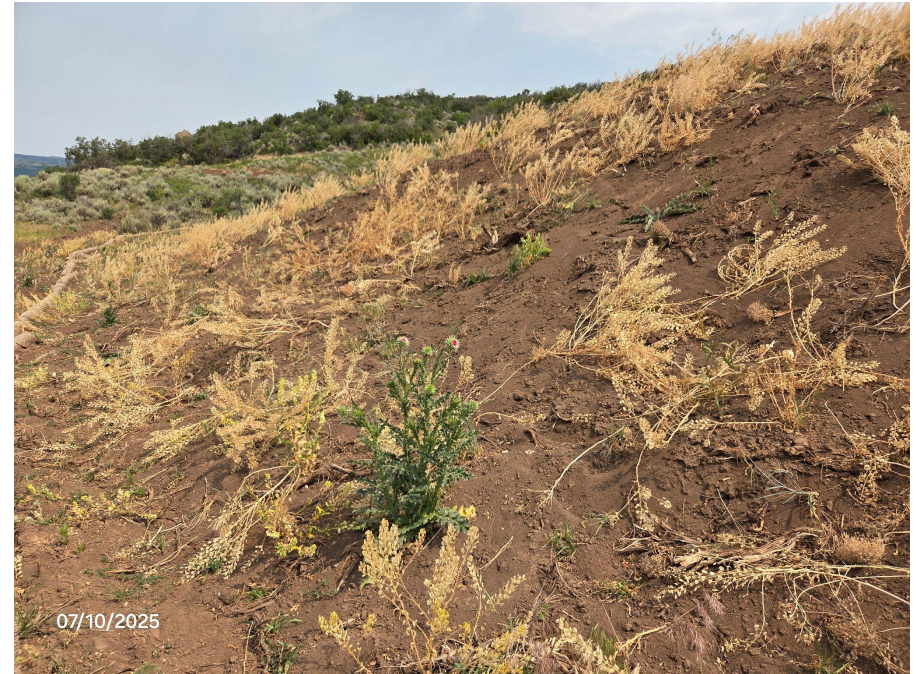
Photo 5: Photos 5-6 taken from the topsoil stockpile on the east end of the Location. Photos example showing BMPs to protect the topsoil stockpile, as well as management efforts to prevent the spread and establishment of Undesirable Plant Species are missing or insufficient; Noxious weeds (Musk thistle, Bull thistle, Canada thistle) and other Undesirable Plants observed established. Weed management efforts not evident within these (Eastern) areas of the Location.

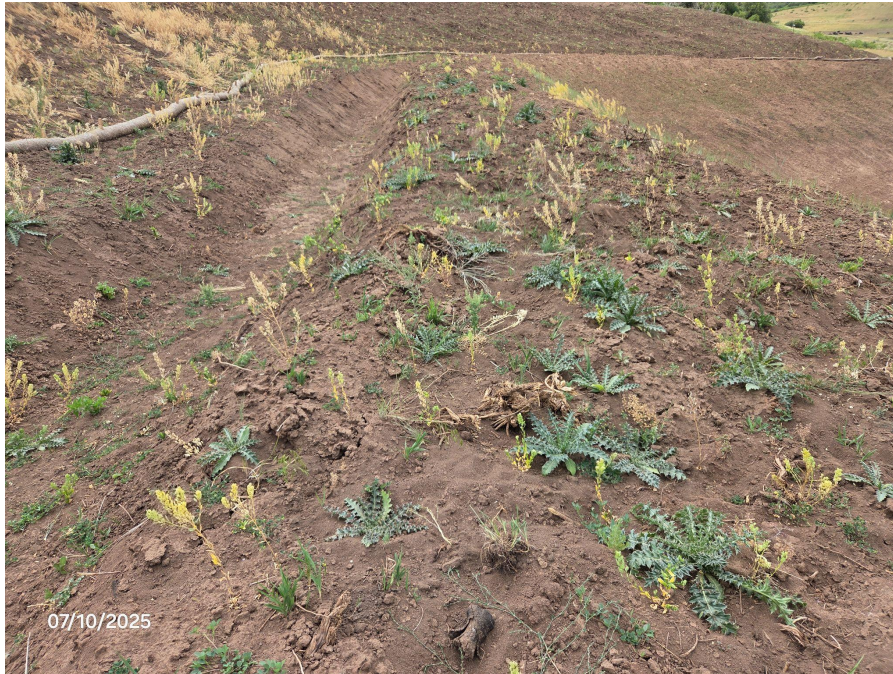
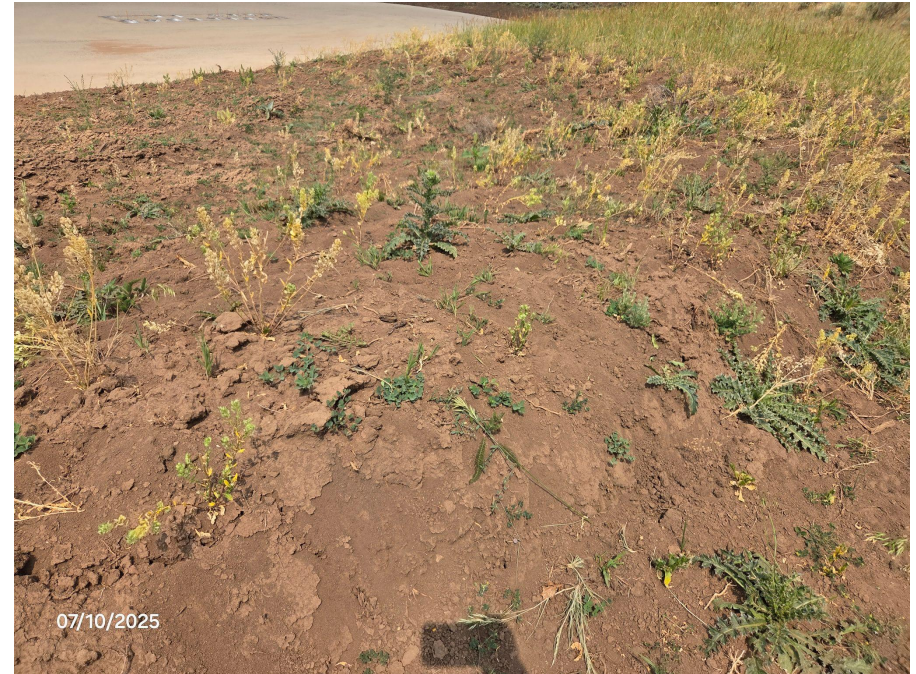
Photo 6: See comments under photo 5.

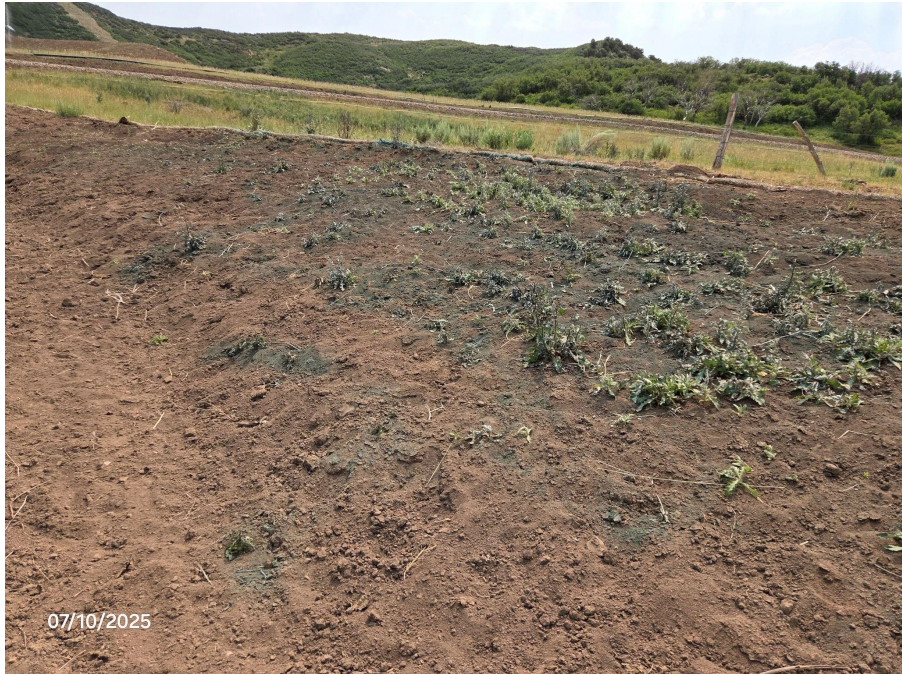
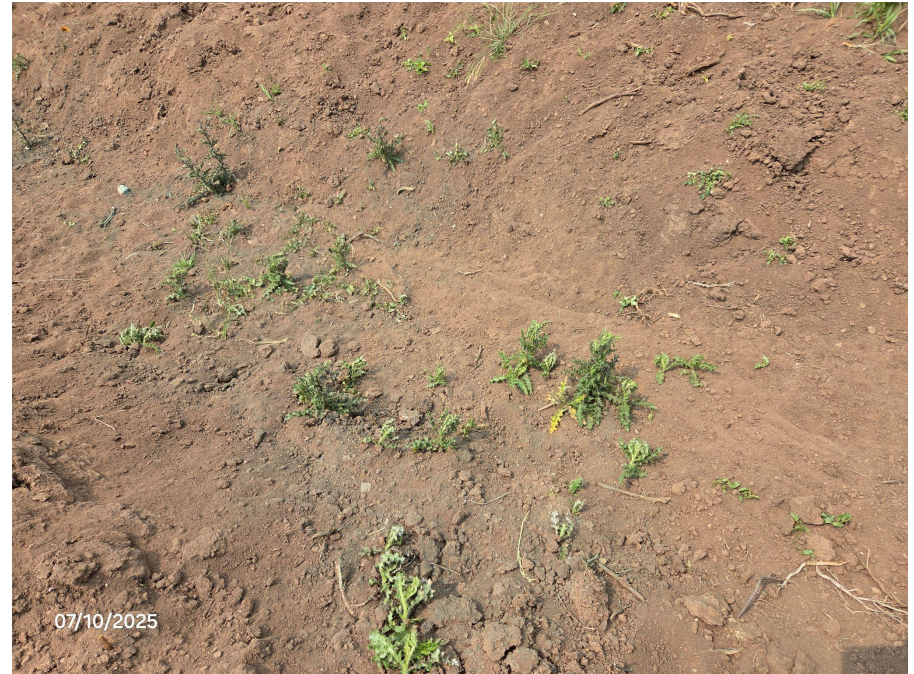
Photo 7: Photos examples showing areas along the West end of the Location where weed management efforts are apparent; applicator used a dye to identify areas that were sprayed.

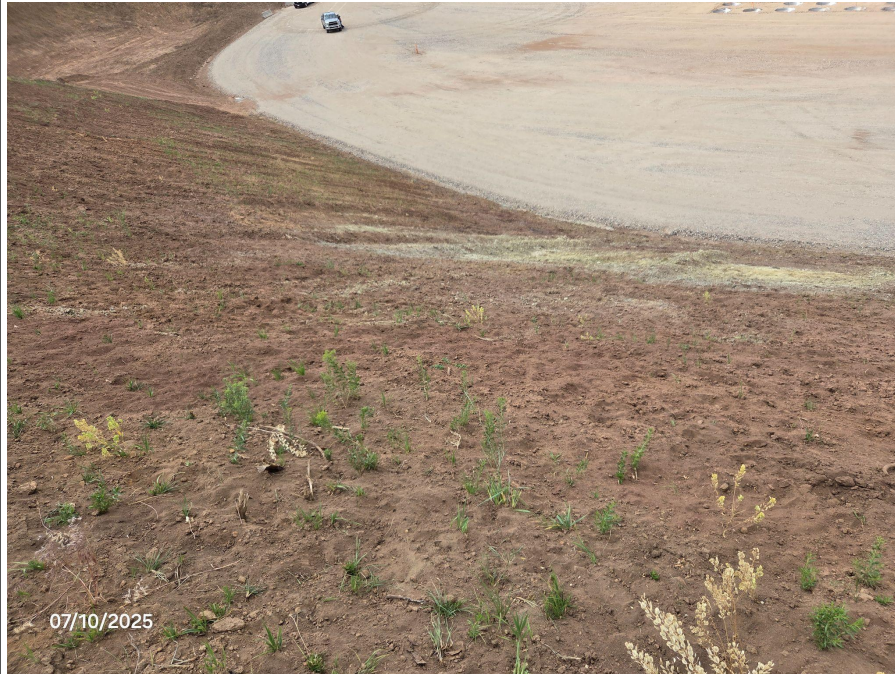
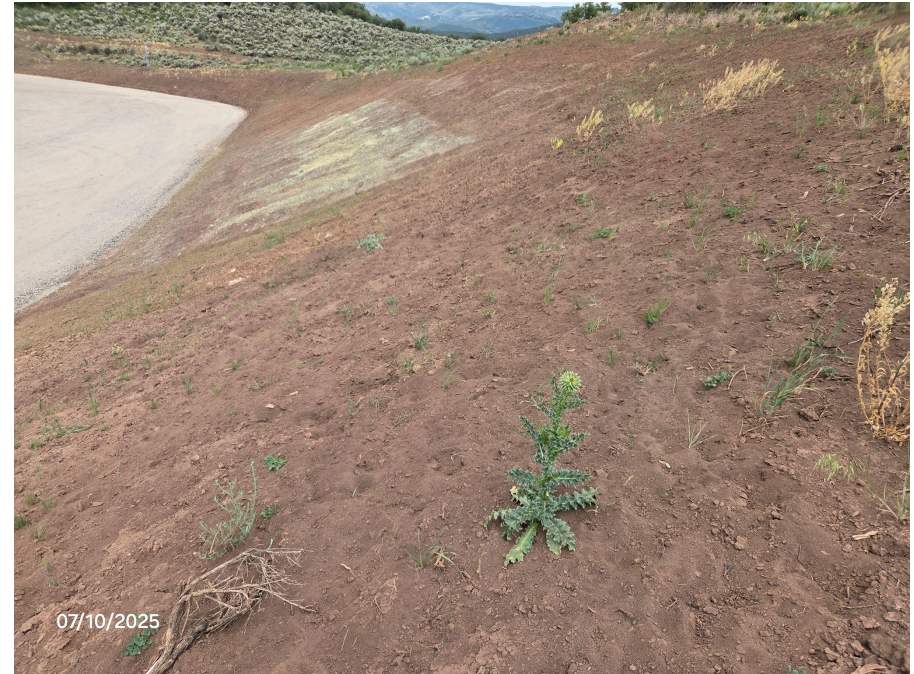
Photo 8: Photos taken from the cut slopes on the east end of the Location; facing south and northwest. Photos examples showing BMPs to stabilize the slopes of the Location remain missing or insufficient; soils remain predominantly bare and exposed; erosion/degradation observed.

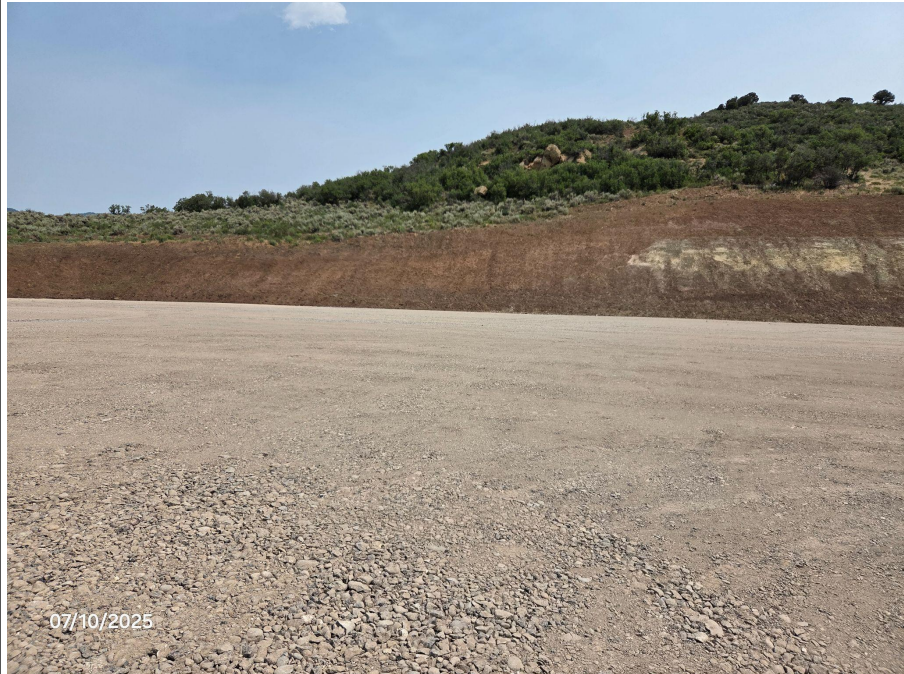
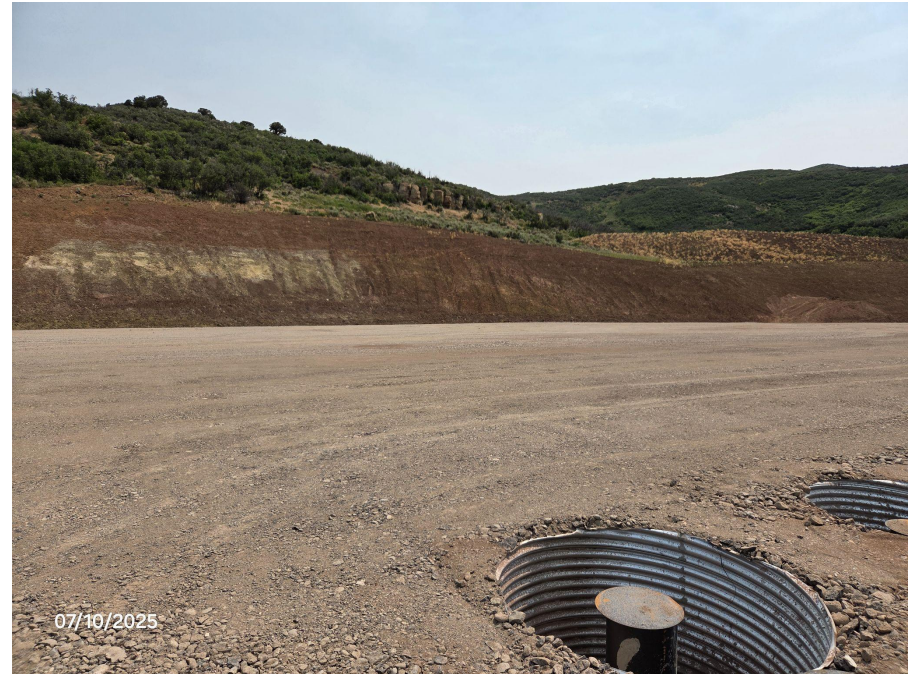
Photo 9: Photos taken from the WPS of the Location, facing northeast and east. See comments under photo 8.

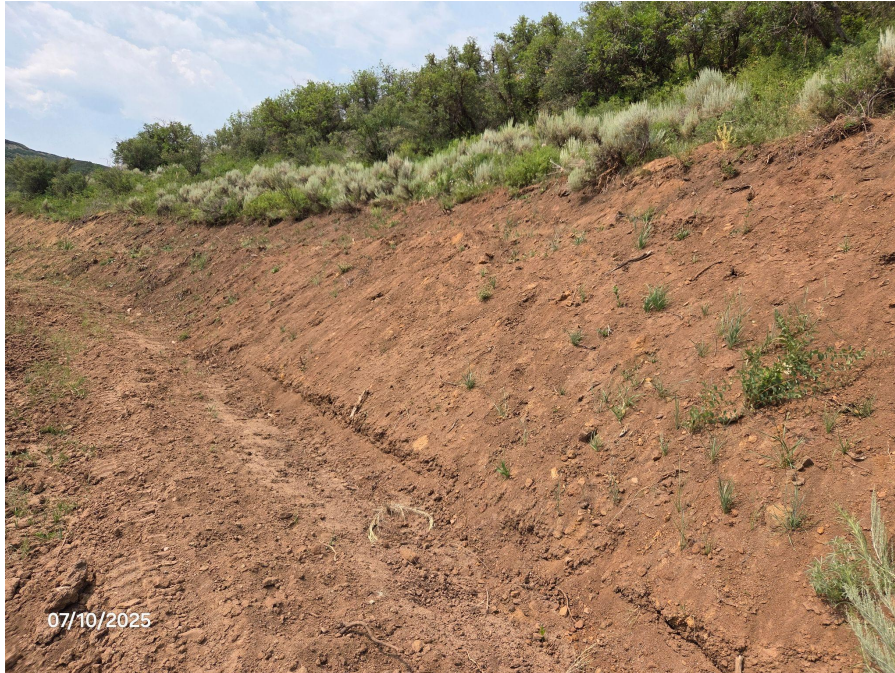
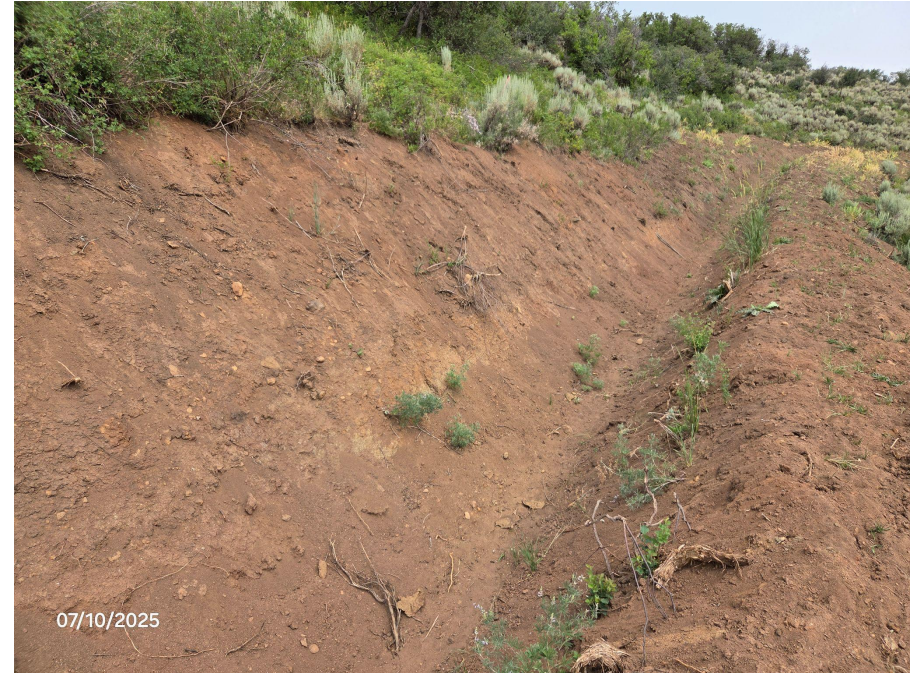
Photo 10: Photos taken from the west end of the Location, facing south and north. Photos examples showing BMPs to stabilize the slopes of the Location remain missing or insufficient; soils remain predominantly bare and exposed; erosion/degradation observed.

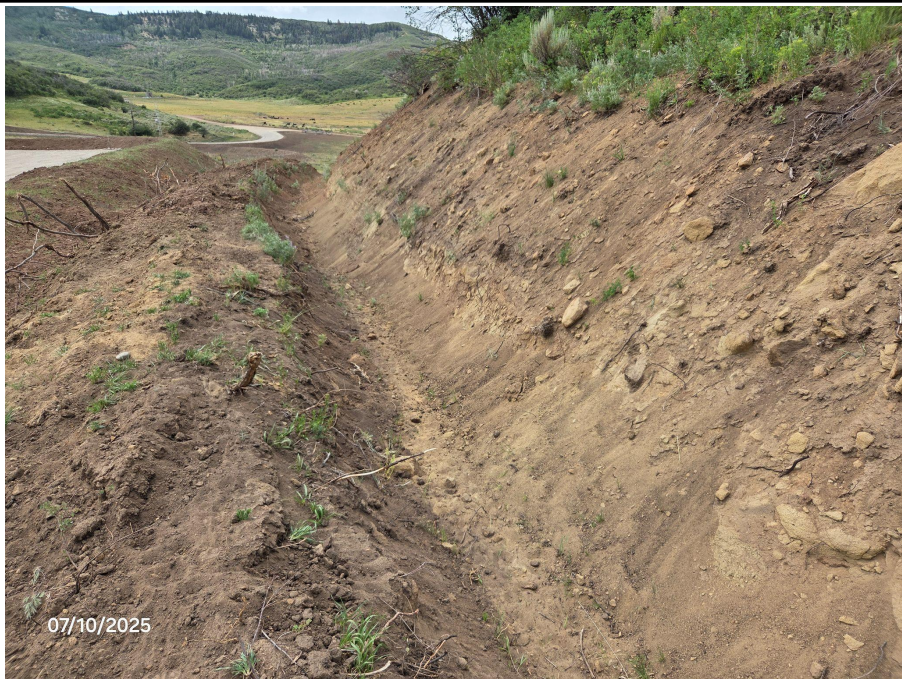
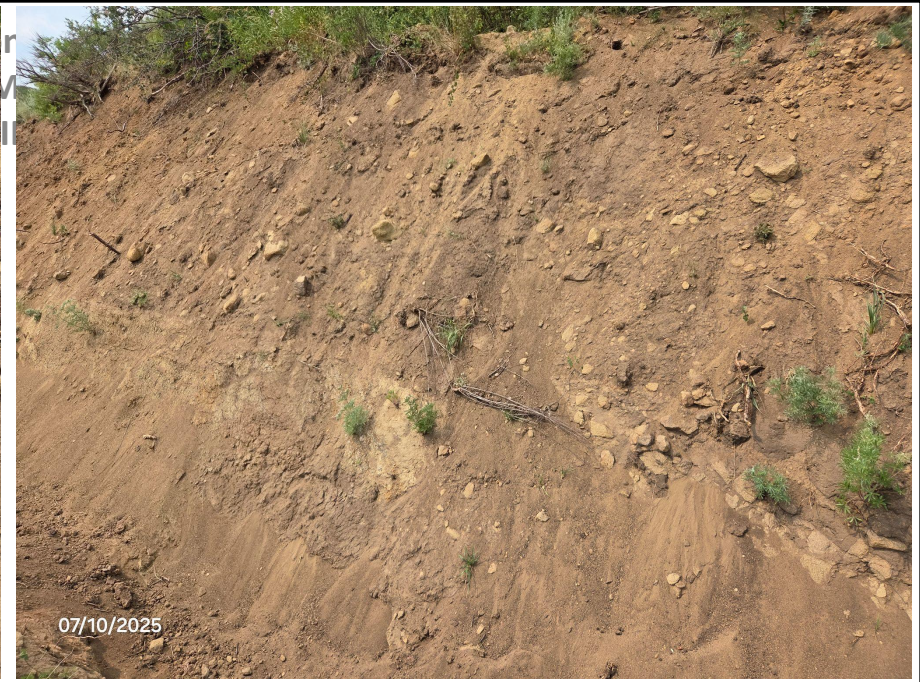
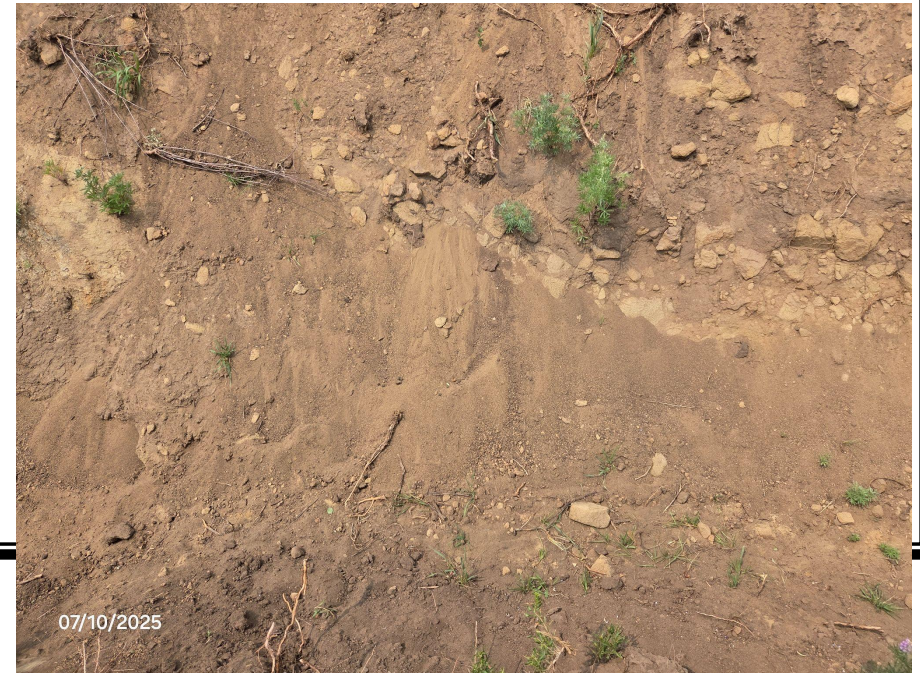
Photo 11: Photos taken from the west end of the Location. Photos examples showing BMPs to stabilize the slopes of the Location remain missing or insufficient; soils remain predominantly bare and exposed; erosion/degradation observed.

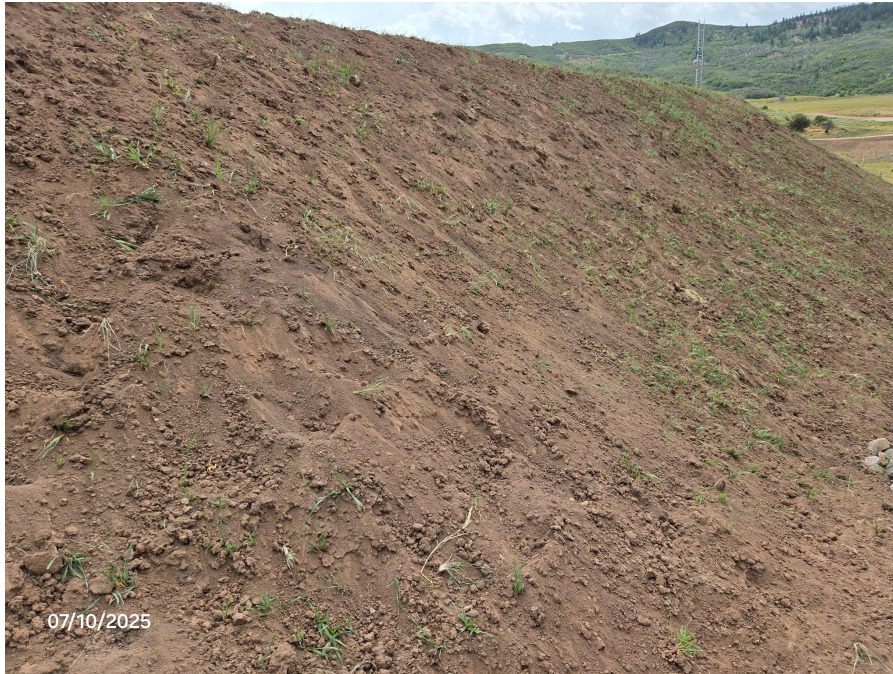
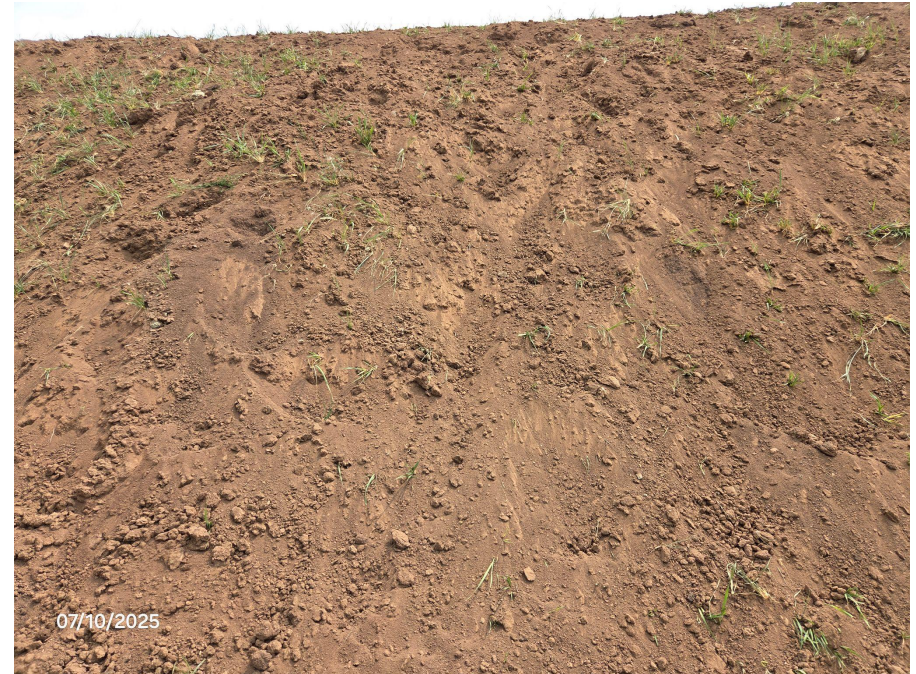
Photo 12: Photos taken from the fill slopes on the west end of the Location. Photos examples showing BMPs to stabilize the slopes of the Location remain missing or insufficient; soils remain predominantly bare and exposed; erosion/degradation observed.

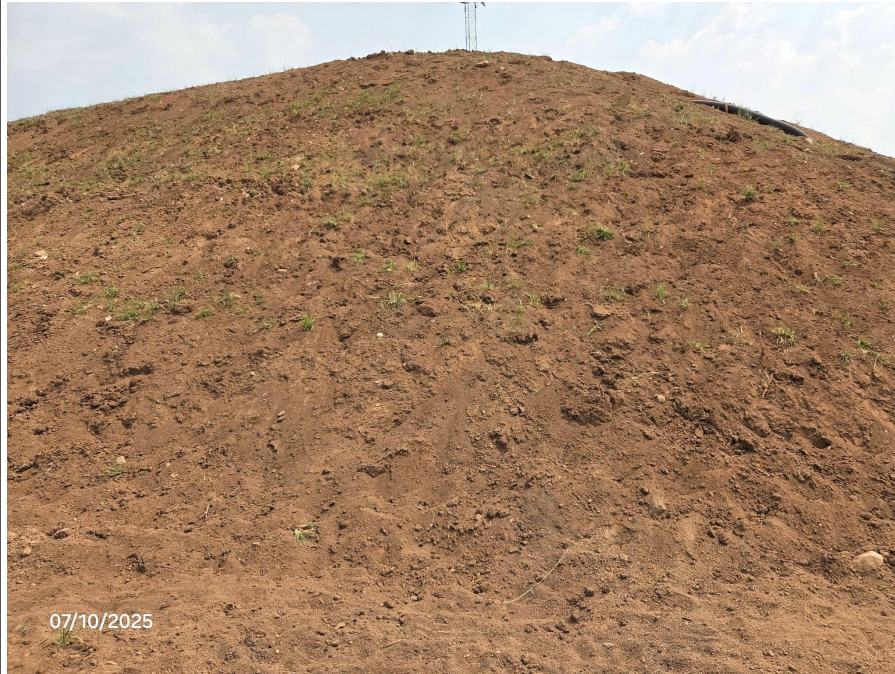
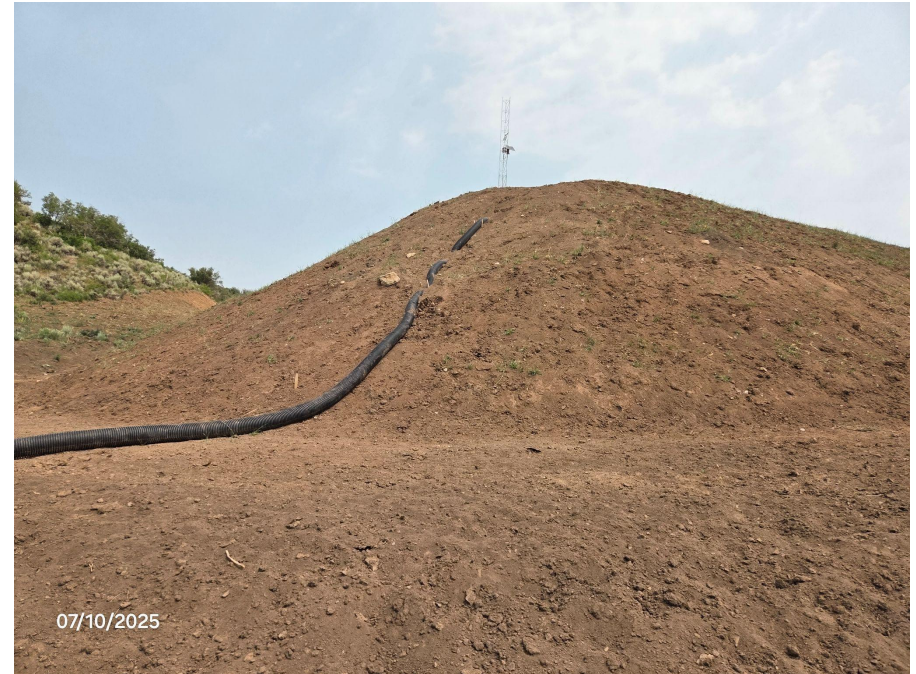
Photo 13: See comments under photo 12.

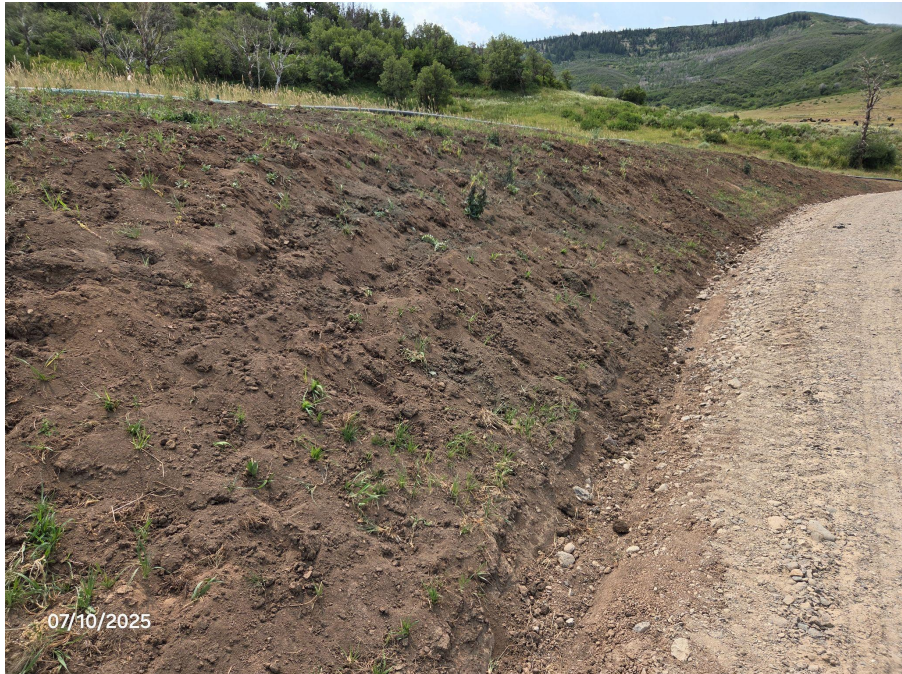
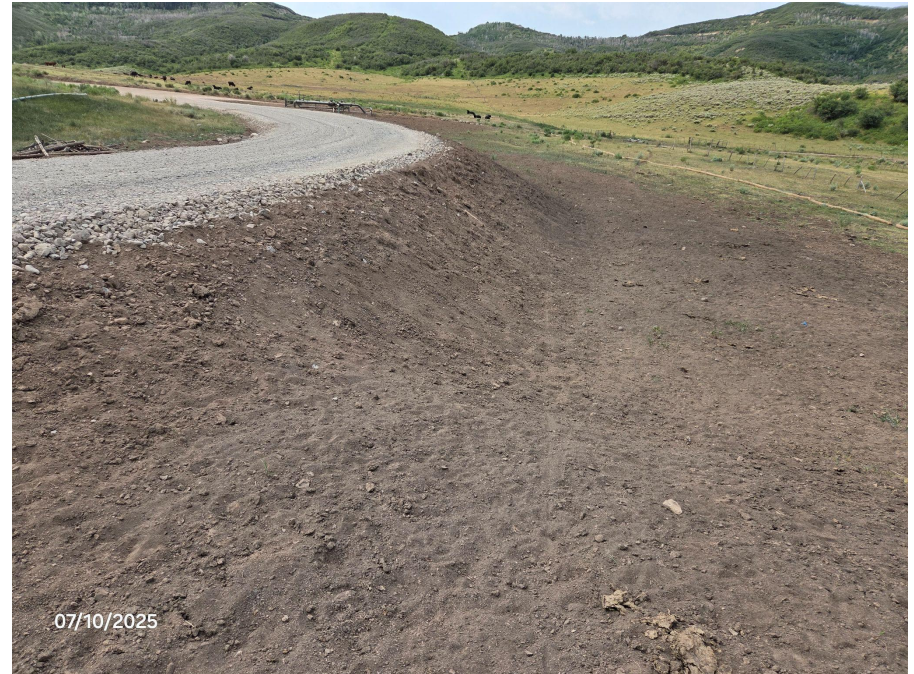
Photo 14: Photos taken from the cut and fill slopes along the access road. Photos examples showing BMPs to stabilize the slopes of the Location remain missing or insufficient; soils remain predominantly bare and exposed; erosion/degradation observed.

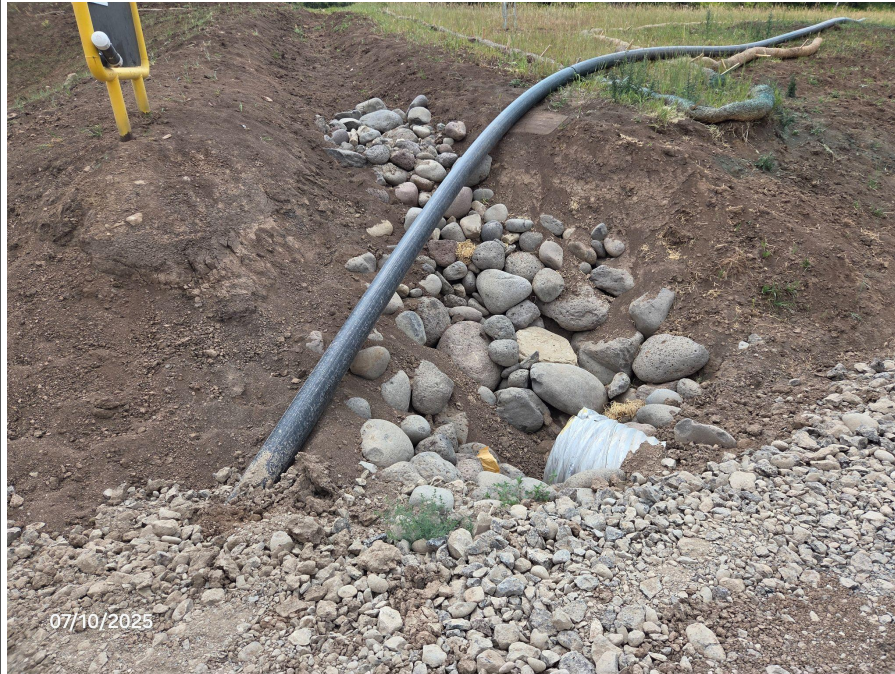
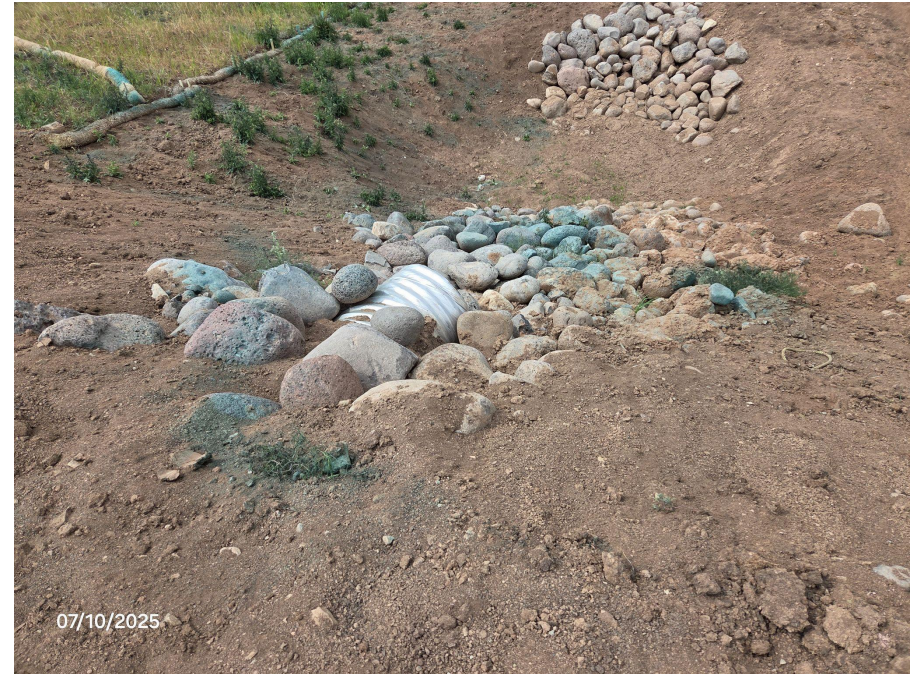
Photo 15: Photos taken from the culvert of the access road/Location entrance. Photos 15-17 examples showing inlet/outlet protections at the culverts, slope drains and sediment traps have been installed. However, BMPs have not been installed per good engineering practices; Operator appears to have only used large, smooth stones, and not appropriately sized multi-angular material. Rip-rap has also not been installed in conjunction with geotextile lining. This will likely facilitate degradation and failure at the inlets/outlets (see photo 19). Maintenance advised.

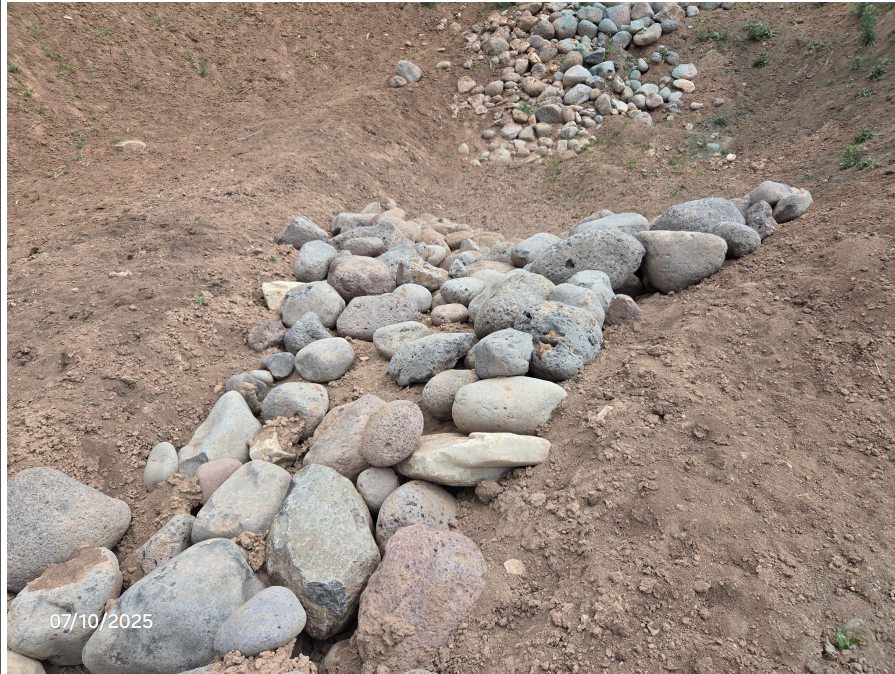
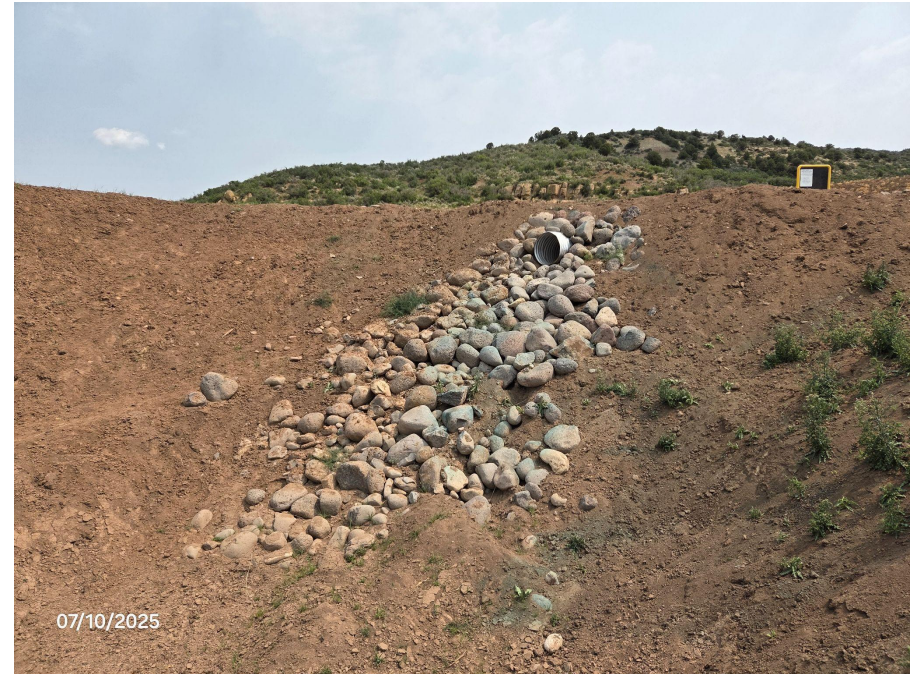
Photo 16: See comments under photo 15.

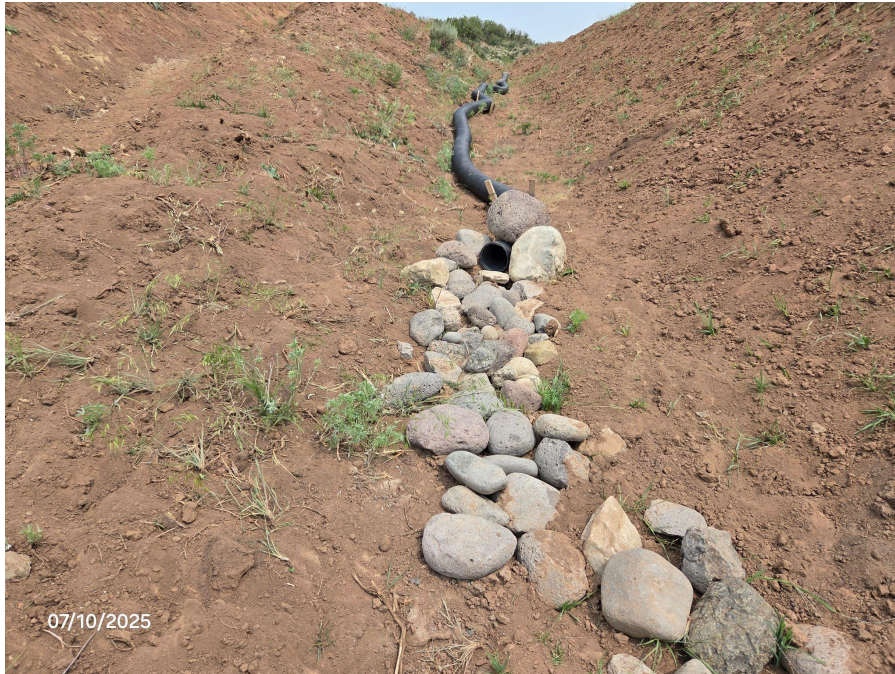
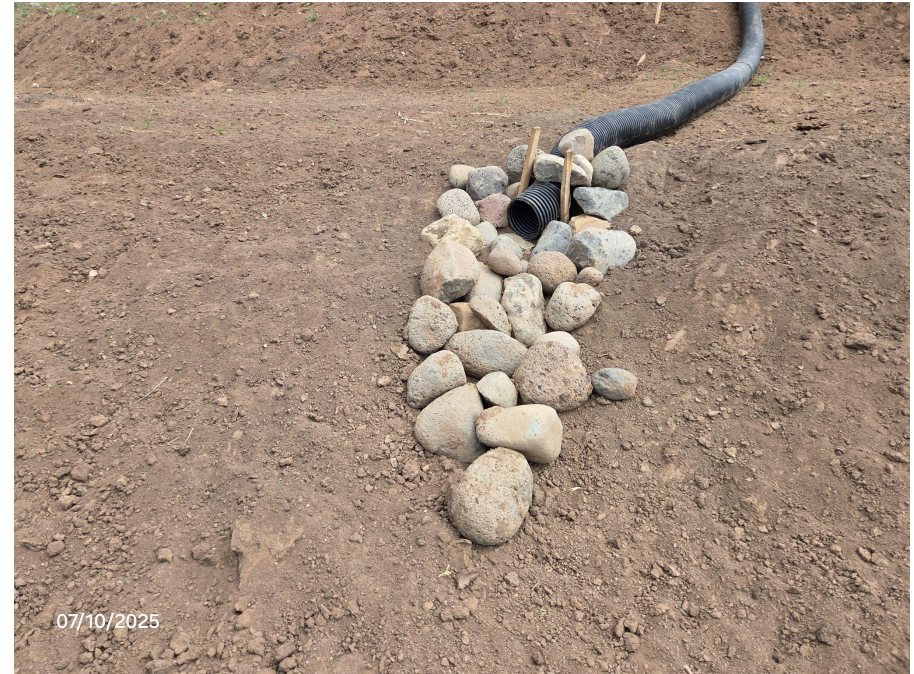
Photo 17: Slope drain outlets on the southwest end of the Location. See comments under photo 15.
