Inspection Photos

Operator: LARAMIE ENERGY LLC #10433

Location ID: 487592

Inspection Doc: 718100633

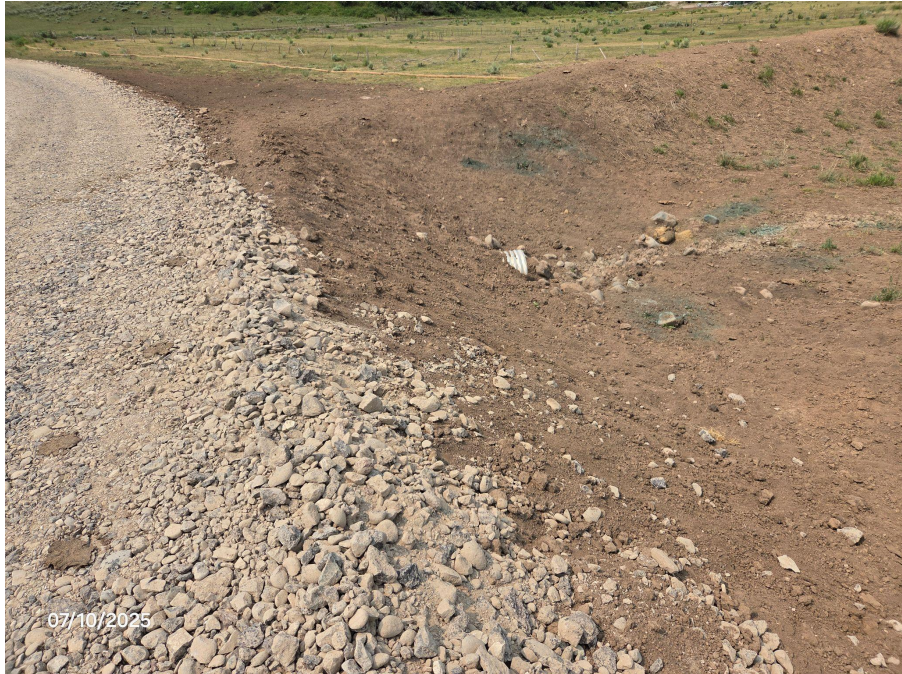
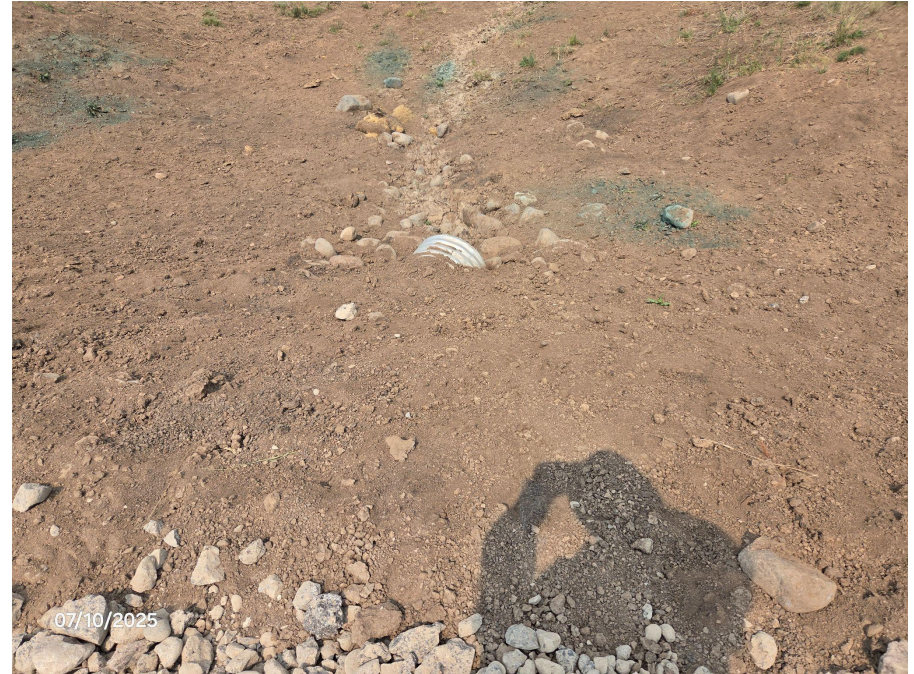
Photo 1: Photos 18-19 taken from the culvert along the access road. Photos show outlet protections at the culvert are missing or insufficient, resulting in failure of the BMP and erosion degradation.

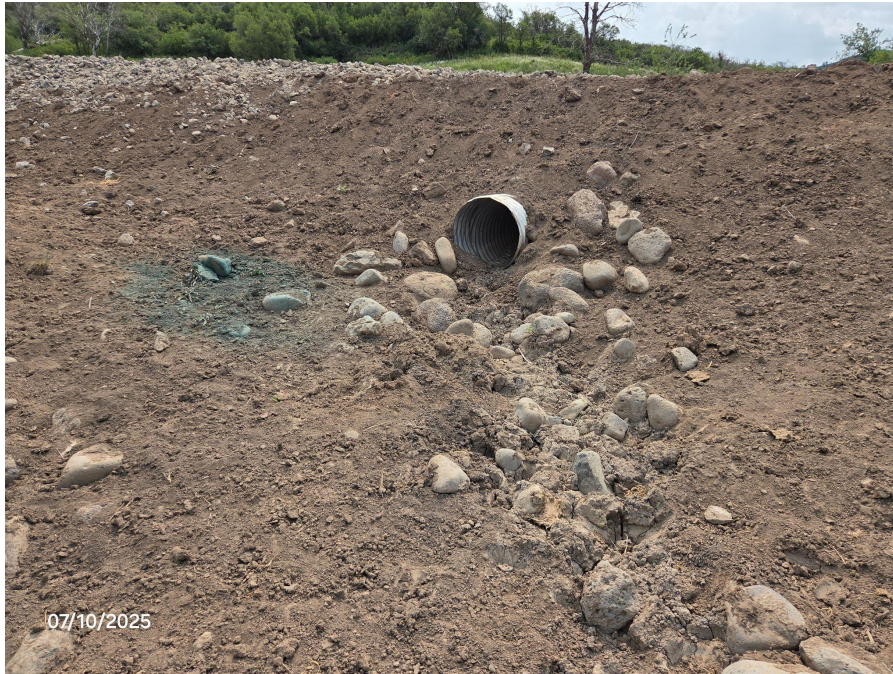
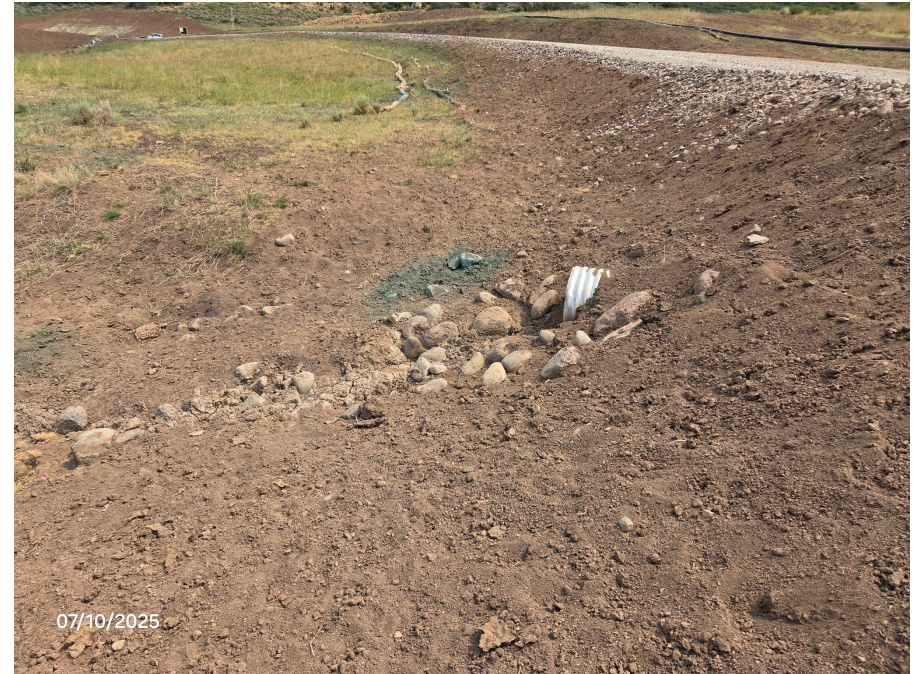
Photo 19: See comments under photo 18.

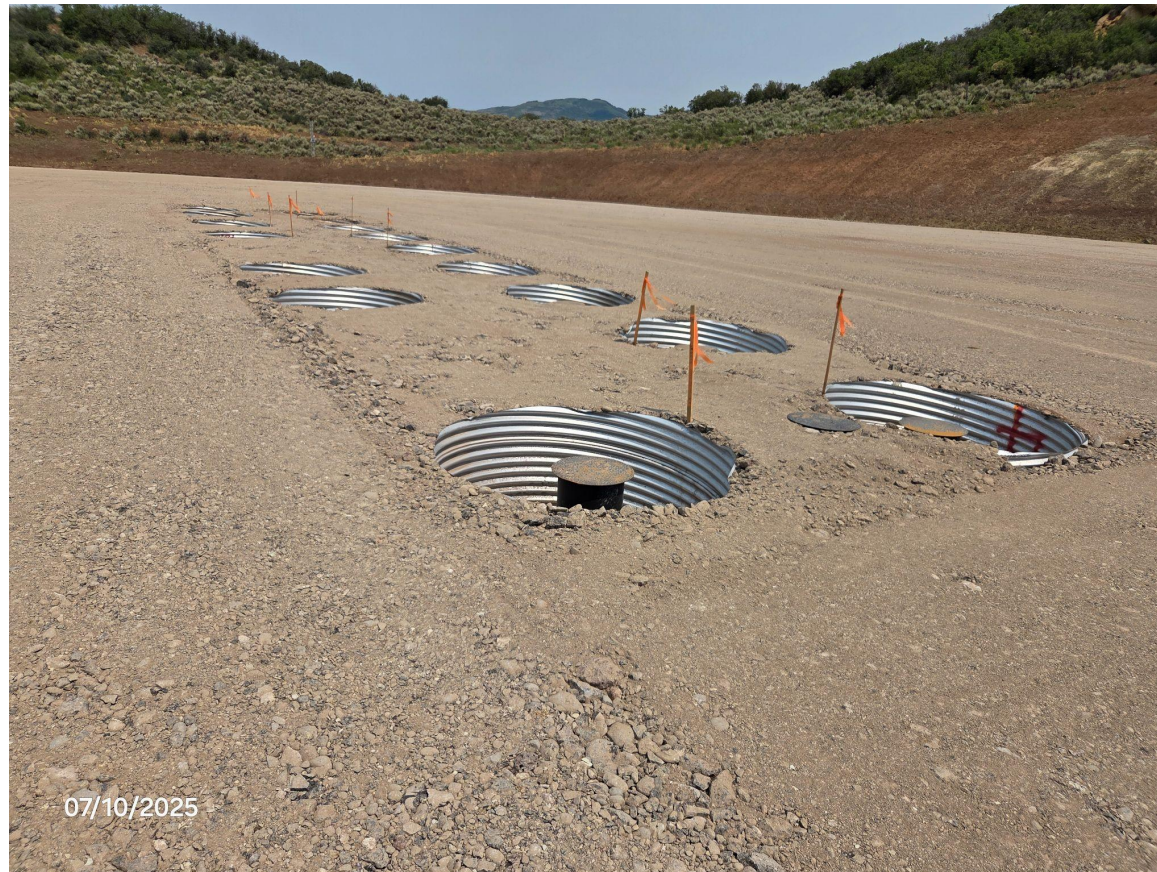
Photo 20: Photo shows cellars are missing required covers/fence.
