Inspection/Audit Photos

Location Name: TEP ROCKY MOUNTAIN LLC Castle Springs Federal B Pad

Location # 335054

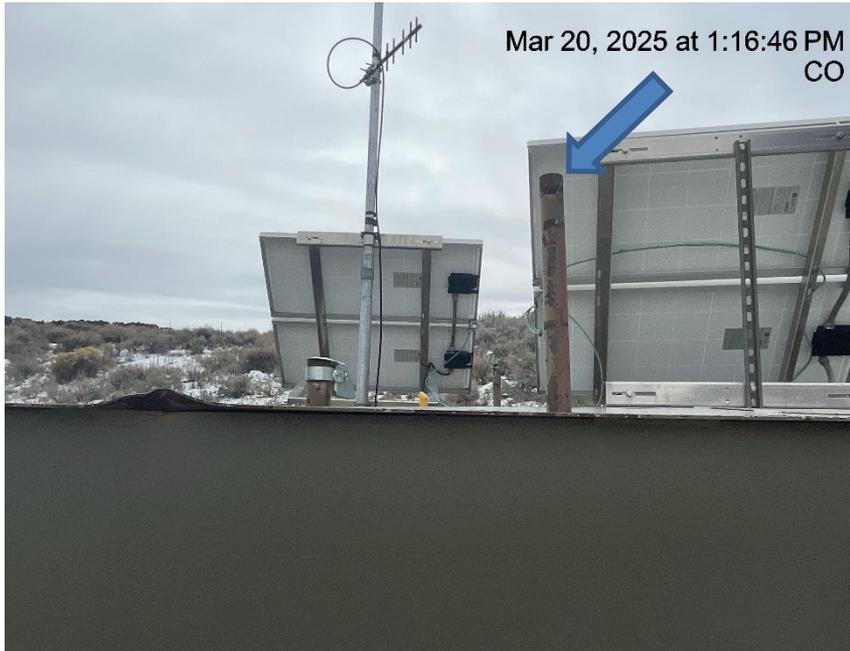
Photo # 5853 From inspection 708906068 conducted on 03/20/2025 PRV vent line does not comply with CECMC pressure safety device rules

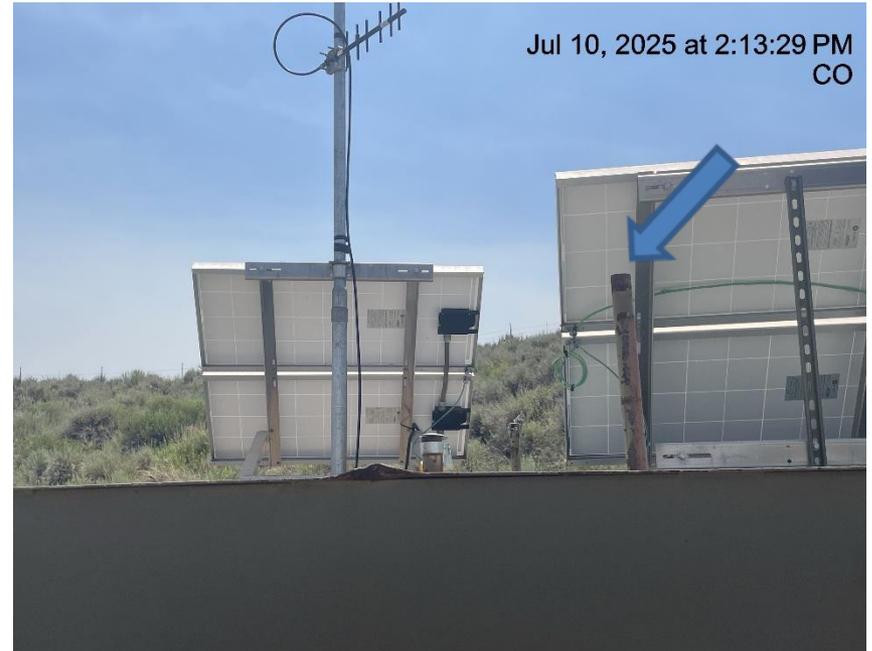
Photo # 1036 PRV vent line does not comply with CECMC pressure safety device rules

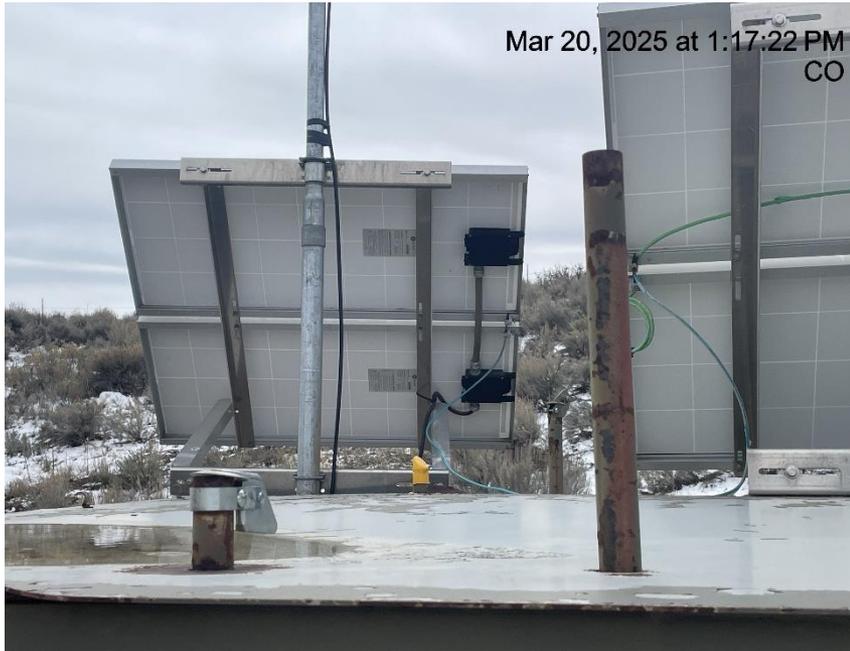
Photo # 5854 From inspection 708906068 conducted on 03/20/2025 PRV vent line does not comply with CECMC pressure safety device rules

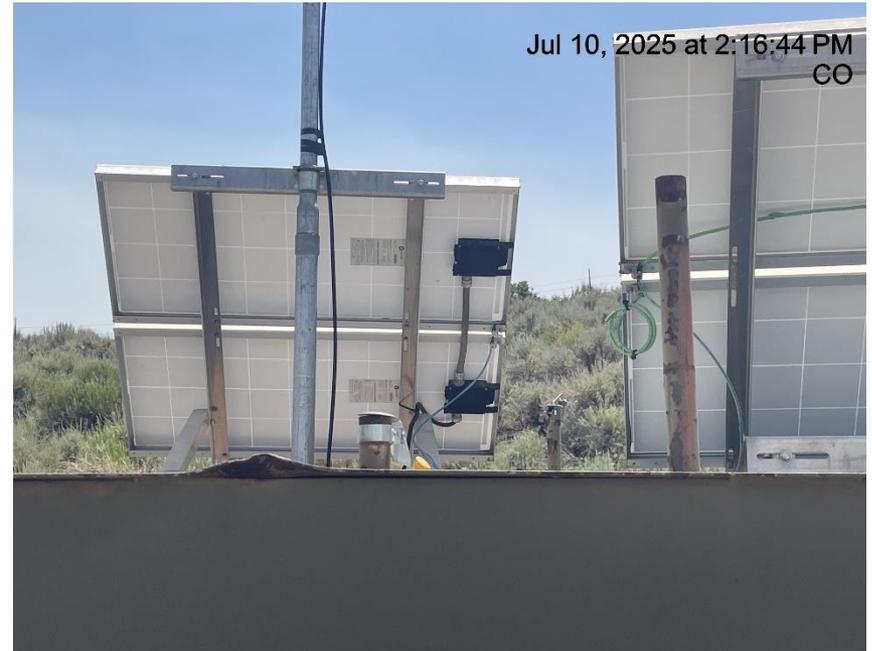
Photo # 1037 PRV vent line does not comply with CECMC pressure safety device rules

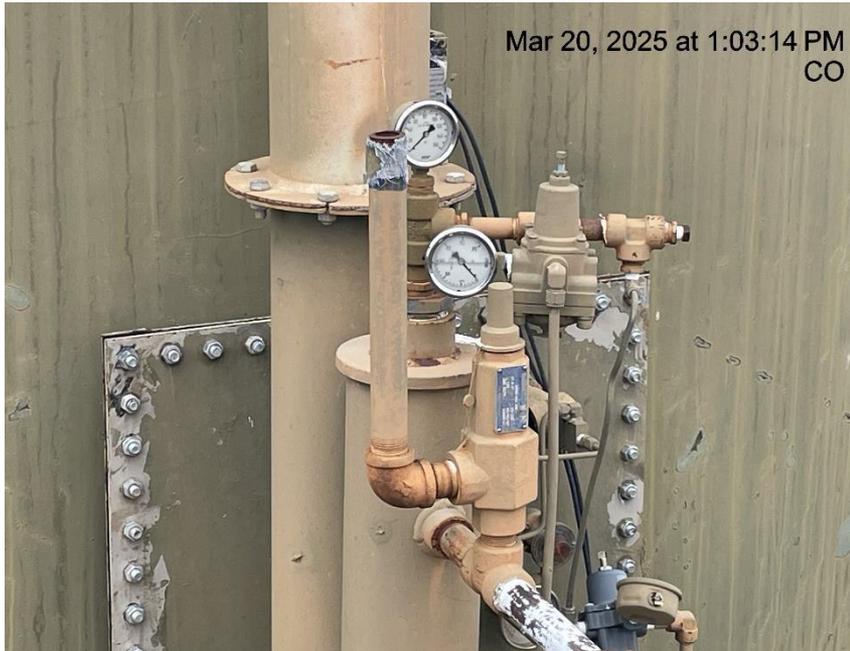
Photo # 5855 From inspection 708906068 conducted on 03/20/2025 PRV vent line does not comply with CECMC pressure safety device rules

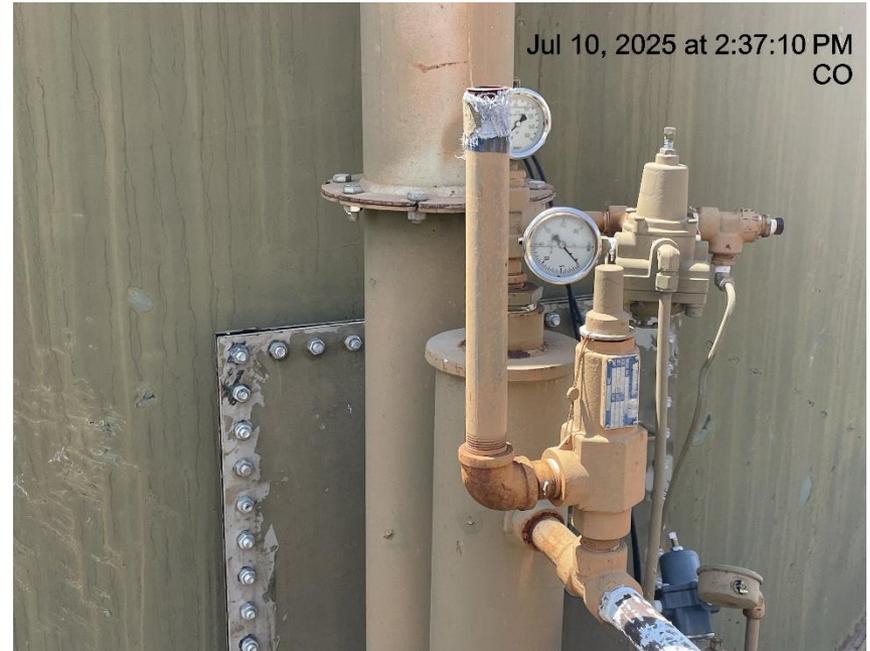
Photo # 1038 PRV vent line does not comply with CECMC pressure safety device rules

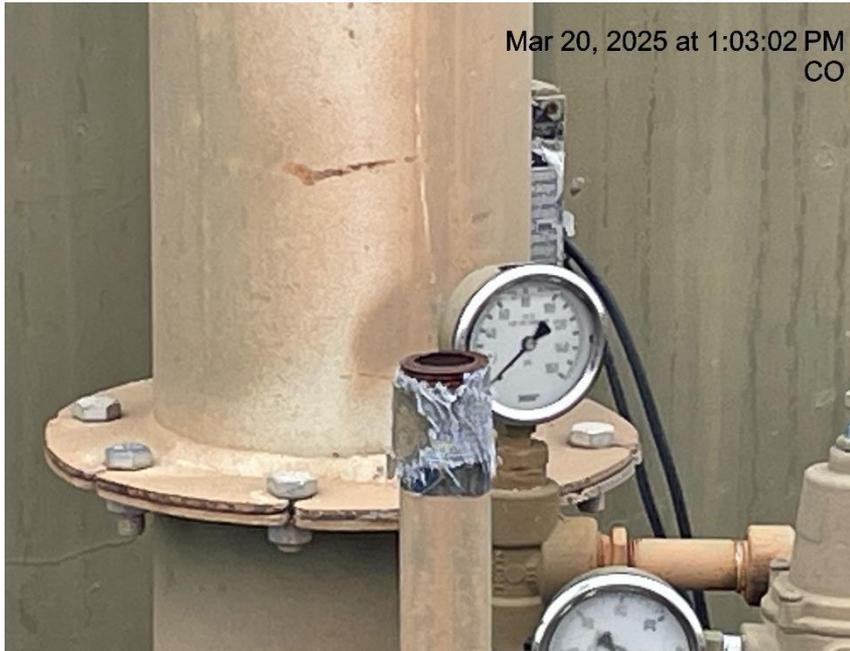
Photo # 5856 From inspection 708906068 conducted on 03/20/2025 PRV vent line does not comply with CECMC pressure safety device rules

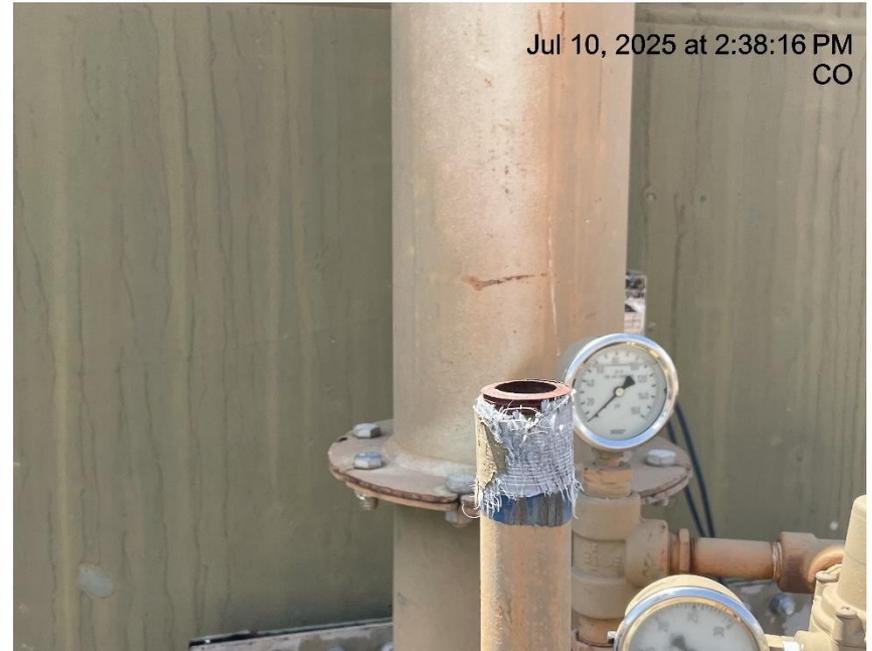
Photo # 1039 PRV vent line does not comply with CECMC pressure safety device rules

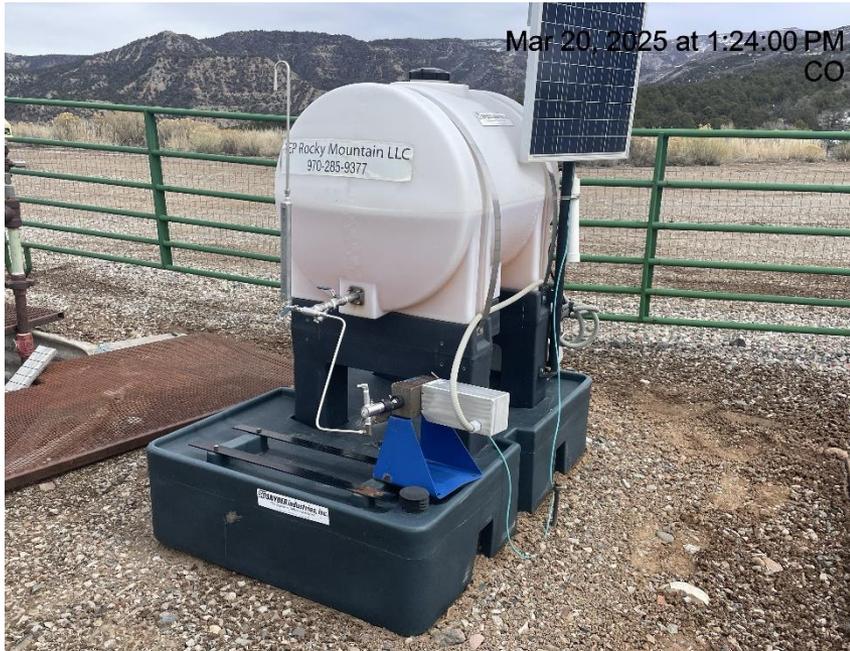
Photo # 5857 From inspection 708906068 conducted on 03/20/2025 Unused equipment

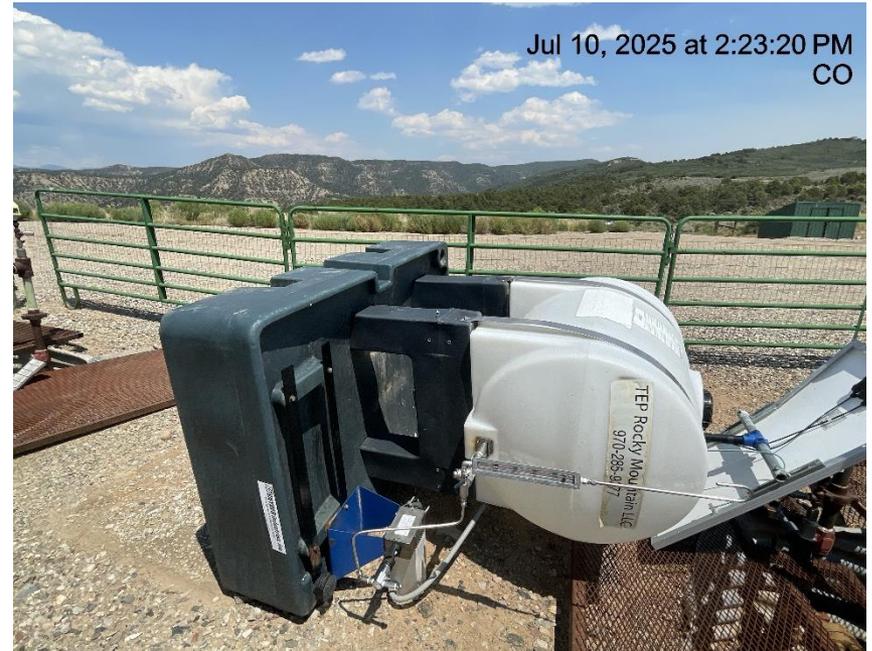
Photo # 1040 Unused equipment

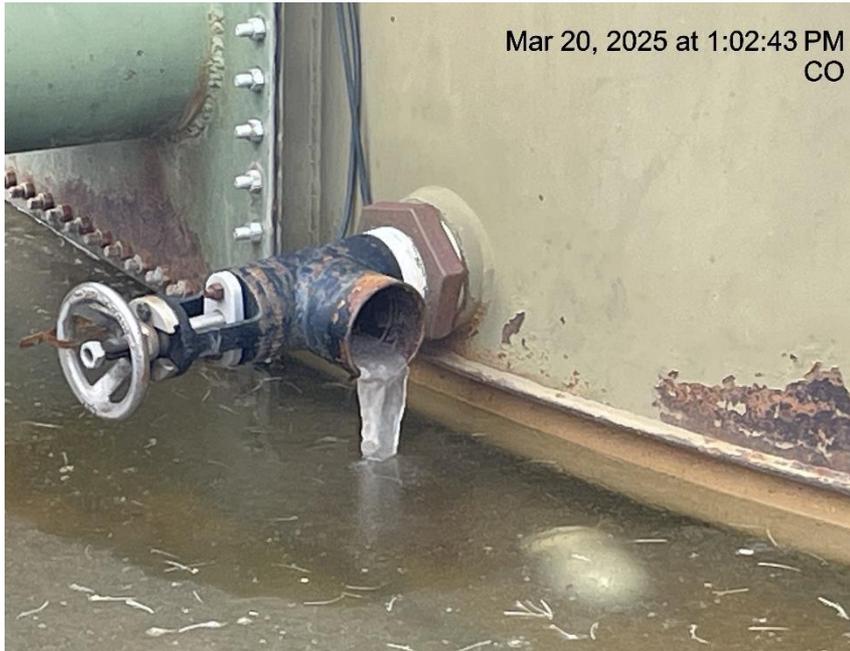
Photo # 5859 From inspection 708906068 conducted on 03/20/2025 Open ended load line

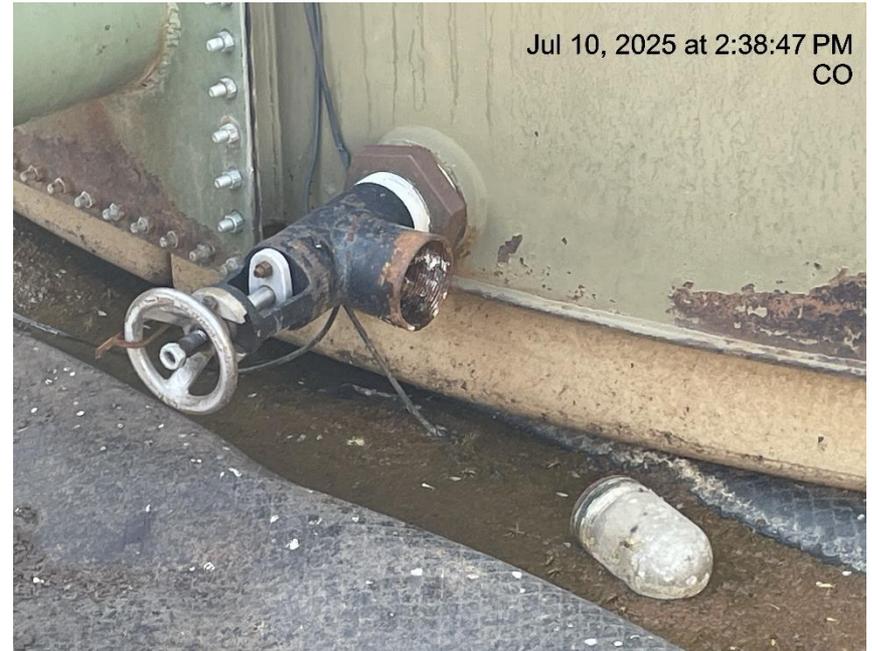
Photo # 1041 Open ended load line

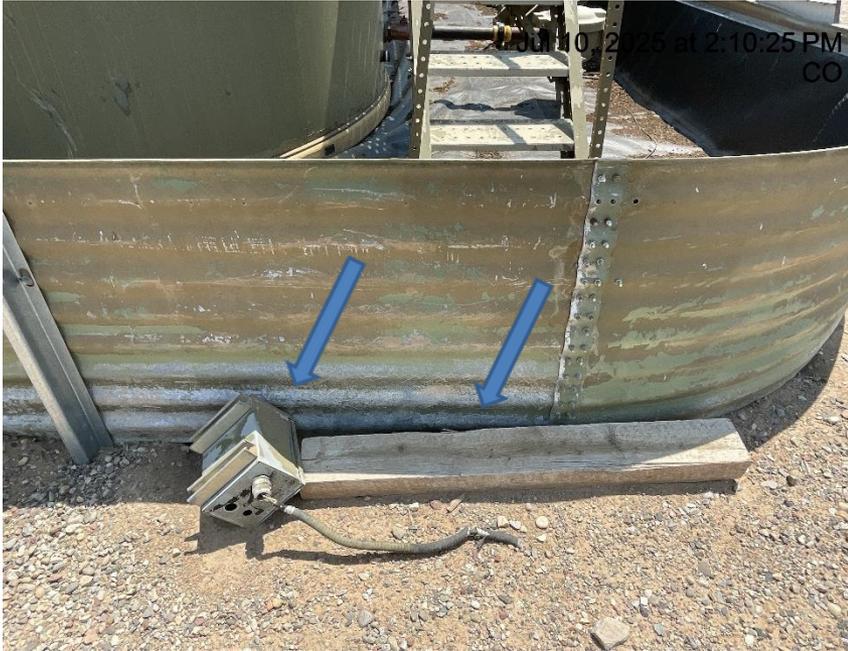
Photo # 1042 Debris

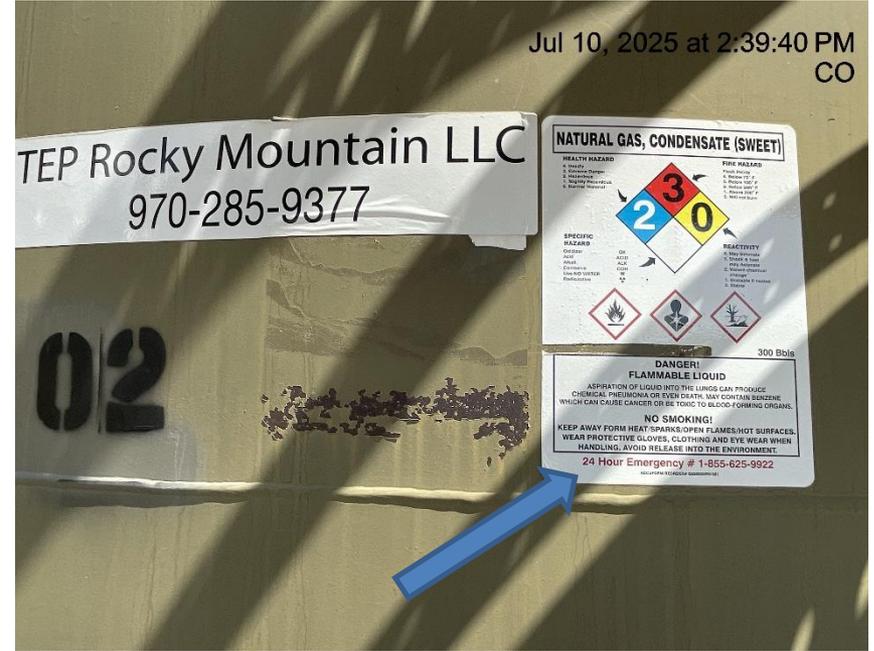
Photo # 1043 Emergency # on tank label disconnected/not in service

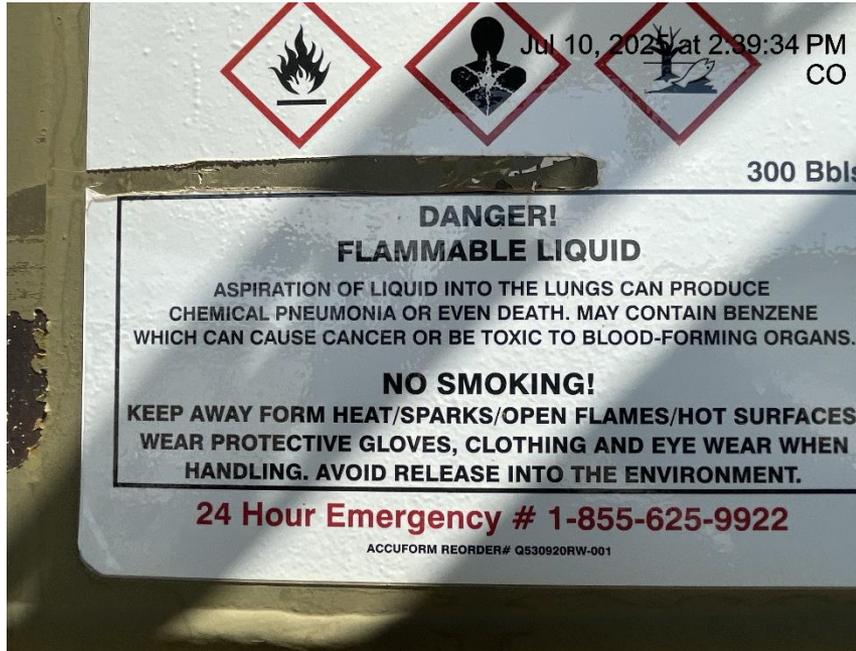
Photo # 1044 Emergency # on tank label disconnected/not in service

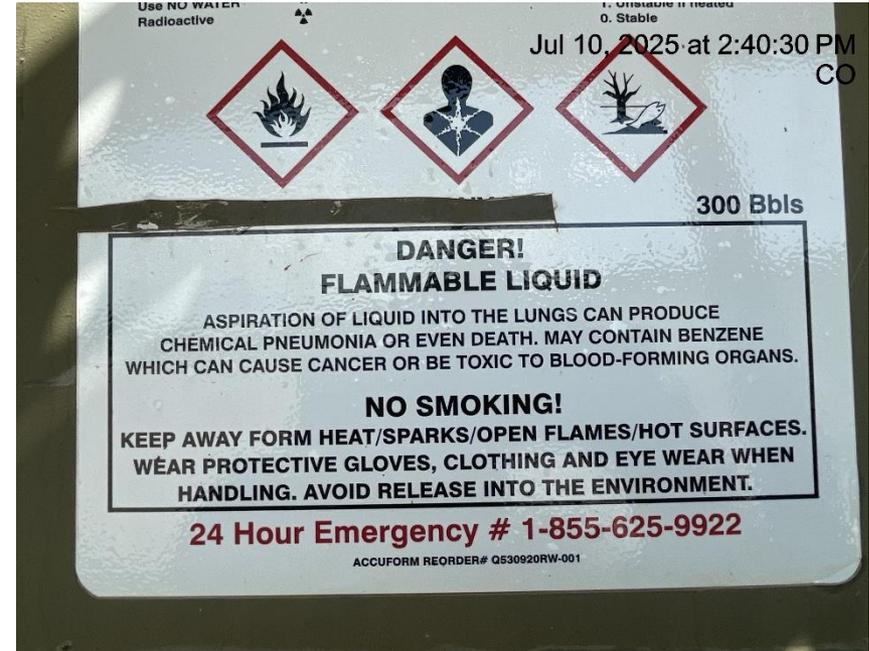
Photo # 1045 Emergency # on tank label disconnected/not in service
