Inspection Photos

Operator: LARAMIE ENERGY LLC #10433

Location ID: 391336

Inspection Doc: 718100637

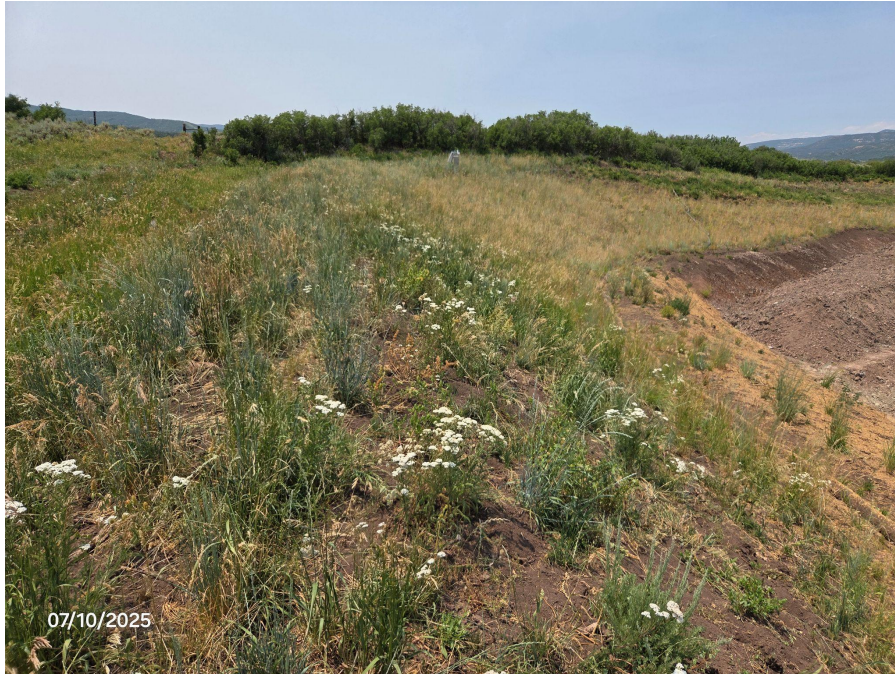
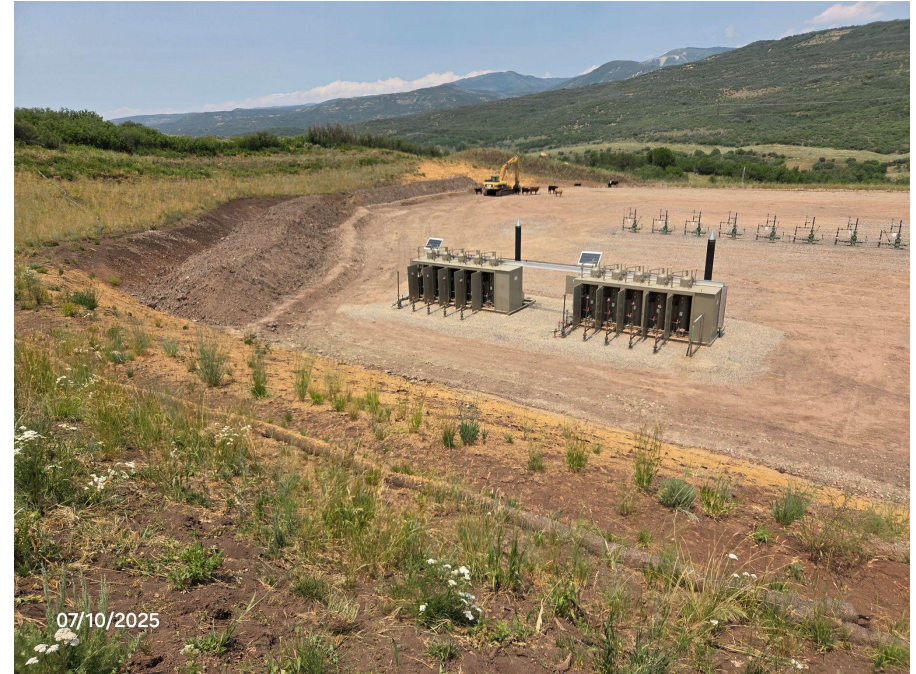
Photo 1: Photos 1-2 taken from the south end of the Location. Photos provide an overview from west, northwest, northeast to east. All wells have been drilled or abandoned. Location is subject to 1003 rules.

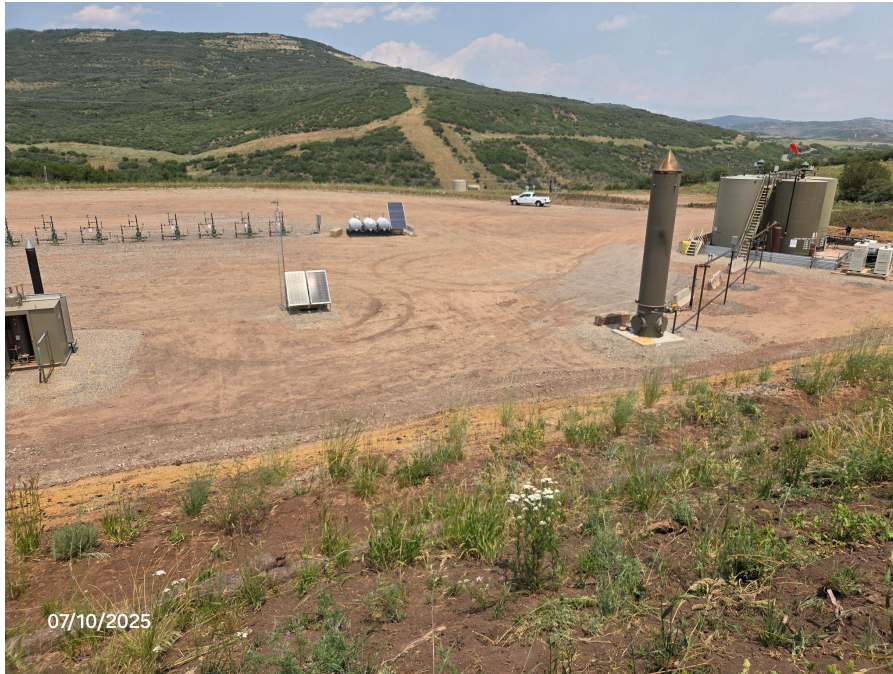
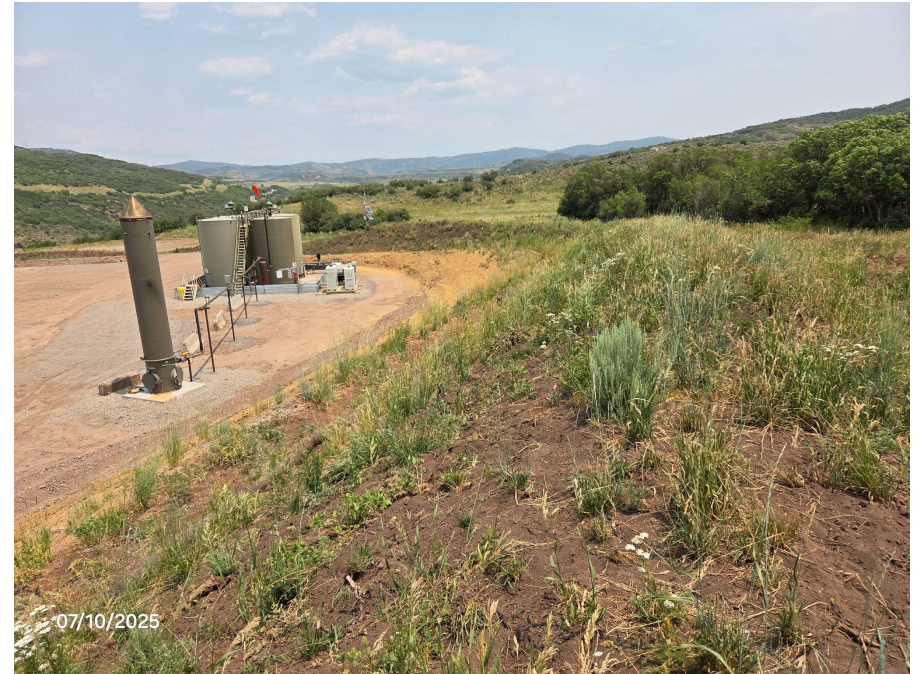
Photo 2: See comments under photo 1.

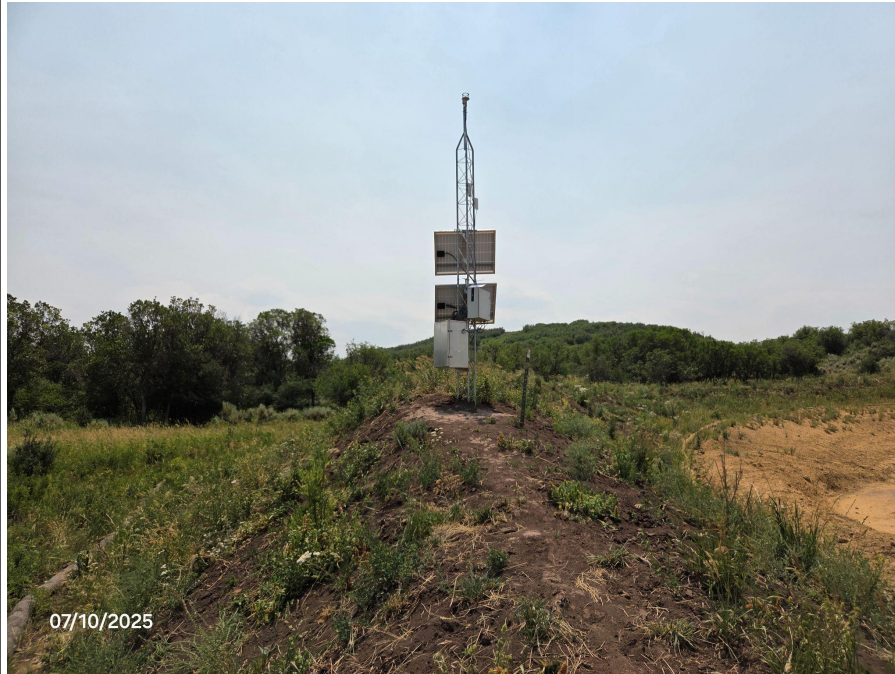
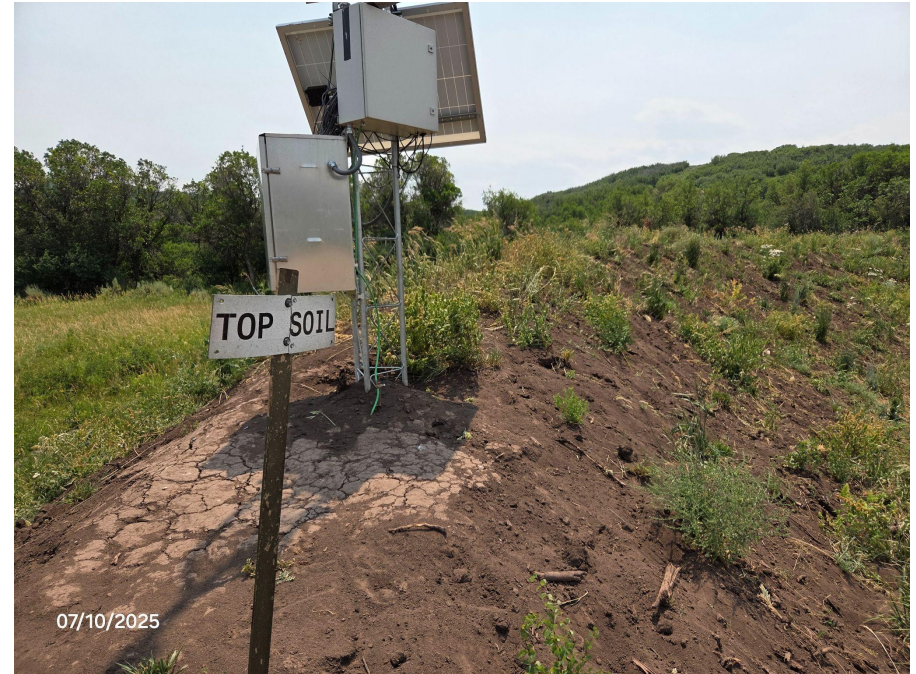
Photo 3: Photo taken from the topsoil stockpile on the southeast end of the Location, facing south. Operator has constructed three metal solar towers with concrete bases on top of the topsoil stockpiles on the southeast, west and north end of the Location. This does not comport with 1002.c topsoil protection requirements, and has resulted in compaction and contamination of the topsoil.

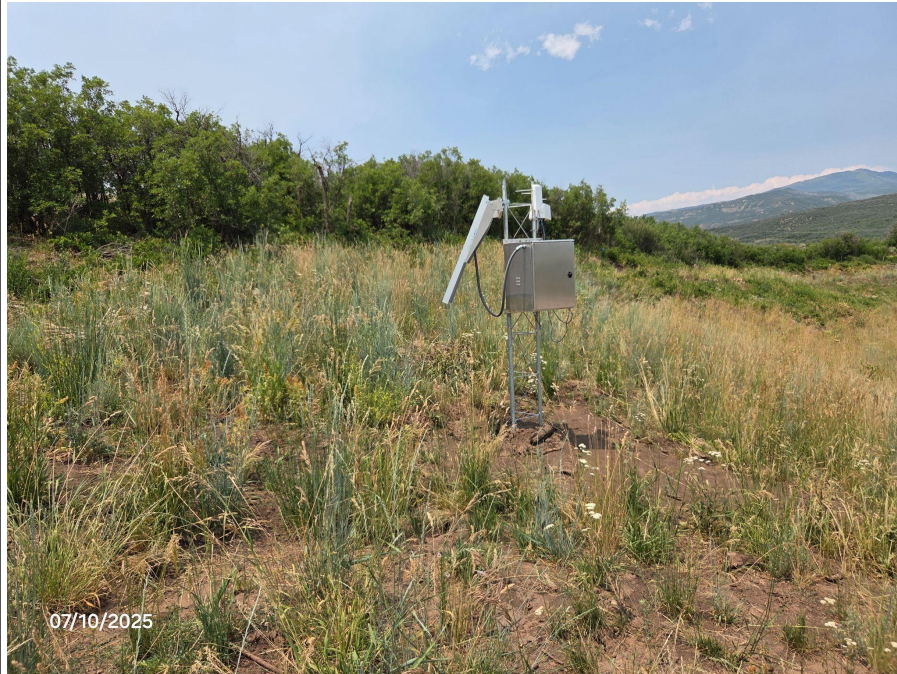
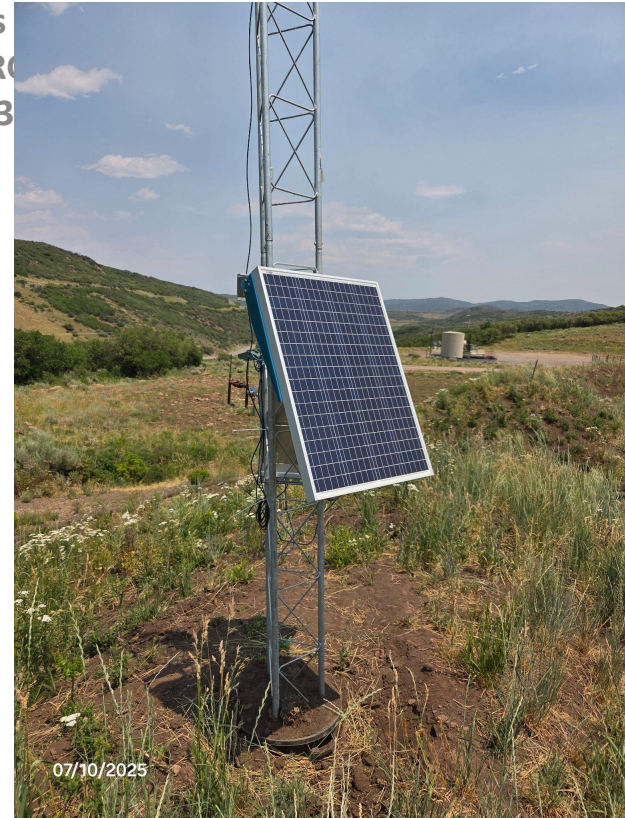
Photo 4: Photo left taken from the west end of the Location facing north; photo right taken from the north end of the Location facing east. See comments under photo 3.

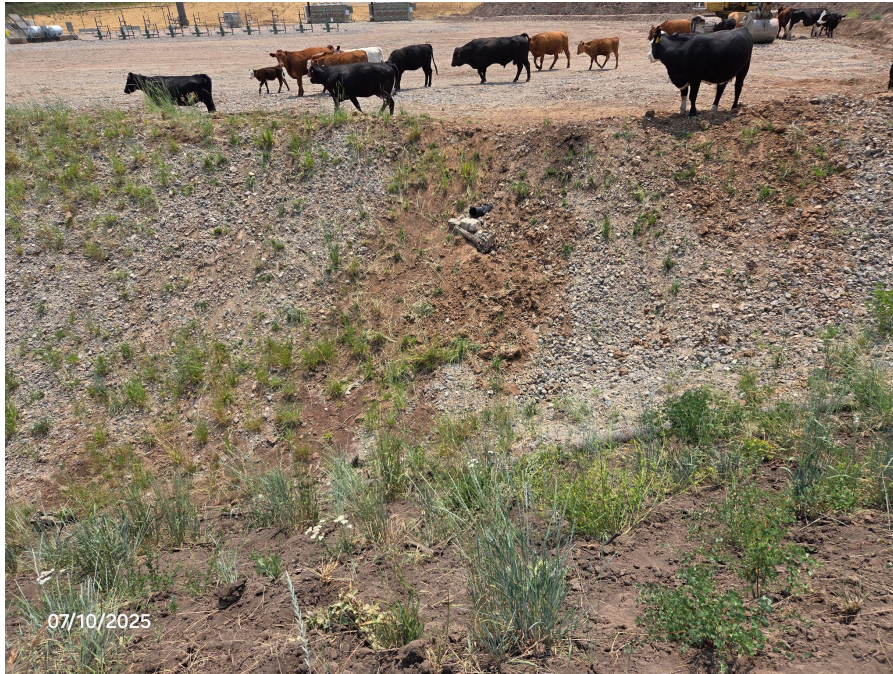
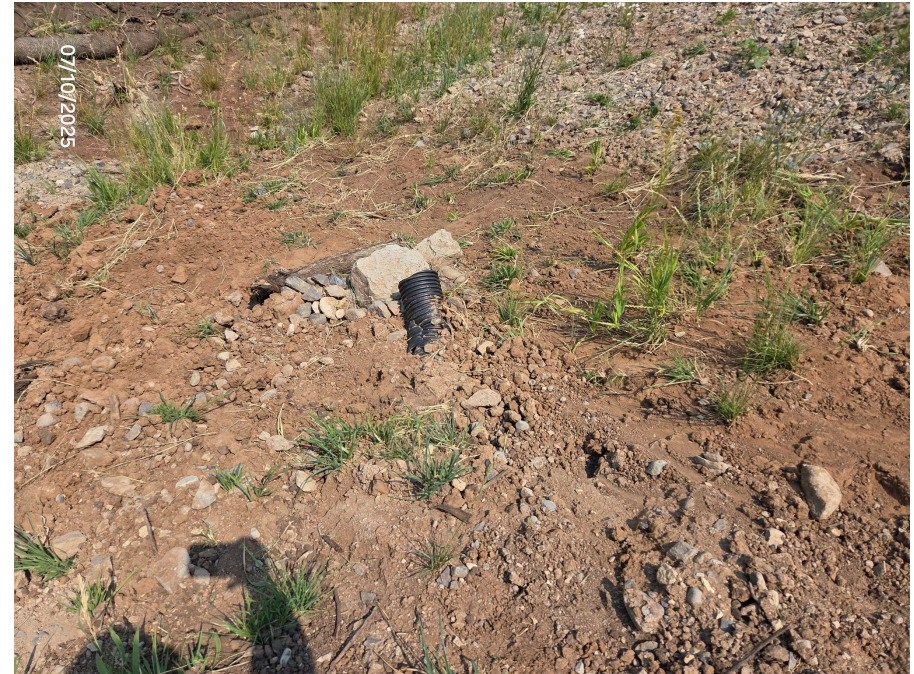
Photo 5: Photos show that the slope drain on the north end of the Location has not been constructed with an appropriately engineered outlet in accordance with good engineering practices. Outlet is inadequate in size, and has been constructed with only 1-2 rocks; per good engineering practices, outlet should protect the entire slope below the drain, be constructed with multi-angular rock of various sizes and geotextile lining.

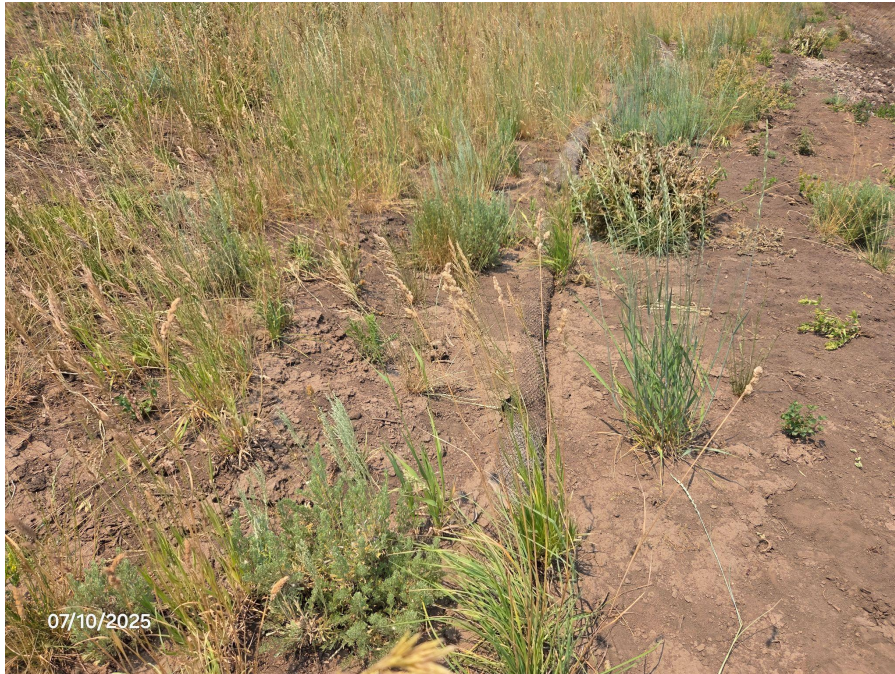
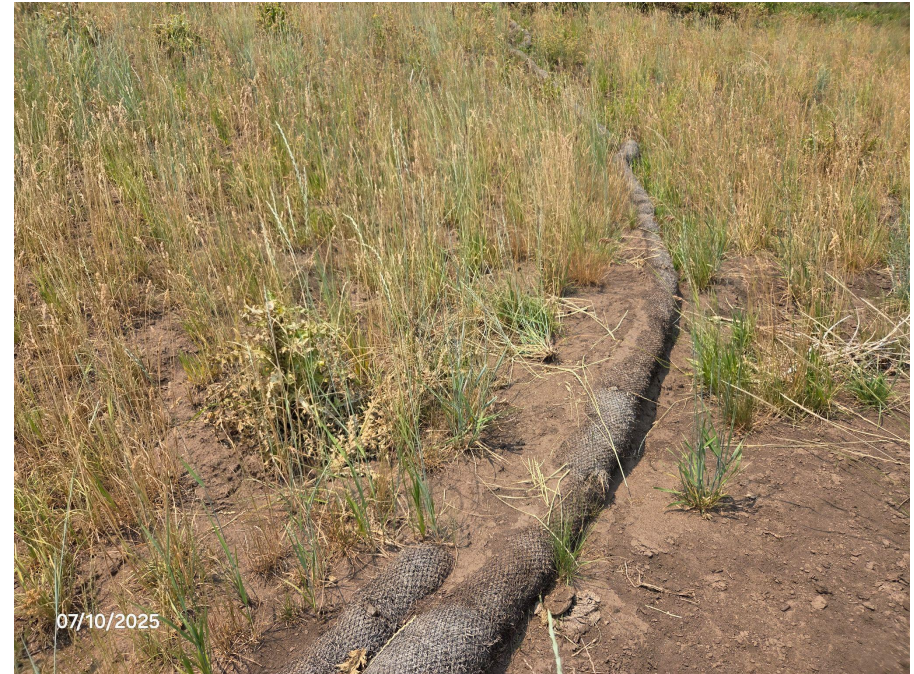
Photo 6: Photos taken from the west end of the Location. Erosion log has filled with sediment and/or is in disrepair. Photos 6-9 examples showing BMPs implemented throughout the Location are missing, insufficient and/or are no longer in proper functioning condition.

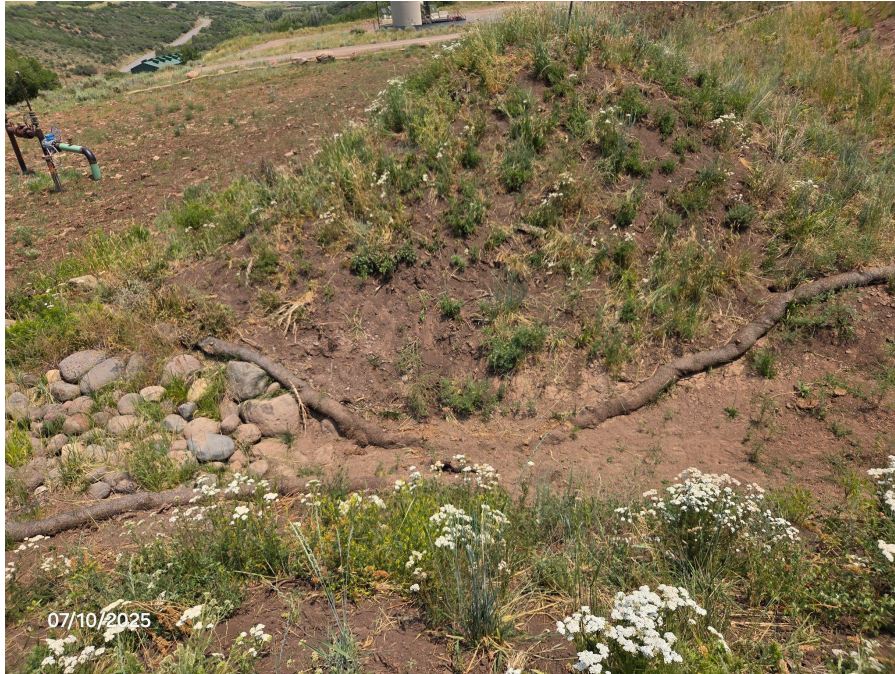
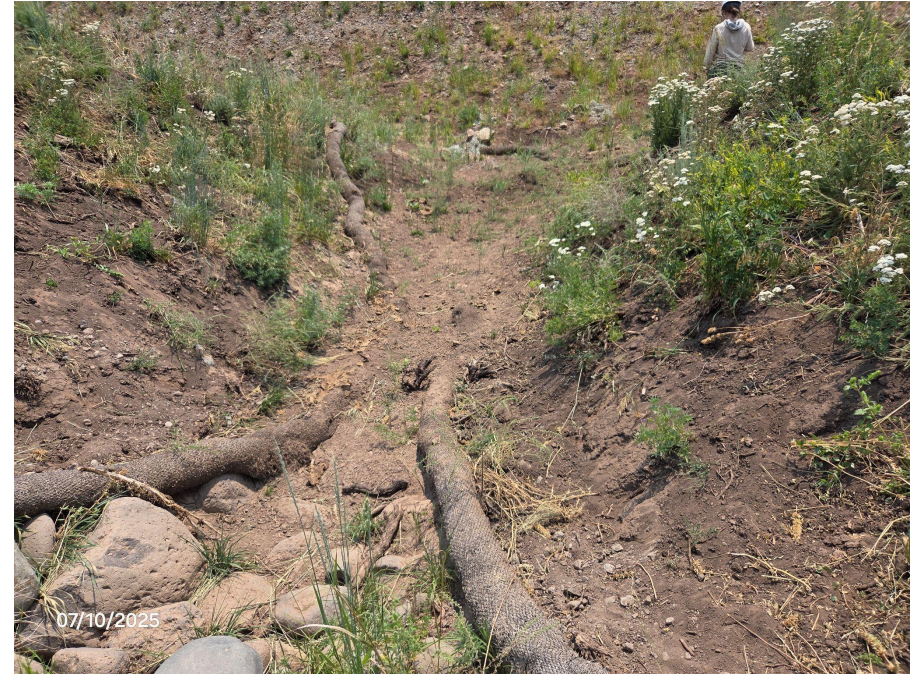
Photo 7: Photos taken from the topsoil stockpiles on the north end of the Location. See comments under photo 6.

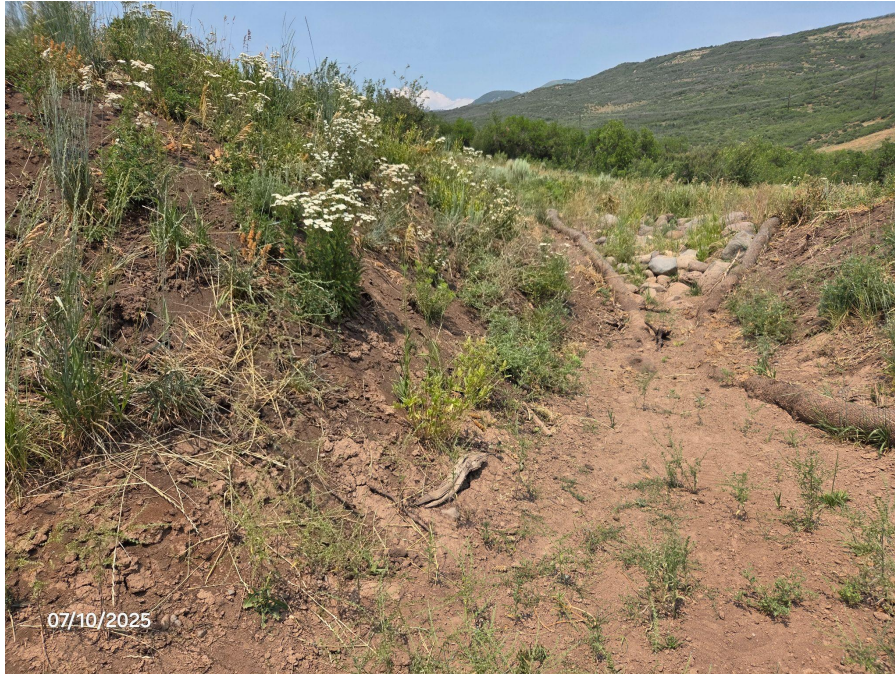
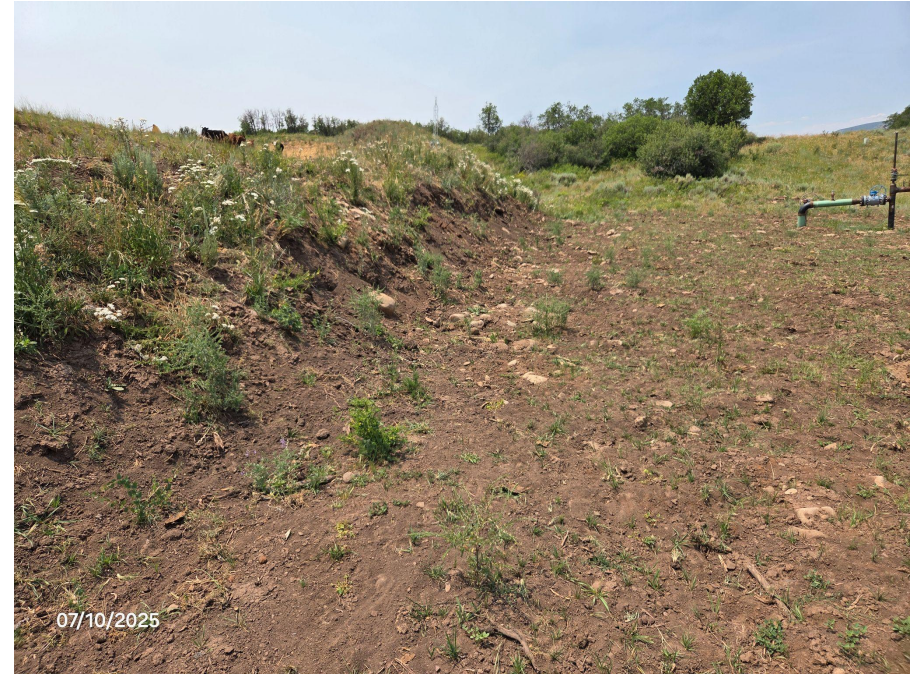
Photo 8: Photos taken from the topsoil stockpiles on the north end of the Location. See comments under photo 6.

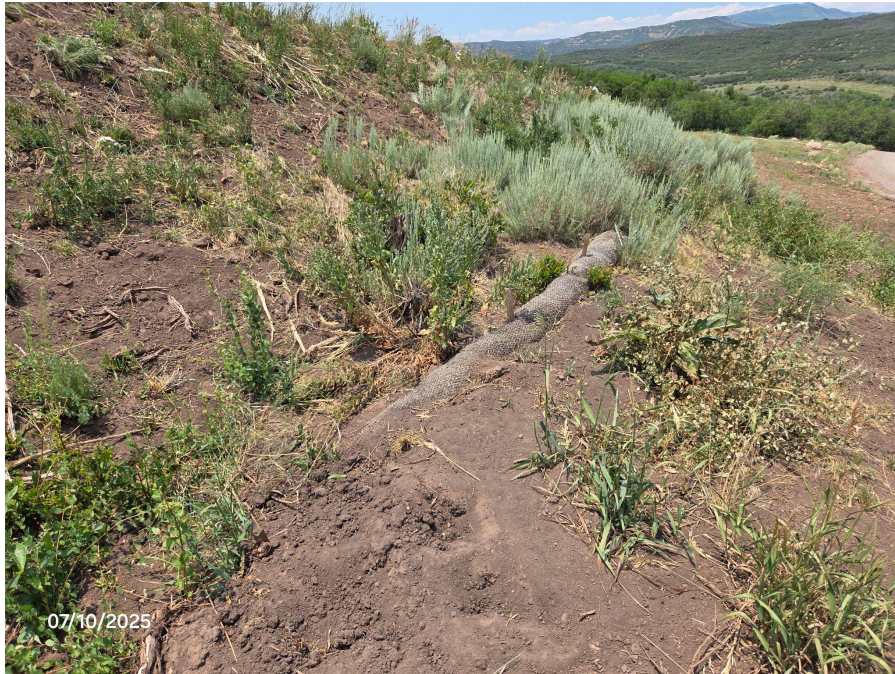
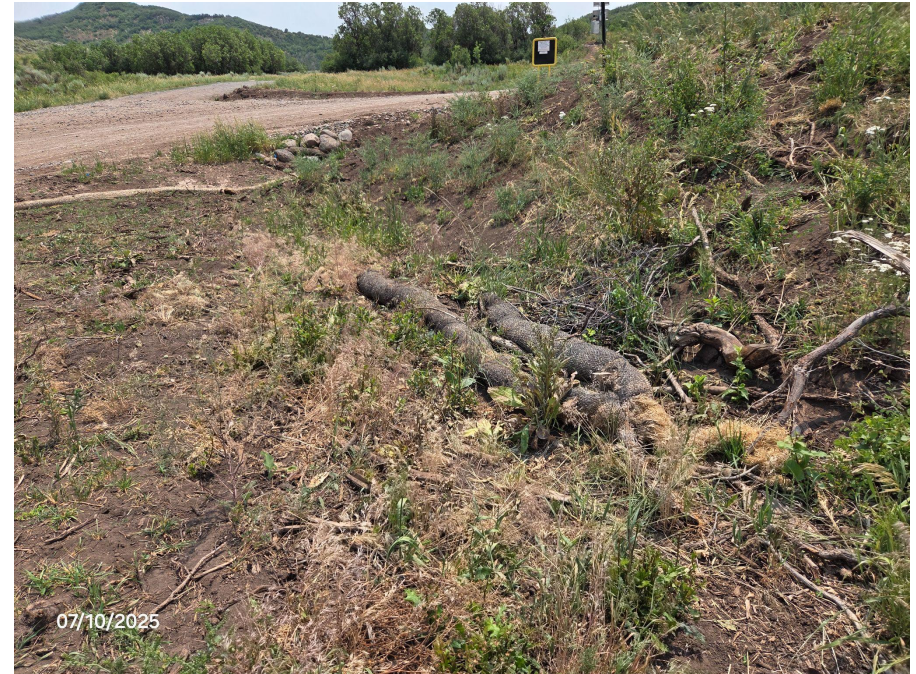
Photo 9: Photos taken from the topsoil stockpiles on the east end of the Location, facing north and south. See comments under photo 6.

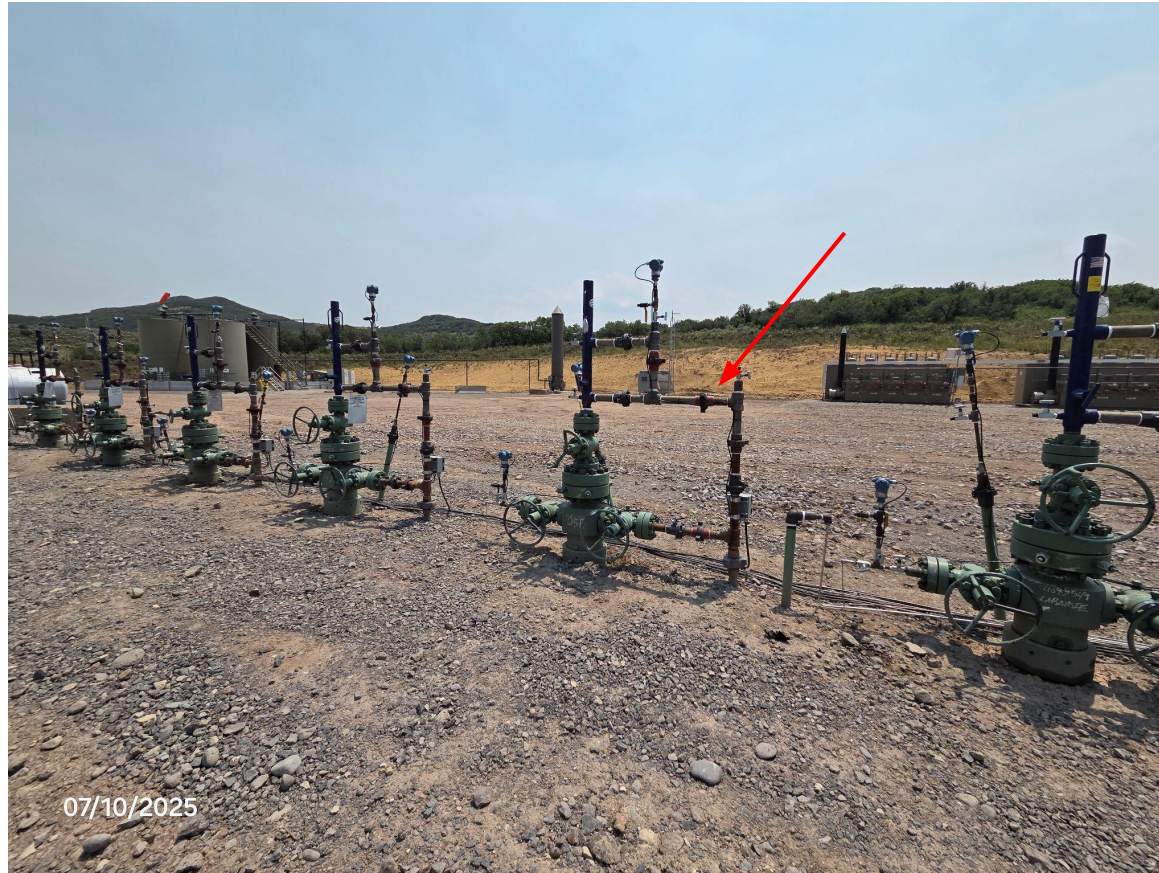
Photo 10: Signage not posted at the 05E well

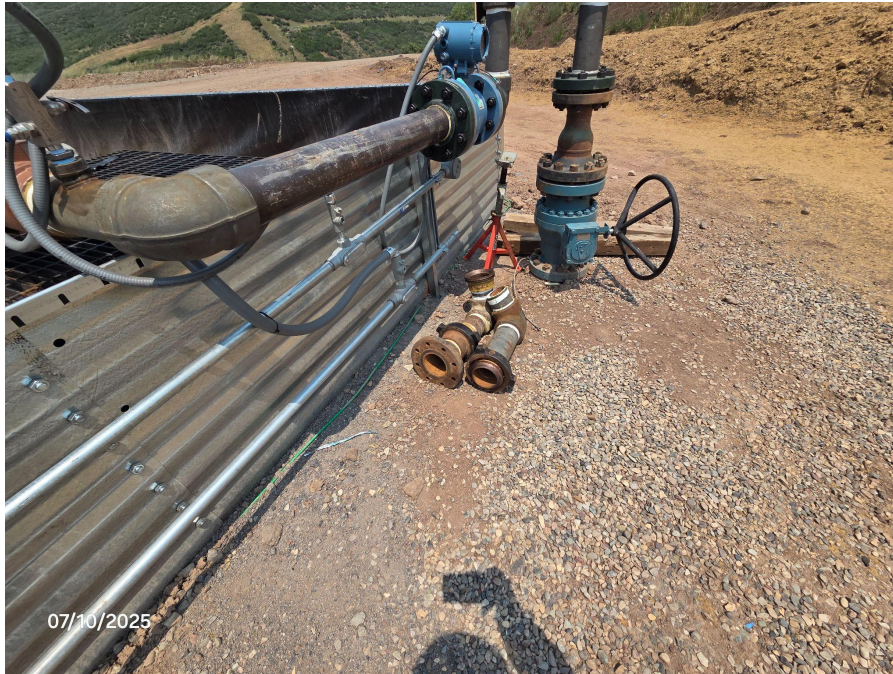
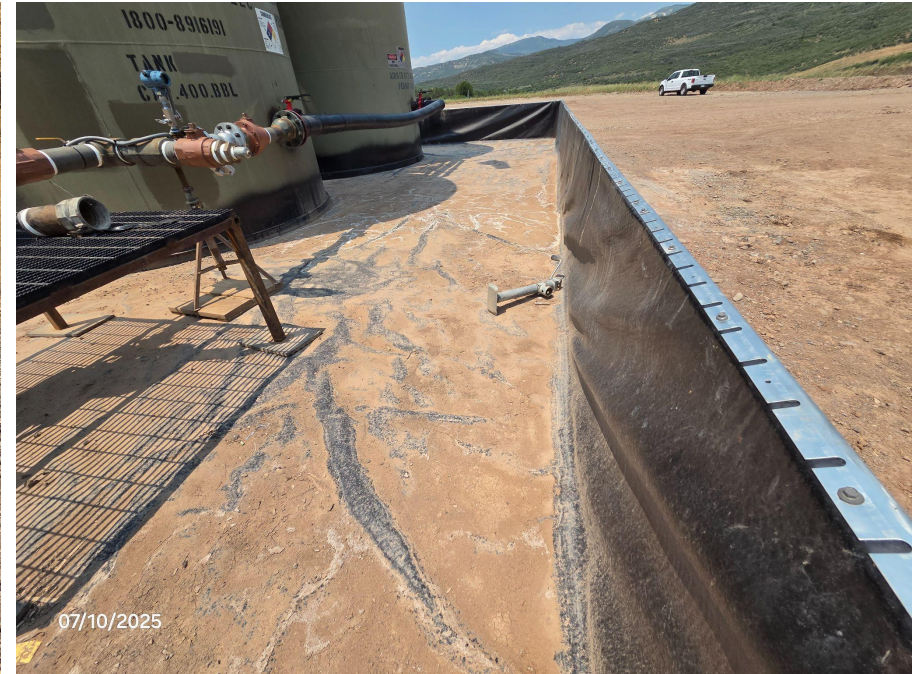
Photo 11: Unused equipment at battery facility.

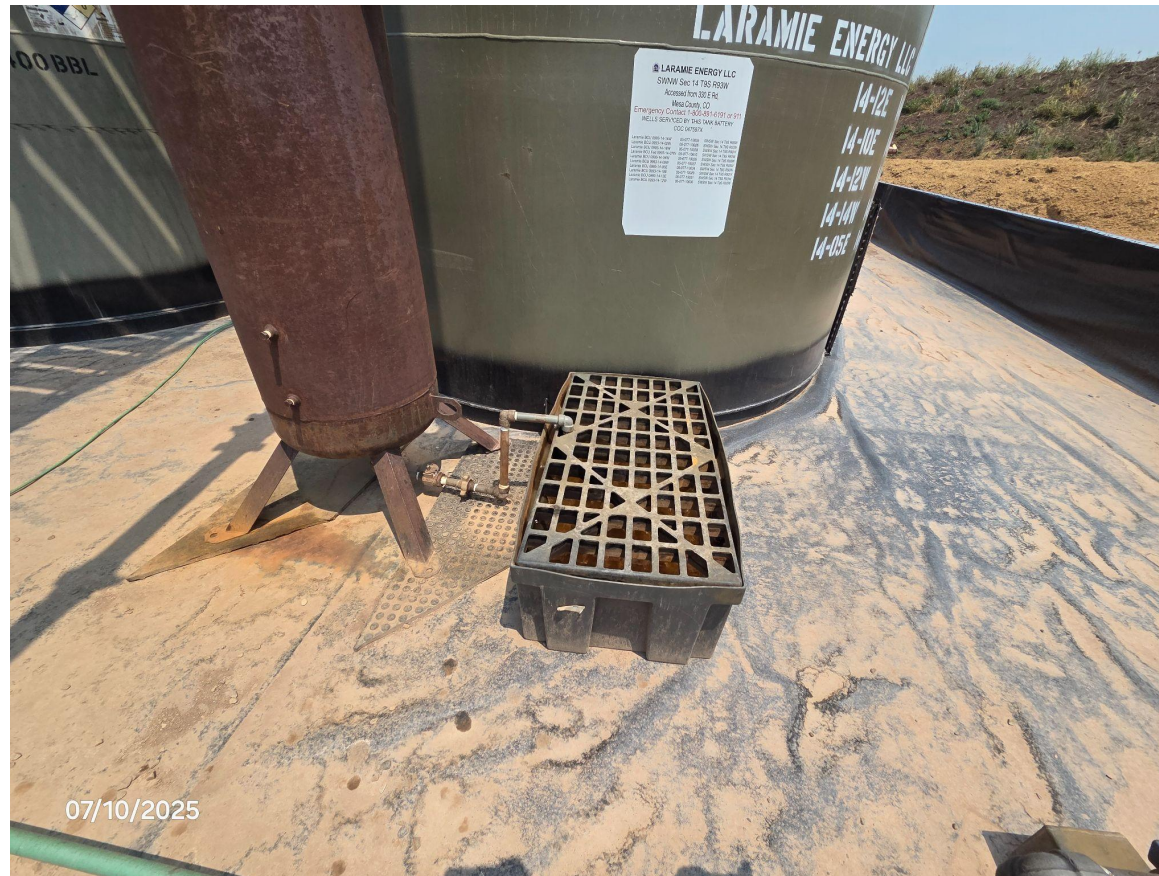
Photo 12: Containment at the knock-out has filled with fluid.

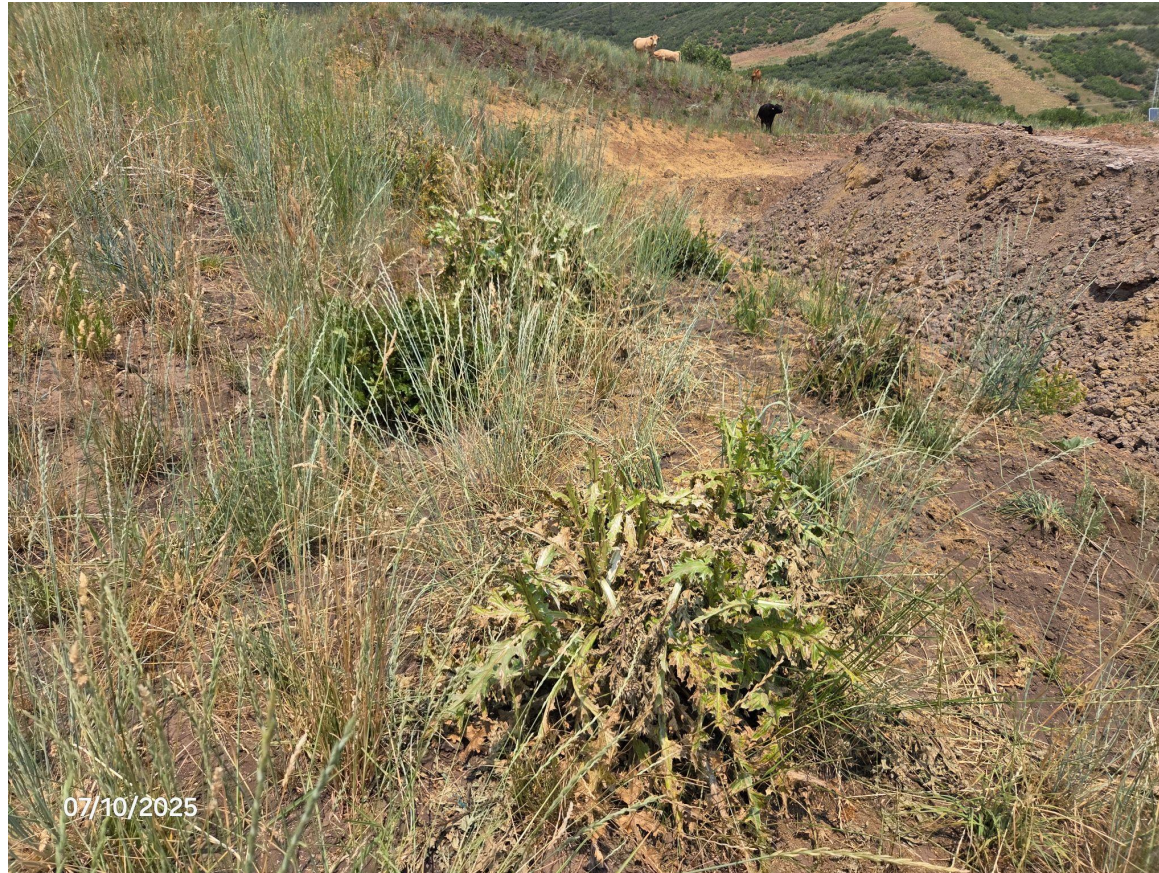
Photo 13: Photo example showing weed management efforts throughout the Location is apparent.
