Inspection Photos

API: 061-06838

Operator: INVESTMENT EQUIPMENT LLC

Inspection Date: 7/15/2025

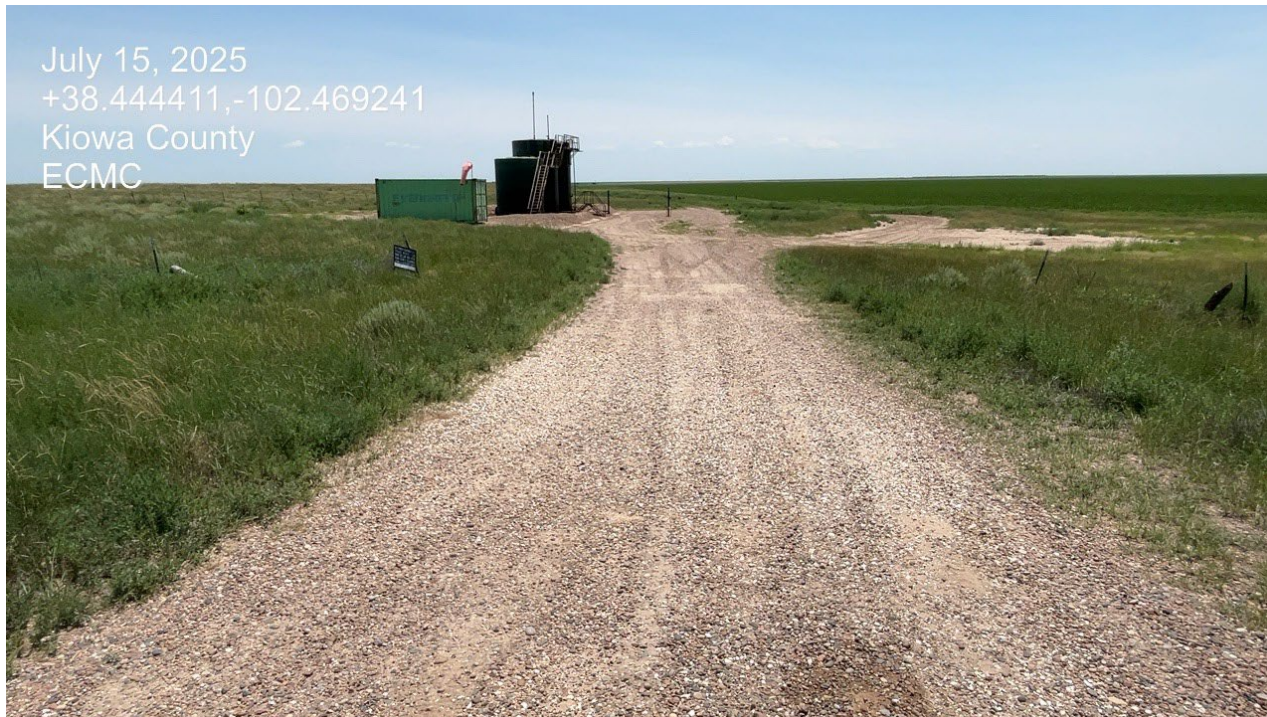
Photo 1. Facing southeast toward the location. The H₂S wind sock has been installed.

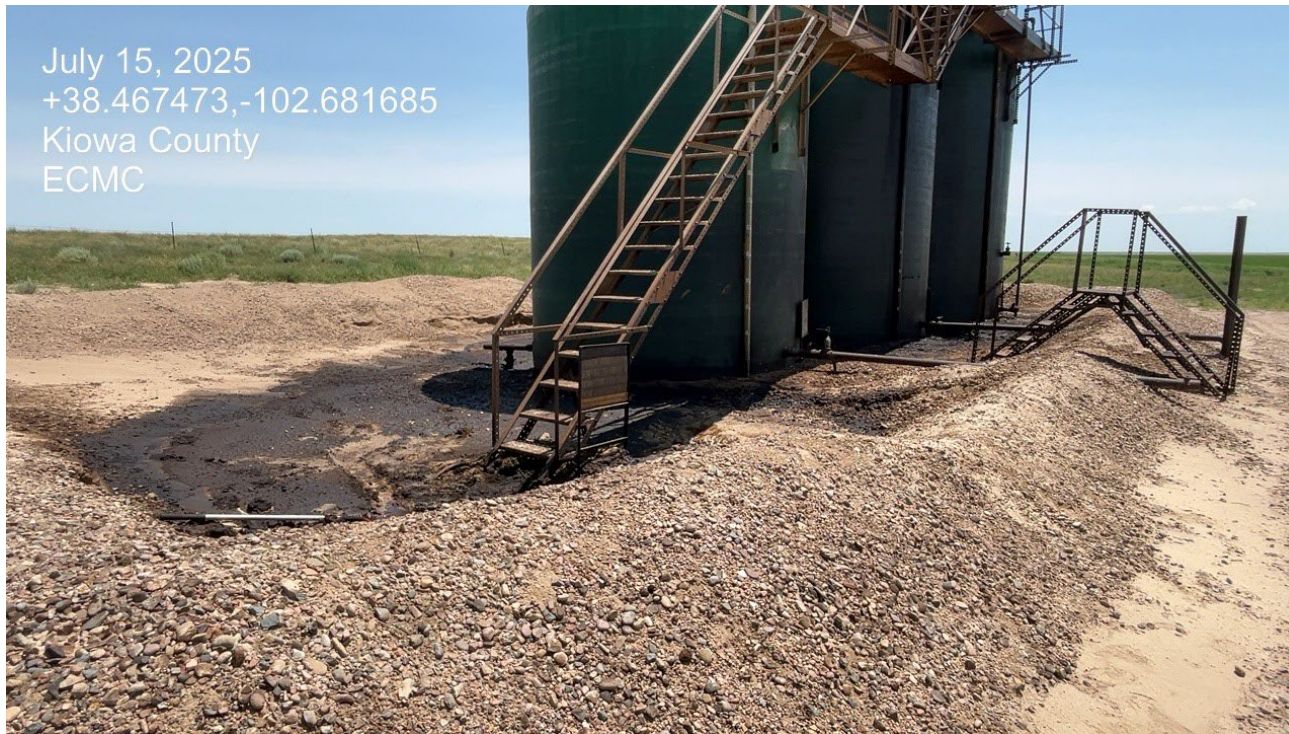
Photo 2. Facing toward the tank battery. There is a new recent spill that has occurred which will need to be reported and cleaned up.

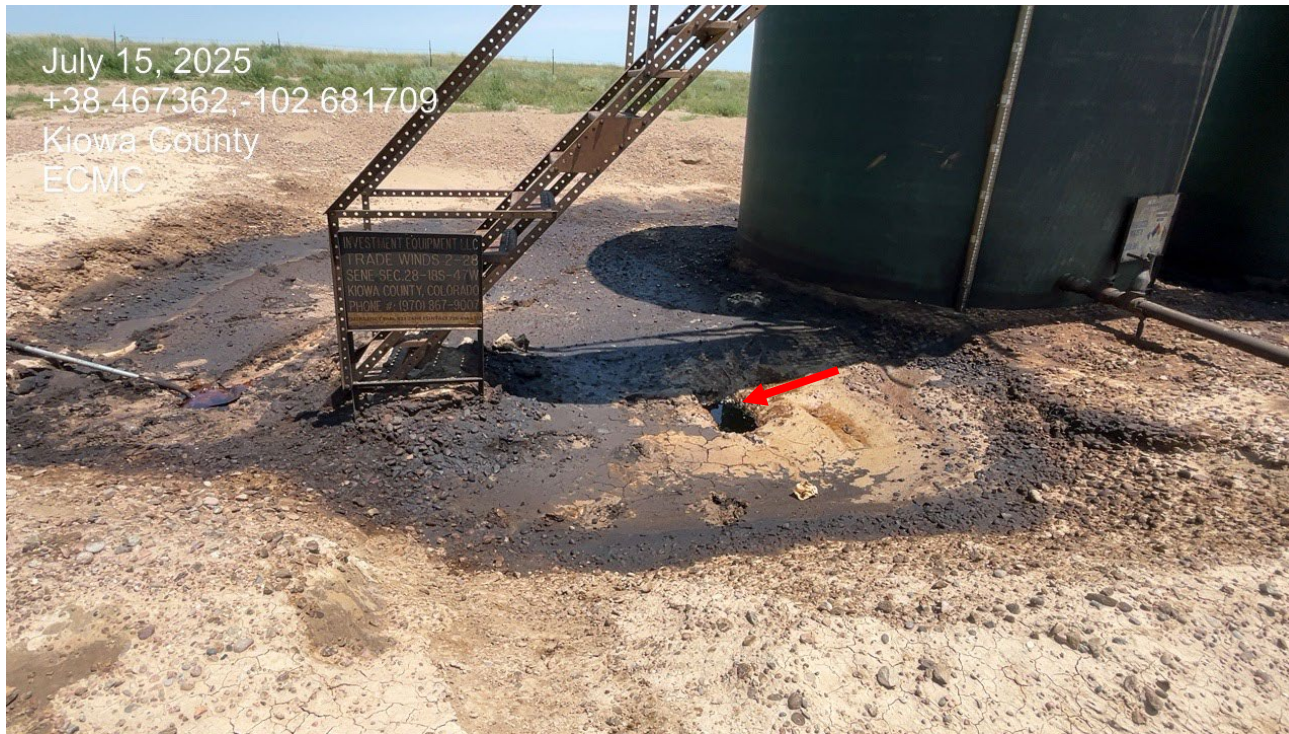
Photo 3. View of inside the containment shows signs of a recent spill with oily freestanding liquids shown at red arrow.

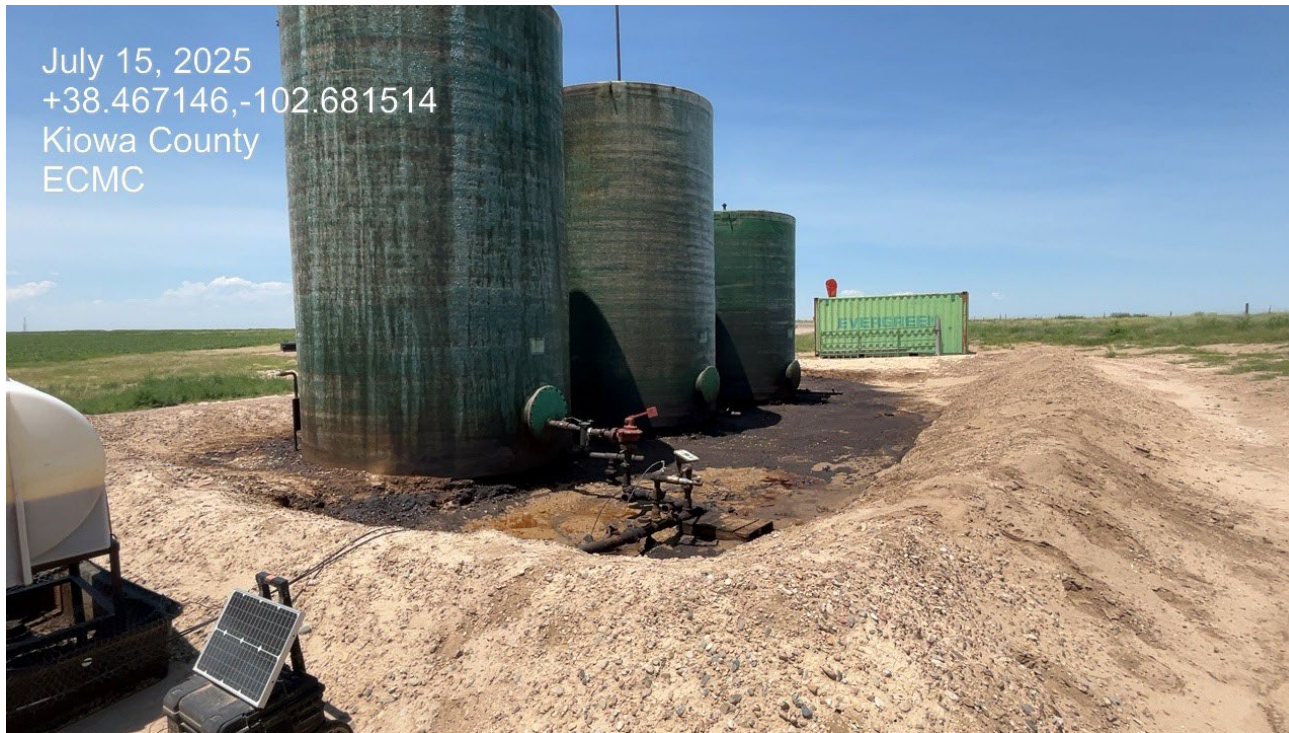
Photo 4. Facing northwest at the backside of the tank battery.

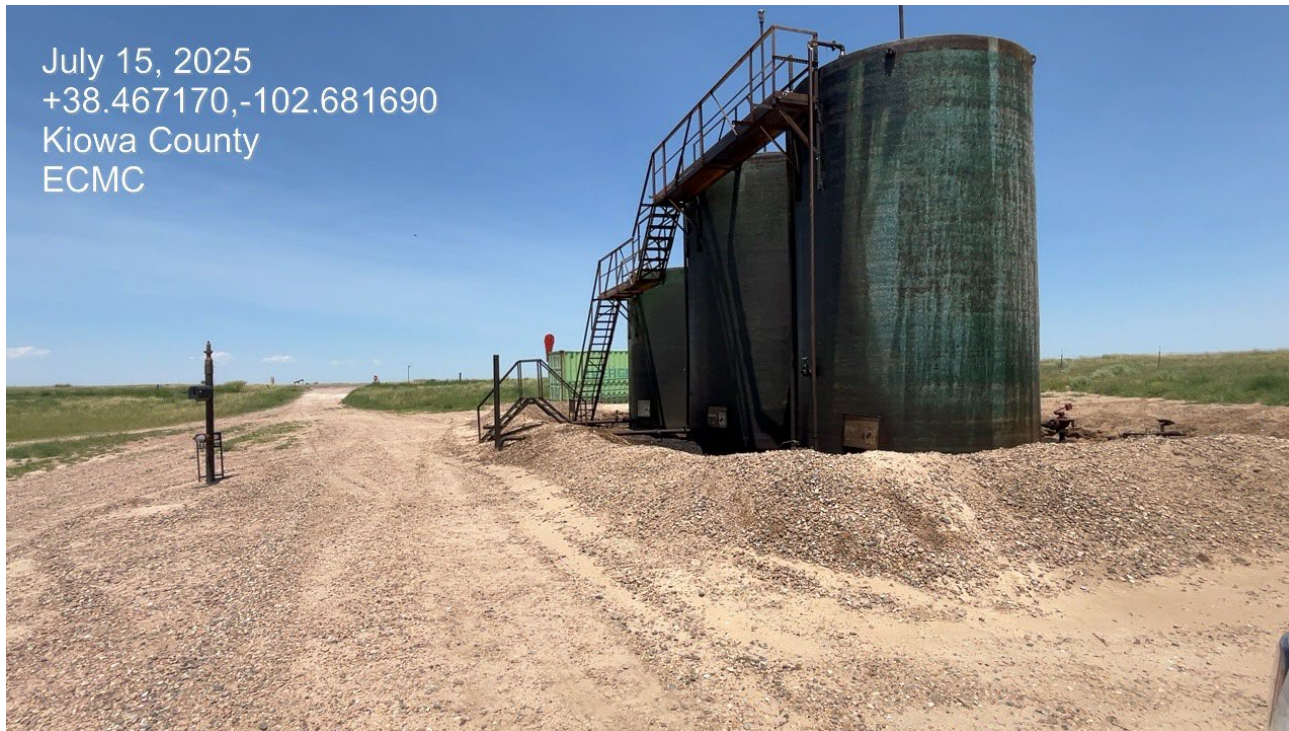
Photo 5. Facing north toward the tabk battery.

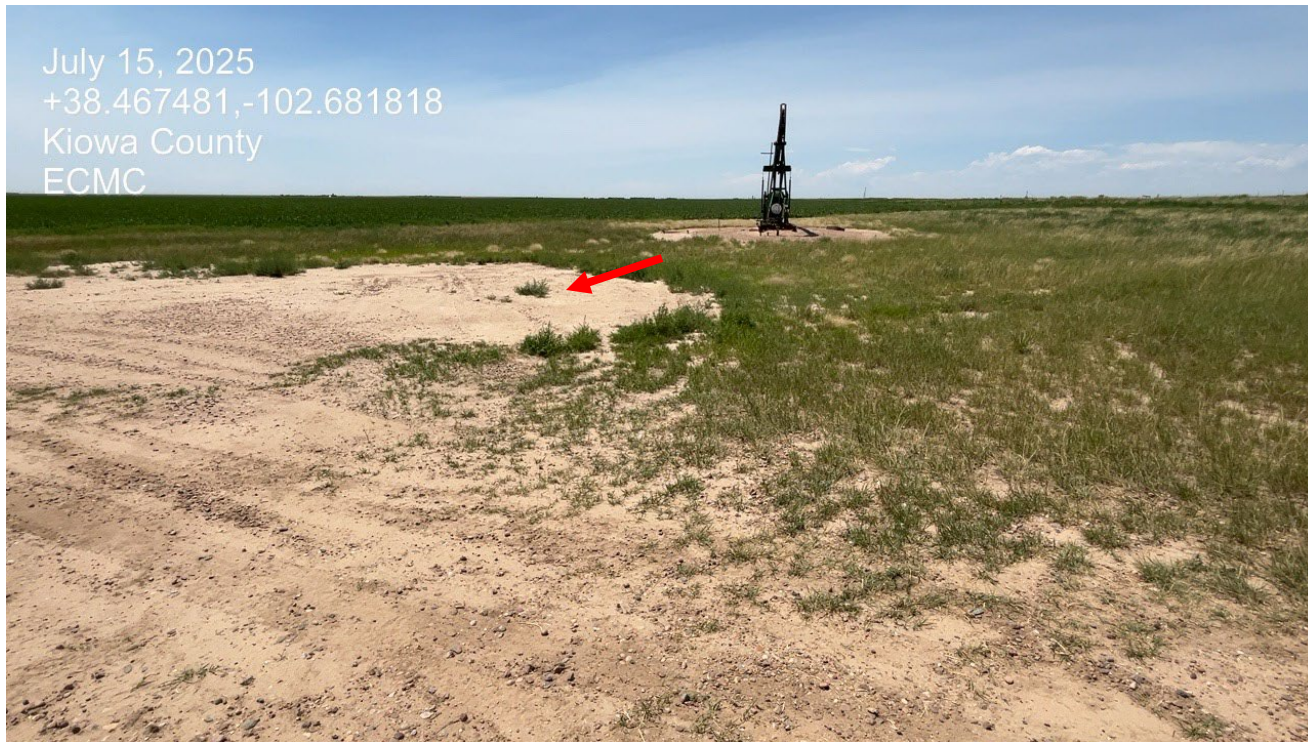
Photo 6. Facing west at the location. The pile of contaminated soils have been removed. The area at red arrow has not been reclaimed.
