Inspection Photos
Cosslet A 9 Flowline
Spill ID 478542/Remediation Project No 18952

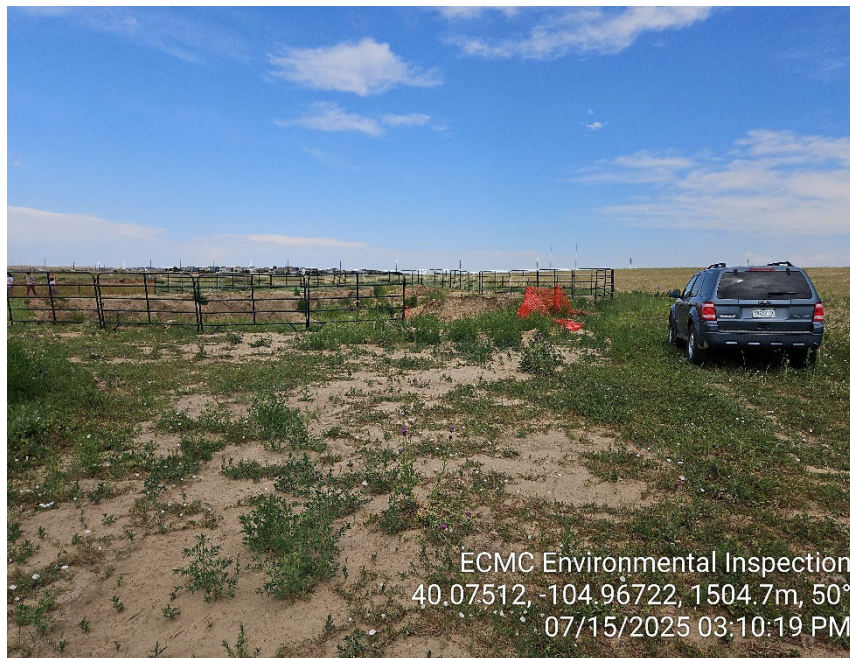
Photo 1 – Location photo. Downed fencing/weeds.

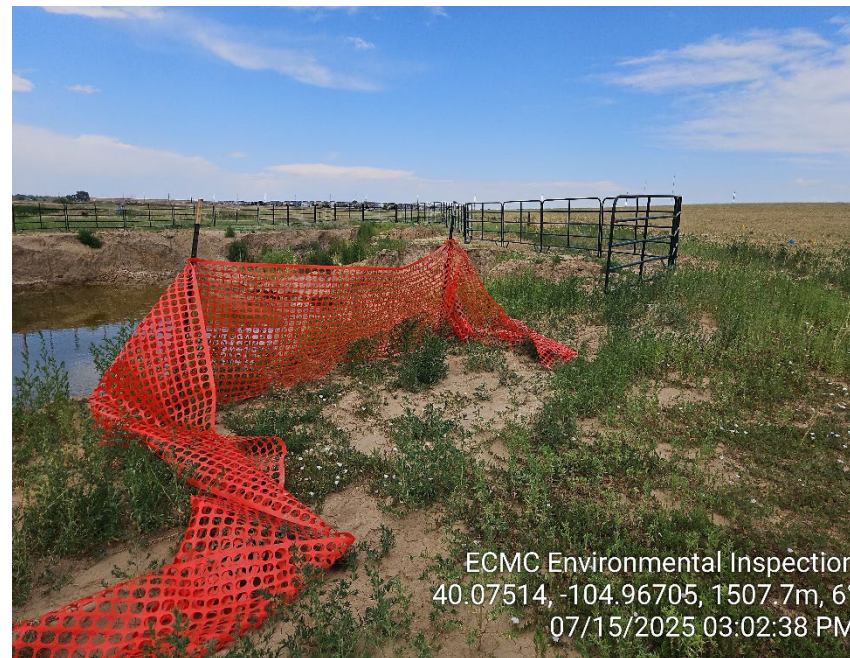
Photo 2 - Downed fencing/weeds.

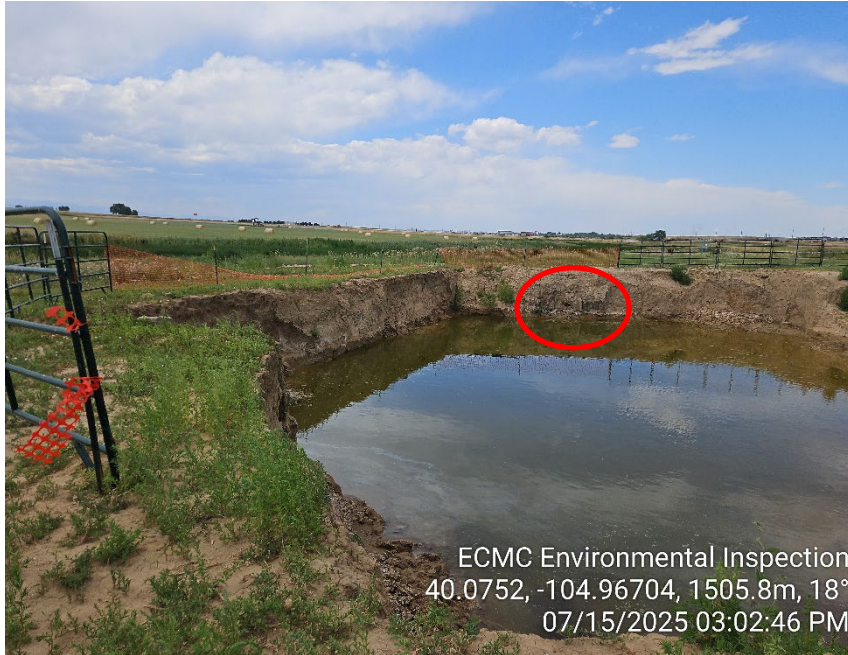
Photo 3 – Open excavation. Sheen observed on groundwater. Hydrocarbon impacts visible on north excavation sidewall. Downed fencing/weeds.

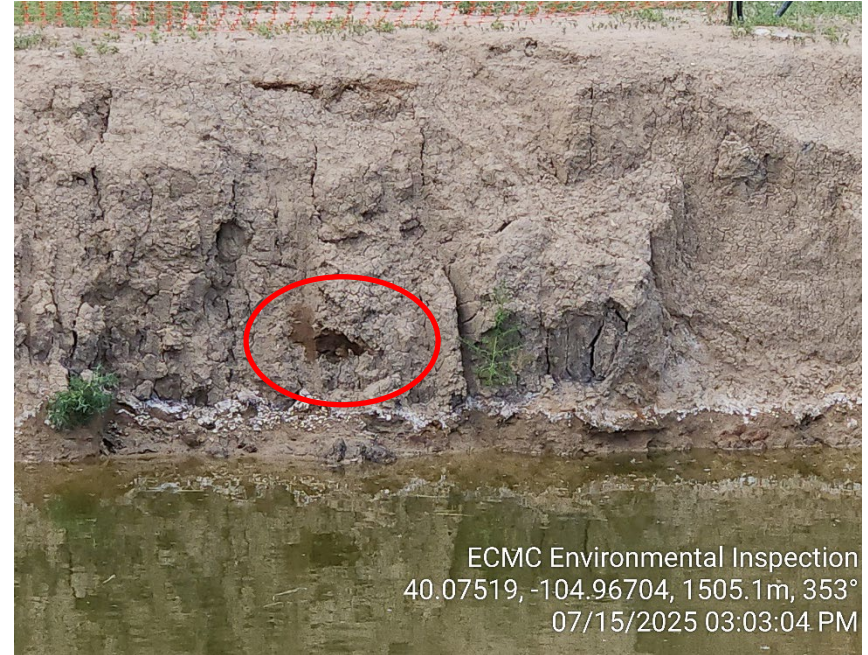
Photo 4 - Hydrocarbon impacts visible on north excavation sidewall.

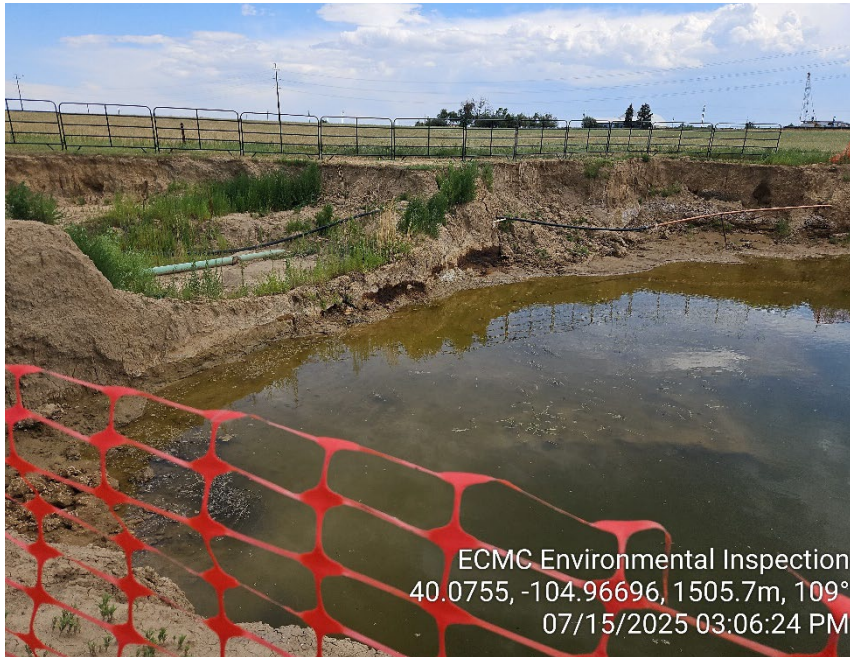
**Photo 5 – Impacts visible within open excavation.
Free product was observed pooling on soil next to
groundwater. Weeds.**

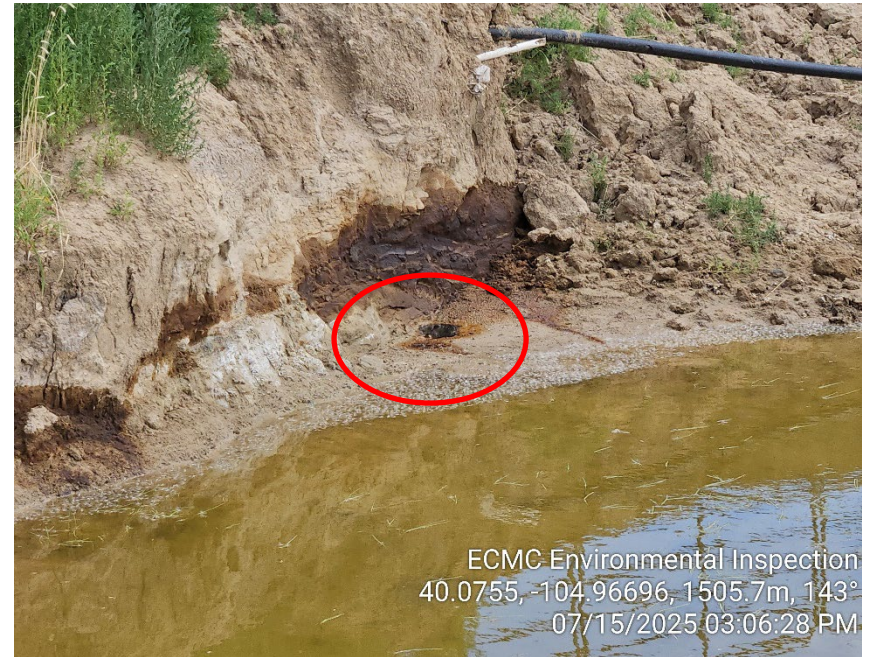
**Photo 6 - Impacts and free product in open
excavation.**

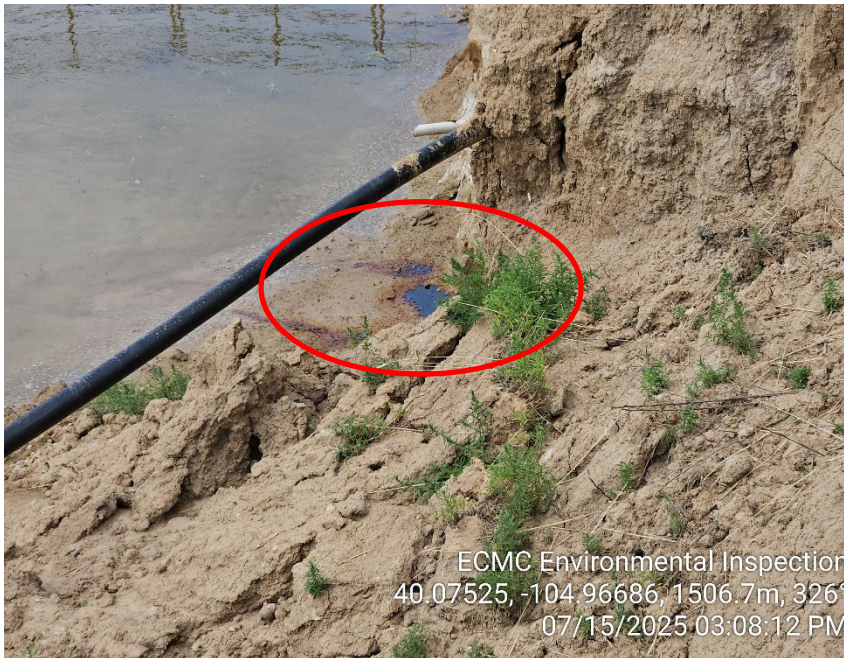
Photo 7 – Impacts and free product in open excavation. Sheen visible on groundwater.

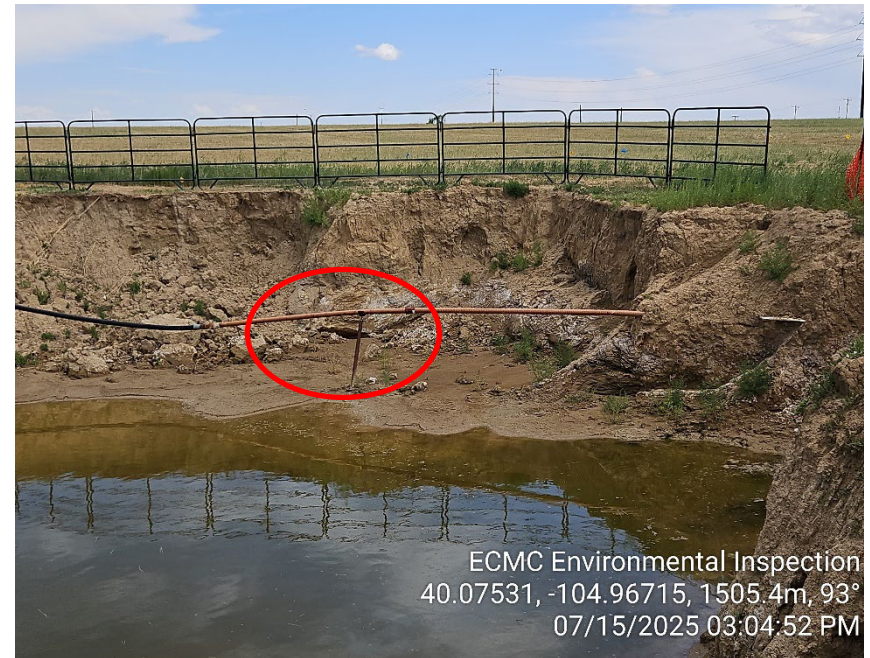
Photo 8 - Open excavation. Hydrocarbon impacts visible on south excavation sidewall. Downed fencing/weeds.

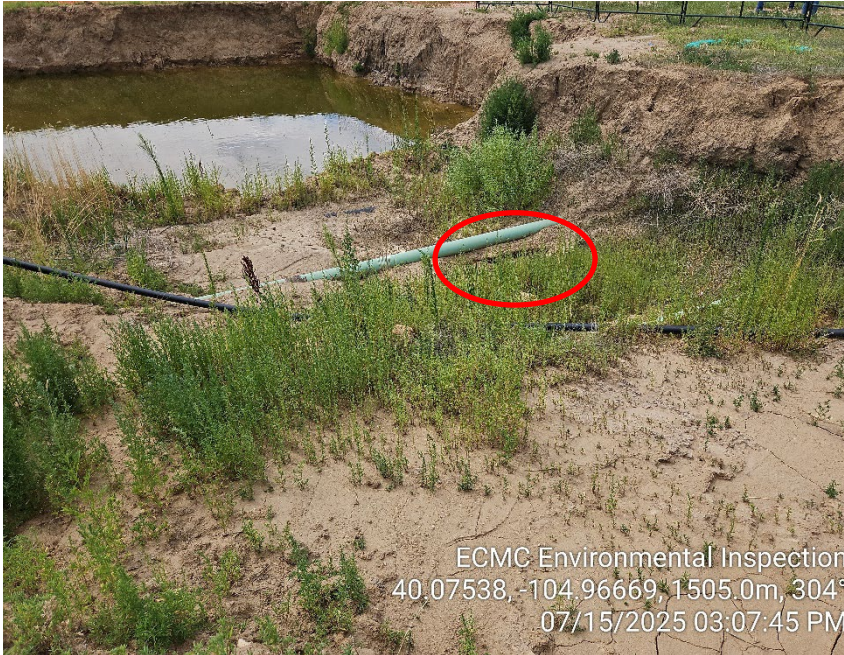
Photo 9 – Open excavation with weeds. Impacts visible below pipeline.

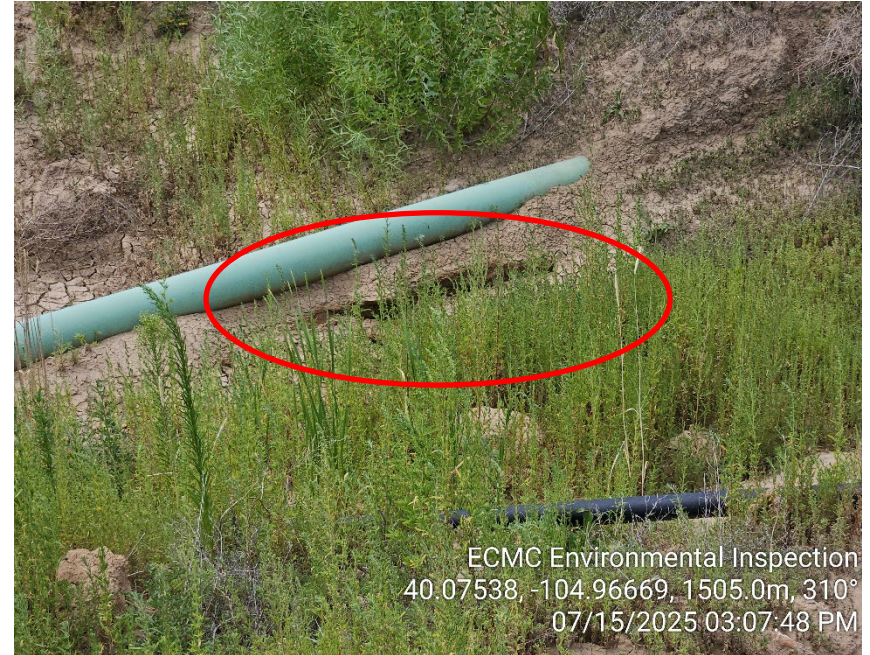
Photo 10 - Open excavation with weeds. Impacts visible below pipeline.

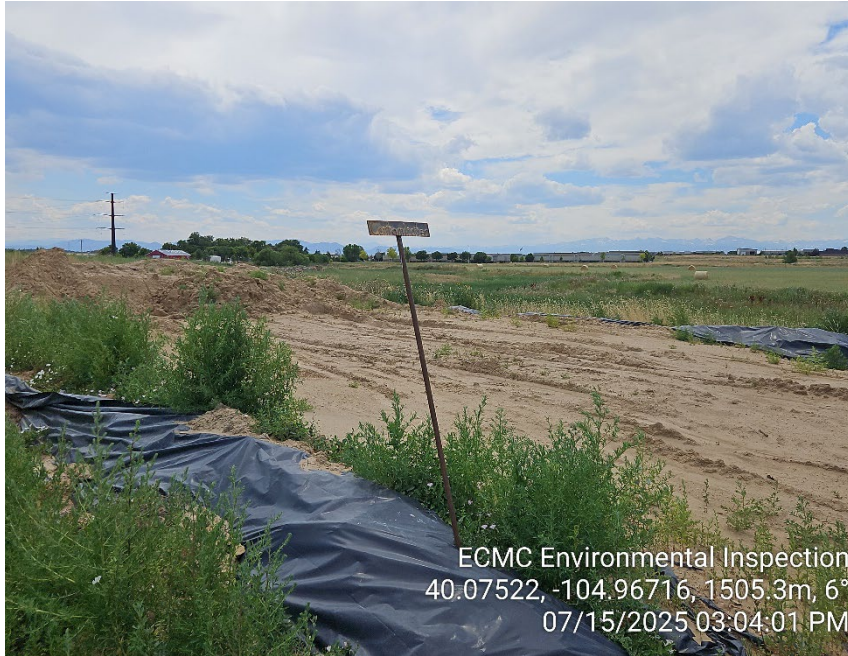
Photo 11 – Contaminated stockpile. Inadequate BMPs. Weeds.

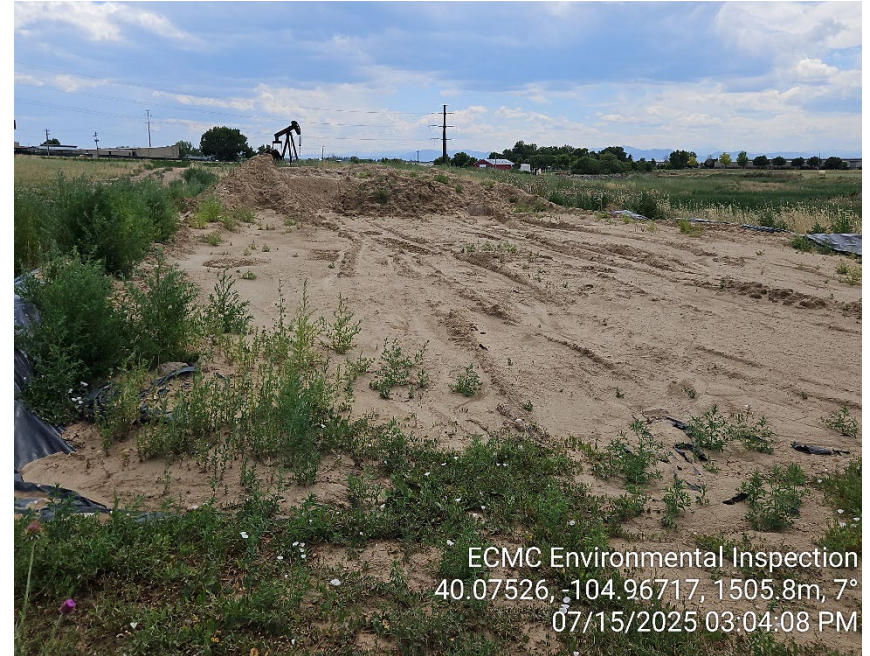
Photo 12 - Contaminated stockpile. Inadequate BMPs. Weeds.

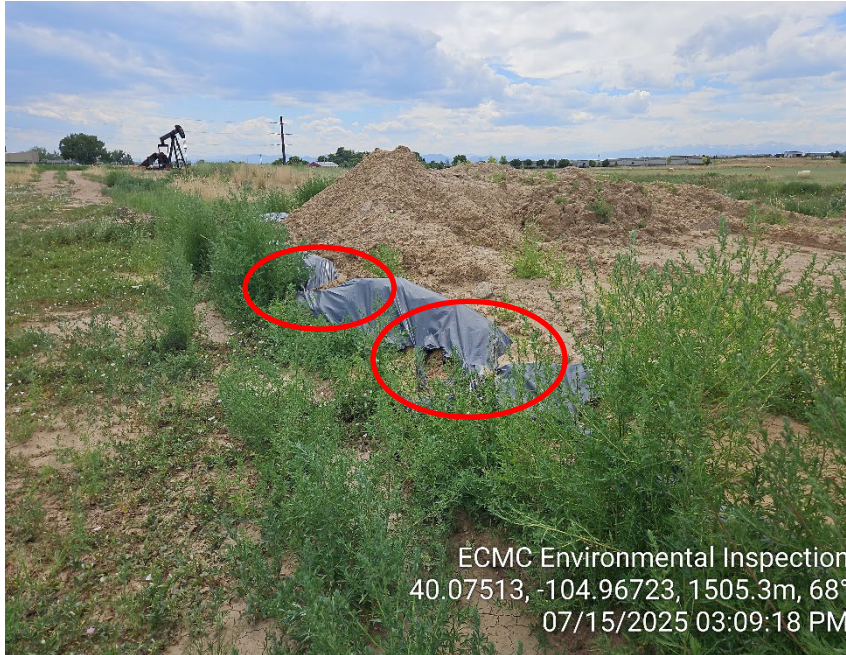
Photo 13 – Contaminated stockpile. Inadequate BMPs with torn liner and observed sediment transport. Weeds.

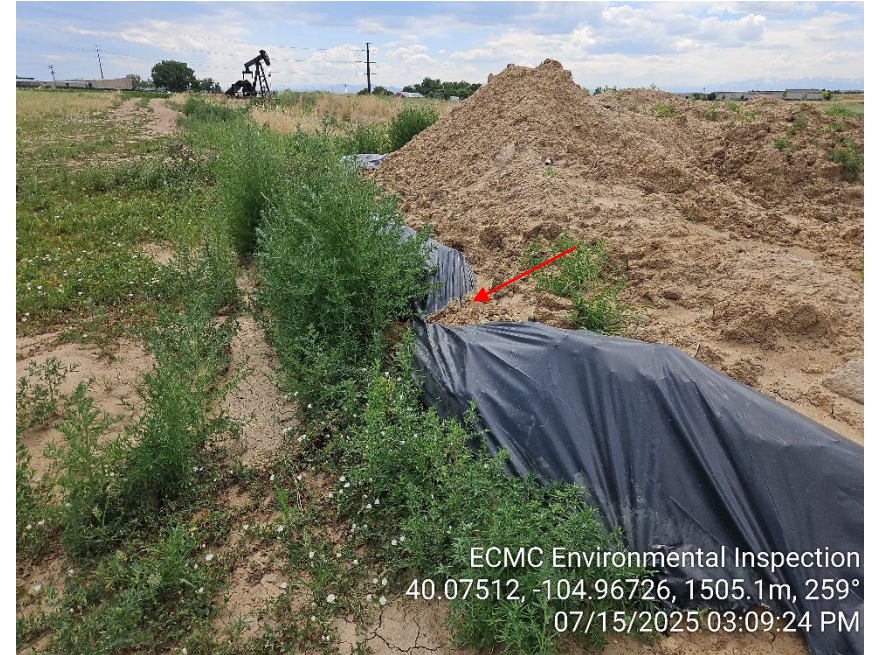
Photo 14 - Contaminated stockpile. Inadequate BMPs; observed sediment transport. Weeds.

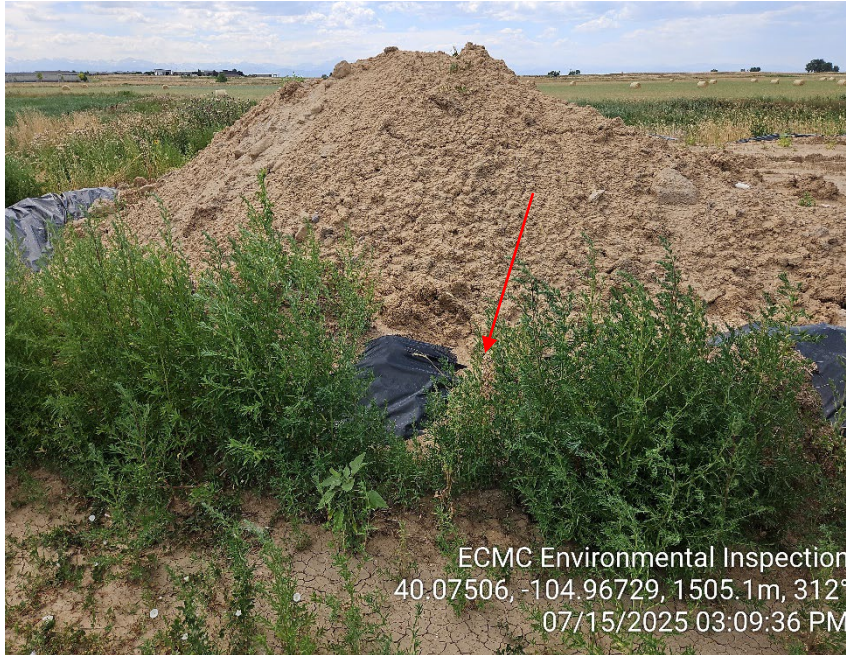
Photo 15 – Contaminated stockpile. Inadequate BMPs; observed sediment transport. Weeds.

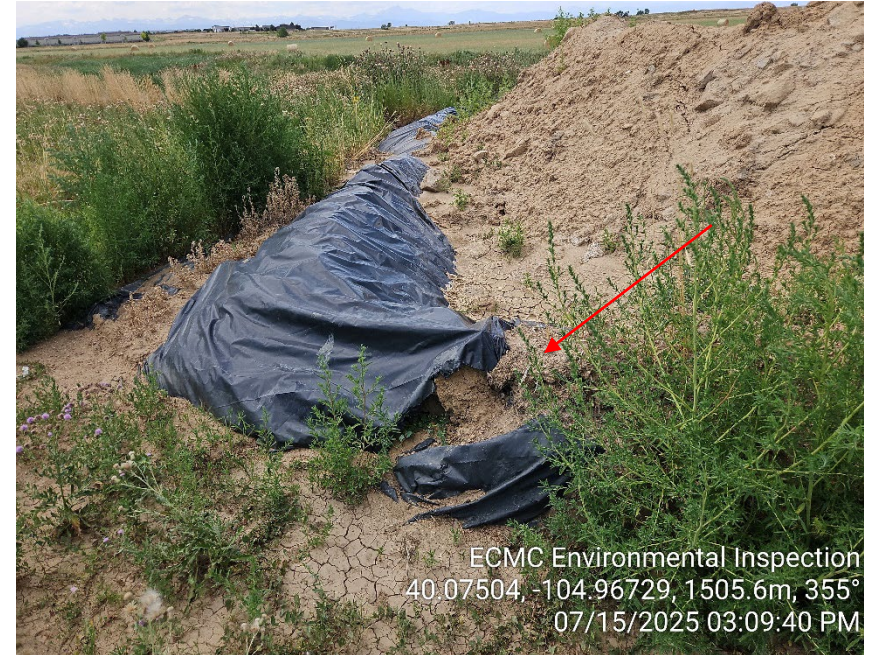
Photo 16 - Contaminated stockpile. Inadequate BMPs; observed sediment transport & torn liner. Weeds.

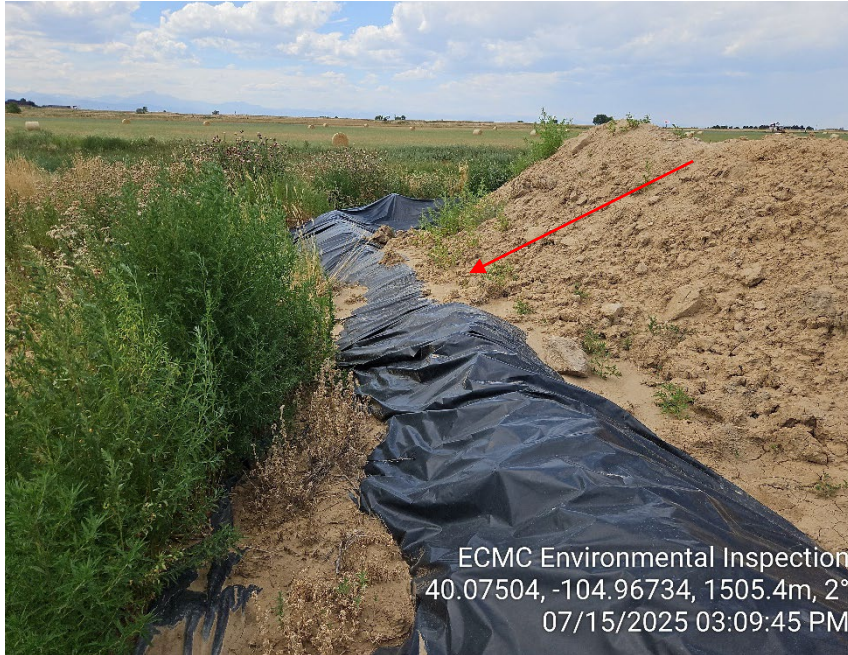
Photo 17 – Contaminated stockpile. Inadequate BMPs; observed sediment transport. Weeds.

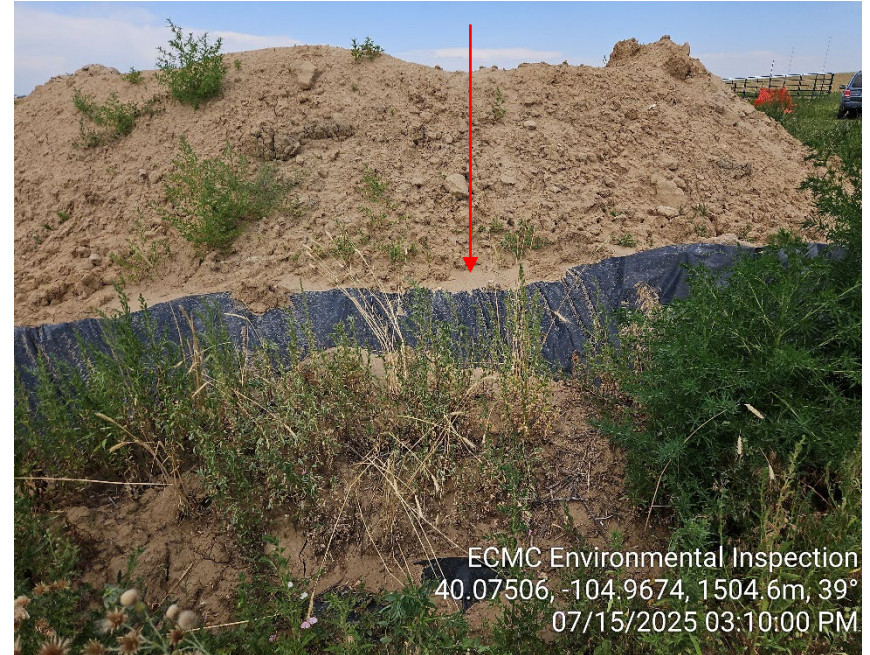
Photo 18 - Contaminated stockpile. Inadequate BMPs; observed sediment transport. Weeds.

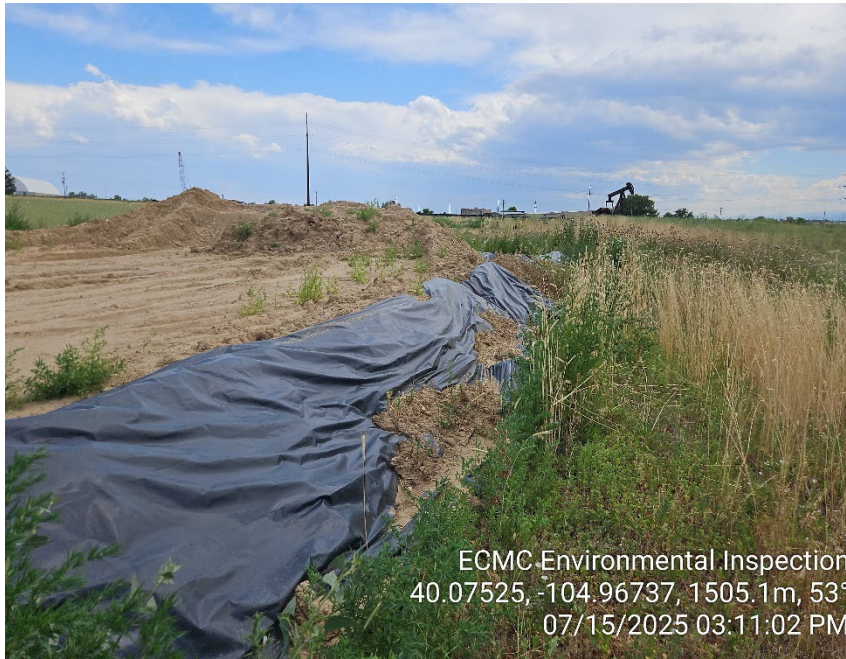
Photo 19 – Contaminated stockpile. Inadequate BMPs. Weeds.

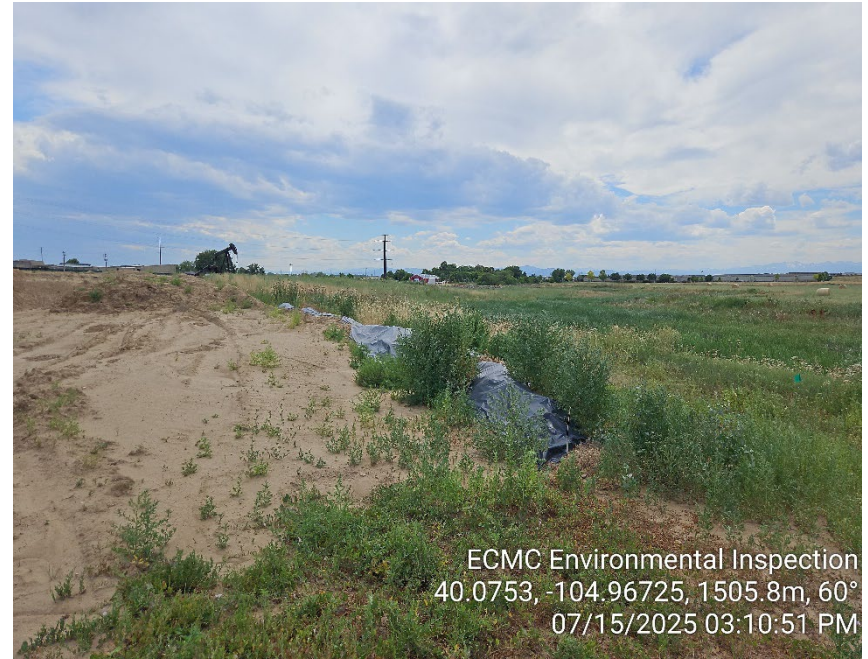
Photo 20 - Contaminated stockpile. Inadequate BMPs. Weeds.

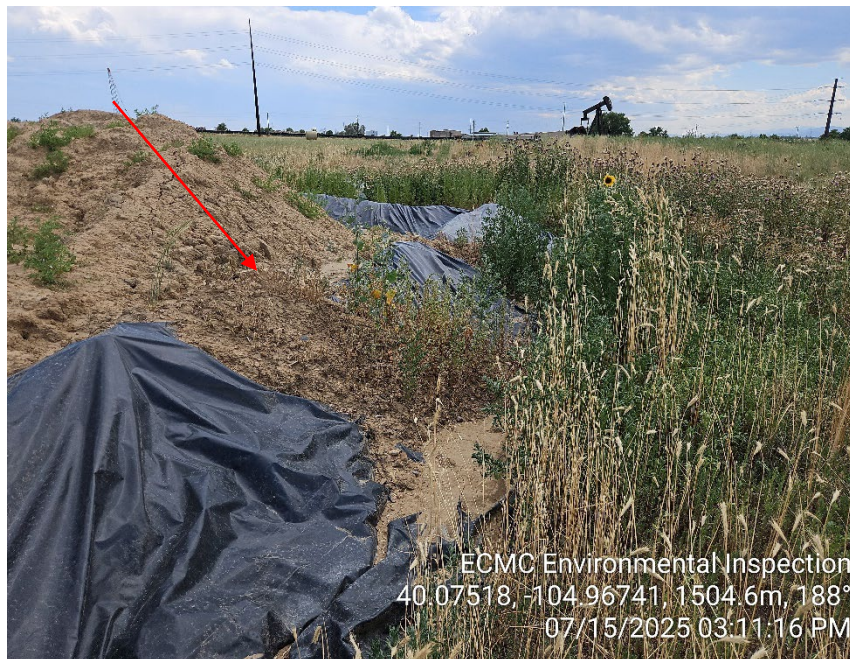
Photo 21 – Contaminated stockpile. Inadequate BMPs; observed sediment transport. Weeds.

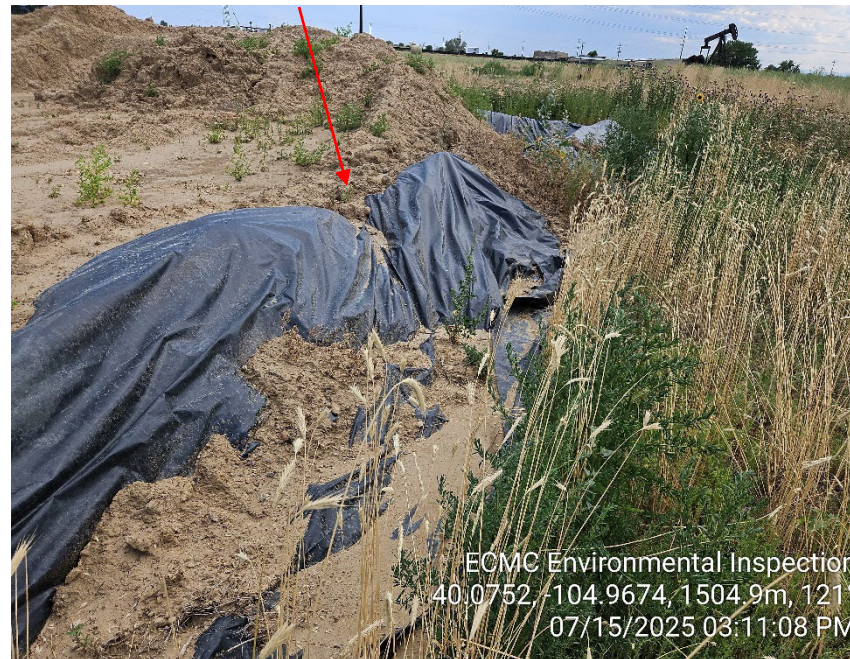
Photo 22 - Contaminated stockpile. Inadequate BMPs; observed sediment transport. Weeds.
