Inspection Photos

API:061-05138

Operator: WESTERN OPERATING COMPANY

Inspection Date: 7/15/2025

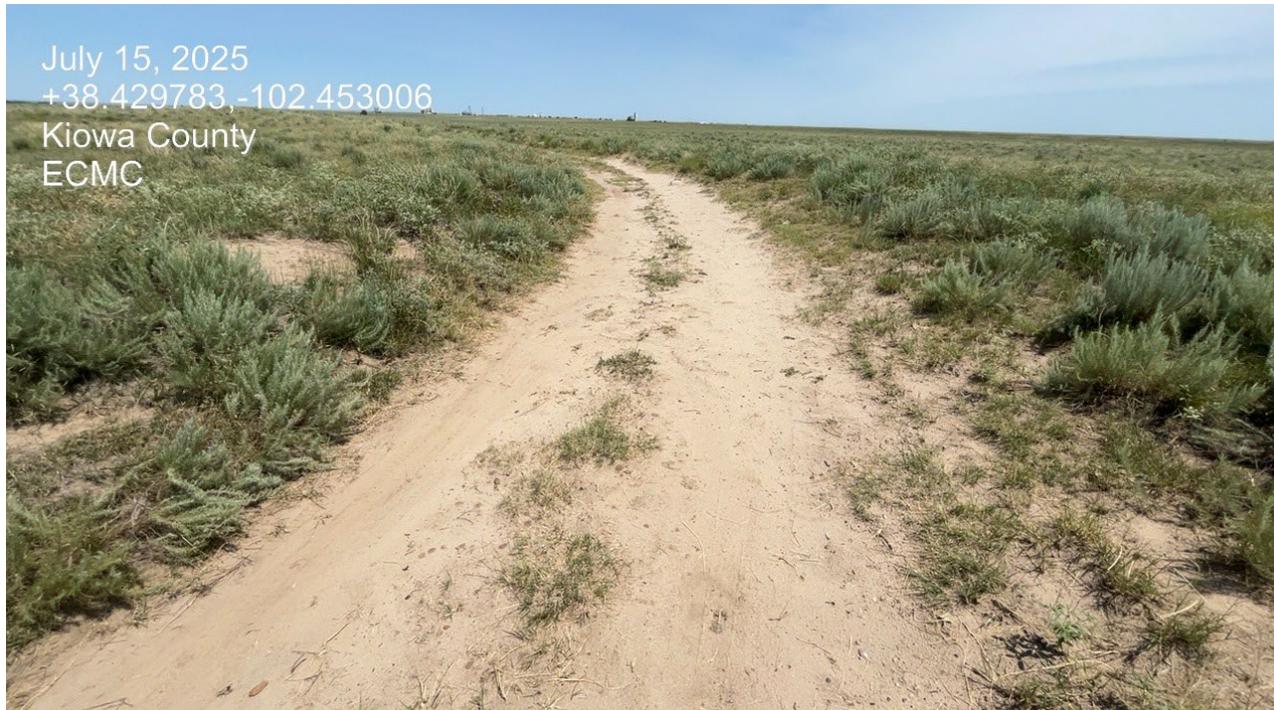
Photo 1. Facing northeast along the access road. The road needs to be recontoured to original grade and reclaimed.

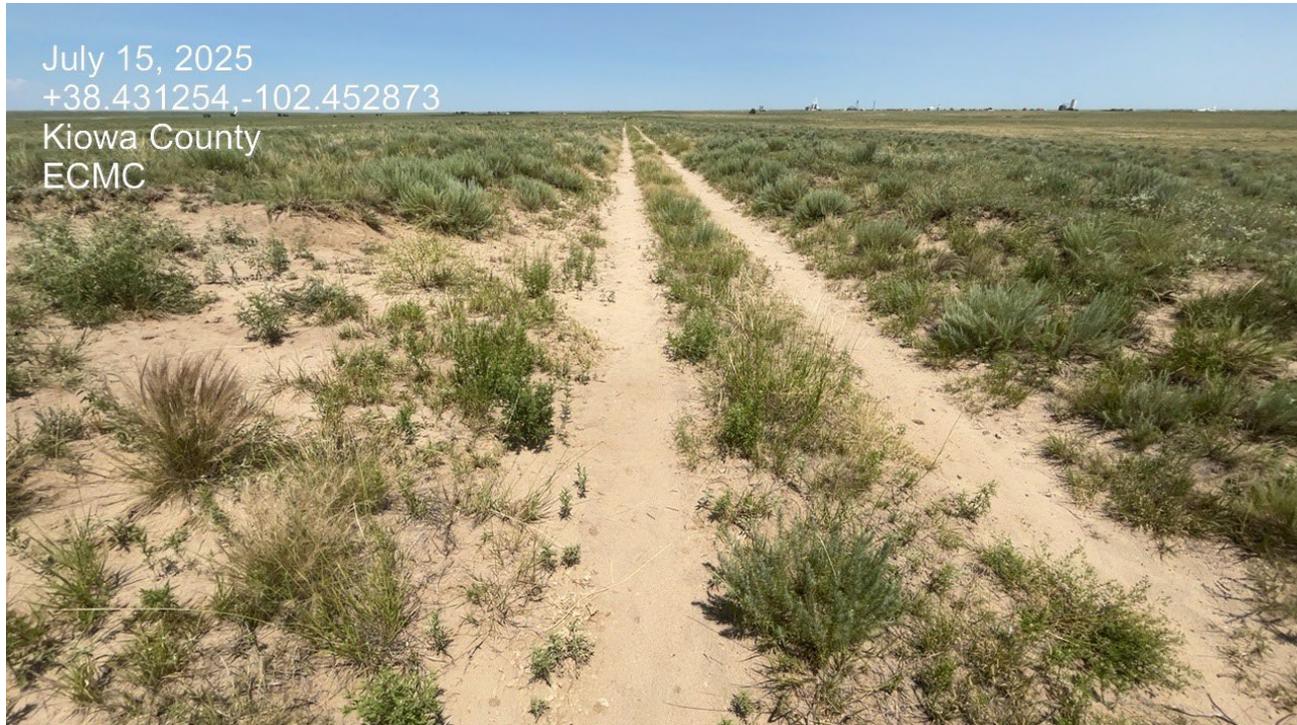
Photo 2. Facing north along the access road. The road needs to be recontoured to original grade and reclaimed.

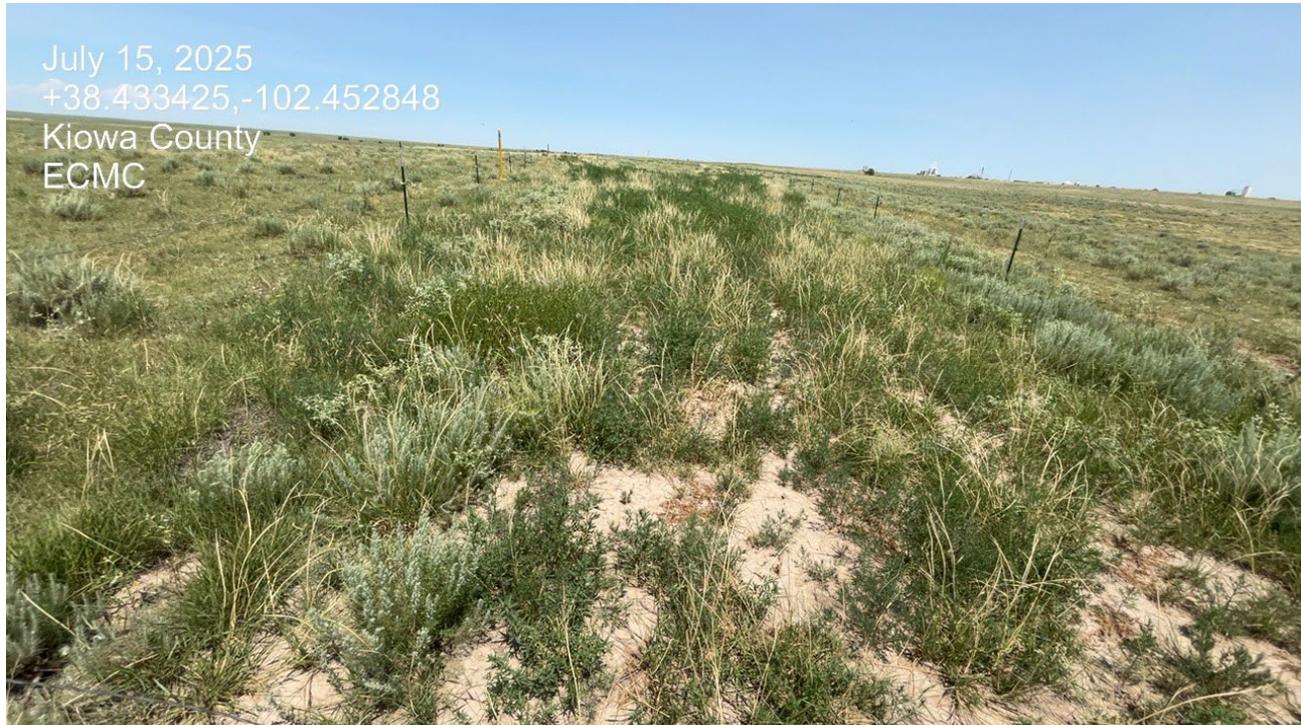
Photo 3. Facing north at the recontoured portion of the road.

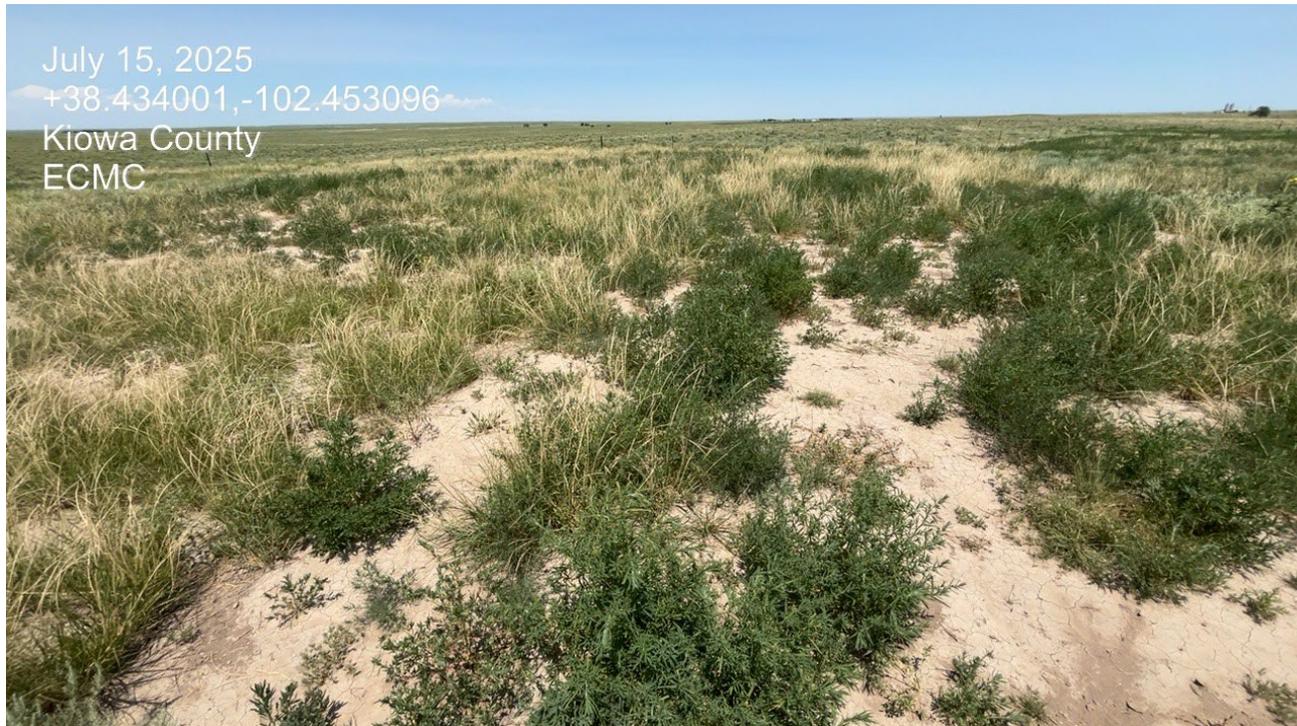
Photo 4. Facing northwest toward the location. There is some perennial vegetation establishing. Undesirable weeds need to be controlled.

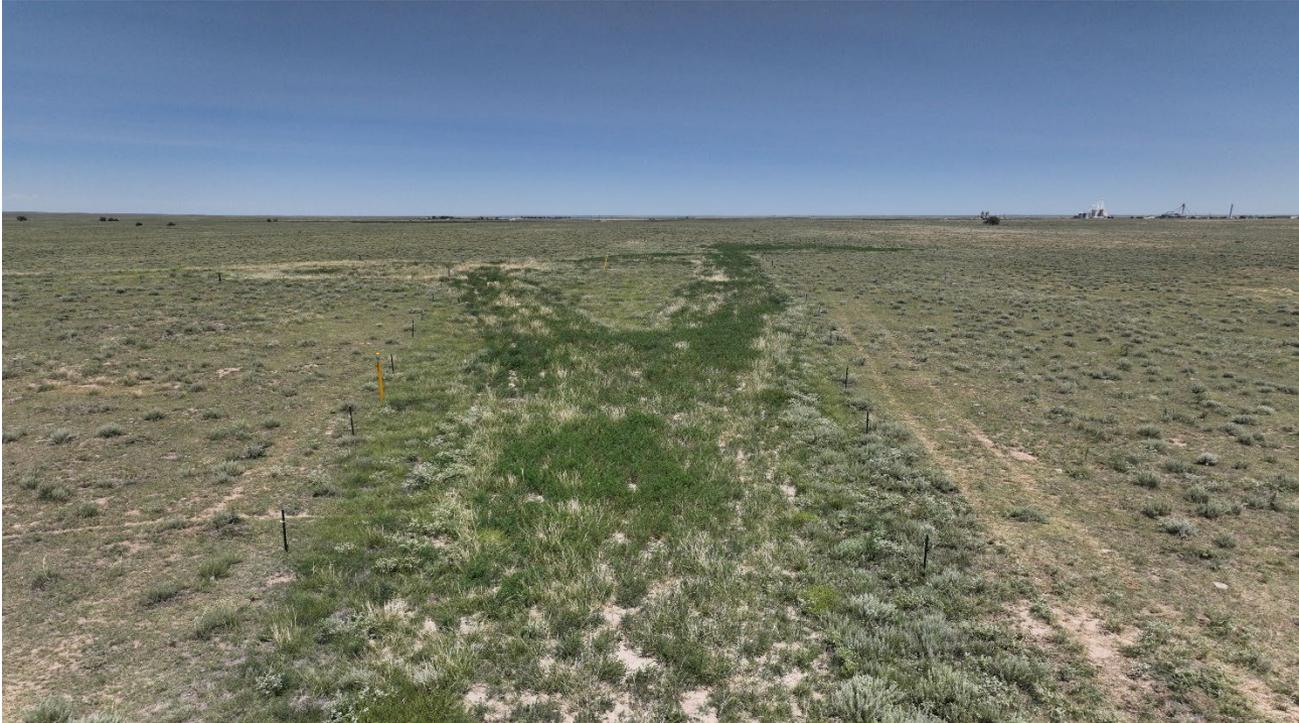
Photo 5. Drone aerial photo facing north overlooking the reclaimed portion of the road and location.

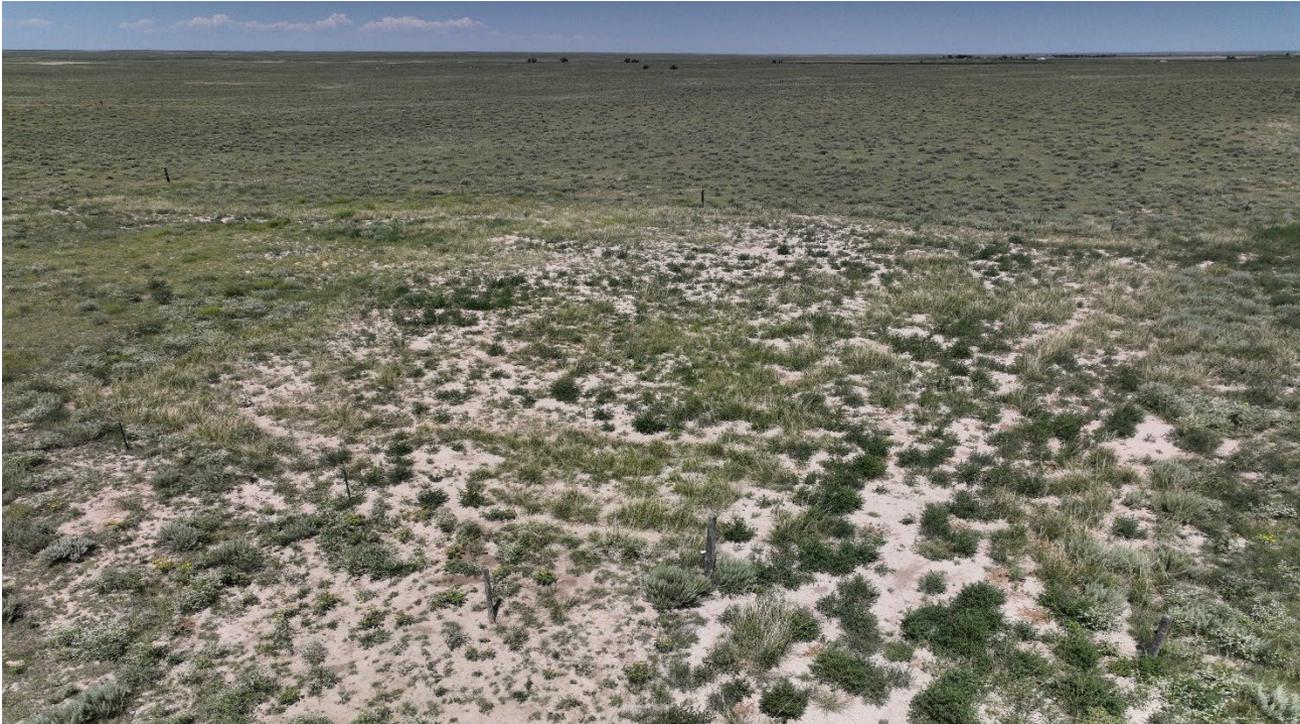
Photo 6. Drone aerial photo facing northwest toward the location.

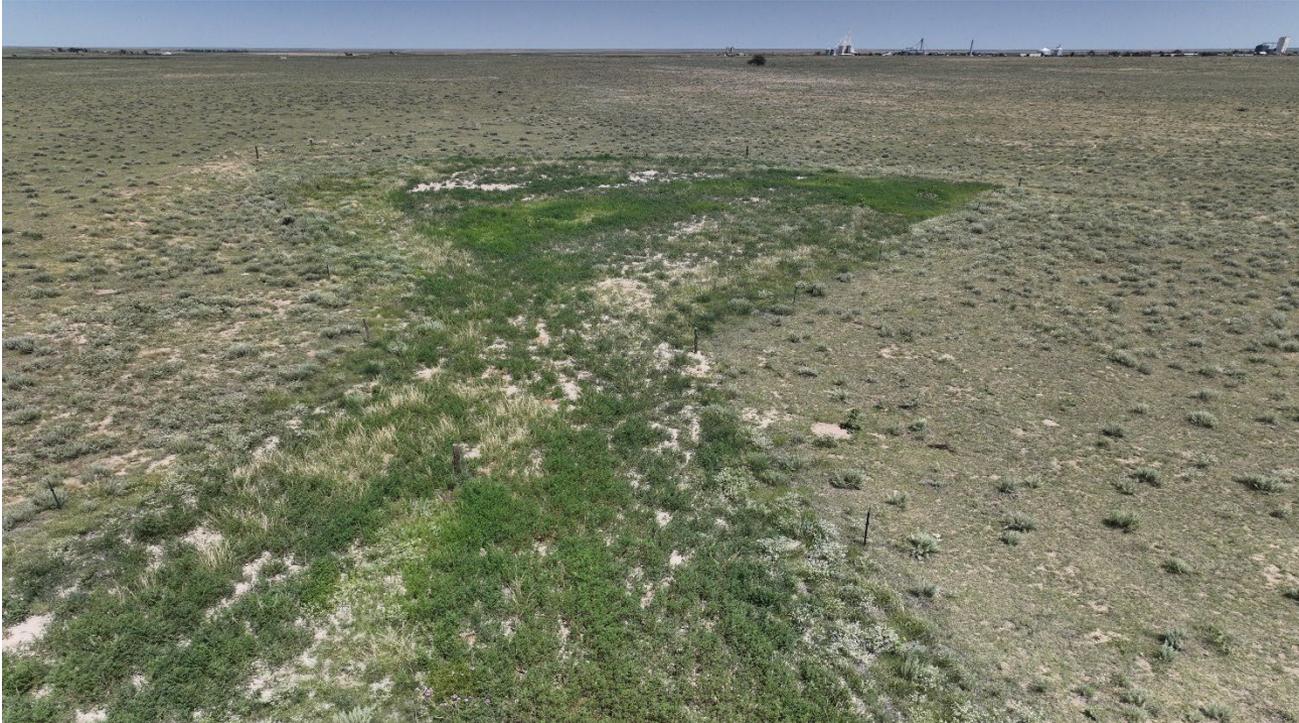
Photo 7. Drone aerial photo facing northeast toward the location. The dark green vegetation is mostly undesirable weeds (Kochia) which needs to be controlled.

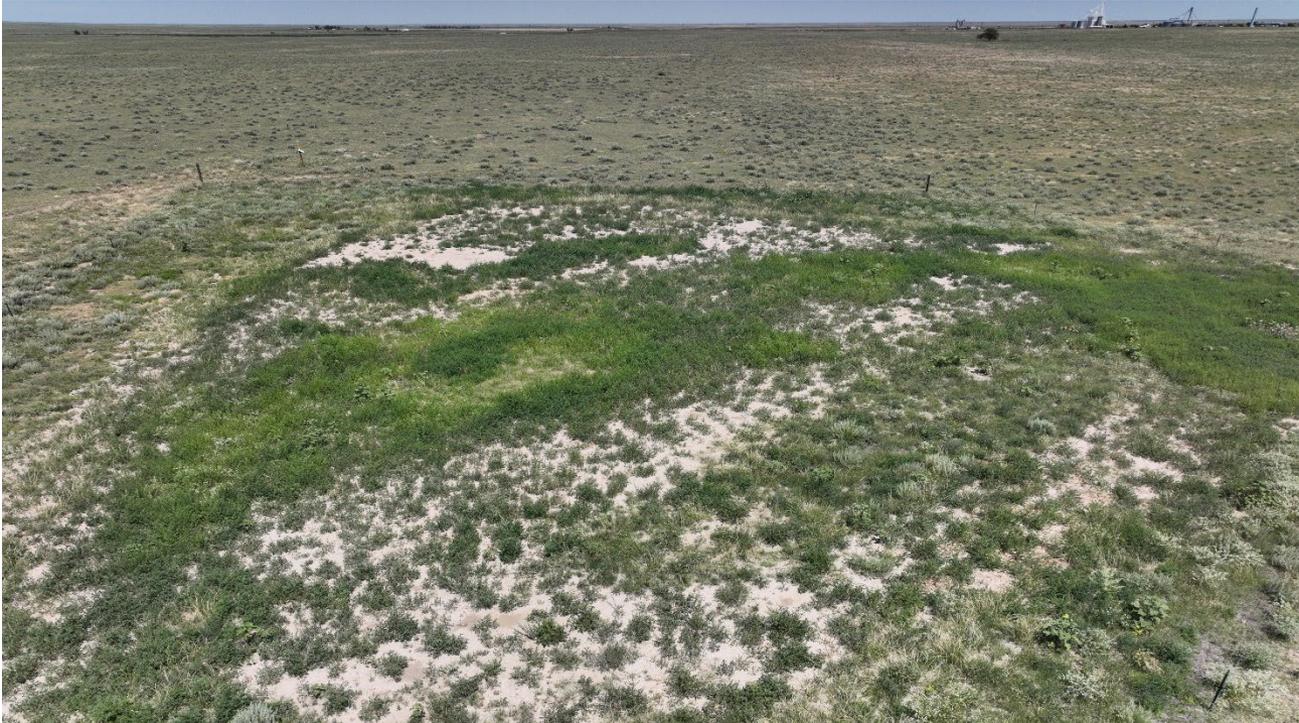
Photo 8. Drone aerial photo facing northeast at the location.

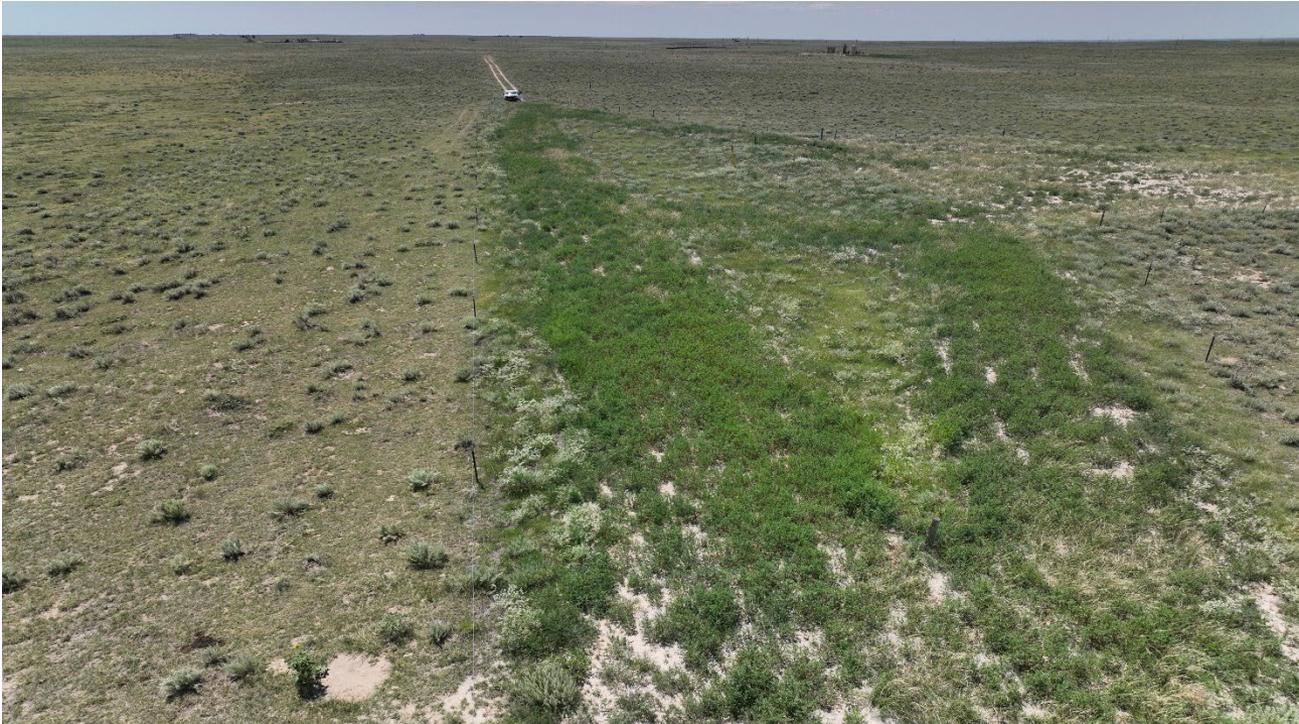
Photo 9. Drone aerial photo facing south toward the reclaimed access road.
