## Inspection/Audit Photos

Location: UTAH GAS OP LTD DBA UTAH GAS CORP SOUTH DOUGLAS CREEK 7314

Location ID: 315141

Date: 07/15/2025

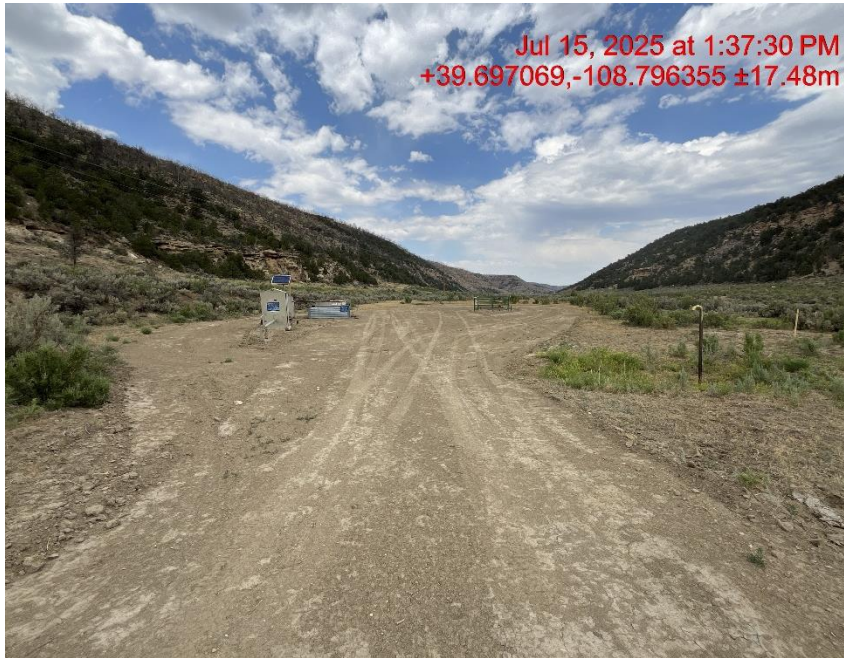
Photo # 9982 Entrance to location

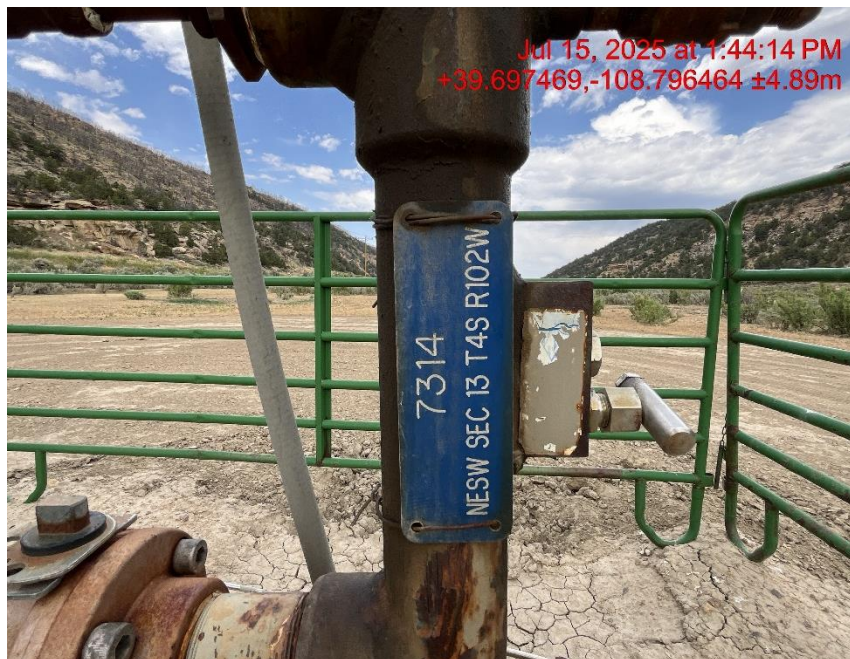
**Photo # 9986 Wellhead sign lacks required information/not in compliance with CECMC rules**

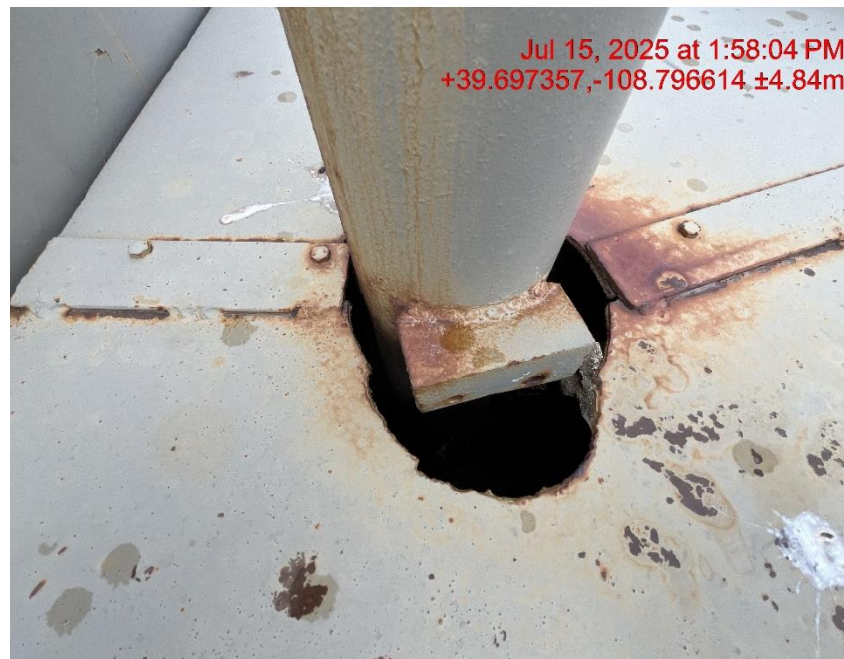
**Photo # 9998 Hole in separator building open to wildlife/available for entry by wildlife**

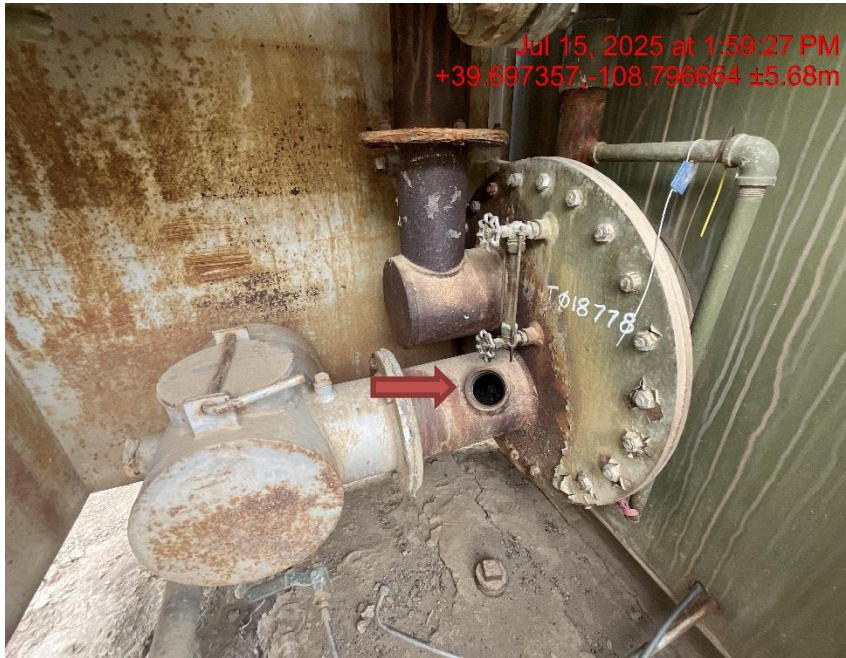
**Photo # 9999 Separator heater open to wildlife/available for entry by wildlife**

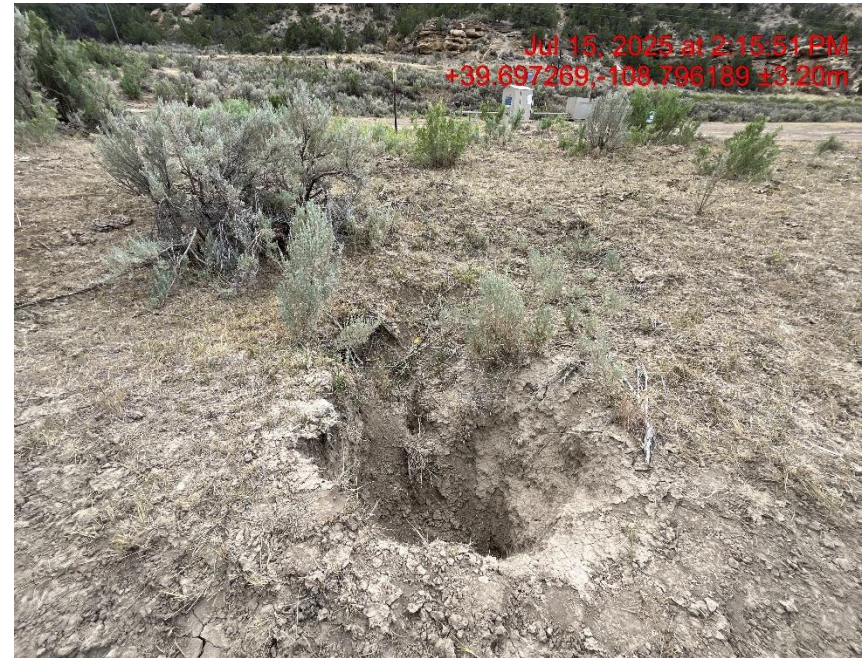
**Photo # 0012 Subsidence on SE side of location, additionally is a wildlife hazard/personnel safety hazard**

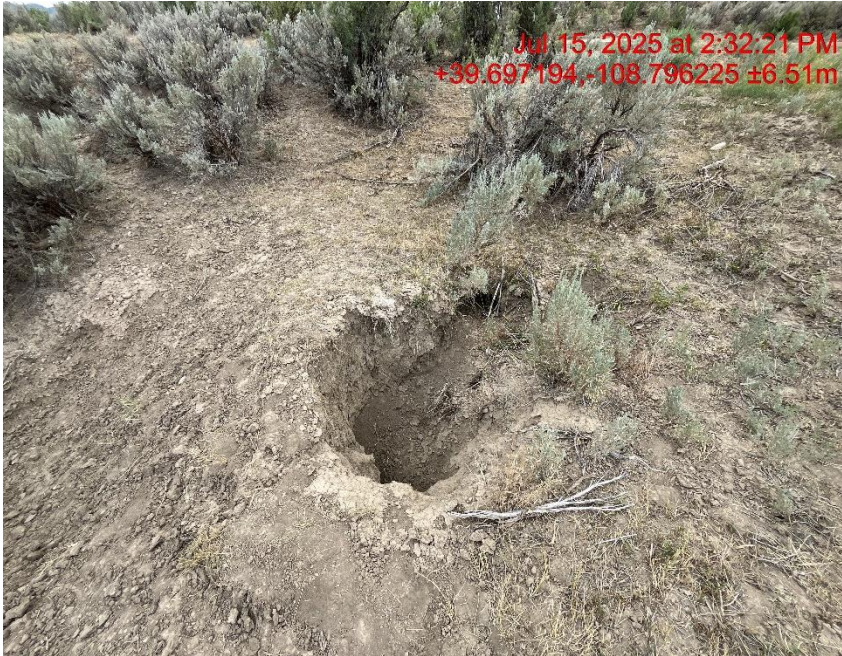
**Photo # 0028 Subsidence on SE side of location, additionally is a wildlife hazard/personnel safety hazard**

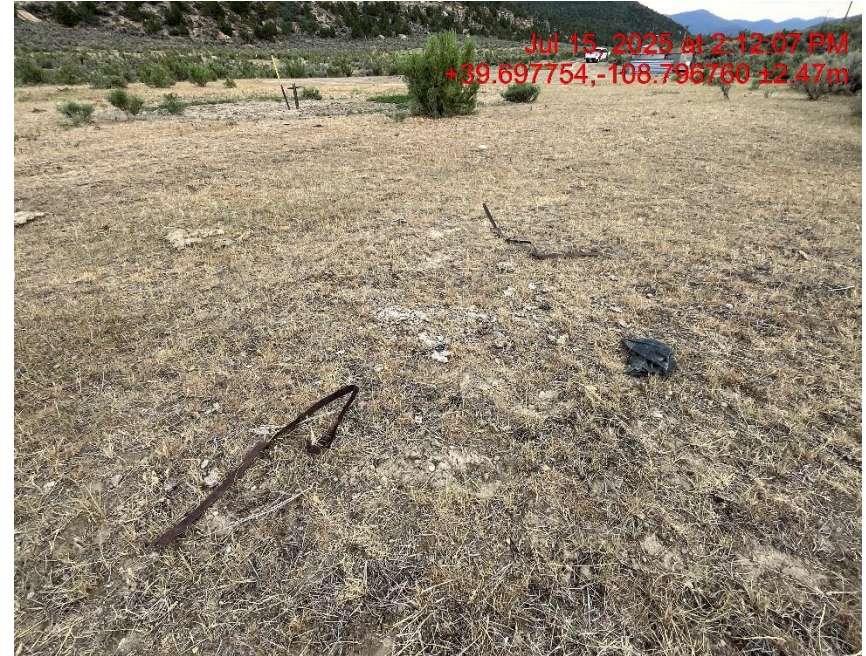
**Photo # 0010 Debris on location**

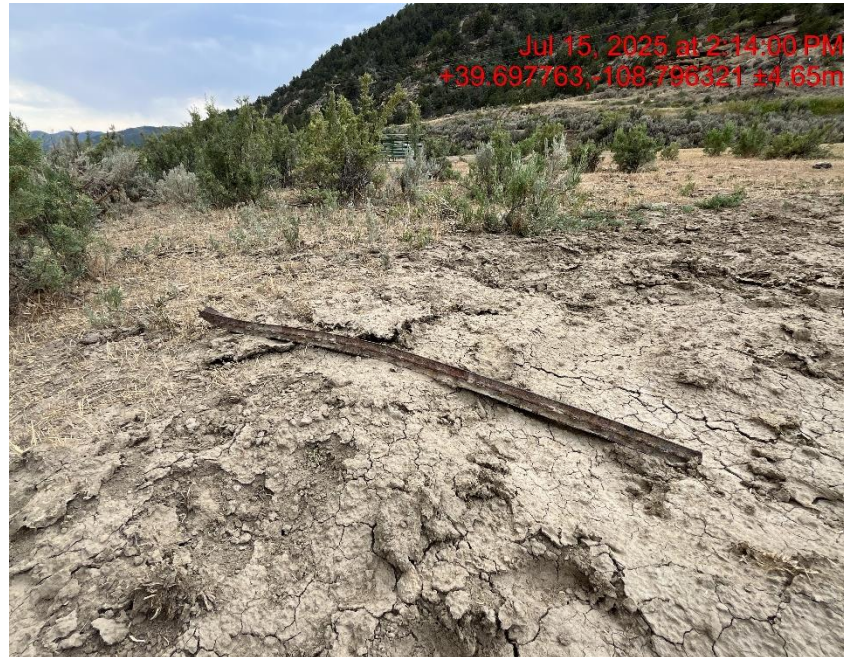
Photo # 0011 Debris on location
