Final Reclamation and Stormwater Inspection

Operator: KERR MCGEE OIL & GAS ONSHORE LP - 47120

Location ID: 320364

Well Name: DREYER #1

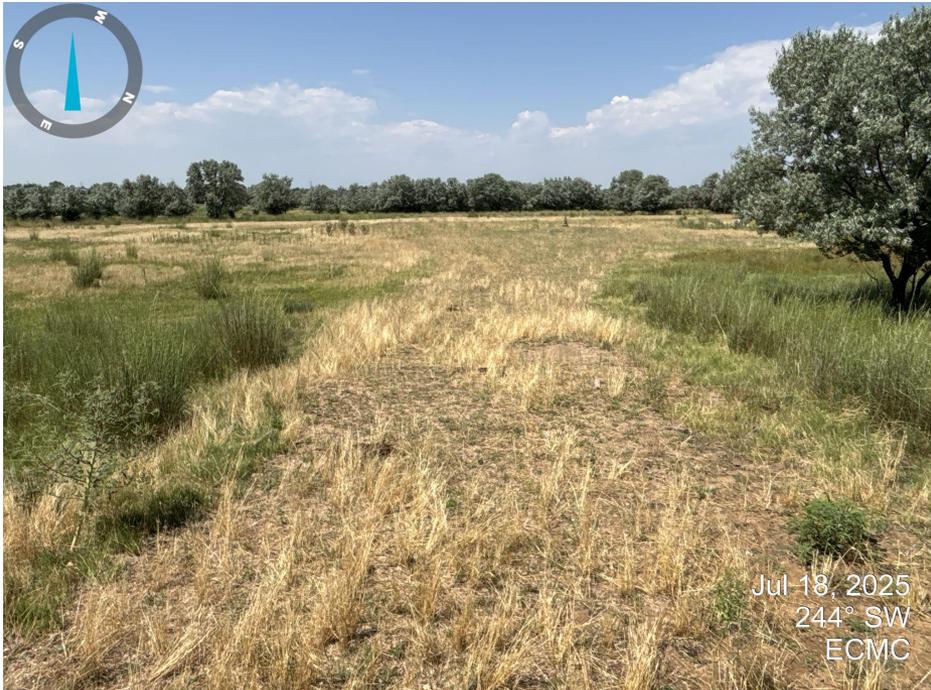
Photo 1. Looking west across the location. Desirable vegetation is present on location but appears to have a coverage lower than the surrounding reference area.

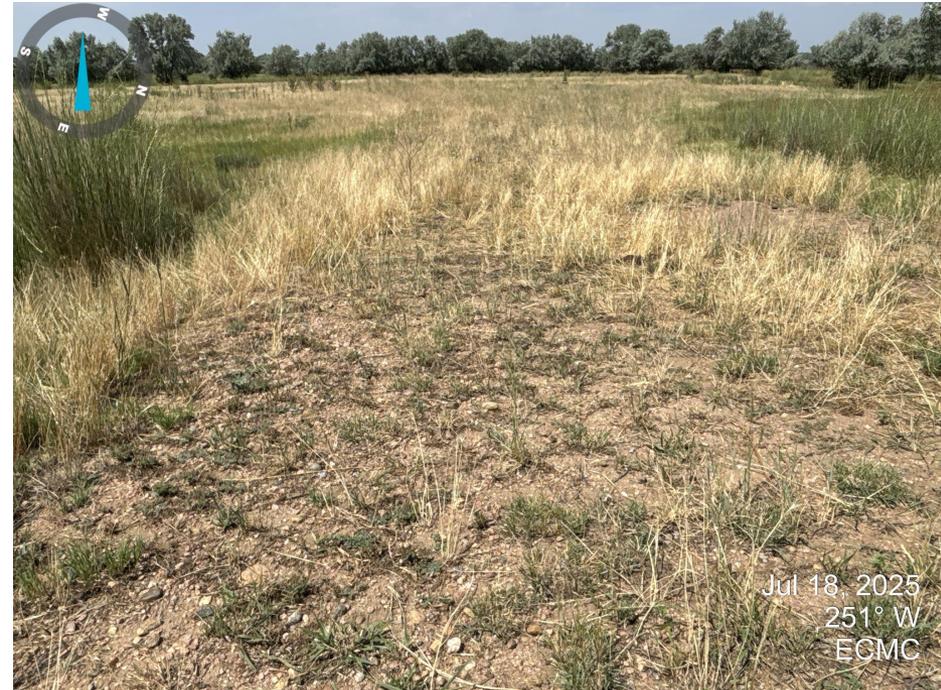
Photo 2. Photo taken on the access road near the location. A relatively high amount of gravel remains on location and may be affecting establishment of desirable vegetation.

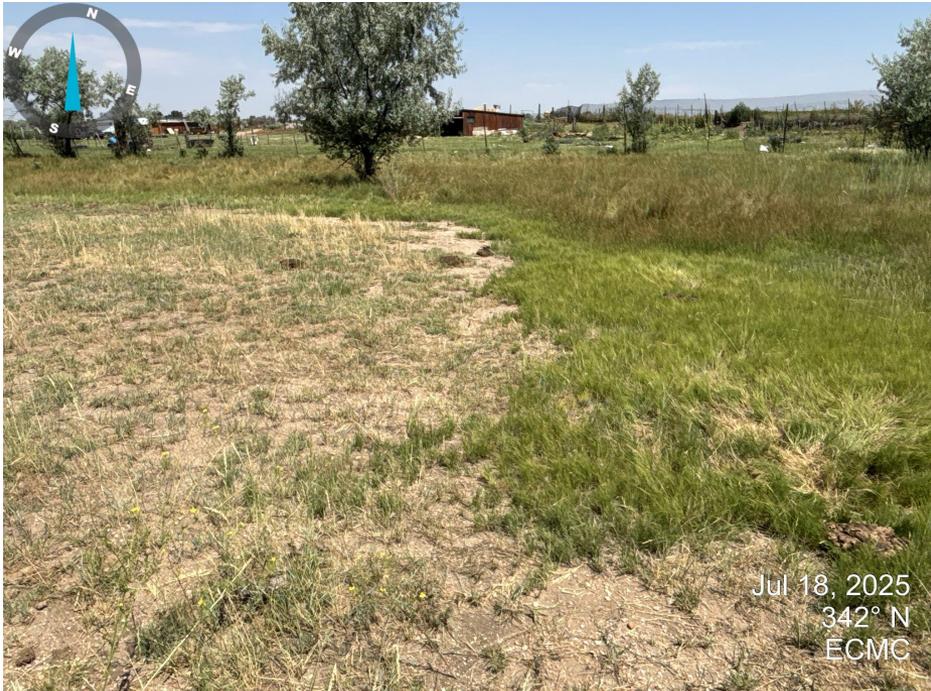
Photo 3. Photo taken on the north side of the location looking north. Illustrating reference vegetation on the right and disturbance area on the left. Vegetation on location does not appear to have reached 80% coverage of the reference area.

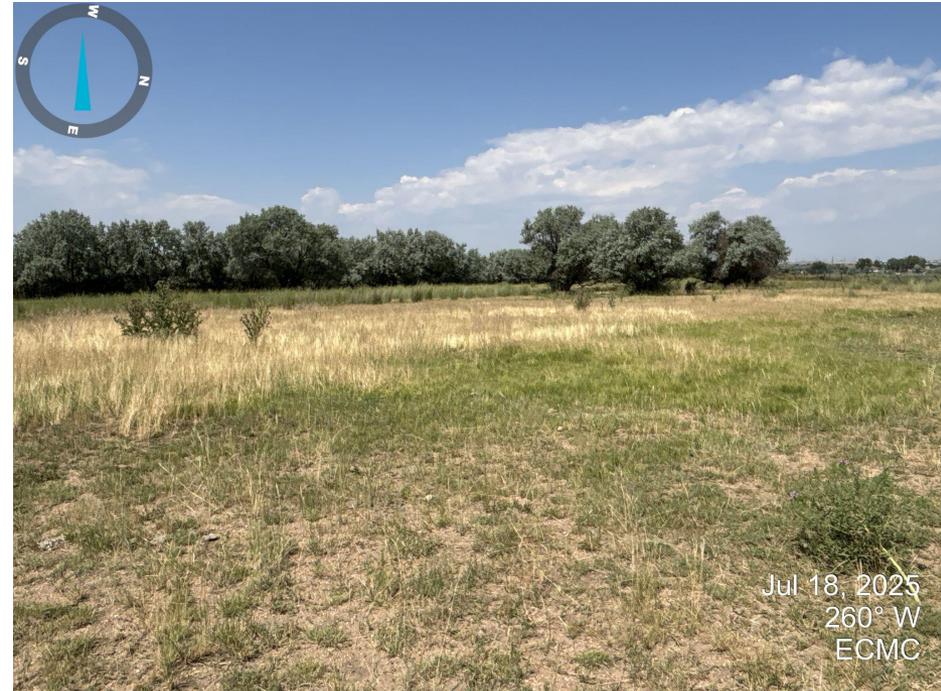
Photo 4. Looking west from the wellbore. No oil and gas equipment remains. Desirable vegetation is present on location but does not appear to have reached 80% coverage of the reference area.

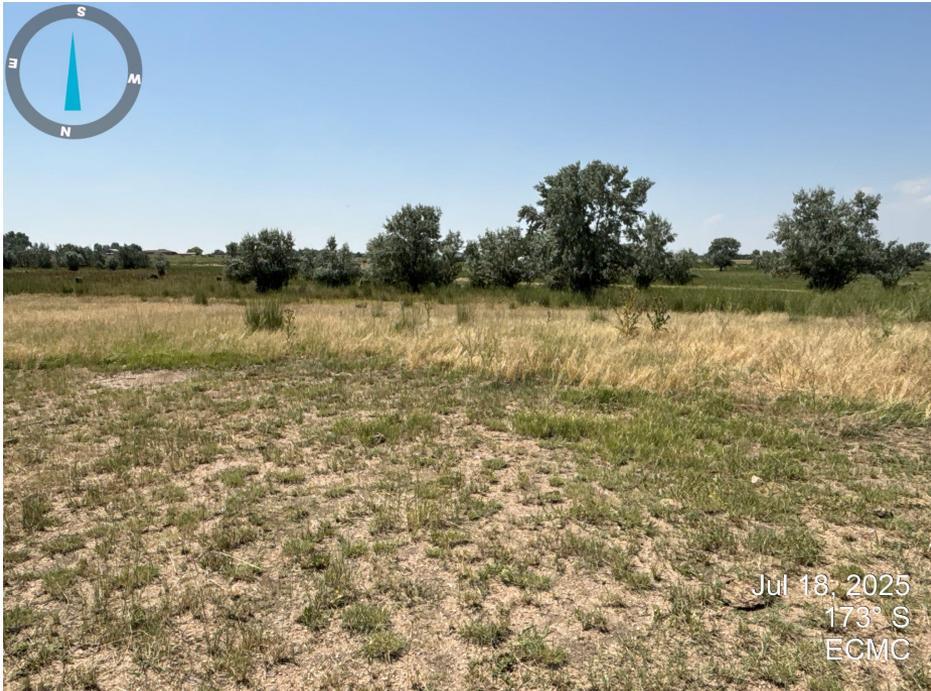
Photo 5. Looking south from the center of the location. See photo 4 comments.

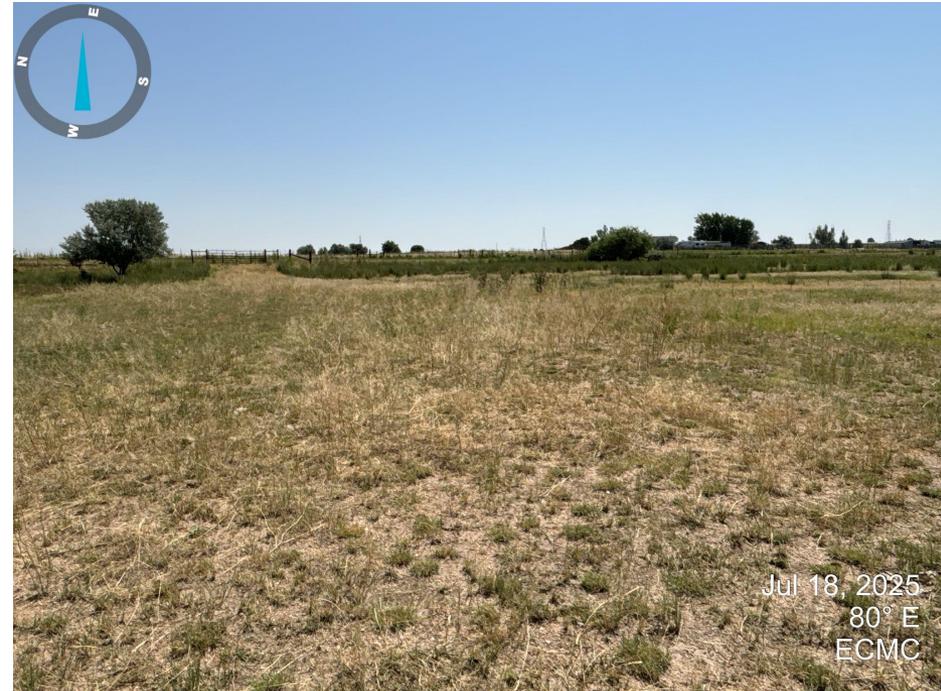
Photo 6. Looking east from the center of the location. See photo 4 comments.

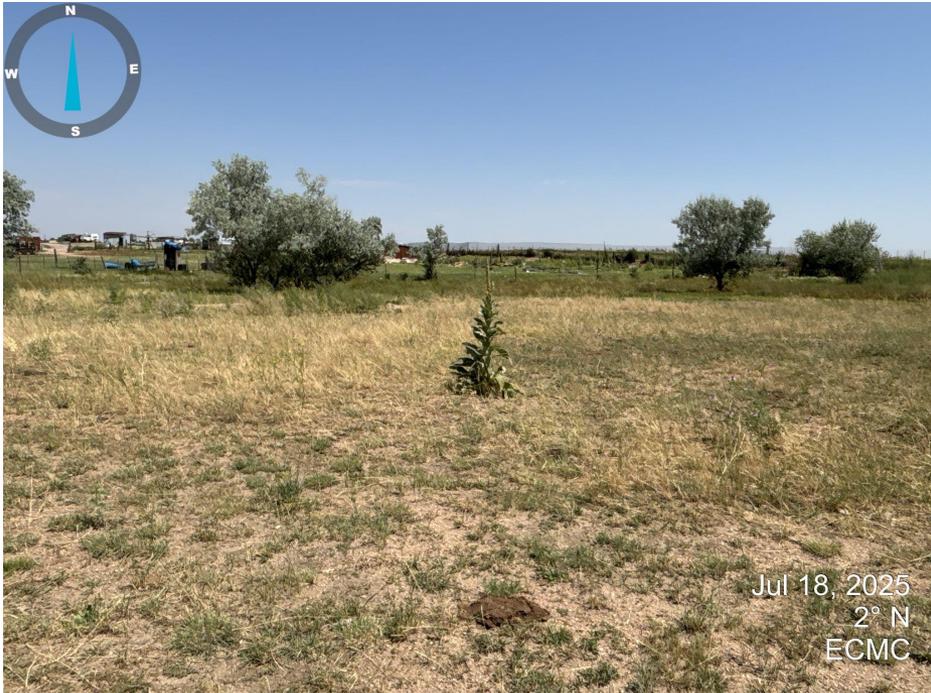
Photo 7. Looking north from the center of the location. List C noxious weed mullein is present on location.

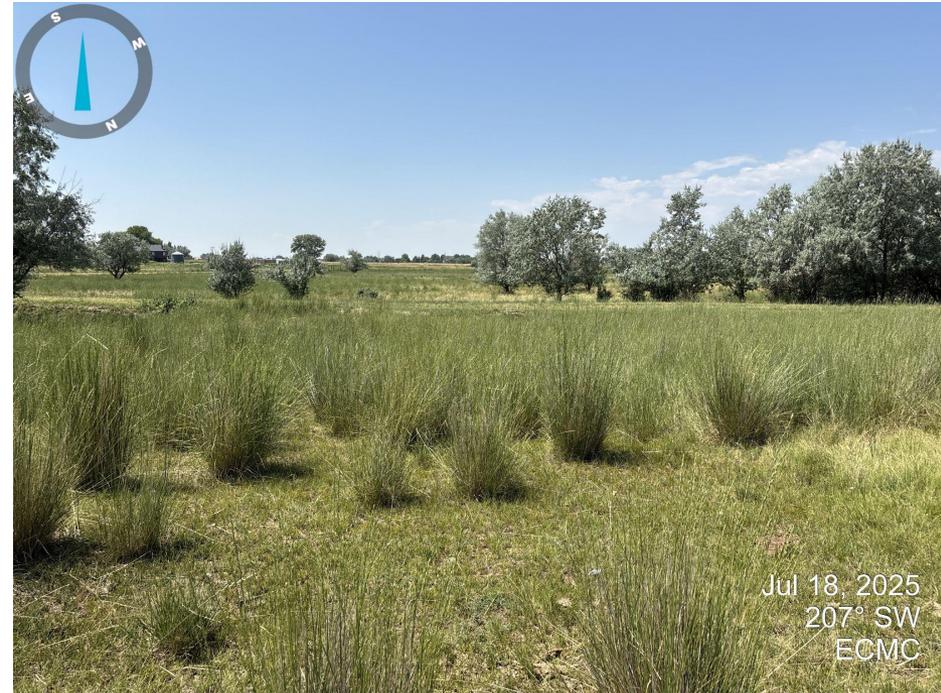
Photo 8. Reference vegetation to the south of the location. Reference vegetation is relatively high quality, consisting of salt grass and western wheatgrass.
