SUNDRY NOTICE

1. OGCC Operator Number: 100185 4. Contact Name: DeAnne Spector
2. Name of Operator: ENCANA OIL & GAS (USA) INC
3. Address: 370 17TH ST, STE 1700 City: DENVER State: CO Zip: 80202
5. API Number: 05-077-09420 OGCC Facility ID Number:
6. Well/Facility Name: Orchard Unit 7. Well/Facility Number: 20-12H (K20OU)
8. Location (Qtr/Qtr, Sec, Twp, Rng, Meridian): NESW Sec. 20-T8S-R96W 6th PM
9. County: Mesa 10. Field Name: Orchard
11. Federal, Indian or State Lease Number: COC-64191

Well: Orchard Unit 20-12H (K200U)

5.5" Casing & Cementing Remediation

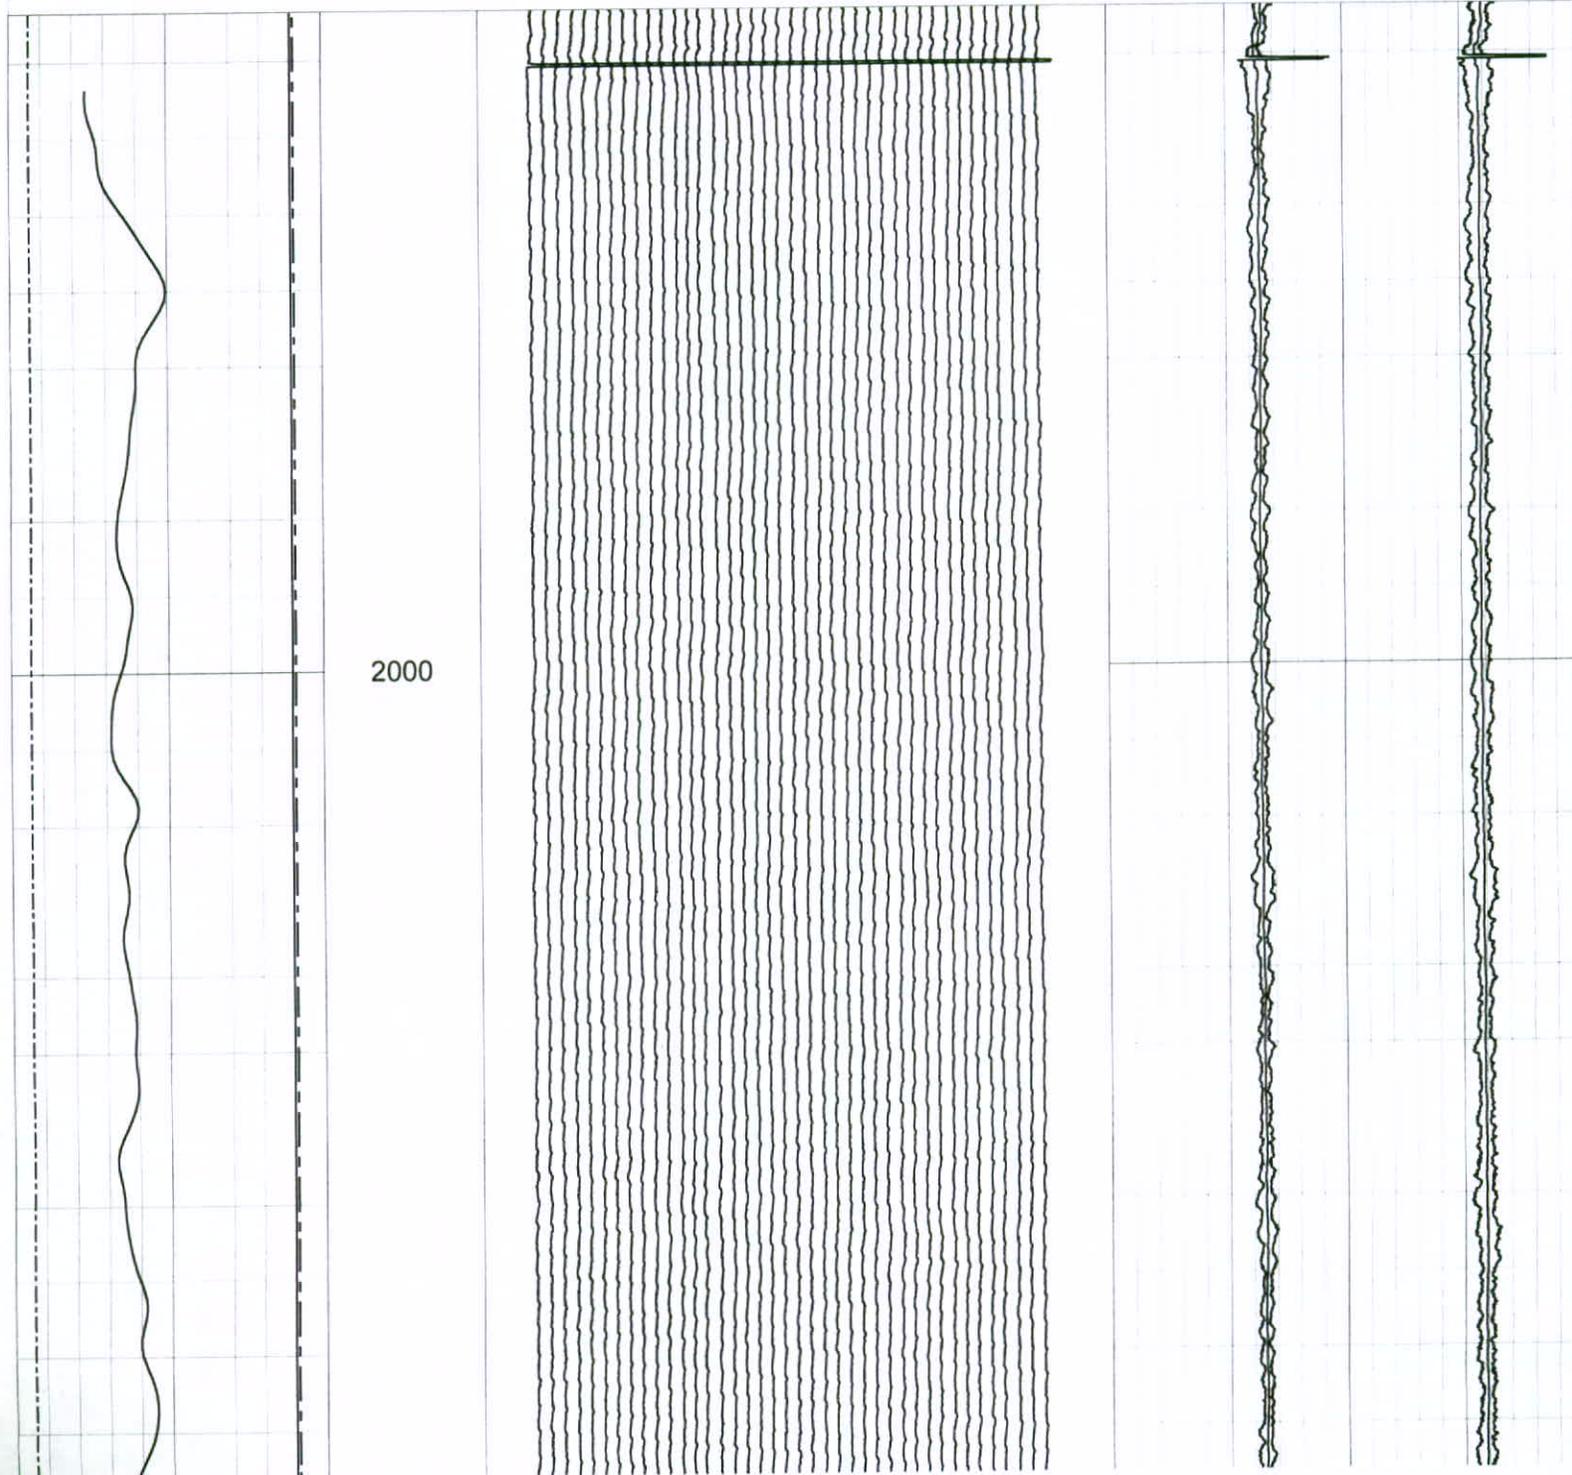
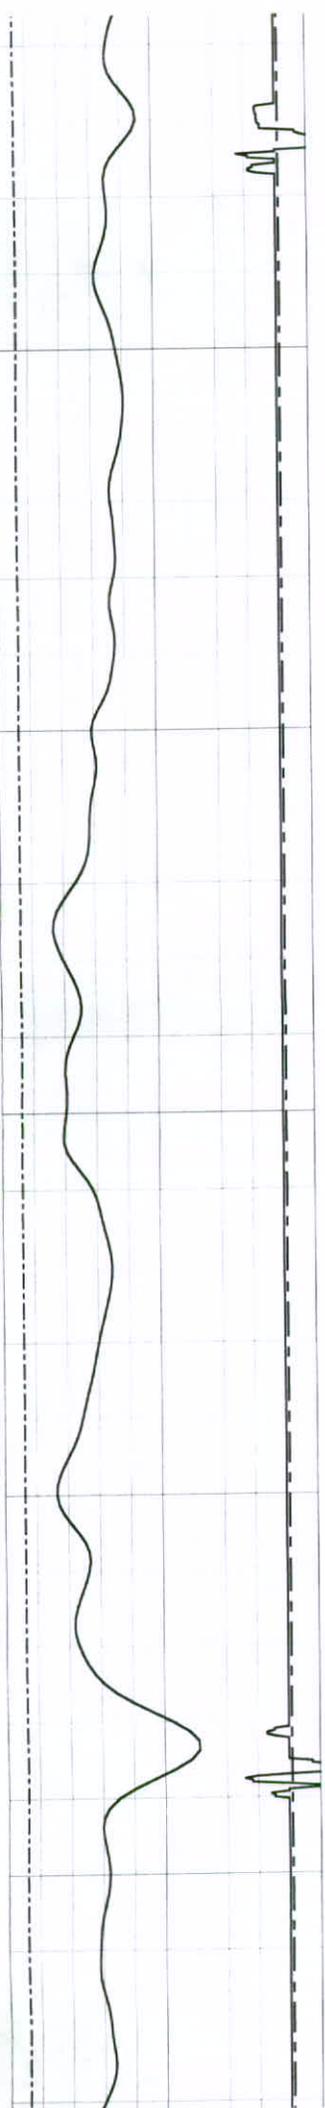
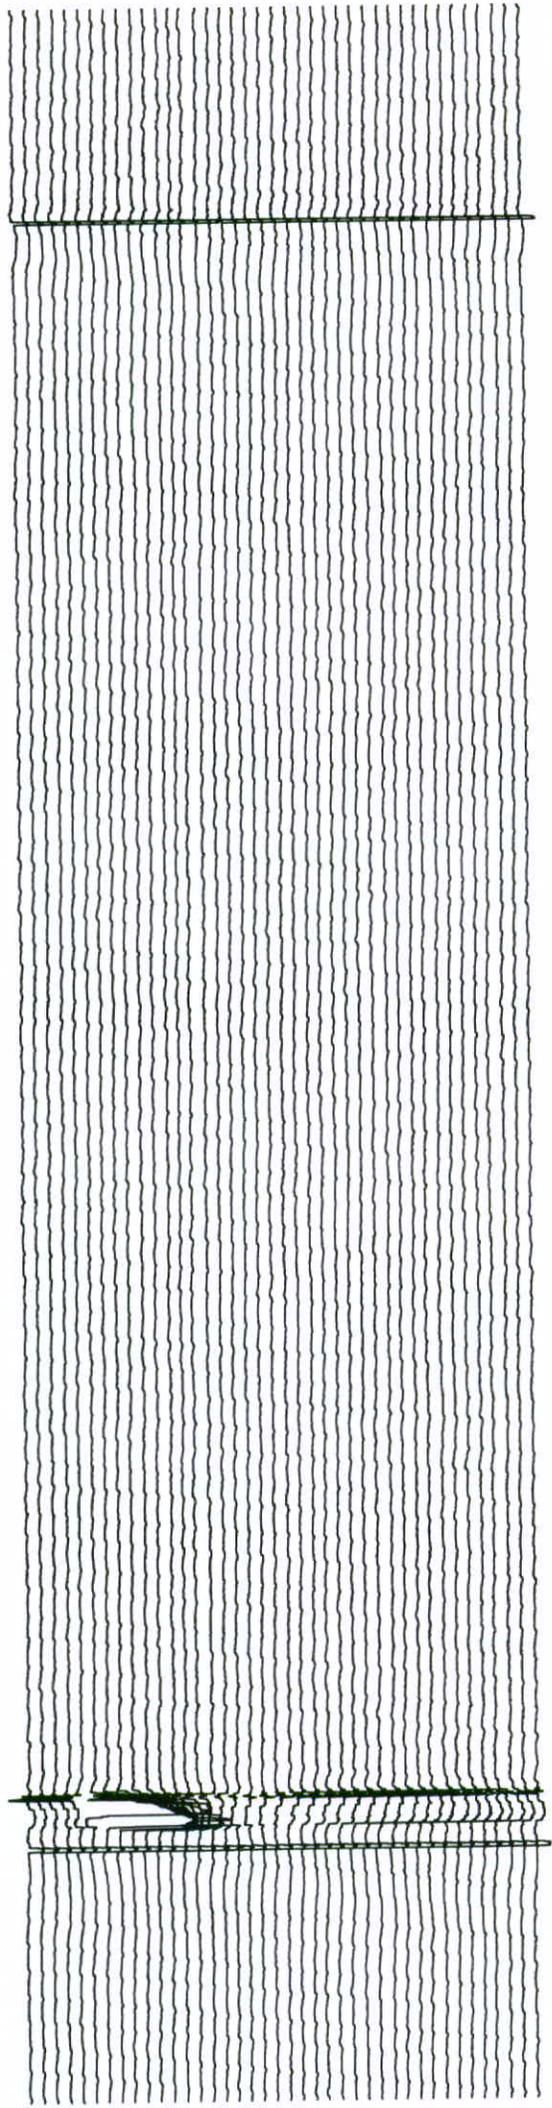
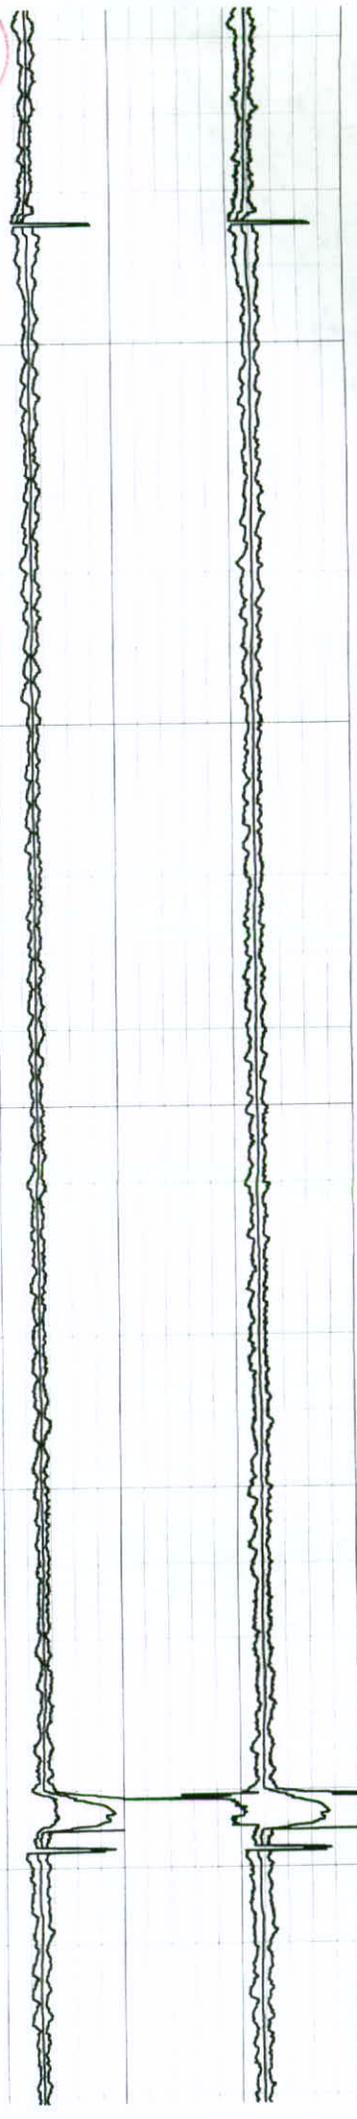
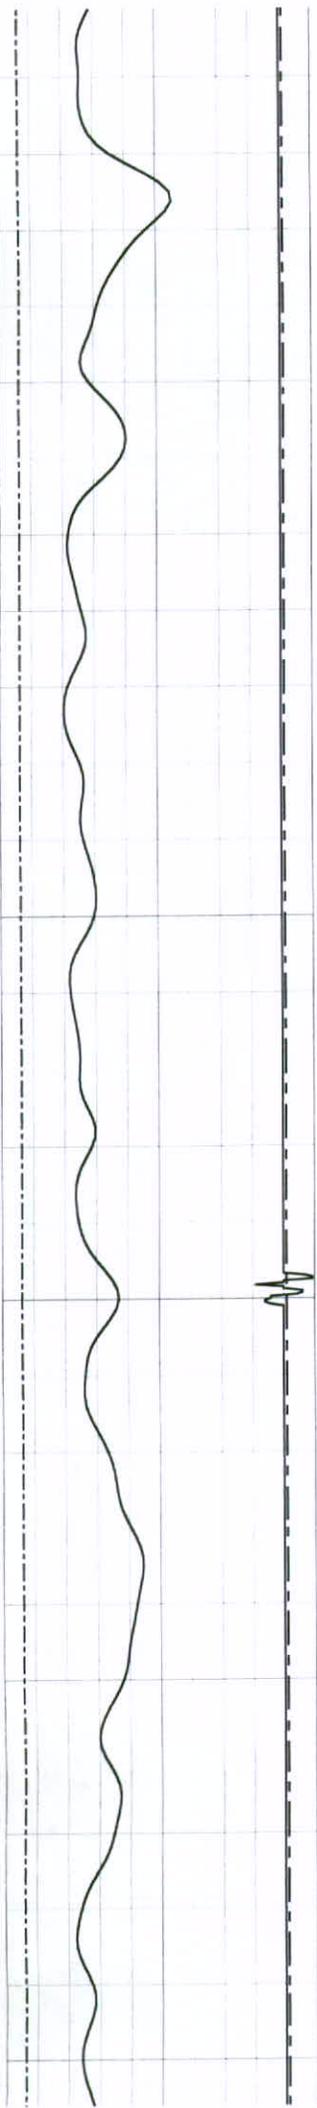
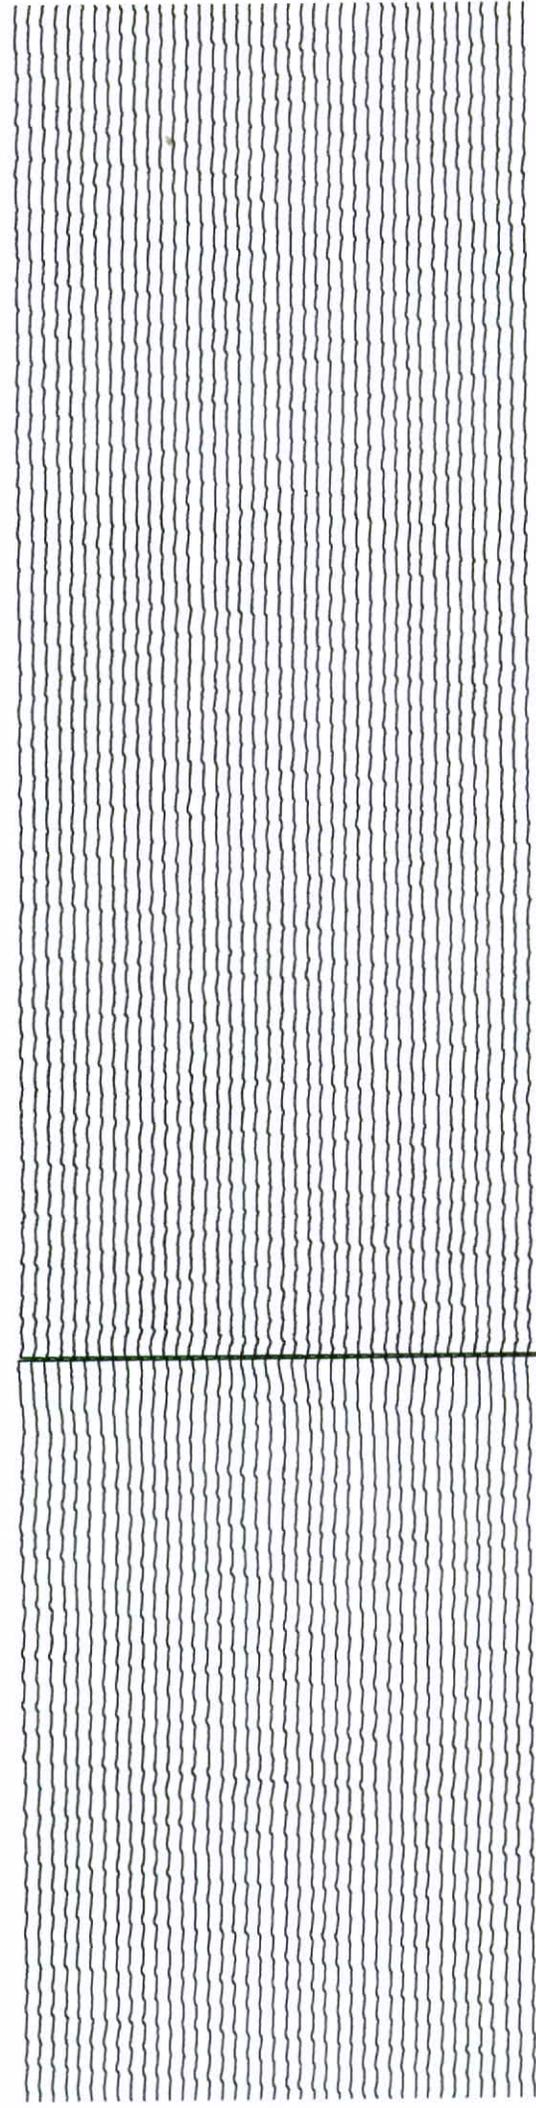
It was determined that a hole/split is in the 5.5" casing just above the collar at 2069' MD. This remediation procedure includes steps to cut and pull 5.5" CSG, evaluate the 9-5/8" Intermediate CSG w/ 40-arm caliper log, and patch/cement new 5.5" CSG in place. Following the successful patch & cement job, the cement and plugs will be drilled out, pushed to the frac plug between Stages 4 & 5, and the completions will resume for Stages 5-18.

I've attached the 5.5" CSG inspection log which is zoomed in at the point of failure.

5 1/2" CSG
FAILURE →

- 1 MIRU workover rig, ND WH, NU BOPE, blow well down
 - 2 MIRU wireline crew. RIH w/ chemical cutters to make first cut in 5.5" CSG at 6360' (~200' above uppermost cement stringer).
 - 3 POOH w/ cutter, confirm cutter fired. RIH w/ 2nd chemical cutter to cut just below the hole in 5.5" CSG. Make the 2nd cut at 2140' (10' below collar of JT below hole). POOH w/ cutter, confirm cutter fired. RDMO wireline crew.
 - 4 RU LD Machine to LD 5 1/2" Casing.
 - 5 MIRU Casing Crew. Spear 5.5" CSG (Fish #1 from Surface to 2080') and POOH laying down 48 JTS + cut CSG stub (~2080' total)
*Note: String Weight (in air) of 2080' of 5.5" 17.0# CSG is ~35,400 lbm.
Please confirm JT count of pipe pulled out of the hole.*

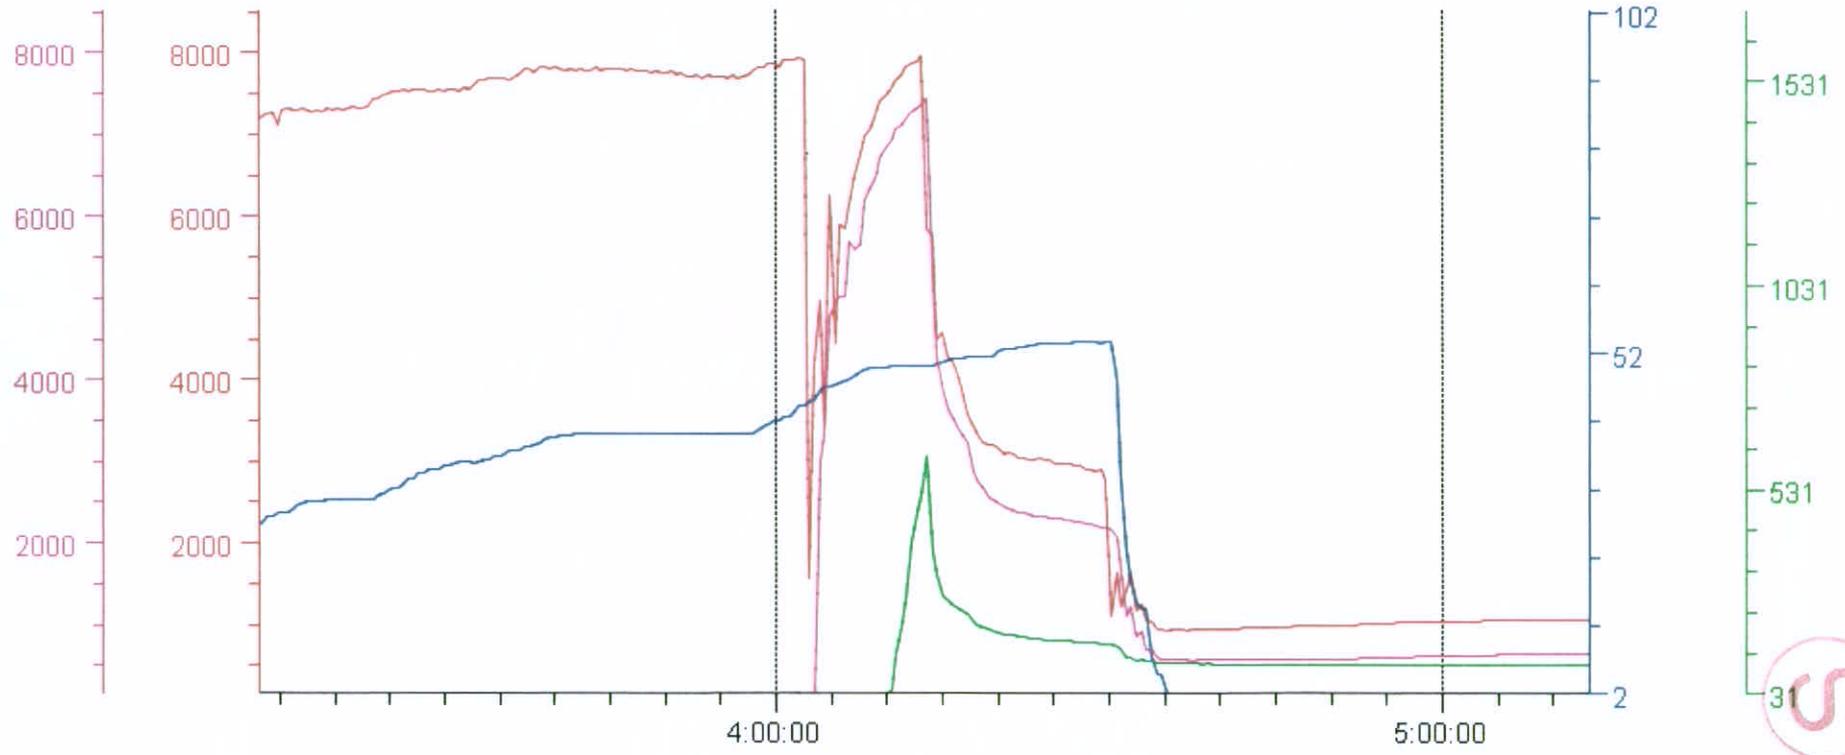
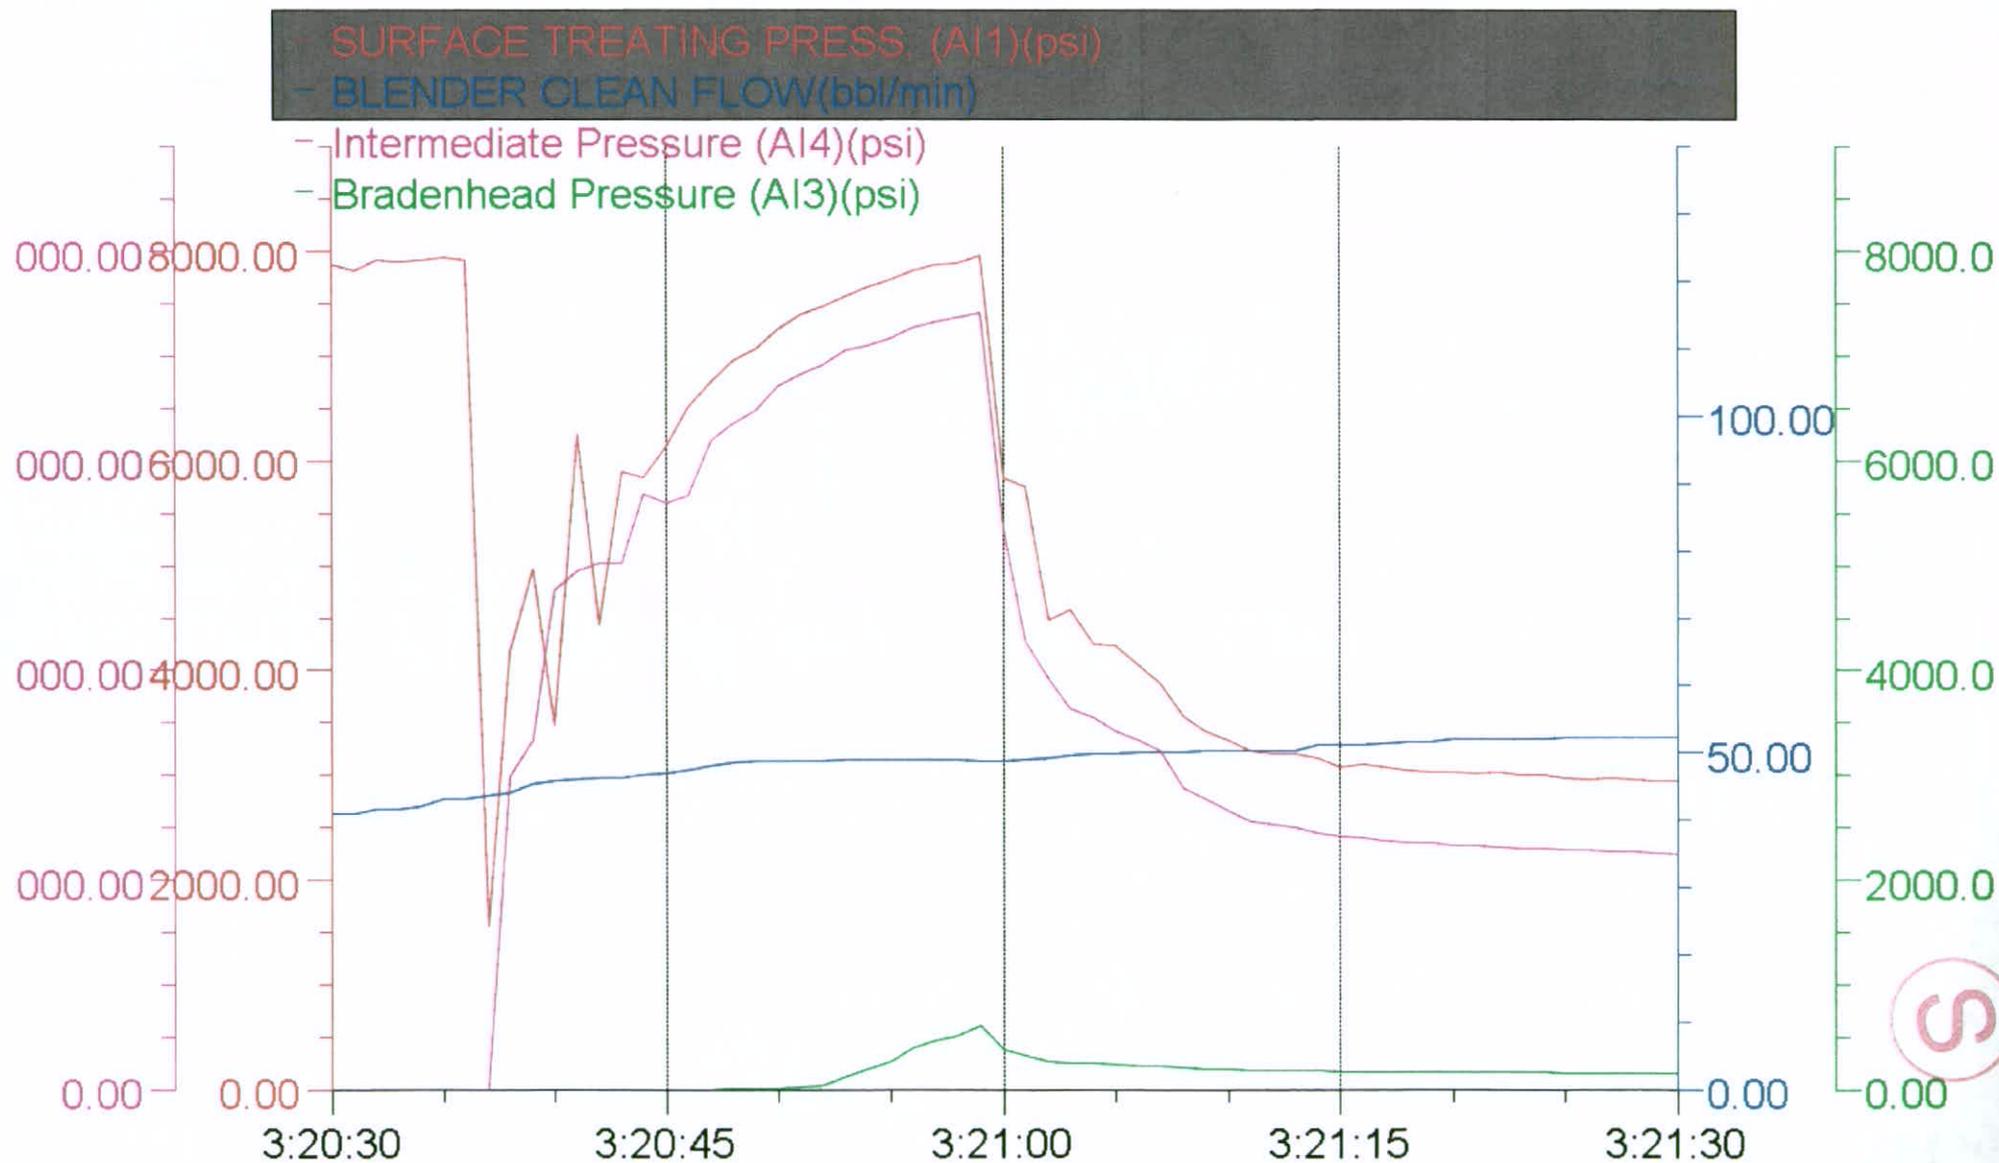
K200UStage5Frac

During the beginning of the Stage 5 completion, surface treating pressure decreased sharply which was matched by an increase in Intermediate CSG pressure. Surface CSG pressure increased as well. The job was shut down, a CBP was set at 8020', and all pressures were bled down to zero psi where they have remained since the plug was set. A 2nd CBP + cement will be set at 7400' MD for additional well control and safety.

I've attached the frac graphs from the point at which casing failed. I've also attached the specs/diagram of the Logan 10K psi overshot CSG patch we're planning on running with new 5.5" CSG.

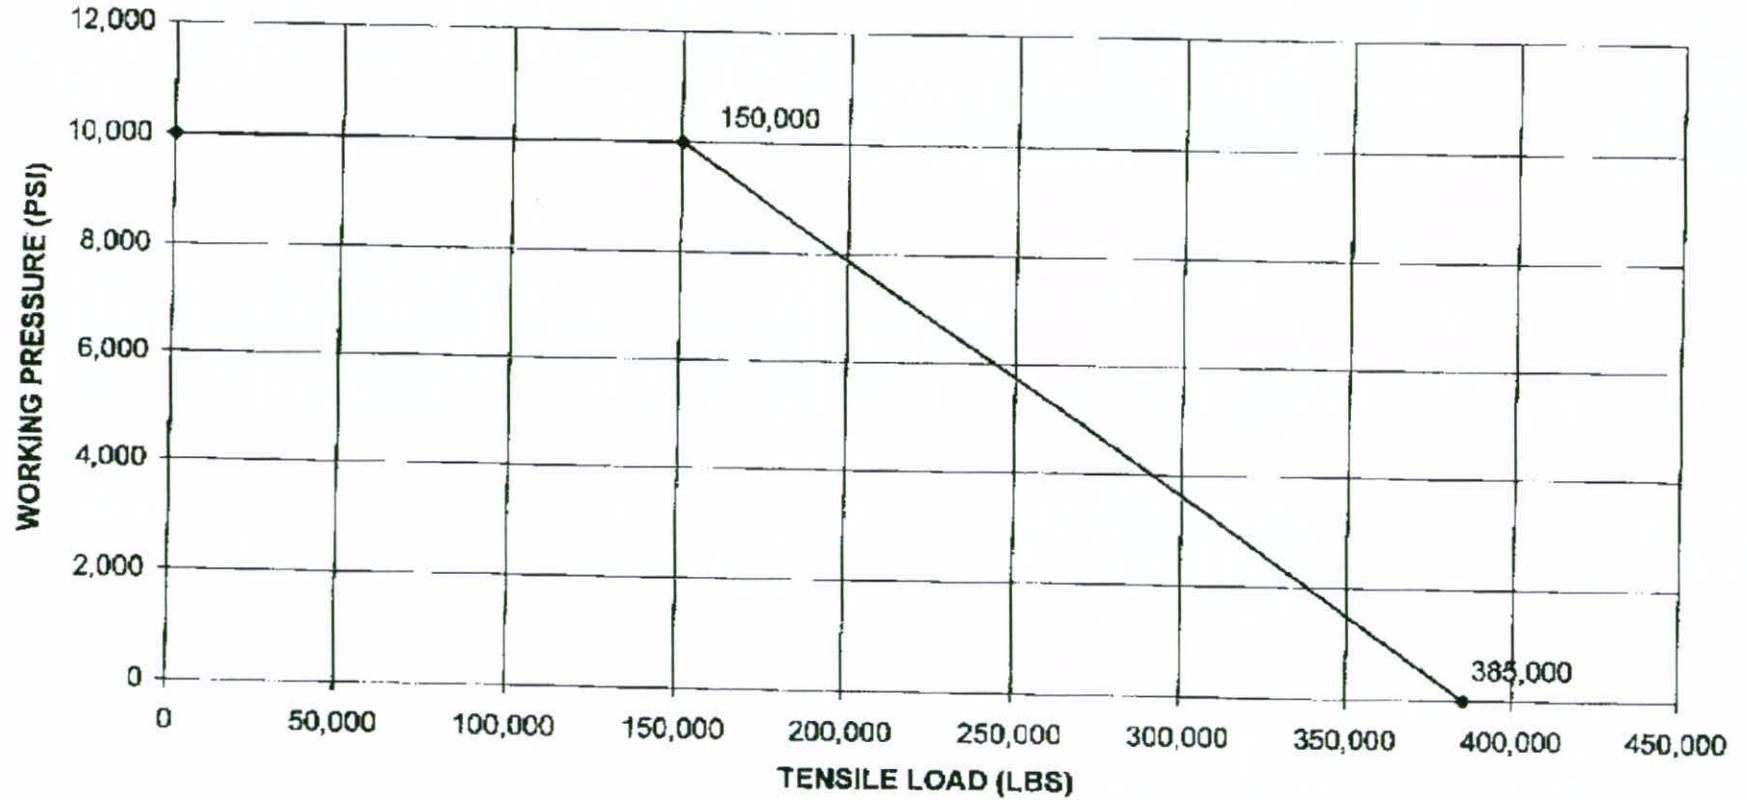
**STRENGTH DATA FOR LOGAN 7.0" OD HIGH PRESS PKOFF FOR
5-1/2 CASING, 10,000 PSI MAX WP 125K YIELD MAT'L
510L-007-001**

COLLAPSE PRESSURE:
11,310 PSI @ 0 TENSILE
7947 PSI @ 385K TENSILE

TORQUE:
T.S. TO BWL = 6680 FT/LBS
BWL TO GDE = 1500 FT/LBS

- 11 RIH with Logan 10K psi Overshot Patch on 5.5" 20# P110 CSG. Also, include a cement stage tool (ie., DV Tool) above casing patch to cement 5.5" CSG inside 9-5/8" Intermediate CSG from overshot patch to surface.

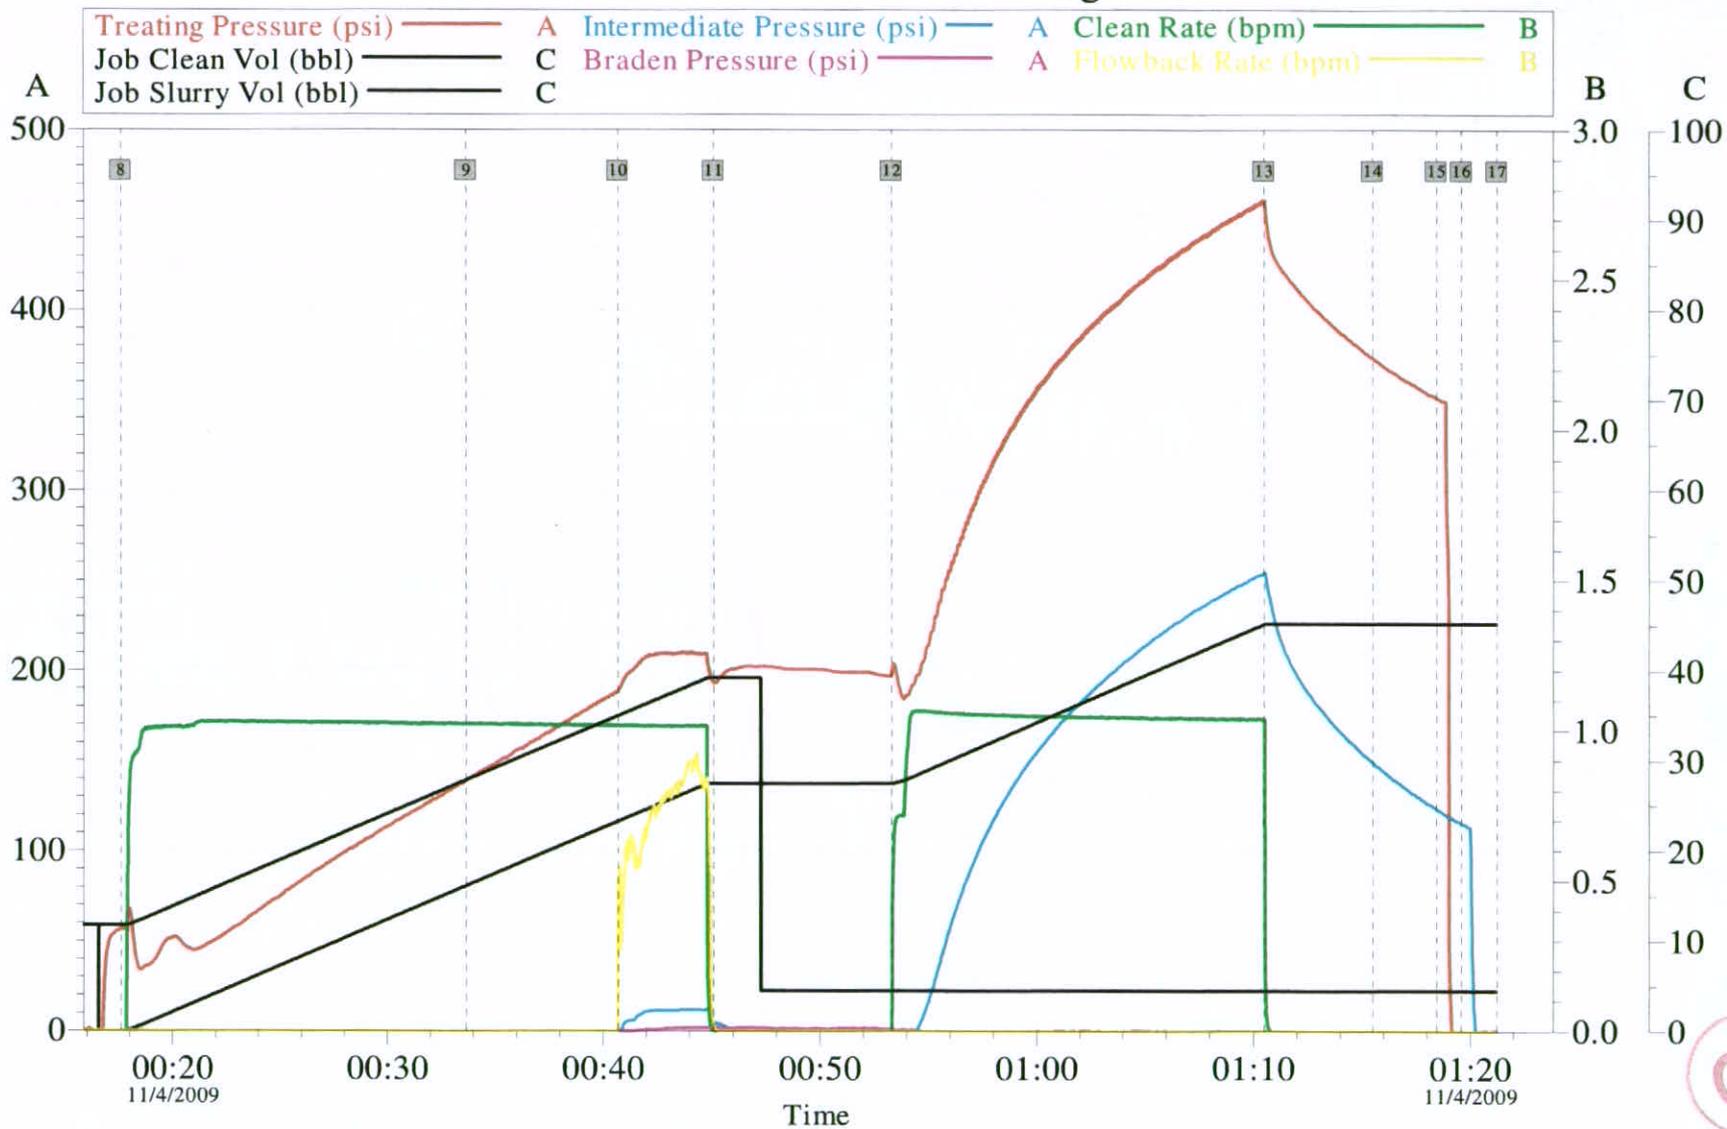
ENCANA 20-12H Test Casing

I've attached a graph from a pump/pressure test we performed against the Bradenhead. We pumped down 5.5", established circulation thru the hole @ ~2100' to the 9-5/8" Intermediate CSG, shut in the 9-5/8" CSG, and pressured up the 9-5/8" CSG to ~250 psi (5.5" was at ~450 psi). During the pumping and pressure testing, the Bradenhead remained at zero and did not show any signs of flow. In the attached graph, the red "Treating Pressure" line is from 5.5" CSG, the teal line is Intermediate CSG. I'm hoping this means we have no leaks in our Surface CSG--more testing will be done to confirm.
