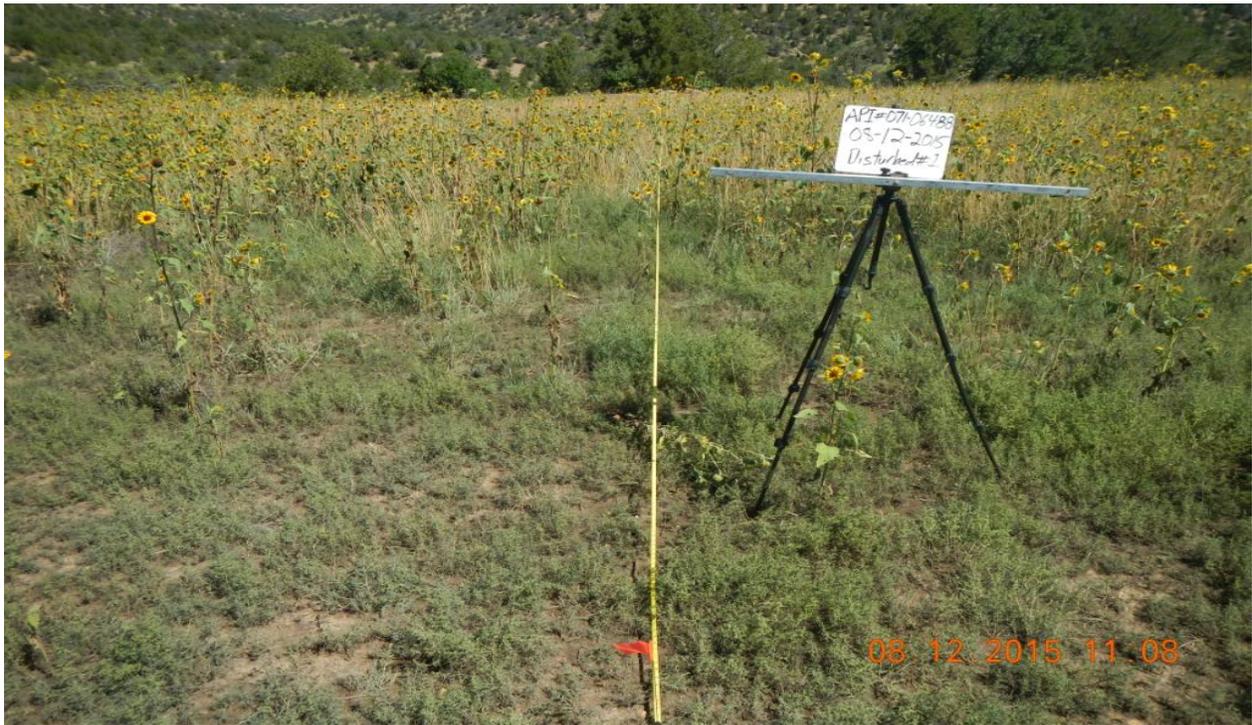
photo 1: Beginning of the vegetation transect facing north at the location. (Disturbed 1)

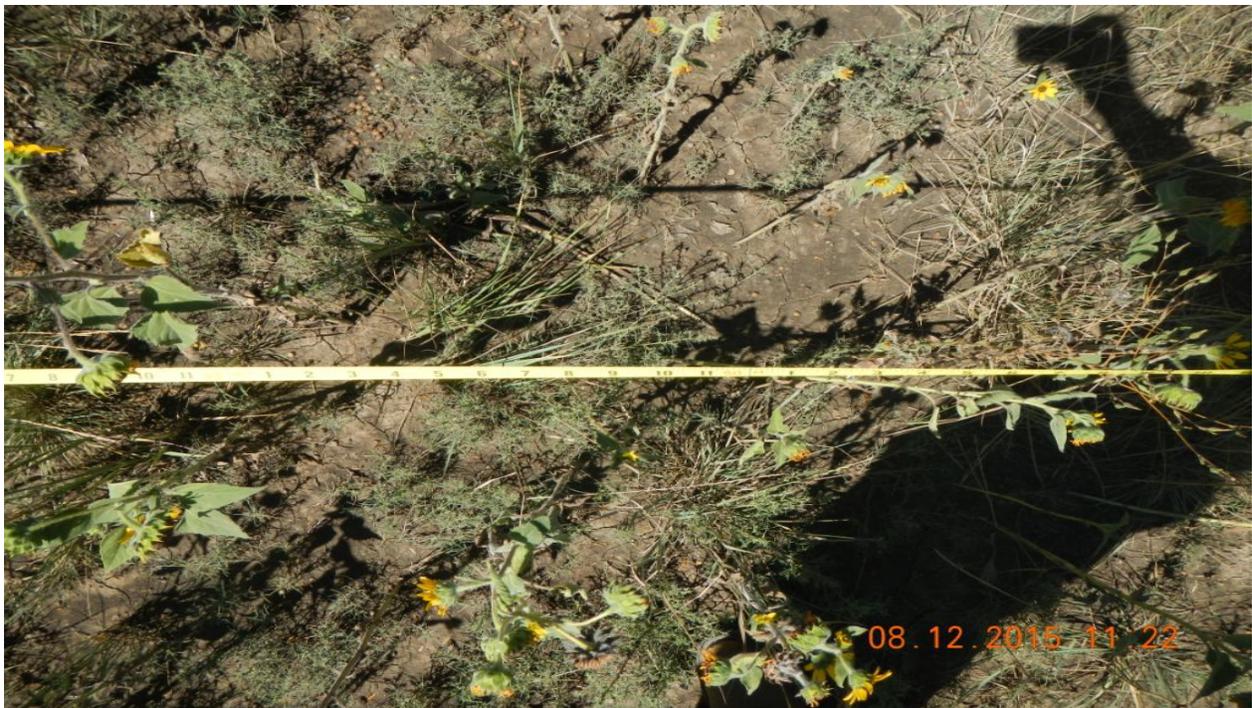
photo 2: Ground view at the midpoint of the transect.

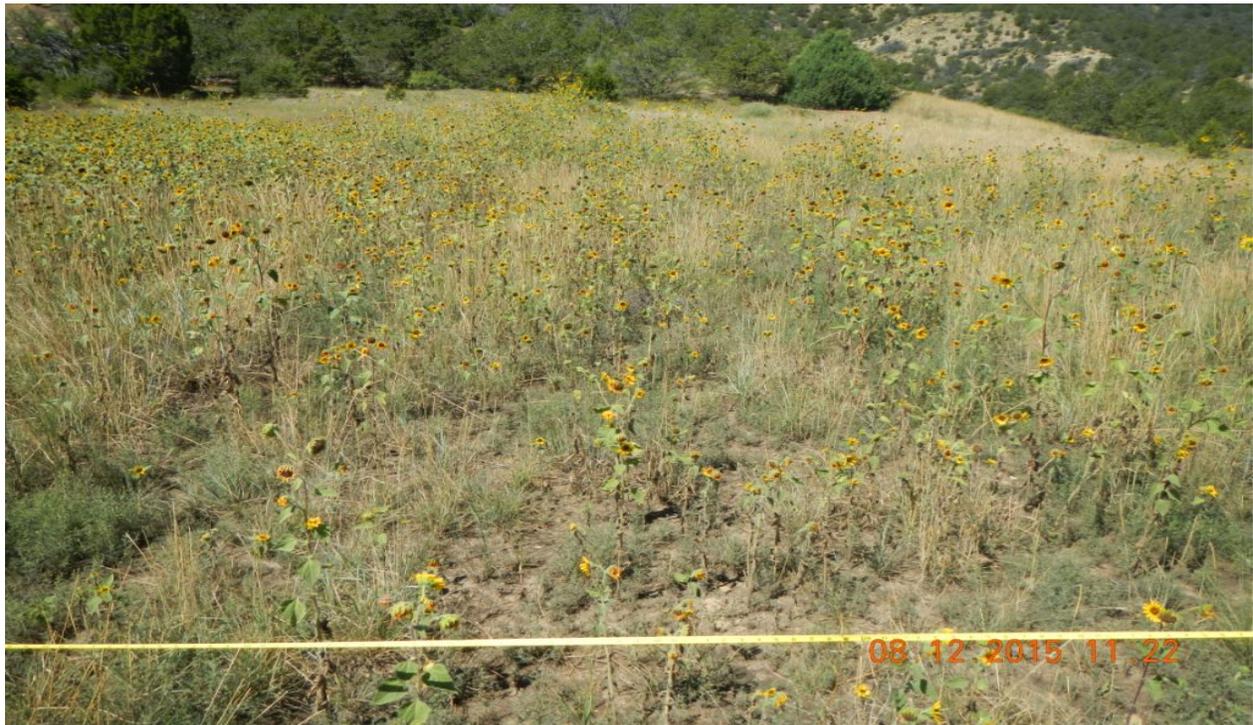
photo 3: Facing west at the midpoint of the transect.

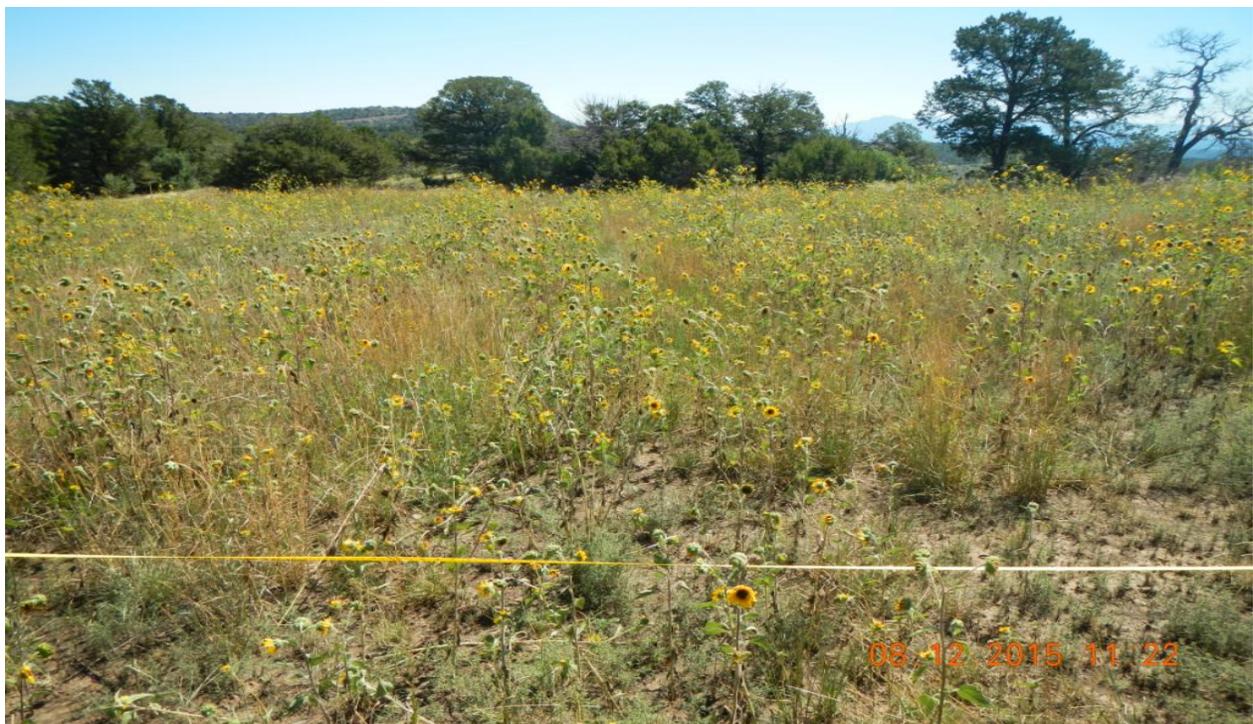
photo 4: Facing east at the midpoint of the transect.

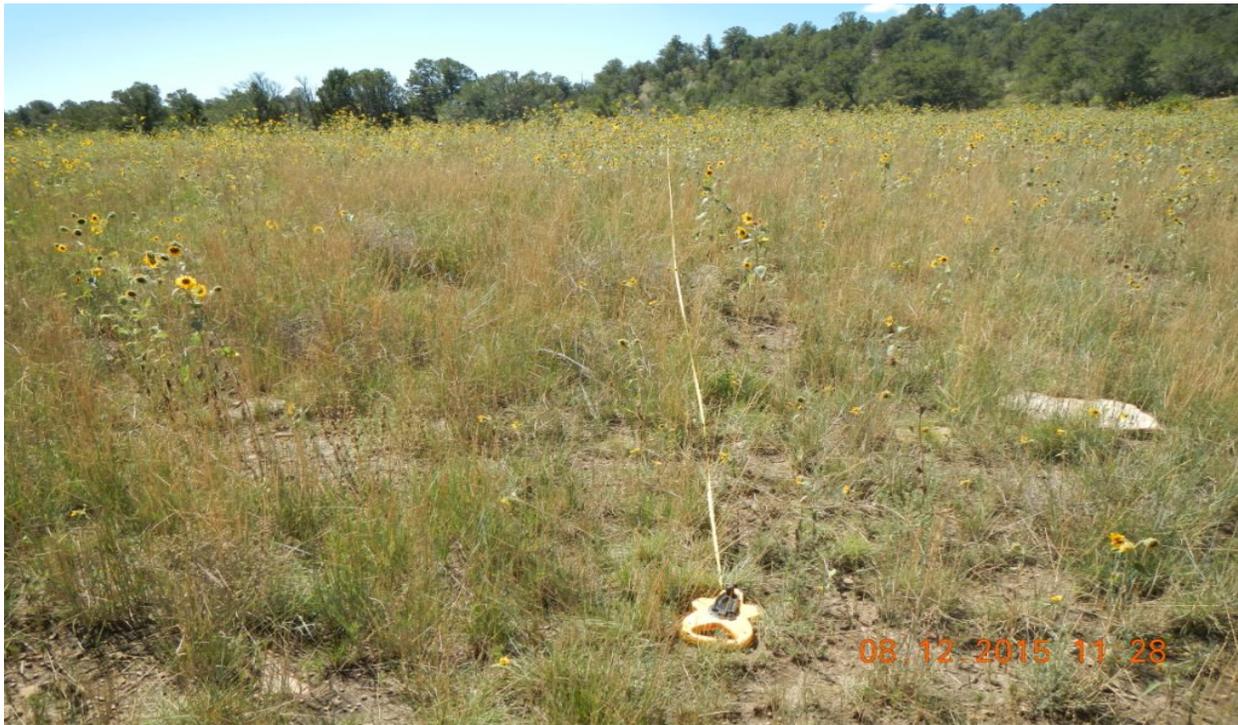
photo 5: End of the vegetation transect facing south at the location.

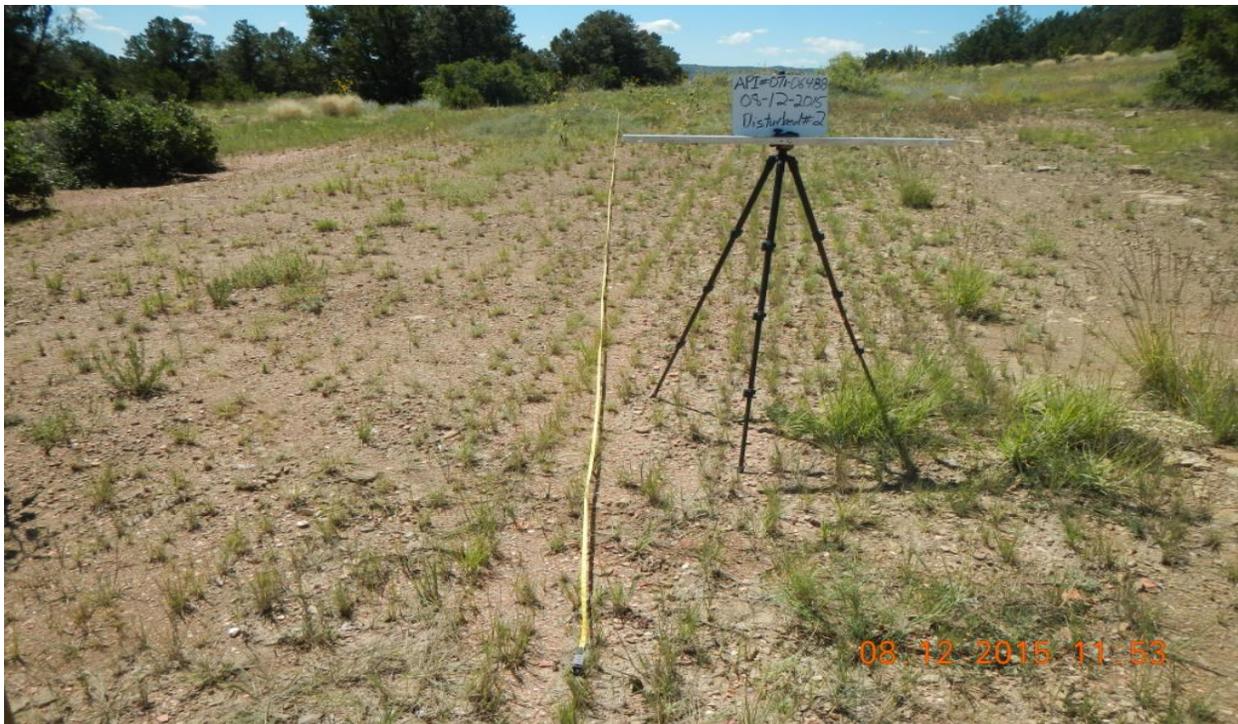
photo 6: Beginning of the vegetation transect facing southeast along the access road. (Disturbed 2)

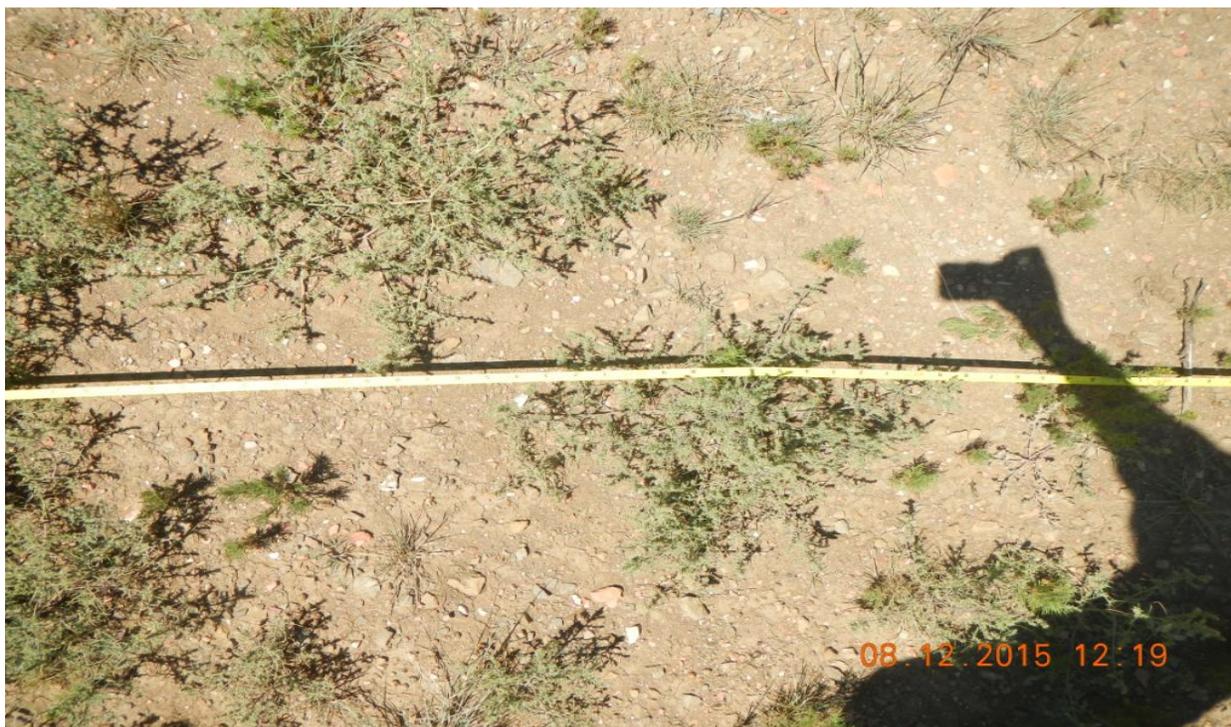
photo 7: Ground view at the midpoint of the transect.

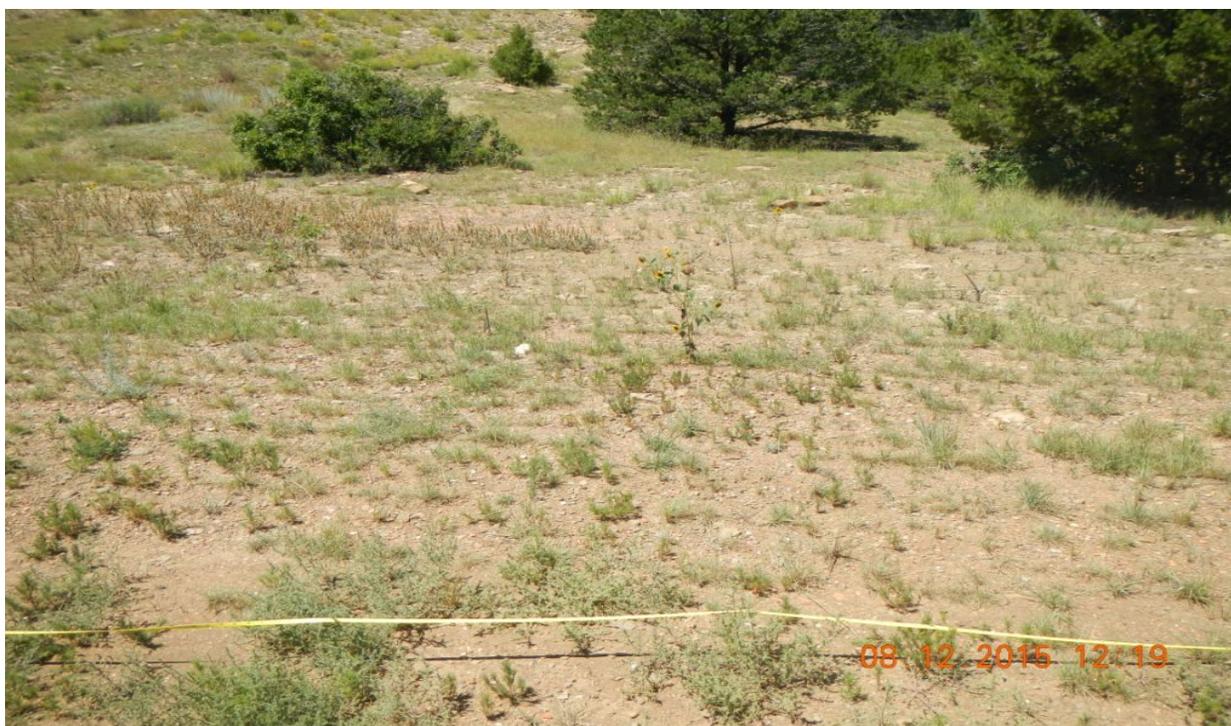
photo 8: Facing southwest at the midpoint of the transect.

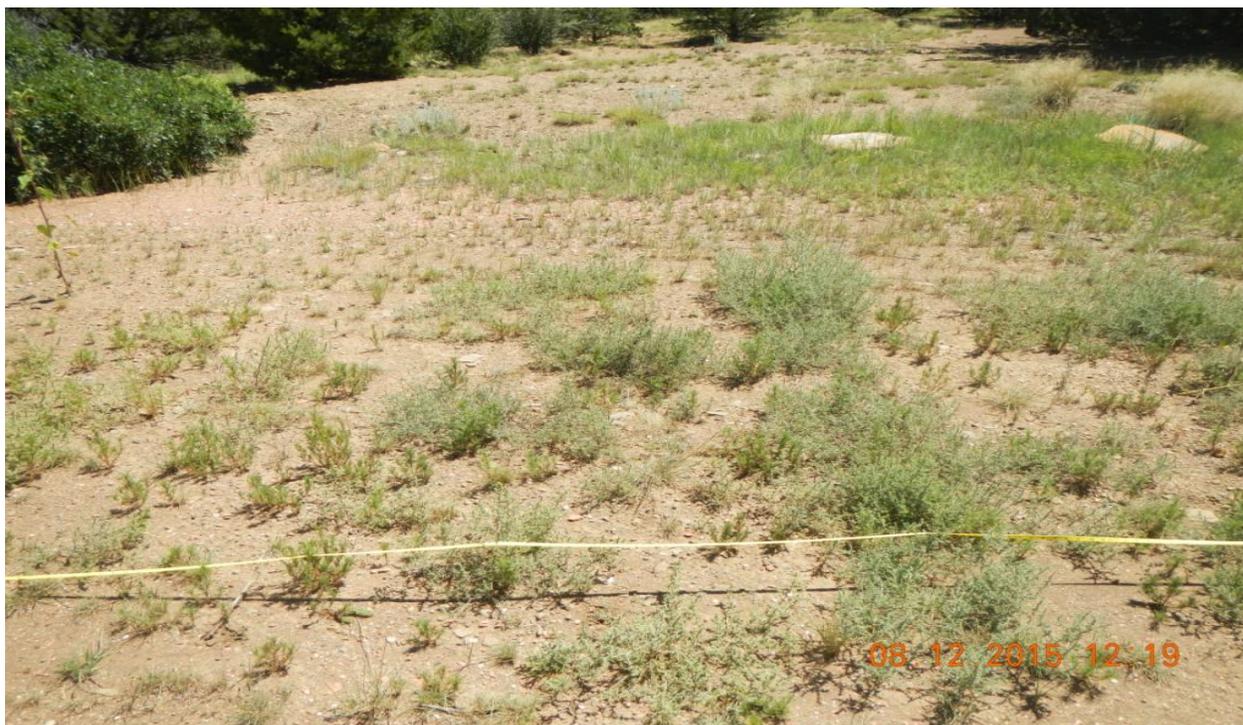
photo 9: Facing northeast at the midpoint of the transect.

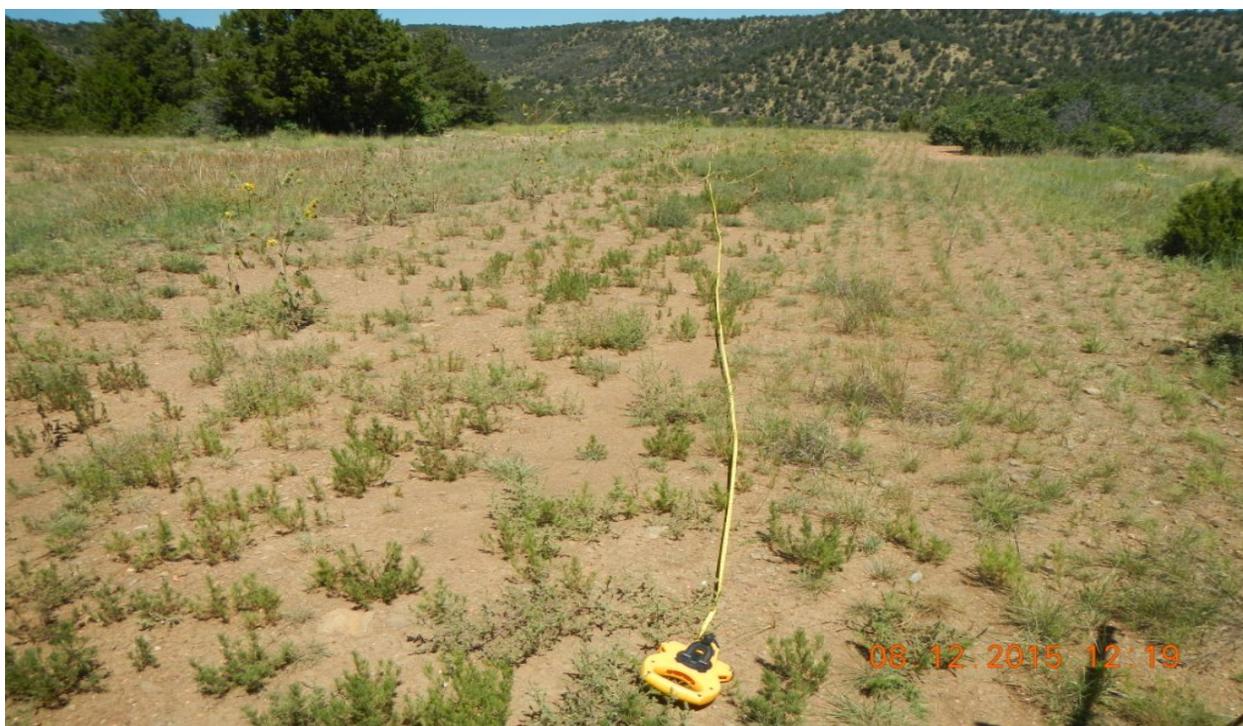
photo 10: End of the vegetation transect facing northwest along the access road.

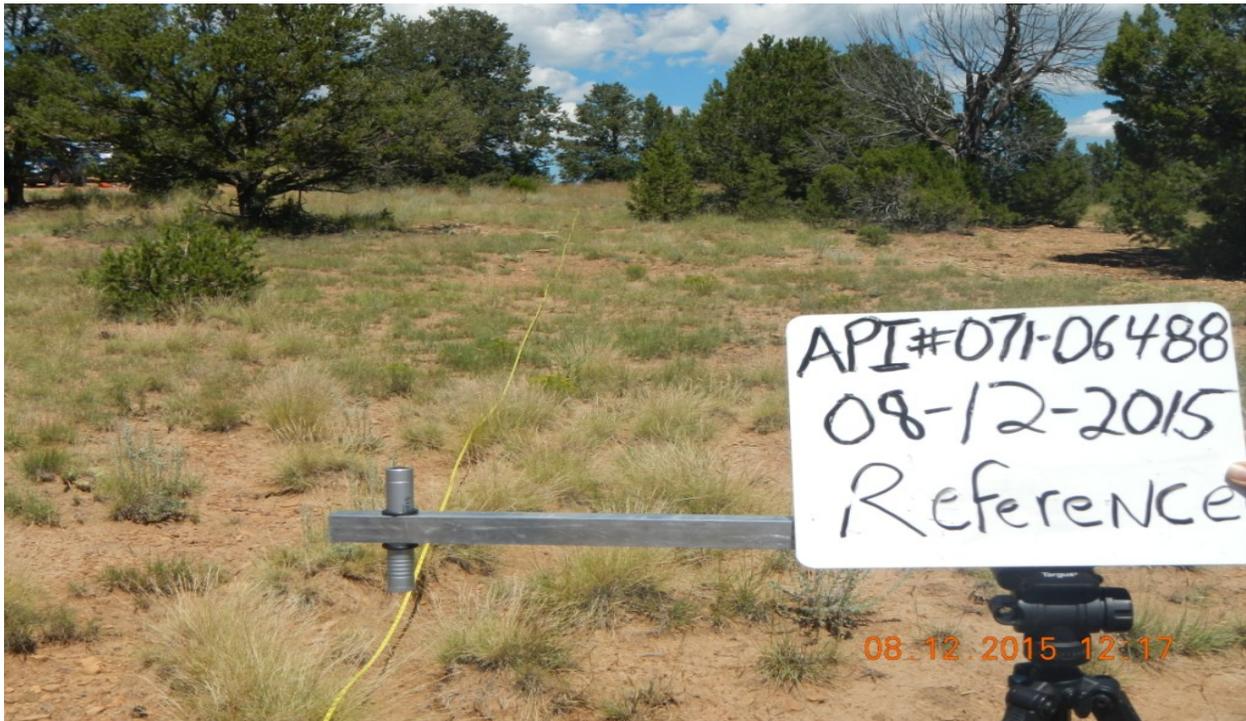
photo 11: Beginning of the vegetation transect facing northwest at undisturbed site. (Reference)

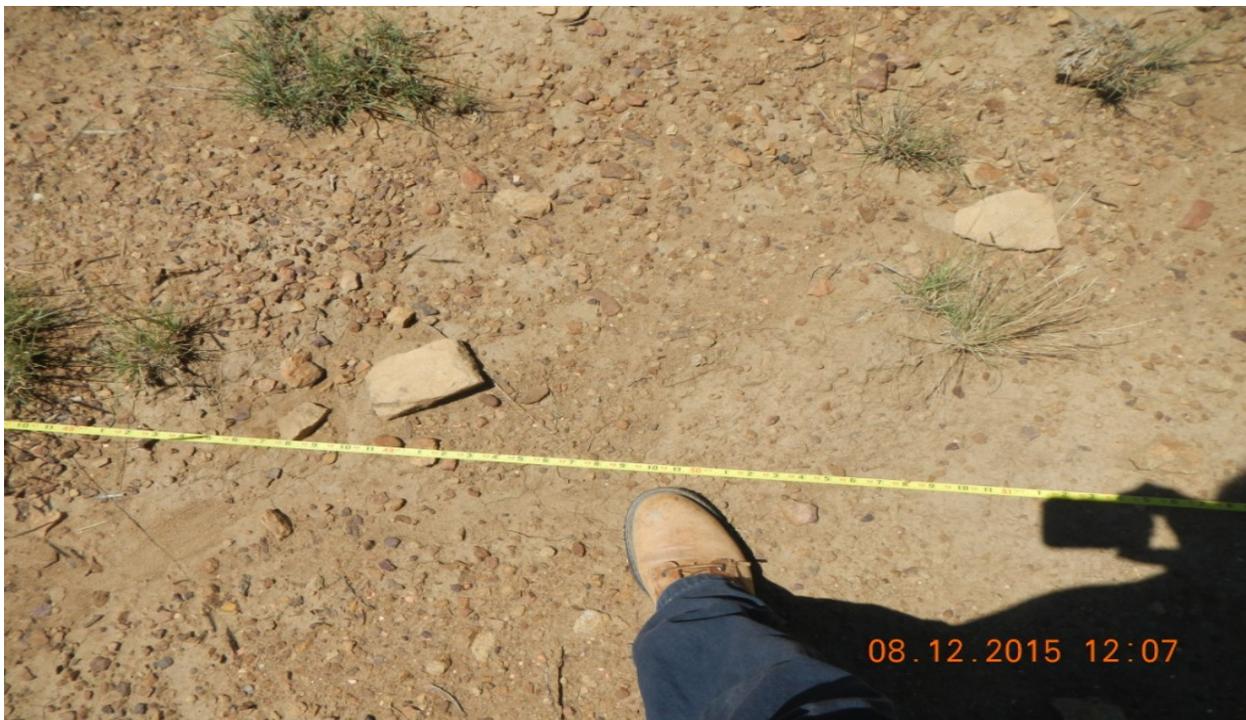
photo 12: Ground view at the midpoint of the transect.

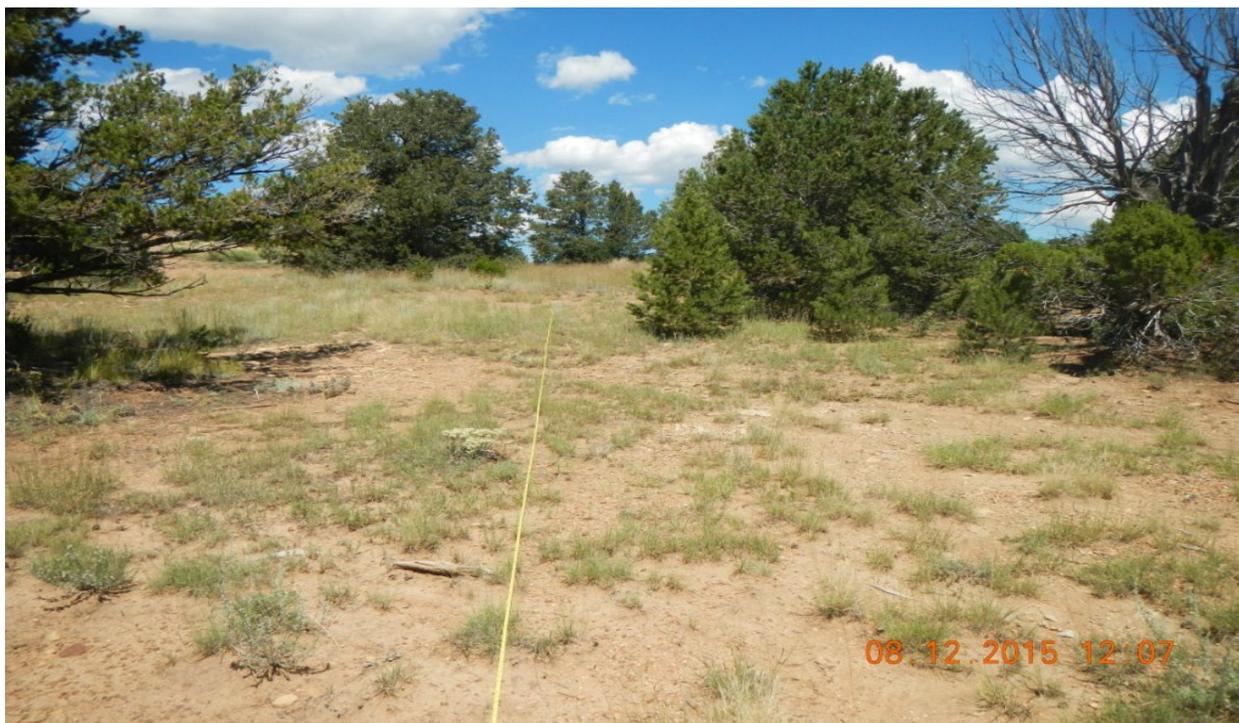
photo 13: Facing northwest at the midpoint of the transect.

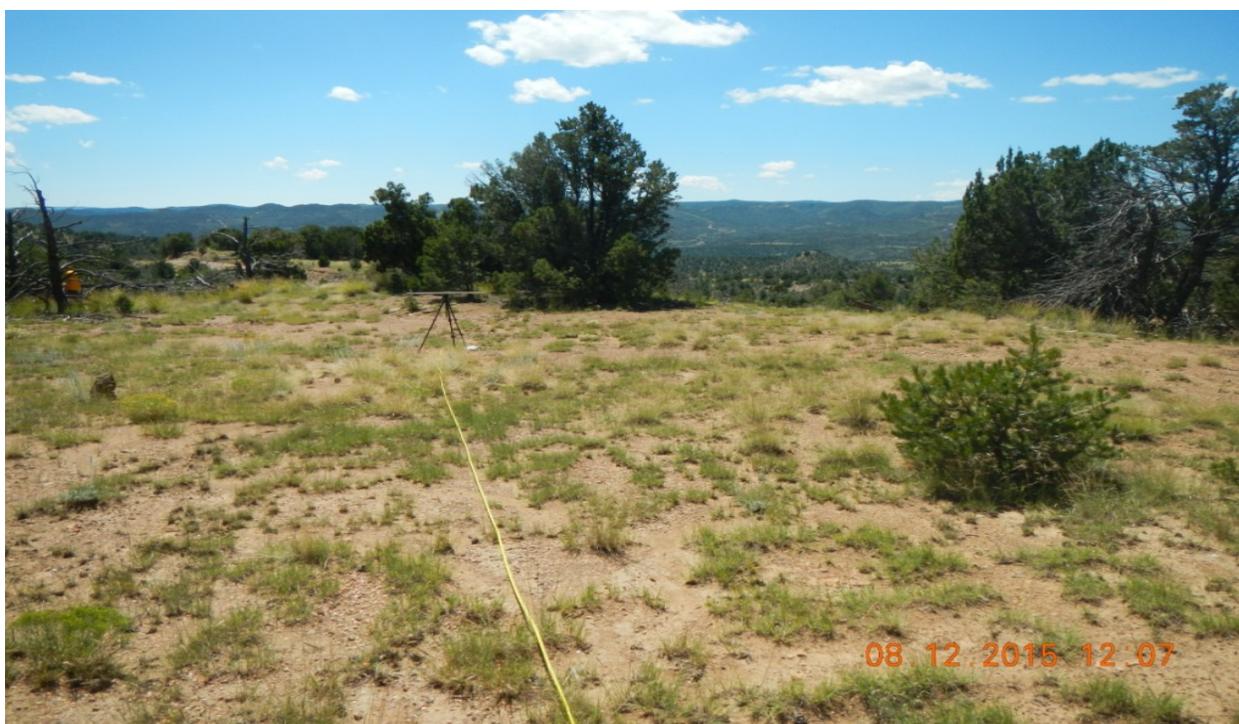
photo 14: Facing southeast at the midpoint of the transect.

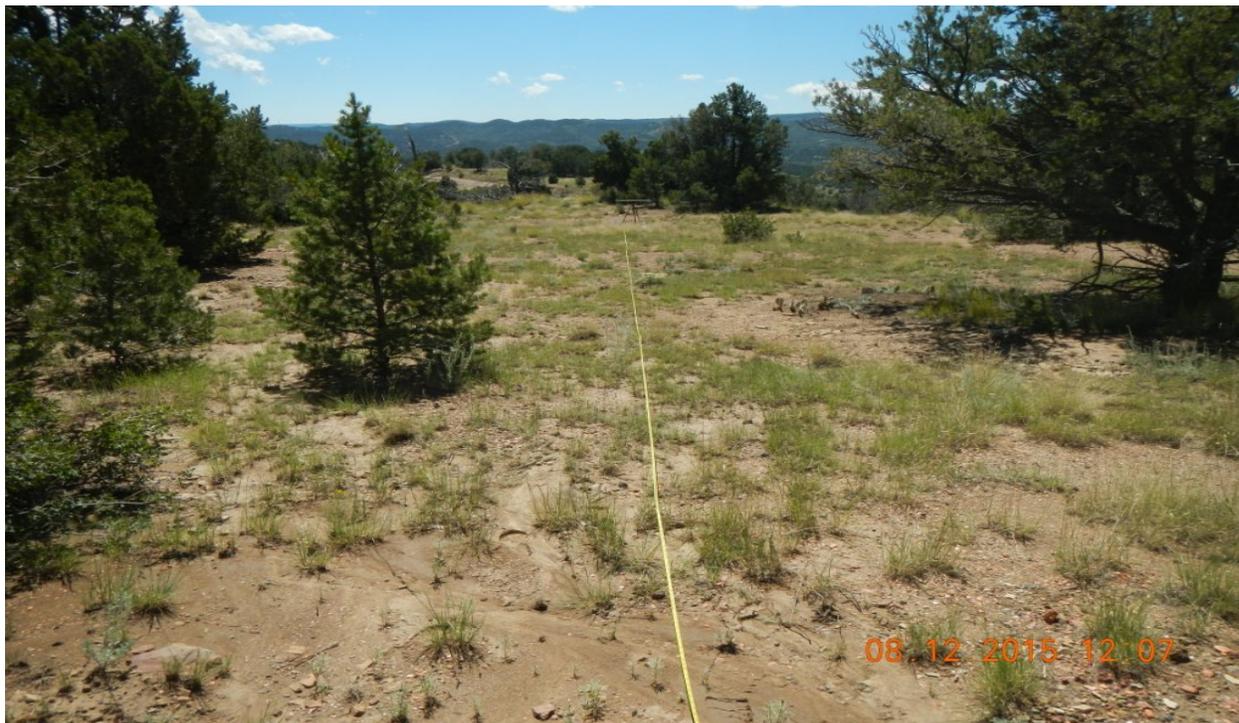
photo 15: End of the vegetation transect facing northwest at the undisturbed site.
