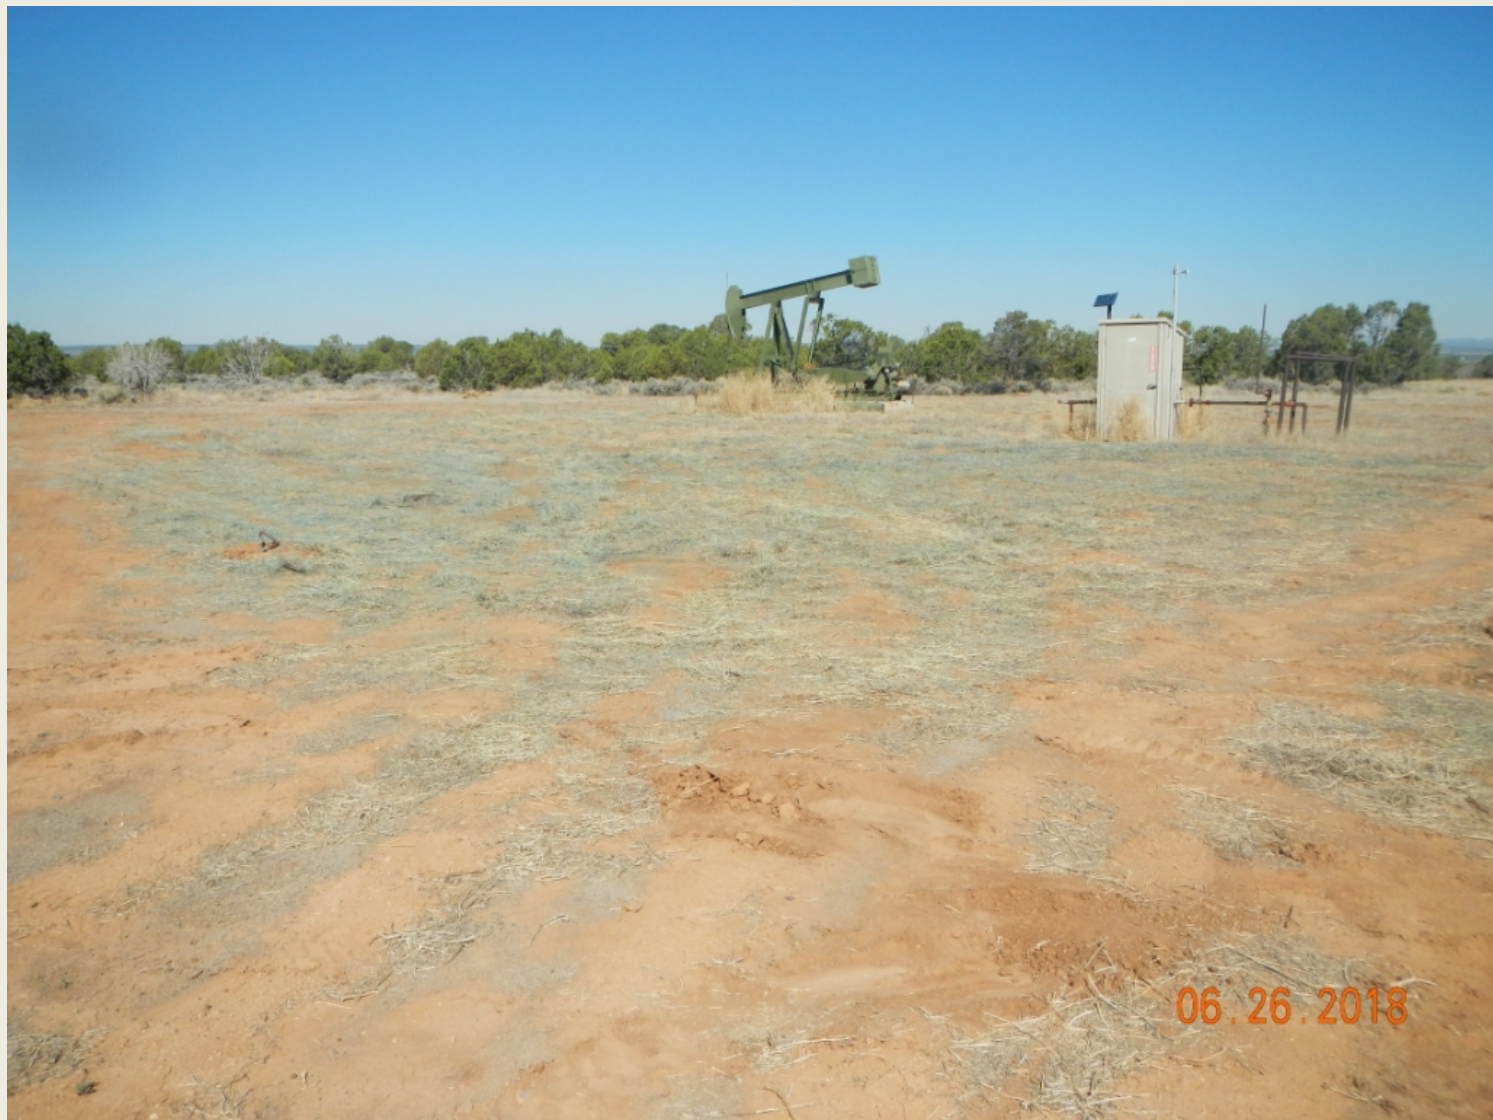
**Photo 1. View of the project area from the well pad entrance facing center. Area was recently mowed.**

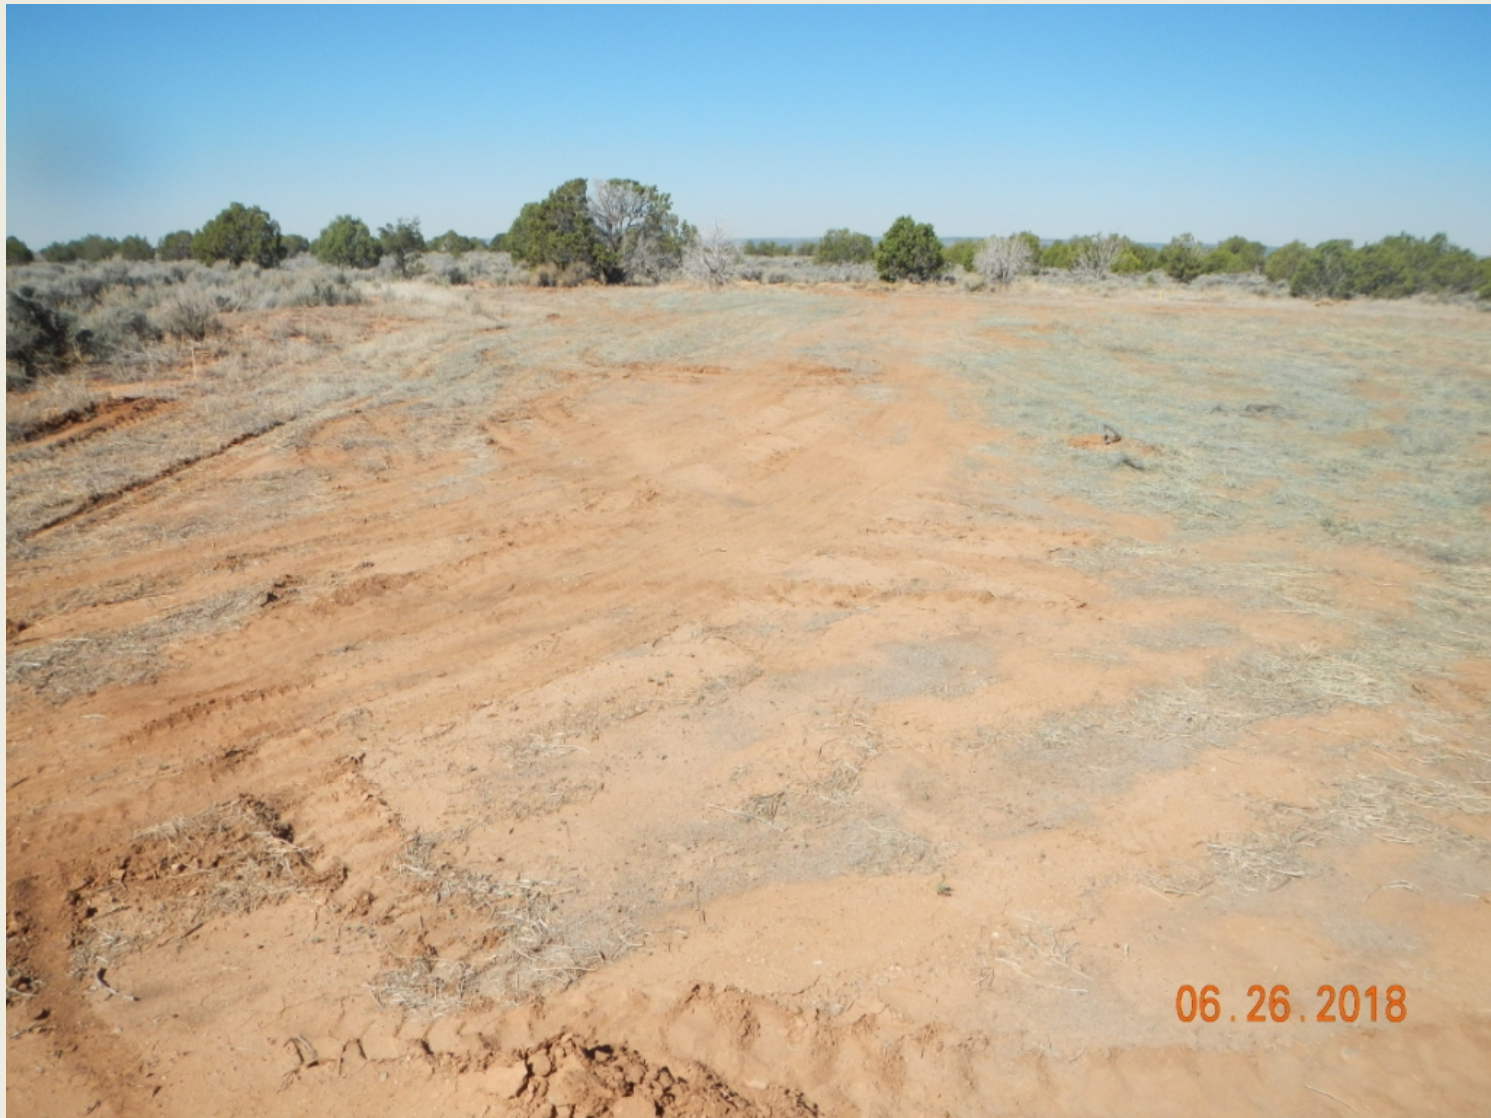
**Photo 2. View of the southern portion of the project area from the entrance to the well pad facing westward. Well pad was mowed on this day.**

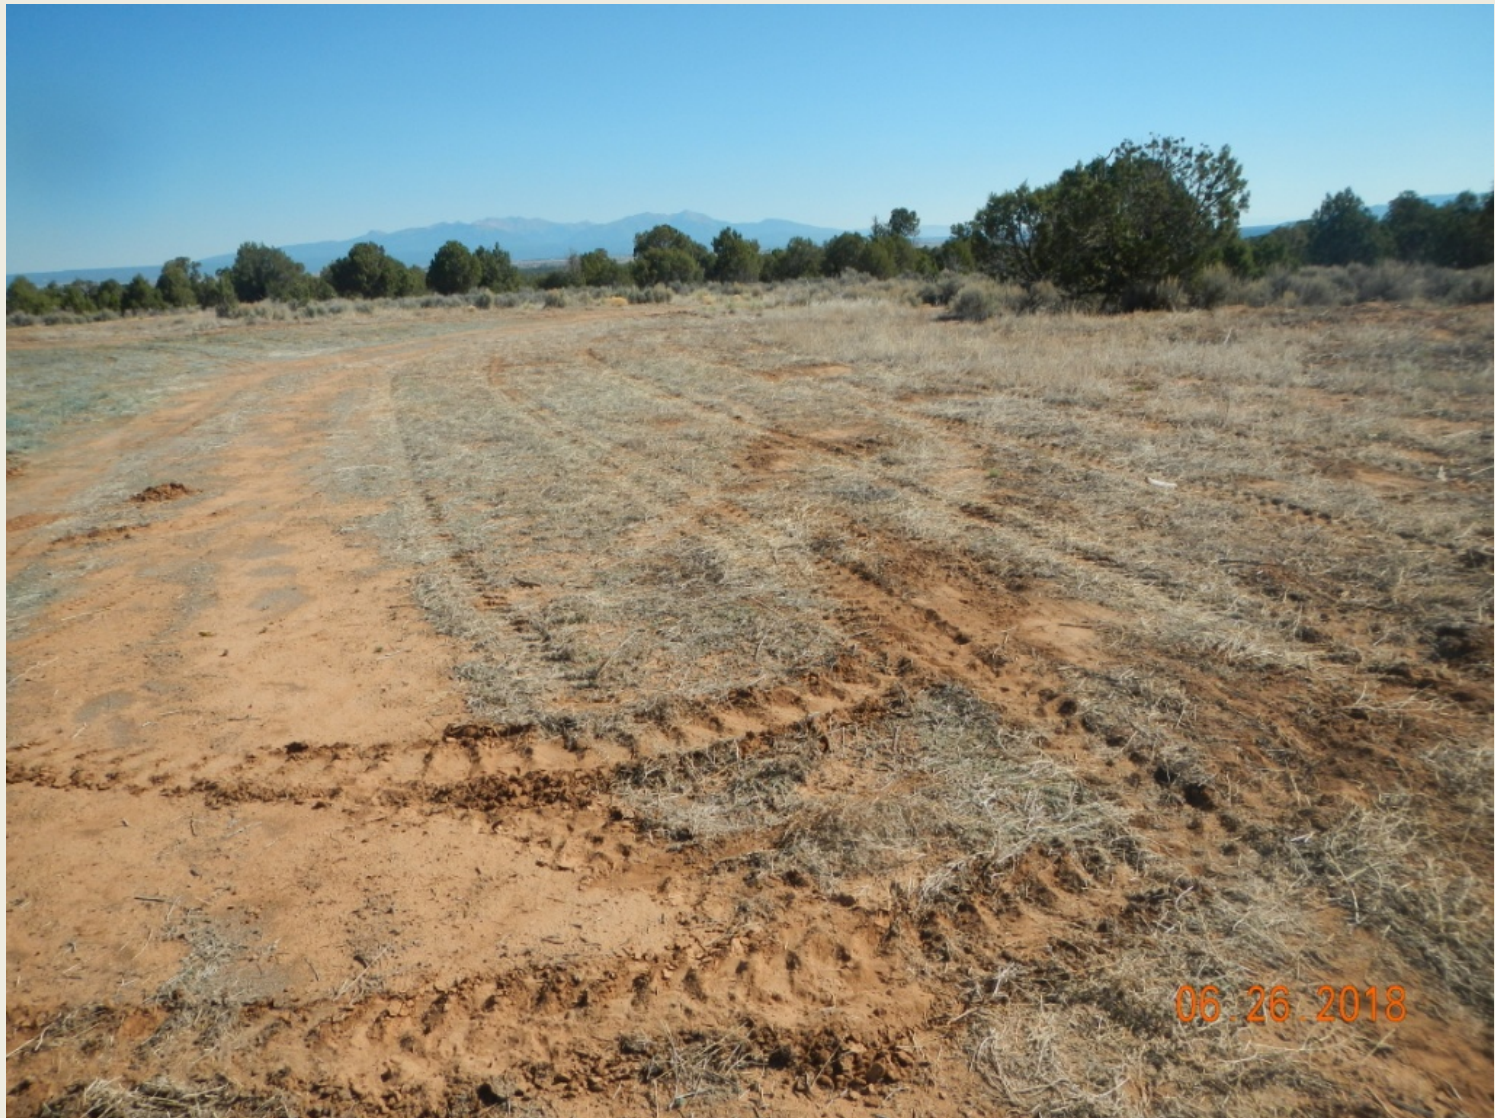
**Photo 3. View of the southeastern portion of the project area from the well pad entrance facing northeastward.**
