Inspection Photos

11/25/2019

Operator: WESTERN OPERATING COMPANY -
95620

Location ID: 312292
Logan County, CO

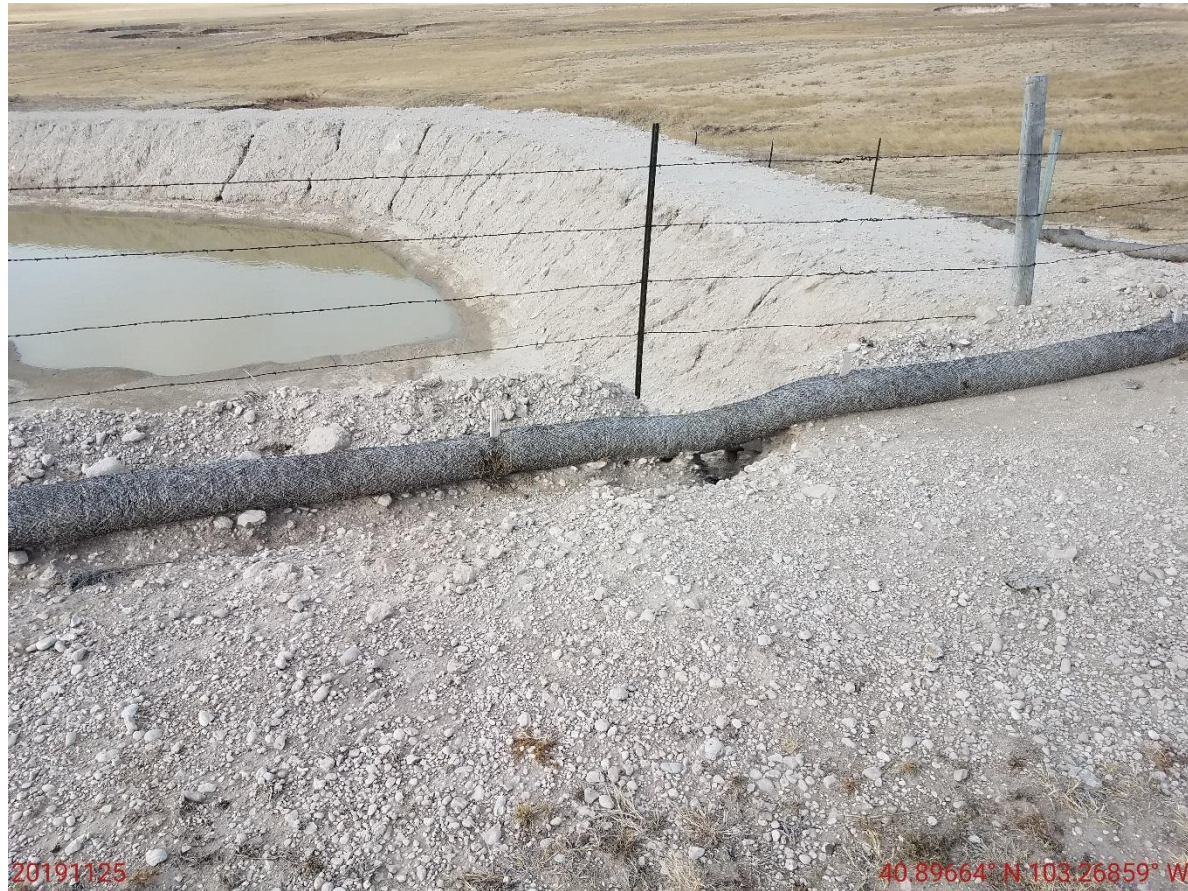
Photo 1: Photo taken from the west end of the pad (east end of pit). Previous inspections documented a gully forming on the east end of the pit and required Operator to repair and stabilize. Previous inspections also documented that Operator installed wattles on the location, however, BMP was not installed in accordance with good engineering practices. Photo shows wattle remains in improper functioning condition, and erosion degradation has been allowed to continue at the pit.

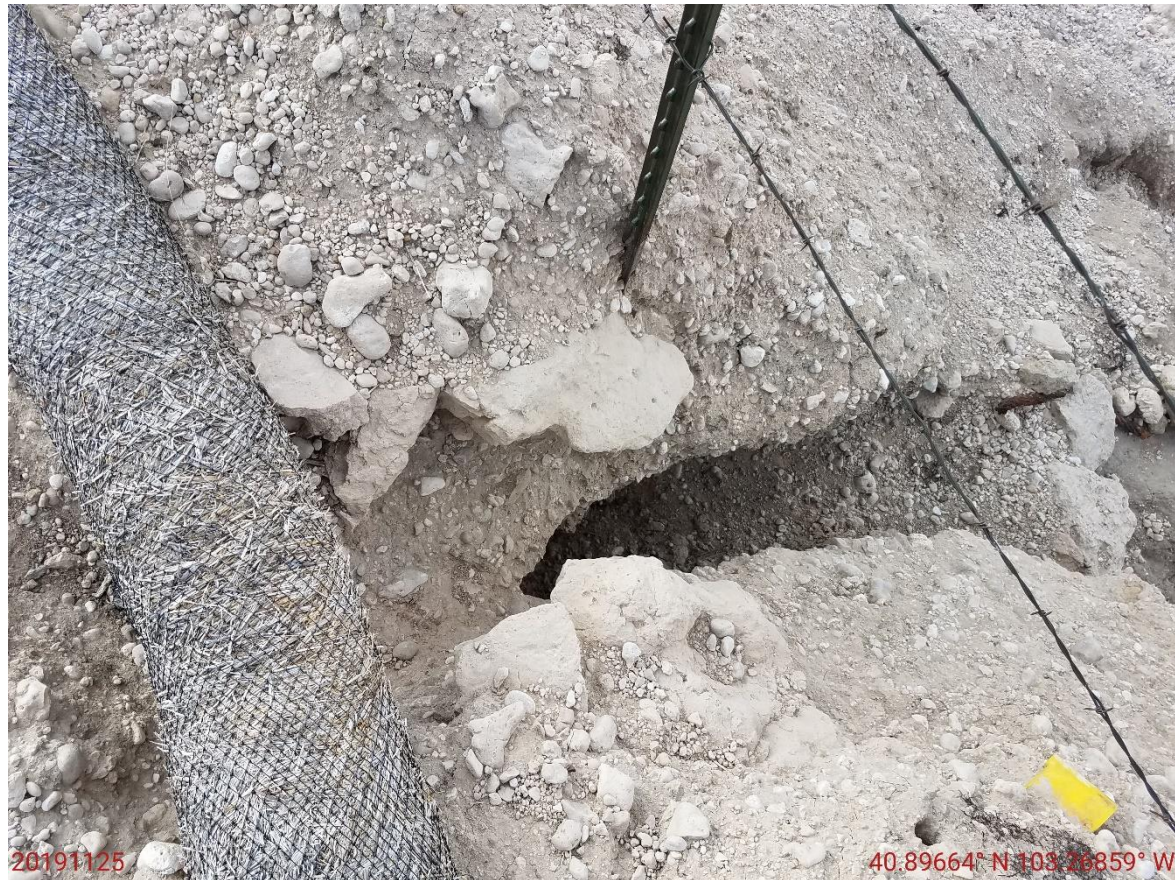
Photo 2: Continued from photo 1. Photo shows erosion degradation has been allowed to continue at the pit. Erosion degradation appears to be beginning to cut into and under the location.

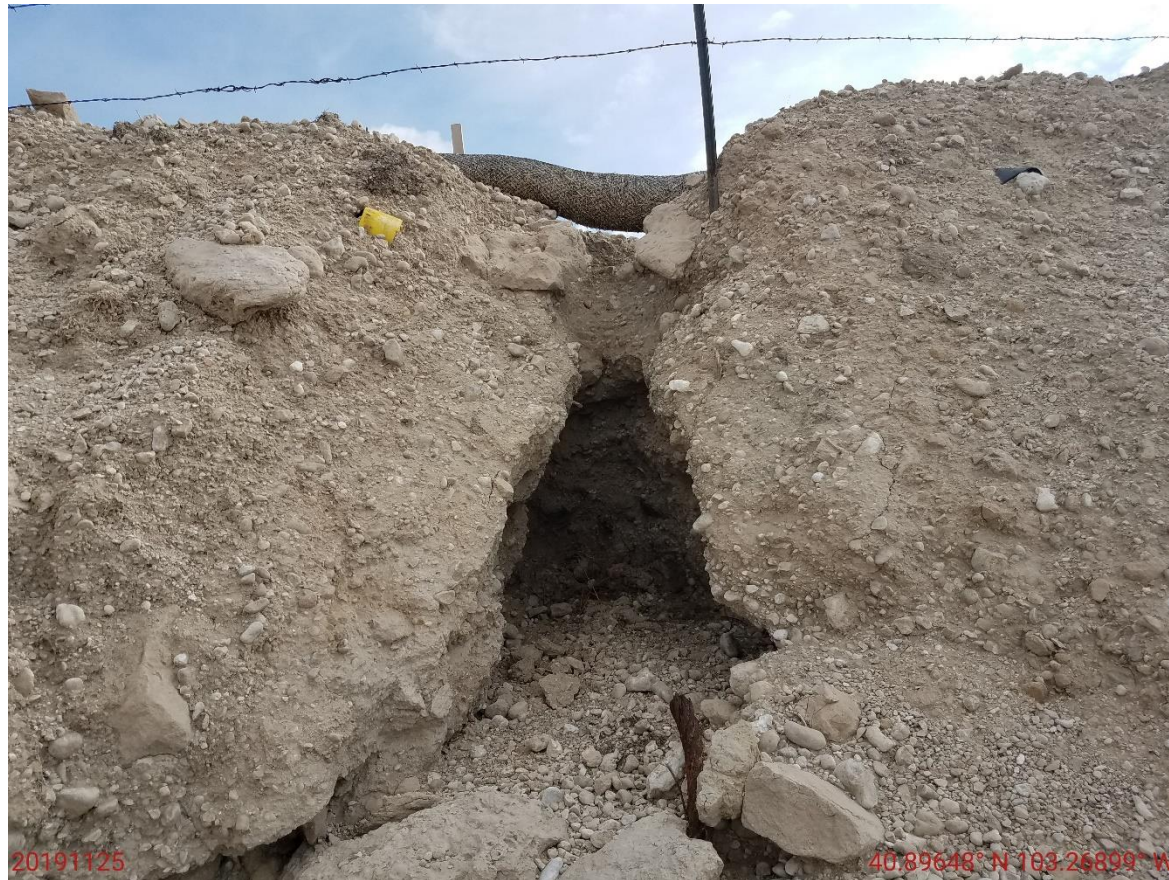
Photo 3: See comments under photo 2.

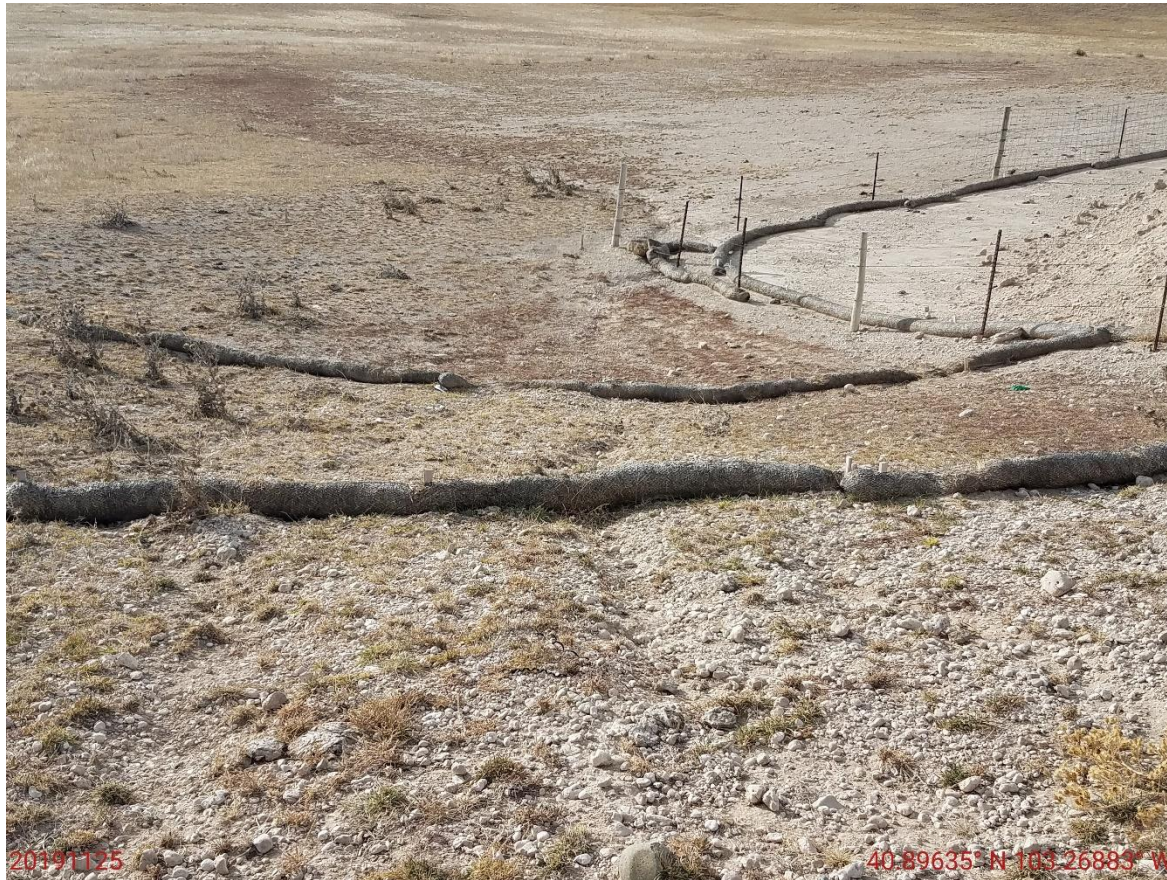
Photo 4: Photo taken from the south end of the production area, facing southwest. Previous inspections documented that wattle BMPs have not been installed in accordance with good engineering practices, and that no stabilization BMPs have been installed per CAs. Photo shows BMPs remain insufficient and erosion degradation has been allowed to continued.

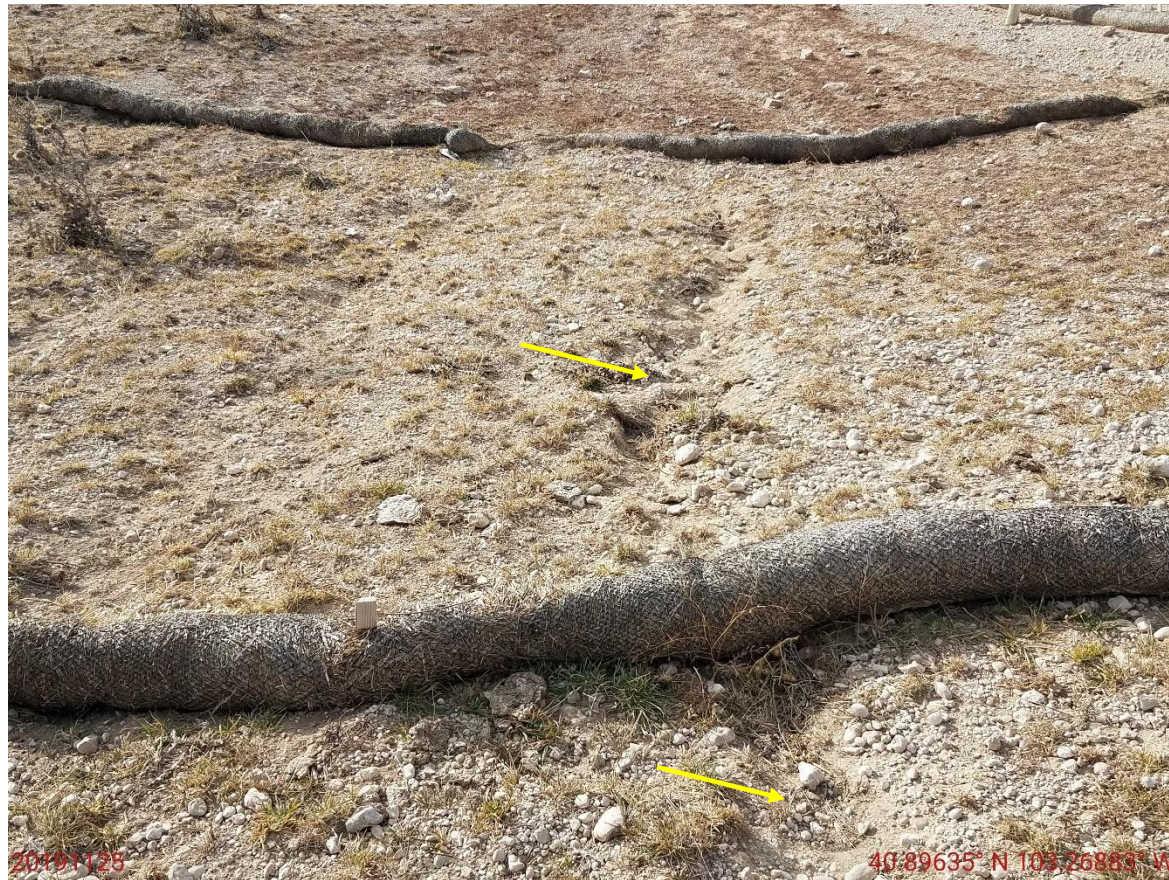
Photo 5: See comments under photo 4.

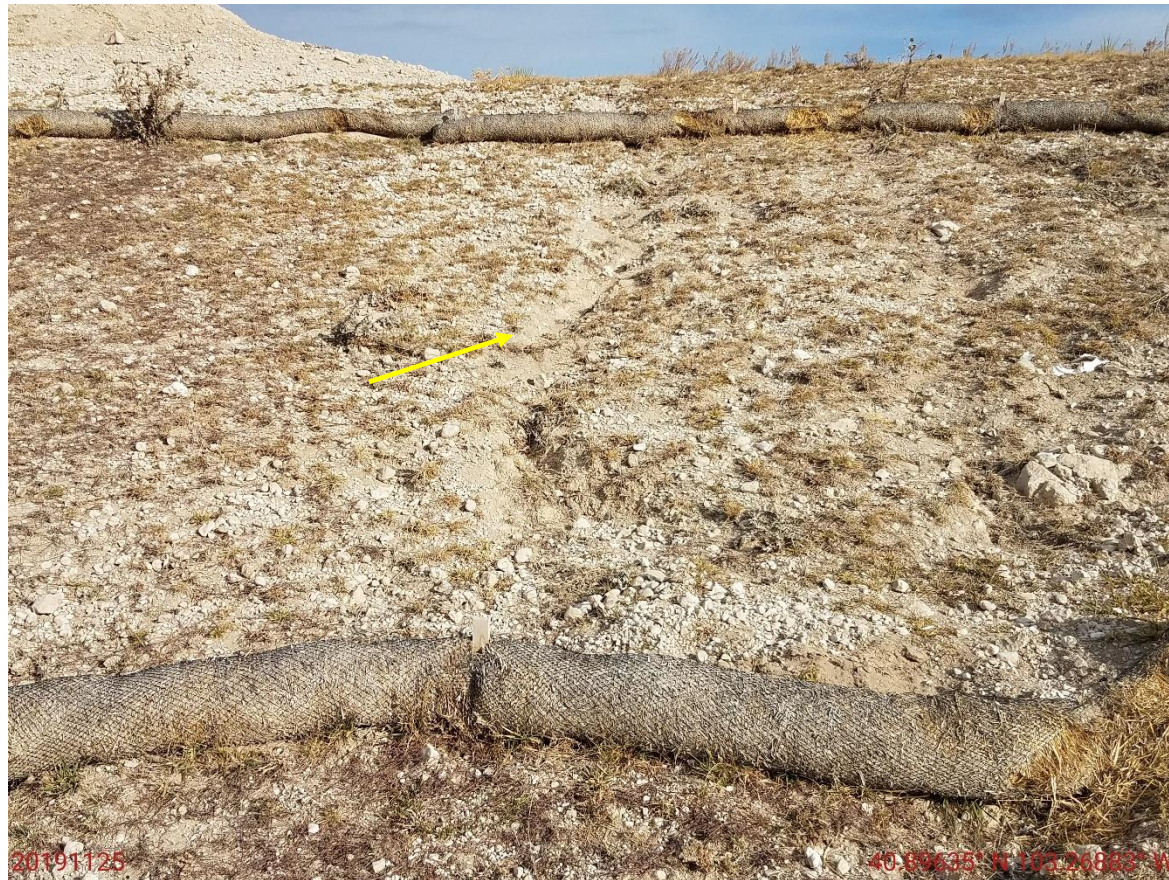
Photo 6: See comments under photo 4.

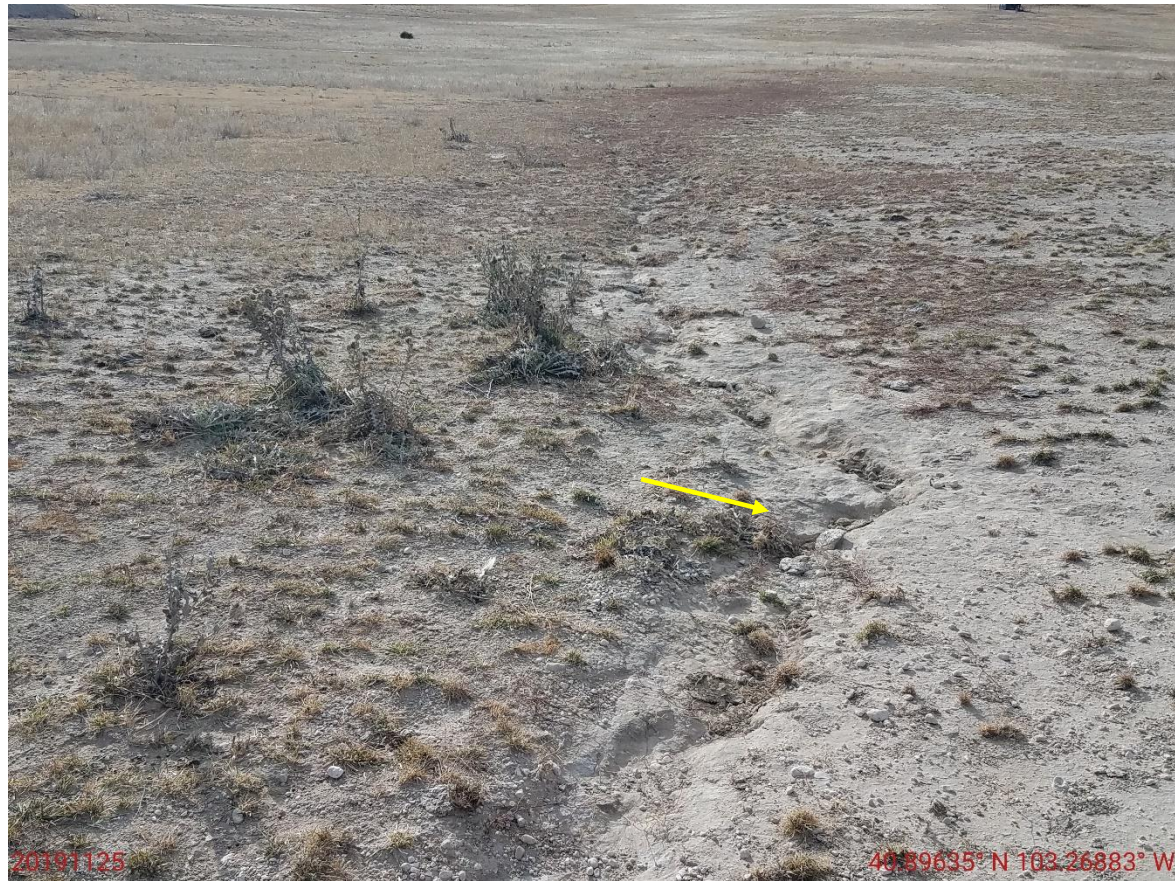
Photo 7: Photo taken from the interim areas on the south end of the pit, facing south. Previous inspections required stabilization control BMPs to stabilize the seeded soils to mitigate further erosion degradation. Photo shows stormwater erosion degradation has been allowed to continue; Operator has failed to install required BMP.

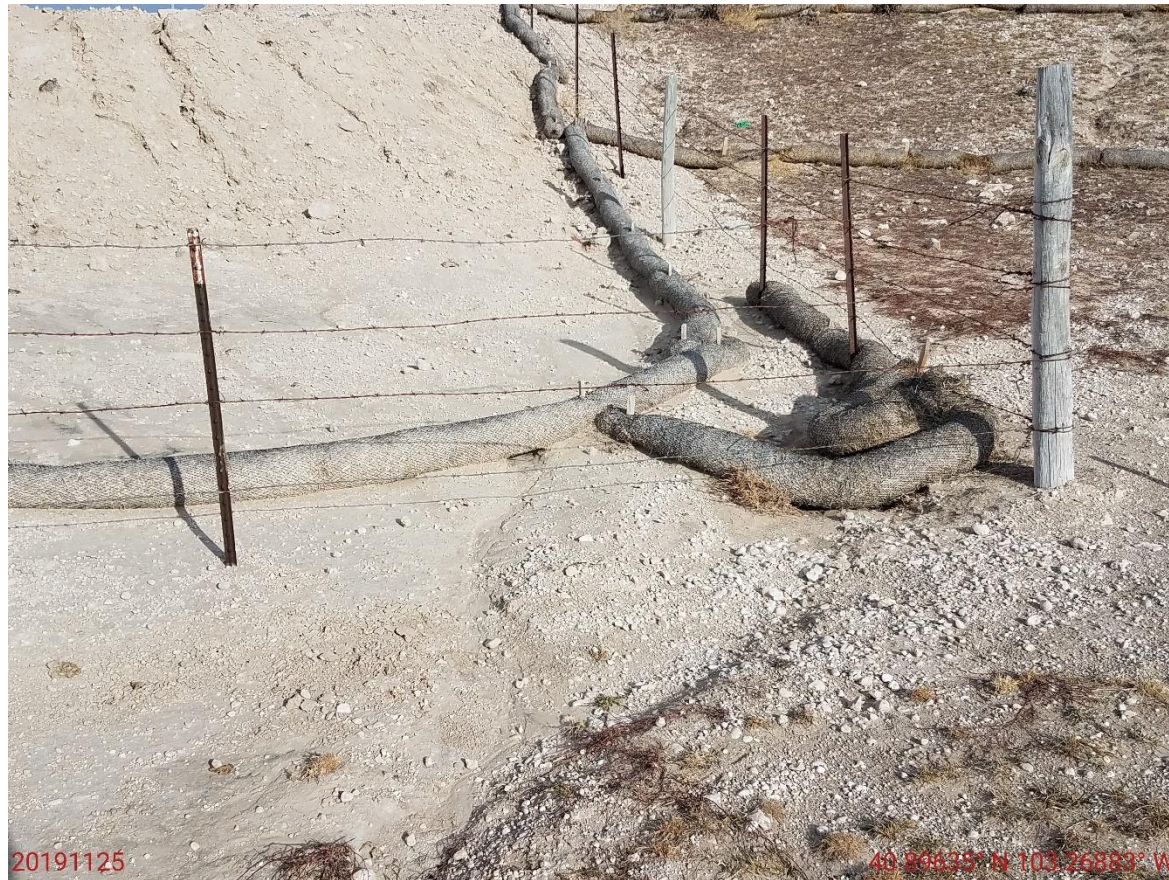
Photo 8: Photo taken from the south end of the pit. Photo shows straw wattles around pit. Previous inspections documented that wattle BMPs were not installed in accordance with good engineering practices. Photo shows wattles remain improperly installed. Many wattles have been “blown out” and are now debris.

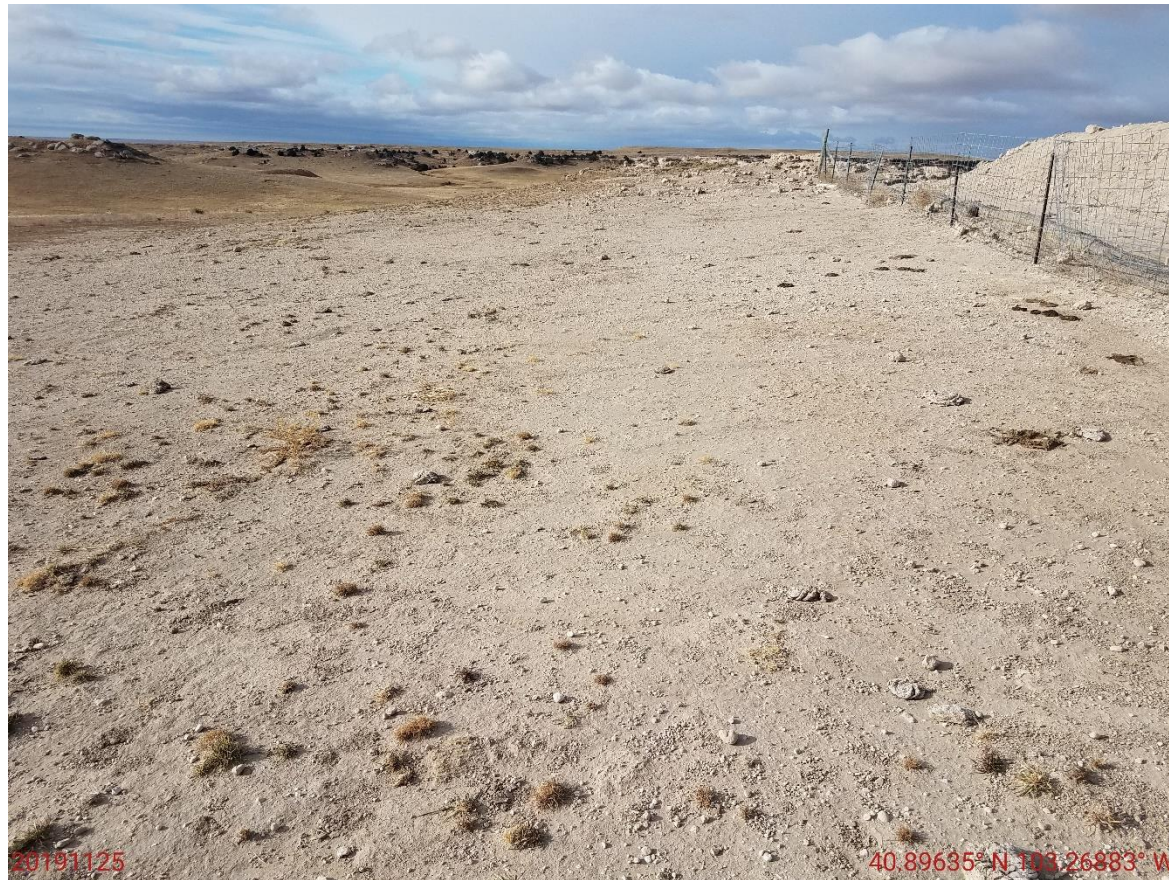
Photo 9: Photo taken from the southeast end of the pit, facing west. Photo shows areas where previous seeding activities were conducted. Photo shows vegetation has failed to establish in these areas. Impacted soils likely remain.

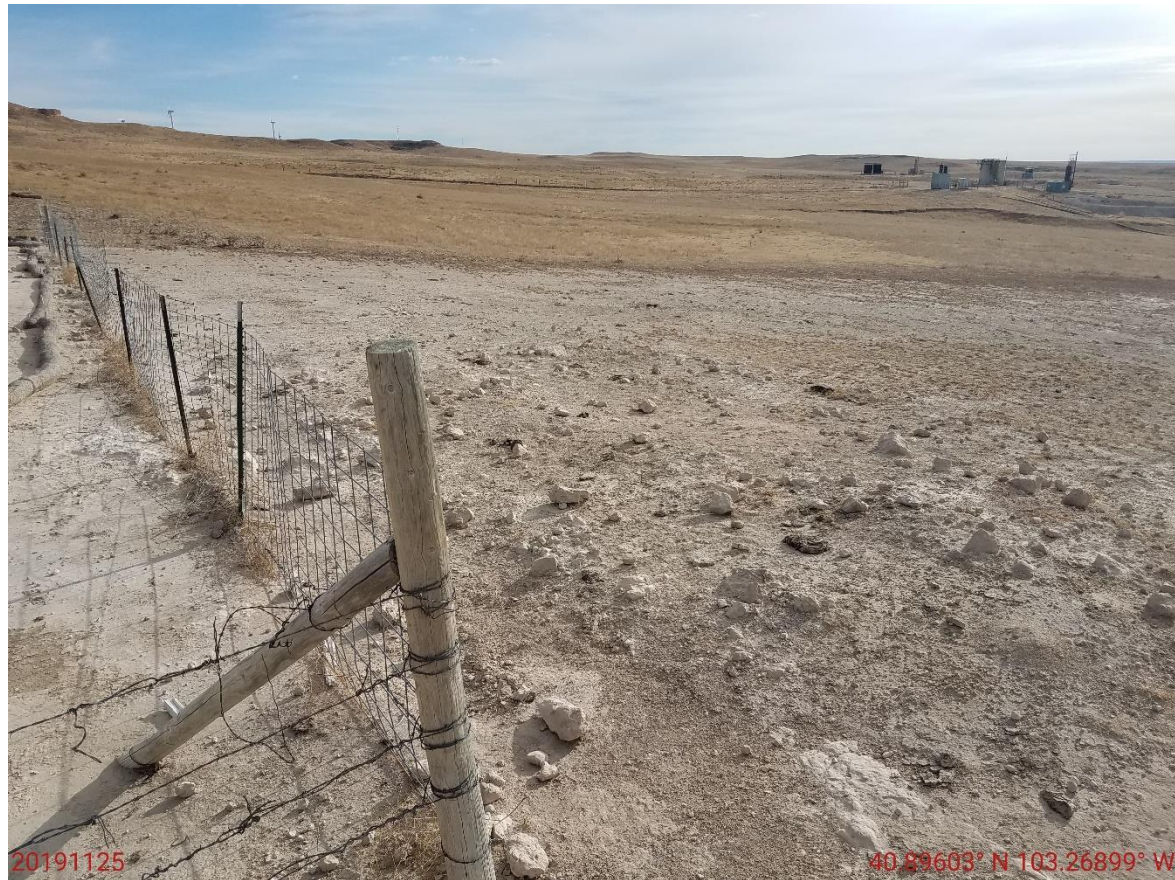
Photo 10: Photo taken from the southwest corner of the pit, facing east. See comments under photo 9.

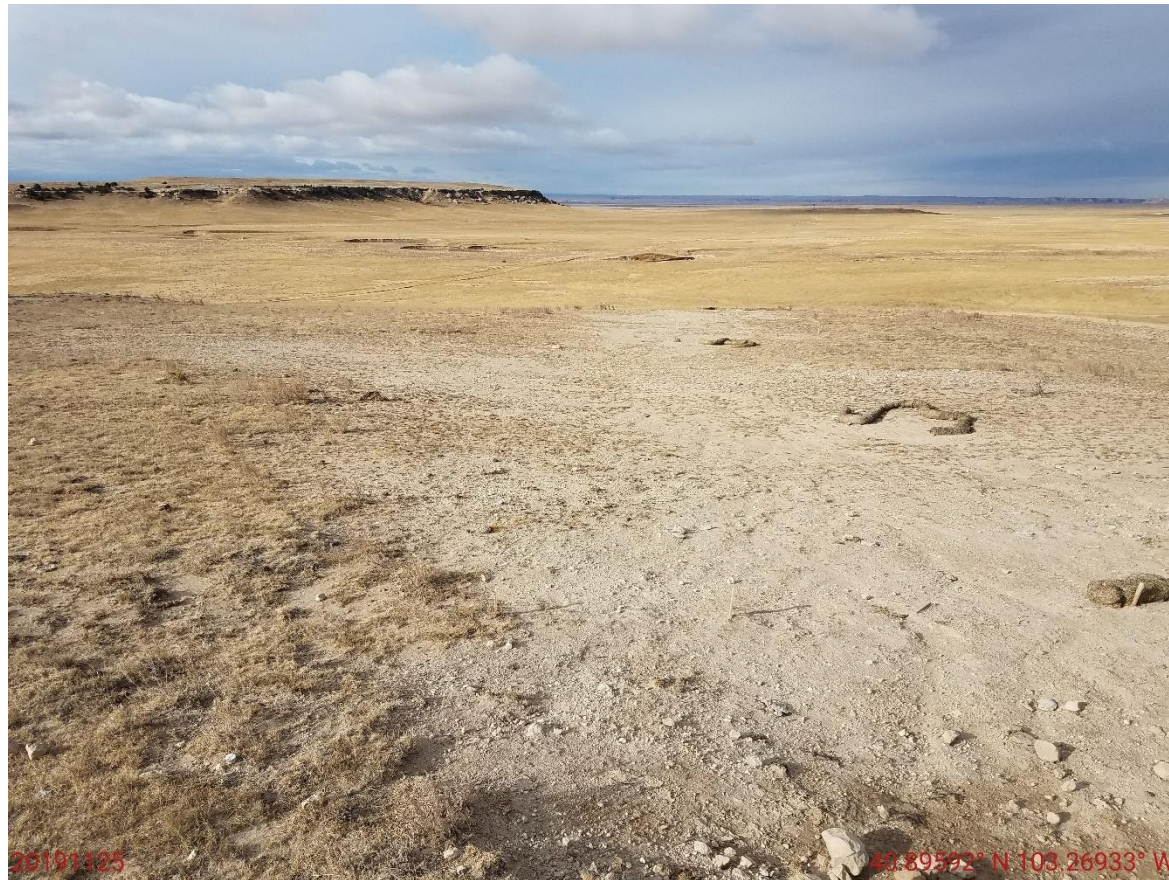
Photo 11: Photo taken from the southwest end of the pit, facing west. Photo shows wattle BMPs have not been maintained and are now debris. Photo also shows areas where reclamation has failed, and erosion degradation has been allowed to continue.

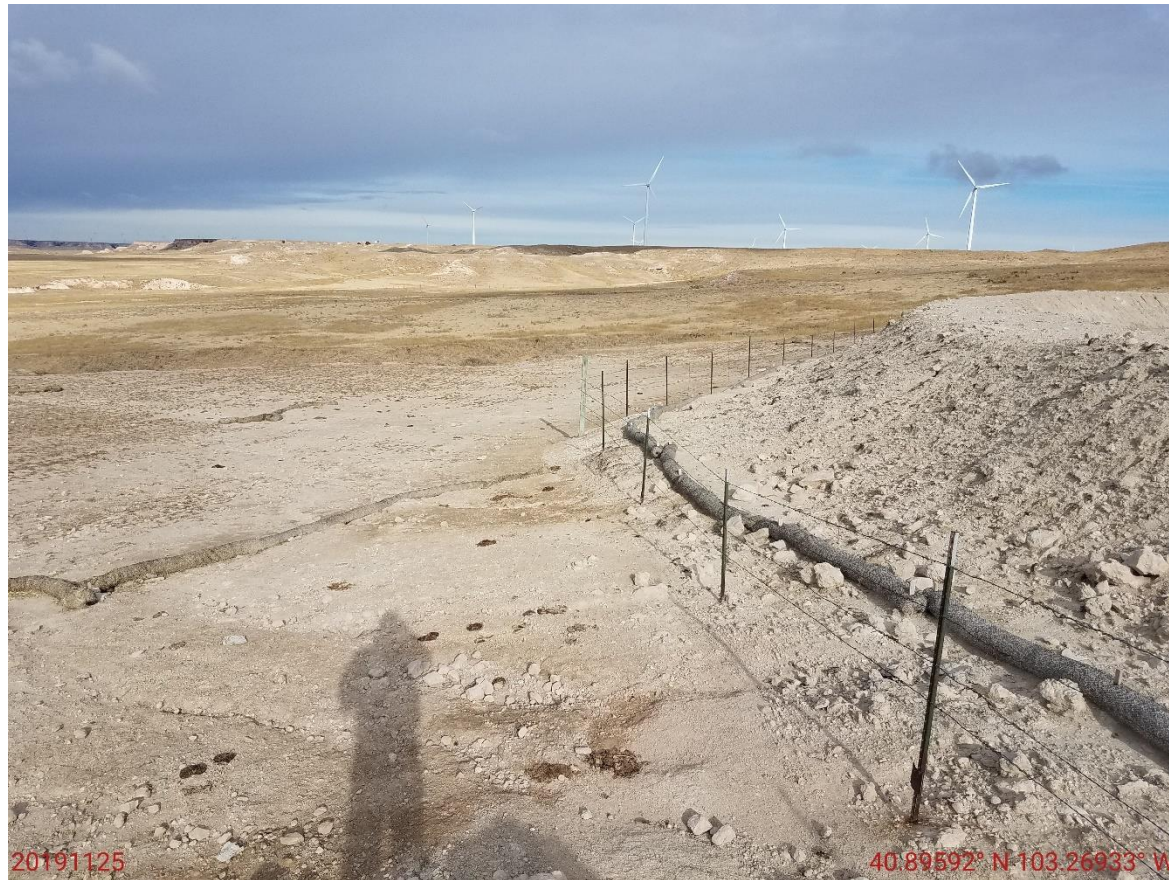
Photo 12: Photo taken from the southwest end of the pit, facing northwest. See comments under photo 11.

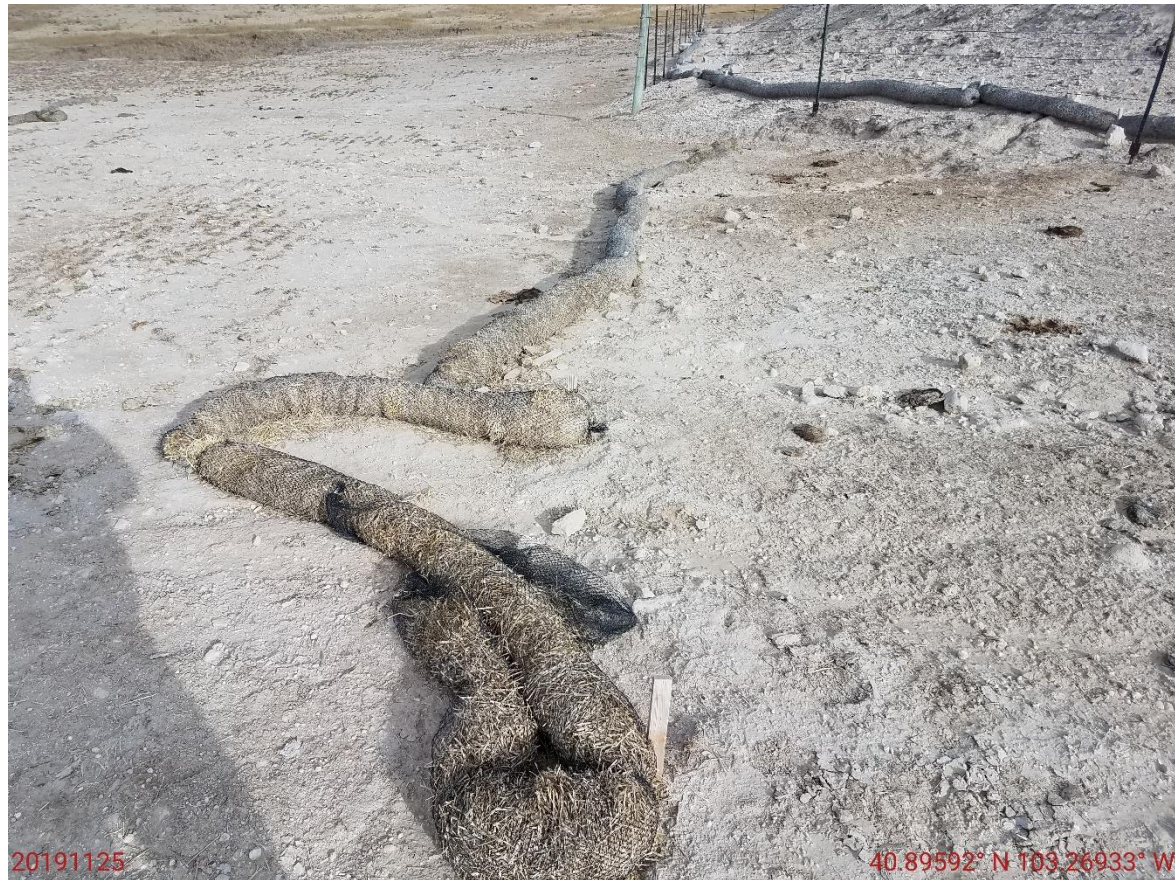
Photo 13: Photo shows wattle in disrepair. This is considered debris.

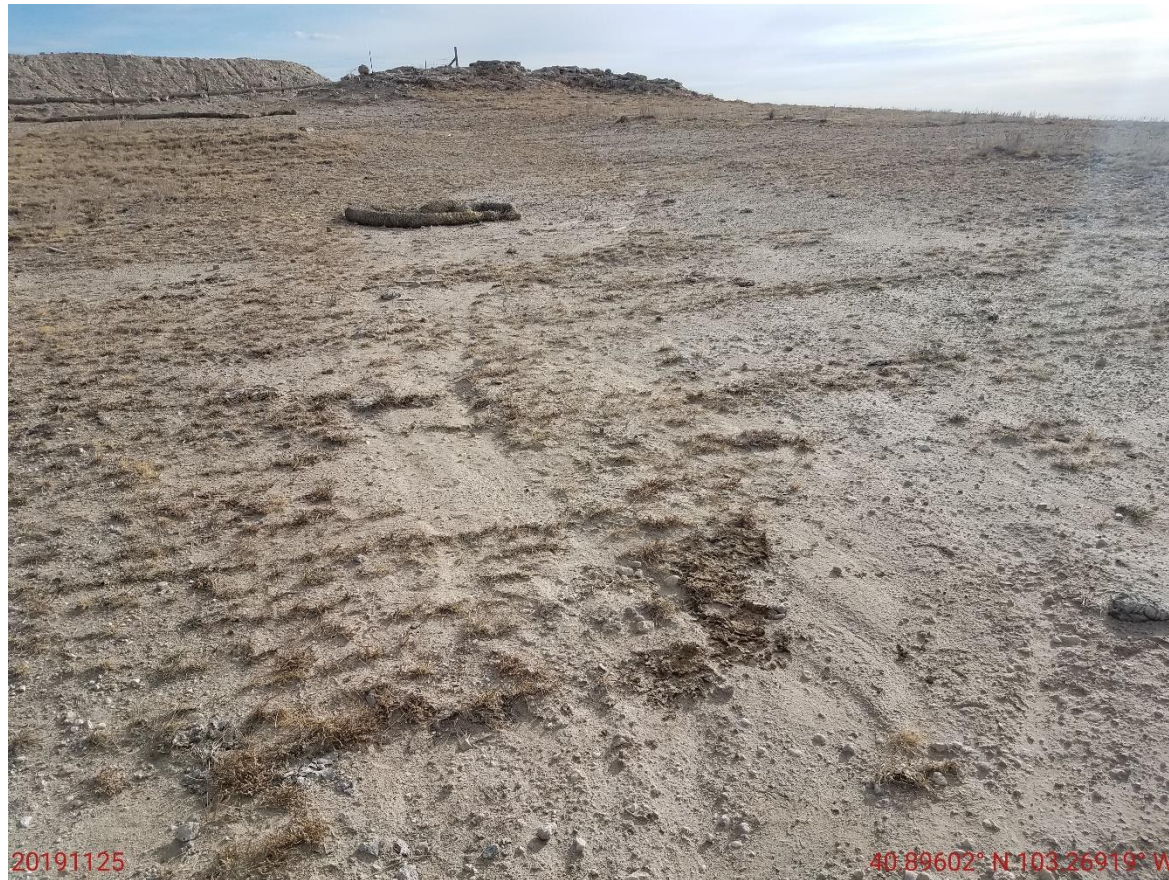
Photo 14: Photo taken from the west of the pit, facing east. Photo shows wattles have not been maintained, and stormwater erosion degradation has been allowed to continue.

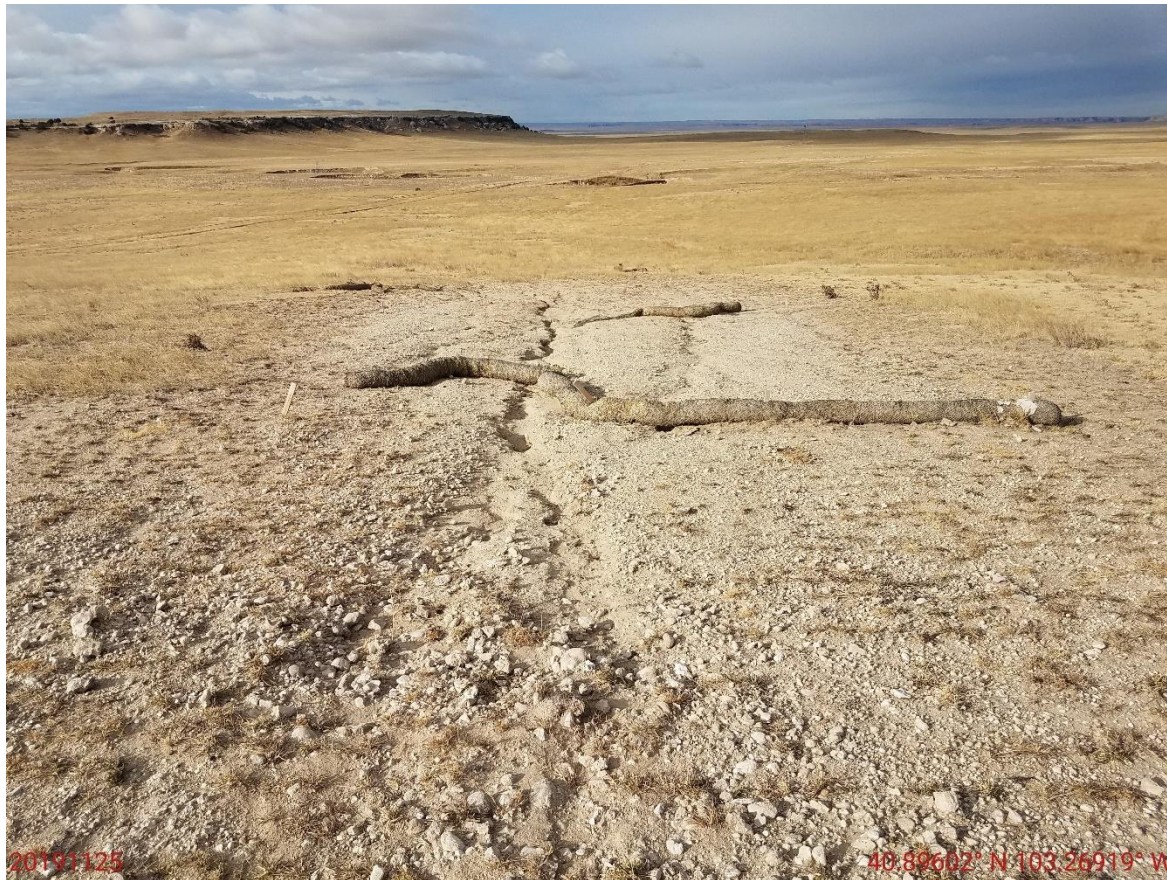
Photo 15: Photo taken from the west of the pit, facing west. Photo shows erosion degradation and wattle debris.

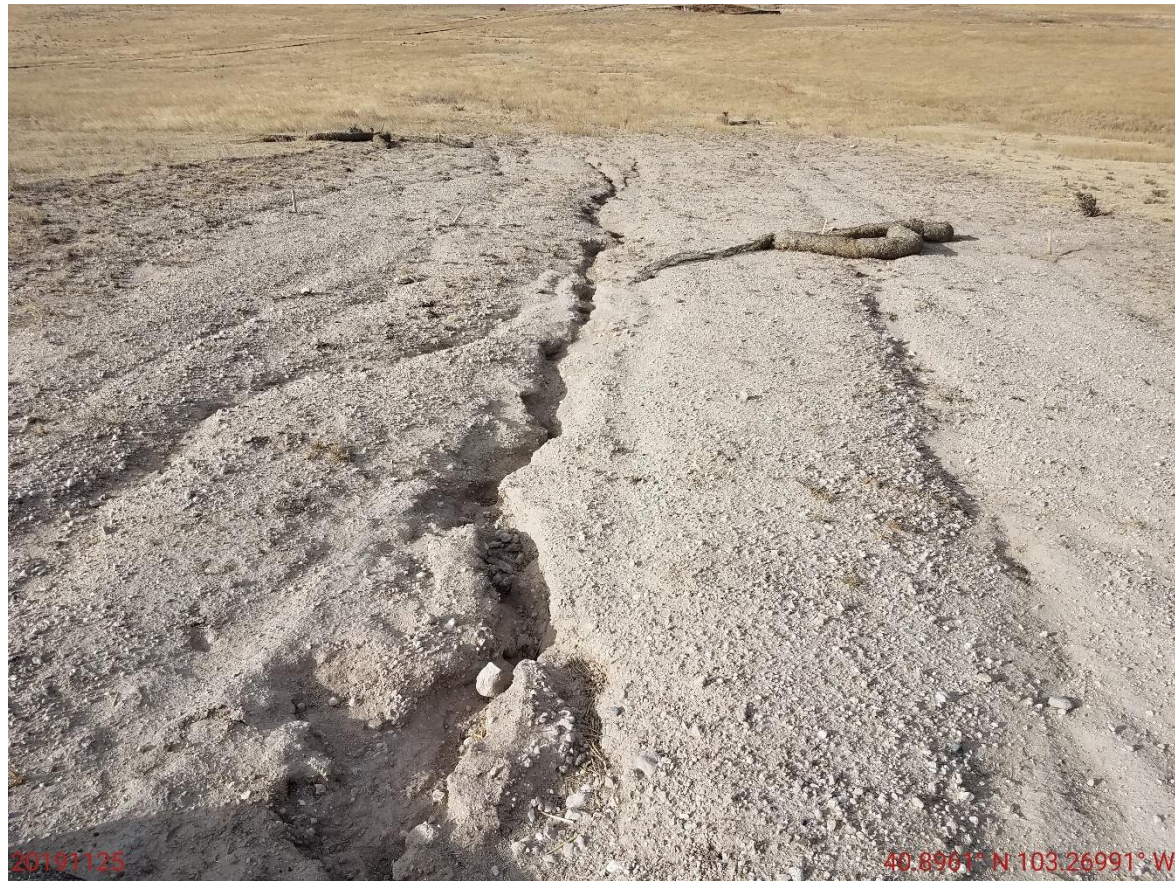
Photo 16: See comments under photo 15.

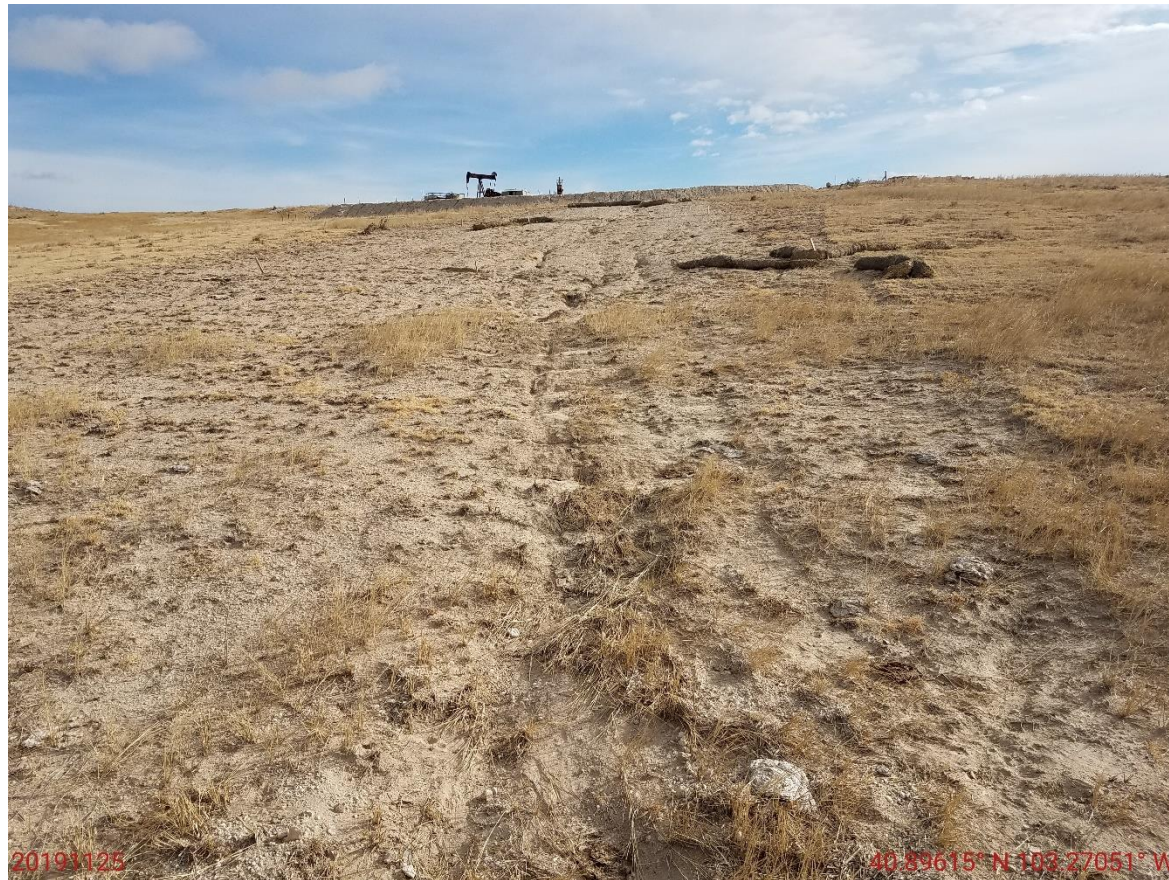
Photo 17: Photo taken from the west of the pit, facing east. See comments under photo 15.

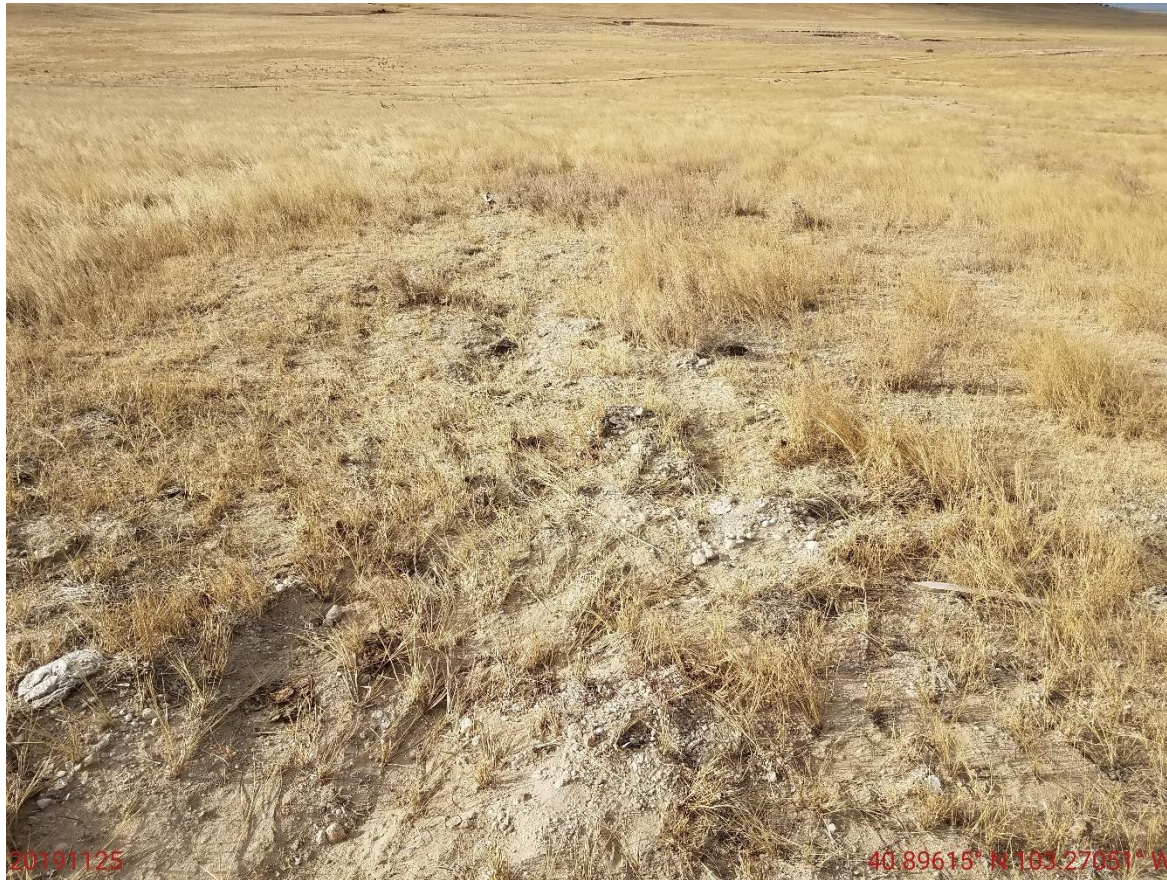
Photo 18: Photo taken from the west of the pit, facing west. Photo shows sediment deposition. Stormwater runoff from the location has continued to expand the off-location disturbance area.

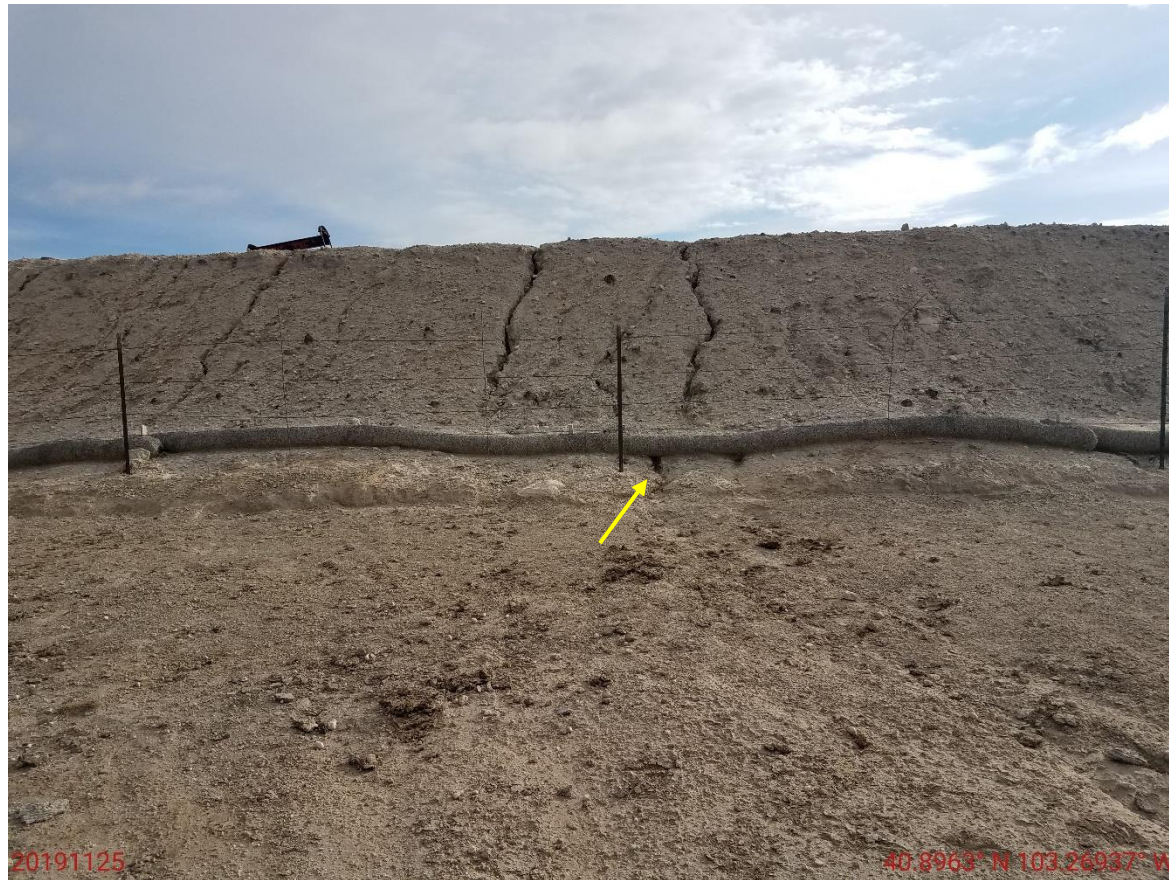
Photo 19: Photo taken from the west end of the pit, facing east. Photo shows erosion degradation from the pit. Photo also shows wattles were not installed in accordance with good engineering practices, resulting in failure of the BMP.

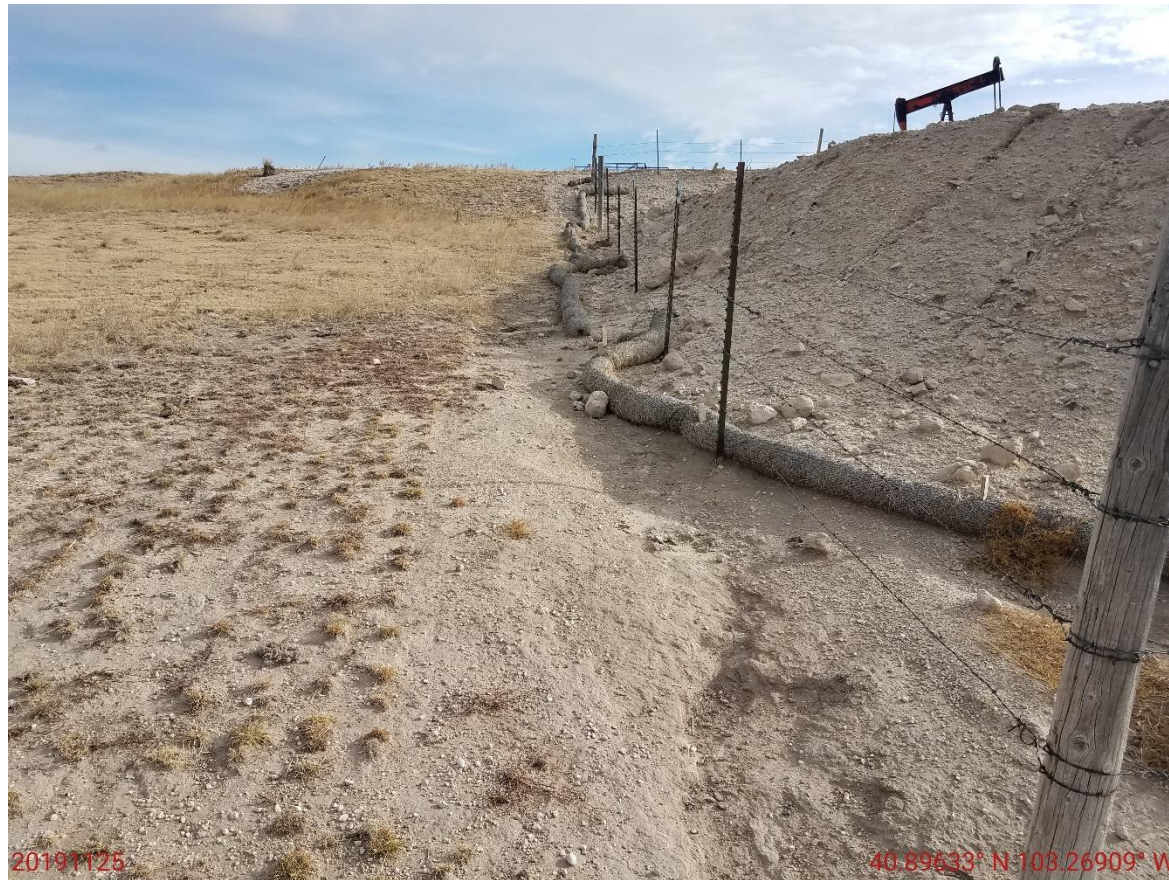
Photo 20: Photo taken from the west end of the location , facing east. See comments under photo 19.

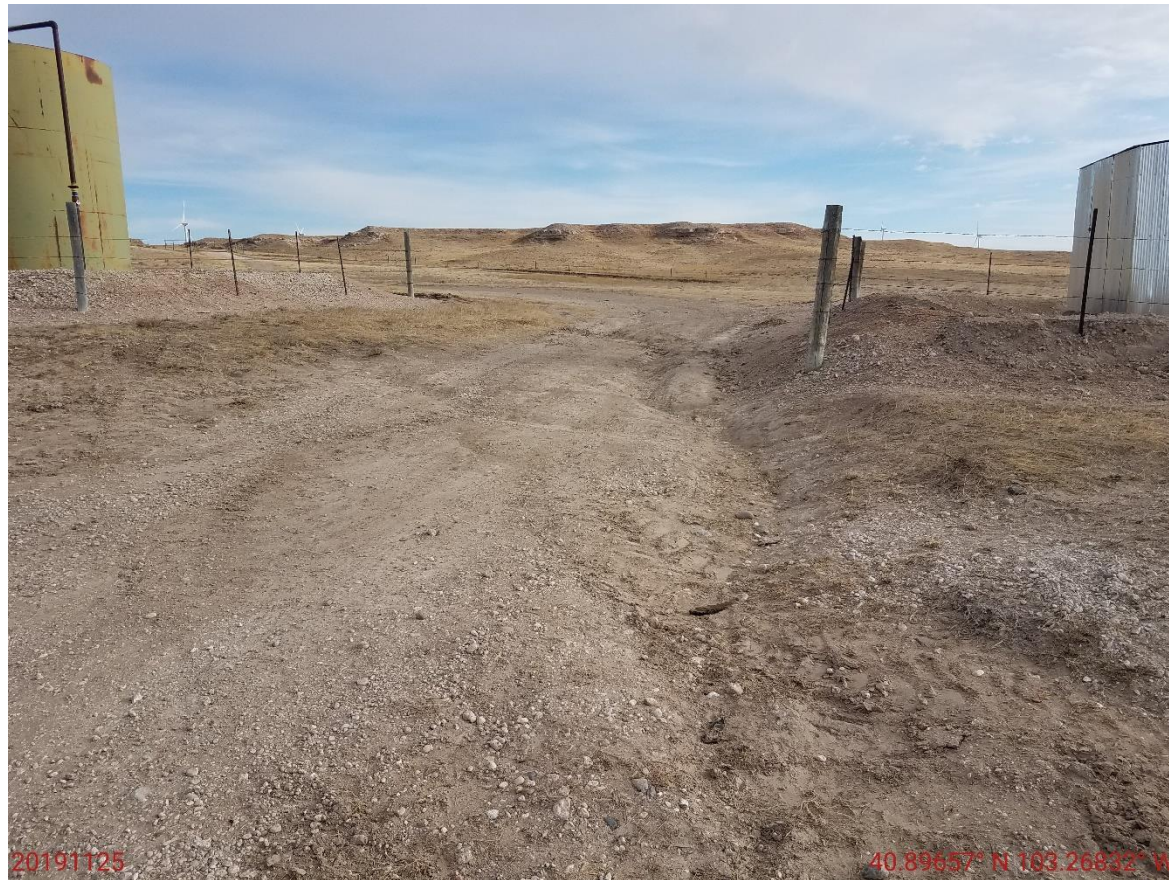
Photo 21: Photo taken from the southeastern area of the pad. Photo shows erosion degradation on access road.
