Inspection Photos

11/25/2019

Operator: WESTERN OPERATING COMPANY -
95620

Location ID: 312292
Logan County, CO

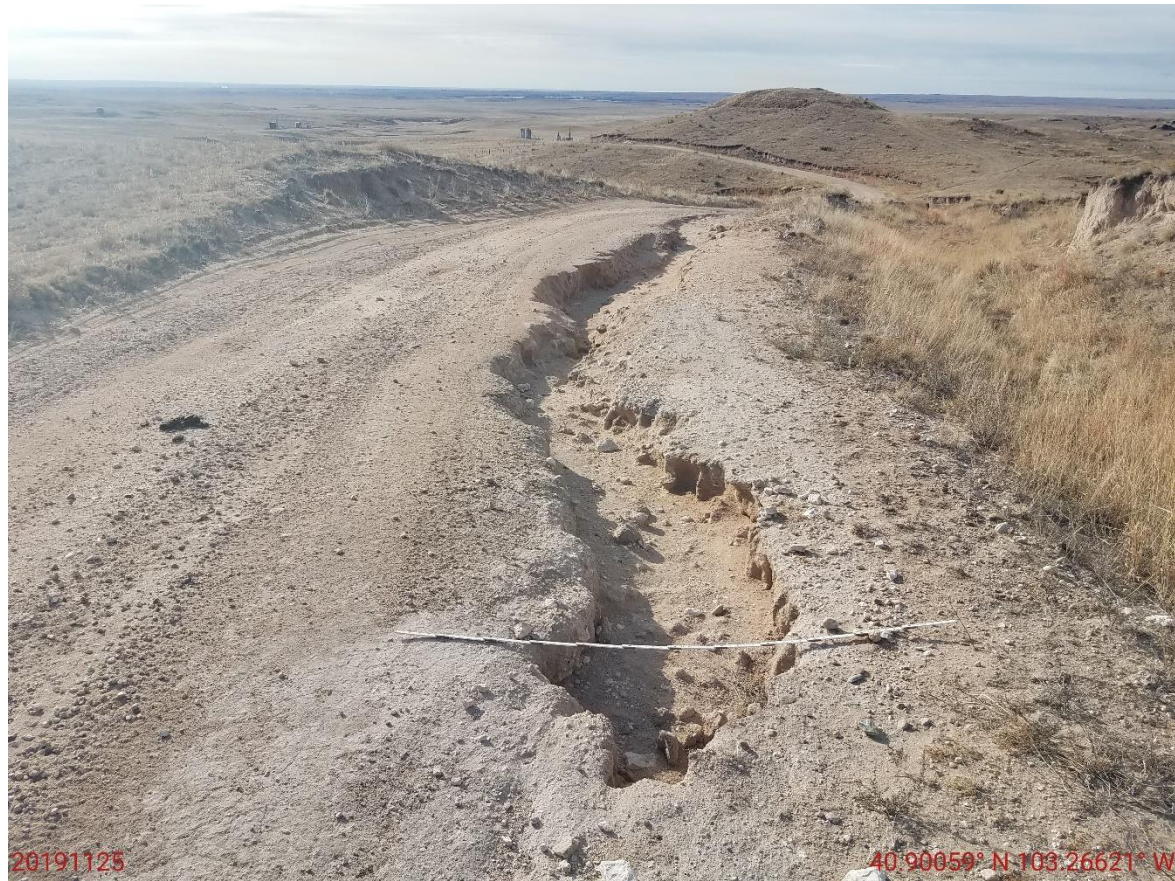
Photo 22: Photo taken from the access road north of the location, facing south. Photo shows erosion degradation on the access road. 6 foot measuring stick for reference.

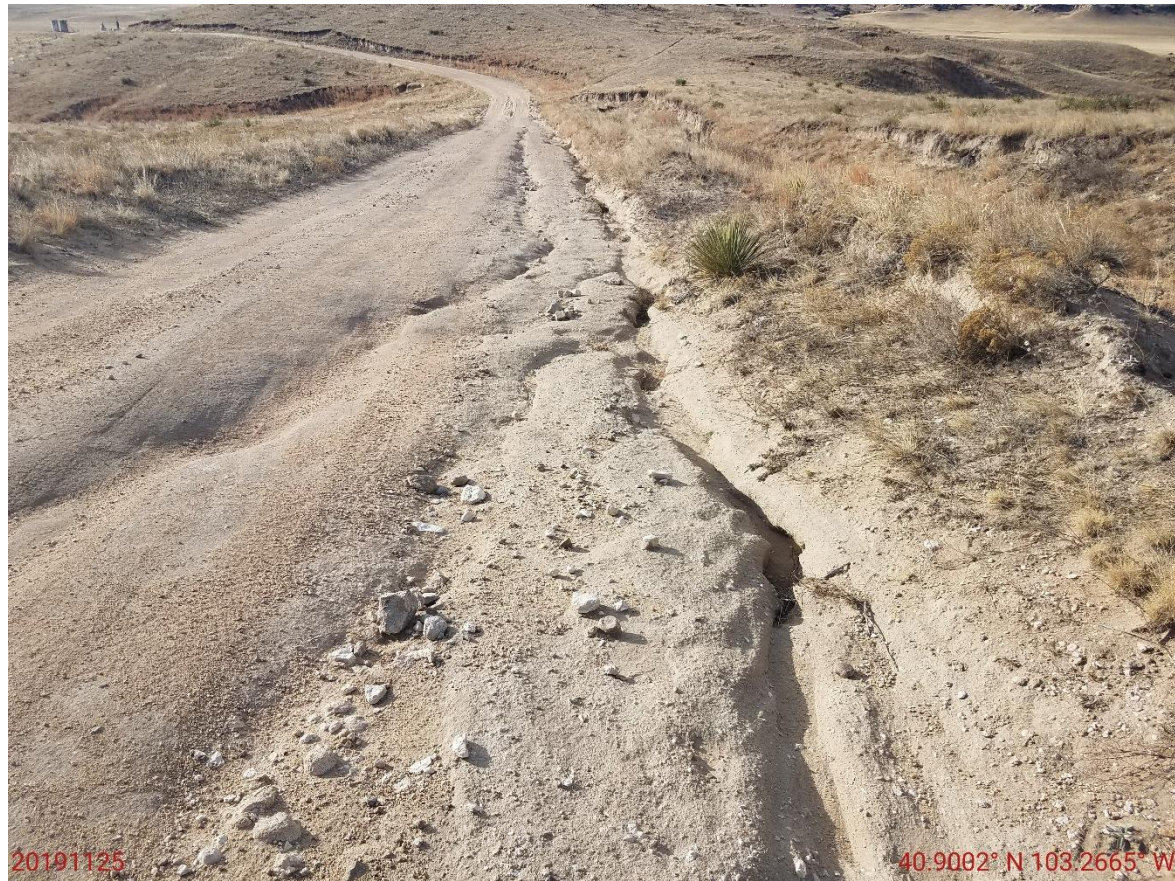
Photo 23: Photo taken from the access road north of the location, facing south. Photo shows erosion degradation on the access road. 6 foot measuring stick for reference.
