Stormwater Management and Erosion control

Location Name: CAERUS PICEANCE LLC HYRUP-68S96W /12SESE

Location #: 312719

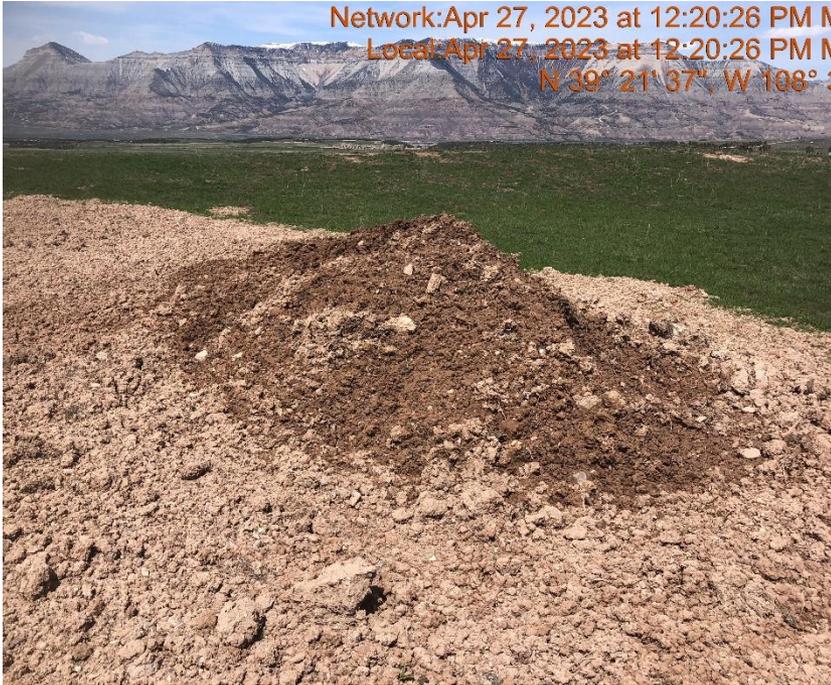
Photo #9743 Insufficient Stock piled soils BMPs.

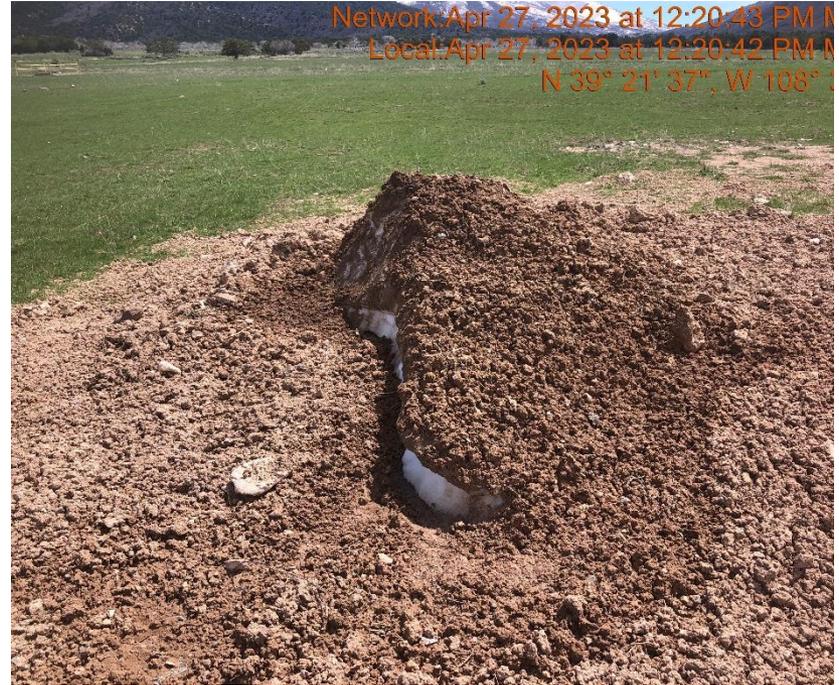
Photo #9744 Insufficient Stock piled soils BMPs.

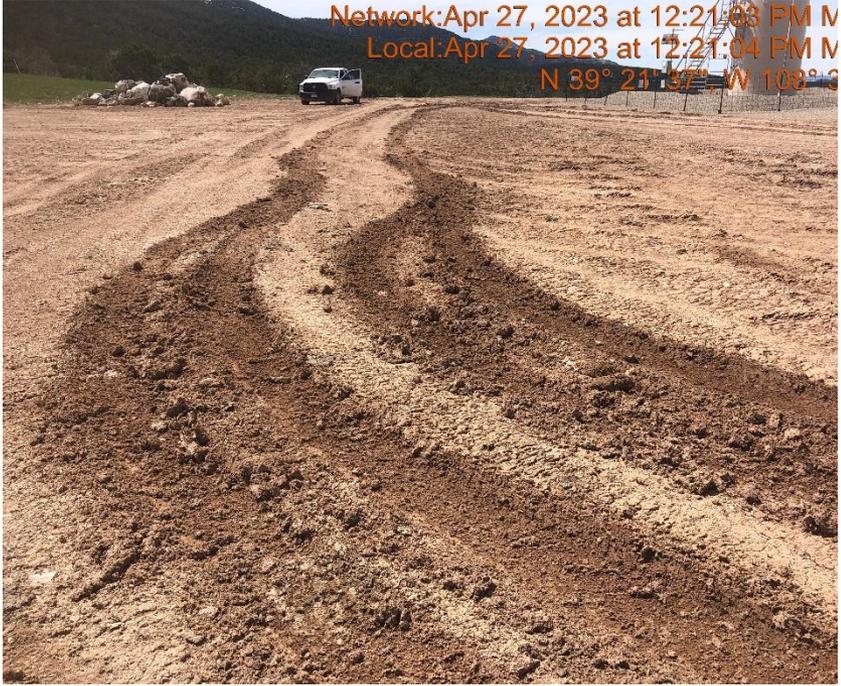
Photo #9745 Location lacks stabilization.

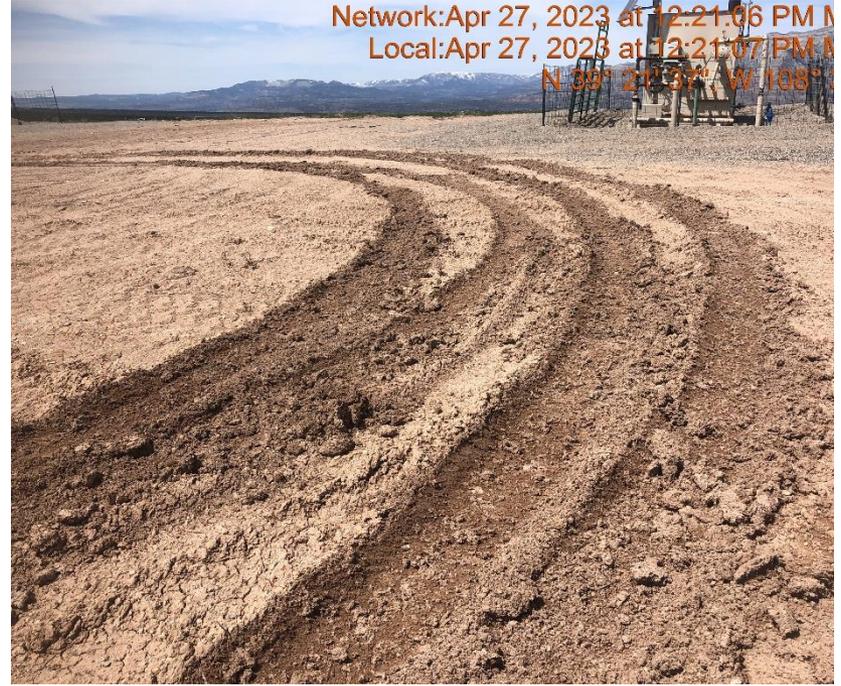
Photo #9746 Location lacks stabilization.

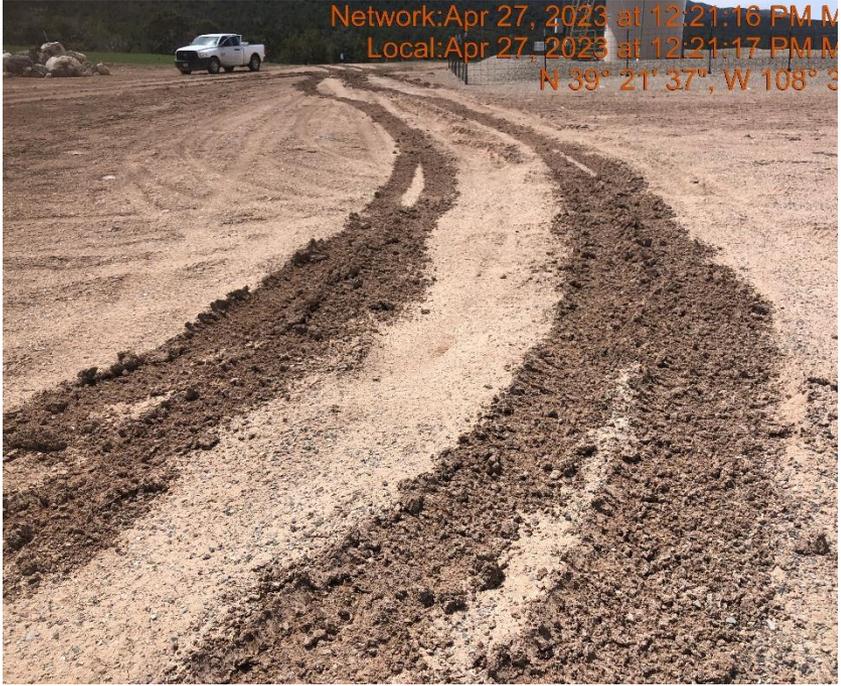
Photo #9747 Location lacks stabilization.

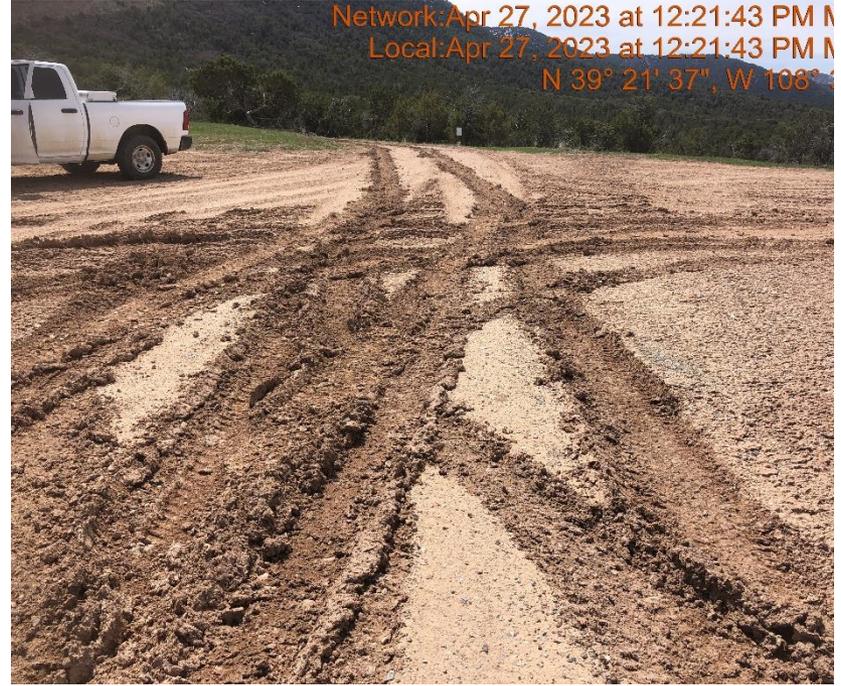
Photo #9749 Location lacks stabilization.

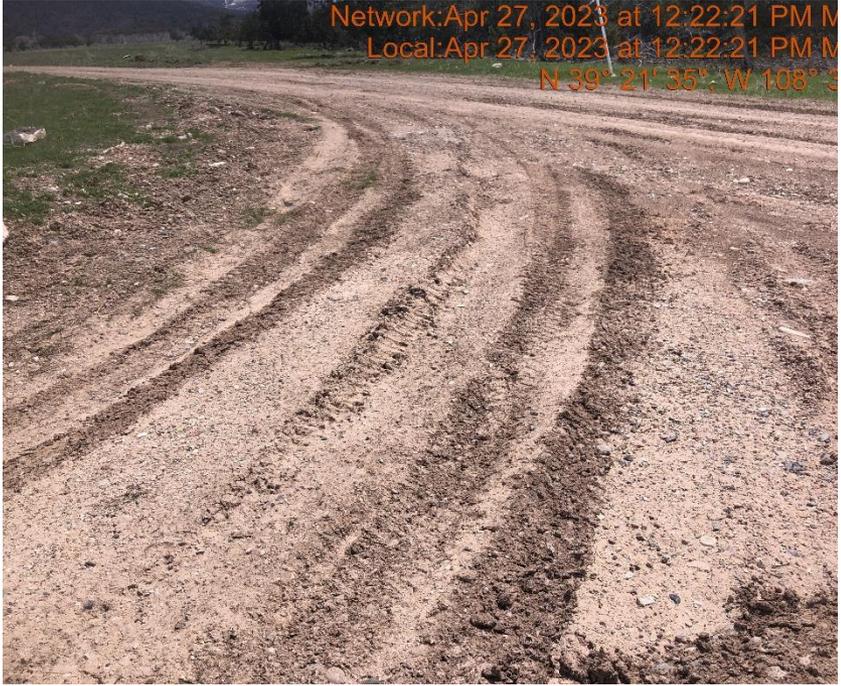
Photo #9752 Insufficient tracking BMP at entrance to minimize the transport of sediment.

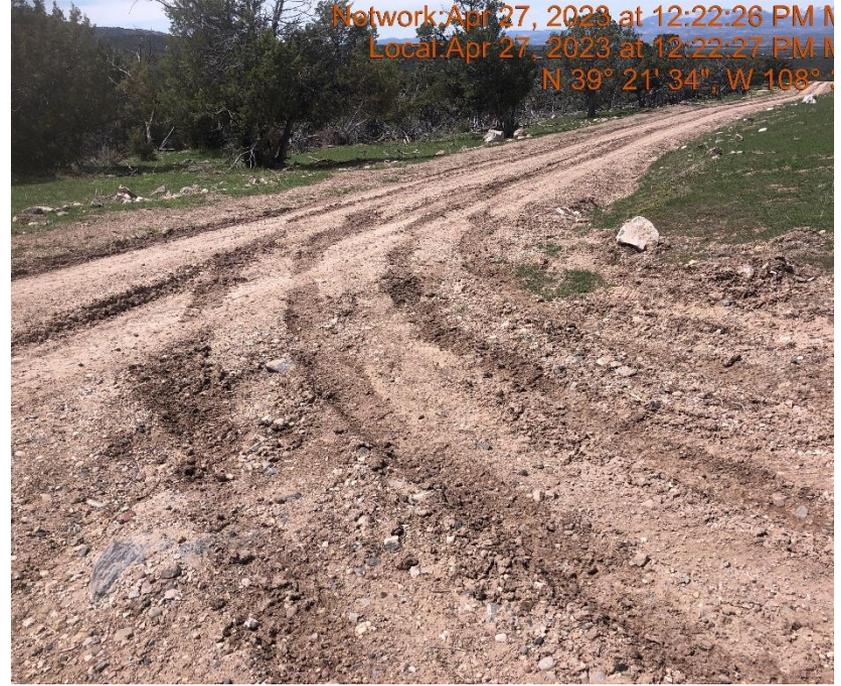
Photo #9753 Insufficient tracking BMP at entrance to minimize the transport of sediment.

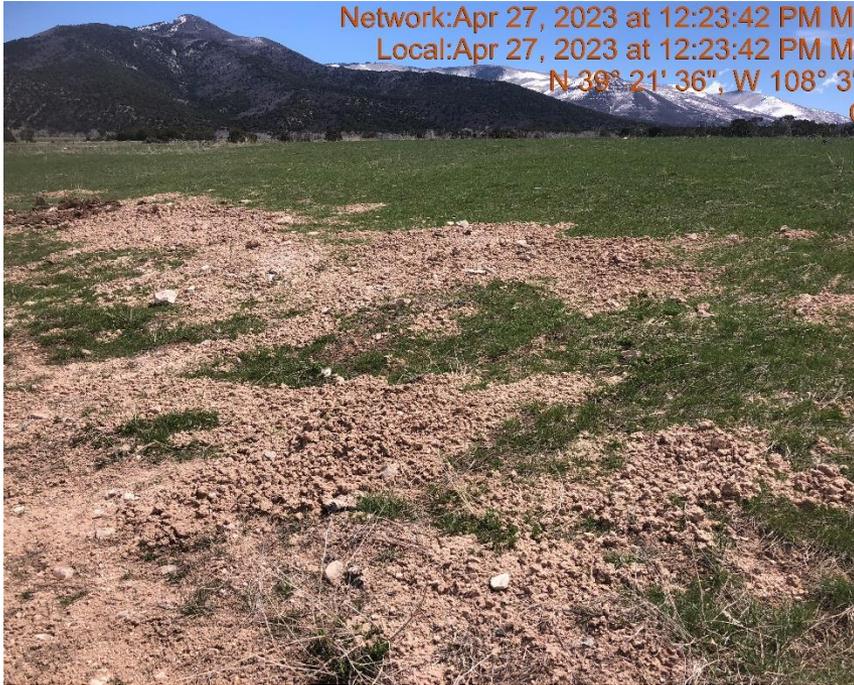
Photo #9754 Sediment has been transported off location.
