June 24, 2008

RE: Complaint 200130491
Water Well Analysis
Well Permit 191959
SWSW 10 34S, 65W Las Animas County, Colorado

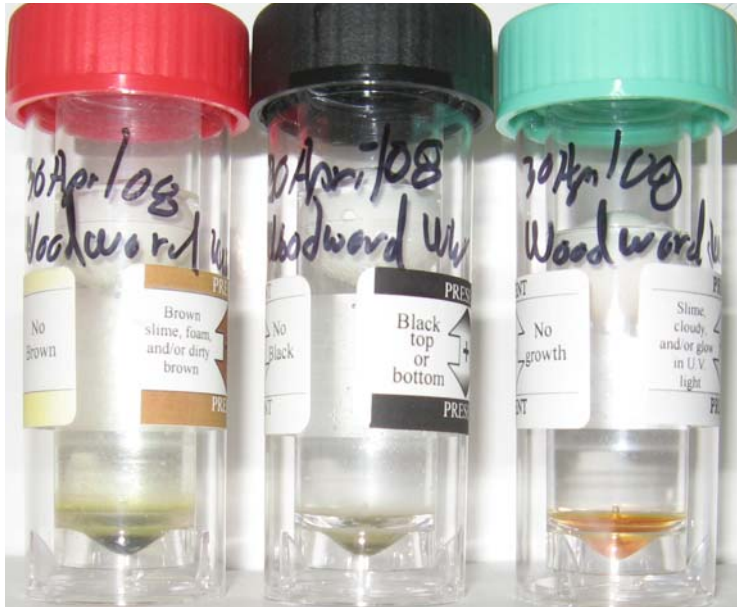
Photograph 1. BART Kits April 30, 2008

The COGCC collected samples to analyze for the presence of iron, slime and sulfur bacteria in your water well. Samples from your water well were tested for the presence of iron-related (IRB), sulfate reducing (SRB) and slime forming (SLYM) bacteria using Biological Activity Reaction Test (BART) kits. In addition to detecting the presence of bacteria the BART Kits allow for an estimation of the size of the population and/or the rate at which they can metabolize and/or grow through an observable change or reaction. This reaction rate is referred to as the “aggressivity” of the bacterial population. The aggressivity levels of the bacteria are described as **Not Detected, Background, Moderately Aggressive, Very Aggressive, or Extremely Aggressive Levels**. The results of the tests are provided below and documented in Photographs 1 and 2. The progress of the bacterial growth on day zero is seen in Photograph 1. Photograph 2 shows the progress of the bacterial tests two days after the cultures were started. Photograph 3 shows the progress of the bacterial tests five days after the cultures were started.

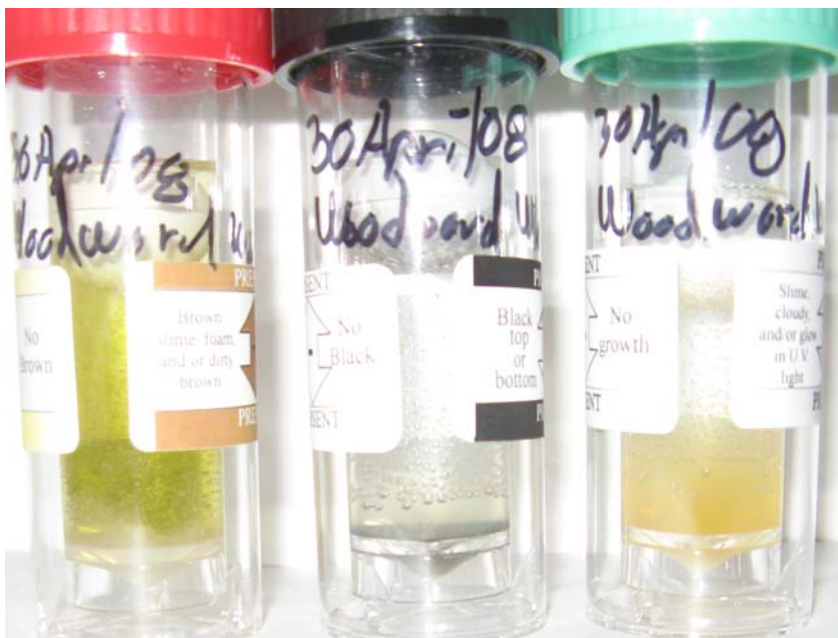
Photograph 2. BART Kits May 2, 2008

The test indicated that SRB were present at Very Aggressive levels in your well water. The culture turns black if SRB are present. A black precipitate formed in the black topped tube after 2 days as seen in Photograph 2.

SLYM bacteria were present at Very Aggressive levels in the water sample collected from this well. Photograph 2 shows development of cloudy culture media after two days in the green capped vial. The media would stay clear for the eight days of the test if bacteria were not present or only present at background levels.

Slime forming, sulfate reducing and iron related bacteria are present at **moderate to high levels** in your well. You may still want to consider treating the well and the distribution system with disinfecting solutions on a regular basis. Once bacterial colonies are established they are difficult to eliminate; therefore, you may need to establish a schedule for periodic disinfection of your well system to help control the bacteria present in it. The chlorination process is more easily accomplished if you have a frost-proof hydrant near the well head that you can use to remove the chlorinated water from the well. One technique that water well professionals use is to re-circulate the chlorine solution down the sides of the well shortly after adding the chlorine. This helps to kill bacteria on the sides of the well and on the pipes in the well.

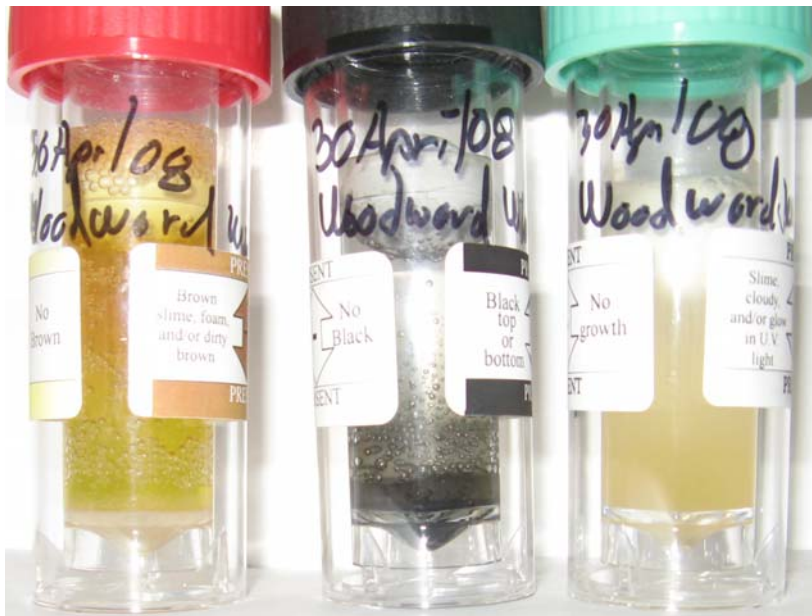
Photograph 3. BART Kits May 5, 2008

IRB bacteria were detected at Moderately Aggressive levels in the water sample collected at this well. The culture turns red with foam at the top to indicate the presence of IRB. The development of red color and foam can be seen in Photograph 3 after 5 days from initiation of the test.

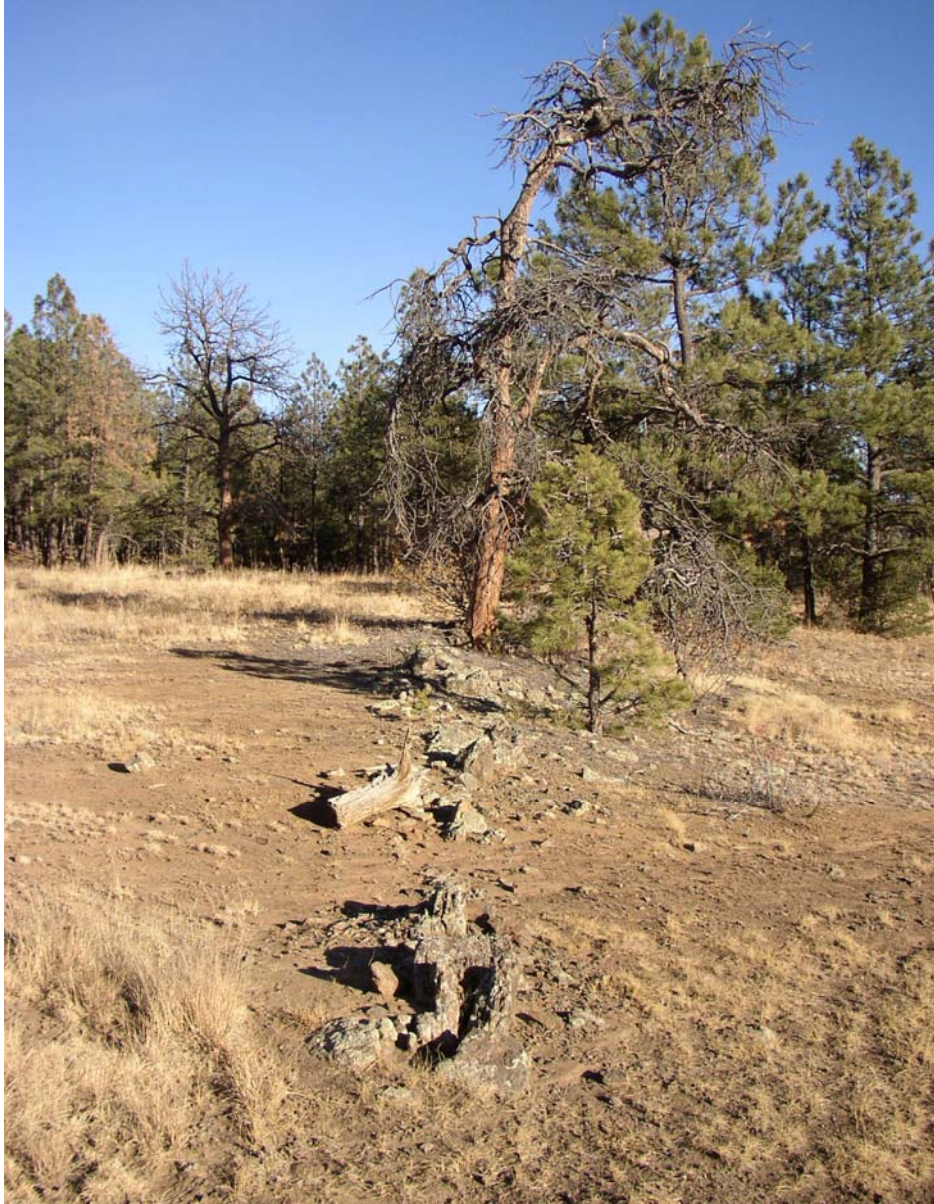
Photograph 4. Stressed vegetation near a methane seep in Las Animas County.

crew did not gain access to those roads last year. Photograph 4 below shows a seep in Las Animas County and illustrates stressed vegetation so that you might better recognize the possible impacts of methane seepage on vegetation. If you are aware of any unusual patches of stressed vegetation or areas that will not support vegetation on your property please contact me.
