Well ID: RMV 209-20

Monitor Date: 7/9/2008

Reclamation Status as of July 2008: Reclaimed

Vegetation Community: Salt Desert Scrubland Low Elevation

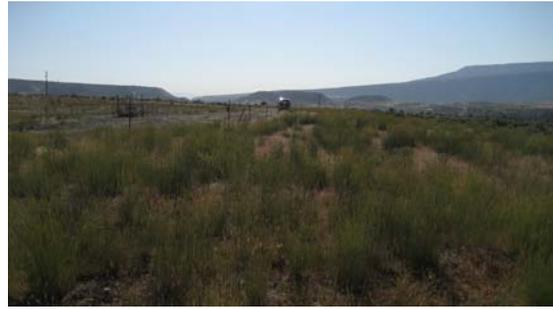
RMV 209-20 East

East of well head and north of road needs re-ripping and seeding. Area was re-disturbed and fence removed / damaged.

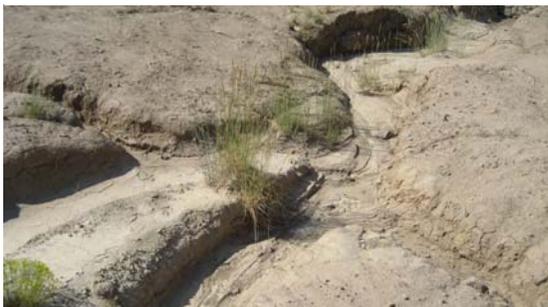
RMV 60-17 Erosion Picture 2

Gullying in E and SE portion of pad; appears check dams installed in SE portion of gully. Erosion photo 1: gully looking NE. Erosion photo 2: gully looking SE. Erosion photo 3: showing check dams in gully in SE corner looking SE. Erosion photo 4: gully in access road (looking E).

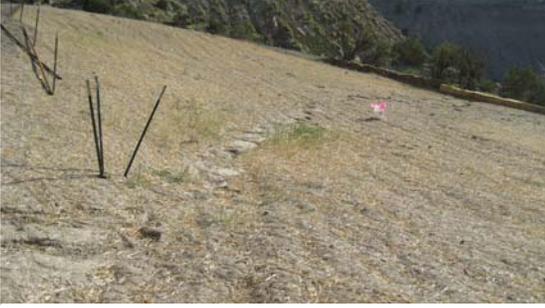
RMV 89-17 Erosion Picture 2

Erosion photo 1: southwest part of pad looking west. Erosion photo 2: southwest part of pad looking E.
