Well ID: RMV 90-20

Monitor Date: 7/15/2008

Reclamation Status as of July 2008: Reclaimed

BLM RECLAMATION TIMETABLE:

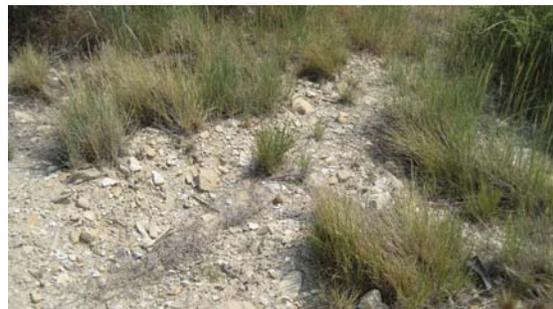
RWF 314-16 Erosion Picture 1
Photo Date: 7/10/2008

Erosion Issues: Minor

Some rilling on slope directly behind and southwest of smaller/lower condensate tanks.

Repair erosion to south west of condensate tanks.
