**Well Pad
Monitoring Reports & Photos**

Well ID: CLOUGH 21

Monitor Date: 7/9/2008

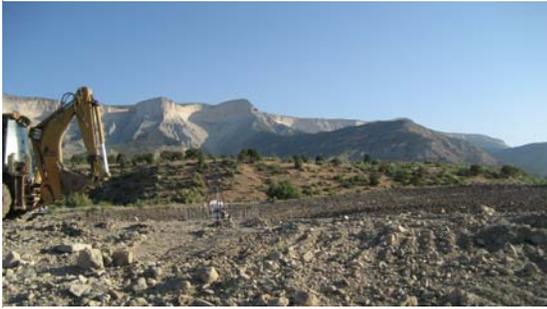
CLOUGH 21 North

Reclamation Status as of July 2008: Not reclaimed

Area not yet seeded, currently graded and tracked.

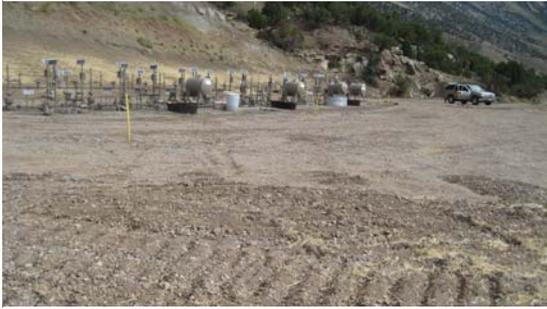
DOE 1-M-25 North

Seeded in late spring 2008- no growth yet.

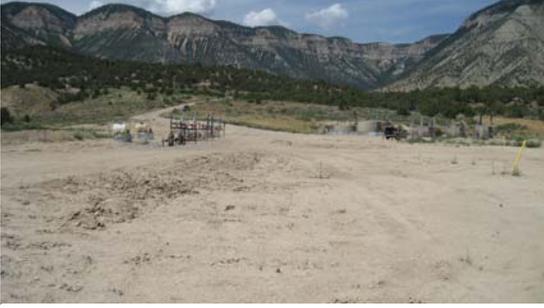
DOE 1-M-29 North

Noxious Weeds Present? Yes Jointed goat grass on portions of reclaimed area. Cheatgrass interspersed among desirables on reclamation area. Halogeton present.

Only 5% of site has been reclaimed. This small portion that has been reclaimed looks good. Rest of site needs reclamation.

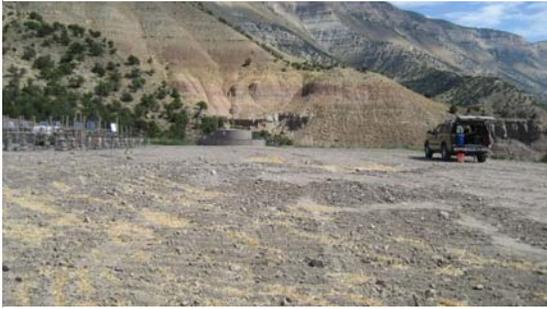
DOE 1-M-35 North

Seeded late spring 2008.

Noxious Weeds Present? No Russian thistle, kochia present.

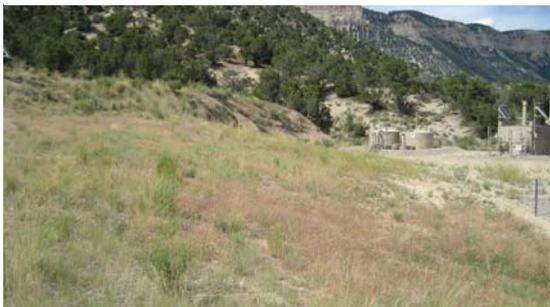
DOE 1-W-20 North

Comments Cheatgrass dominates cover.

Noxious Weeds Present? Yes Cheatgrass interspersed somewhat heavily among desirables.

Some weed control for cheatgrass or overseed in weedy areas.

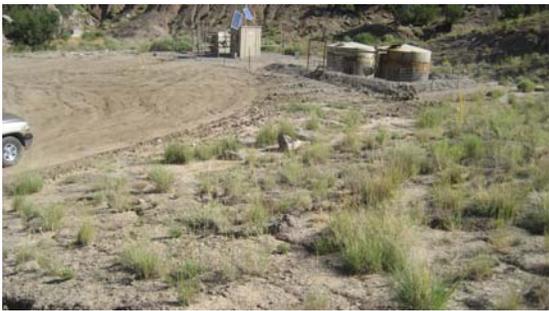
DOE 1-W-28 North
Photo Date: 7/22/2008

Comments Low cover, sparseness consistent with surroundings.

Noxious Weeds Present? Yes Cheatgrass, halogeton, and bindweed but very minimal. Cheatgrass on north and northwest portion more heavy but patch is relatively small.

Cover in surrounding undisturbed area looks equally sparse, not sure if anything needs to be done other than monitoring. Weeds are not too much of a problem.

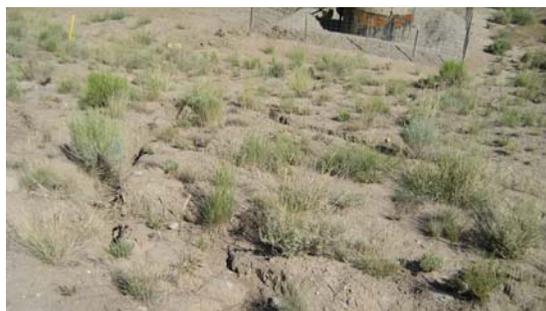
DOE 1-W-28 Erosion Picture 1
Photo Date: 7/22/2008

Erosion Issues: Rills >3" Erosion features consistent with surrounding undisturbed are but are noted.
Erosion photo 1: rilling consistent w/ surrounding undisturbed.
Erosion photo 2: same.
Erosion photo 3: same.

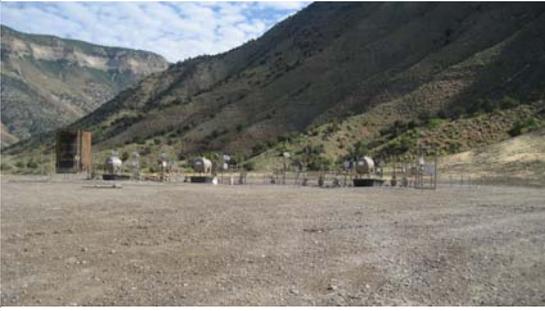
DOE 2-M-36 North

Seeded and mulched. Not crimped, just tracked

Size: No seedlings

No plants to be seen- continue to monitor. Seeded late spring 2008.
