Prather Spring Site Investigation Phase 1 - Progress Report

COGCC and Joint Companies

November 24, 2008

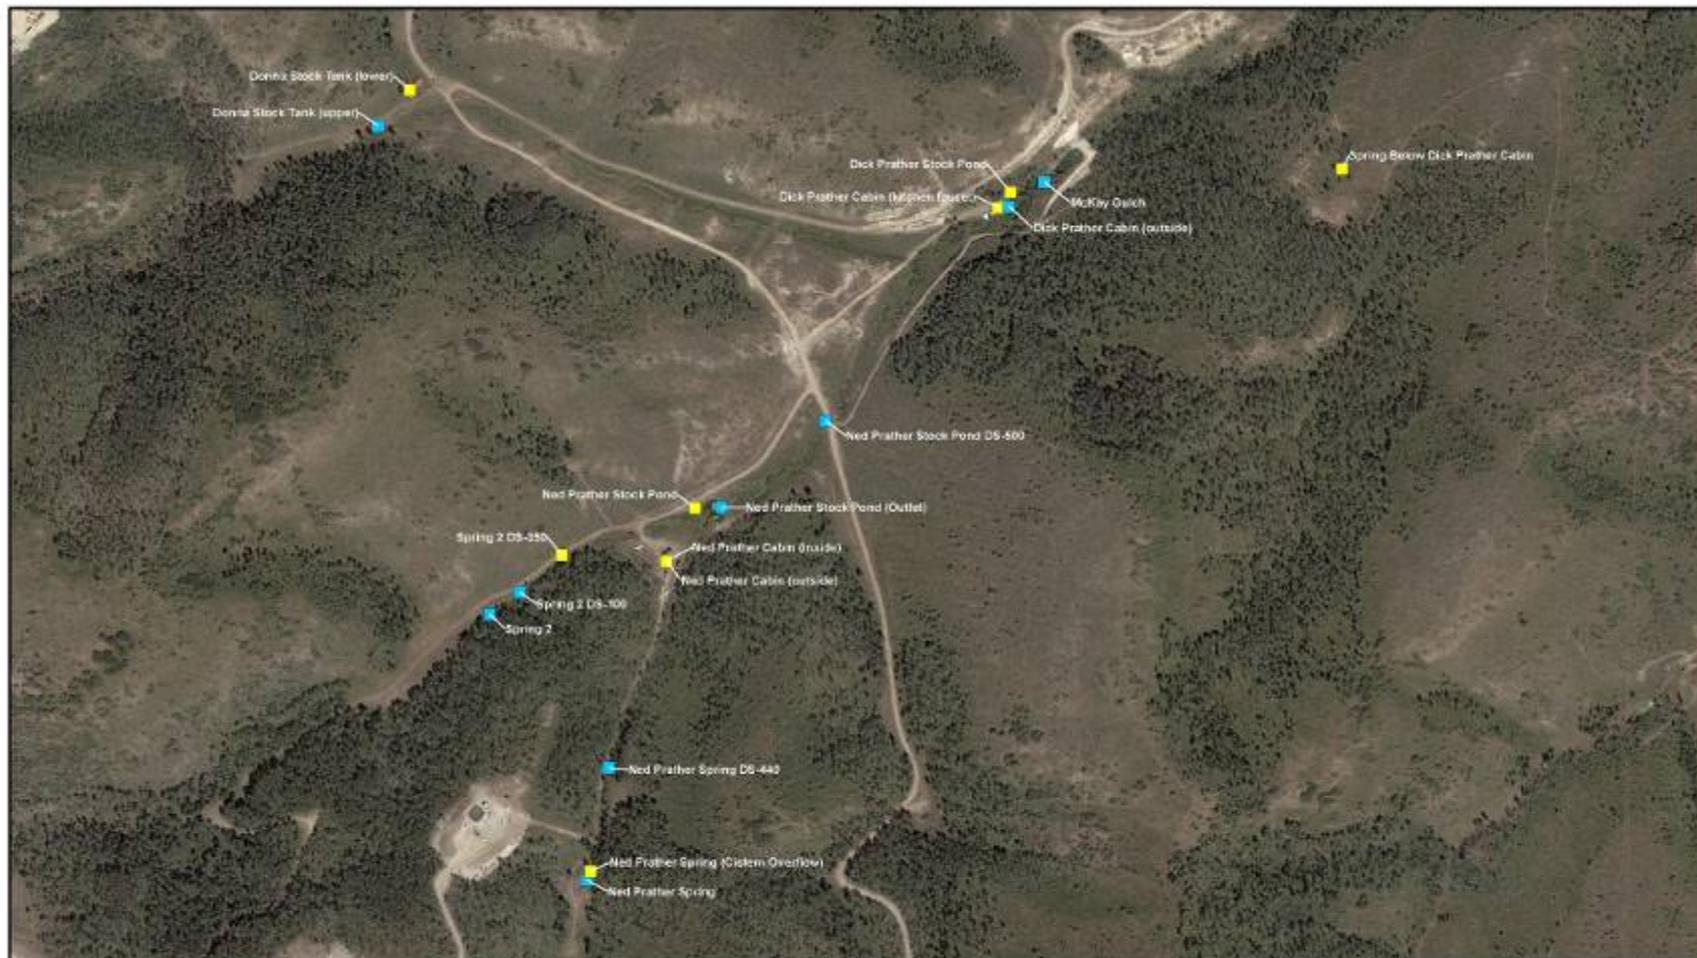
FIGURE 2 Surface Water Monitoring Station Map

Surface Water Sampling Locations

- Routine Surface Water Sampling Location
- Other Surface Water Sampling Location

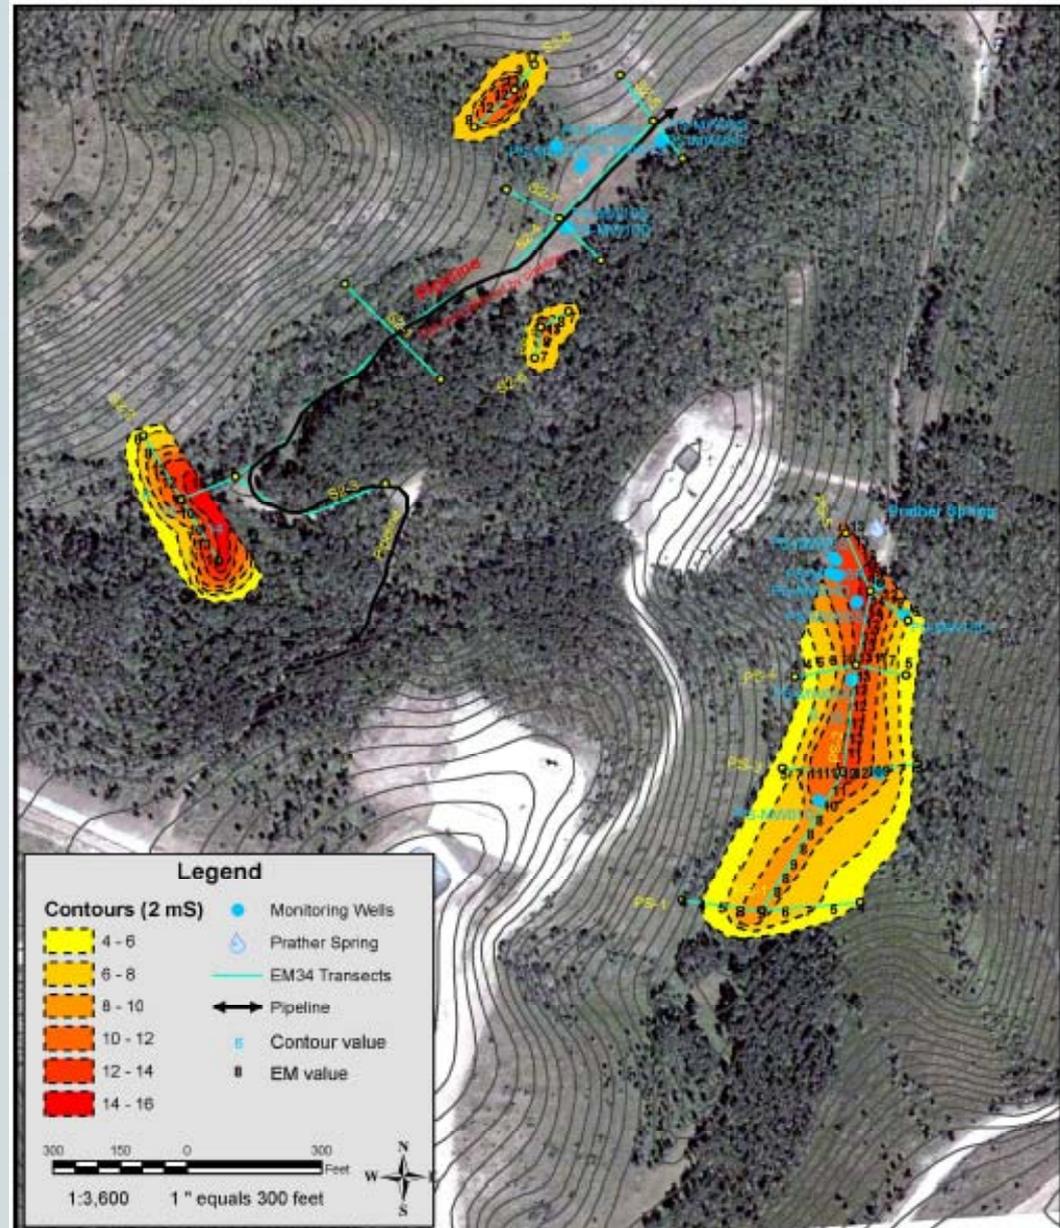
EM-34 Map

- EM-34 Survey
 - Natural gas pipeline
- Soil Gas Survey
 - All results non-detect
- Monitoring Well Installations
 - 21 wells installed in shallow flow zone
 - Auger methods (no core)

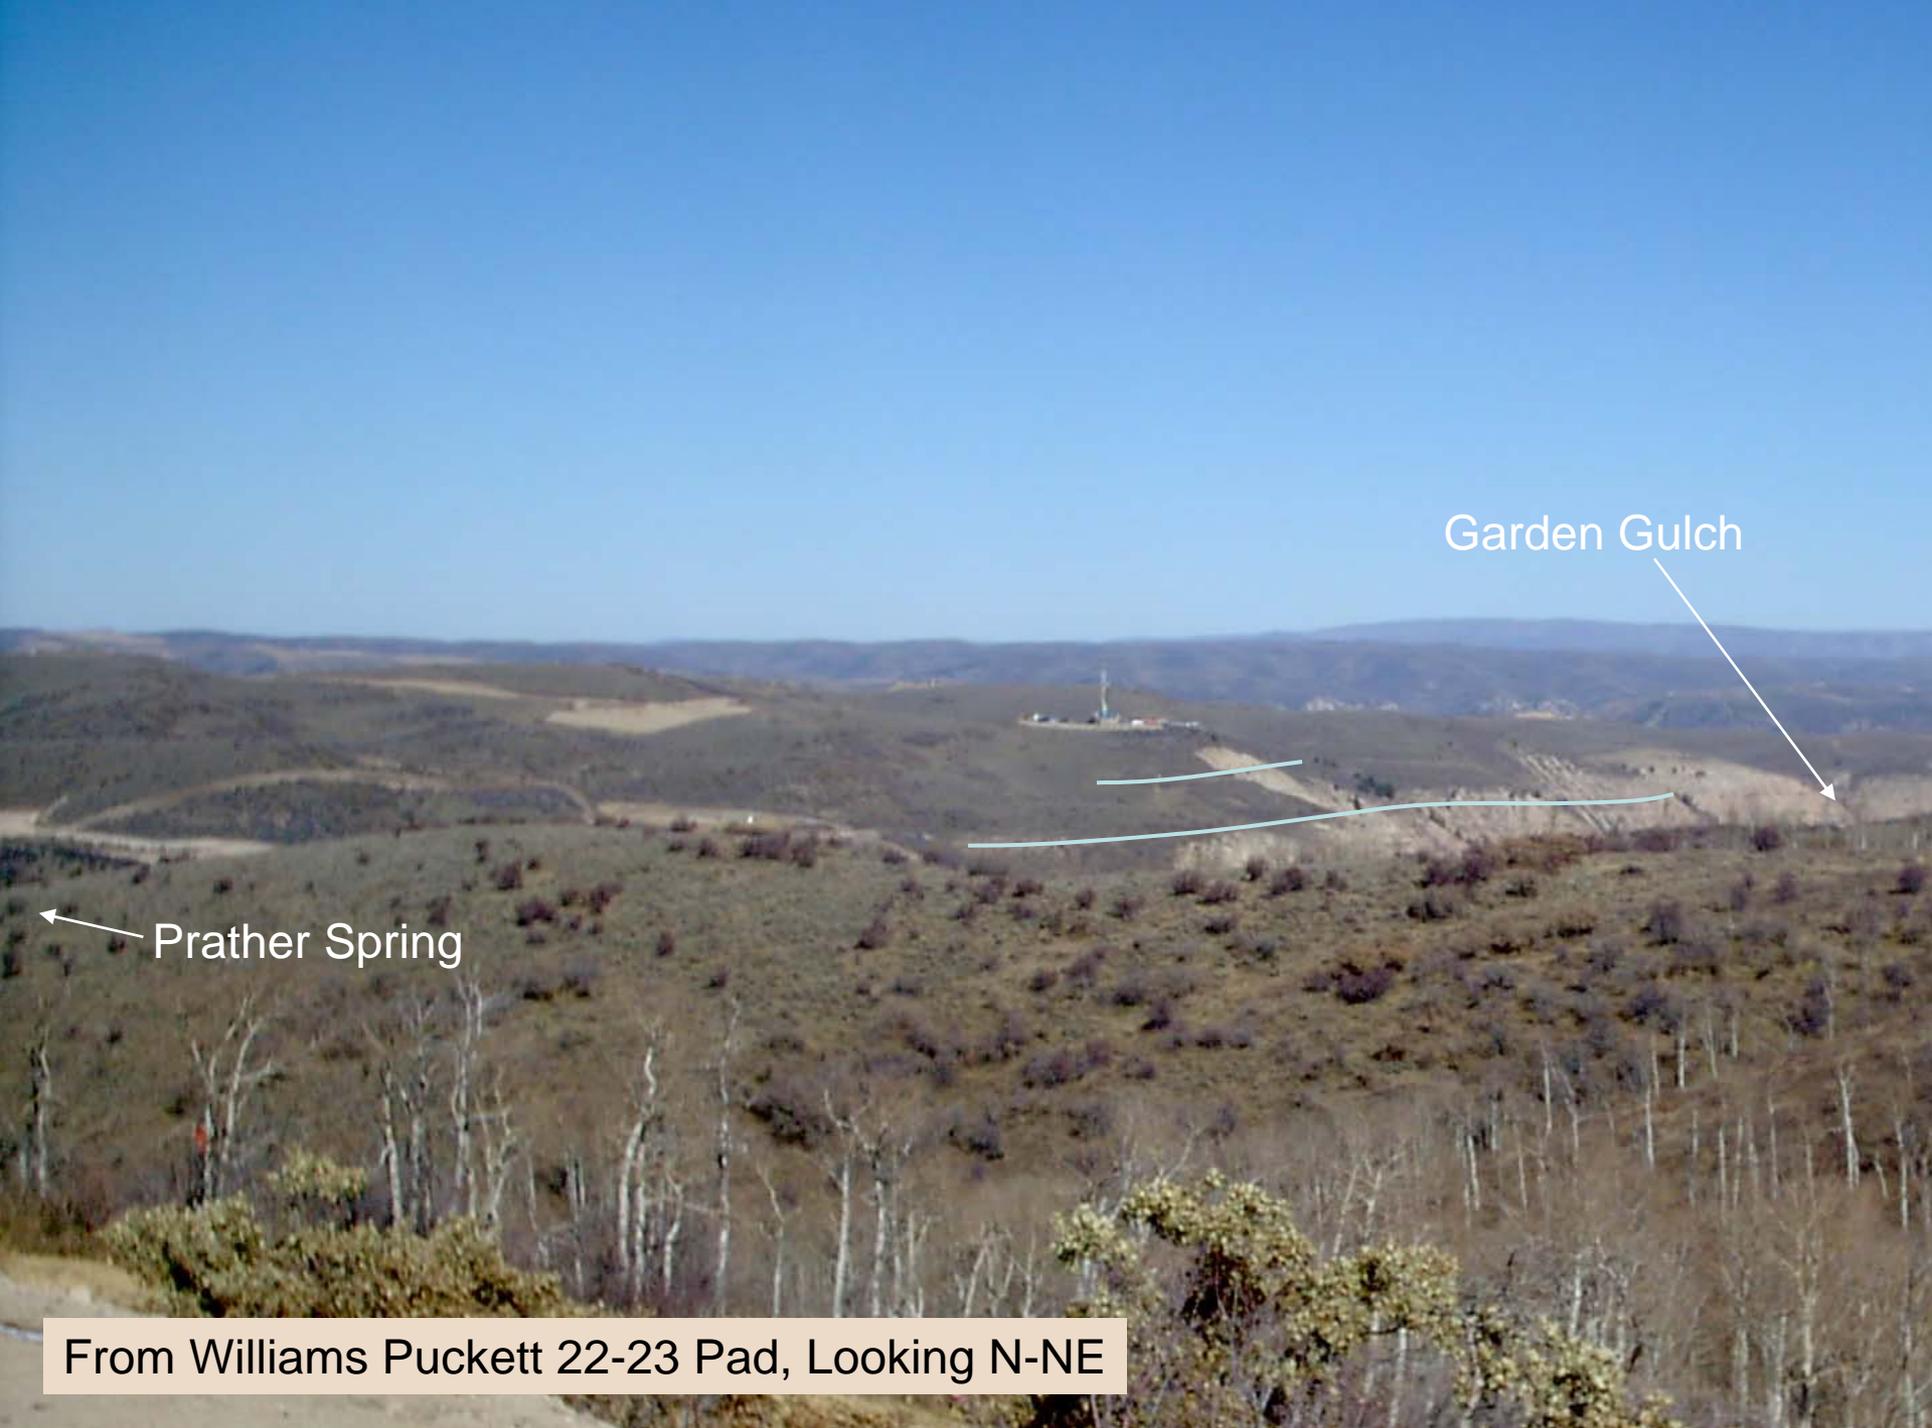
Garden Gulch

Prather Spring

From Williams Puckett 22-23 Pad, Looking N-NE

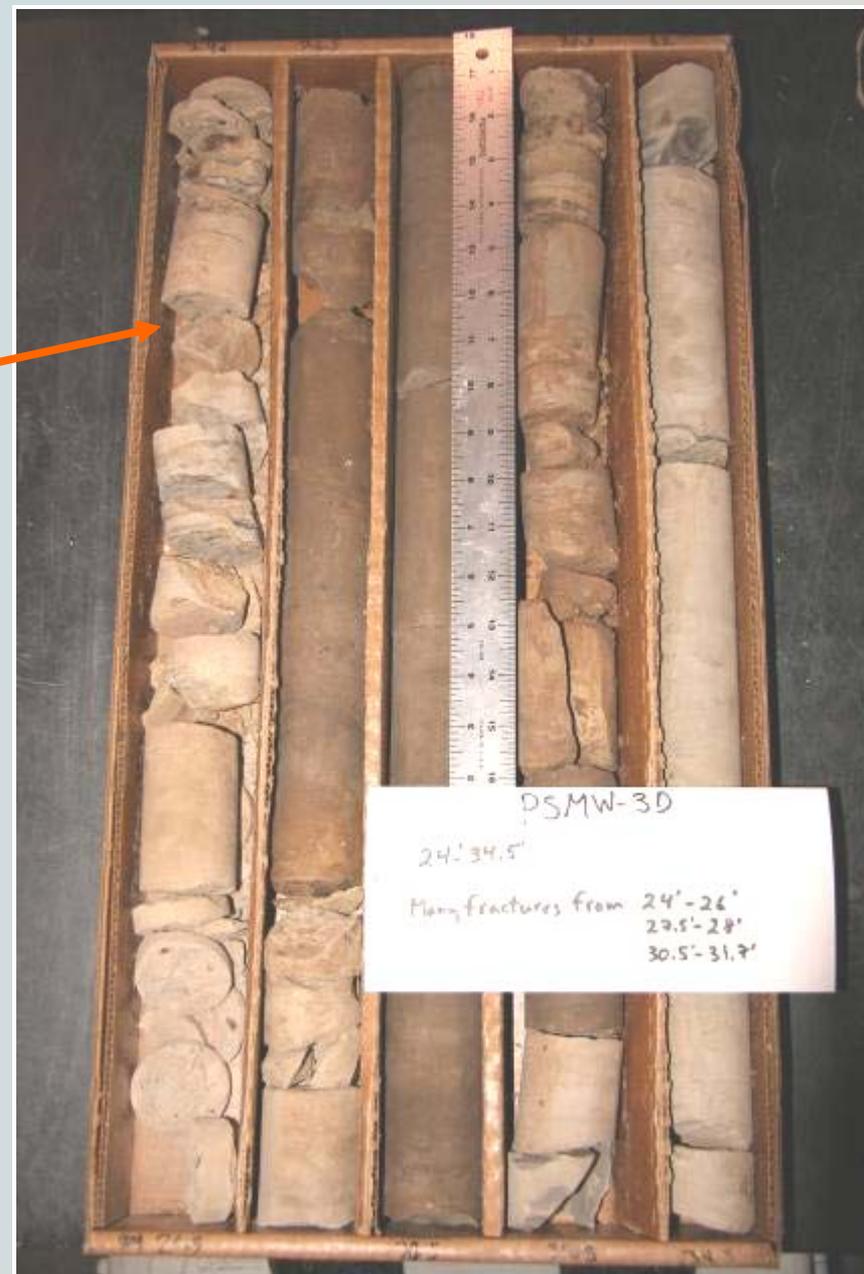
PSMW3D

- 24' to 34.5'
- Highly fractured core interval

- Geologic Conditions
 - Fractures prevalent in upper 10 feet of bedrock
 - Bedrock becomes more competent with depth
 - Review of core

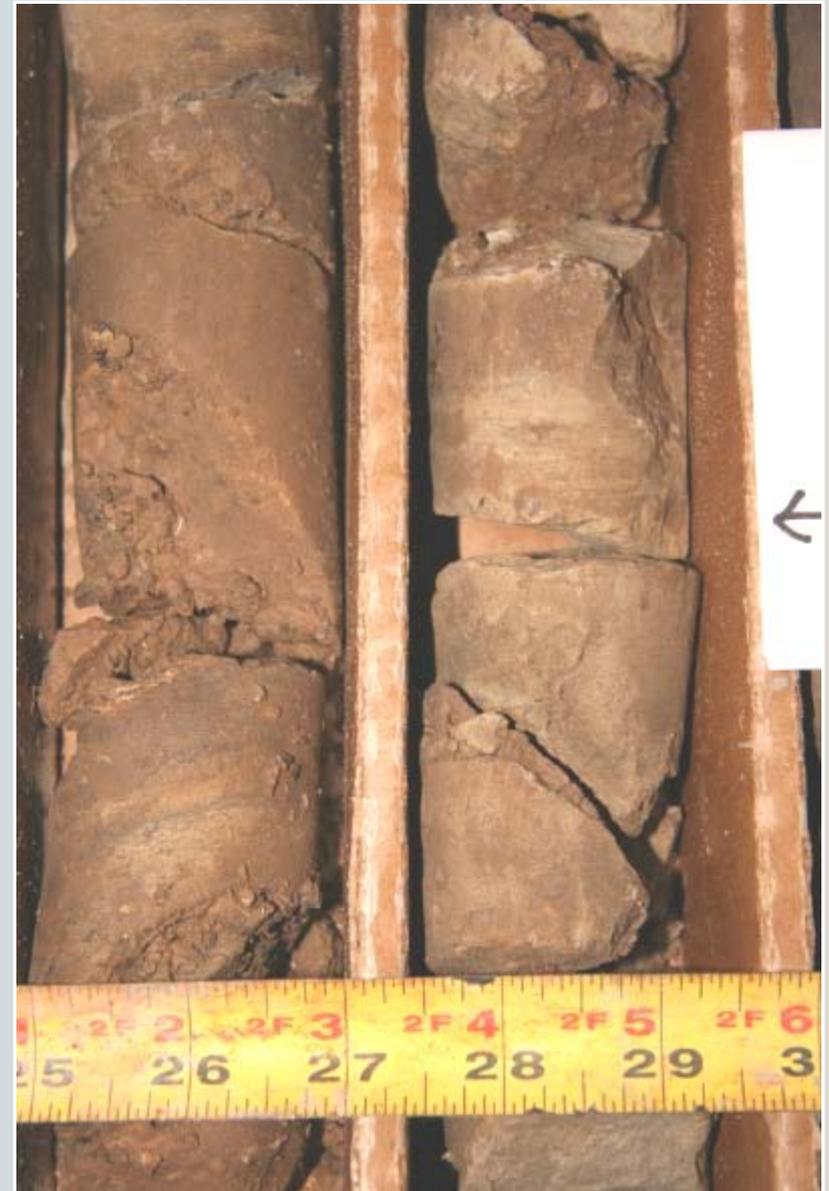
PSMW4D

- 19.5' to 29.5'
- Fracture dip approx 30-40 degrees
- Close-up of mud and clast-filled fracture apertures

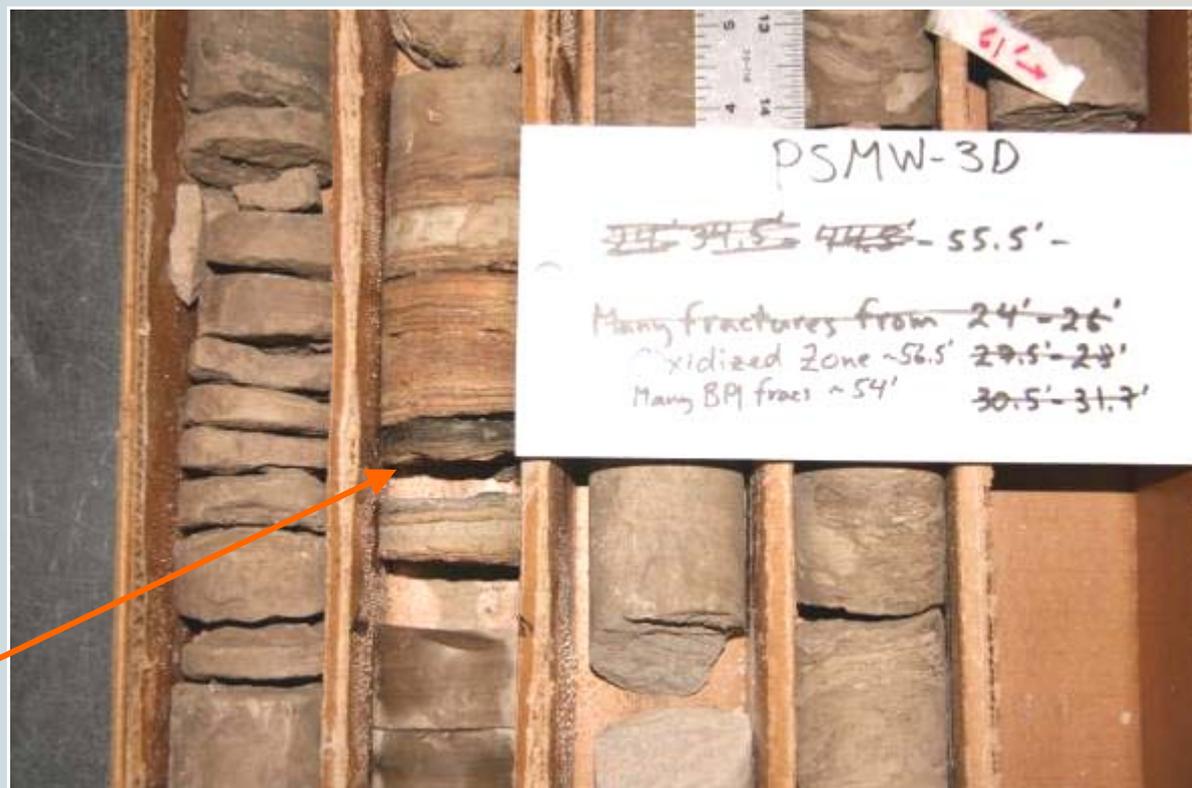
PSMW3D

- 55.5' to 60'
- Bedding plane fractures
- Carbonaceous seam

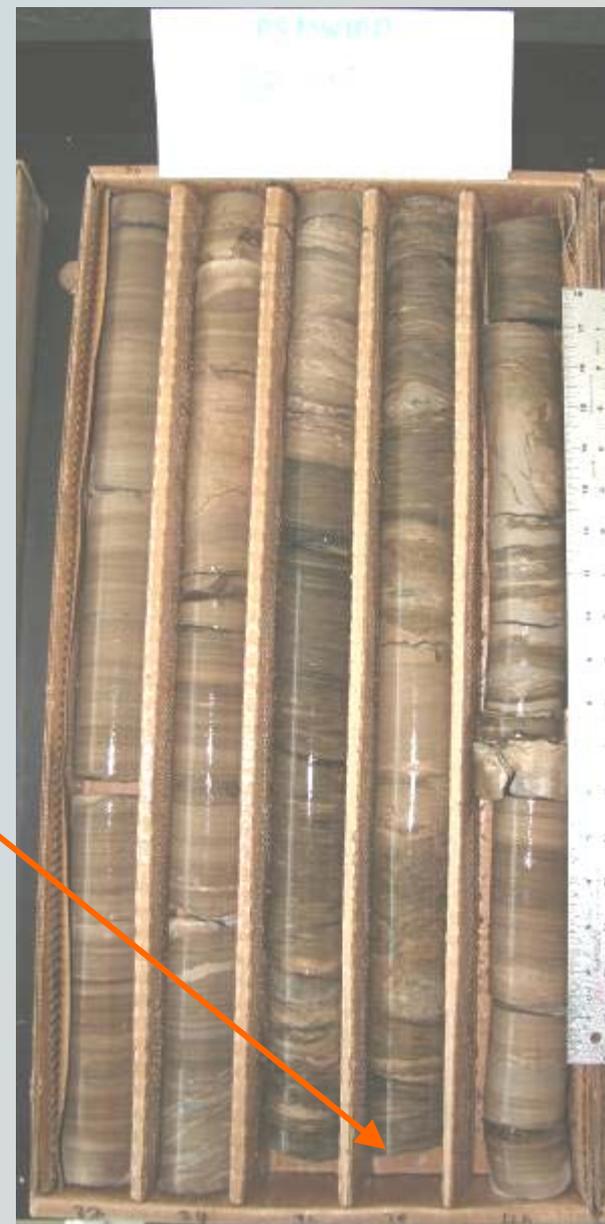
PSMW10D

- 20' to 30'
- Highly fractured from 20' to 23'
- Carbon seam at 28'
